June 6, 2014

RE: **Chiquita Canyon Landfill Master Plan Revision**

Pursuant to the request of Chiquita Canyon Landfill, an oak tree field study evaluation has been conducted by this office to ascertain base line data in regard to native oak tree resources located at 29201 Henry Mayo Drive, City of Castaic. This project study is mandated by the Los Angeles County Oak Tree Ordinance.

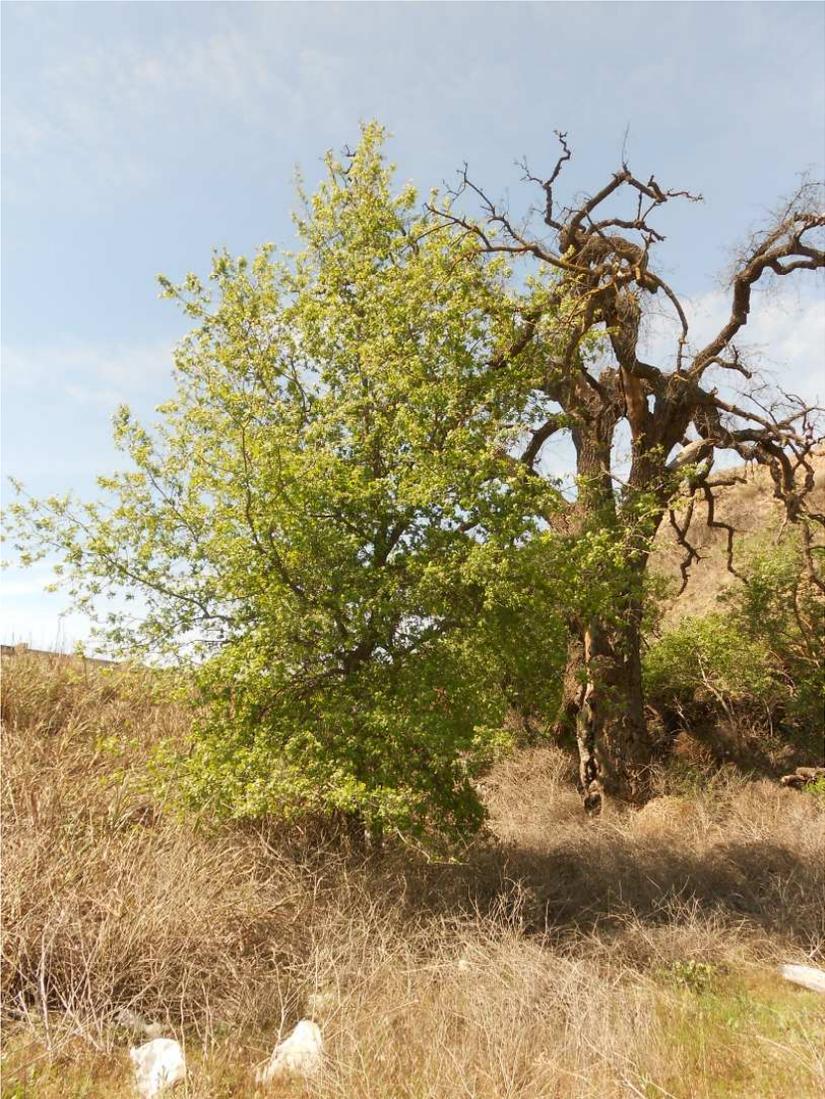
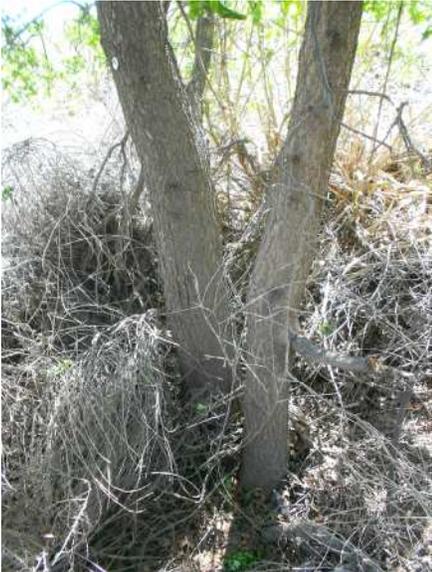
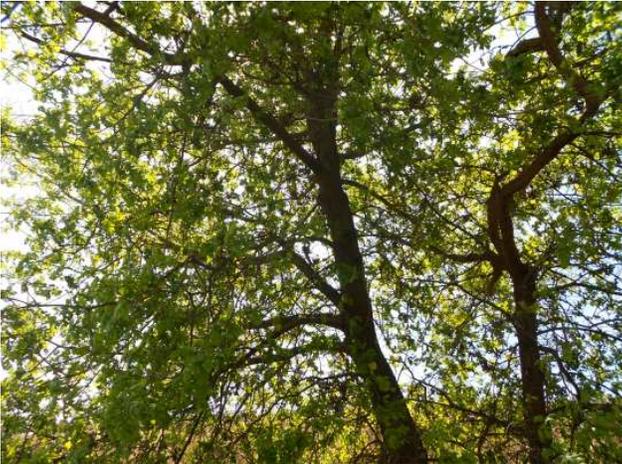
Tree #1

Tag #	Species	Impact Status	DBH in inches	Grade	Vigor	Structure	Height
1	Valley Oak <i>Quercus lobata</i>	Remove	( 10,5 )	B	Good	Fair to Good	20'-30'
2	Coast Live Oak <i>Quercus agrifolia</i>	Remove	( 10,5 )	B-	Good	Fair	15'-20'
3	Coast Live Oak <i>Quercus agrifolia</i>	Remove	( 11.5,6.5 )	B-	Good	Fair	15'-20'
89	Coast Live Oak <i>Quercus agrifolia</i>	Remove	( 18.5,17,14 )	D+	Poor	Poor	25'-30'

Tag #	Tree comments
1	Tree is a native specimen to the site. Tree is a multi-trunk. Trunk base slightly buried by natural fill from adjacent slope. Growing adjacent to large dead oak tree to west.
2	<u>This tree is non native to the site</u> and was planted as part of the installed landscape. Low branching. Some included bark. Tree is multi trunked. Low branching with canopy in contact with ground. Excessive branch production at point of codominance on larger trunk- may be result of precious damage to trunk.
3	<u>This tree is non native to the site</u> and was planted as part of the installed landscape. Low branching with canopy in contact with ground. Trunk base slightly buried by fill. Multi-trunked. Tree is growing within a partially landscaped area directly adjacent to a paved parking/storage facility.
89	Tree is a native specimen to the site. Multi-trunked. Tree is growing in natural area. Trunk base is heavily buried by adjacent natural slope failure. One dead trunk on ground. Exfoliating bark. Middle trunk lying on west trunk. Multiple broken large limbs. Heavy trunk damage and decay. Poor condition of tree is most likely a result of heavy fire damage and excess soil fill on trunk.
