### **CONSOLIDATED SEWER MAINTENANCE DISTRICT CONDITION ASSESSMENT PROGRAM REPORTS PROJECT NOS. Y0TV0708C AND Y0TV0809B**

**CONDITION ASSESSMENT REPORT  
COUNTY OF LOS ANGELES DEPARTMENT OF PUBLIC WORKS  
CONSOLIDATED SEWER MAINTENANCE DISTRICT**

PROJECT NAME:	Y0TV0809B	PROJECT MGR:	Kari Eskridge
PROJECT DATE:	01/23/2009	CONTACT NO:	(626) 300-3390
SUP. DISTRICT(s):	4	MAP PAGE(S):	2029
Report By:	Eric Liu	Report Date:	07/19/2011

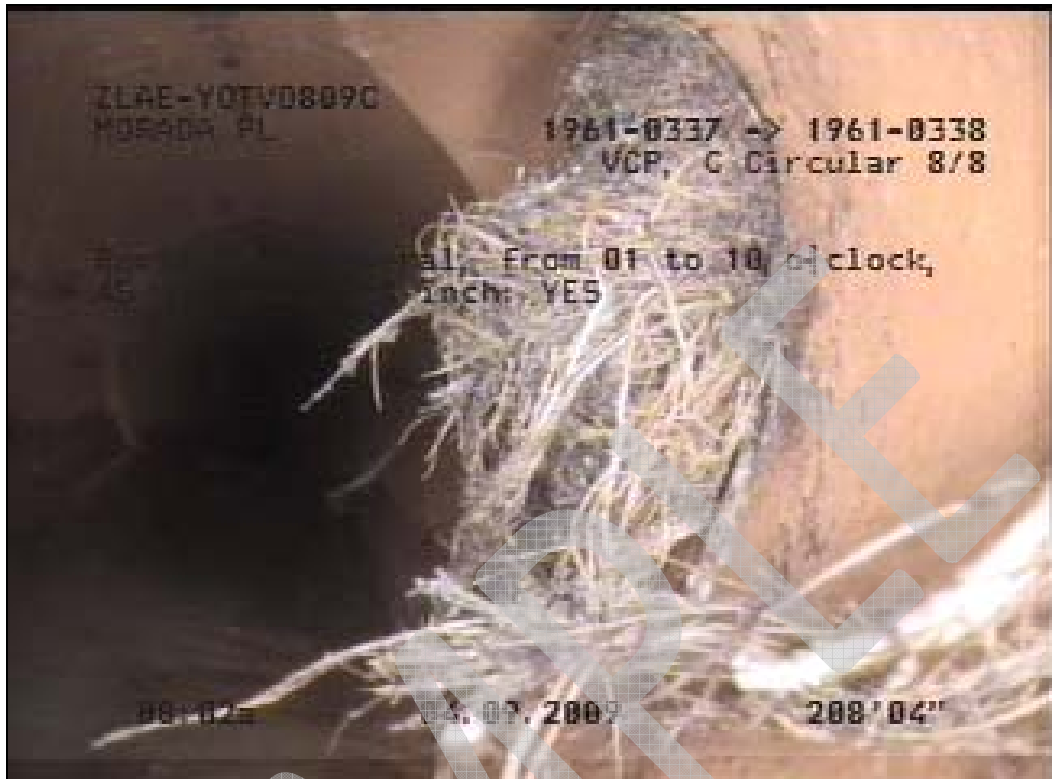
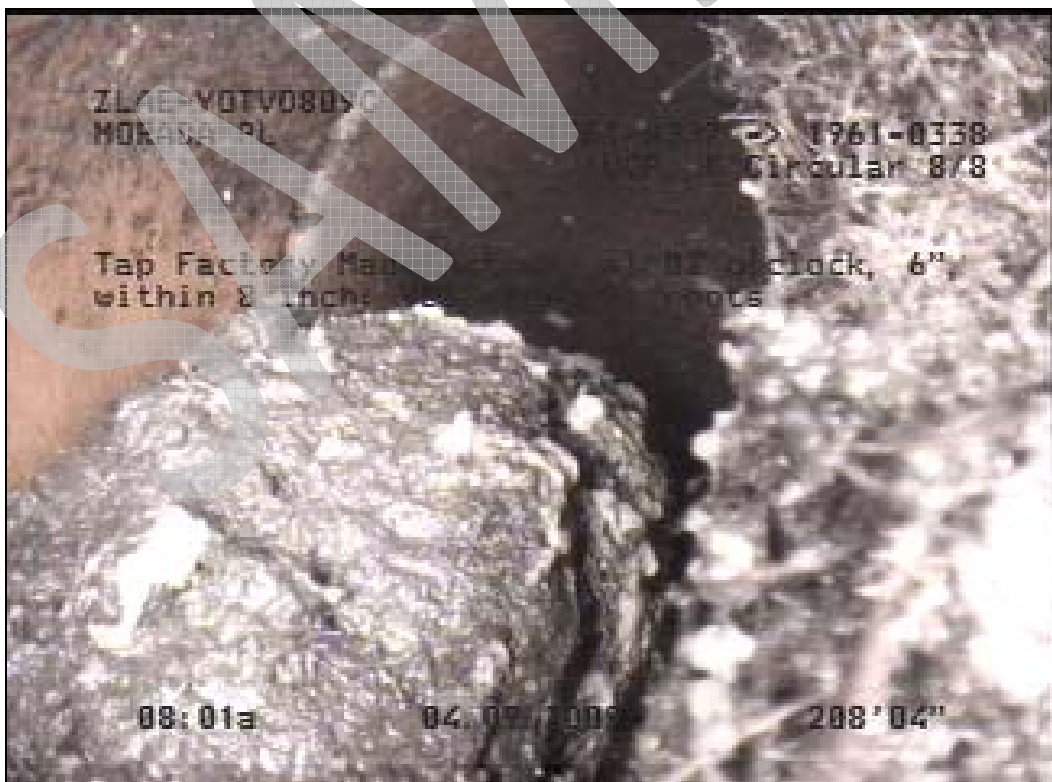
For your reference, we have enclosed photos of your lateral connection showing the presence of the root blockage. Also enclosed are some literature on ways of minimizing sewer overflows and damage to your home.

XXXX  
Roots at Lateral Connection

your sewer lateral within 90 days to remove roots and any other obstructions that may cause a sewage backup.
