CONSOLIDATED SEWER MAINTENANCE DISTRICT CONDITION ASSESSMENT PROGRAM REPORT PROJECT Y0TV0809D

**CONDITION ASSESSMENT REPORT
COUNTY OF LOS ANGELES DEPARTMENT OF PUBLIC WORKS
CONSOLIDATED SEWER MAINTENANCE DISTRICT**

PROJECT NAME: Y0TV0809D	PROJECT MGR: Phyo Kyaw
PROJECT DATE: 01/26/2009	CONTACT NO: (626) 300-3369
SUP. DISTRICT(S): 5	MAP PAGE(S): 1886,1887,1888,1940,1941
Report By: Phyo Kyaw	Report Date: 06/01/09

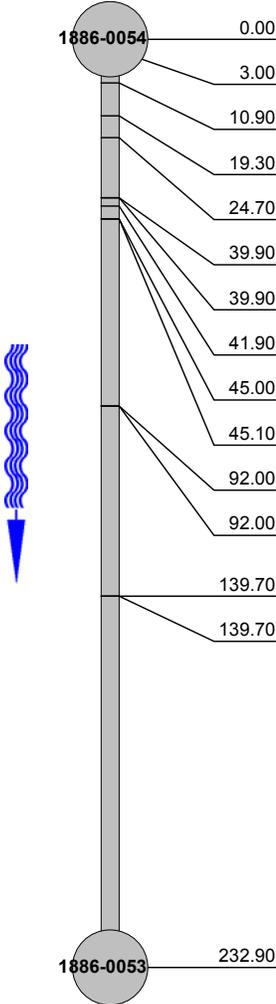
39.90	Roots Fine Joint, from 3 to 7 o'clock, within 8 inch: YES	00:03:39	496, b	M 1
	39.90	Crack Longitudinal, at 9 o'clock, within 8 inch: NO	00:03:51	498, b	S 2

41.90	Crack Multiple, from 9 to 3 o'clock, within 8 inch: NO	00:05:03	500, b	S 3
	45.00	Roots Fine Joint, at 9 o'clock, within 8 inch: YES	00:05:35	502, b	M 1

45.10	Crack Longitudinal, at 3 o'clock, within 8 inch: YES	00:06:17	504, b	S 2
	92.00	Tap Factory Active, at 3 o'clock, 6", within 8 inch: NO	00:08:21	506

92.00	Roots Medium Connection, at 3 o'clock, 25 □, within 8 inch: NO	00:08:46	507, b	M 3
	139.70	Tap Factory Active, at 3 o'clock, 6", within 8 inch: NO	00:10:51	509

139.70	Roots Ball Connection, at 3 o'clock, 65 □, within 8 inch: NO	00:11:06	510, b	M 4
	232.90	Manhole, within 8 inch: NO, Remarks: 1886-0053	00:15:00	512

QSR	QMR	SPR	MPR	OPR	SPRI	MPRI	OPRI
3122	4131	7	9	16	2.33	2.25	2.29

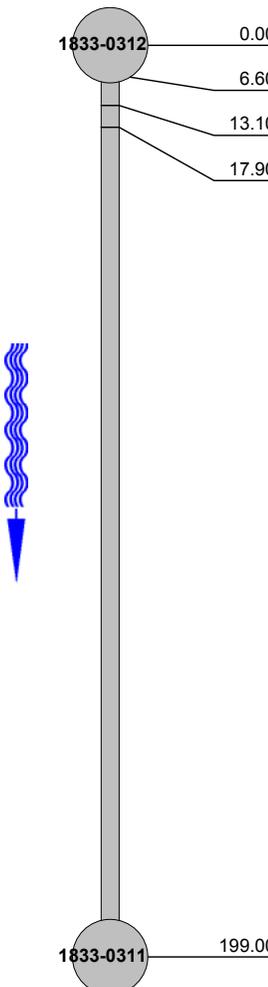
0.00	Manhole, within 8 inch: NO, Remarks: 1833-0312	00:00:35	2895	
	6.60	Crack Multiple, from 10 to 3 o'clock, within 8 inch: YES	00:01:21	2896, b	S 3
	13.10	Water Level, 5 □, within 8 inch: NO	00:01:48	2898	
	17.90	General Observation, within 8 inch: NO, Remarks: Pipe joint Length 5'	00:02:33	2899	
	199.00	Manhole, within 8 inch: NO, Remarks: 1833-0311	00:07:05	2900

QSR	QMR	SPR	MPR	OPR	SPRI	MPRI	OPRI
3100	0000	3	0	3	3	0	3
