# COUNTY OF LOS ANGELES

## DEPARTMENT OF PUBLIC WORKS

**CONSOLIDATED SEWER MAINTENANCE DISTRICT  
CONDITION ASSESSMENT PROGRAM REPORT  
PROJECT NOS. Y0TV1314A1 AND Y0TV1415A**

**CONDITION ASSESSMENT REPORT  
COUNTY OF LOS ANGELES DEPARTMENT OF PUBLIC WORKS  
CONSOLIDATED SEWER MAINTENANCE DISTRICT**

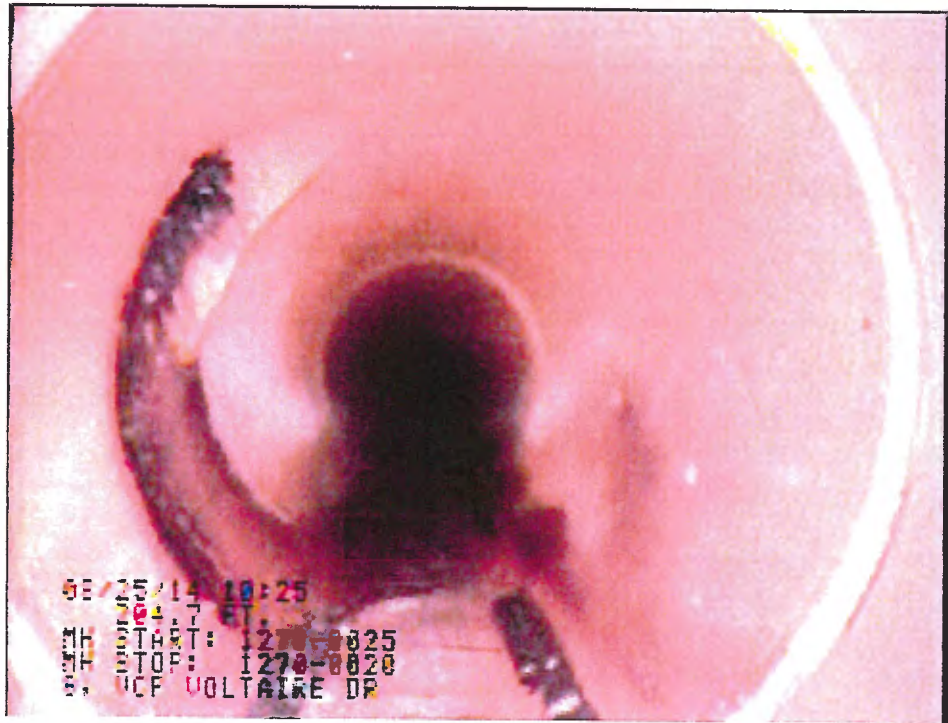
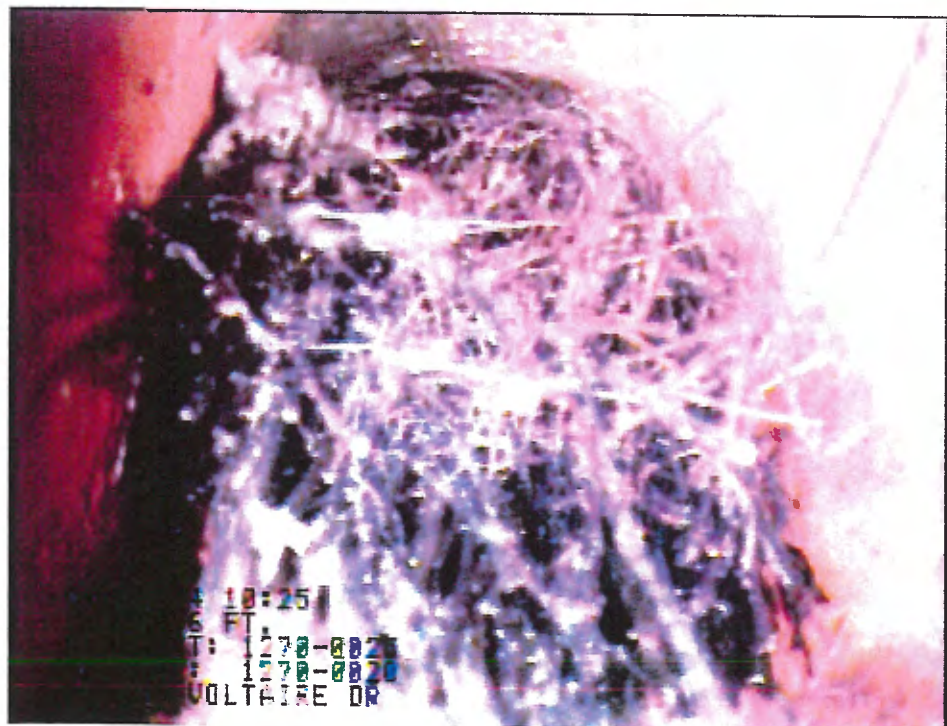
We have enclosed photos of your lateral connection showing the root blockage. In addition, we have included literature on ways to minimize sewer overflows and damage to your home. Please consider establishing a routine cleaning schedule for your sewer lateral to minimize potential plumbing problems caused by root intrusion that are likely to reoccur.

Roots at Lateral Connection

As the property owner, you are responsible for the entire length of the sewer lateral, which includes the portion that extends beyond the property line into the public right of way. We request that you contact a licensed plumber to service your sewer lateral within 90 days to remove roots and any other obstructions that may cause a sewage backup.

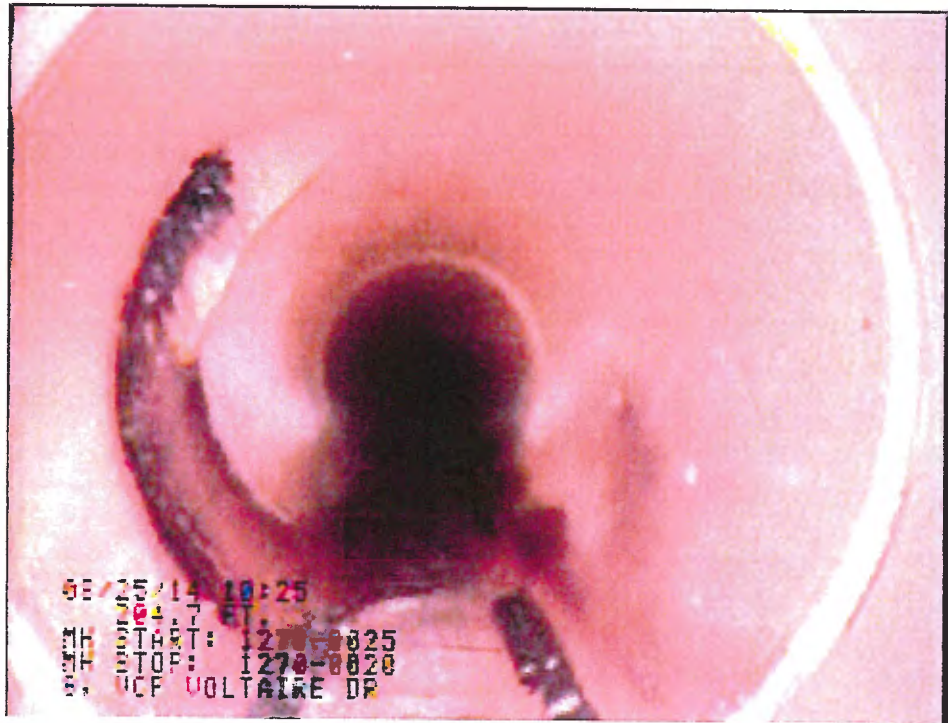
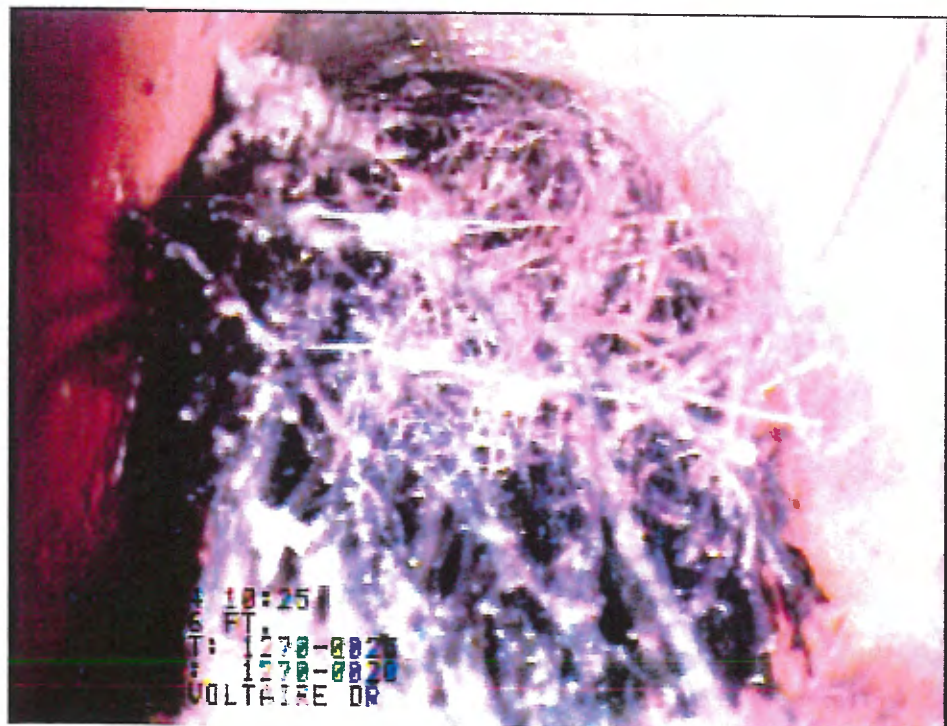
Roots at Lateral Connection
