CONSOLIDATED SEWER MAINTENANCE DISTRICT CONDITION ASSESSMENT PROGRAM REPORT PROJECT NO. Y0TV1011B

**CONDITION ASSESSMENT REPORT
COUNTY OF LOS ANGELES DEPARTMENT OF PUBLIC WORKS
CONSOLIDATED SEWER MAINTENANCE DISTRICT**

PROJECT NAME:	Y0TV1011B	PROJECT MGR:	Hanna Kebede
PROJECT DATE:	08/08/2011	CONTACT NO:	(626) 300-4686
SUP. DISTRICT(s):	5	MAP PAGE(S):	2017 □ 2018
Report By:	Hanna Kebede	Report Date:	09/26/2011

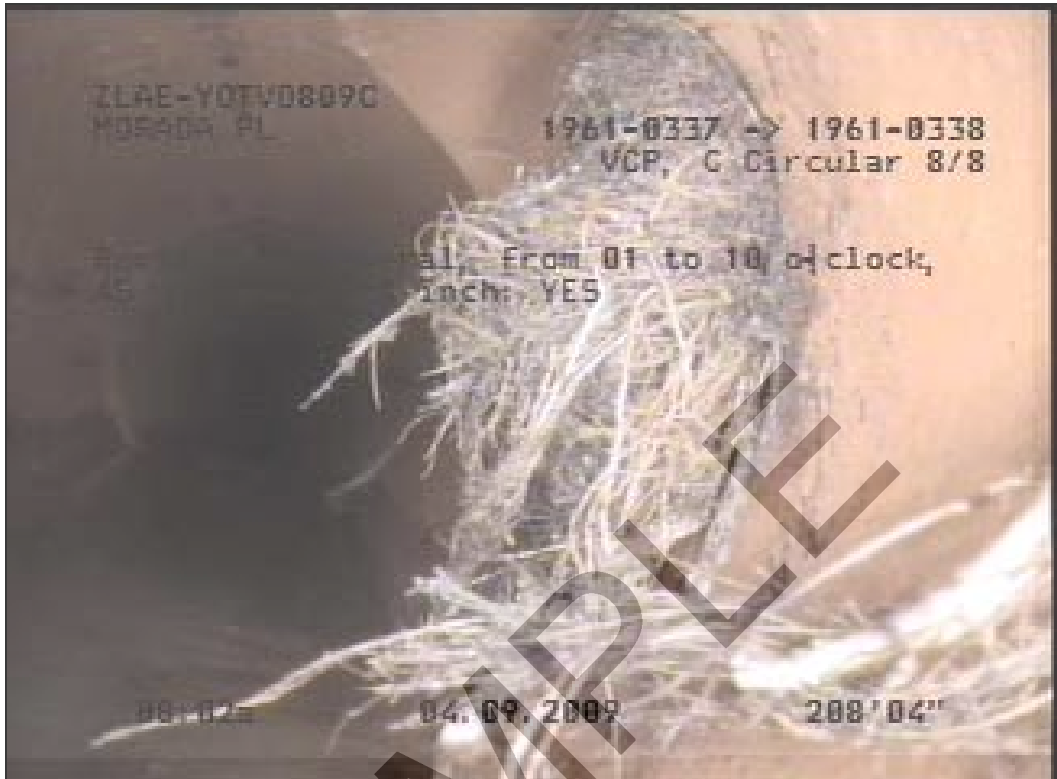
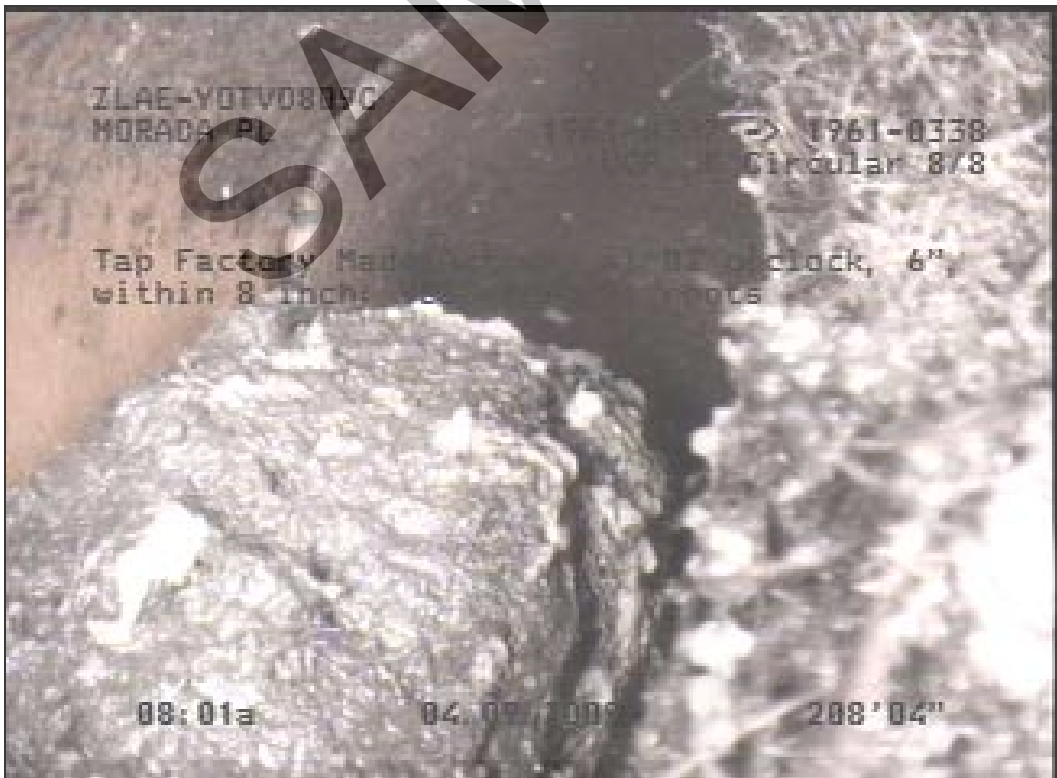
1570 MORADA PLACE
ALTADENA
Roots at Lateral Connection

Using closed-circuit television (CCTV) camera technology, the District recently televised the sanitary sewer mainline and discovered the presence of roots in your sewer lateral connection. The intrusion of the roots from your lateral may block the flow of sewage in the mainline sewer causing a sanitary sewer overflow upstream of your property.

Since the CCTV inspection, the sewer mainline has been cleaned and blockages from root growth have been removed; however, the root blockage in your sewer lateral is still present. As the property owner, you are responsible for the entire length of the sewer lateral, which includes the portion that extends beyond the property line into the public right of way. We request that you contact a qualified plumbing contractor to service

your sewer lateral within 90 days to remove roots and any other obstructions that may cause a sewage backup.
