**CONSOLIDATED SEWER MAINTENANCE DISTRICT
CONDITION ASSESSMENT PROGRAM REPORT
PROJECT Y0TV0809B**

**CONDITION ASSESSMENT REPORT
COUNTY OF LOS ANGELES DEPARTMENT OF PUBLIC WORKS
CONSOLIDATED SEWER MAINTENANCE DISTRICT**

PROJECT NAME:	Y0TV0809B	PROJECT MGR:	Kari Eskridge
PROJECT DATE:	01/12/2009	CONTACT NO:	(626) 300-3390
SUP. DISTRICT(s):	4	MAP PAGE(S):	2029
Report By:	Eric Liu	Report Date:	02/22/2011

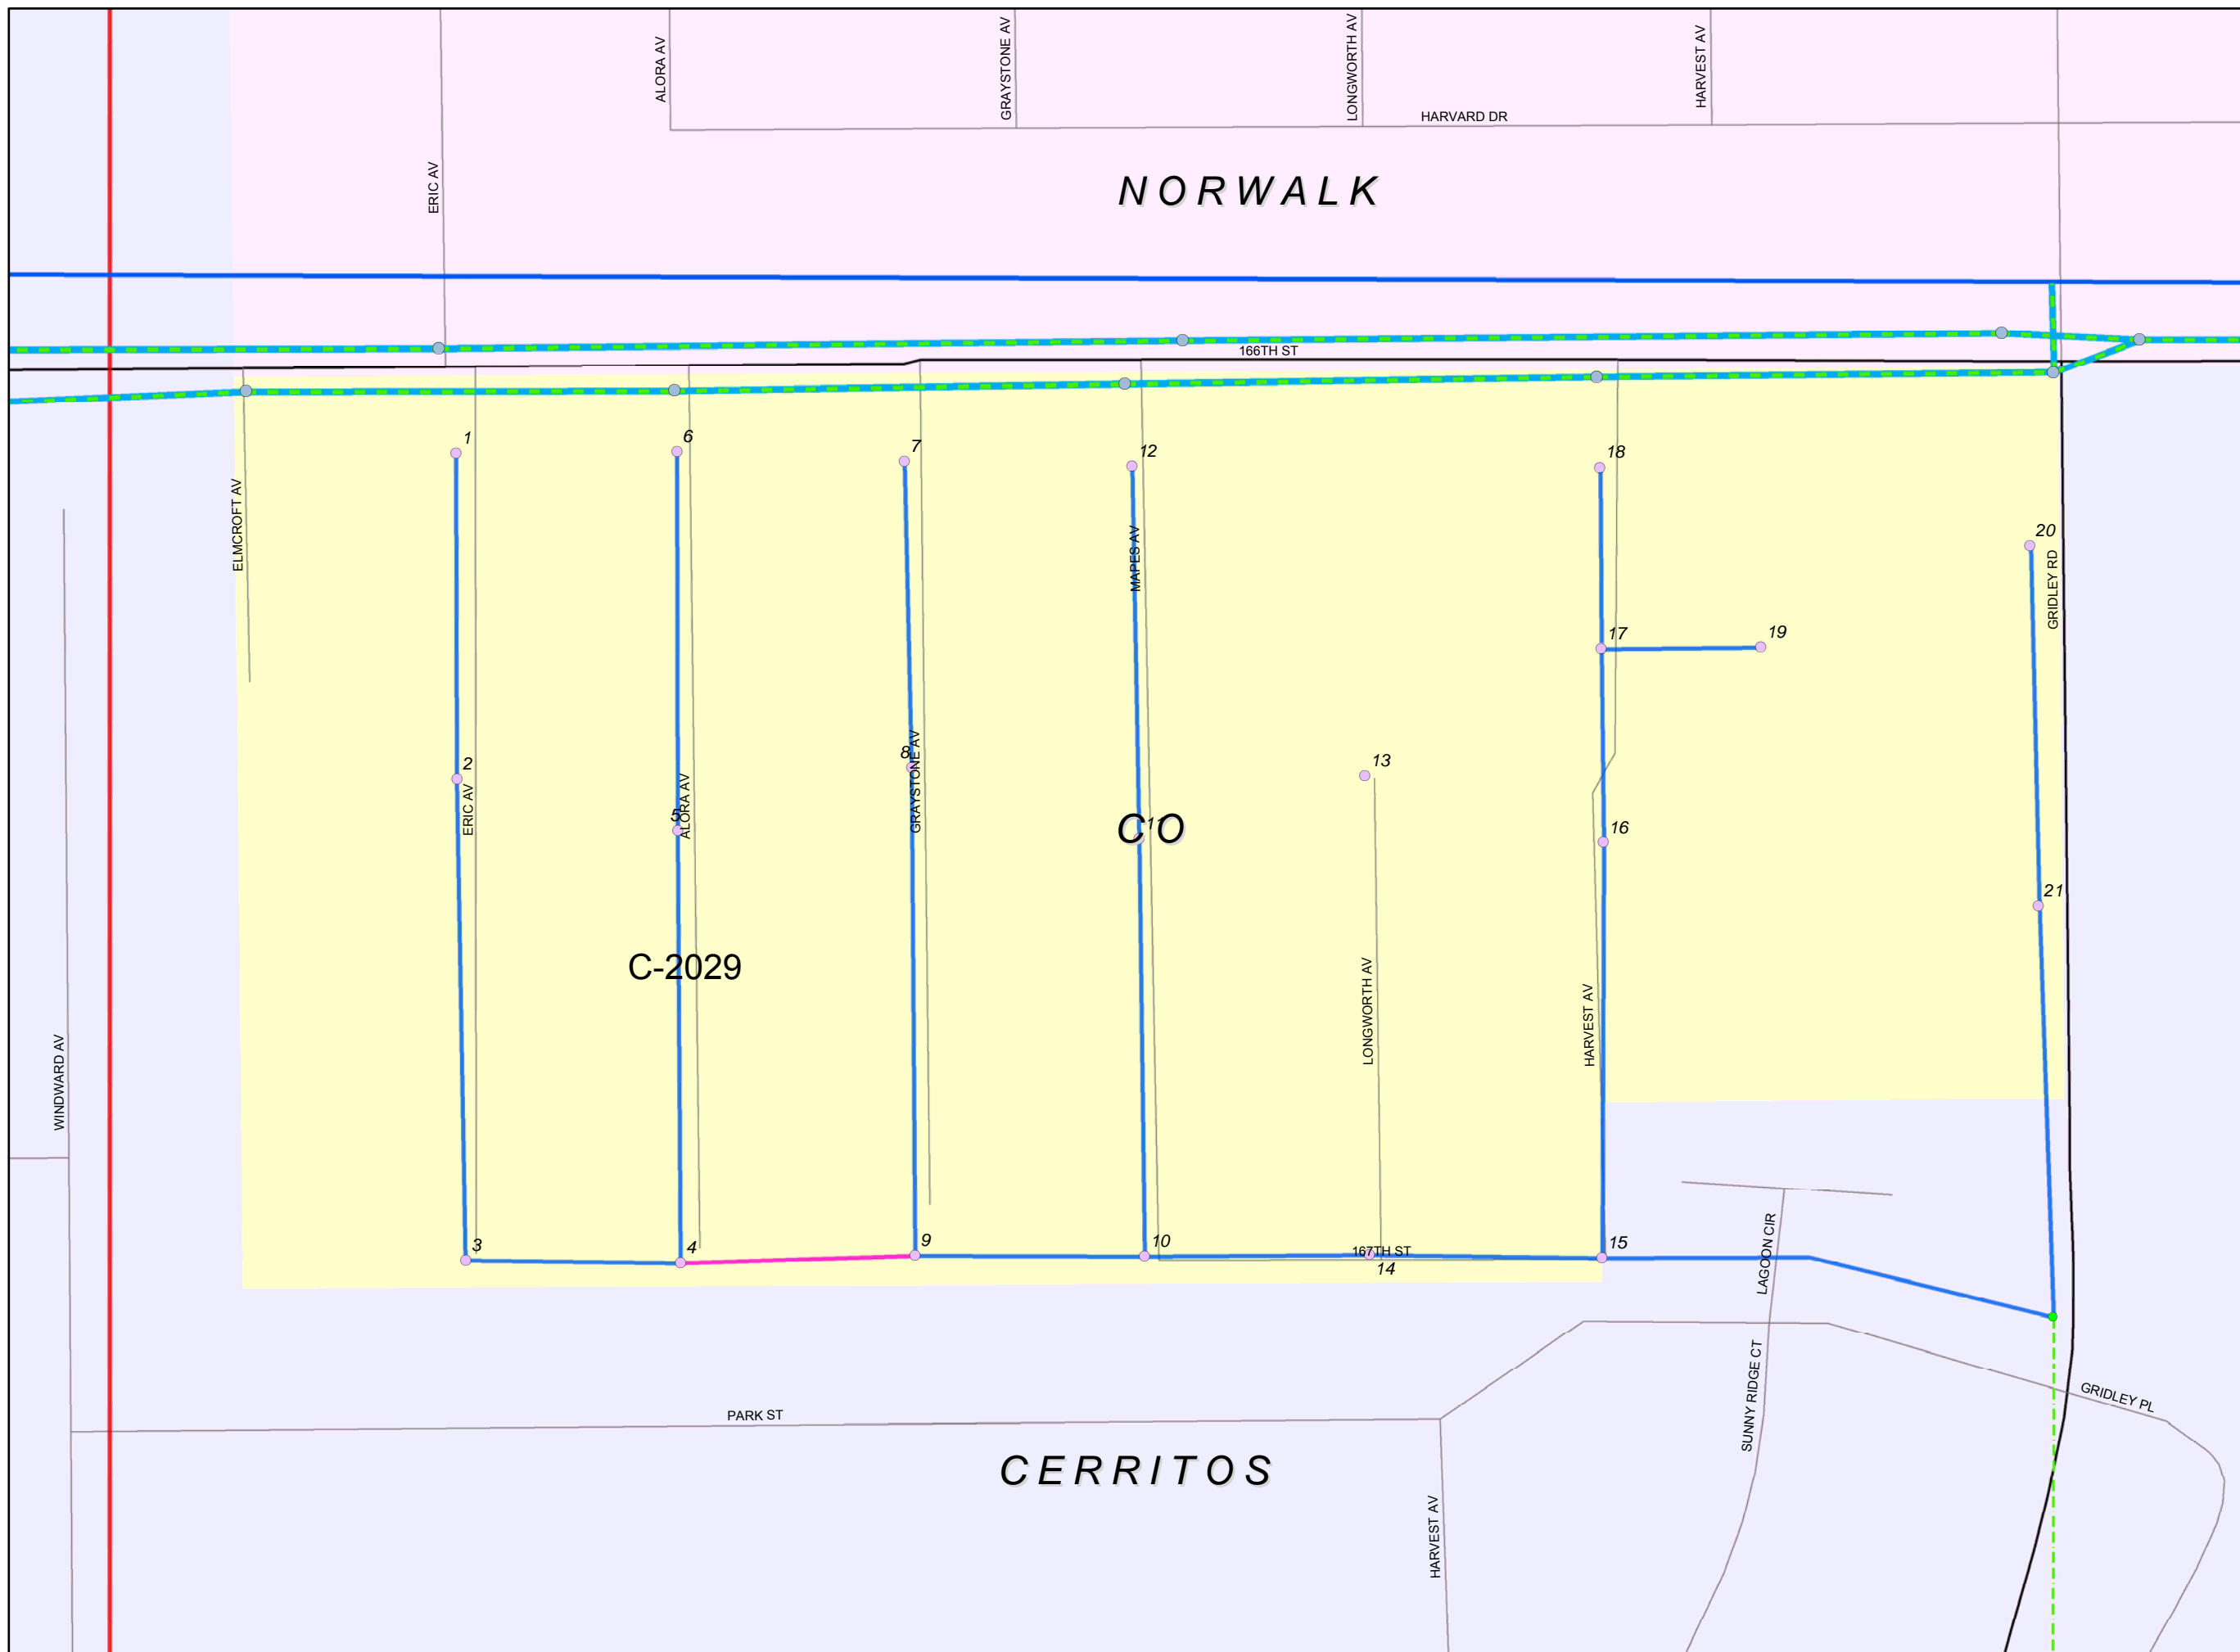
QUICK
 MAINTENANCE
 RATING
 (QMR)

The segment had deficiencies discovered inside the lateral connections to the mainline. The District does not maintain lateral lines; it is the responsibility of the property owner to maintain their respective lateral lines to facilitate the flow of wastewater from their property to the mainline. A letter had been sent to the lateral owner notifying them of the maintenance issues discovered in their lateral. A sample lateral notice letter is provided in Enclosure 2 for your reference. The corrective action taken is noted on the Quick Maintenance Rating Report Priority List (Enclosure 2).

ITEM NO.	QMR	START MH	END MH	STREET	OBSERVATION	CORRECTIVE ACTION TAKEN
1	4121	2029-0004	2029-0009	167TH ST	Root ball lateral: 128'	Letter to home owner: 3/4/10

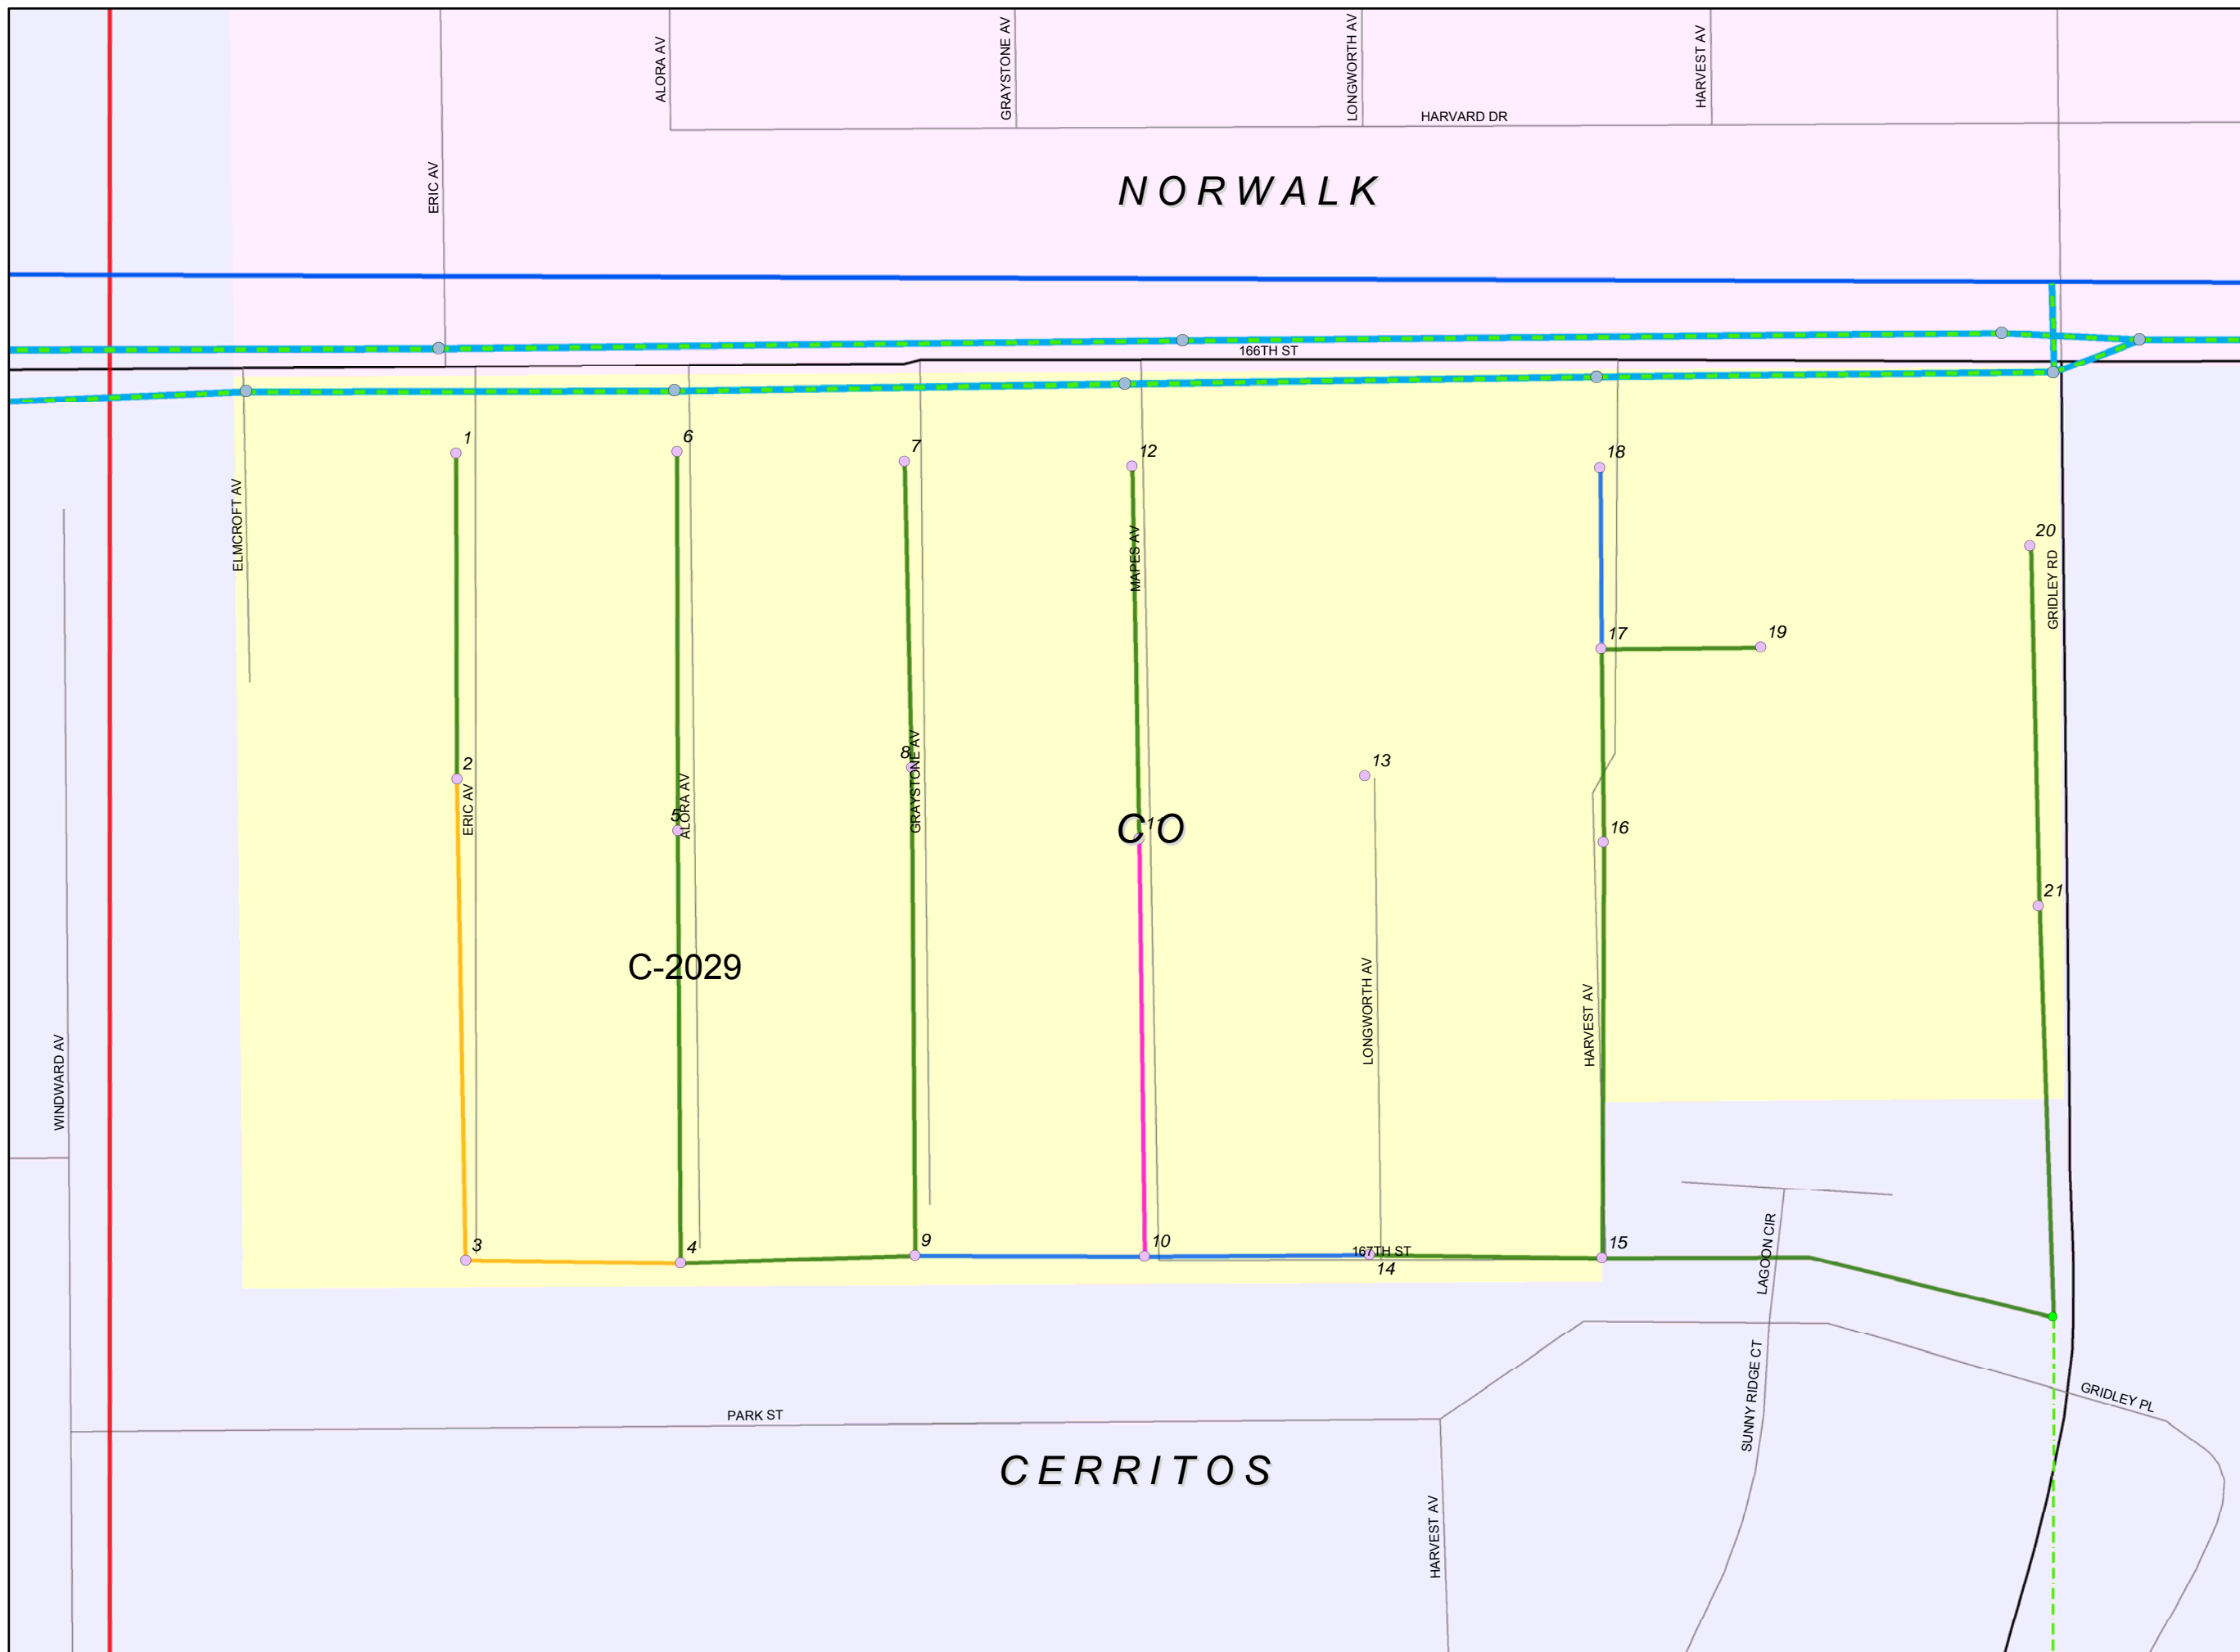
QUICK
 STRUCTURAL
 RATING
 (QSR)

Our inspection revealed that approximately 94.1 percent of the inspected pipe segments within the Unincorporated County of Los Angeles were free of severe structural defects. However, the remaining 5.9 percent of the inspected pipe segments had a PACP structural grade of 4 as indicated in the Quick Structural Rating Table shown below. The segment required a point repair to address the fractures in the pipe. The point repair was performed by District maintenance crews under force account on 02/20/2010.

Item No.	QSR	Start MH	End MH	Street	Observation: Location	Proposed Corrective Method	Length of Repair (FT)
1	4131	2029-0010	2029-0011	MAPES AV	Fractures: 187'-192'	Point Repair: CSMD (completed 02.10.2010)
