## Distribution Repair Order

Information: Structure No: <u>1298284e</u> Reported by: <u>Wallace</u> ,	CAD ID: <u>GO 03181</u>		Incident Date: 03//18//2015 Time: 10:01 RO Date: 03//18//2015 Time: 10:01 Cell Number: (310) 3867711	
Problem: Car Hit Pole Circuit: STOCKER	Cause: Damaged/Bro Code 17036	oken Pole	Sub: WINDSOR HILLS	
Location: overhill dr n/o northridge,				
Access: <u>Street</u> Seq No: <u>#4215</u> Duration: <u>47</u> Enviromental Release? <u>No</u> Tree Crew Needed? <u>No</u>	Foreman: Crew Size: <u>1</u> Enviromental Other? <u>No</u> Grounding Needed for Tre	District Notified? <u>No-</u>		
Load Off (Individual or Downstream): not yet				
Other Departments: TeleComm	Transmission	Other Utility	Other

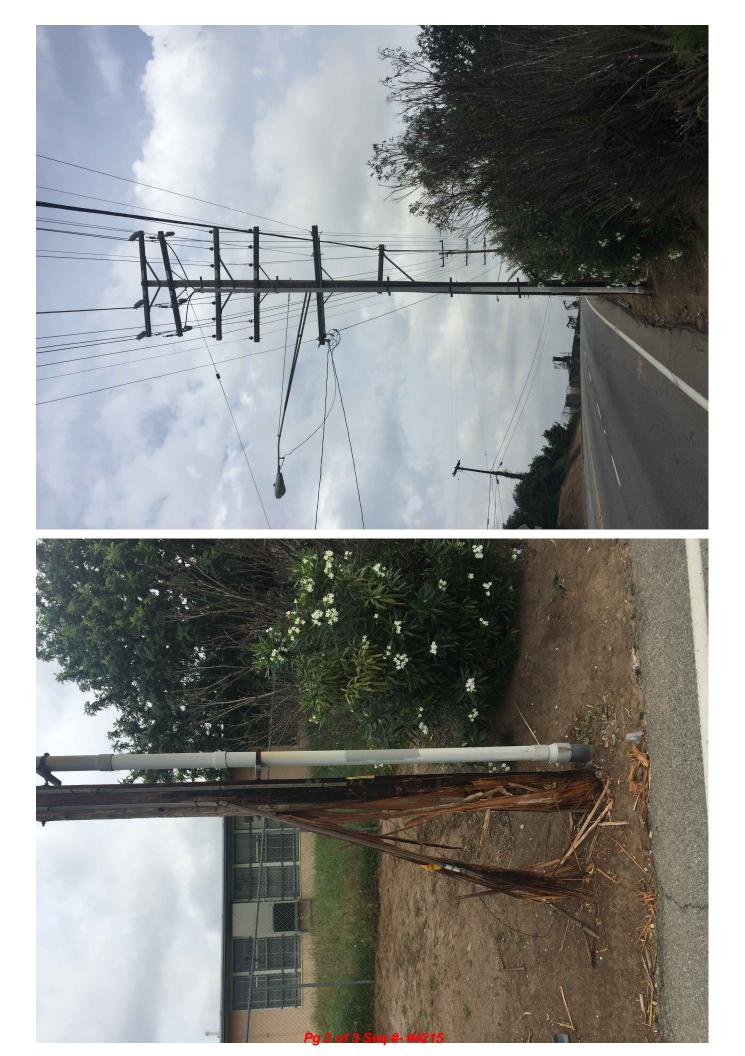
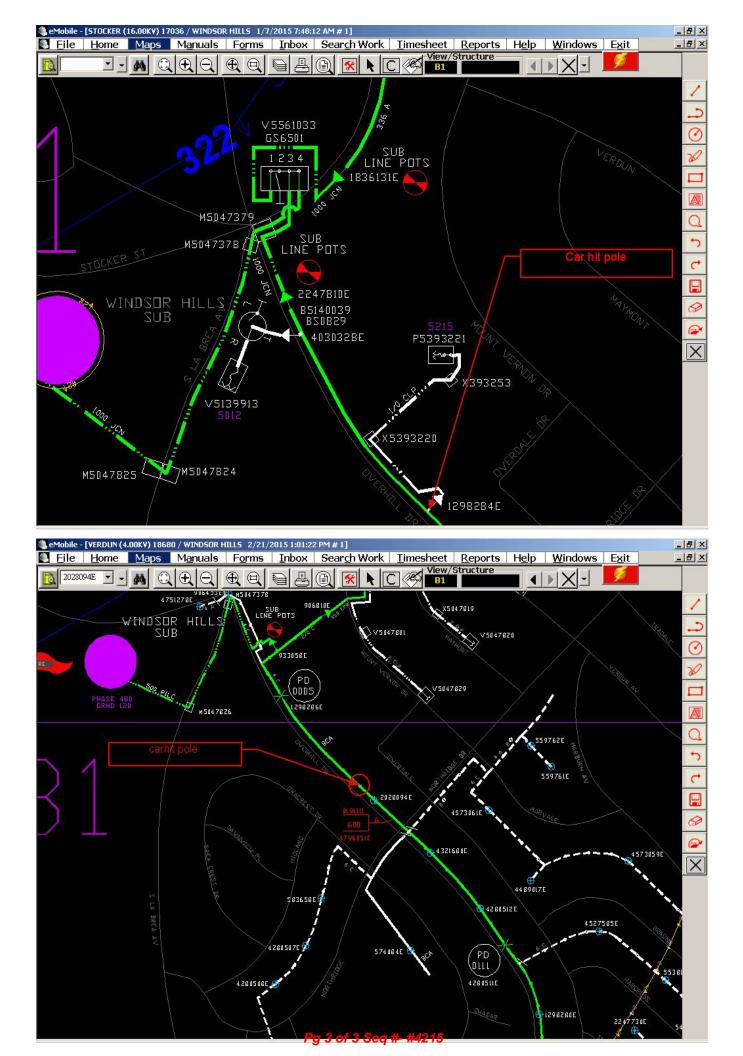
Remarks:(Status of Line, Access Instructions, Special Instructions) CAR HIT POLE, 4 circuits--- STOCKER 16, OVERHILL 4KV, NORTHRIDGE 4KV, VERDUN 4KV.

will need traffic control to take lane. no pole stamp or nail. looks like a 55ft pole would be 5 feet higher to give some room to work. Fim say 45 it is wrong. will need unistruts and pipe straps for 3" riser. no load is off yet

5-Steel Pin 10 ft #82 Xarm Material Code - 10060240 1-55 ft Pole Material Code - TBD 10-Polymer Clamp Top 25kV 2 Flange Insulator Material Code - 10116334 3-Polymer Clamp Top 25kV 3 Flange Insulator Material Code - 10116335 3-ARRESTER 16KV/25KV POLYMER Material Code - 10109143 5-V Brace 60" Material Code - 10067347
