## **COMPREHENSIVE ASBESTOS, HAZMAT & XRF-LEAD ASSESSMENT**

### **High Desert Hospital**

44900 60th Street West, Various Buildings, Interior and Exterior

Project Number: Atch-211061

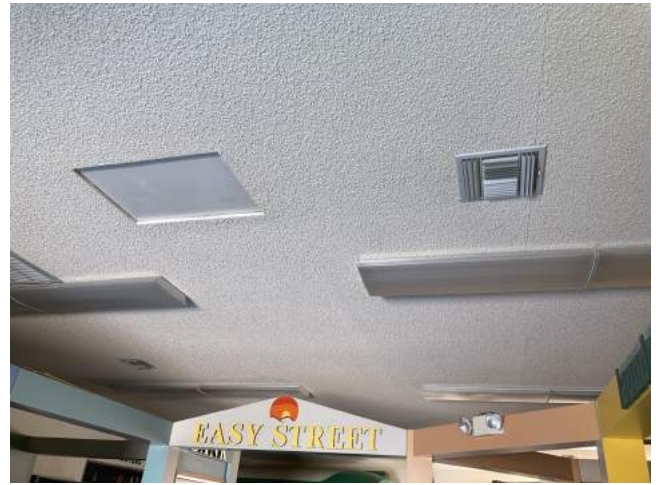
View of Acoustic Spray-On

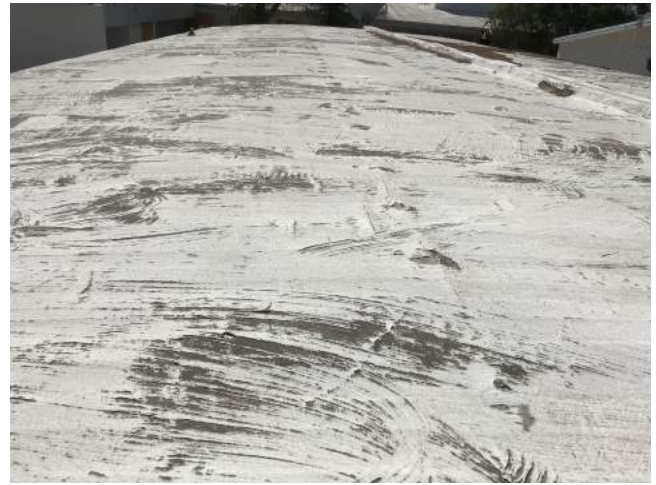
View of Woven Roof Material with Sealant

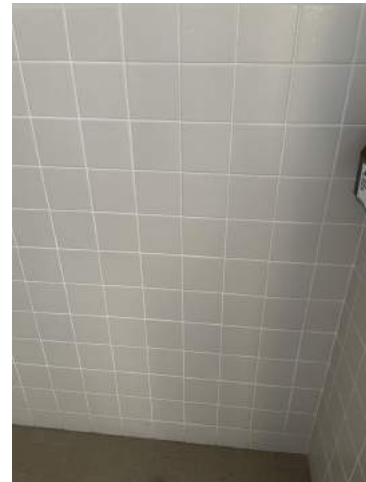
View of 4" x 4" Brown Ceramic Wall Tile
