**Sunshine Canyon Landfill  
Independent Monitor  
Quarterly Site Monitoring Status Report  
January 1, 2016 – March 31, 2016**

**City of Los Angeles Department of City Planning**

**County of Los Angeles Department of Regional Planning**

May 16, 2016

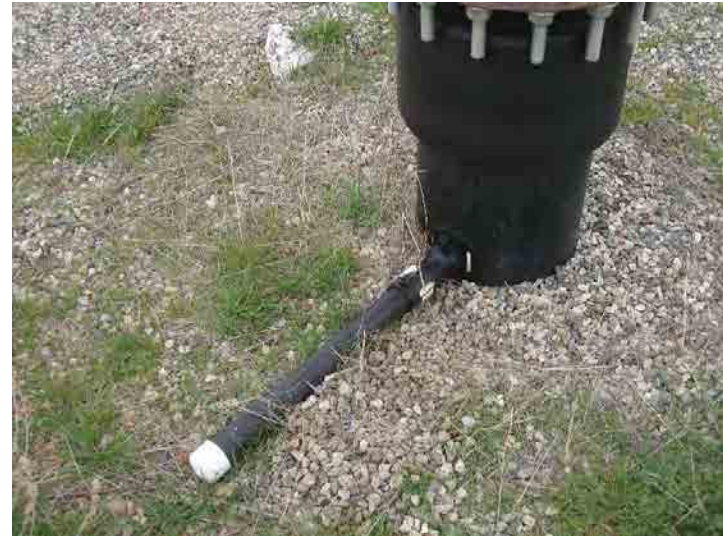
**Photo 157: Flare 8 Vacuum Leak: January 27, 2016**

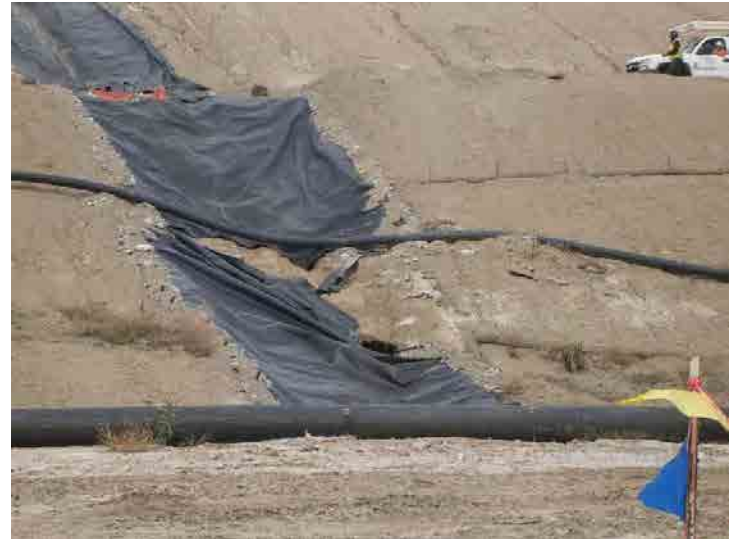
**Photo 330: County South Slope Drainage Failure: January 27, 2016**

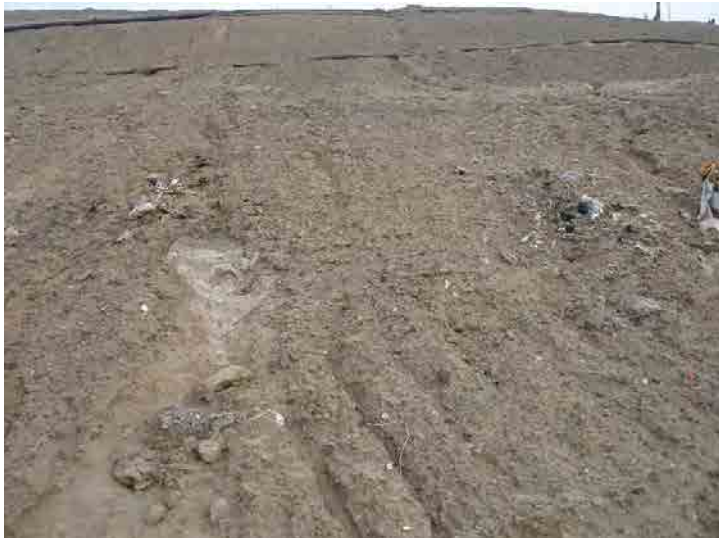
**Photo 331: County South Slope Inert Waste Exposed: January 27, 2016**

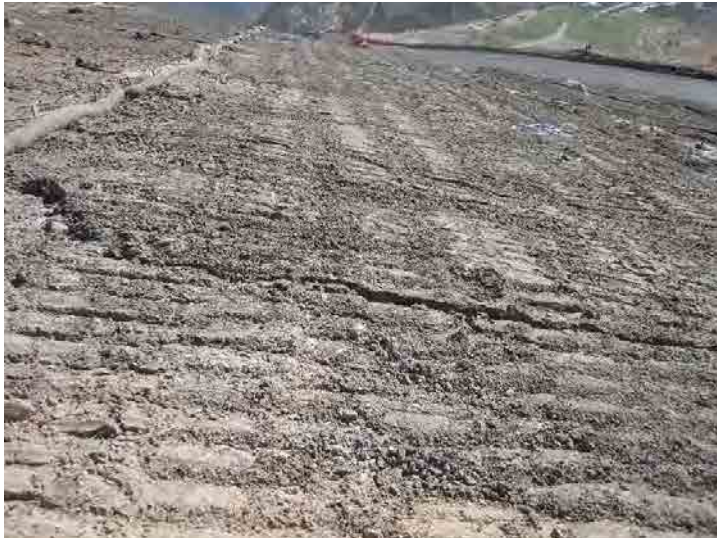
**Photo 359: City Slope Erosion Repair, Inert Waste Exposed: February 24, 2016**

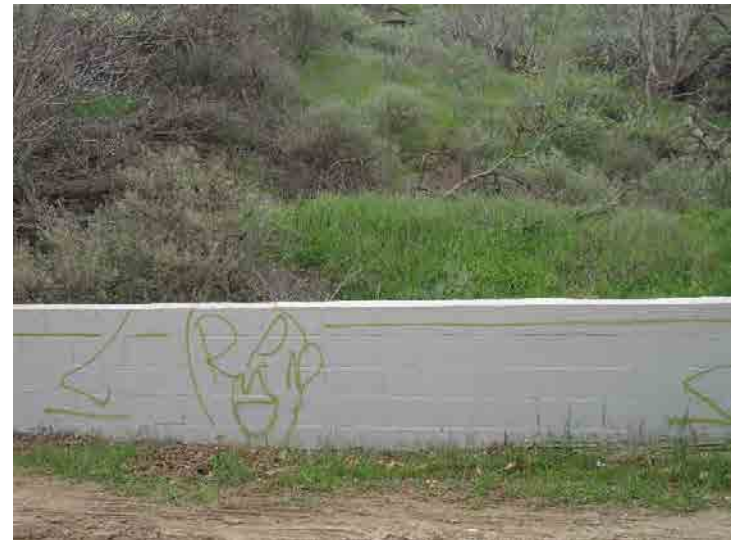
**Current Status/Comments** – On January 27th, graffiti was observed on the white block wall south of the landfill entrance near the gas company's meter station.

**Photo 532: Graffiti Frontage Wall on San Fernando Road: January 27, 2016**

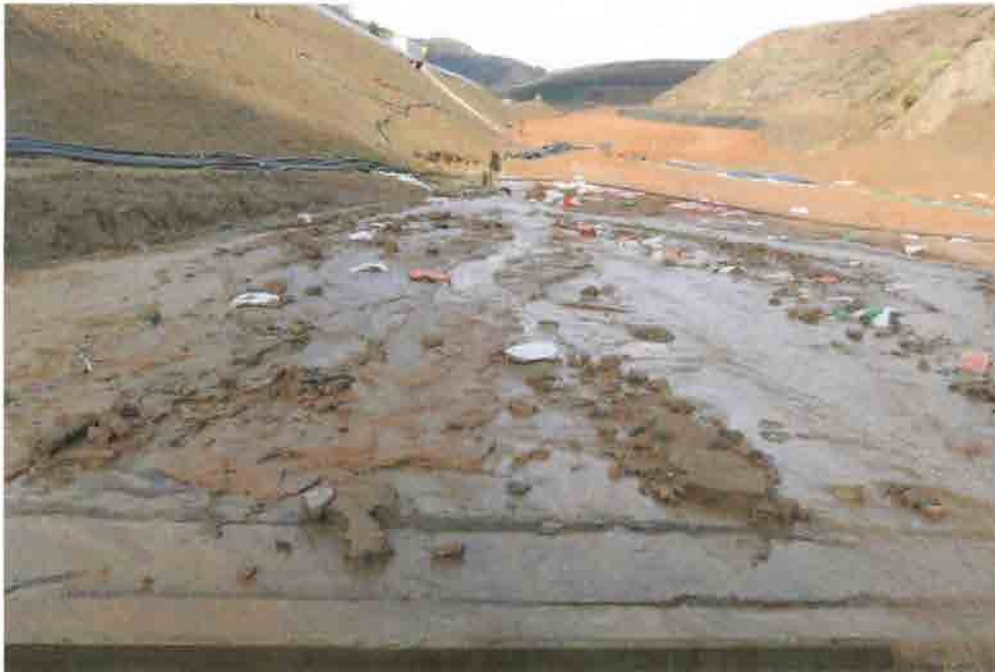
Photo 3: Runoff from cell CC3B

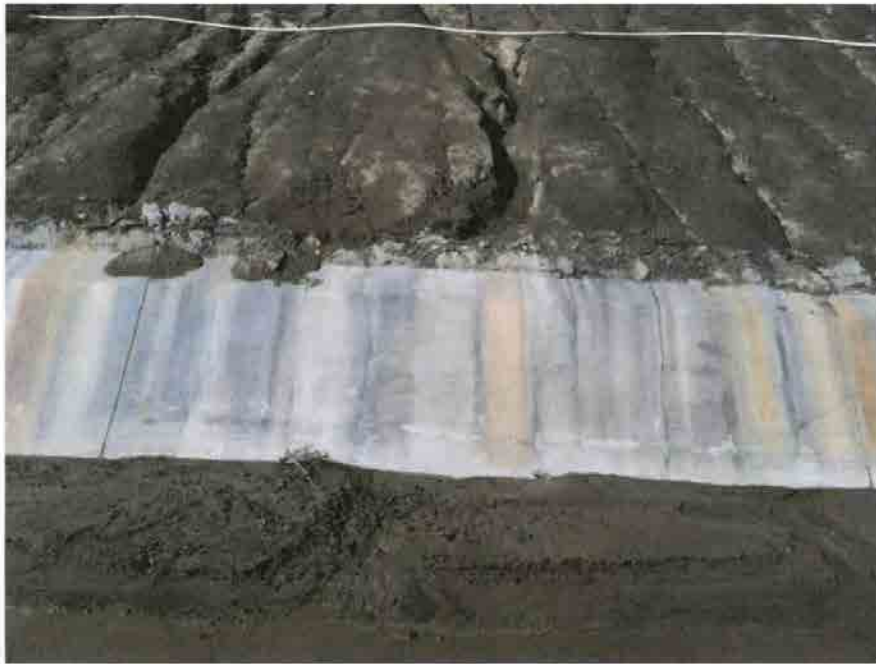
Photo 7: Sediment into channel between Basin A and Basin D

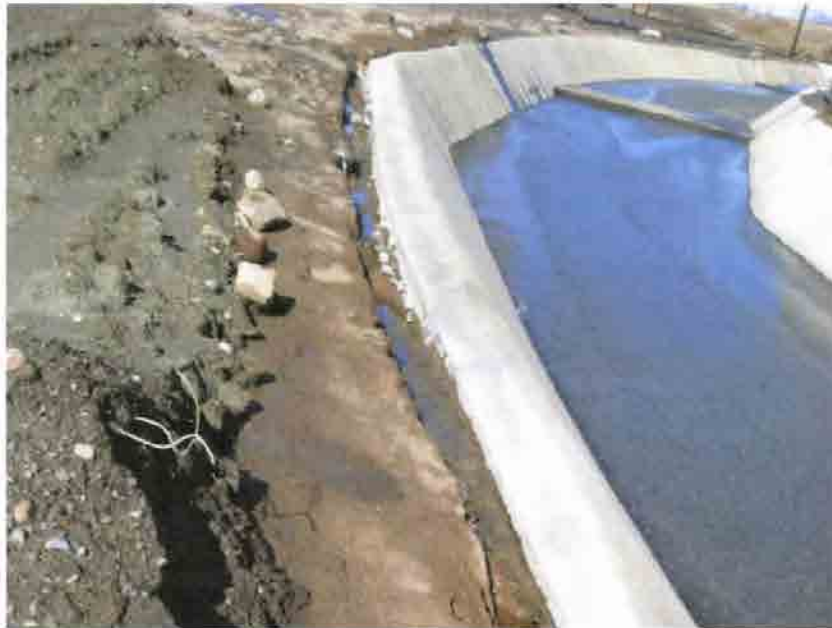
Photo 13: Erosion along edge of west side drainage channel

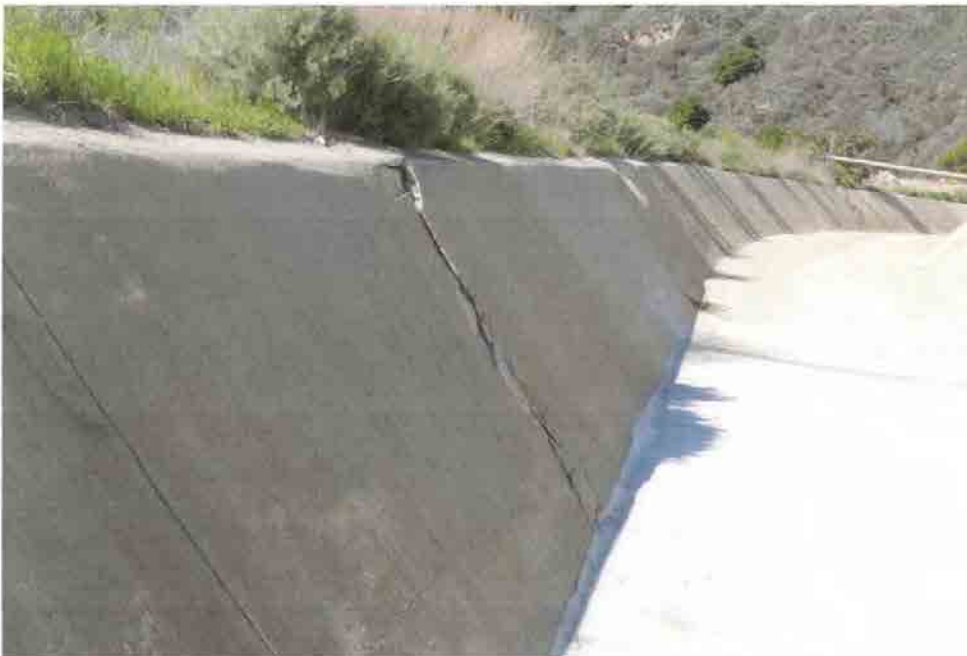
Photo 2: Crack on side wall channel between Basin A and Basin D

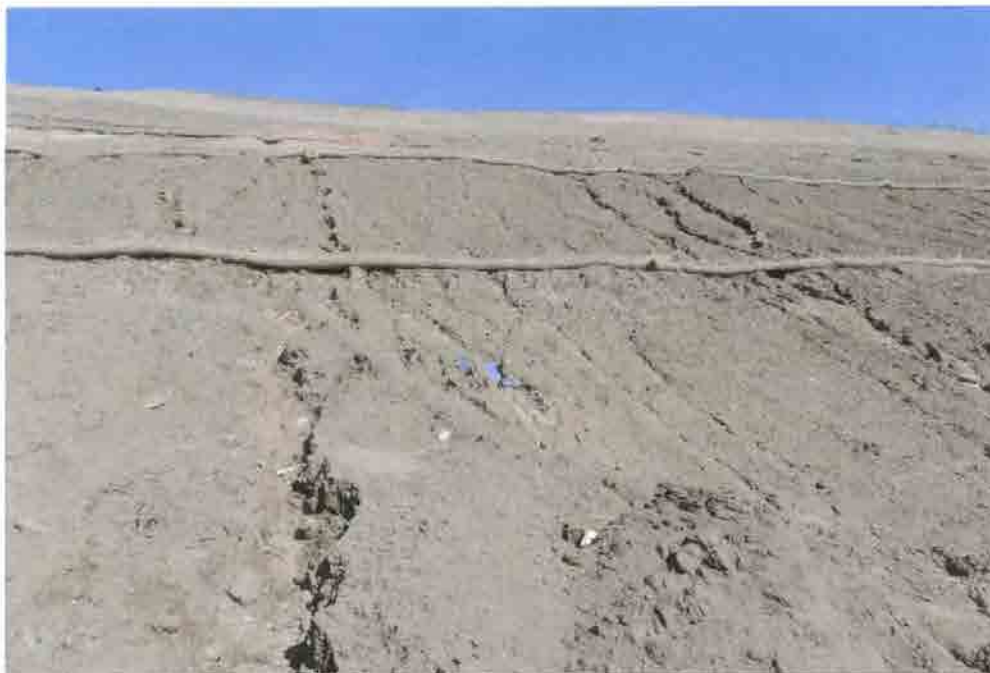
Figure 4: Erosion gullies on side slope at Cell II

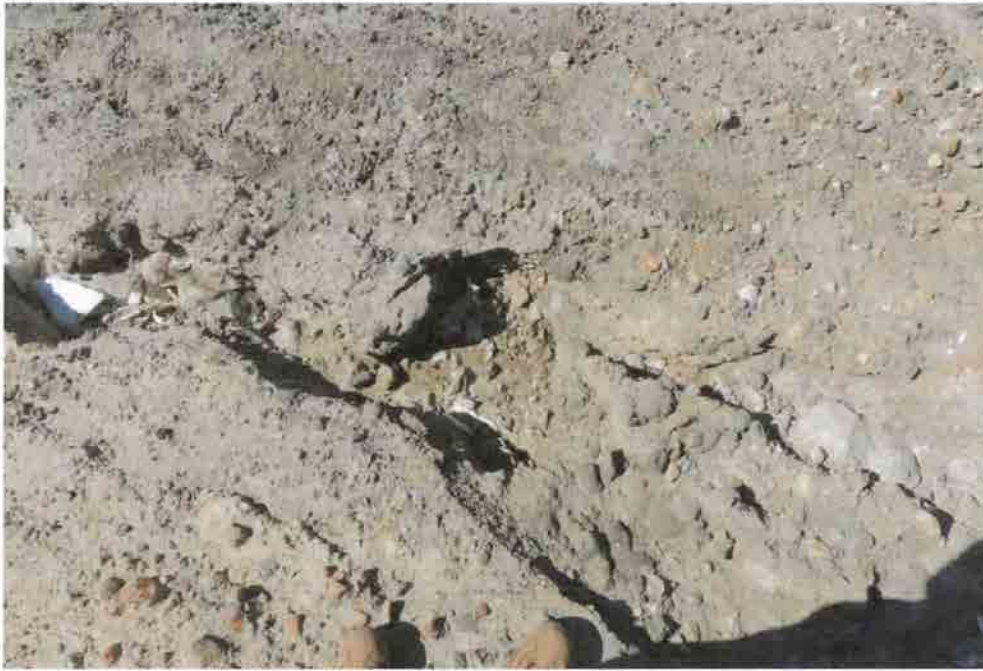
Photo 5: Deep gully on on side slope at Cell II showing refuse

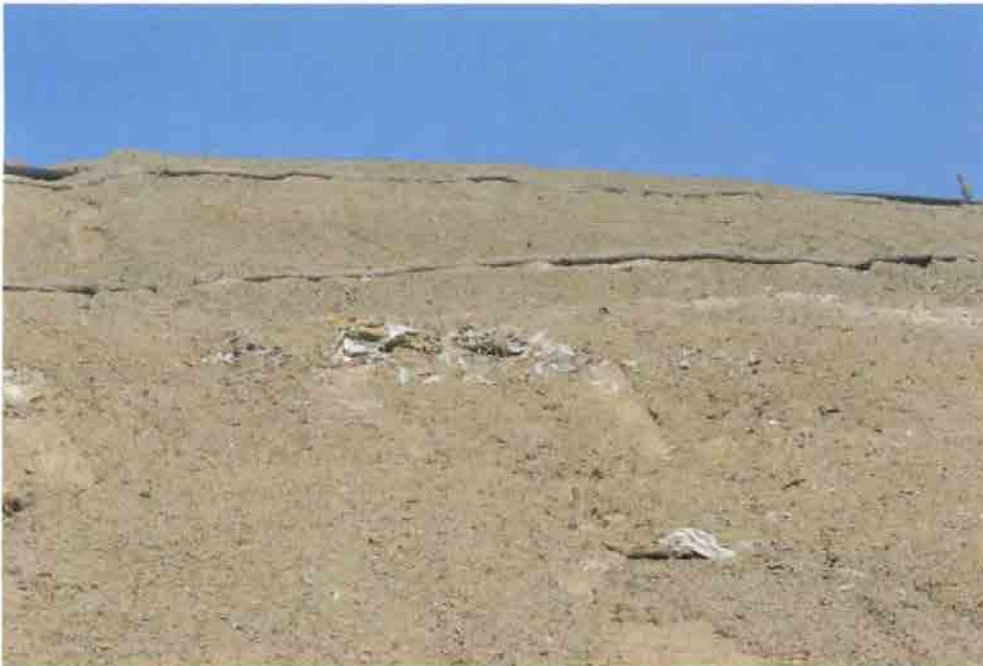
Photo 6: Inert waste showing on southeast facing slope of old county landfill

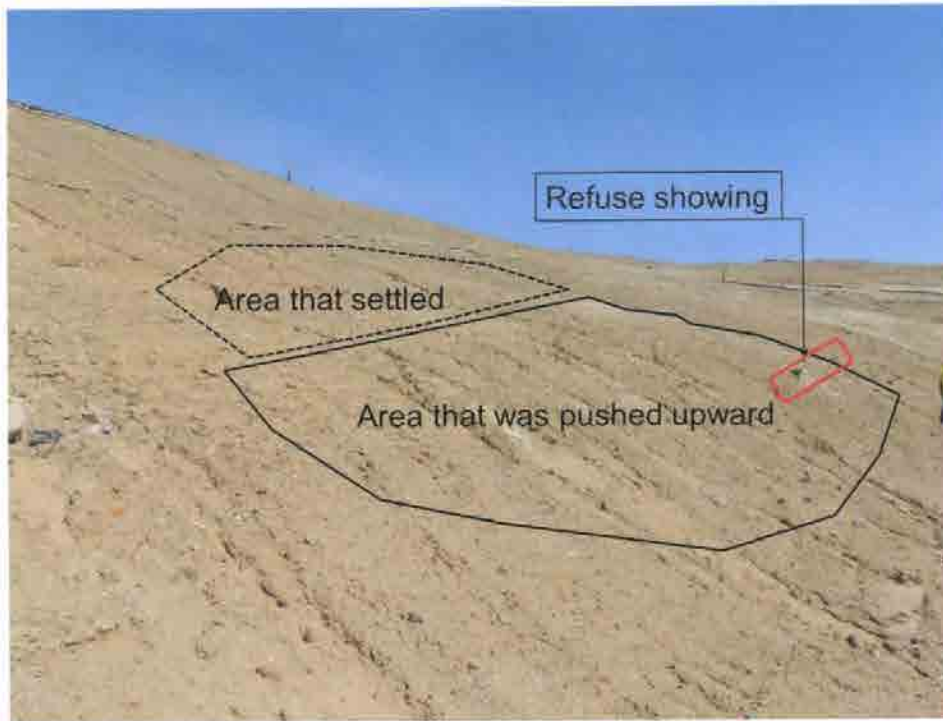
Photo 7: Area where inert waste is showing on southeast facing slope of old county landfill

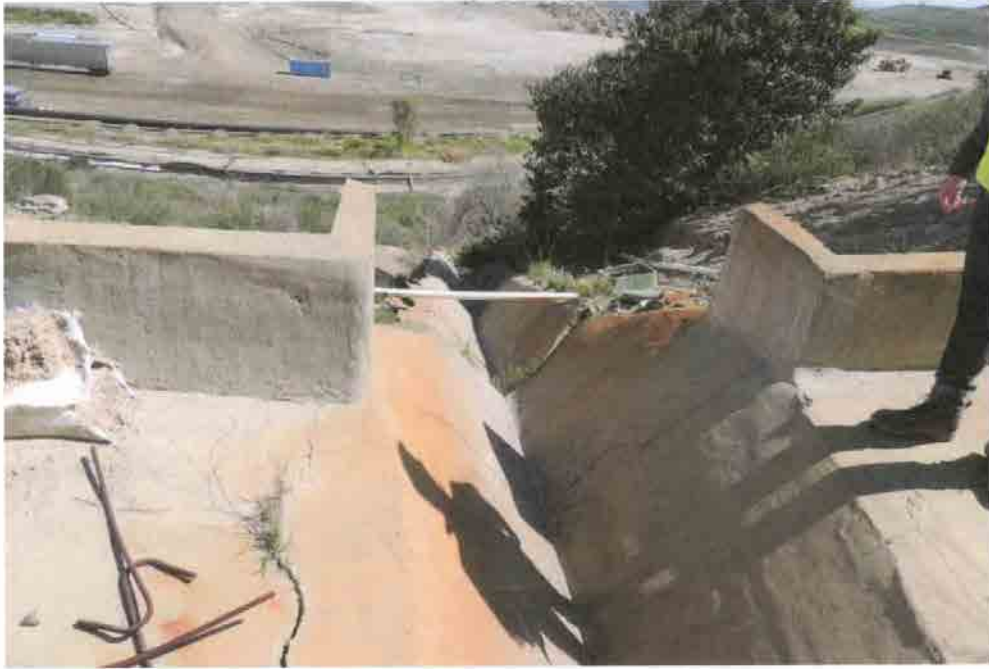
Photo 9: Crack in downchute at coastal sage mitigation area

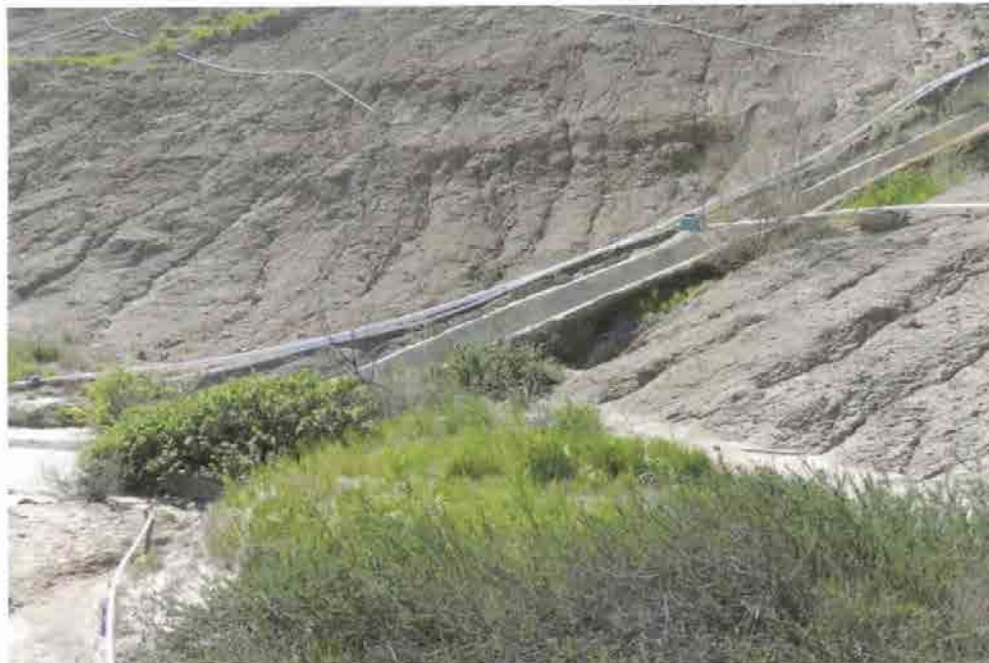
Photo 10: Erosion along edge of downchute at coastal sage mitigation area

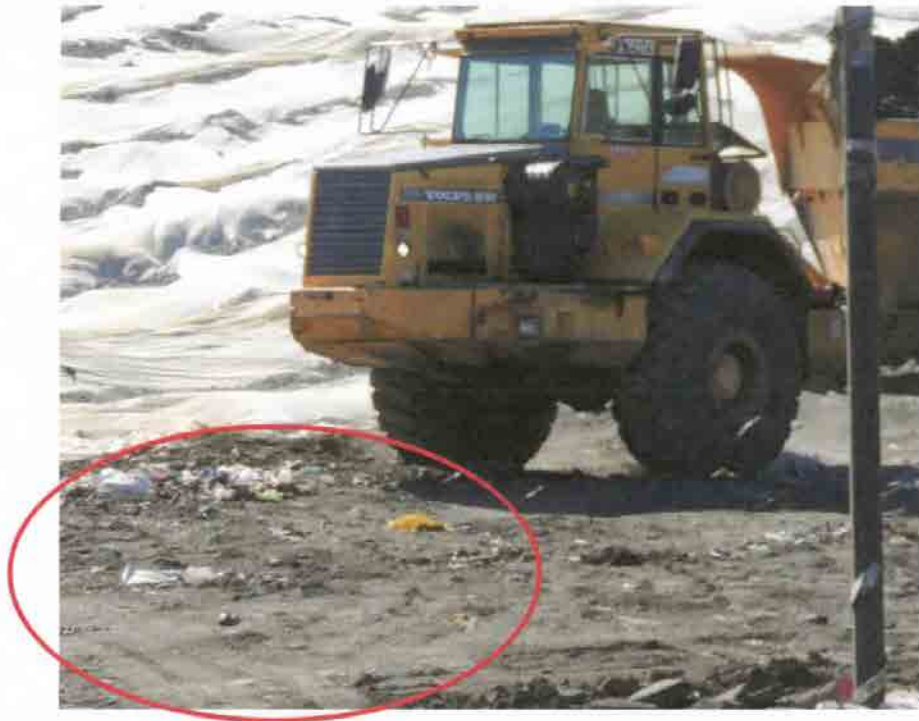
Photo 11: Waste not covered by ADC along the edges

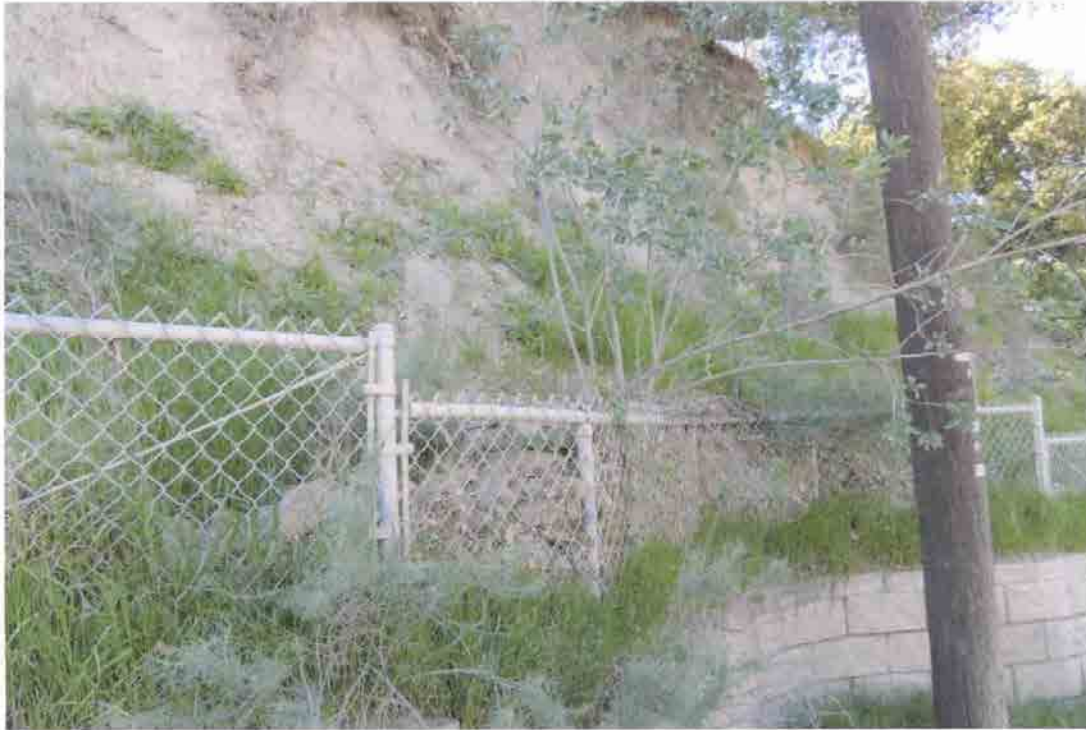
Photo 13: Soil accumulated against the wire fence at wall along San Fernando Road

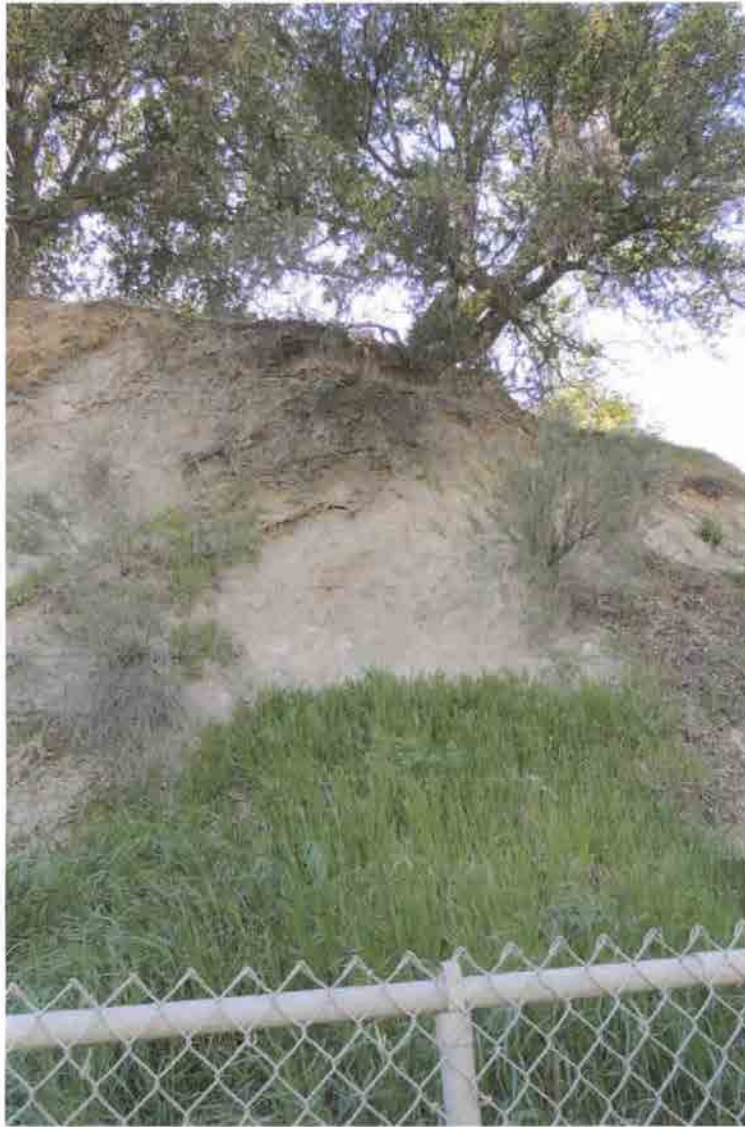
Photo 14: At risk tree above slope at wall along San Fernando Road
