**Sunshine Canyon Landfill  
Independent Monitor  
Quarterly Site Monitoring Status Report  
October 1, 2015 – December 31, 2015**

**City of Los Angeles Department of City Planning**

**County of Los Angeles Department of Regional Planning**

February 12, 2016

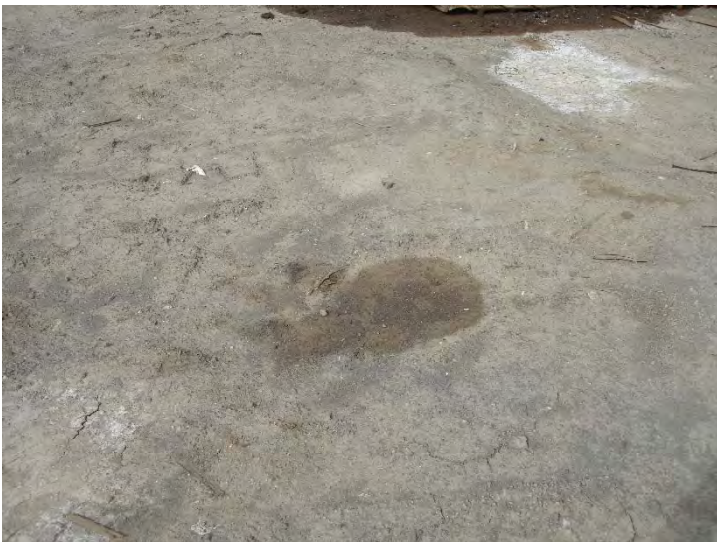
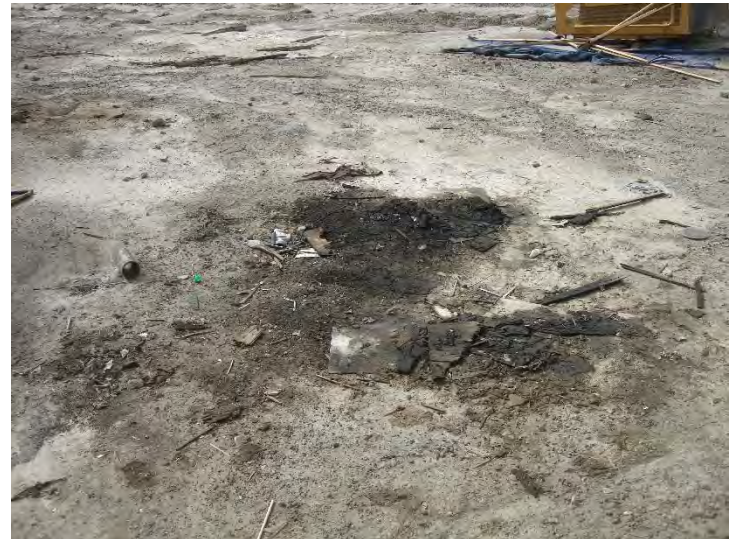
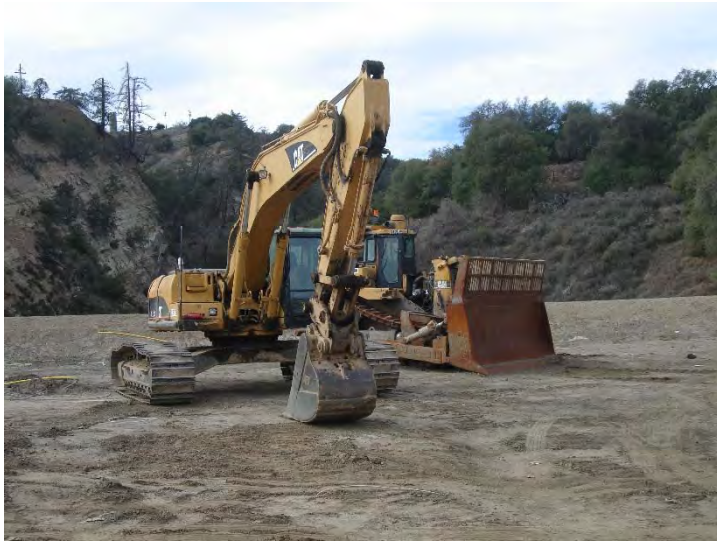
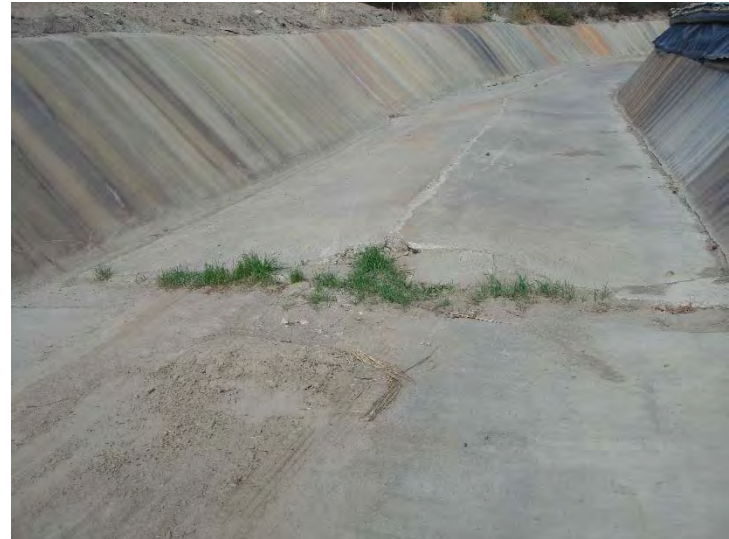
**Photo 37: Equipment Leaking Oil Near Basin A: October 28, 2015**

**Photo 38: Equipment Leaking Oil Near Basin A: October 28, 2015**

**Photo 39: Equipment Leaking Oil Near Basin A: October 28, 2015**

**Photo 40: Equipment Leaking Oil Near Basin A: October 28, 2015**

**Photo 41: Equipment Leaking Oil Near Basin A: October 28, 2015**

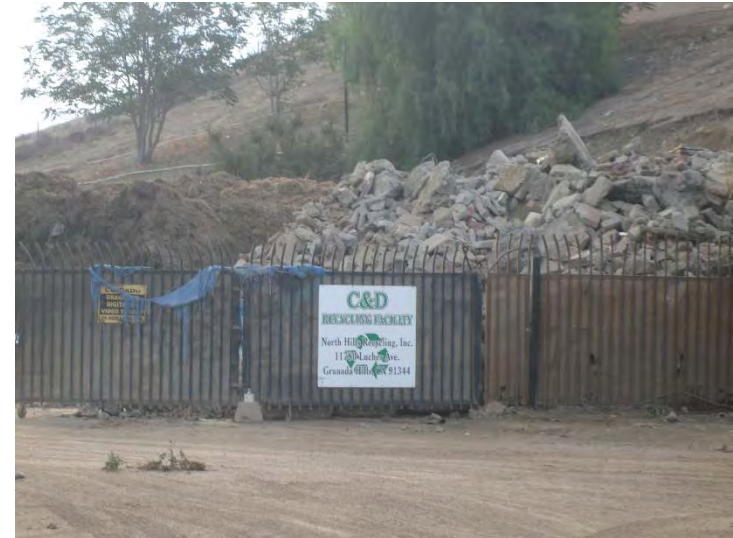
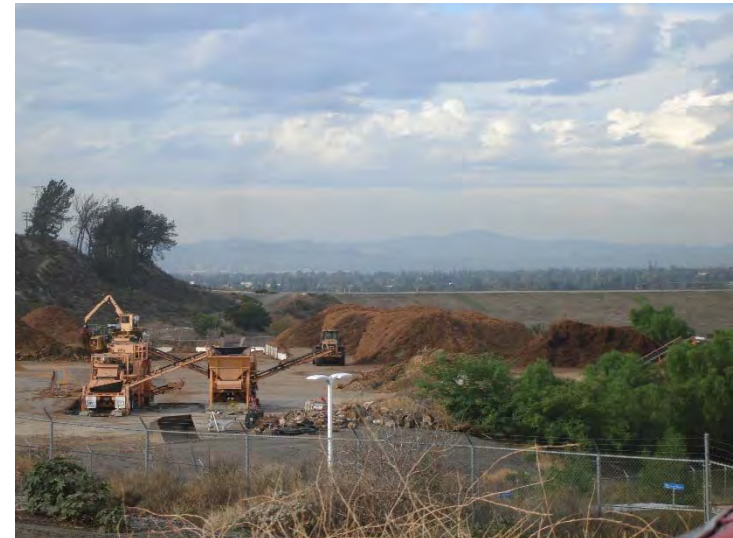
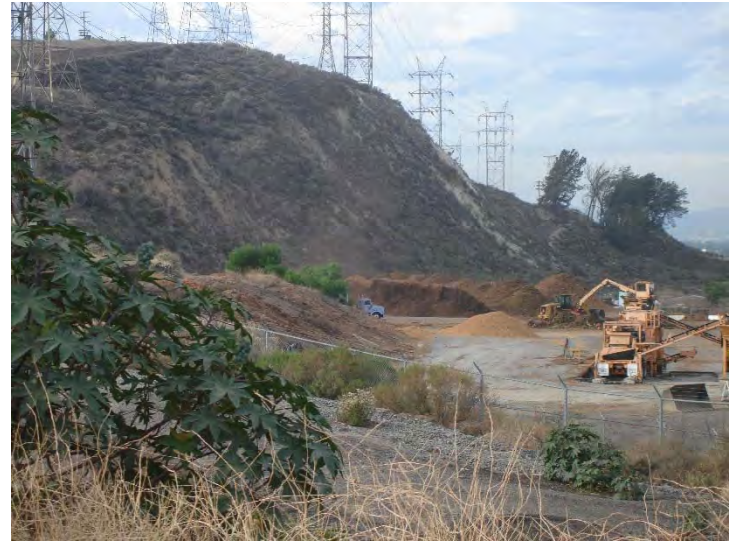
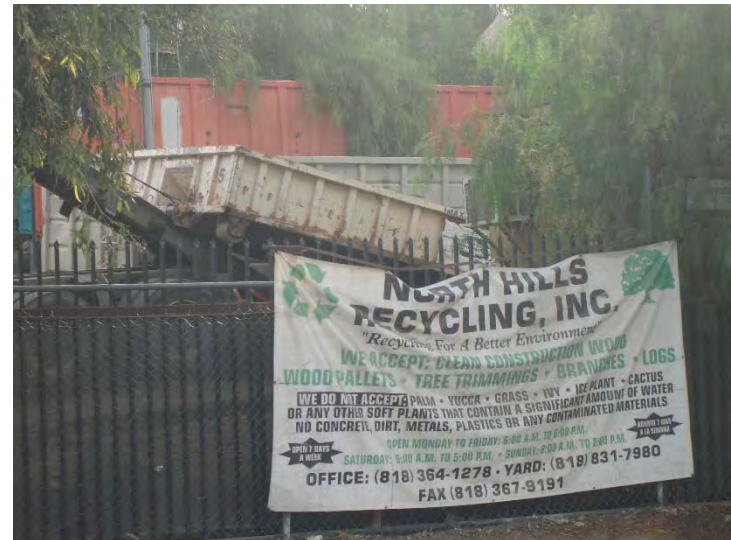
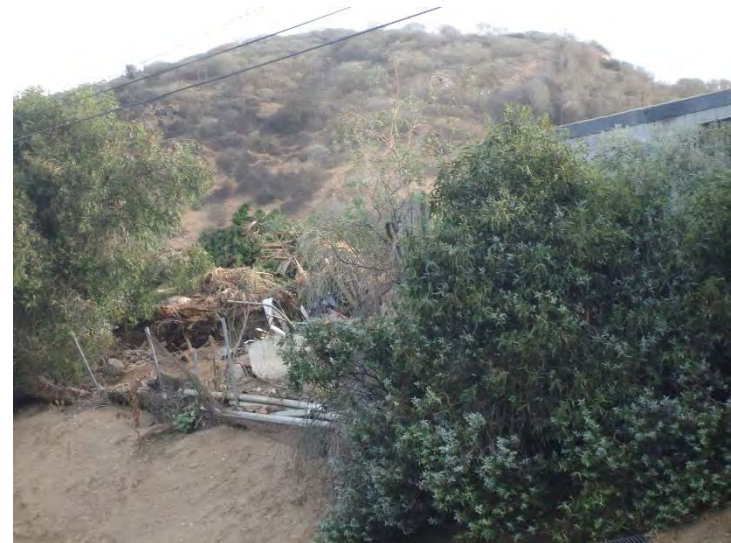
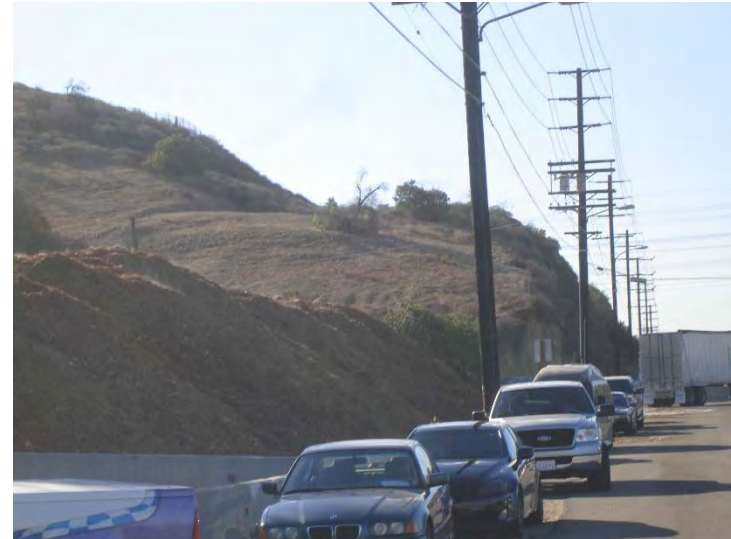
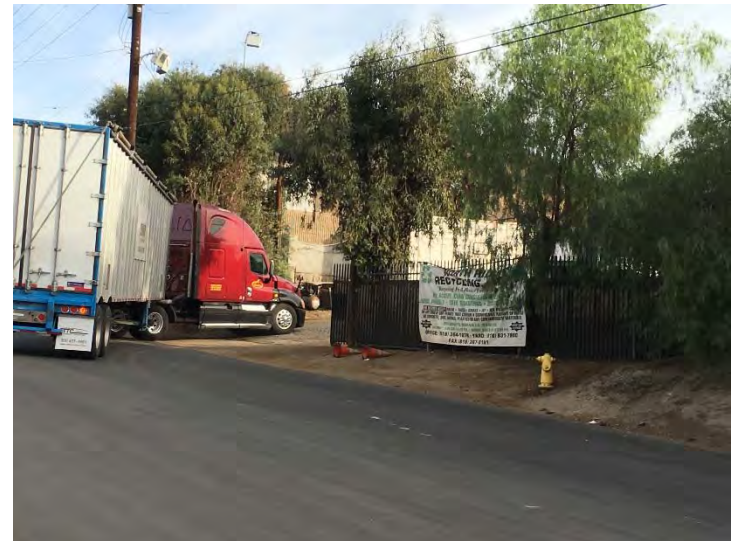
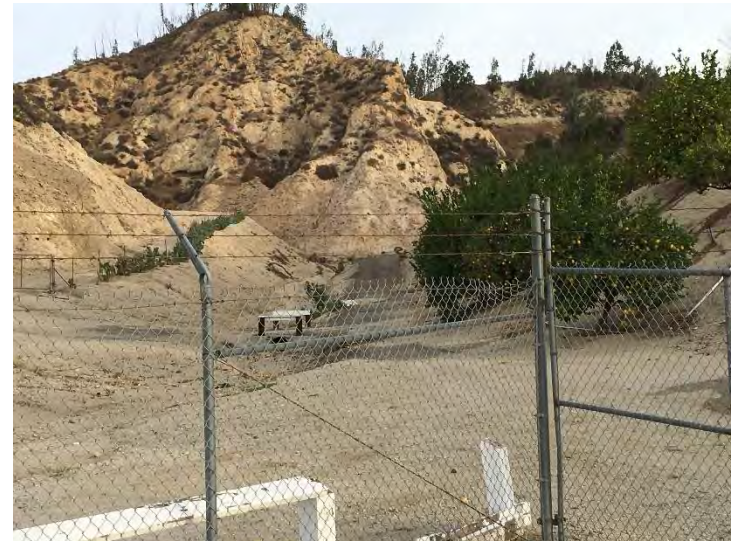
The monitors drove to the greenwaste processing facilities on Blucher Avenue. Strong greenwaste odors were detected coming from the C&D Recycling and North Hill Greenwaste facilities area. At the landfill, the monitors detected condensate odors at the sewer connection deep well pump. The covers to the deep well were not secure with the locking bolts, and the foam seal was broken.

Photo 369: Greenwaste Odor Source: October 14, 2015

Photo 370: Greenwaste Odor Source: October 14, 2015

Photo 371: Greenwaste Odor Source: October 14, 2015

Photo 372: Greenwaste Odor Source: October 14, 2015

**Photo 373: Greenwaste Odor Source: October 14, 2015**

Photo 377: Greenwaste Odor Source: October 28, 2015

Photo 378: Greenwaste Odor Source: October 28, 2015

Photo 379: Greenwaste Odor Source: October 28, 2015

Photo 380: Greenwaste Odor Source: October 28, 2015

Photo 381: Greenwaste Odor Source: November 16, 2015

**Photo 385: Greenwaste Odor Source: November 16, 2015**

**Photo 387: Greenwaste Odor Source: December 9, 2015**

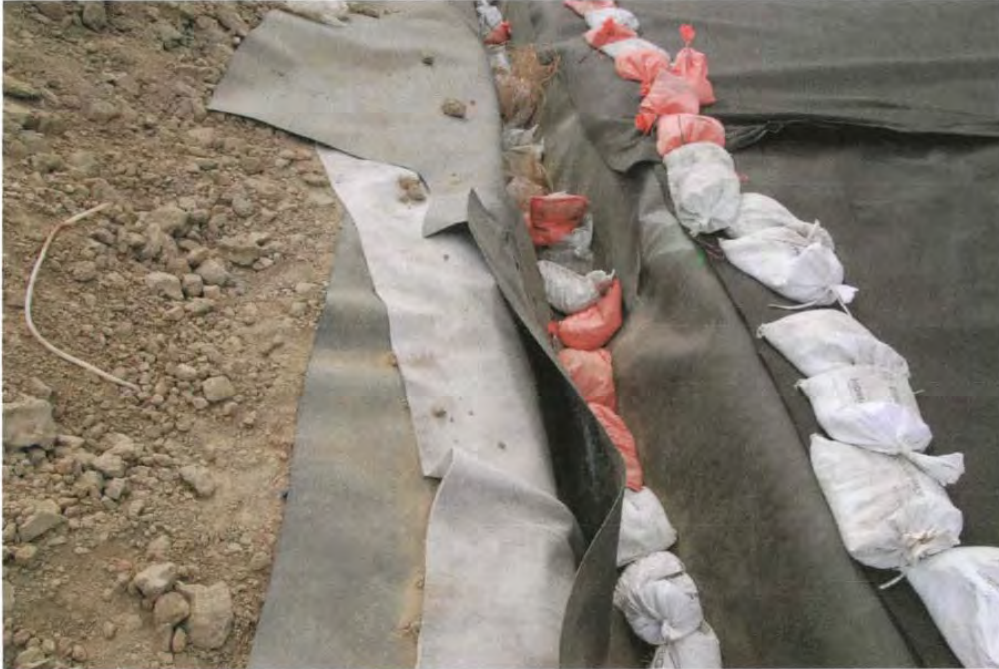
Photo 1: Liner system on slope

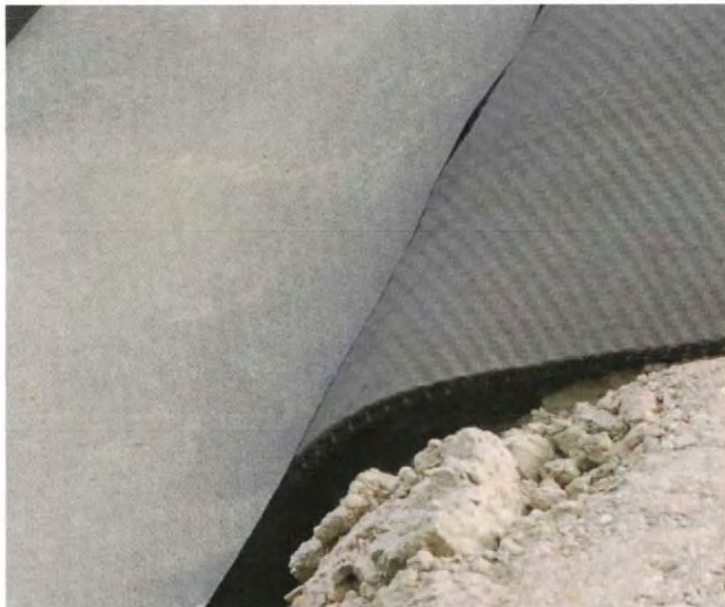
Photo 2: Geocomposite gas collection layer under liner
