**Sunshine Canyon Landfill
Independent Monitor
Quarterly Site Monitoring Status Report
January 1, 2018 – March 31, 2018**

May 25, 2018

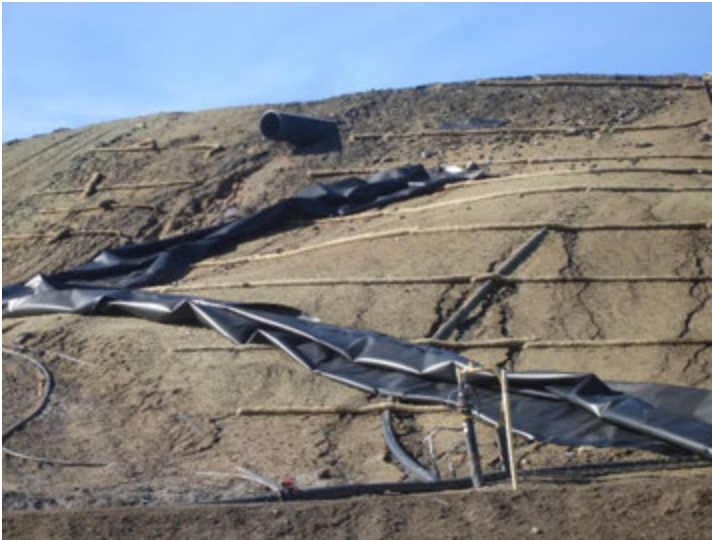
Photo 341: CC3B Slope Drainage Failure: January 10, 2018

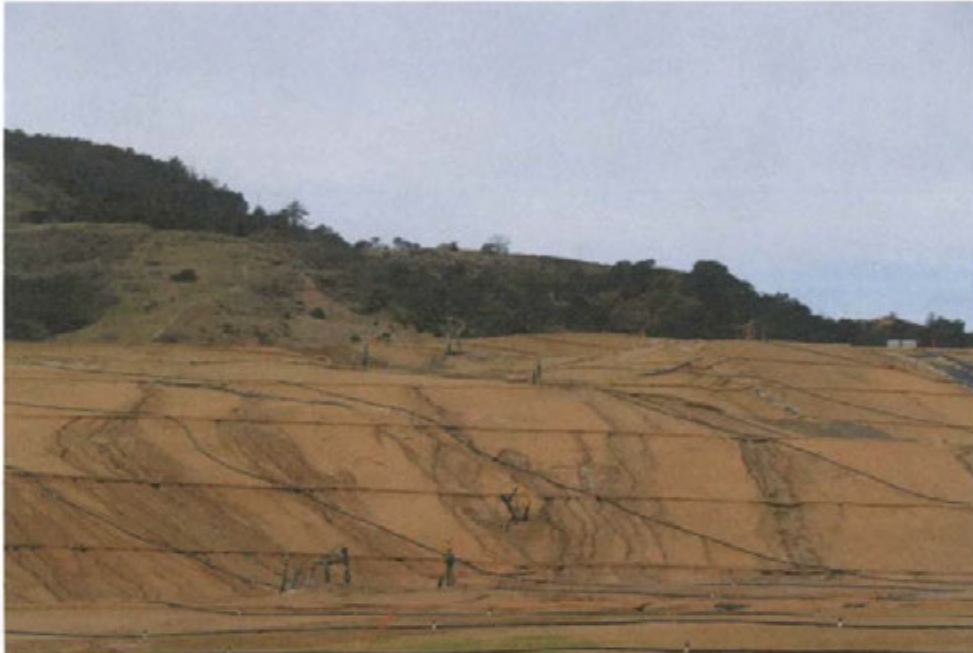
Photo 5: Gullies on Hydro seeded Slope – Note Gullies Under Wattles

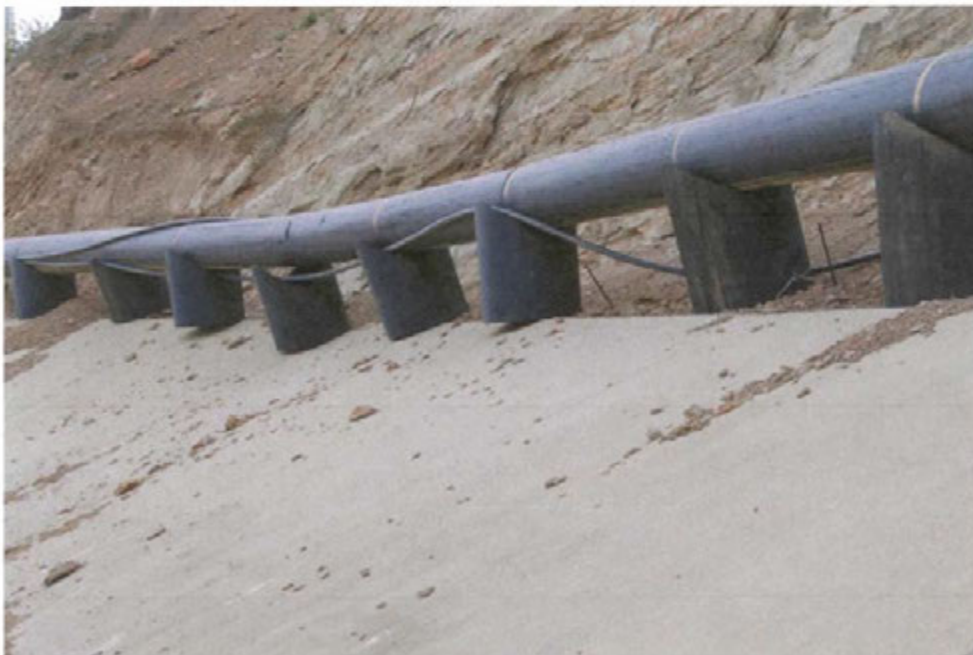
Photo 6: Leaning Supports of LFG Header to Flare 3 in Basin A

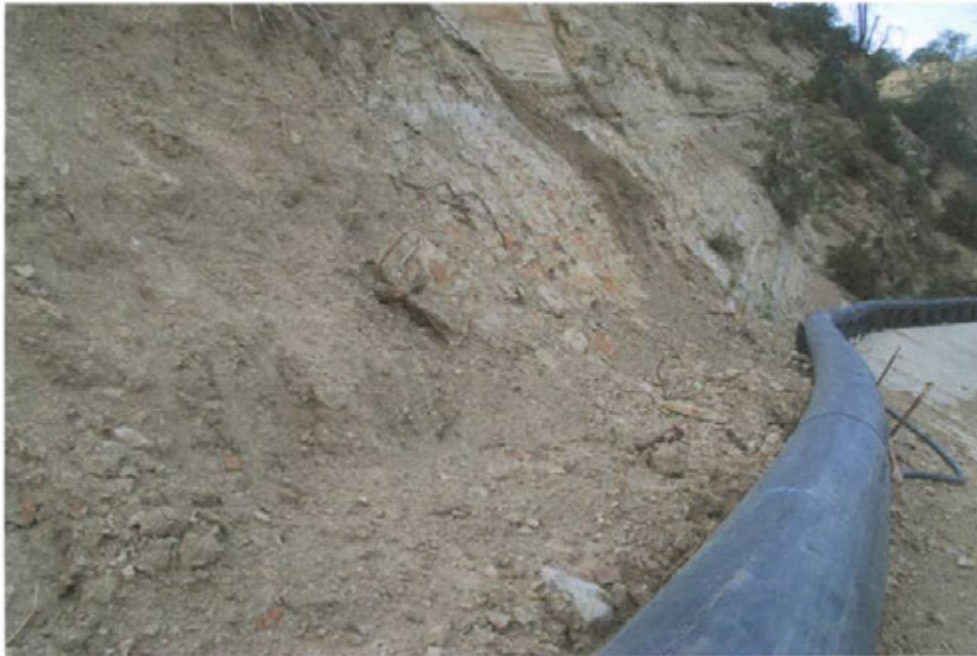
Photo 7: Sloughed Soil and Pushing Against f LFG Header to Flare 3 in Basin A

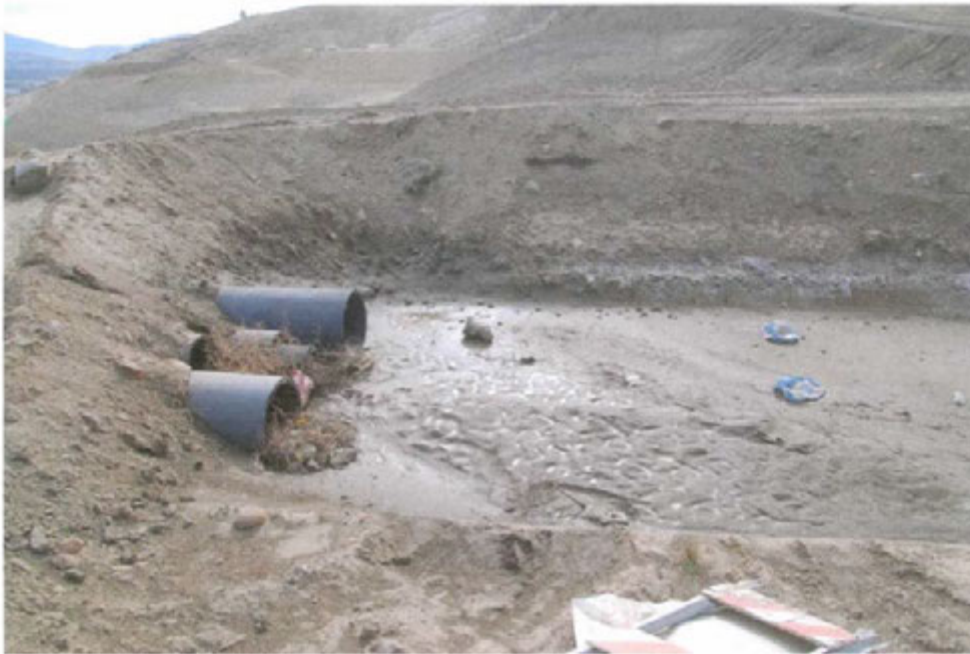
Photo 9: Sediments Accumulation Downgradient from Basin A – Pipes do not offer enough flow capacity

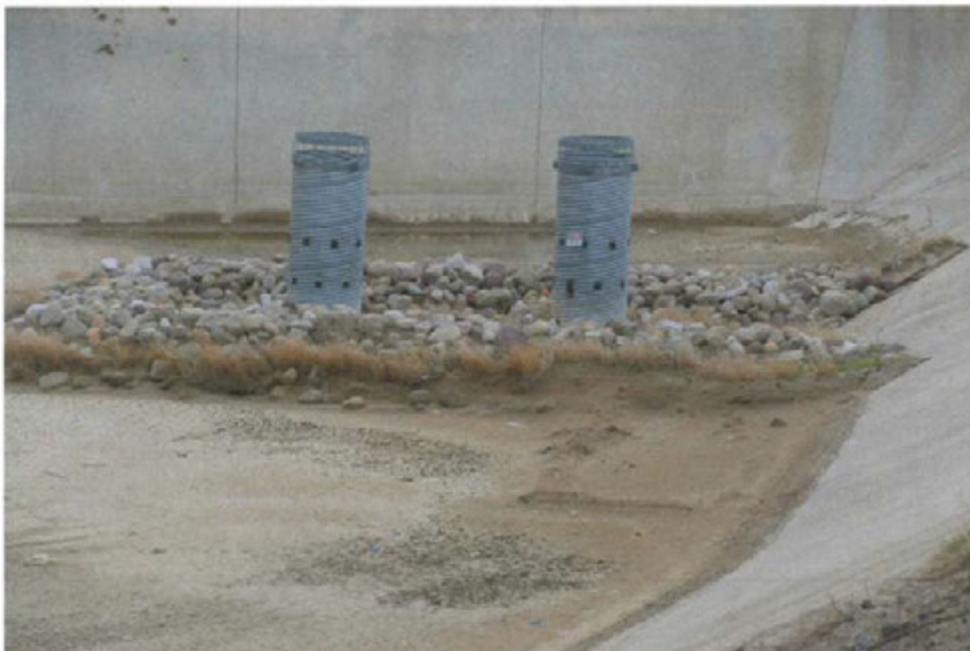
Photo 10: Sediments Accumulated in Basin B

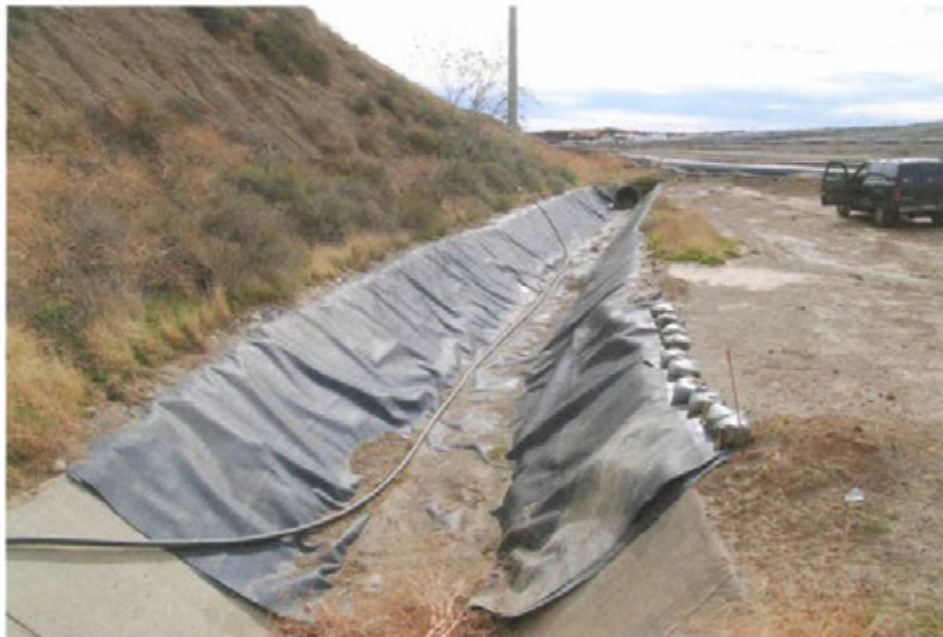
Photo 11: Repaired and Re-attached Geomembrane in Shotcrete Channel between Basin D and Access Road to Flare 9 and 10

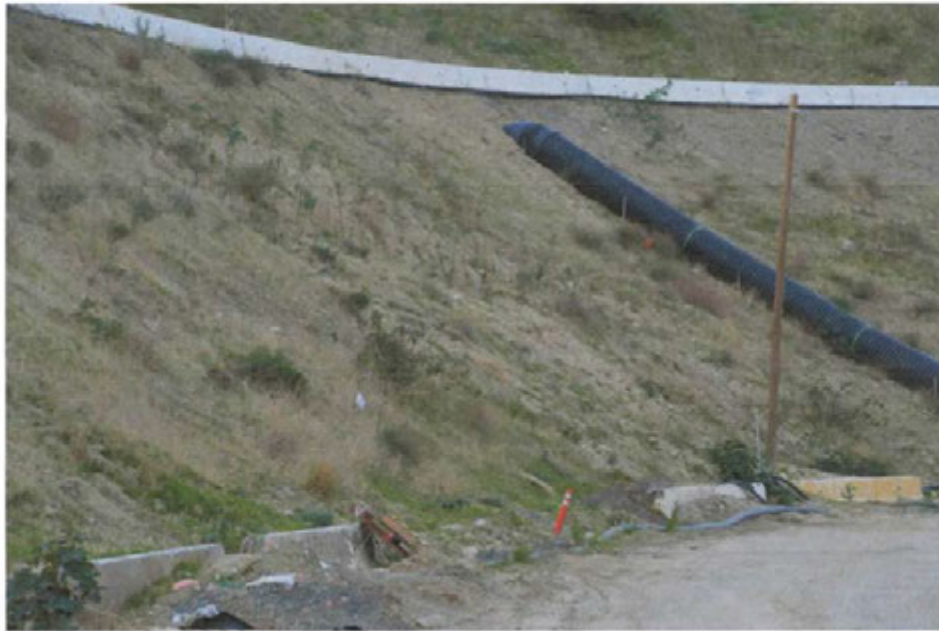
Photo 13: Sloughing Tilted Utility Pole on Embankment of Main Access Road near Entrance of Terminal Basin

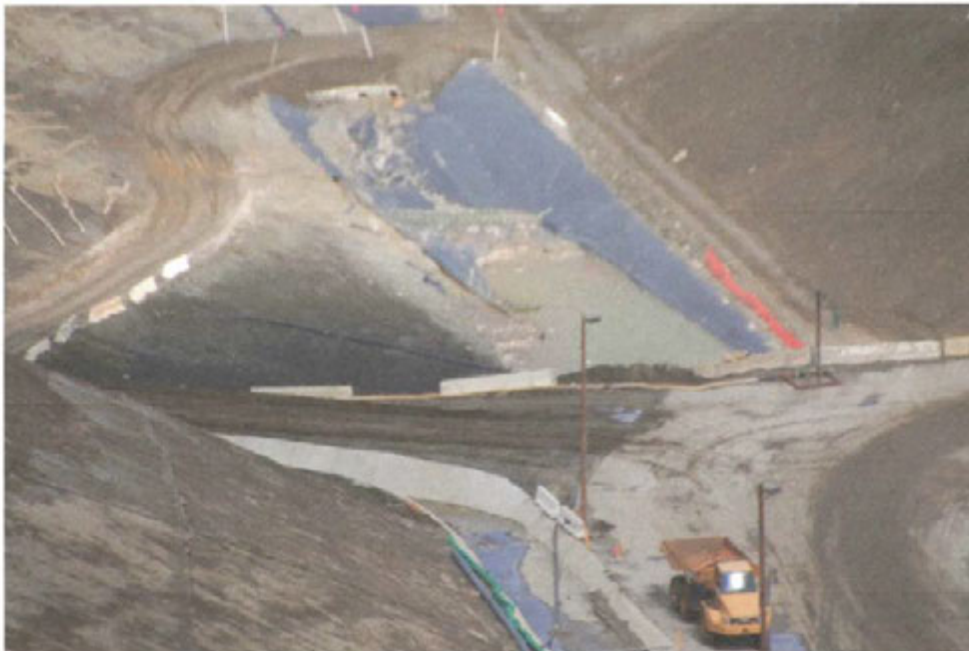
Photo 2: Water and refuse in lined collection area around Cell CC4 Phase 2

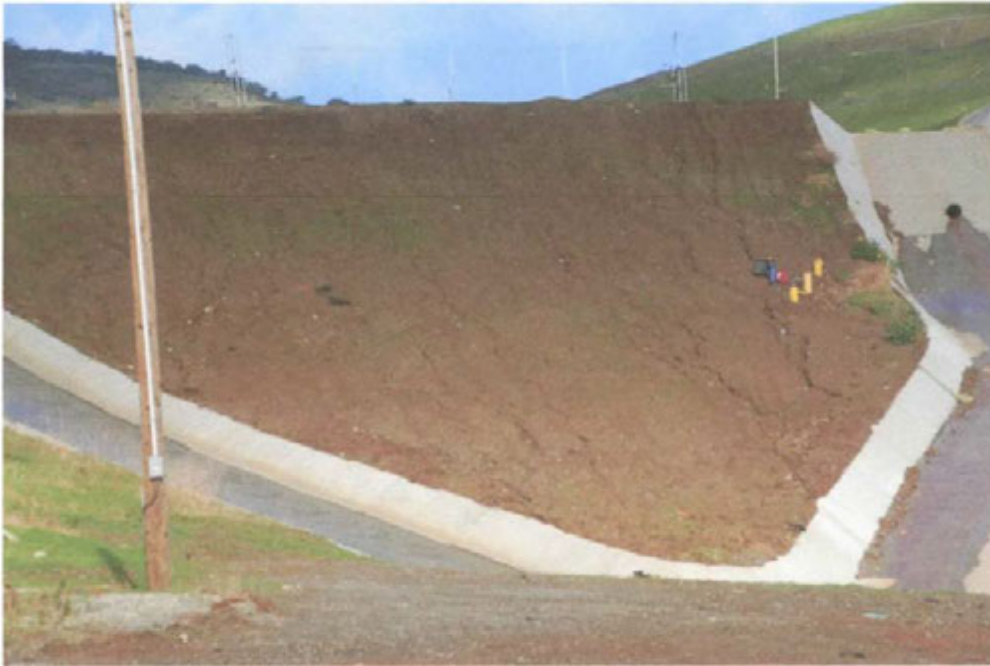
Photo 3: Erosion on upstream face of earthen basin embankment at Cell CC3

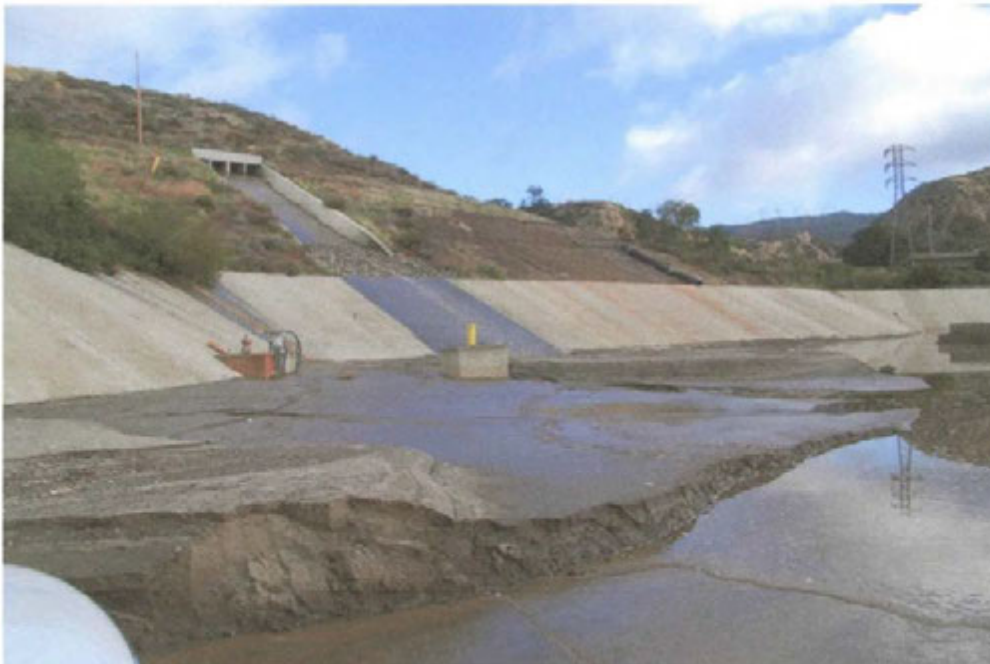
Photo 4: Sediments in Terminal Basin Upstream of Gabion Wall

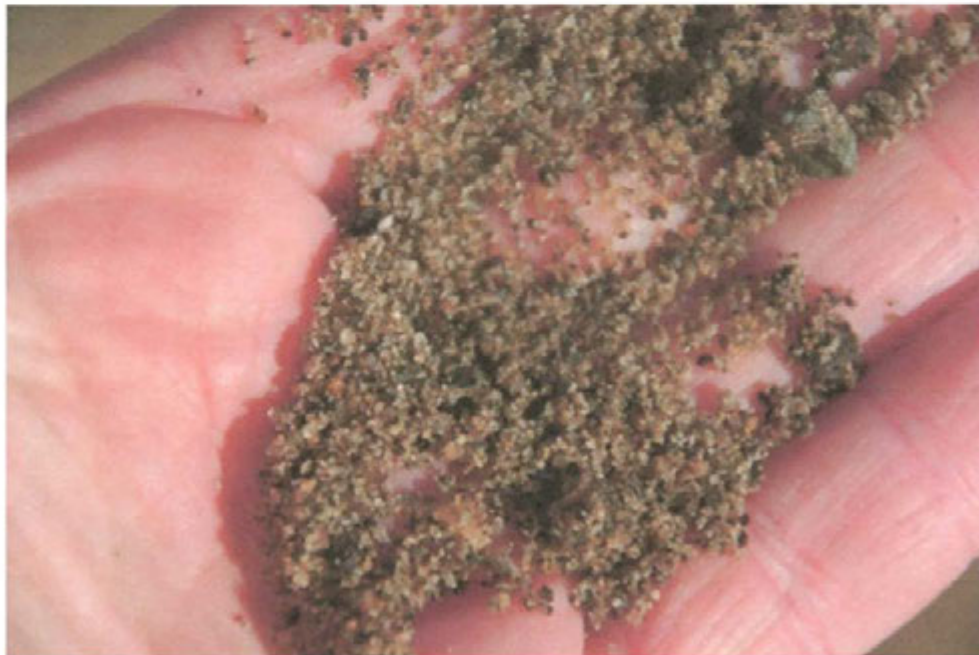
Photo 6: Coarse Sand Observed in Sediments in Terminal Basin

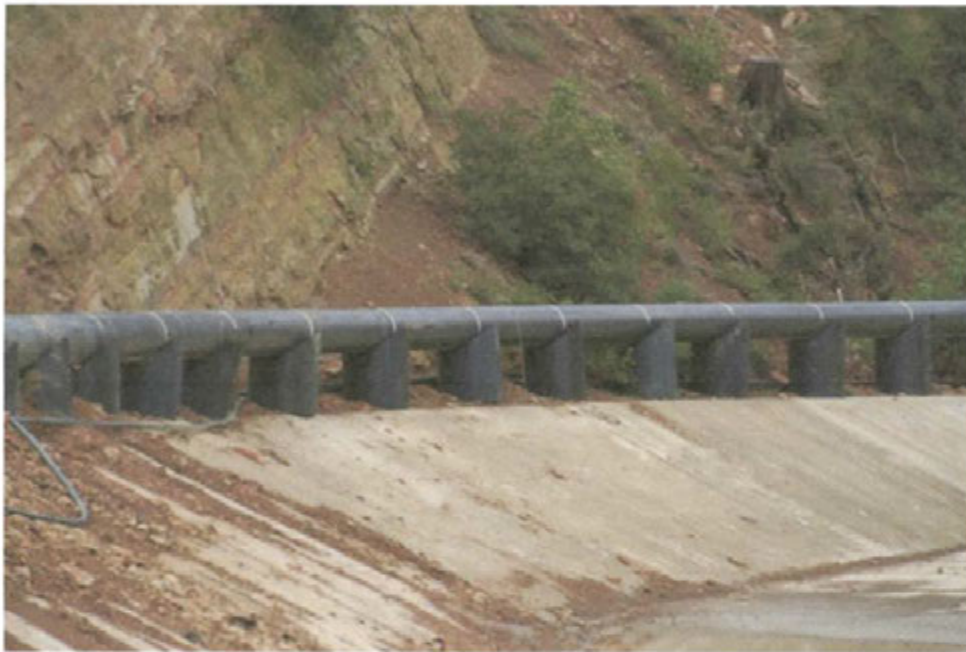
Photo 9: Leaning Supports of LFG Header to Flare 3 in Basin A

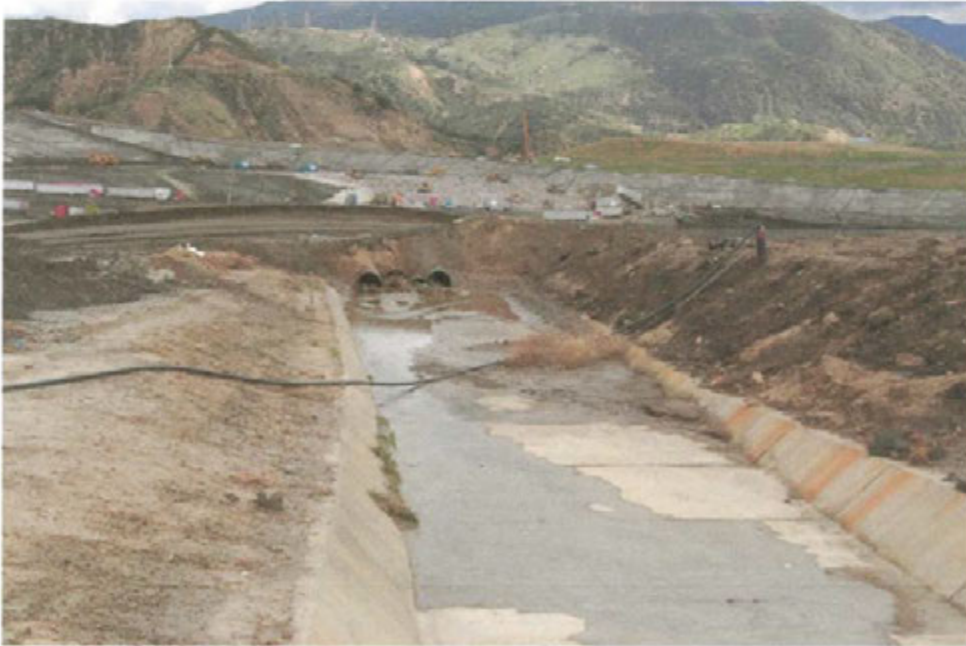
Photo 10: Sediments Accumulation Downgradient from Basin A – Pipes may not offer enough flow capacity

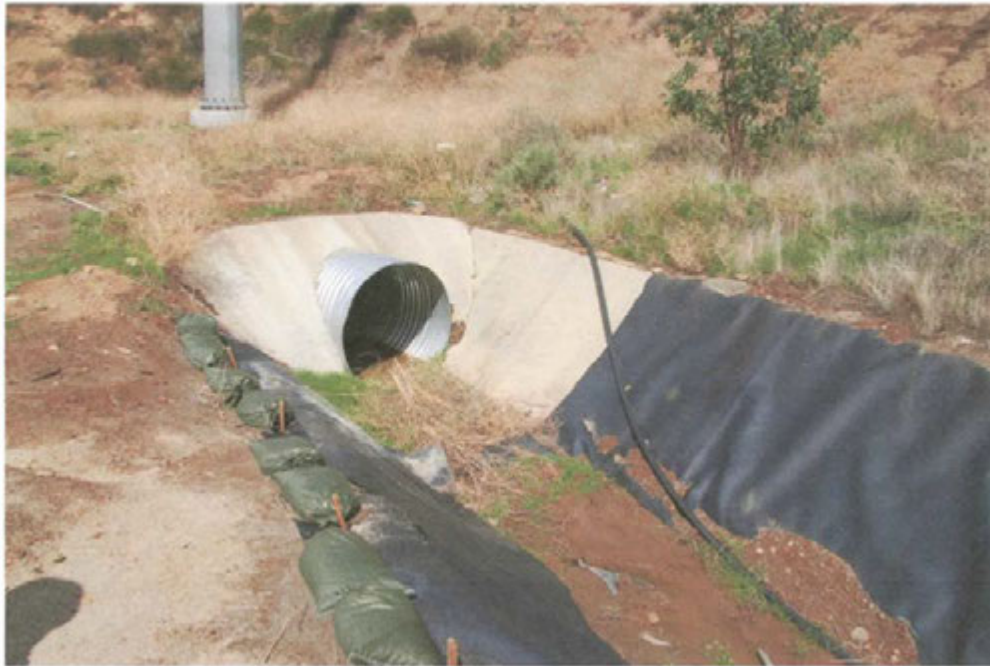
Photo 13: Sediment and debris on geomembrane lined channel between Basin B and Basin D

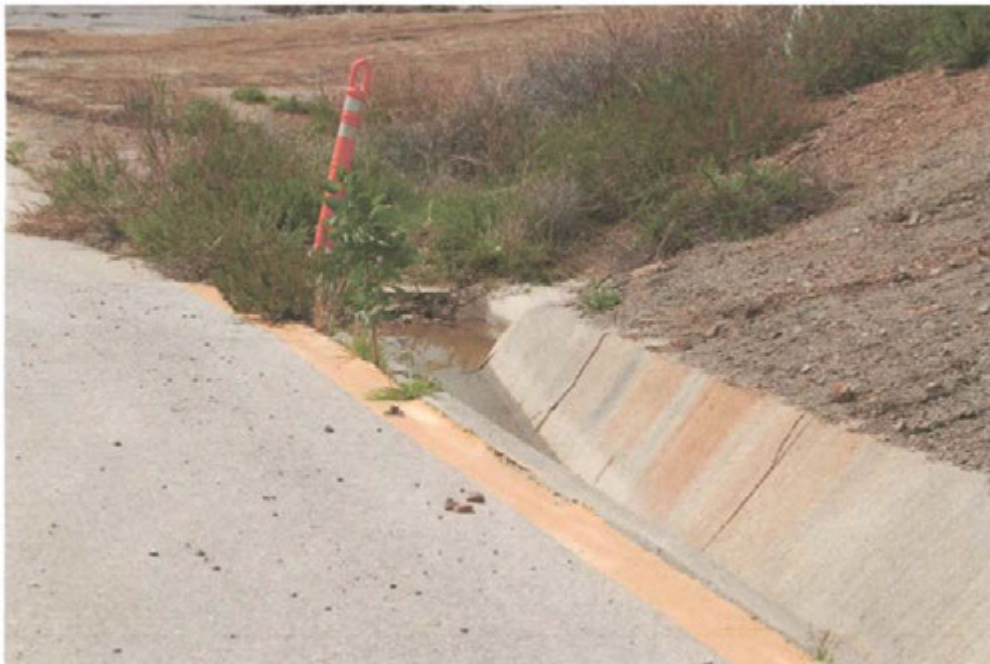
Photo 14: Blocked drainage ditch along access road to Flare 9-11

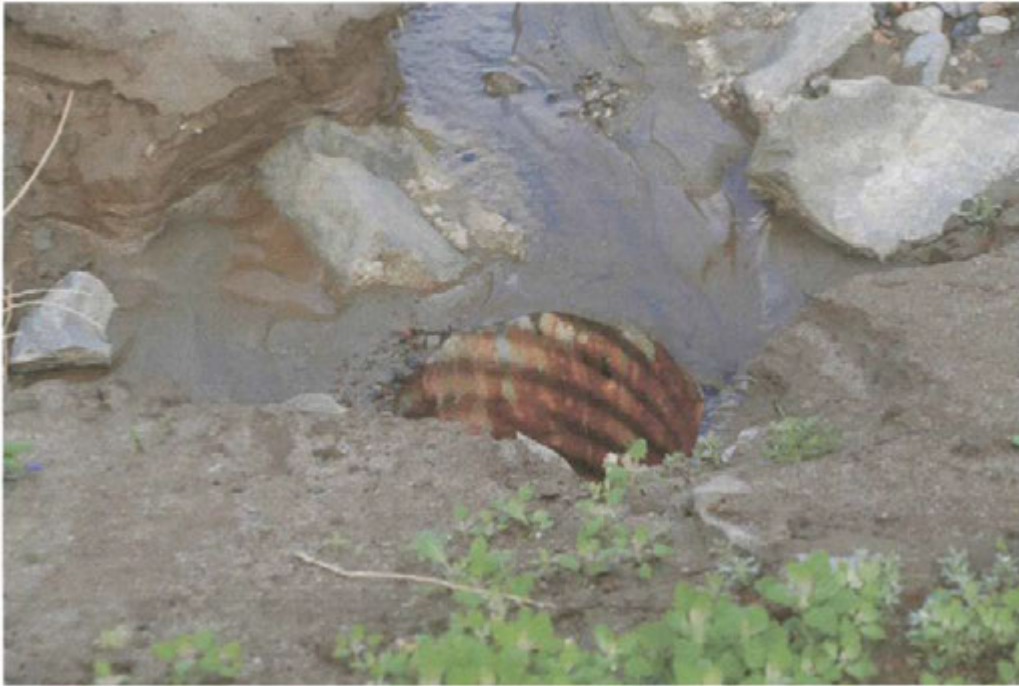
Photo 15: Unguarded intake to drain pipe in earthen basin at Cell CC3

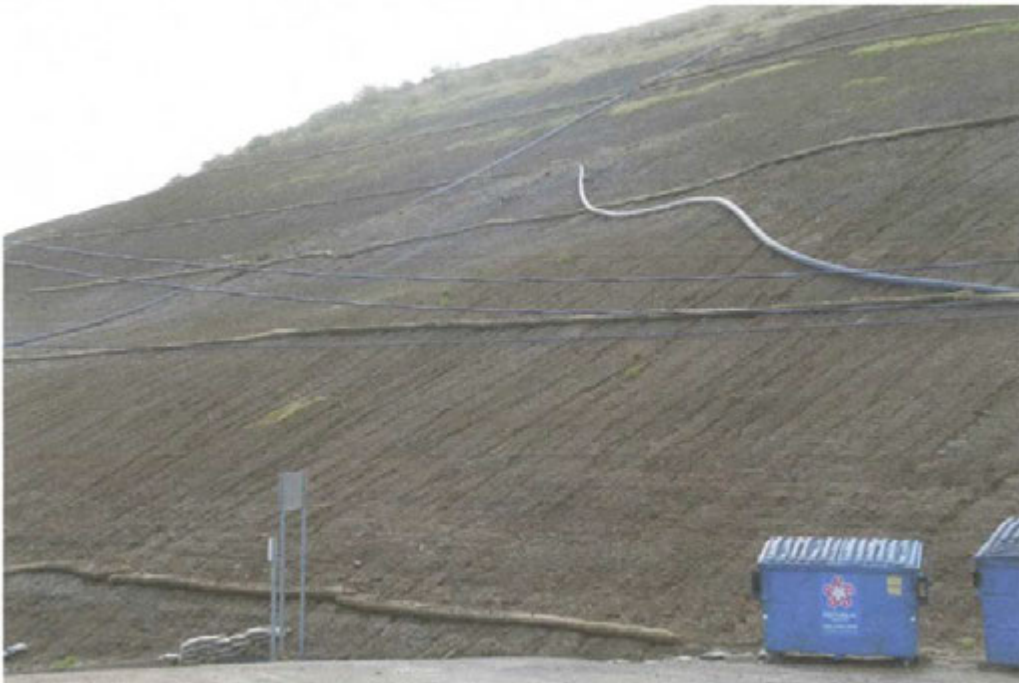
Photo 16: Slump near Administration Pad

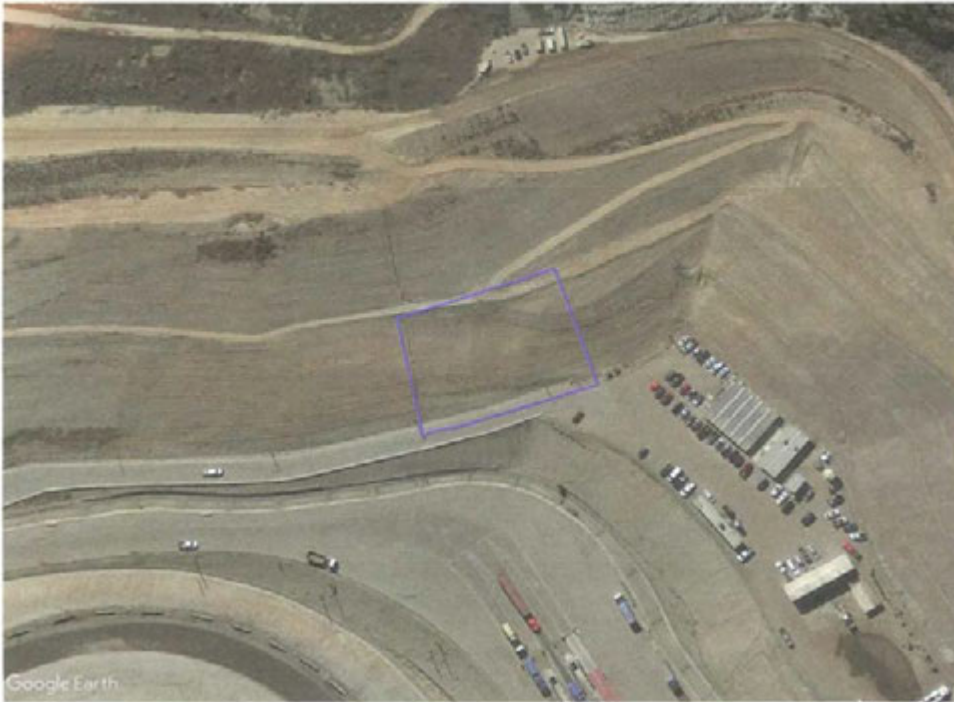
Figure 1: Area along Access Road to Administration Pad with Slump

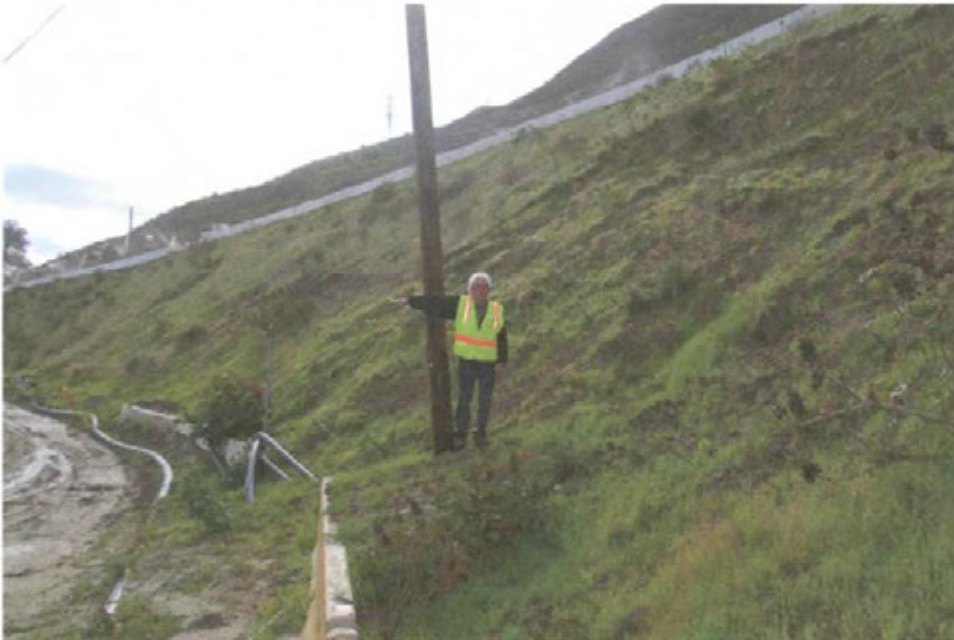
Photo 17: Sloughing and Tilted Utility Pole on Embankment of Main Access Road near Entrance of Terminal Basin

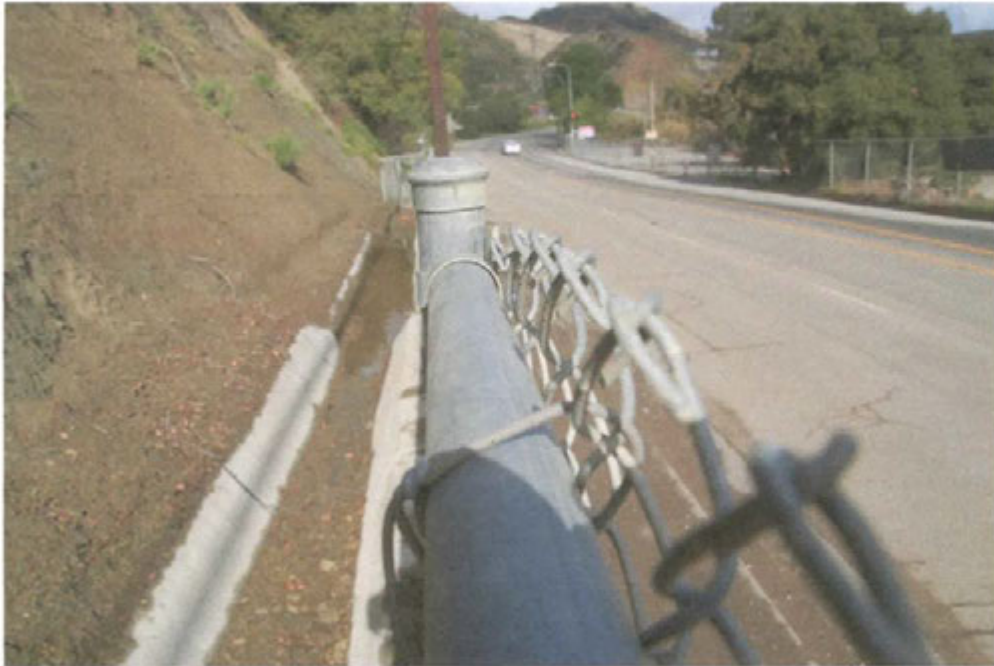
Photo 18: Soil in drainage swale on top of wall along San Fernando Road

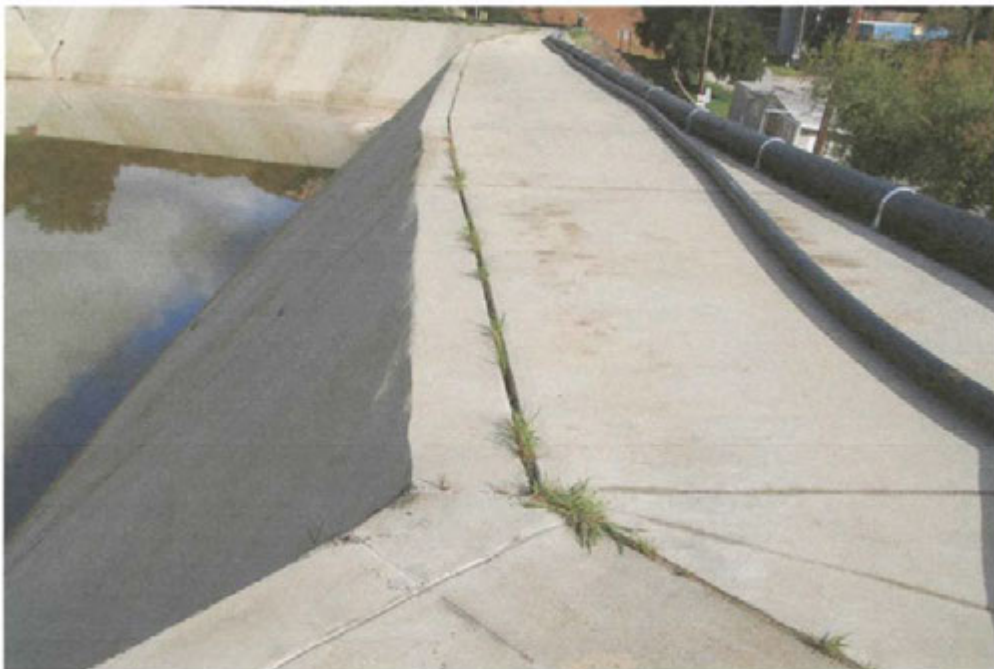
Photo 19: Gap between slabs at Terminal Basin

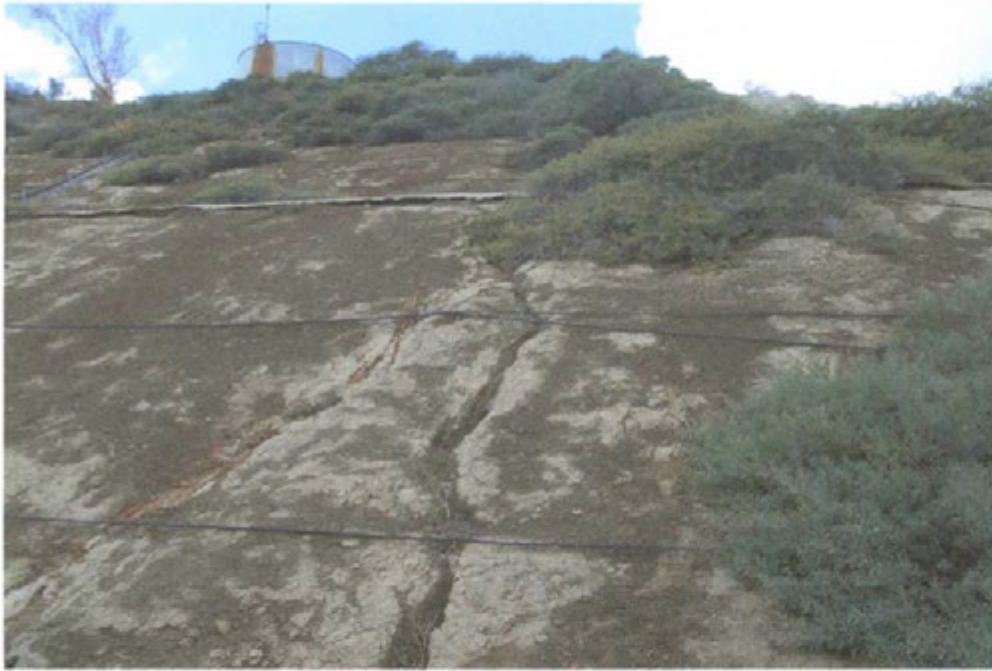
Photo 20: Undermined drainage channel on hillside near Flare 1

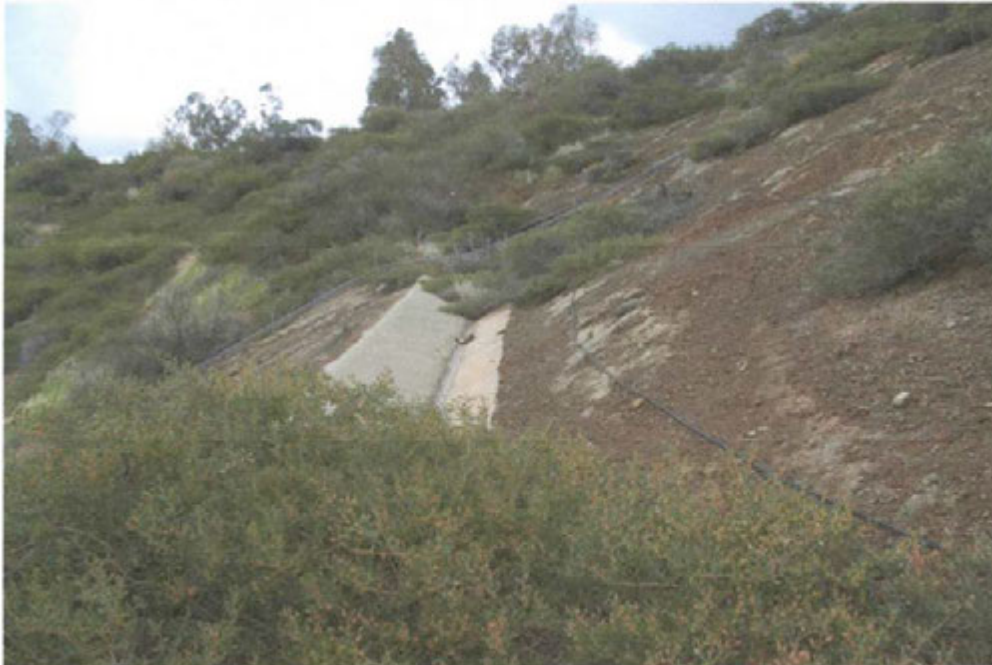
Photo 21: Sediment and vegetation in drainage channel on hillside near Flare 1

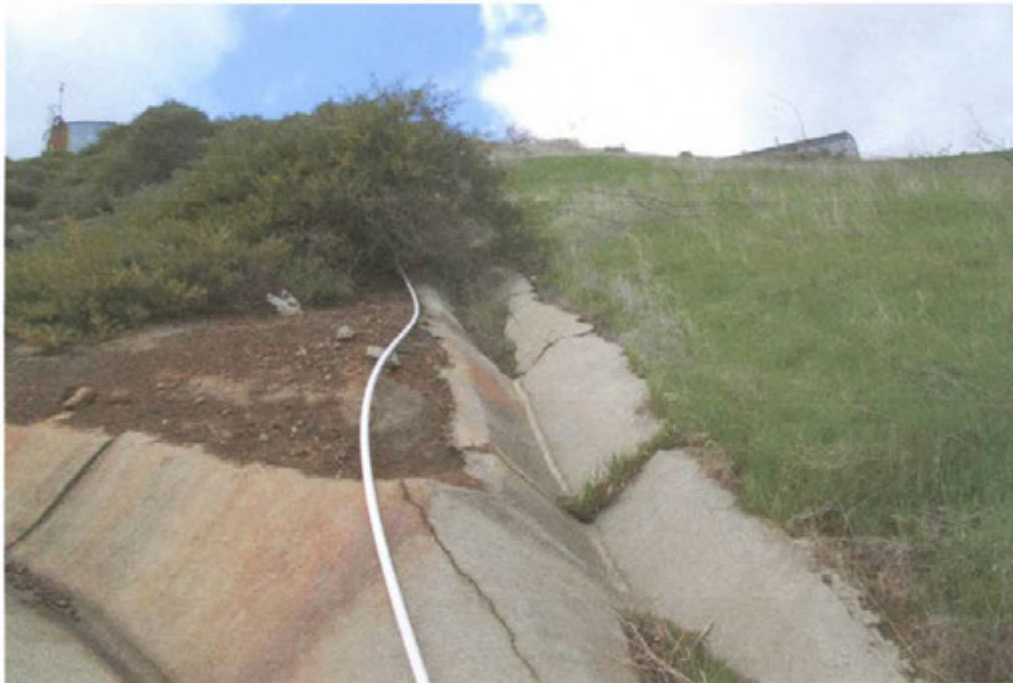
Photo 22: Cracks in drainage channel on hillside near Flare 1
