**Sunshine Canyon Landfill  
Independent Monitor  
Quarterly Site Monitoring Status Report  
January 1, 2019 – March 31, 2019**

April 29, 2019

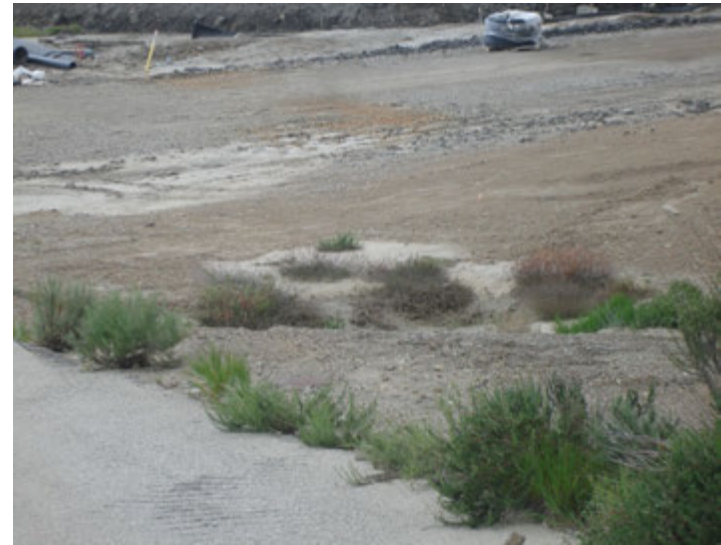
**Photo 184: County Flare Road Plugged Drainage: March 28, 2019**

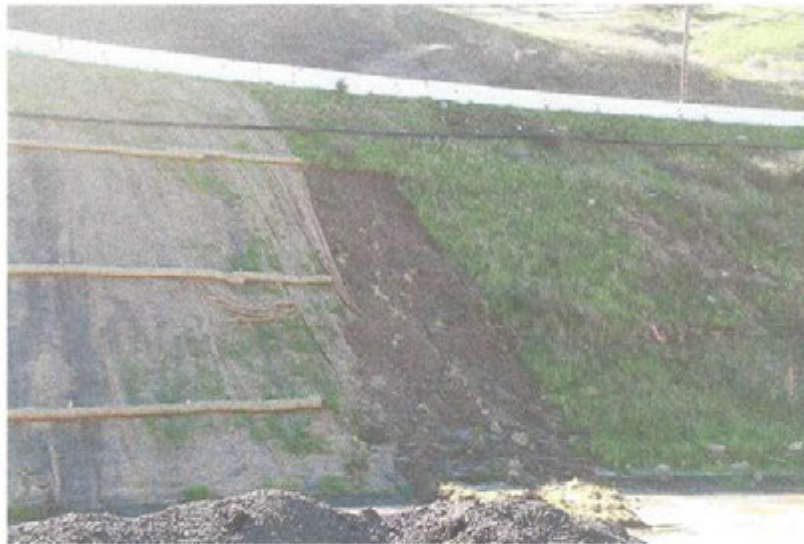
Photo 1: Soil sloughing on slope of embankment of main access road

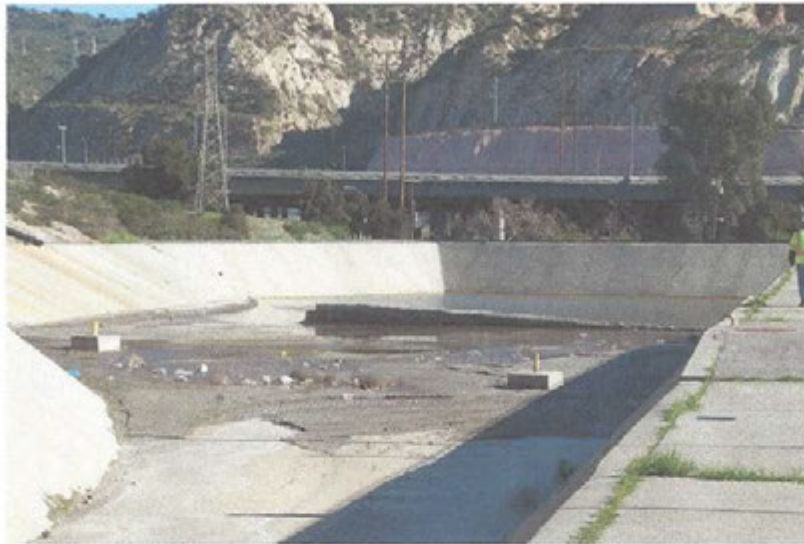
Photo 3: Sediment in Terminal Basin

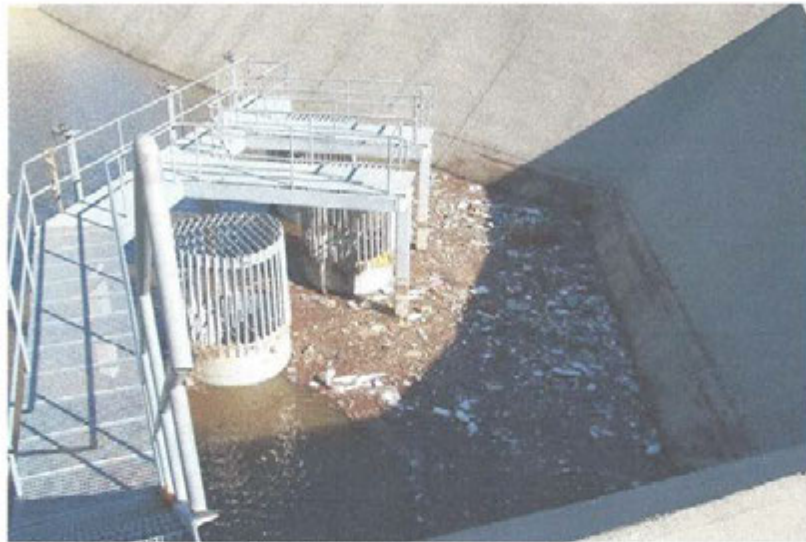
Photo 5: Waste collected behind decant towers at Terminal basin

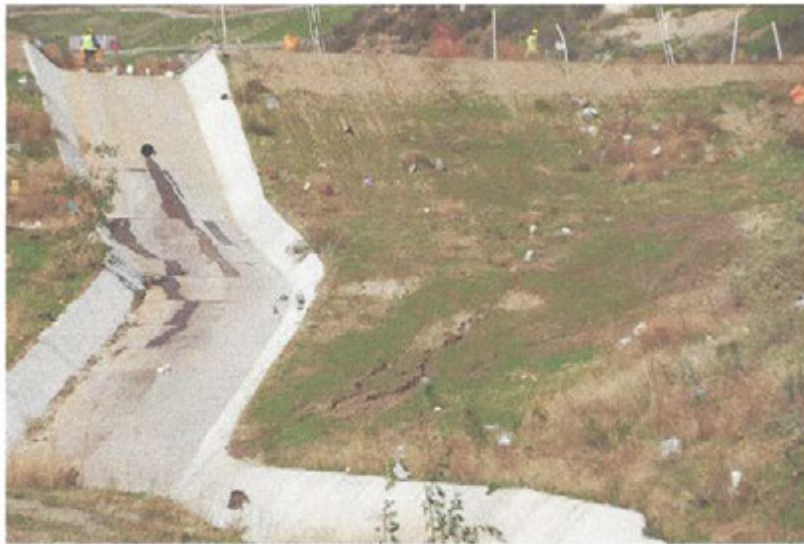
Photo 7: Erosion on slope of embankment for basin CC3

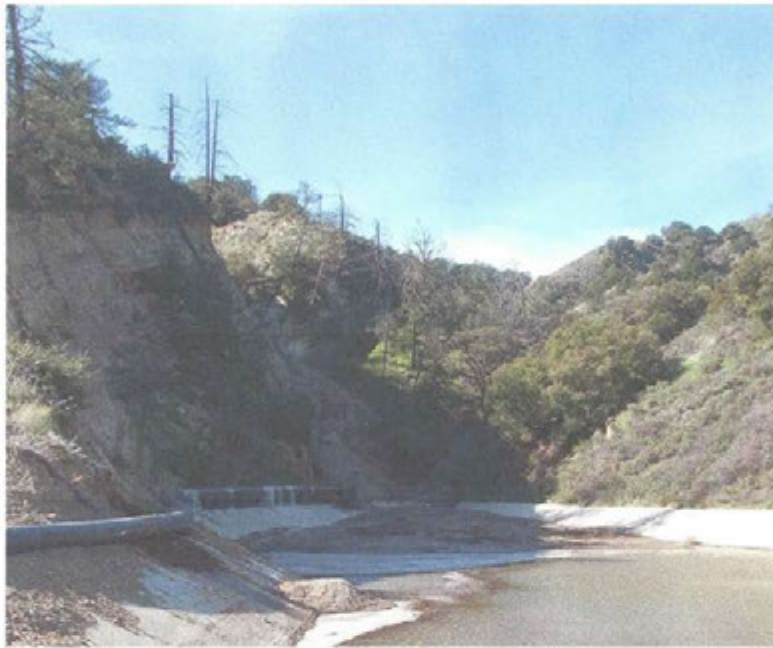
Photo 9: Sediments at back of Basin A

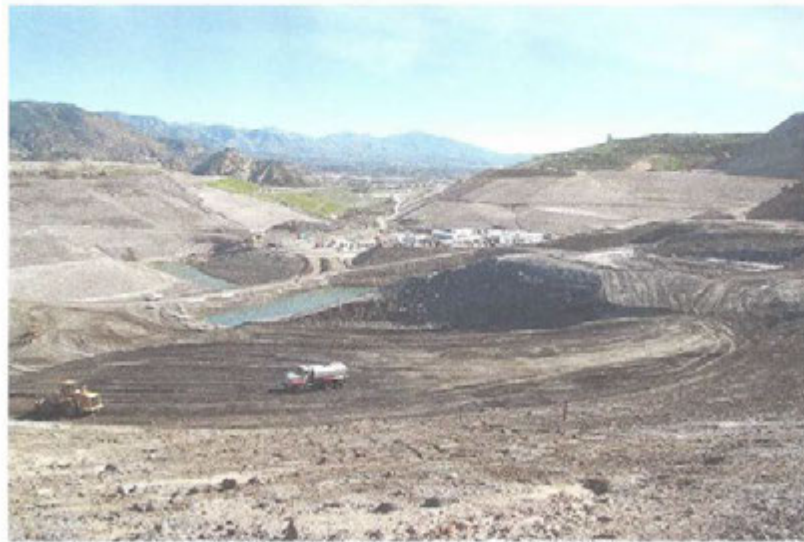
Photo 10: Water collected in temporary basin at toe of buttress

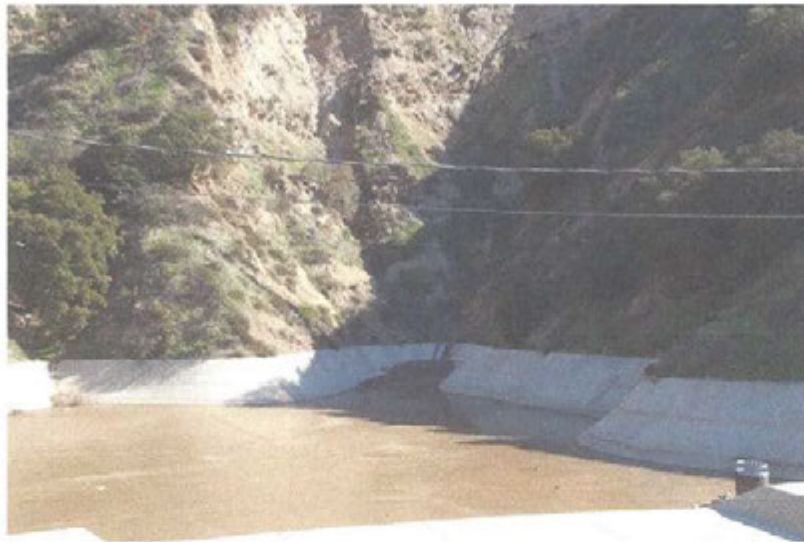
Photo 11: Sediments at back of Basin B

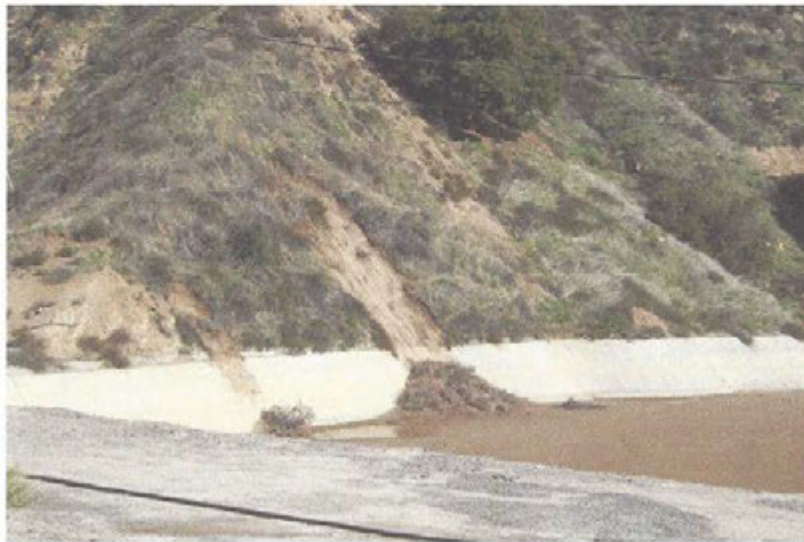
Photo 12: Sloughing on side of Basin B with sediments

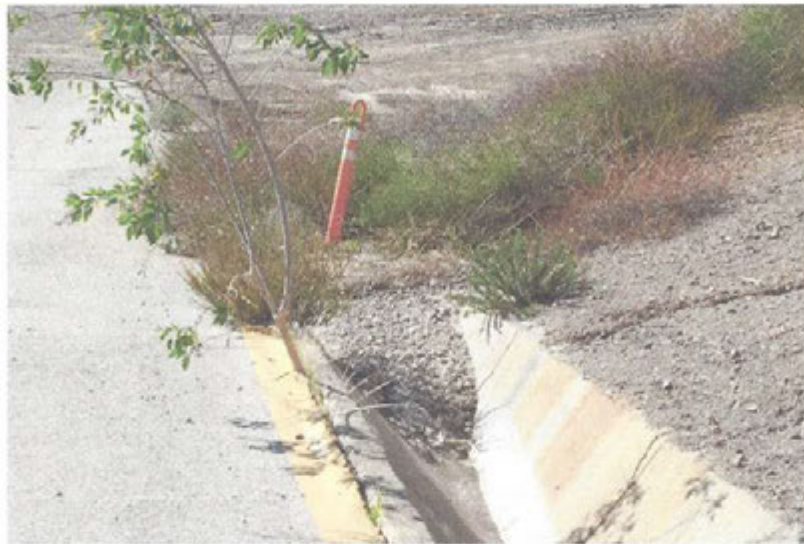
Photo 13: Sediments plugging drain at end of ditch along access road to Flares 9-11

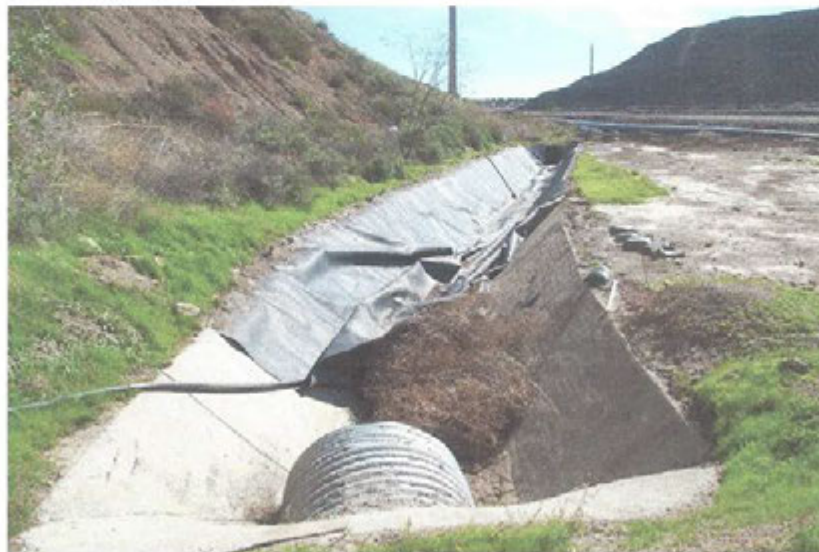
Photo 14: Damage to membrane on first segment of channel west of the access road to Flares 9-11

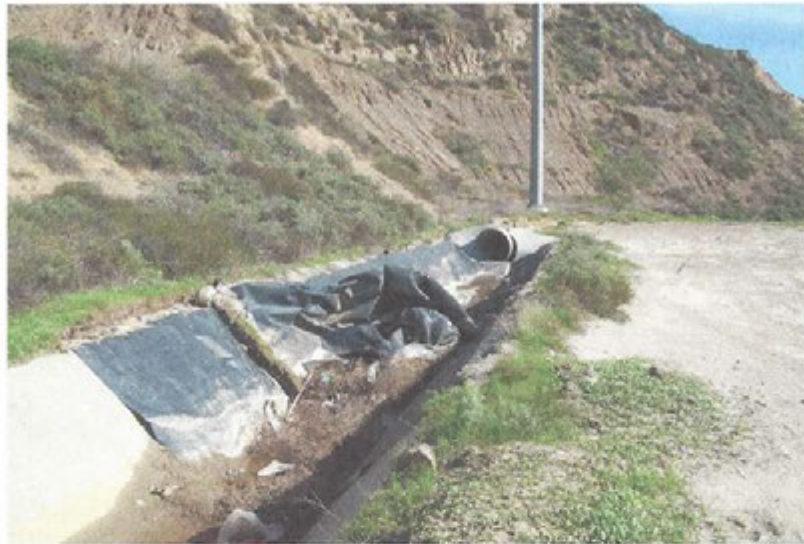
Photo 15: Damage to membrane and culvert on second segment of channel west of the access road to Flares 9-11

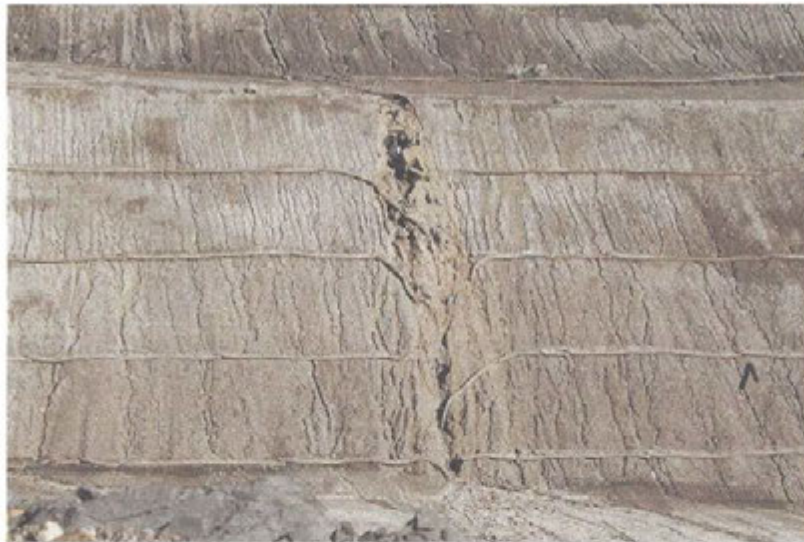
Figure 19: Deep erosion gully exposing refuse on slope of Cell CC3 Phase 3

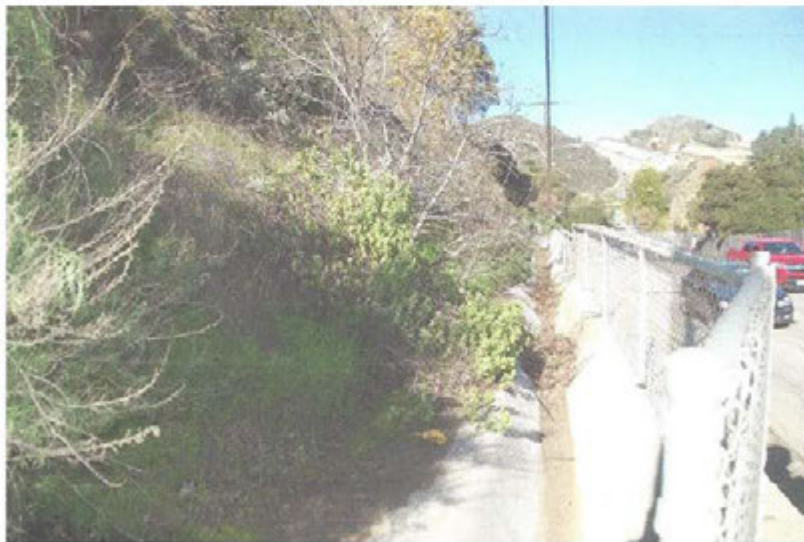
Figure 20: Sediments in drainage swale at wall along San Fernando road

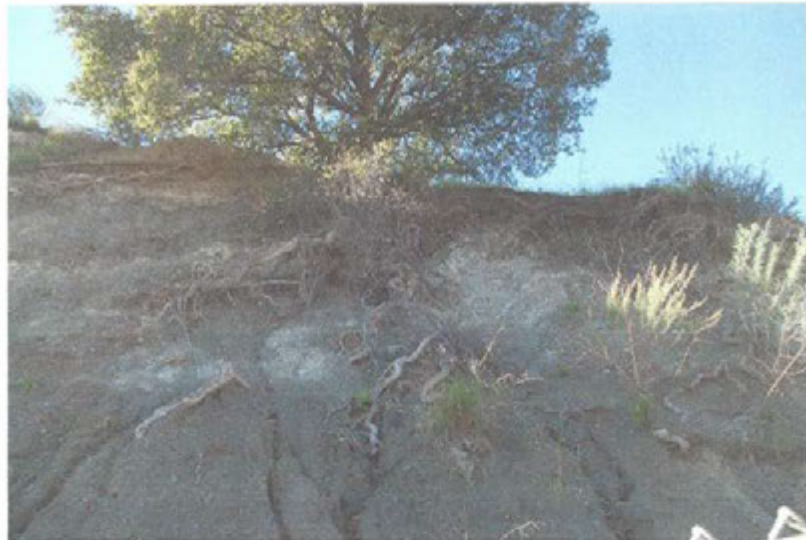
Figure 21: Exposed roots of tree above wall along San Fernando road

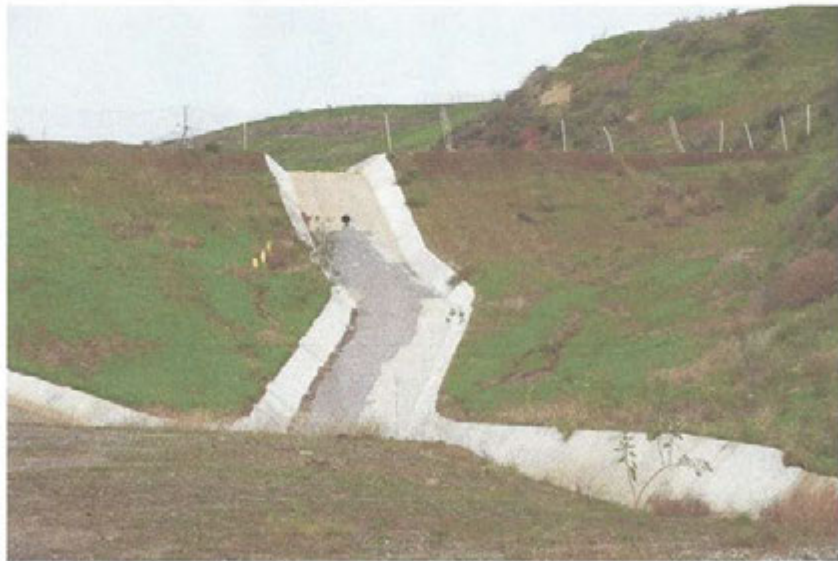
Photo 8: Erosion on slope of embankment for earthen basin CC3

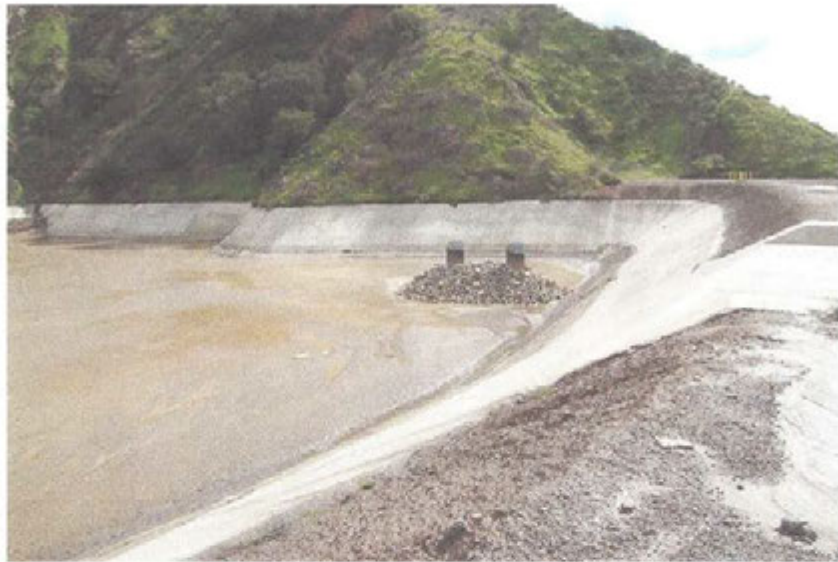
Photo 9: Sediment in basin B

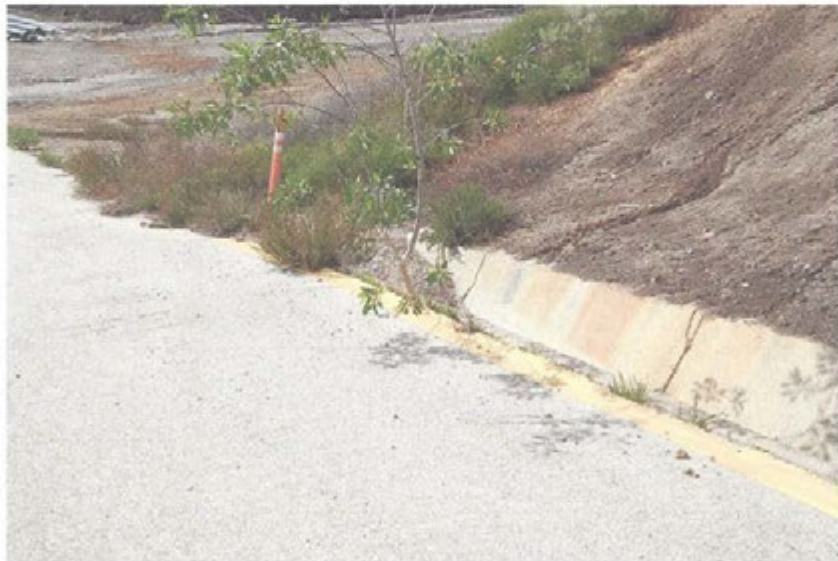
Photo 10: Sediments plugging drain at end of ditch along access road to Flares 9-11

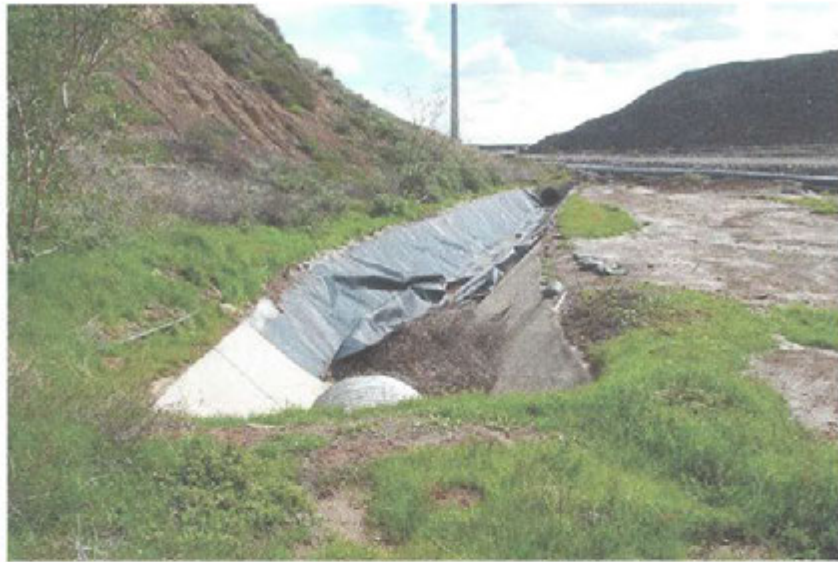
Photo 11: Damage to membrane on first segment of channel west of the access road to Flares 9-11

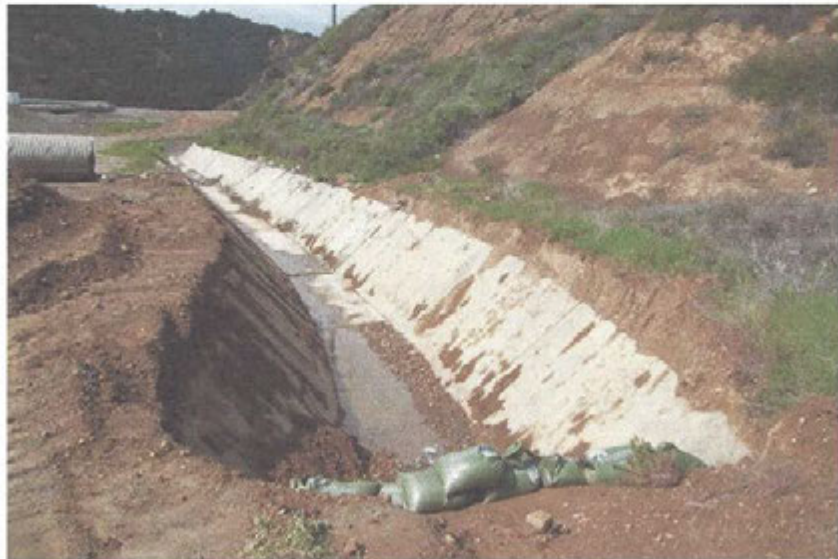
Photo 12: Culvert removed on second segment of channel west of the access road to Flares 9-11

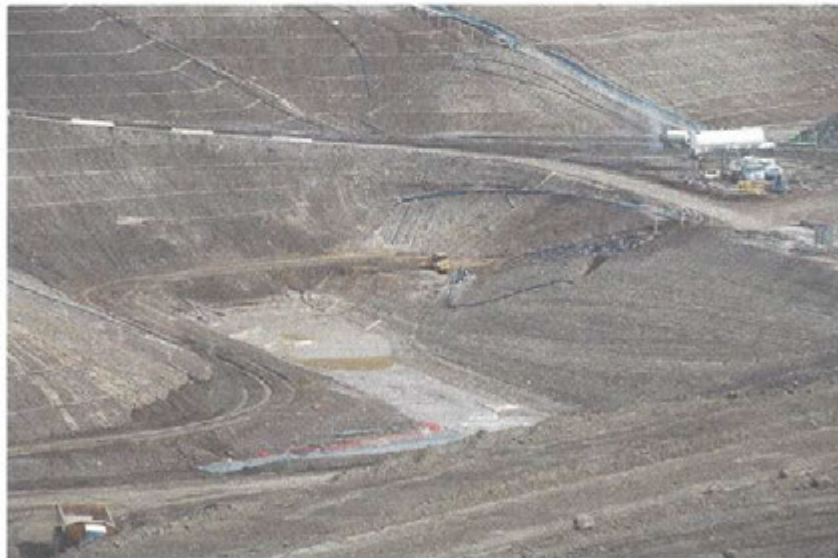
Photo 14: Sediment accumulation in moat around Cell CC4 Phase 3

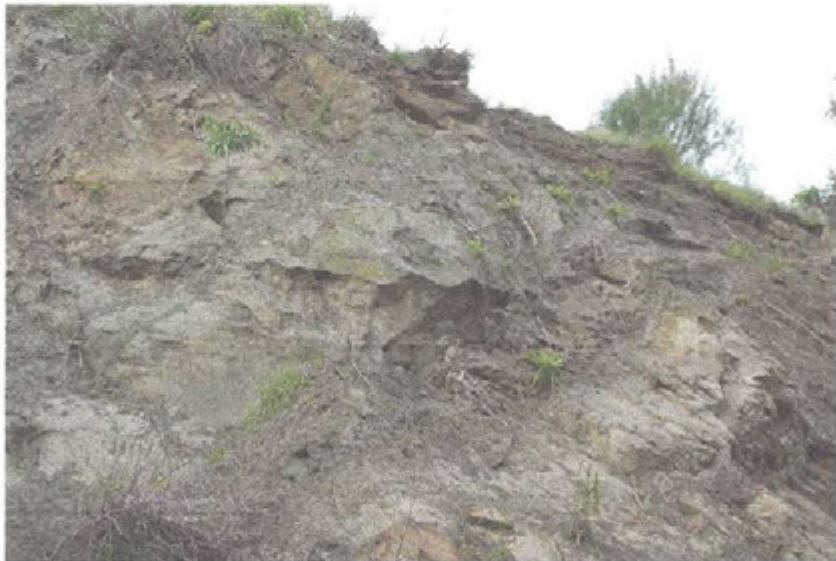
Figure 16: Overhang above wall along San Fernando road

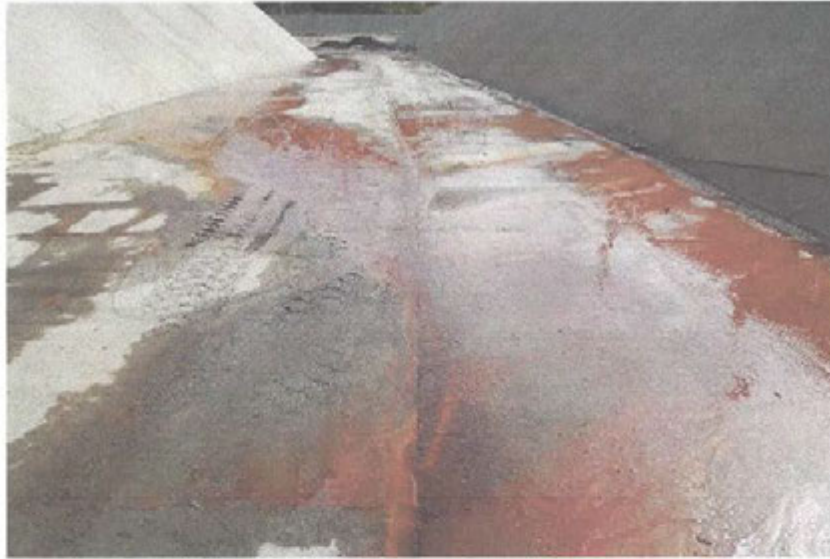
Photo 5: Water flowing out between floor slab joints at Terminal basin

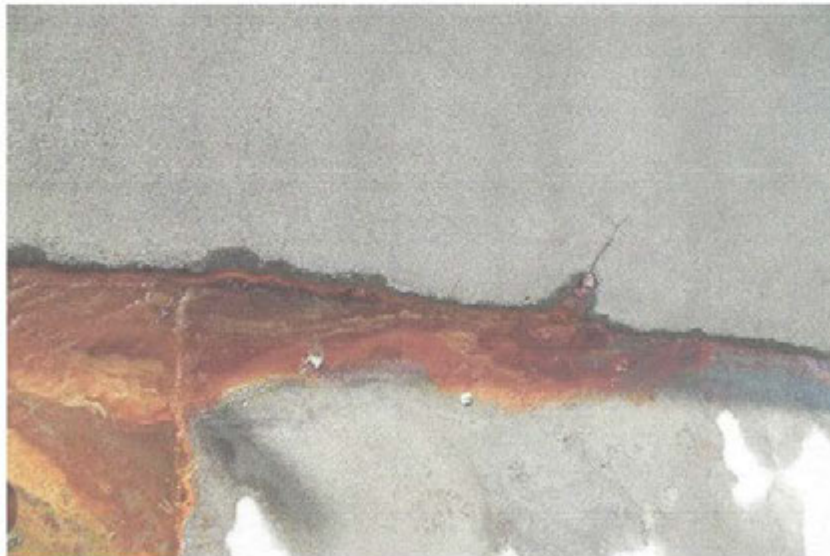
Photo 6: Reddish deposit from water seeping through weep holes at the bottom of the wall

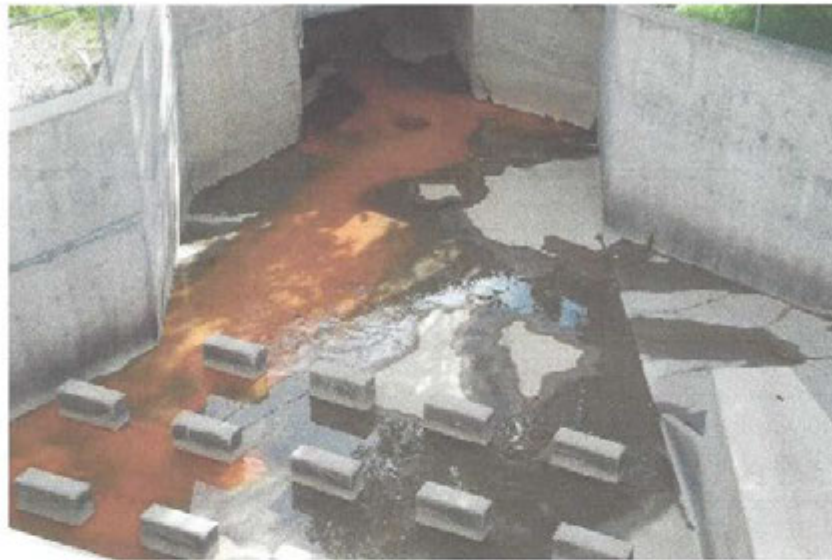
Photo 7: Reddish water exiting Terminal basin

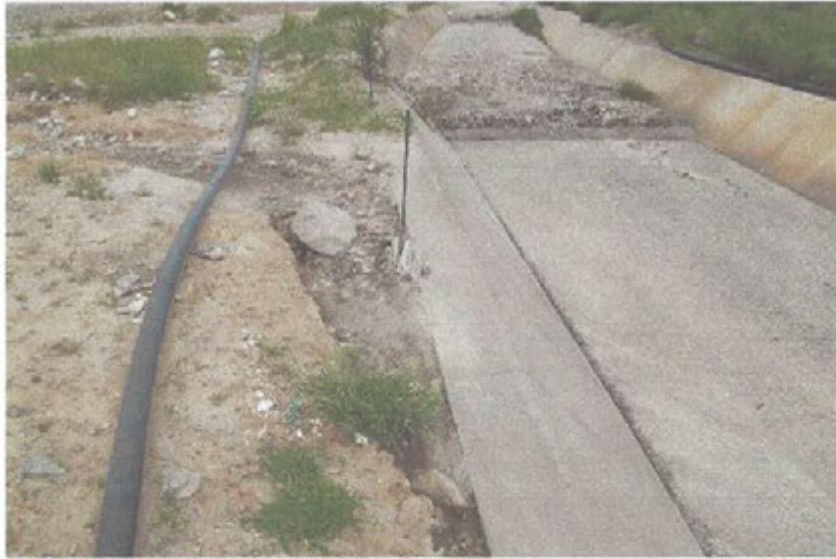
Photo 9: Erosion along edge of channels between Basin B and Terminal Basin and sediments trapped on gabion

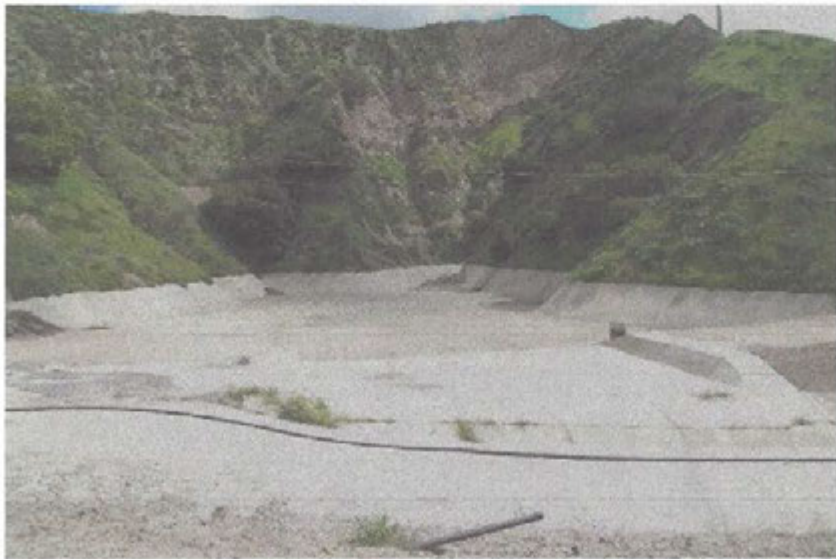
Photo 10: Sediments in basin B

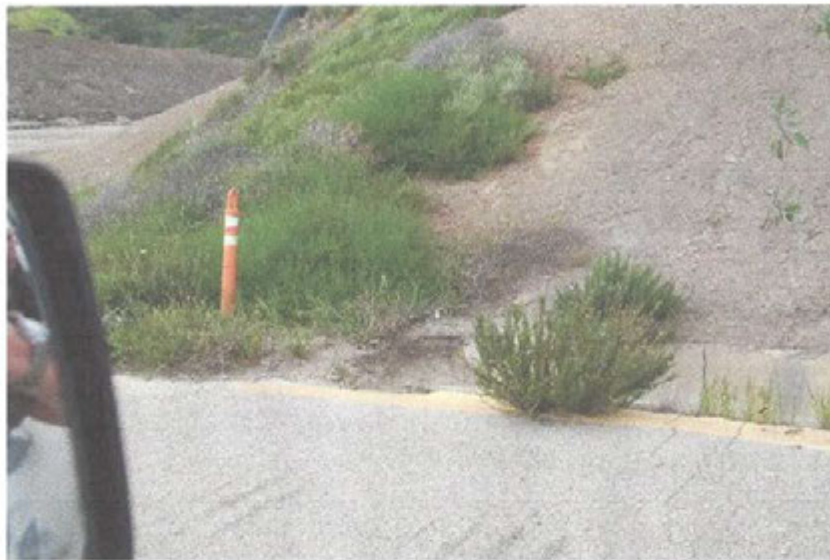
Photo 11: Sediments plugging drain at end of ditch along access road to Flares 9-11

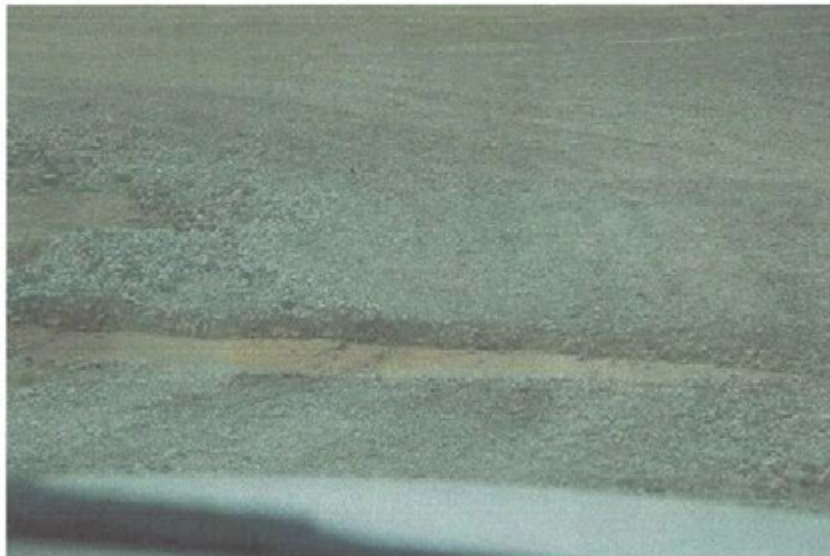
Photo 12: Erosion gully at edge of access road to Flares 9-11

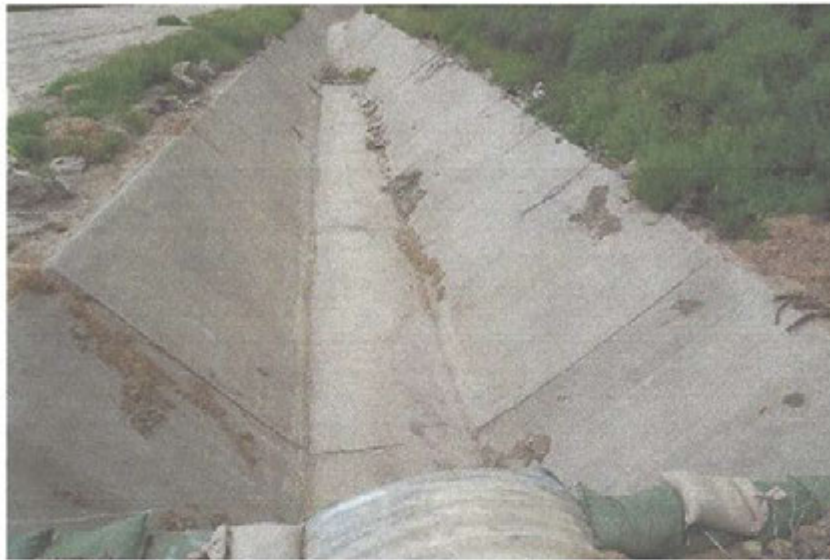
Photo 13: Reinstalled CMP in channel segment between Basin D and power pole

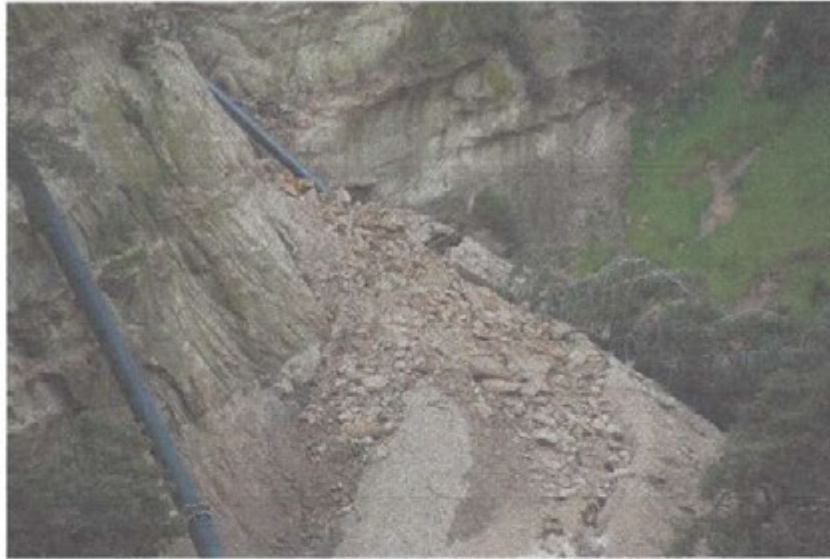
Photo 17: soil and rock slide at back of Basin A

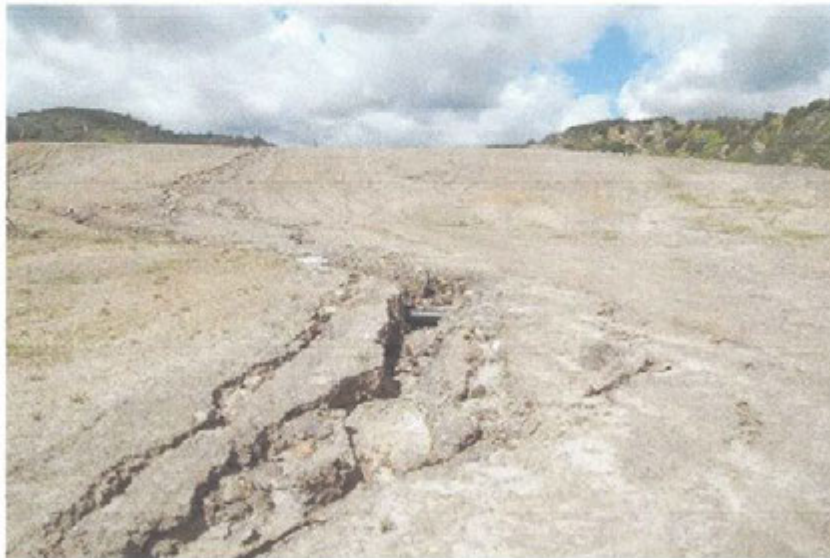
Figure 20: Deep erosion gullies on interim cover – County landfill deck
