**Sunshine Canyon Landfill
Independent Monitor
Quarterly Site Monitoring Status Report
October 1, 2018 – December 31, 2018**

January 9, 2019

The attached Quarterly Site Monitoring Status Report for the Sunshine Canyon Landfill dated January 9, 2019 is the Fourth Quarterly Report for 2018, issued by UltraSystems. This report covers the monitoring period from October 1, 2018 through December 31, 2018 and is prepared for the City of Los Angeles Department of City Planning and the County of Los Angeles Department of Regional Planning.

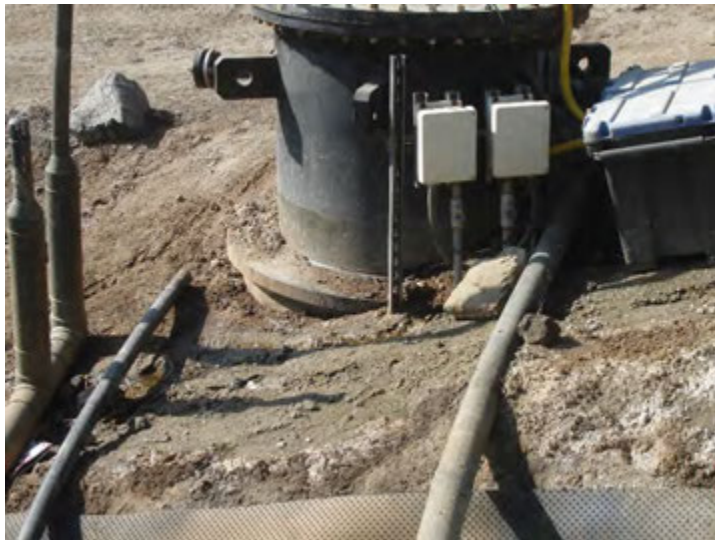
Photo 259: CC3B Alluvial Slope Leak: November 6, 2018

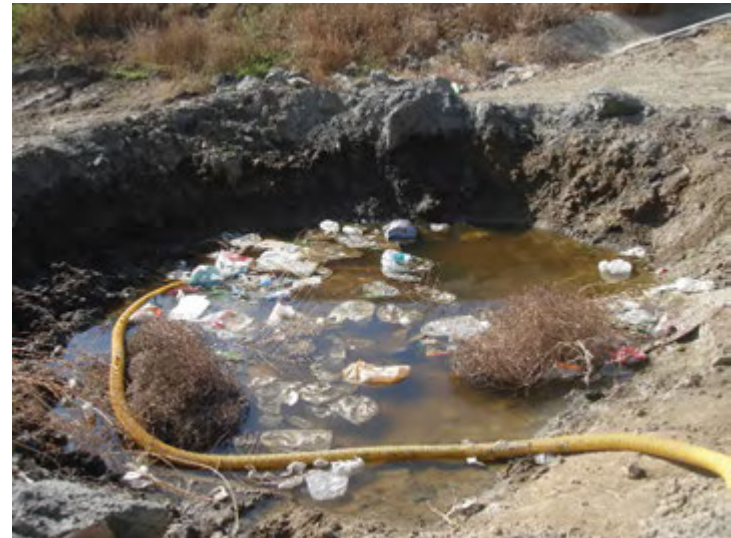
Photo 260: CC3B Alluvial Slope Leak: November 6, 2018

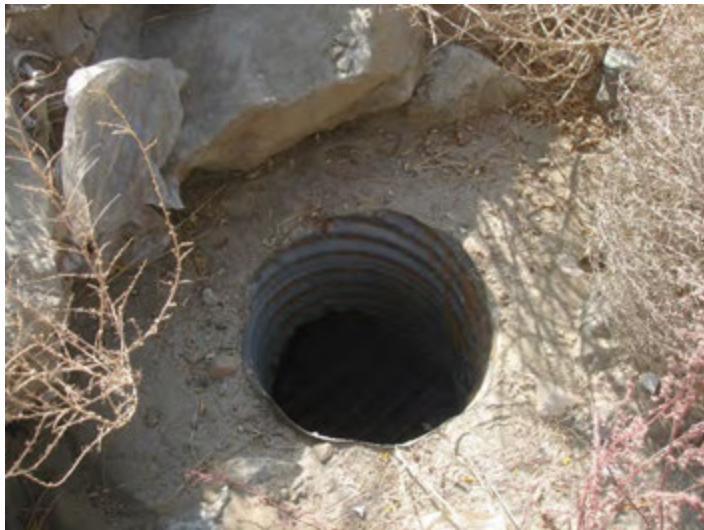
Photo 261: CC3B Alluvial Slope Leak: November 6, 2018

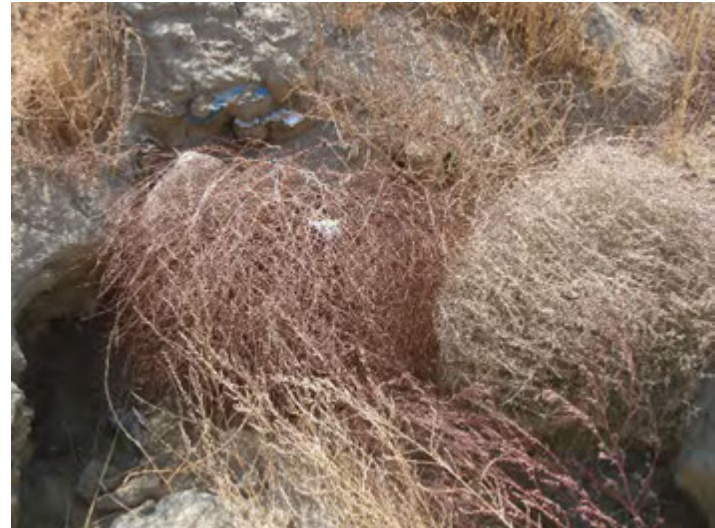
Photo 262: CC3B Alluvial Slope Leak: November 6, 2018

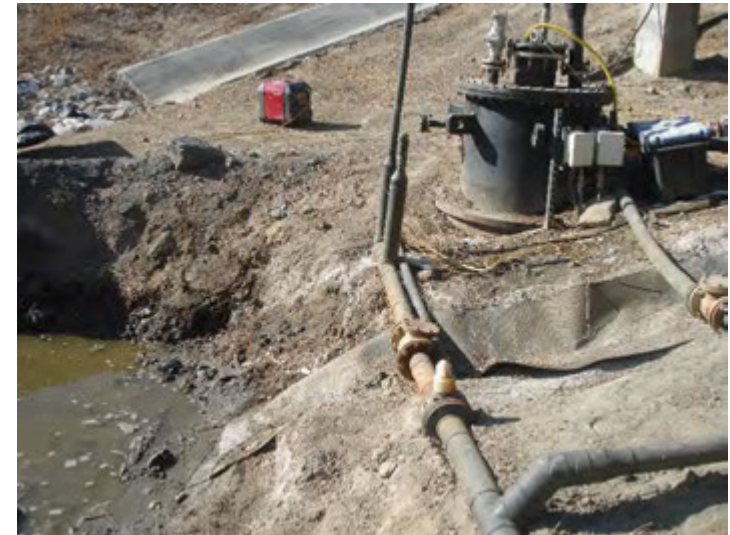
Photo 276: CC3B Alluvial Slope Leak: November 20, 2018

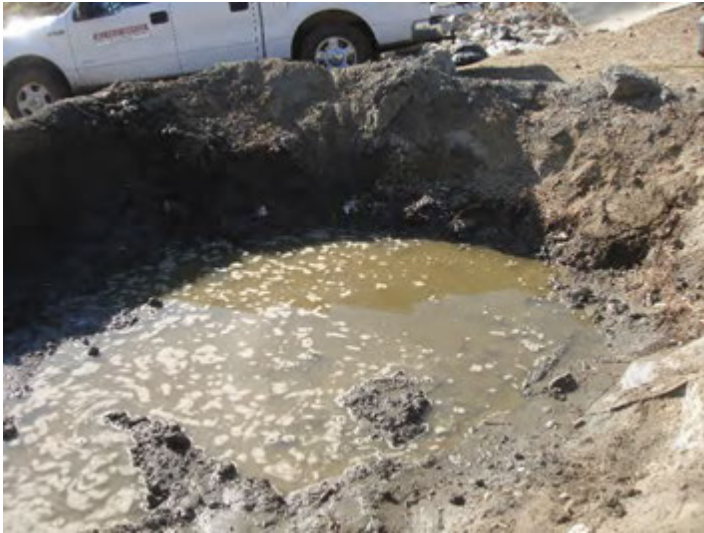
Photo 277: CC3B Alluvial Slope Leak: November 20, 2018

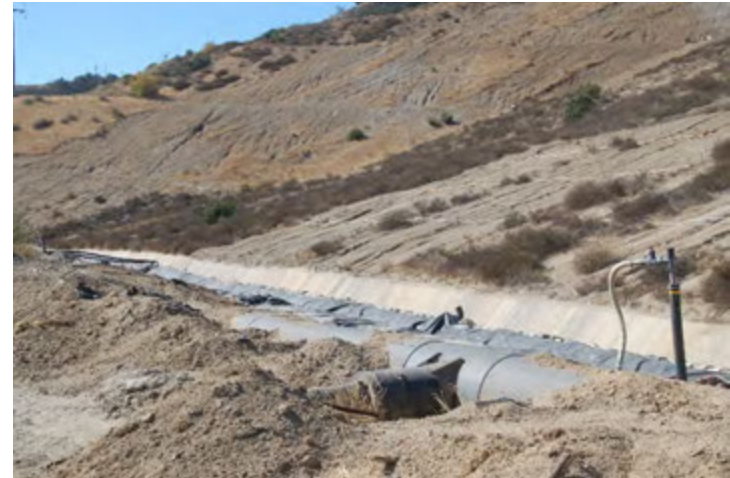
In the 4th Quarter, the sacrificial liner to the westside drainage channel near the County sage mitigation area was being excavated and replaced. A gas collection horizontal collection system was also being installed under this new liner to reduce and prevent any gas migration to any perimeter probes.

**Photo 286: Sacrificial Liner Replacement Near County Sage:
October 13, 2018**

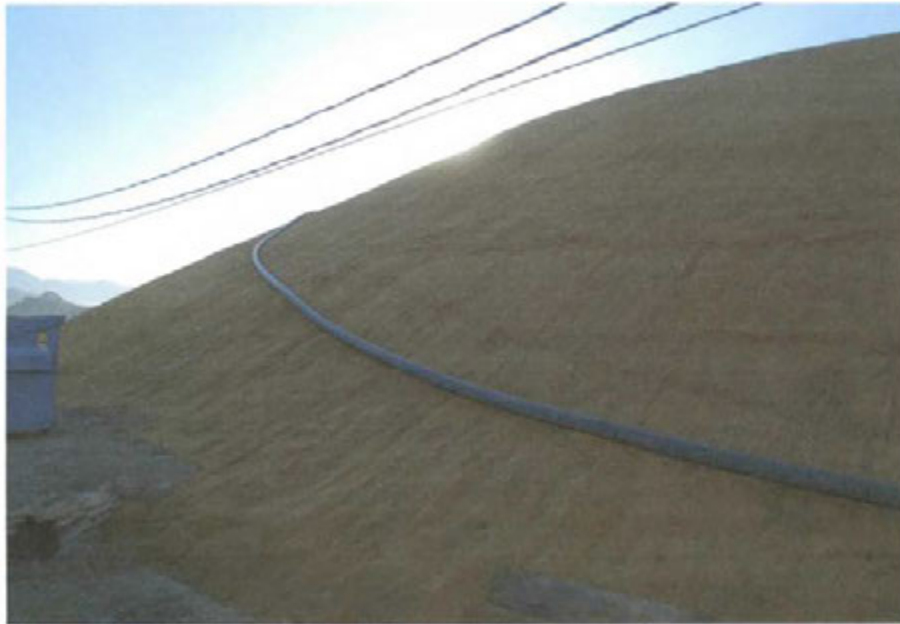
Photo 1: Erosion control blanket on access road near administration pad

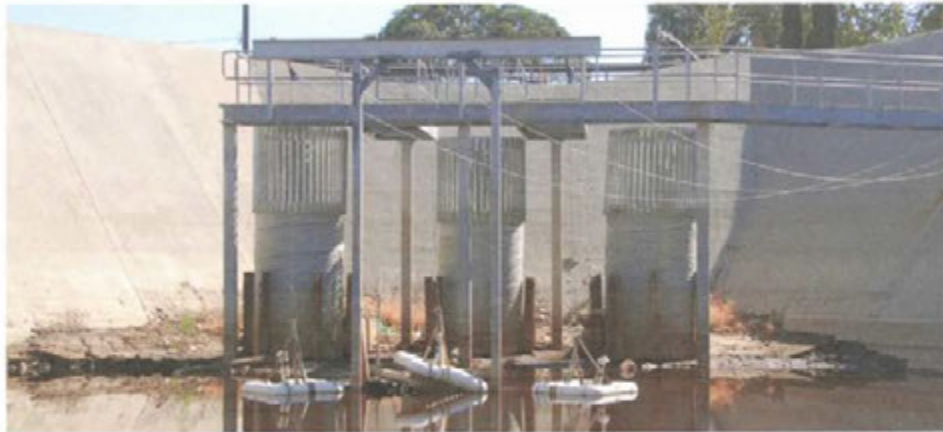
Photo 5: Sediment behind the decant towers of Terminal Basin

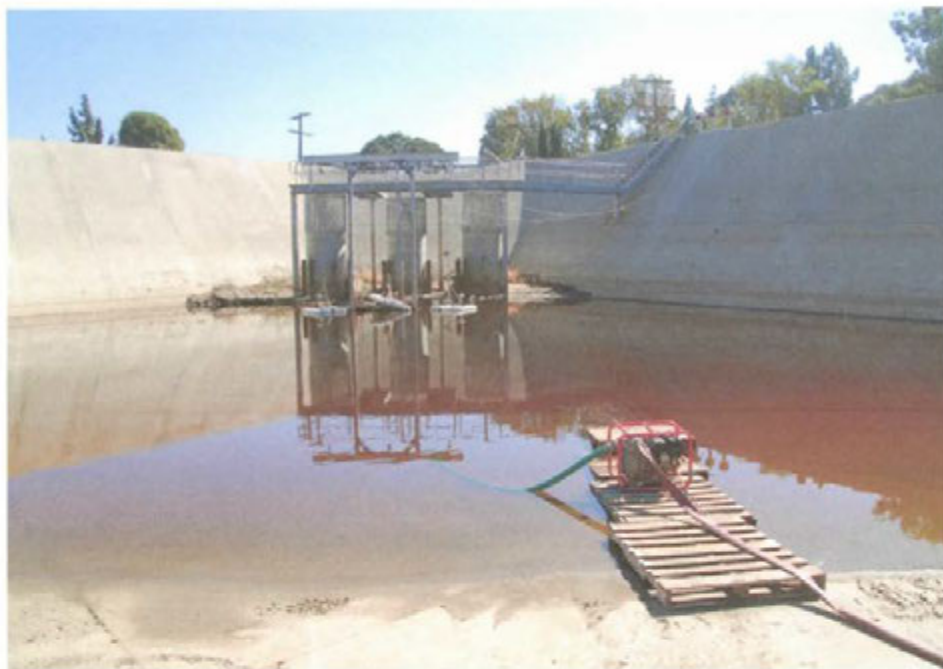
Photo 6: Lowered skimmers and ponding water at Terminal basin

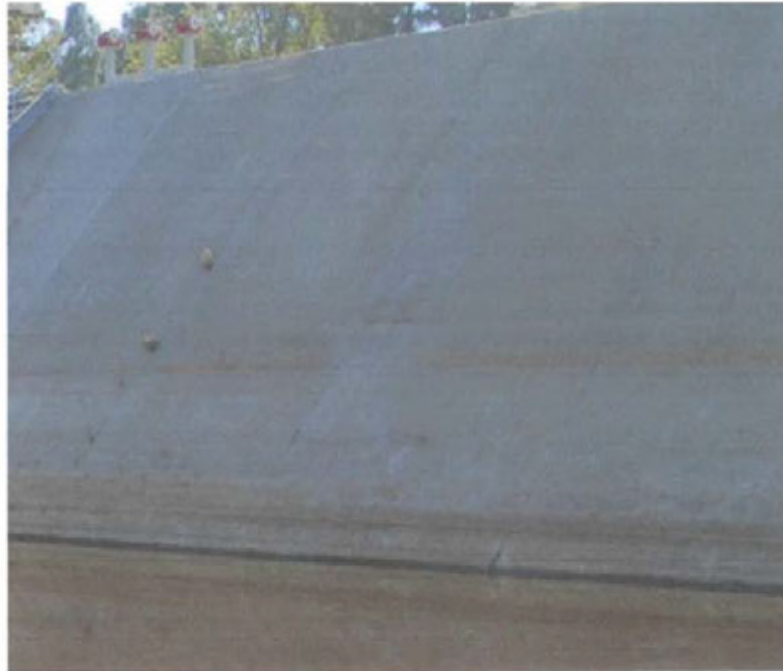
Photo 7: Vegetation in cracks of inside wall of Terminal basin

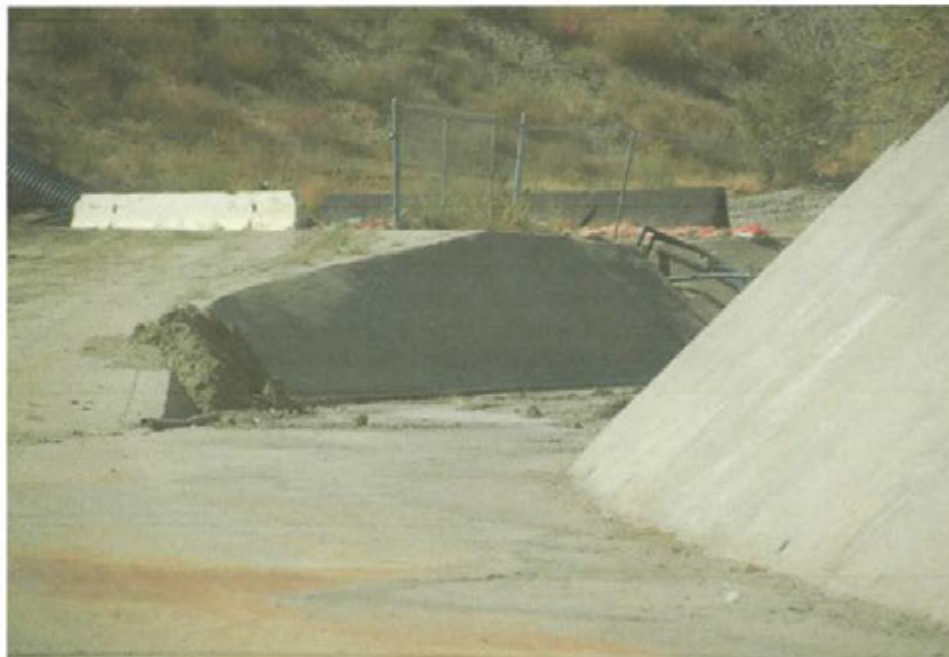
Photo 8: Earth check dam removed at Terminal basin

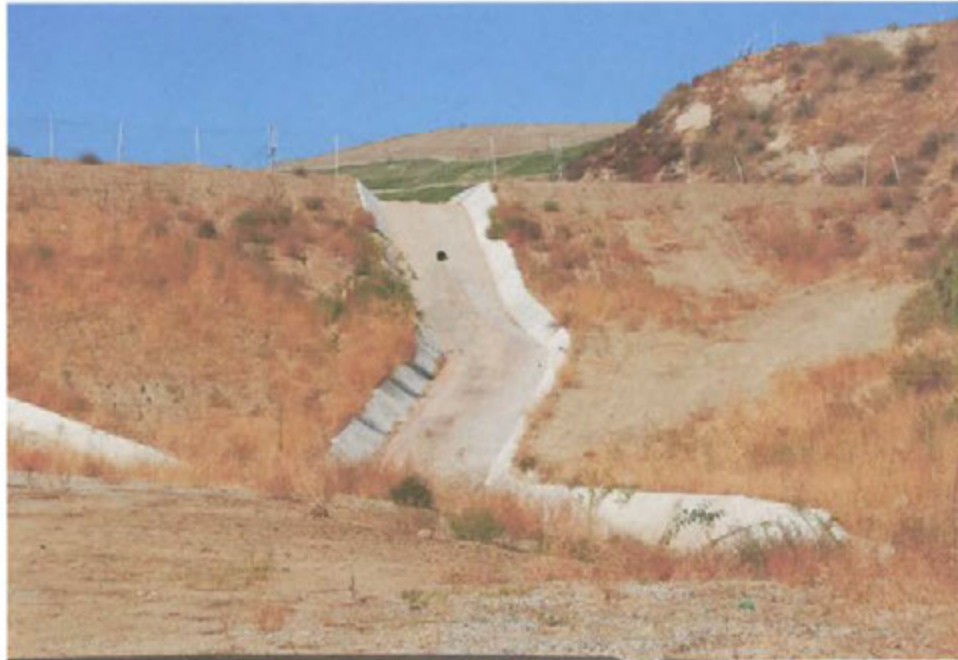
Photo 9: Repaired erosion gullies on downstream side of embankment of cell CC3 basin

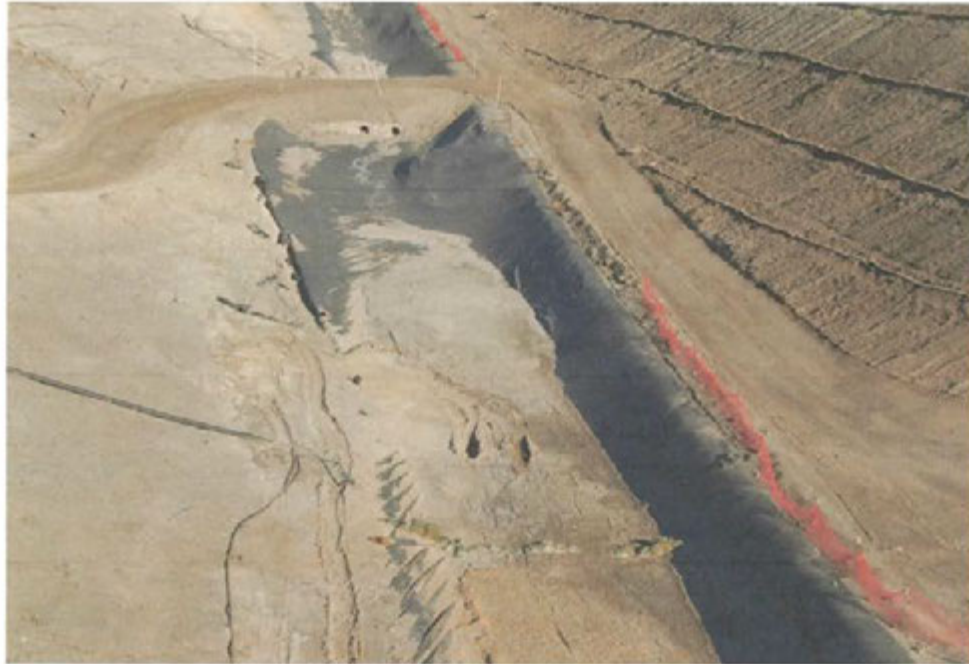
Photo 11: Sediments in moat around Cell CC4 Part 2

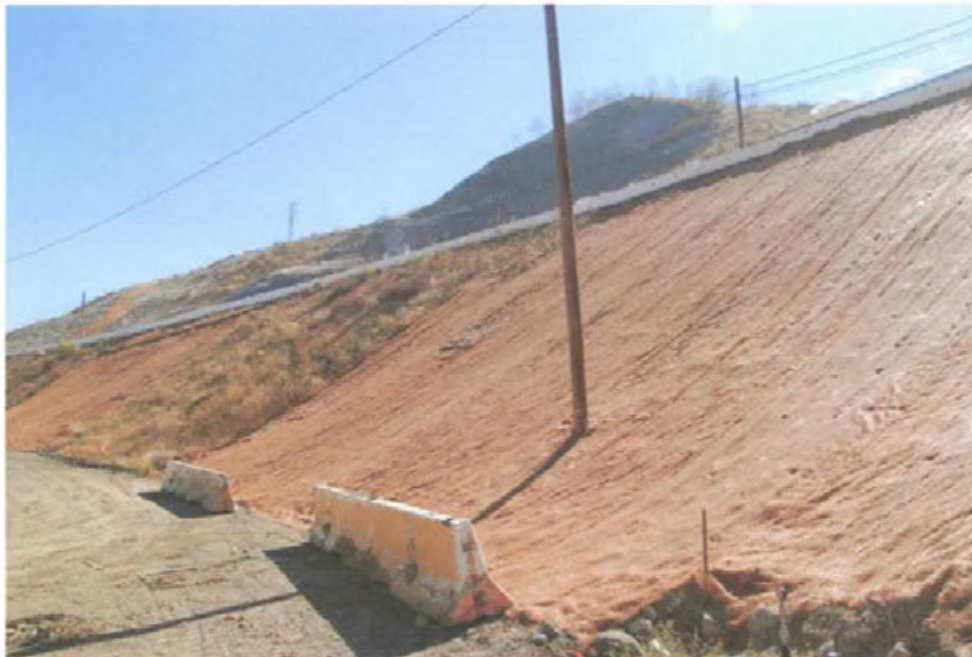
Photo 15: Repaired sloughed areas on slope of access road embankment at Terminal basin

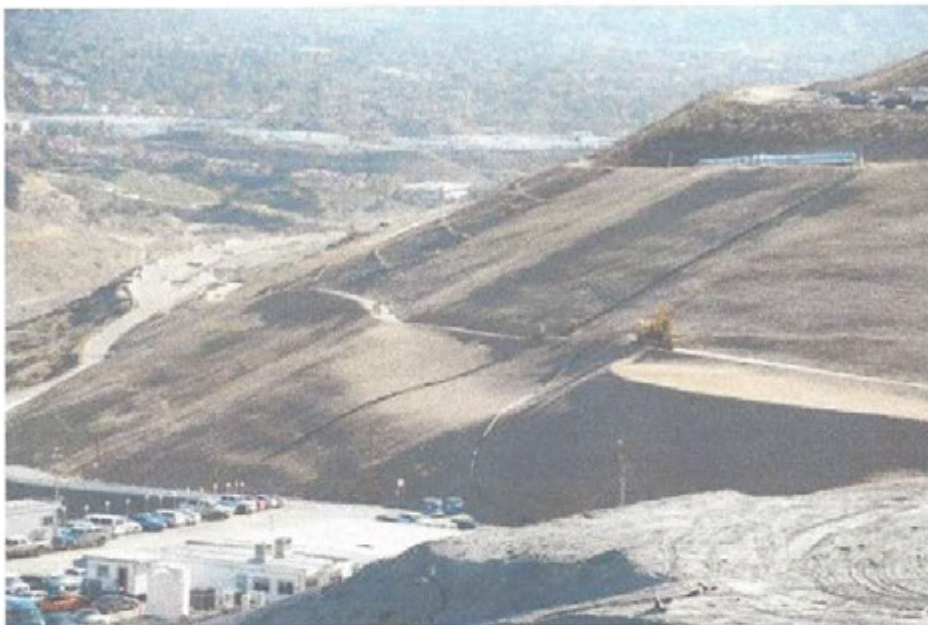
Photo 1: Settlement depression on slope above access road near administration pad

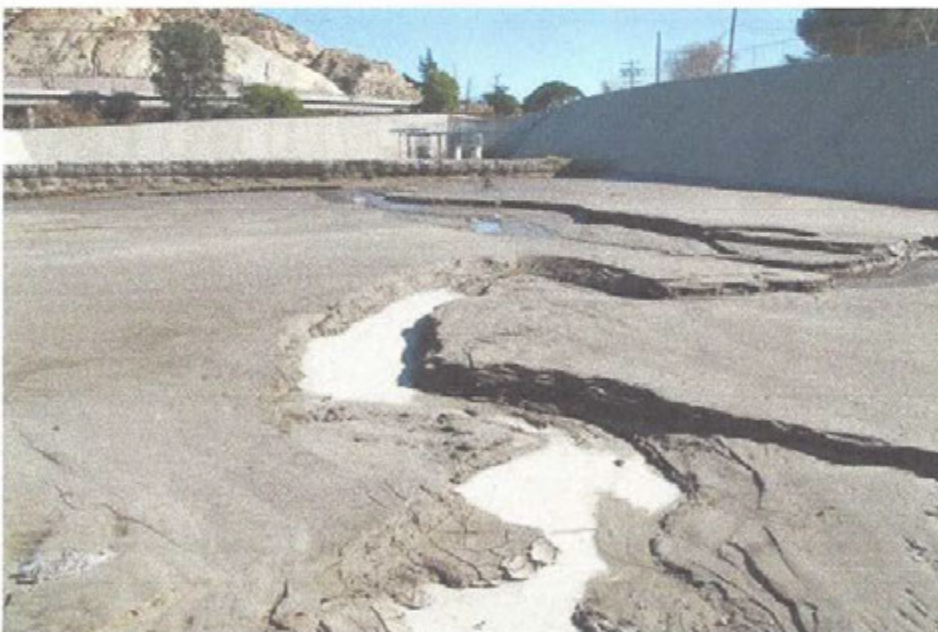
Photo 4: Sediment behind the separator gabion wall of Terminal Basin

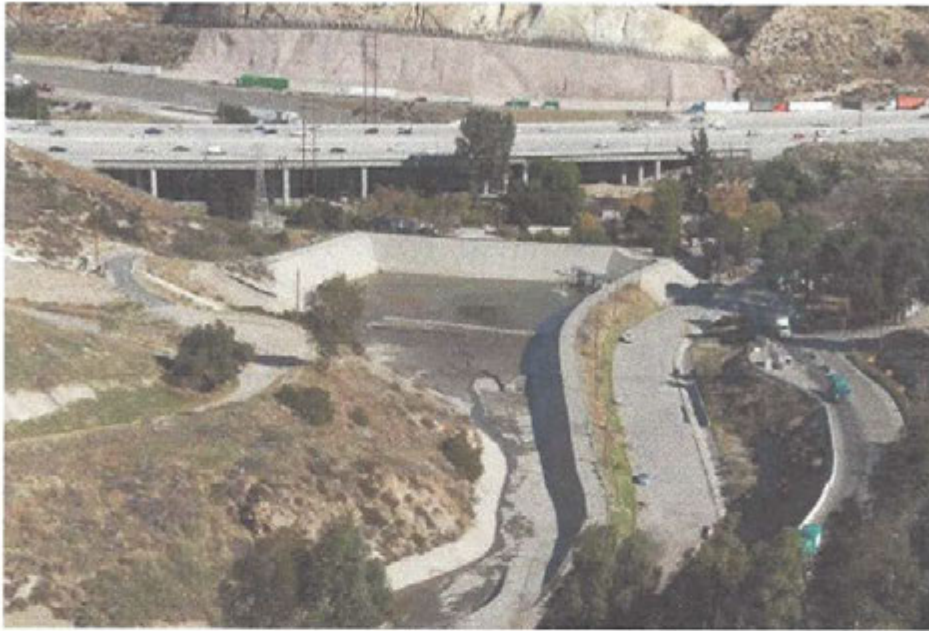
Photo 5: Lowered skimmers and ponding water at Terminal basin

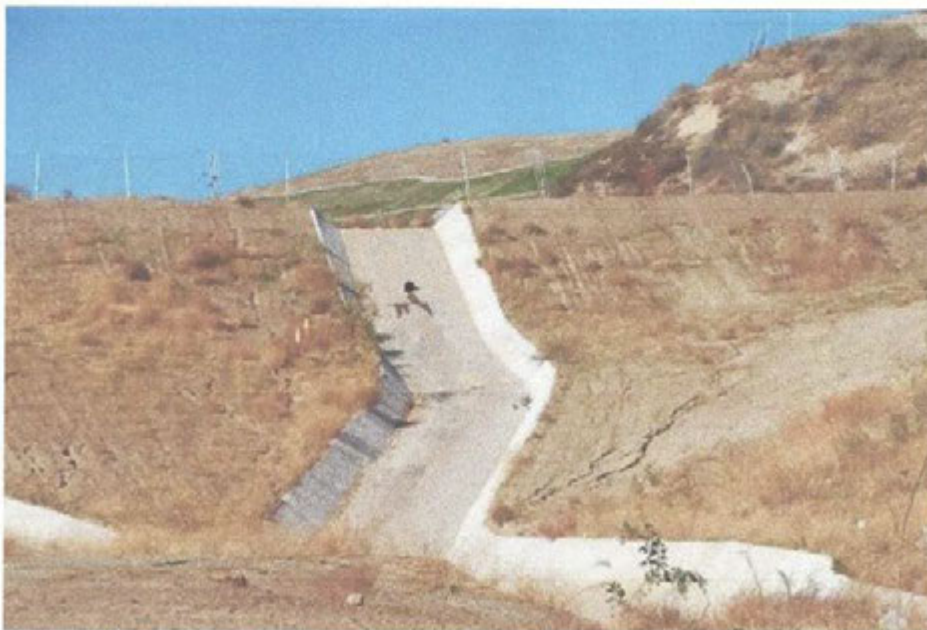
Photo 6: Erosion gullies on downstream side of embankment of cell CC3 basin have reappeared

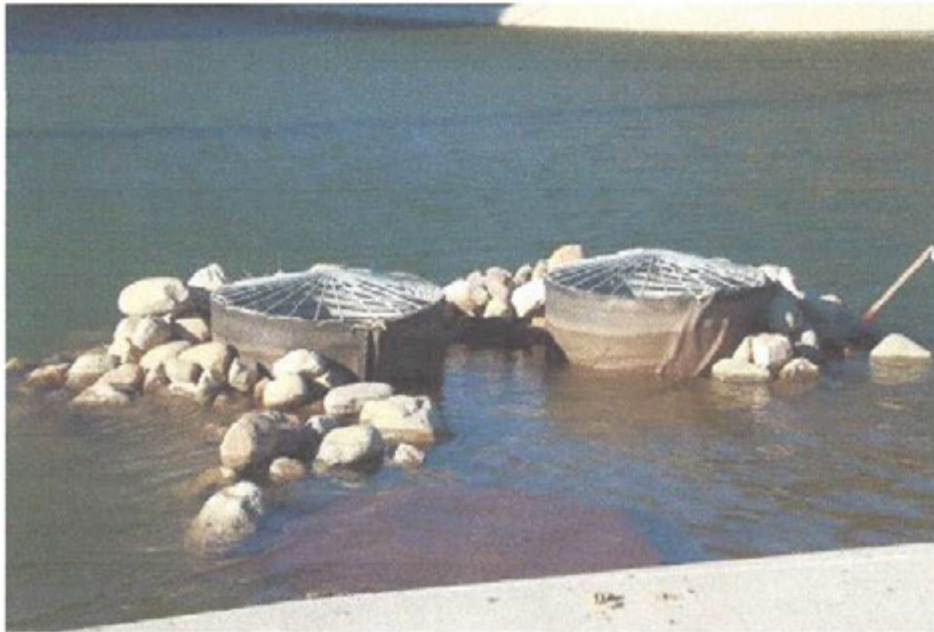
Photo 7: Basin A – water level in basin is near spillway crest

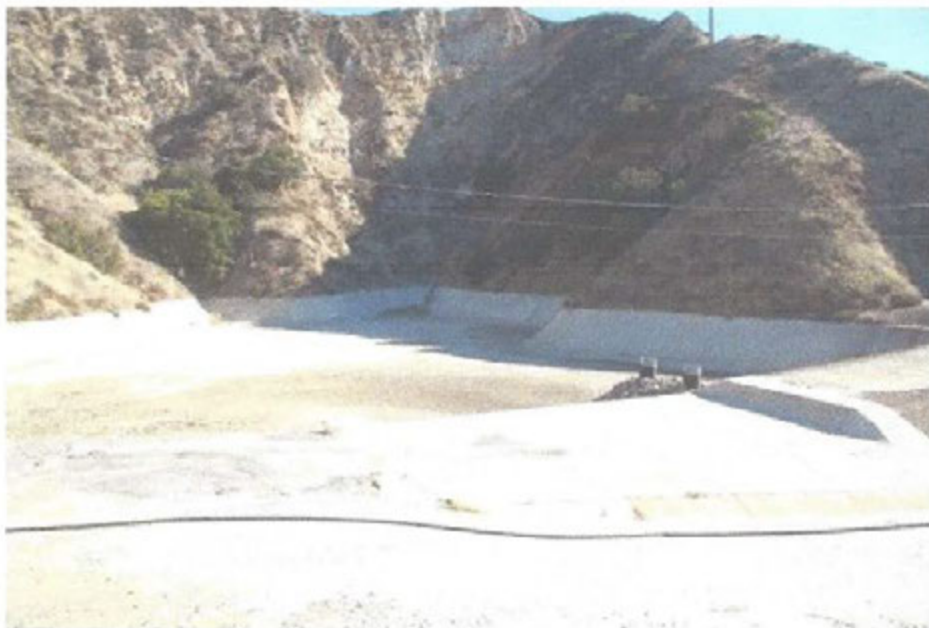
Photo 10: Basin D – small amount of sediments near intake towers

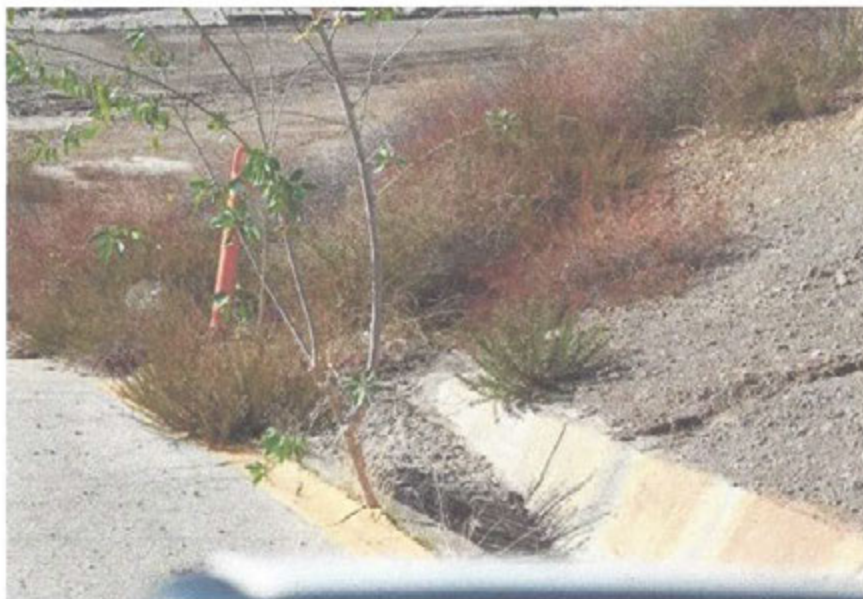
Photo 11: Sediments blocking drainage of ditch along access road to Flares 9-11

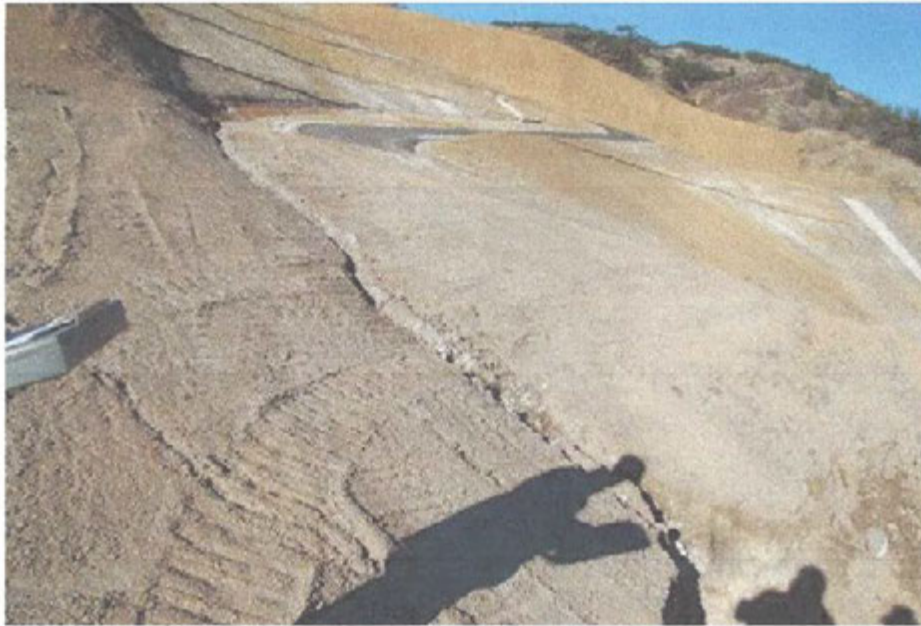
Photo 13: Erosion gully at end of unfinished drainage ditch along road to Flare 3

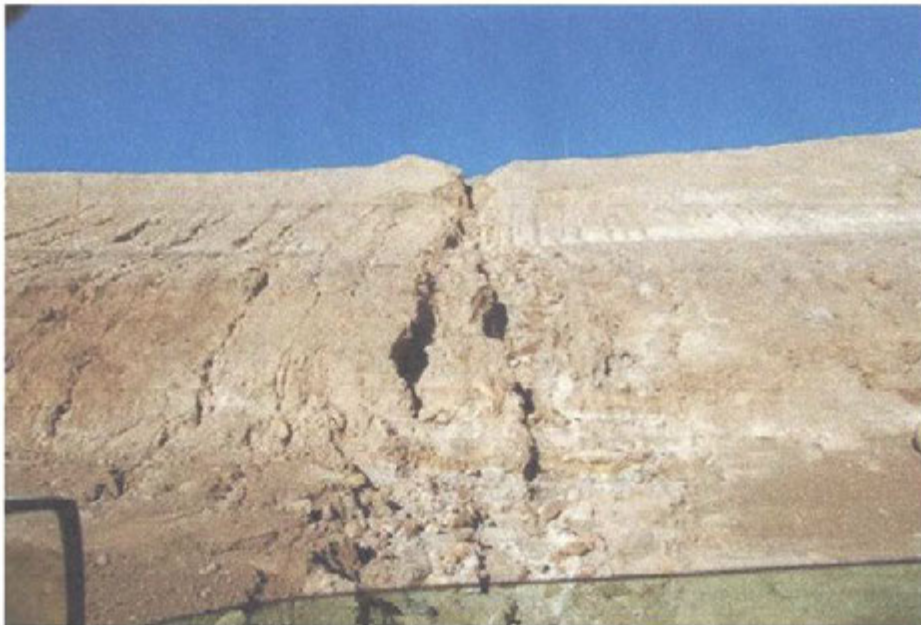
Photo 14: Damage to fill supporting road to Flare 3 from erosion gully shown in Photo 14

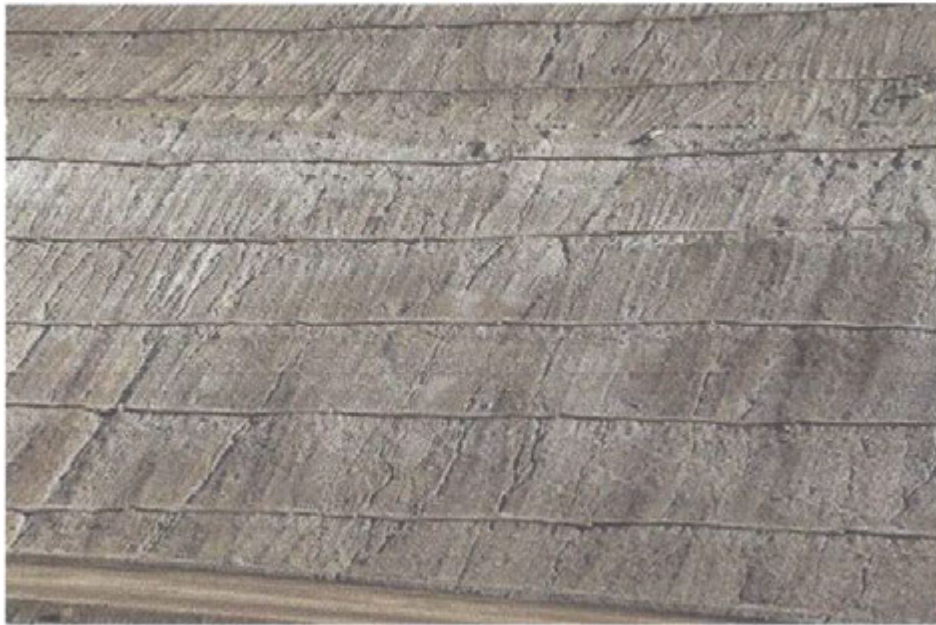
Photo 15: Minor erosion gullies on wattle protected slopes
