February 4, 2020

Mr. Martins Aiyetiwa, P.E.
Senior Civil Engineer
County of Los Angeles, Department of Public Works
900 South Fremont Avenue
Alhambra, CA 91803-1331

Subject: Sunshine Canyon Landfill, Quarterly Vegetation Report
Fourth Quarter 2019 Vegetation Report

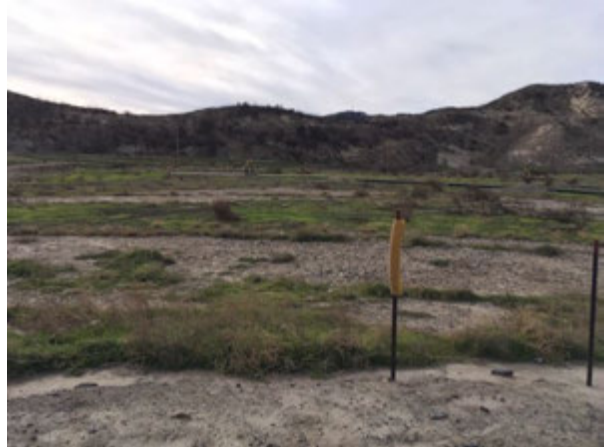
Photo 6. Facing southwest at upper deck. The area shown in this photo is dominated by annual, non-native grasses and Russian thistle in the foreground, and slope that burned during the Saddleridge Fire is visible in the background.

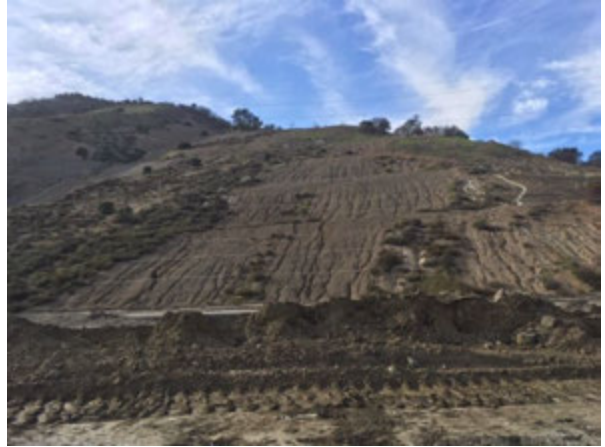
Photo 2. Facing west at the northern-half of the county sage hill, where plant growth has been problematic due to poor soil conditions.

MISCELLANEOUS	
Conditions: <input type="checkbox"/> Trash <input type="checkbox"/> Vandalism <input type="checkbox"/> Erosion	
Comments: None	
RECOMMENDATIONS	
<ul style="list-style-type: none">• Create benches. Consider creation of benches throughout the mitigation area to control soil erosion and to improve soil conditions to improve plant establishment and seed dispersal. This technique has been widely used on steep slopes and in areas where soil erosion is problematic. This technique also allows for opportunities to introduce a high quality soil layer above the poor soils that exist.• Reseed and plant container plants. If creation of benches is feasible, planting methods should include Hydroseeding and broadcast seeding just before a forecasted rain event and planting with container plants with supplemental irrigation during the period of establishment. Container plants should only be planted if temporary irrigation source is available.• Plant within view sheds. Consider planting native species on upper portion of the slope that is visible from public view sheds with appropriate native species. Planting should occur prior to fall/winter rains.• Use soil amendments. Incorporate a soil amendment or mulch with high organic content in select areas as determined by a restoration specialist.• Signage. Install signs indicating that the area is undergoing revegetation.• Weed control. Continue weed control program as needed on a quarterly basis.

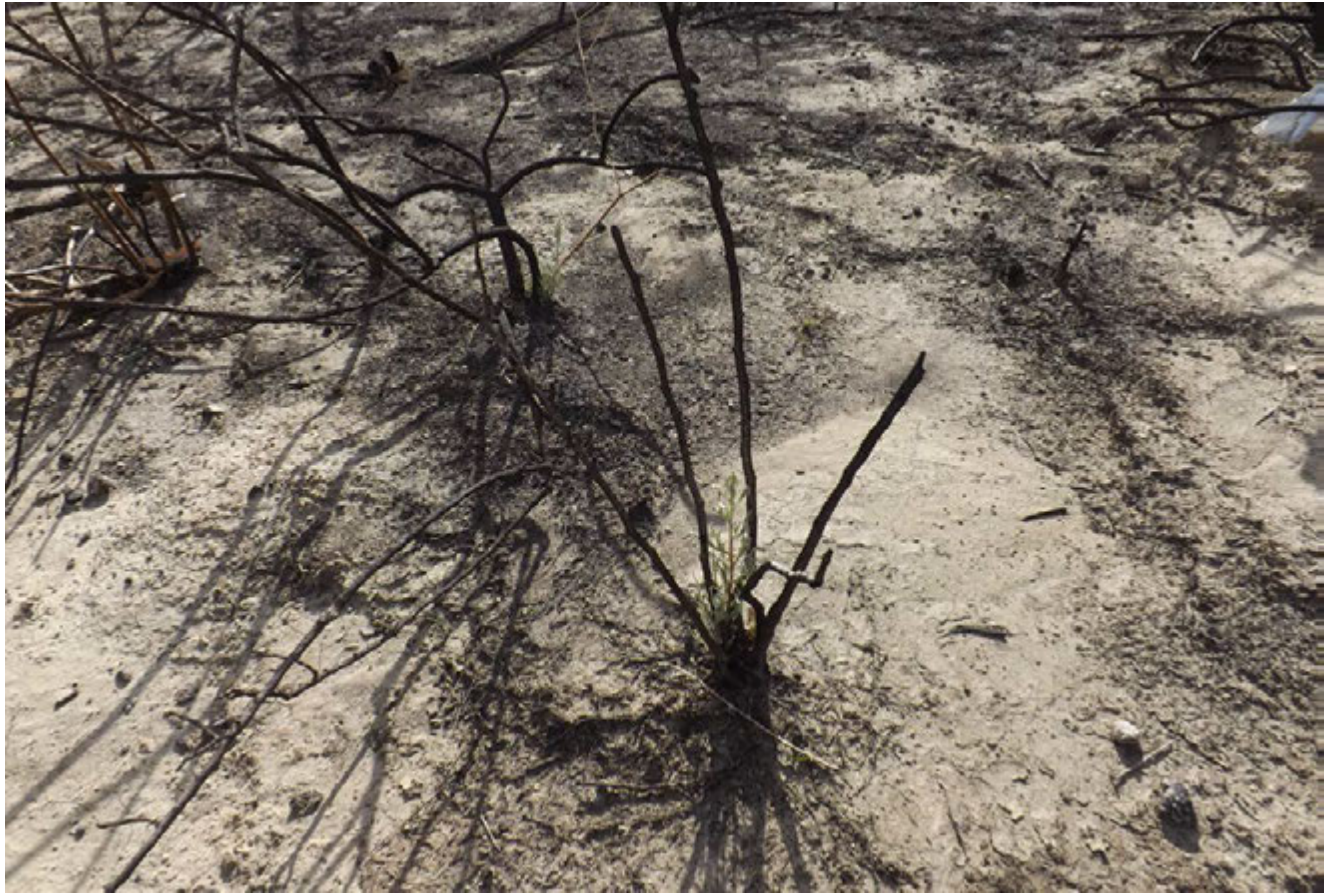
Evidence of crown sprouting on Saltbush species

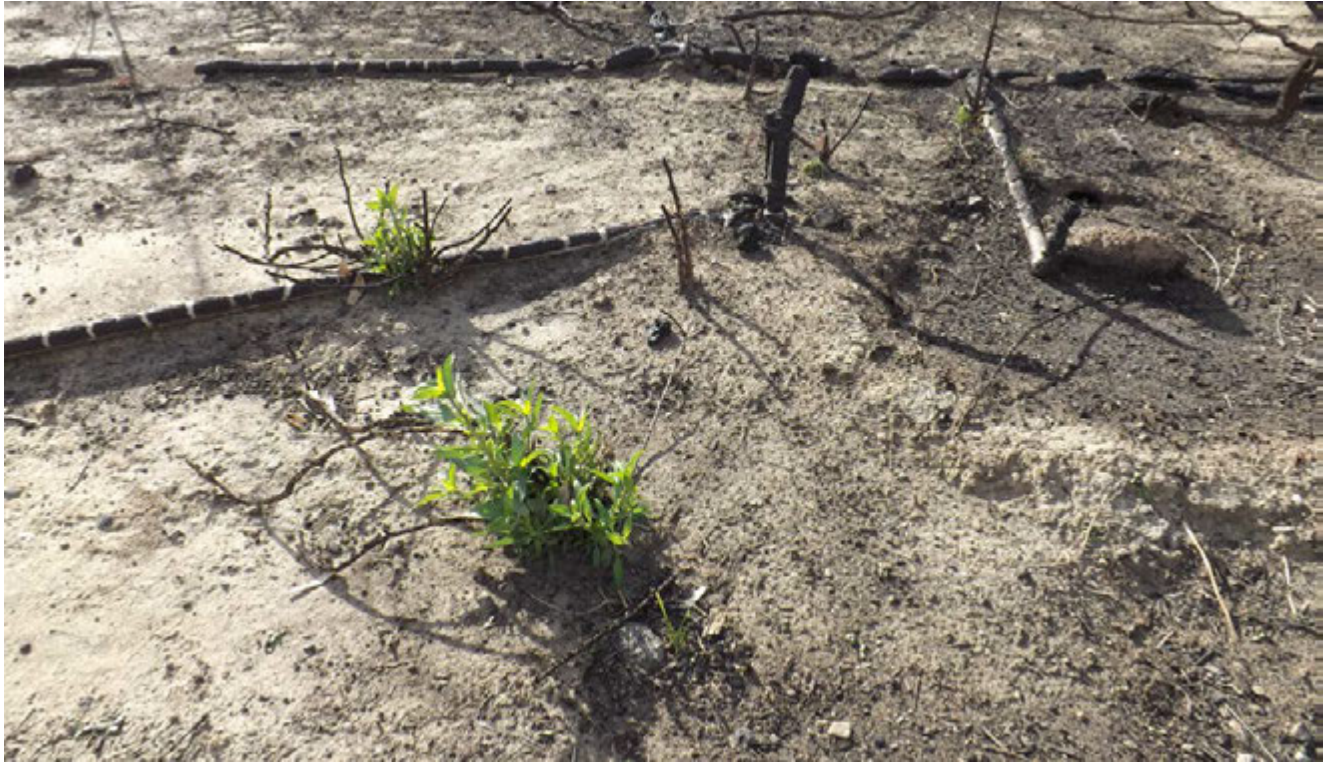
Regrowth on *Encelia californica* (Coast Sunflower)

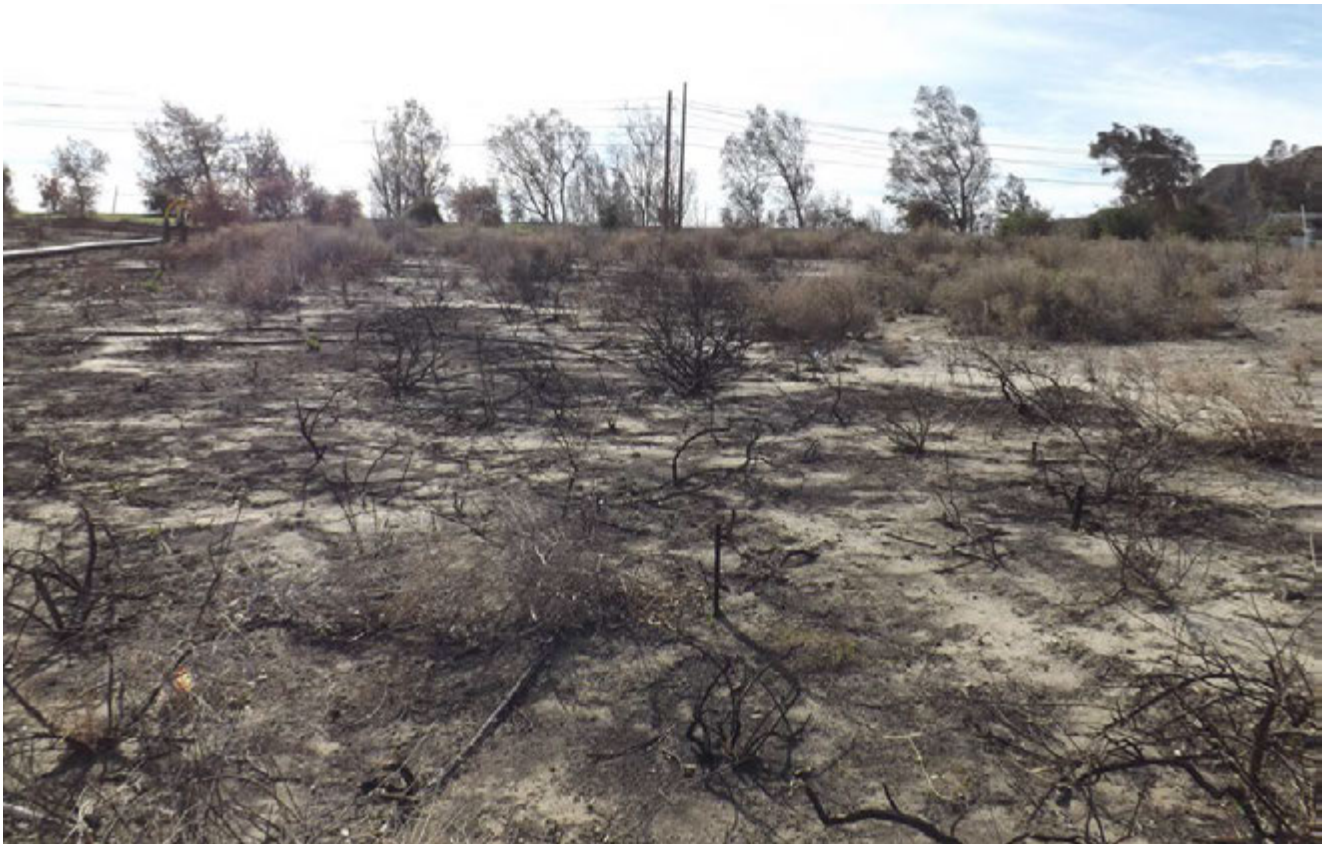
Typical fire damage of vegetation (Deck C)

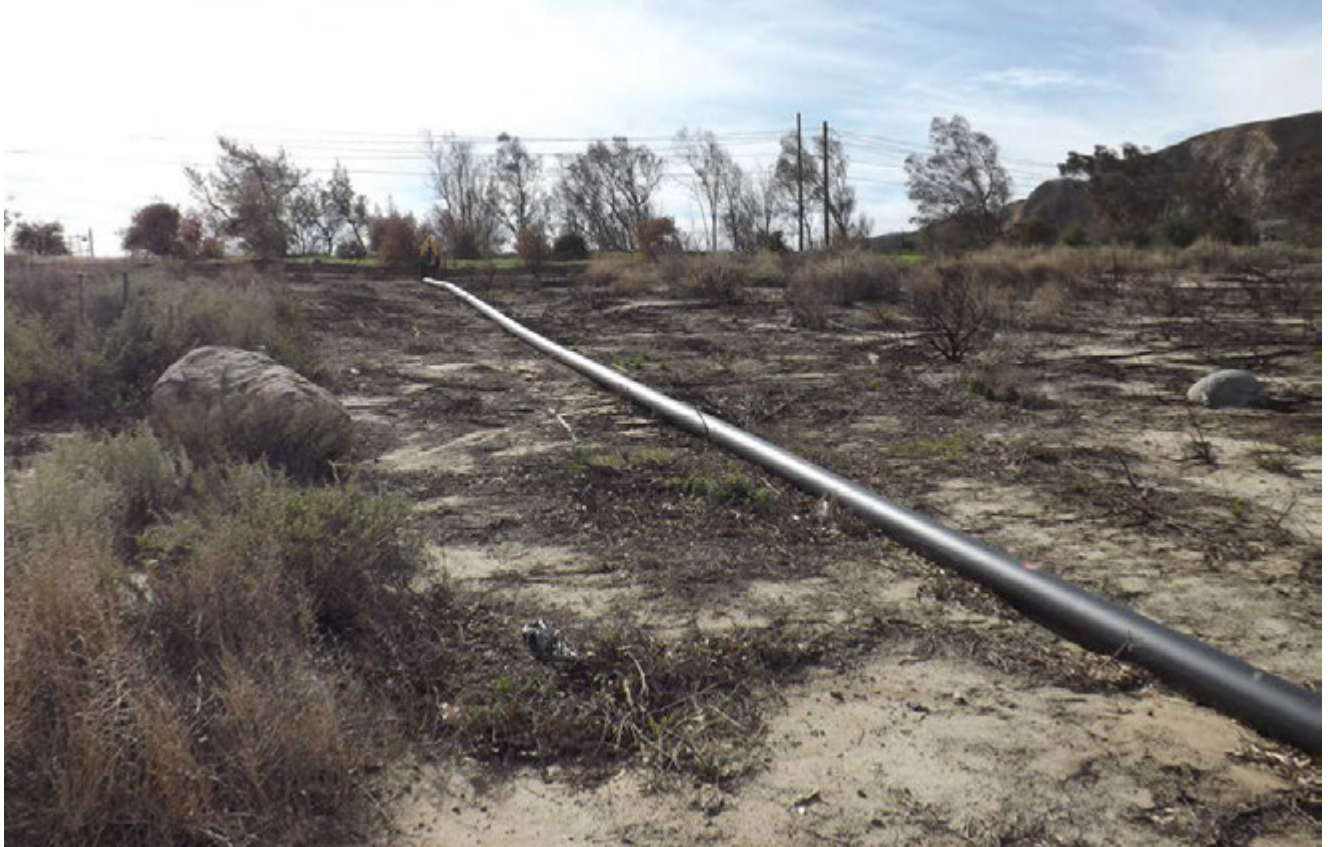
New graded areas with replacement gas lines and wells

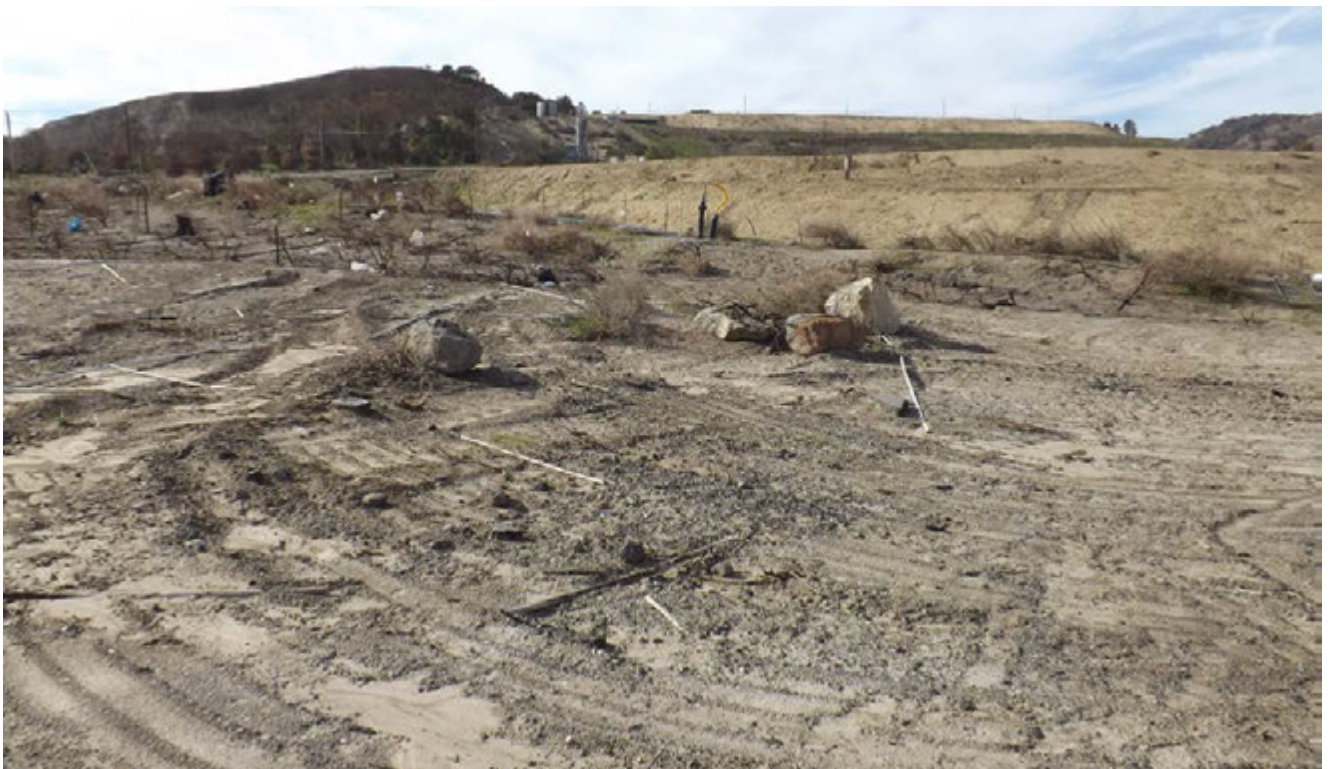
Graded areas where T-Bar Stakes and Boulders have been moved

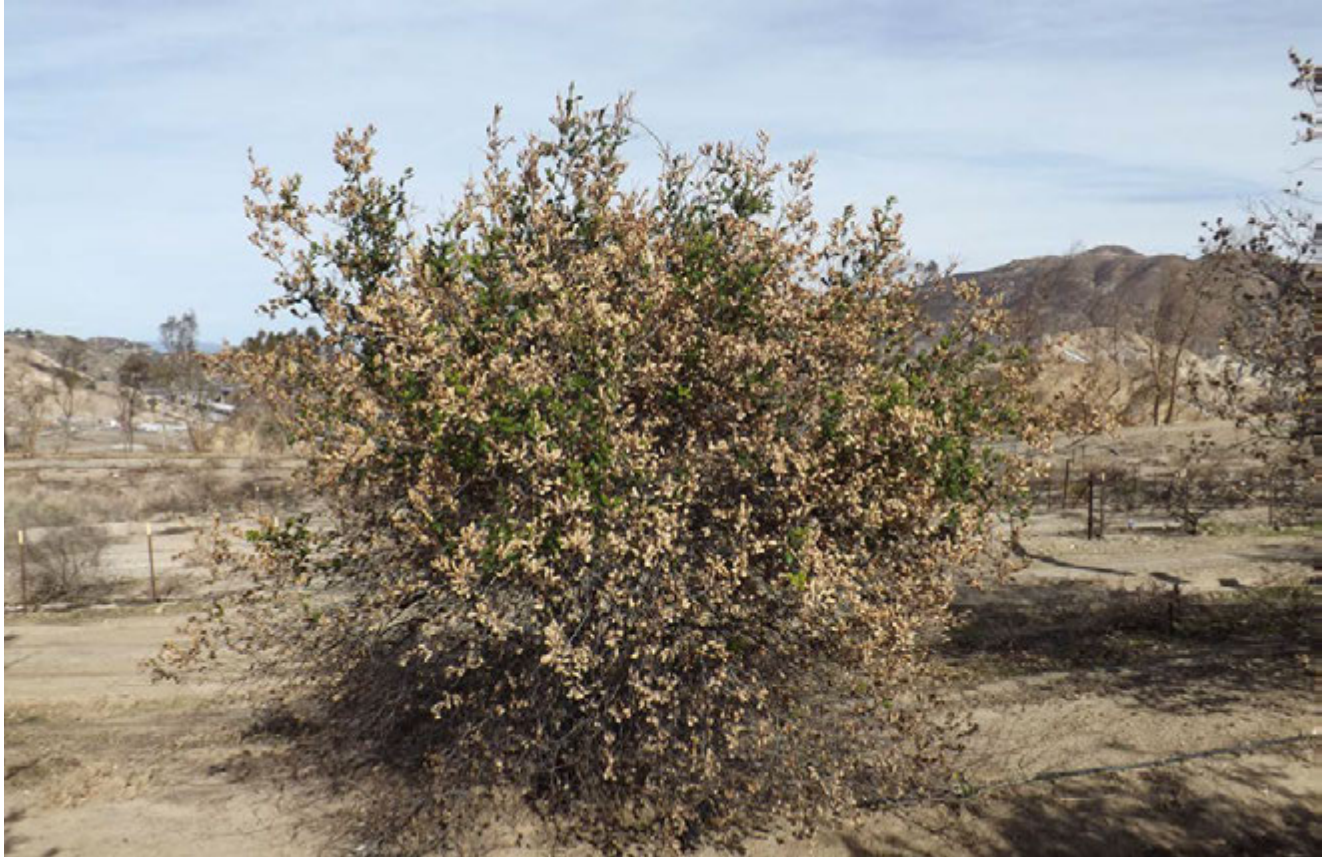
Damaged foliage of PM10 Berm Oak Trees

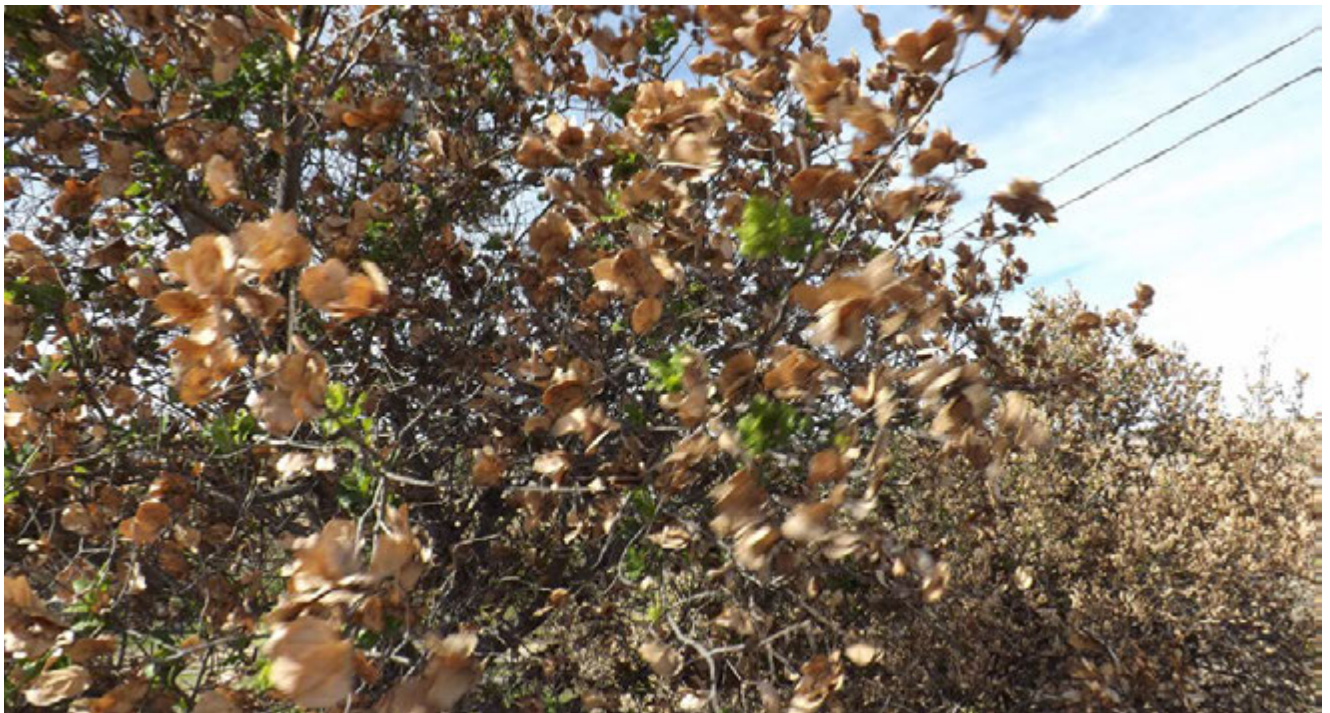
Close up showing recovery and new vegetative growth

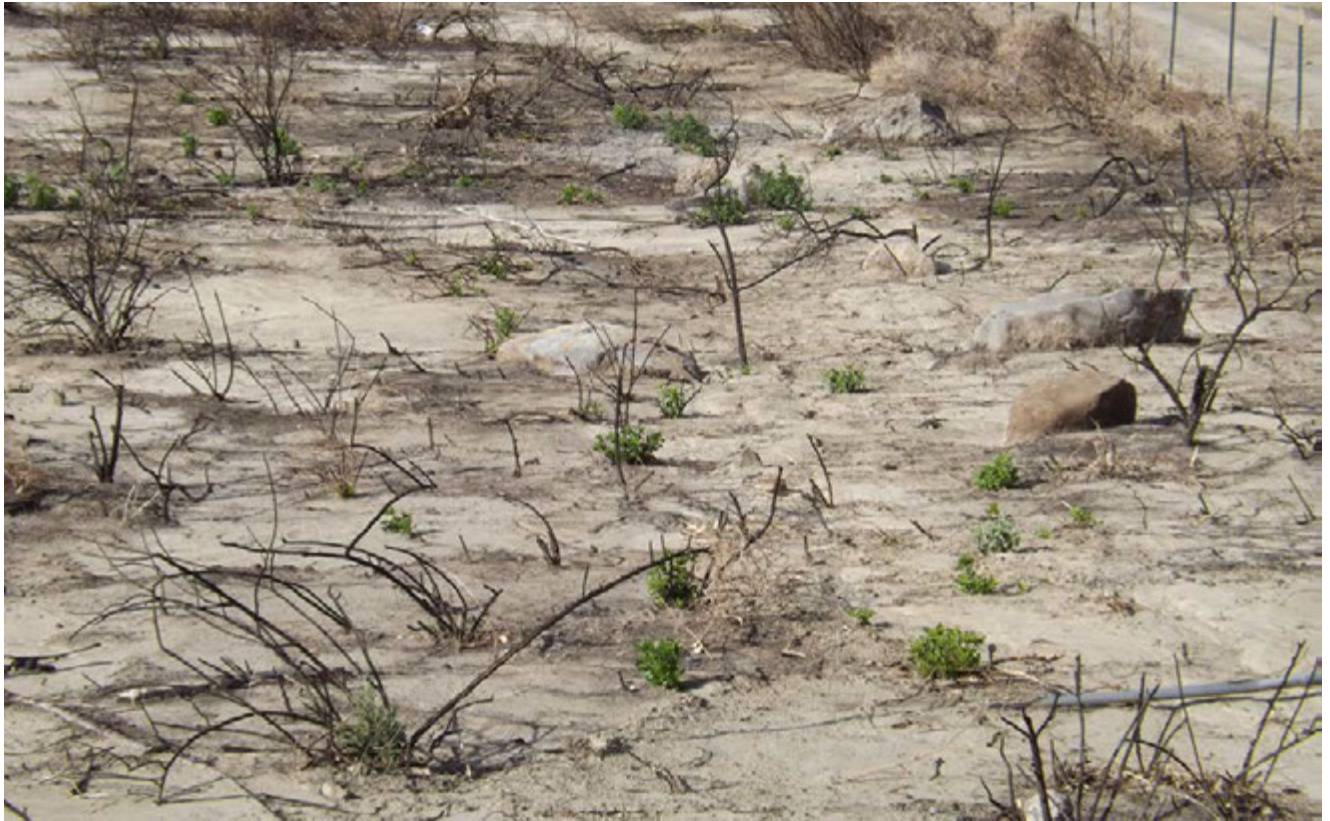
View looking down swale line with new foliage recovery from existing vegetation

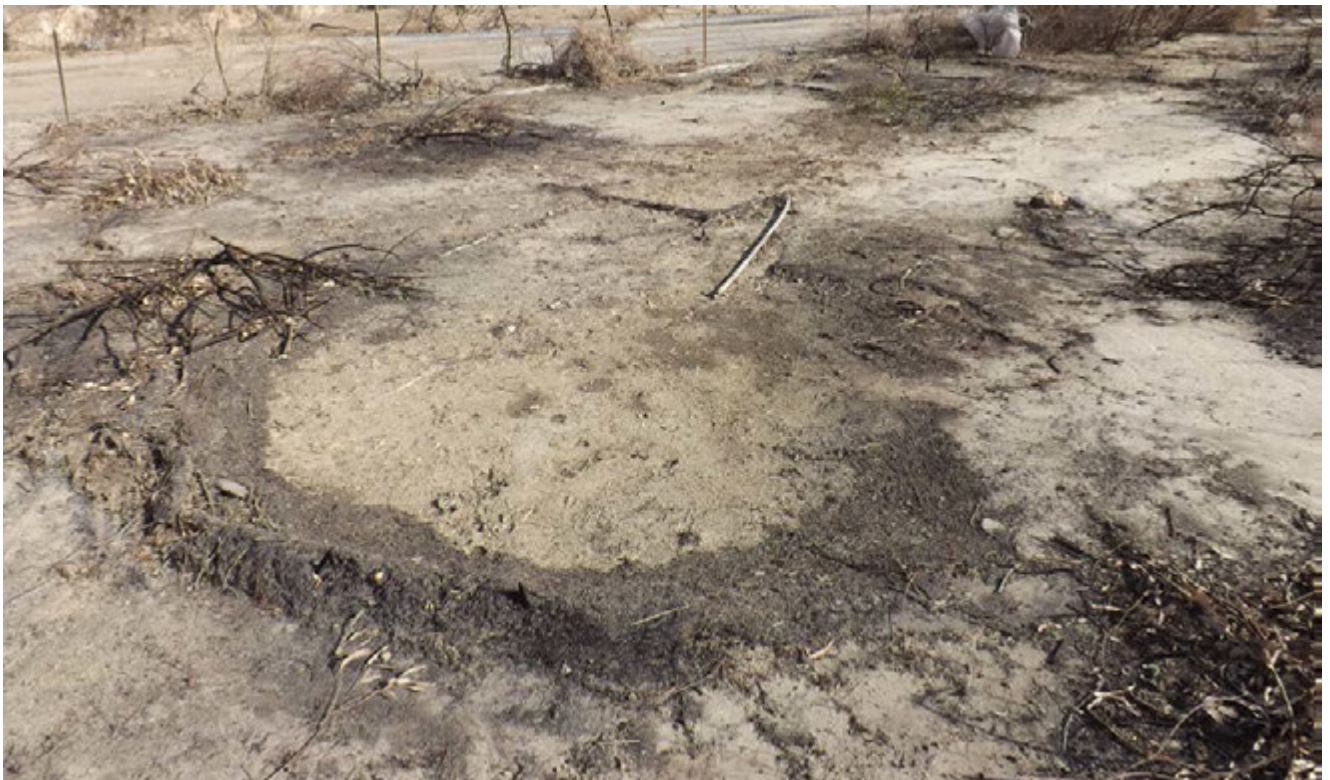
Ash and soil collection along swale line

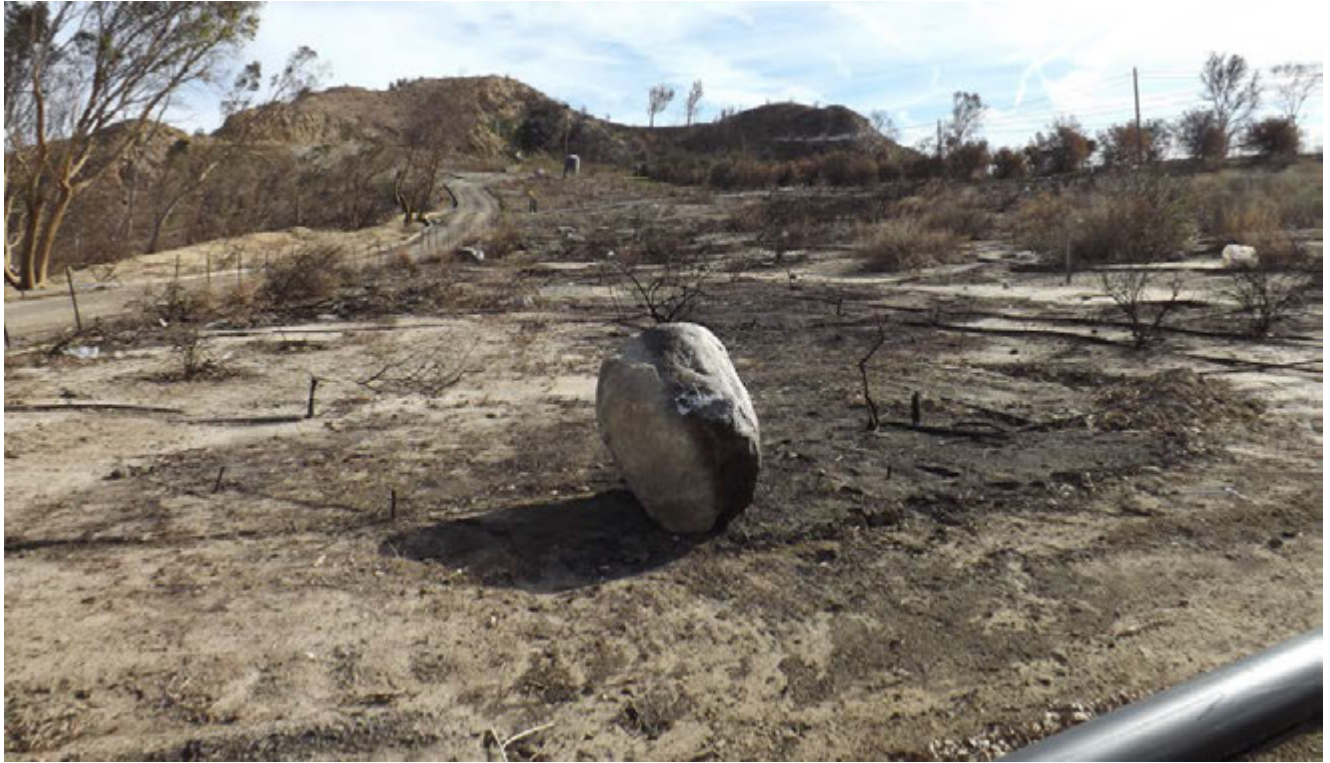
Boulder displaced during fire event/post-fire grading

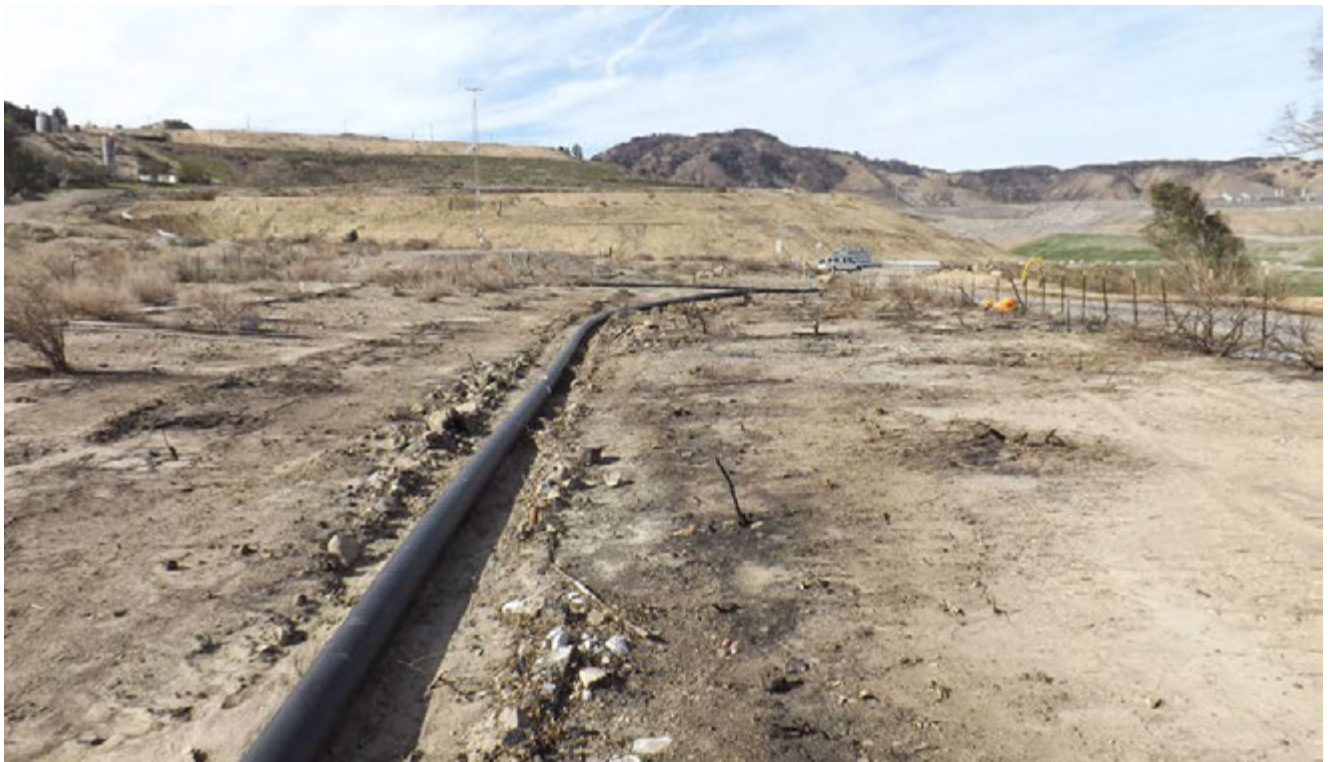
New on-grade gas line where previous vegetated swale used to exist

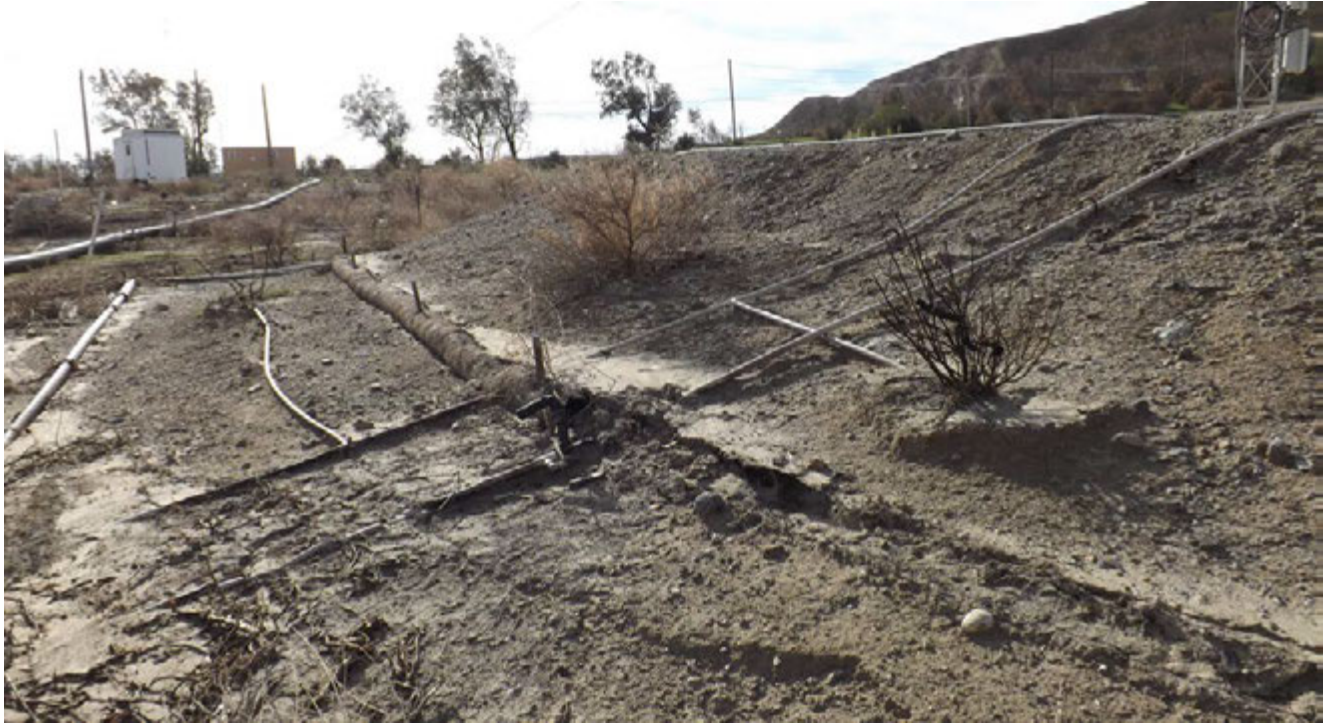
Straw wattle damage from fires

- Erosion from the recent events and exposed soils is minimal, however, additional straw wattle will help to collect any surface or floating seeds that have been exposed due to the grading in the disturbed areas. ADG recommended placing straw wattles within the graded/brush clearance areas, perpendicular to the flowline at 25' on-center. Existing straw wattles within these areas have deteriorated or were burnt in the recent fires.

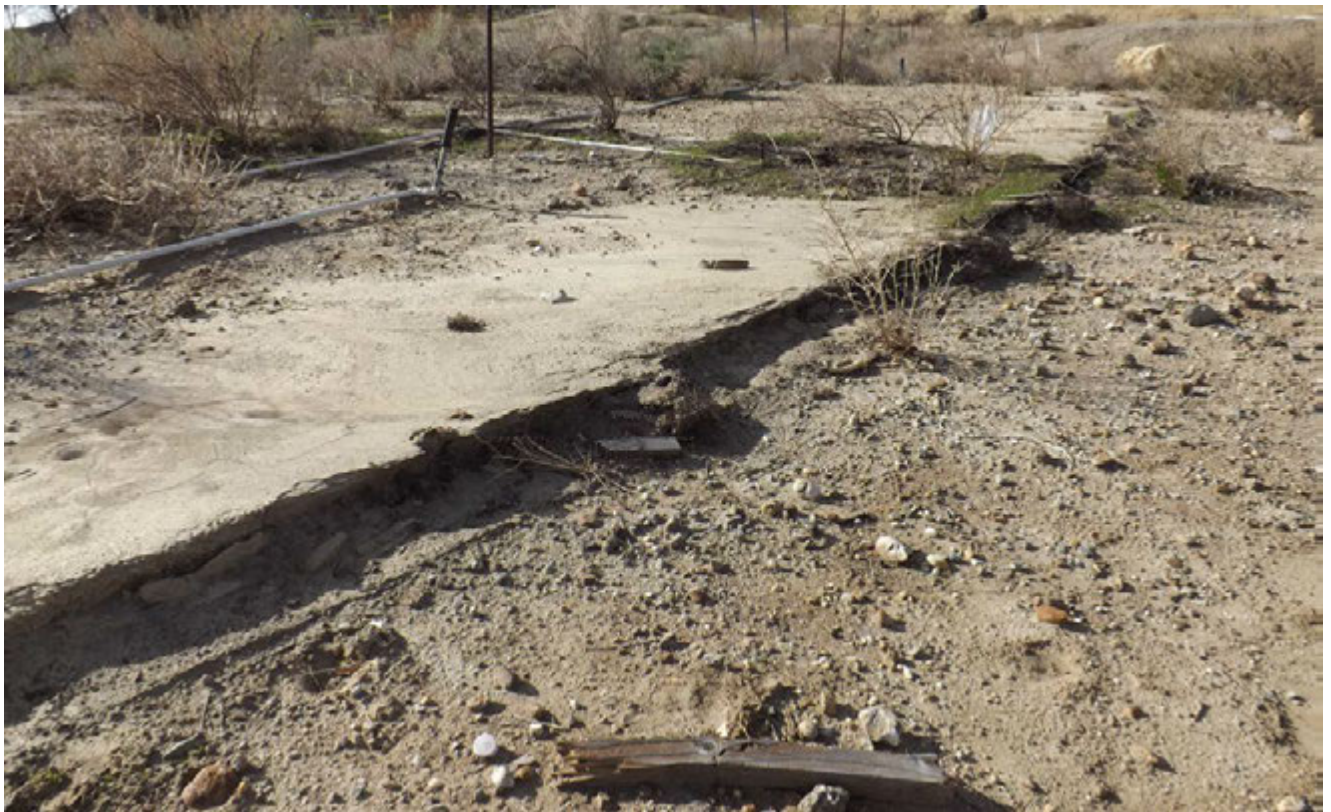
Previous area where straw wattle existed. Note sediment collection build up

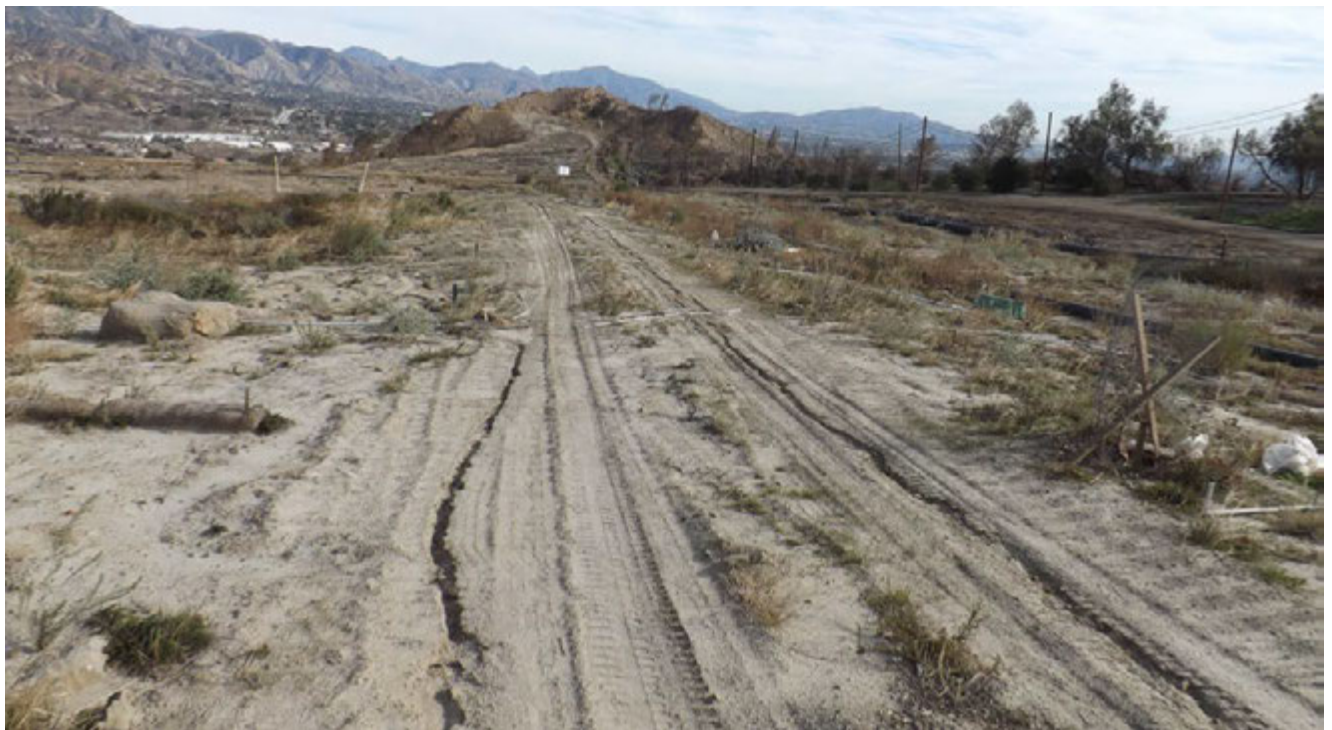
Vehicle access onto deck and damage of irrigation

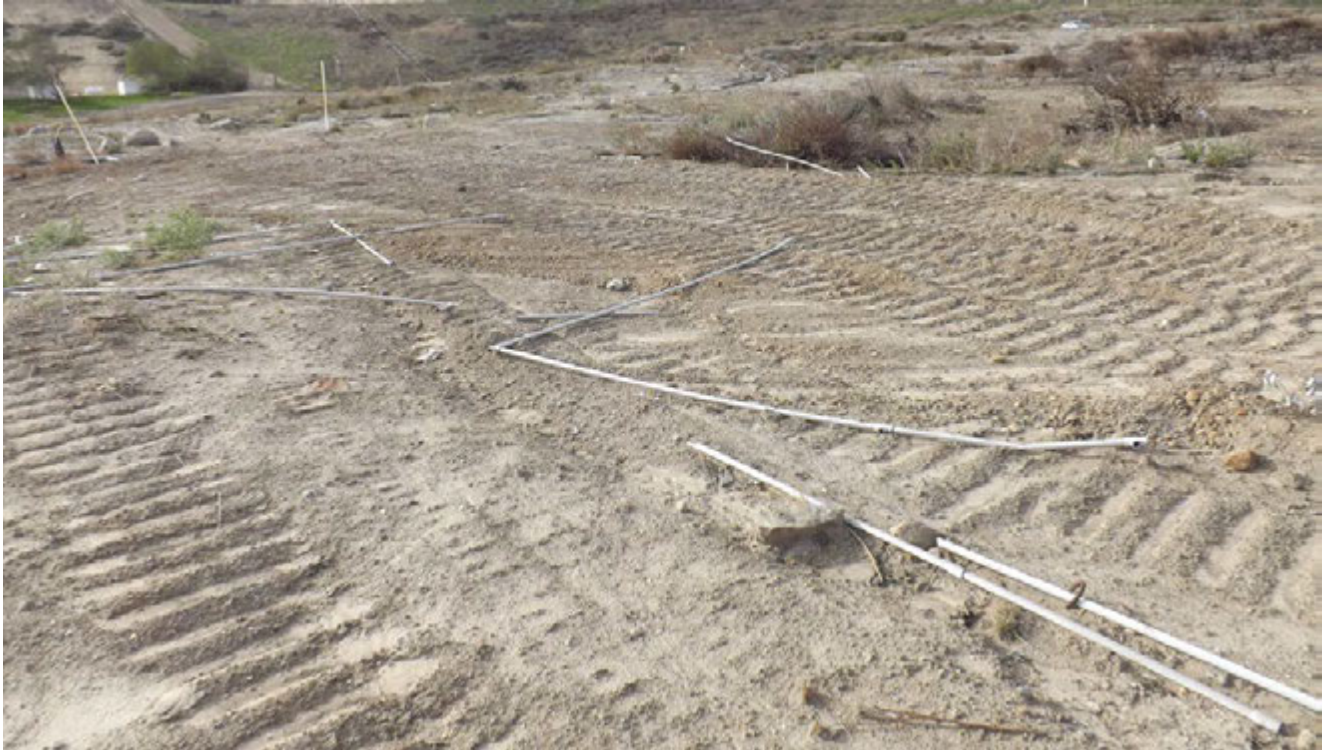
Irrigation Damage due to vehicular traffic

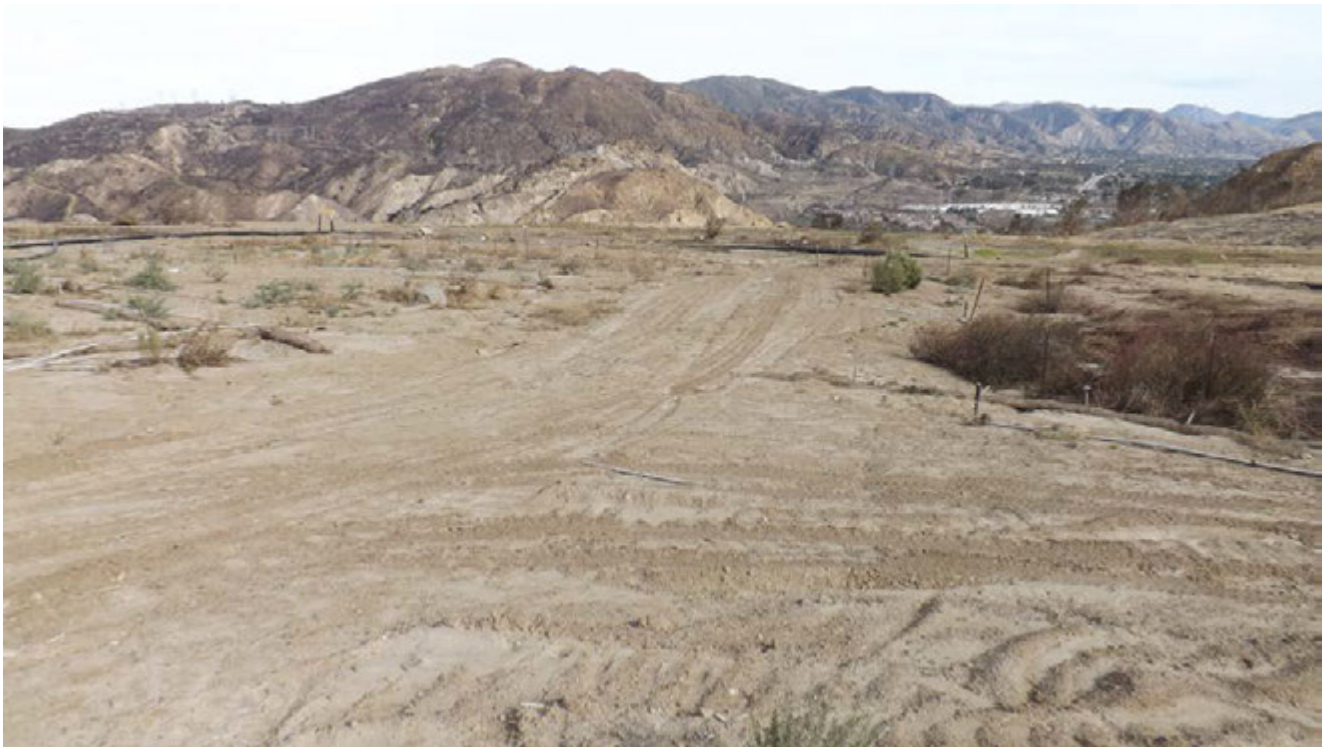
Graded areas on Deck B where vegetation used to exist

- Fire vehicle access and graded has also damaged and removed vegetation that was beginning to establish on the deck. These areas should be reseeded as quickly as possible to take advantage of the winter rains and cooler weather pattern.

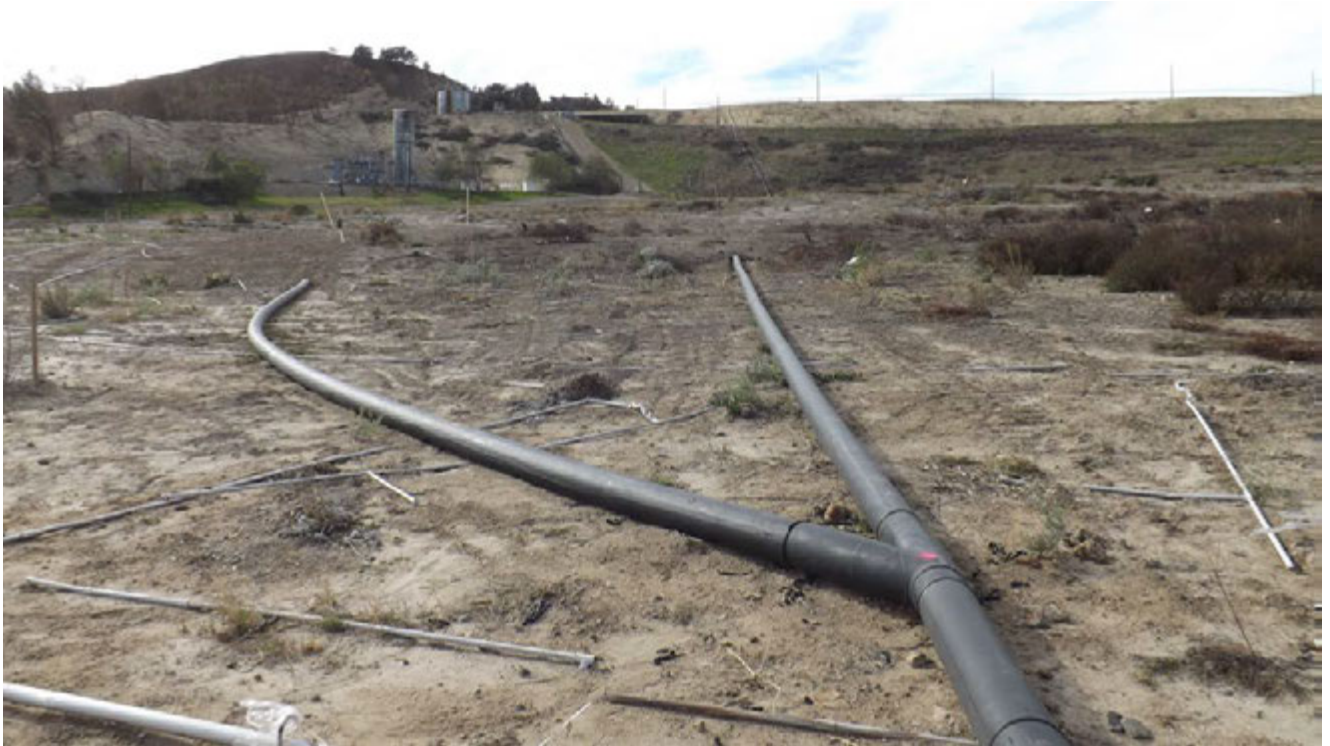
New on-grade gas lines

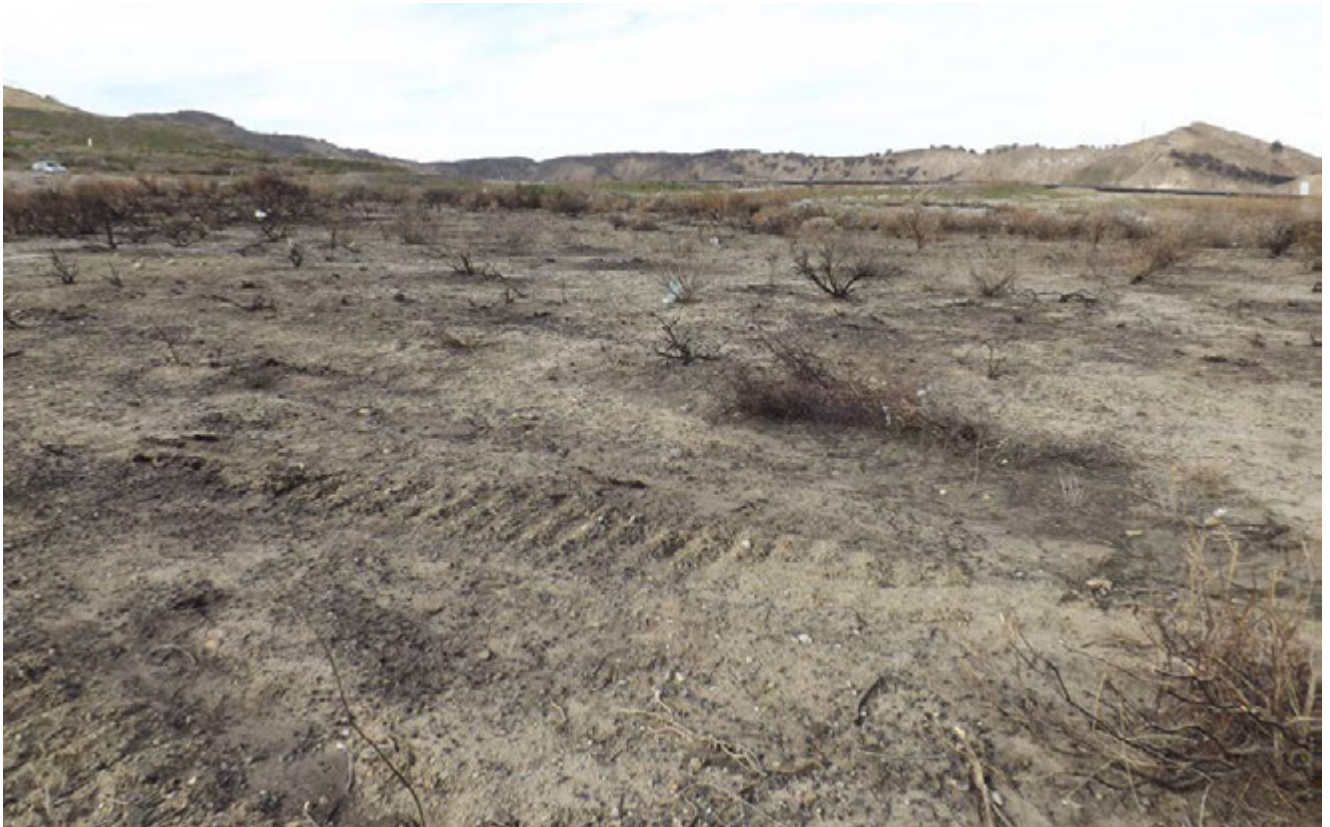
Large existing portion of Venturan CSS burned during fire
