# Los Angeles Regional Water Quality Control Board

## FACILITY INSPECTION REPORT

**Facility Name:** Sunshine Canyon City/County Landfill (CI 2043)

**Summary:** The inspection focused on stormwater retention basins, drainage channels, interim and final covers of the landfill. Areas of concern, including damage to stormwater management system and ponding of stormwater on top of the landfill, were observed.

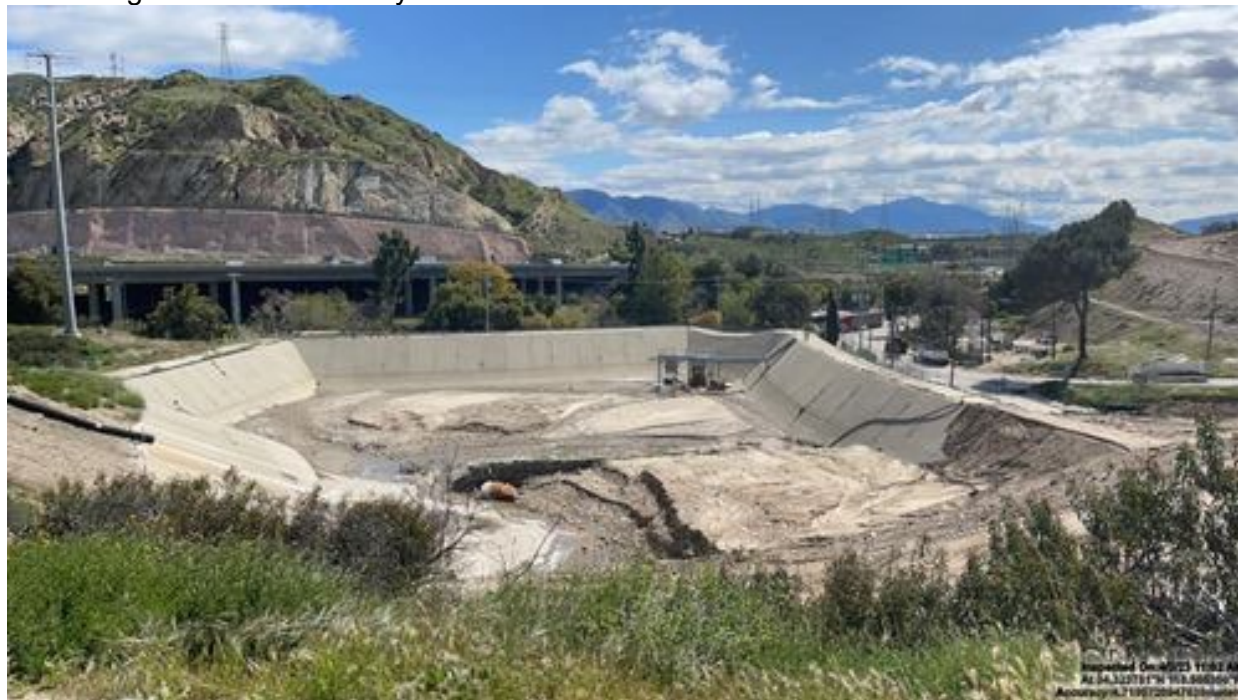
- Observations:**
1. The amount of sediment accumulated in the Terminal Basin was much more than what was observed in previous years (Photo 1). One of the three risers at the outlet of the basin was seriously damaged (ripped from the top) so it was shorter than the other two (Photo 2). As a result, water was flowing out of the basin through the damaged riser only. The depth of sediments in the basin is at the same level as that of the damaged riser. As such, no retention time to allow settling of sediments was available when stormwater enters the basin and then immediately leaves the basin at the outlet. At the other end of the outlet, outside of the basin, yellowish water from the outlet was flowing into a box culvert that is part of the Los Angeles County storm sewer system (Photo 3). The coarse grain size of sediments accumulated at the bottom of the channel indicates that a significant amount of sediment may have been washed into the storm sewer during the storm events since January 2023.

**Photo 1.** The Terminal Basin at the entrance of the Landfill, looking southeast. This sediment basin is at the mouth of the Sunshine Canyon and receives all stormwater runoff generated in the canyon.

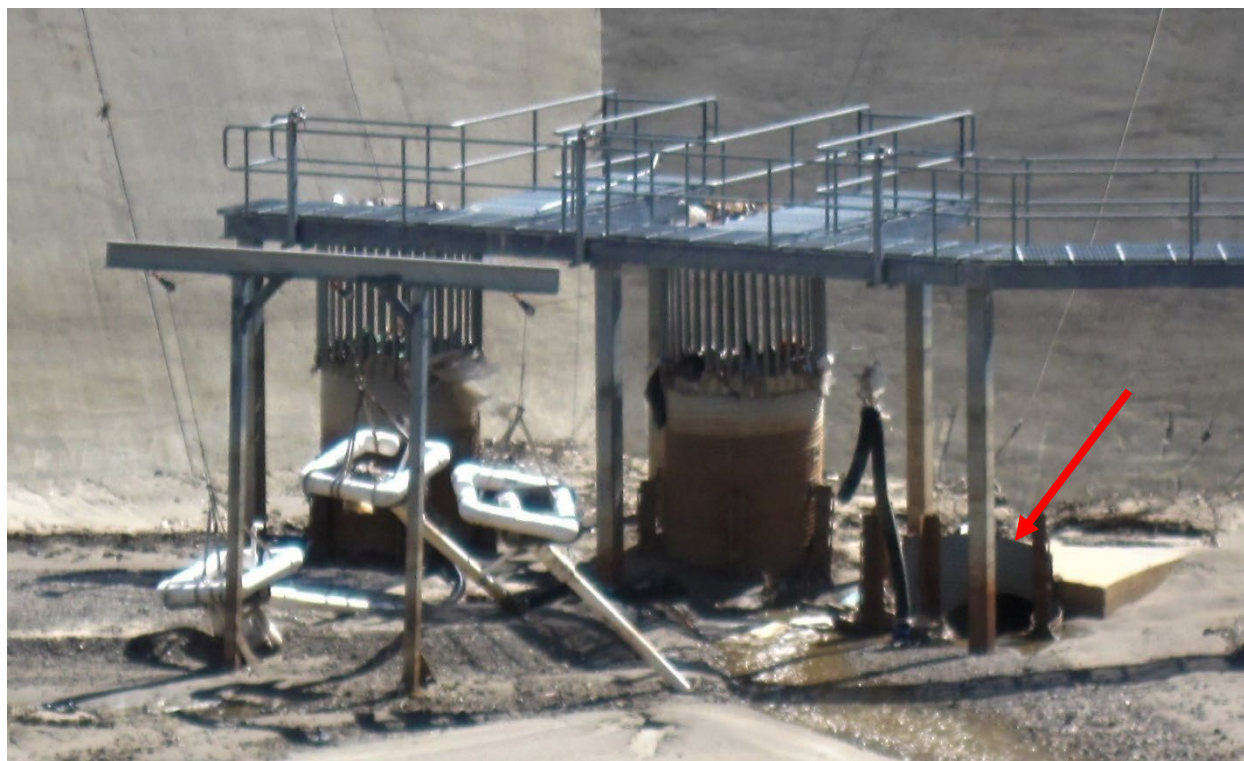
**Photo 2.** A close-up of the three risers of the Terminal Basin that discharge stormwater offsite. The riser on the right (arrow) was damaged (cut from the top end) during a storm in January 2023.

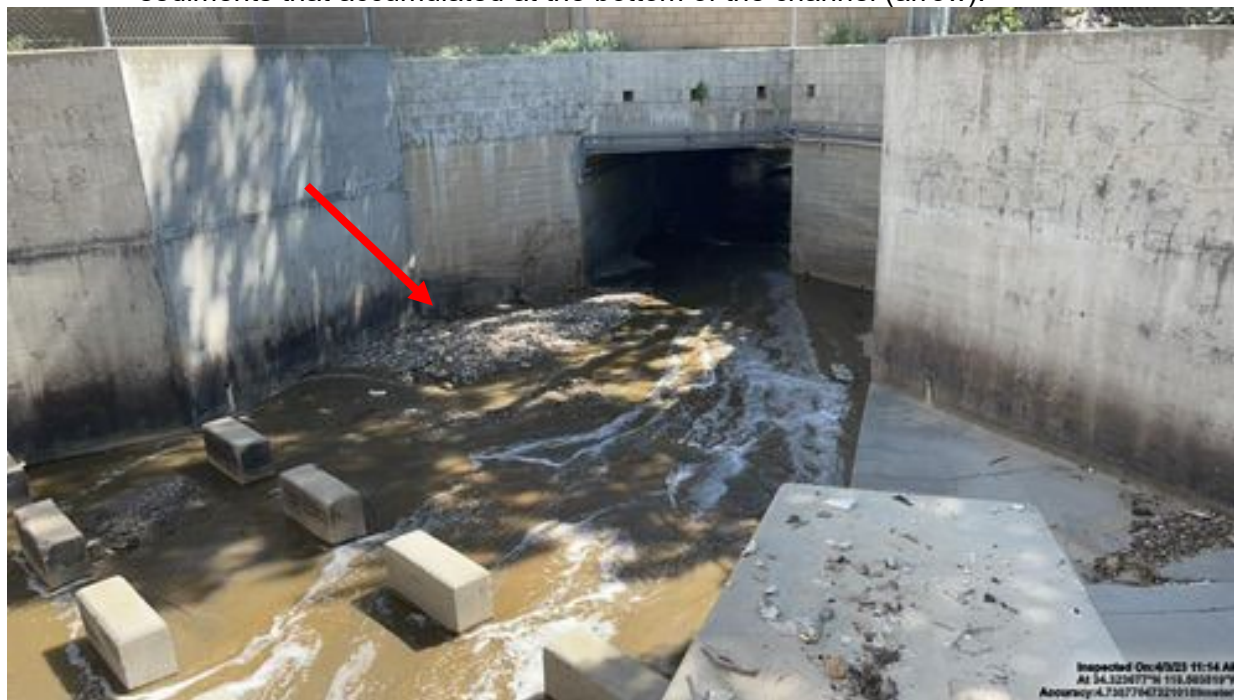
**Photo 3.** Water from the Terminal Basin flows offsite through this box culvert into Bull Creek, which is part of the Los Angeles County storm sewer system. Note the coarse-sized sediments that accumulated at the bottom of the channel (arrow).

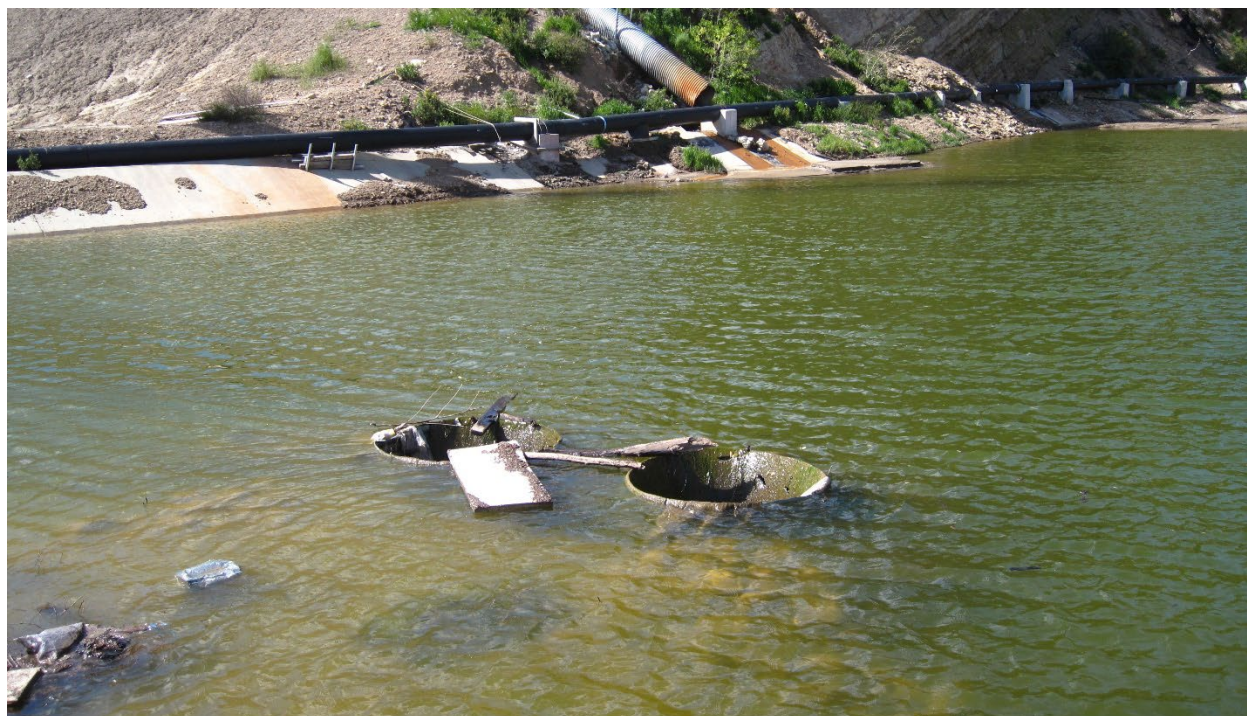
2. Sediment Basin A at the western edge of the Landfill was filled with stormwater, with thick sediment settled at the bottom (Photo 4). The top screens of the two risers at the outlet of the basin were missing. No significant amount of water was being released from the basin at the time of inspection. The Discharger indicated that stormwater collected in the basin was from the native slopes to the west and was used for dust control at the Landfill.

**Photo 4.** Sediment Basin A at the west edge of the Landfill. The top screens of the two risers had been damaged in recent storms and a significant amount of sediment accumulated at the bottom of the base.

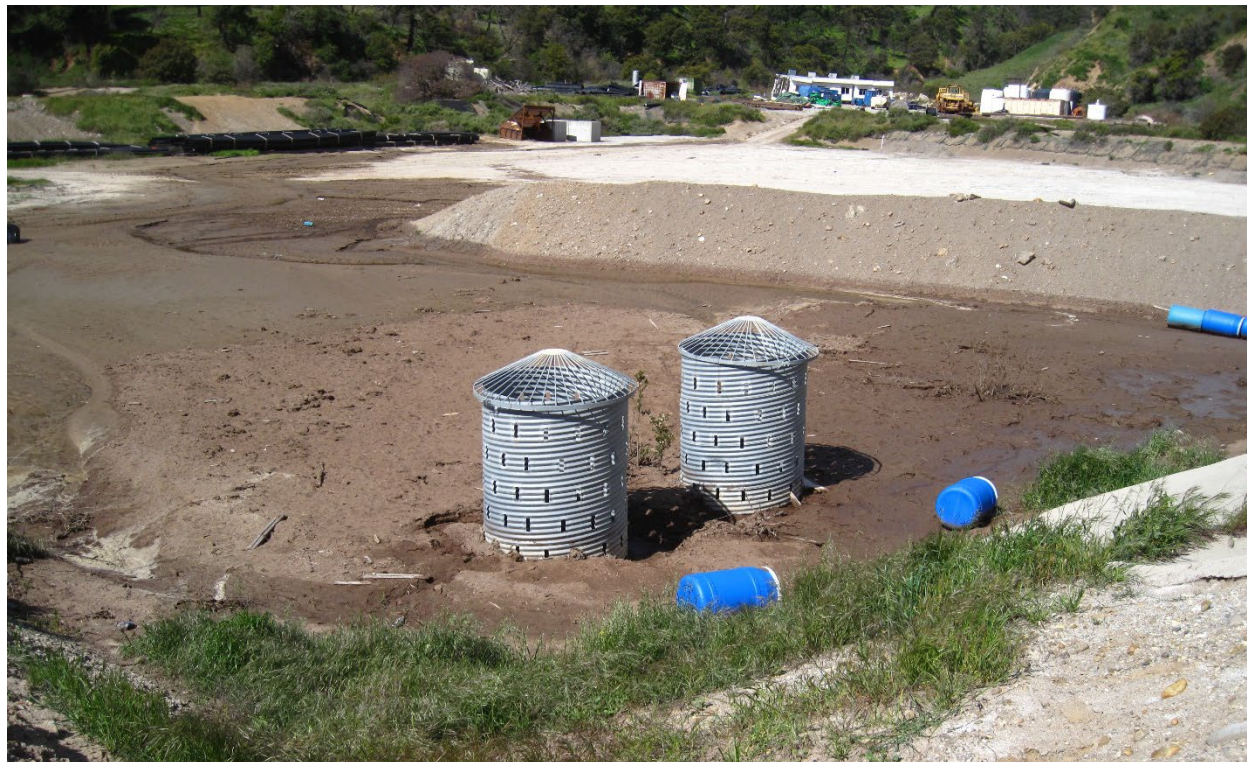
3. Sediment Basin D at the northern end of the Landfill (Photo 5) and Sediment Basin B at the eastern edge of the Landfill (Photo 6) were generally in good condition and had ample capacity left.

**Photo 5.** Sediment Basin D at the northern end of the canyon, looking north. This basin was in good condition and had ample capacity for stormwater runoff from the slopes to the north of the landfill.

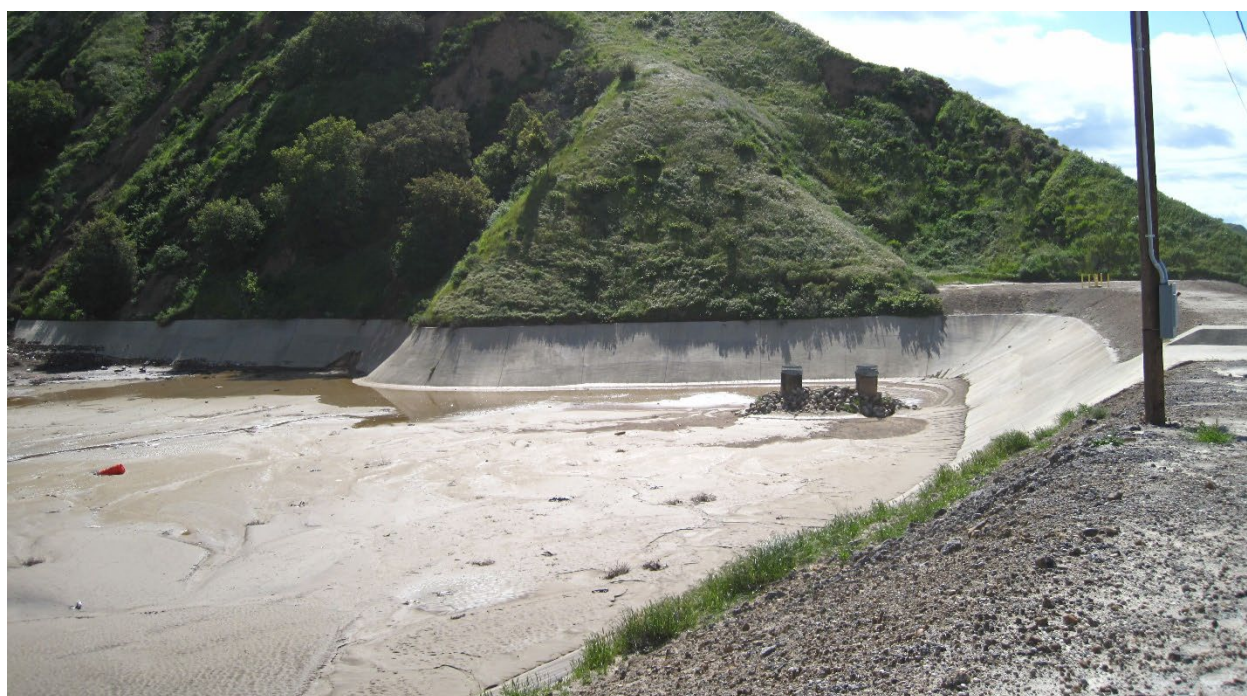
**Photo 6.** Sediment Basin B at the eastern edge of the Landfill, looking east. This basin receives water from Basin D to the north and discharges to the landfill's perimeter channel that ends at the Terminal Basin to the south.

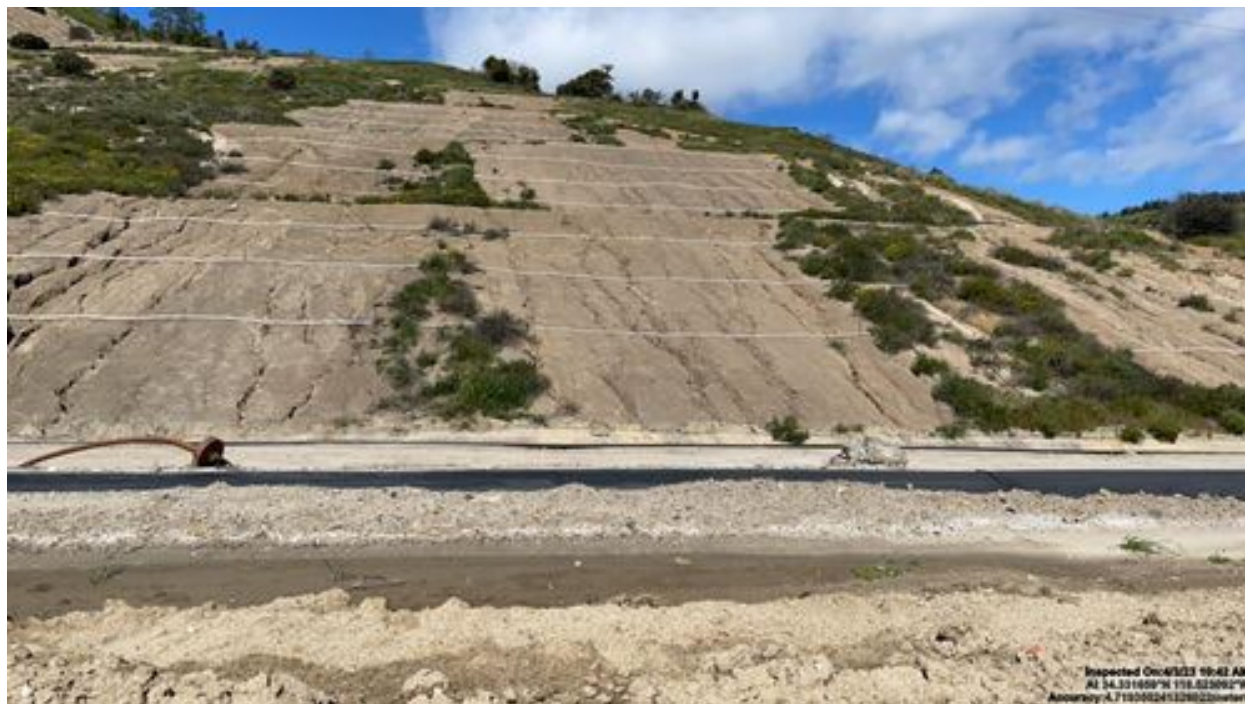
4. As Sediment Basins A, B and D primarily receive runoffs from the native side slopes surrounding the Landfill, sediment accumulated in these basins are from the eroded hillsides adjacent to each of the basins, respectively, not from internal landfill areas (Photo 7).

**Photo 7.** Graded slopes of native rock/soil to the north of the Landfill. Erosion of such slopes is the prime source of accumulation in sediment basins A, B, and D.

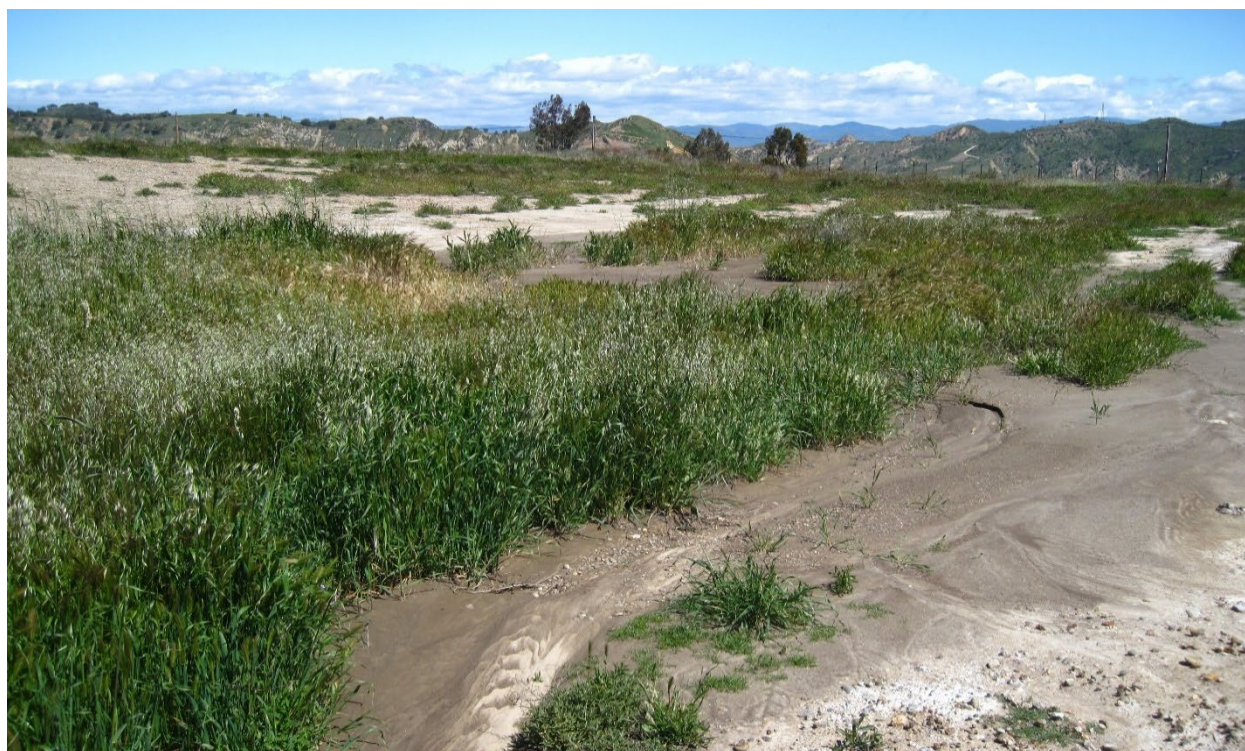
5. An area of depression (approximately 15 x 30 square yards) was observed on the top decks of the closed City Landfill South. The LEA January 31, 2023, inspection report indicates that there was ponding of stormwater in this area. Although no water was observed in the area during the inspection, there was evidence that the area might have had standing water not long ago (Photo 8). The Discharger indicated that the area would be re-graded in the upcoming dry season to improve stormwater drainage. The remediation work will be performed in conjunction with the Landfill's re-vegetation plan.

**Photo 8.** An area of depression on the top deck of the closed City Landfill South. The area is vulnerable to ponding of stormwater.

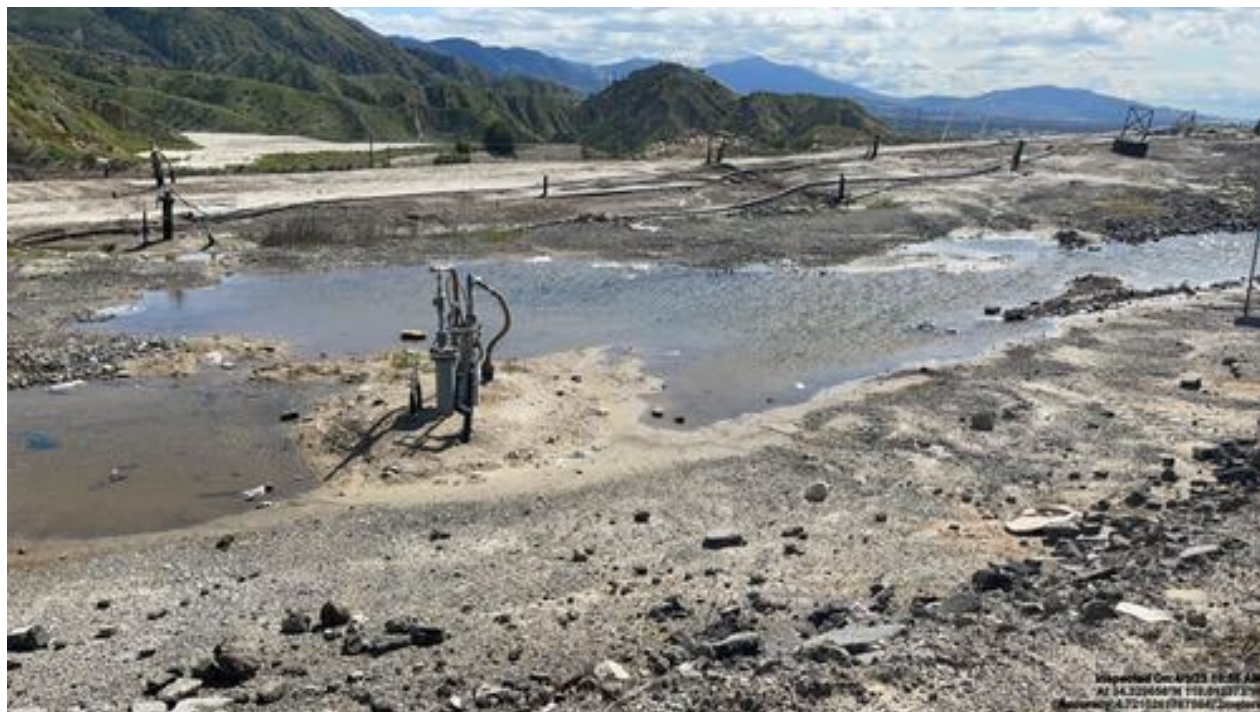
6. An area of stormwater ponding in an area of approximately 50 square yards, with a maximum depth of approximately 6 inches, was observed at the eastern portion of the Landfill, at the vicinity of Sediment Basin B (Photos No. 9). Regional Water Board staff

**Photo 9.** Ponding stormwater on the top deck, at the eastern edge, of the Landfill, near Sediment Basin B.

pointed out that ponding of stormwater on top of the Landfill is a violation of the WDRs and must be corrected. On April 5, 2023, the Discharger informed Regional Water Board staff that standing water in the area had been removed. A photo provided by the Discharger on April 6, 2023 (Photo 10) confirmed that the ponding had been removed.

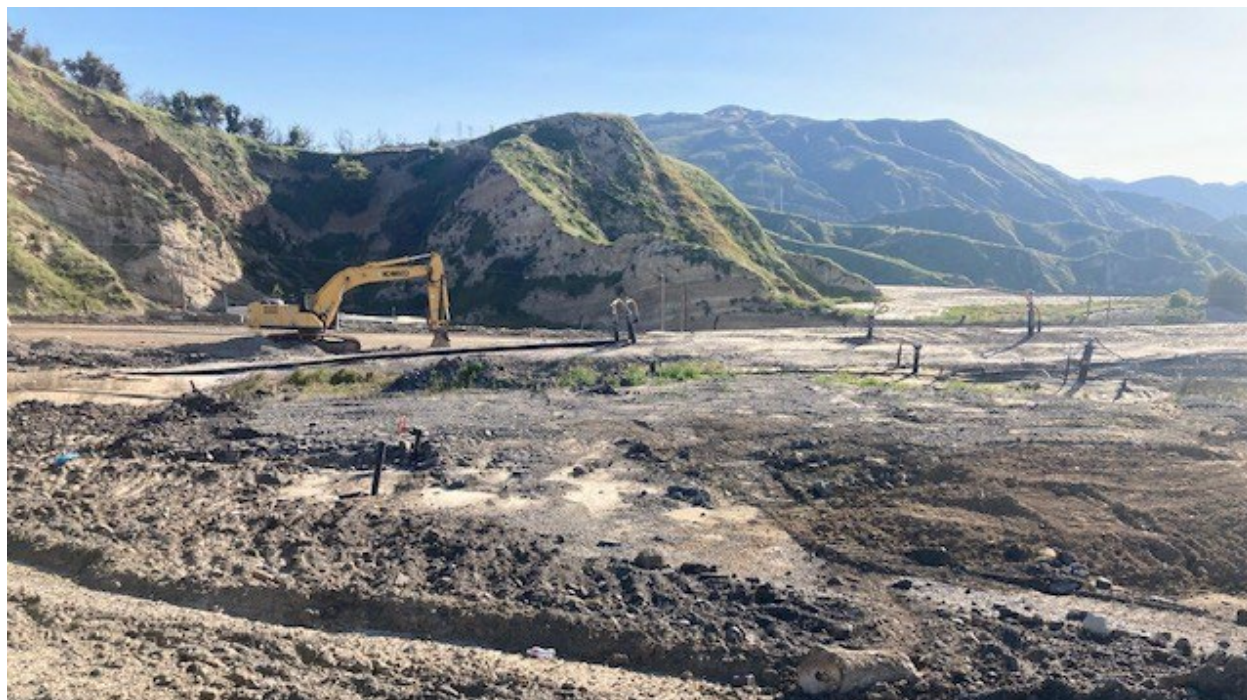
**Photo 10.** A photo of the same area shown in Photos 9 (provided by the Discharger on April 6, 2023), indicates the ponded stormwater had been removed.

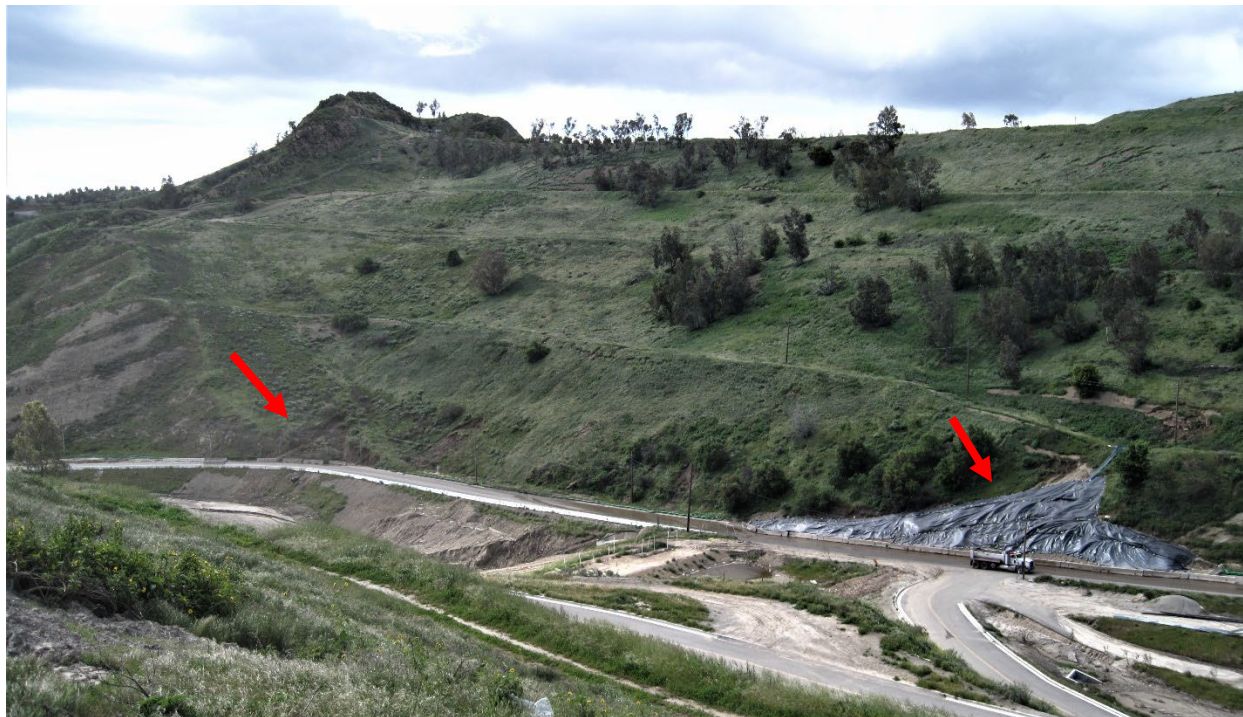
7. The sideslope final cover of the closed City Landfill South was generally in good condition, with no significant erosion or washout problems observed (Photo 11).
8. The concrete lined perimeter stormwater channels surrounding the Landfill's footprint were generally in good condition, with no significant damage (Photo 12).

**Photo 11.** Sideslopes of the closed City Landfill South, looking southwest. The final cover was generally in good condition, with minor scale slope failures on the base (arrows).

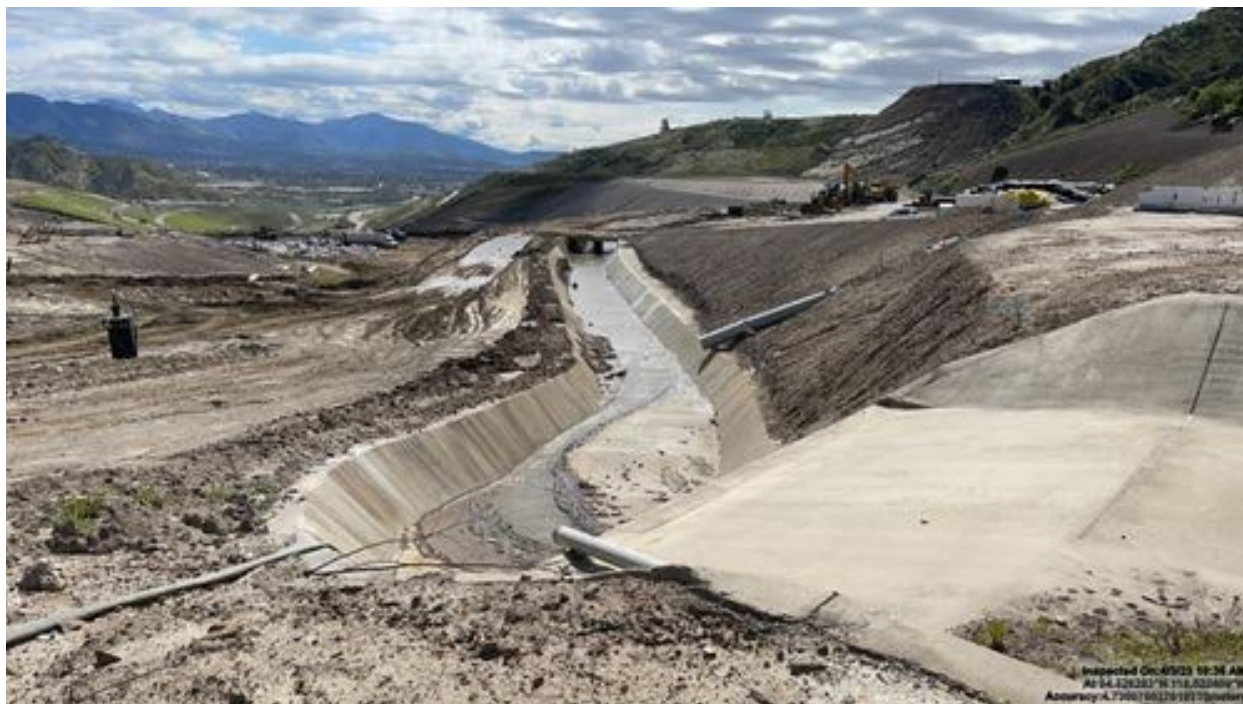
**Photo 12.** A view of the perimeter stormwater drainage channel surrounding the Landfill. The concrete lined channels were generally in good condition.
