RECORD INFORMATION & WITNESS DETAILS	
Witness(es) Present:	N/A
Photographs Taken By:	Eric Morofuji, EHS III
FACILITY / SITE & PHOTOGRAPH DETAILS	
Date Photograph(s) Taken:	2/13/24
DBA / Location Name:	Chiquita Canyon Landfill
Location Address:	29201 Henry Mayo Drive, Castaic, CA 91384

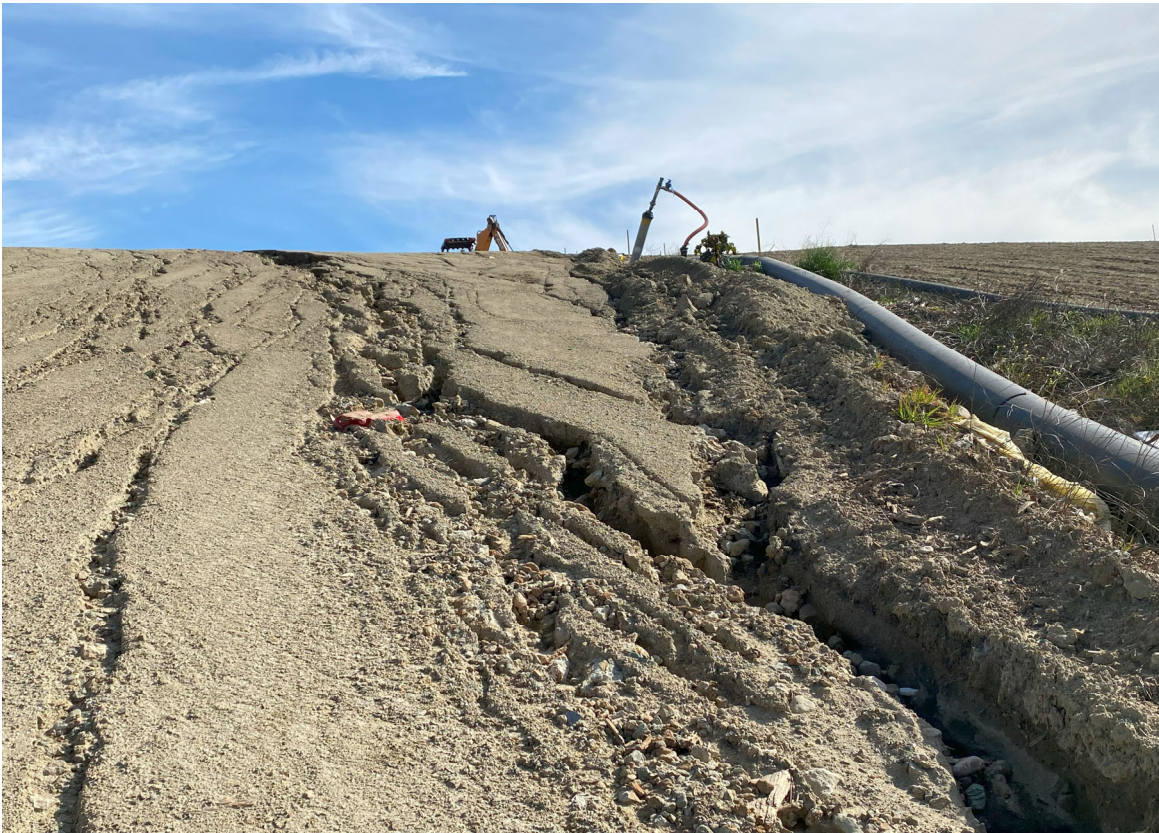
View of:	<p>Heavy erosion observed on slope located at the reaction area. For your reference, the pump at the top of the slope is #1966.</p> <p>.</p>
----------	--

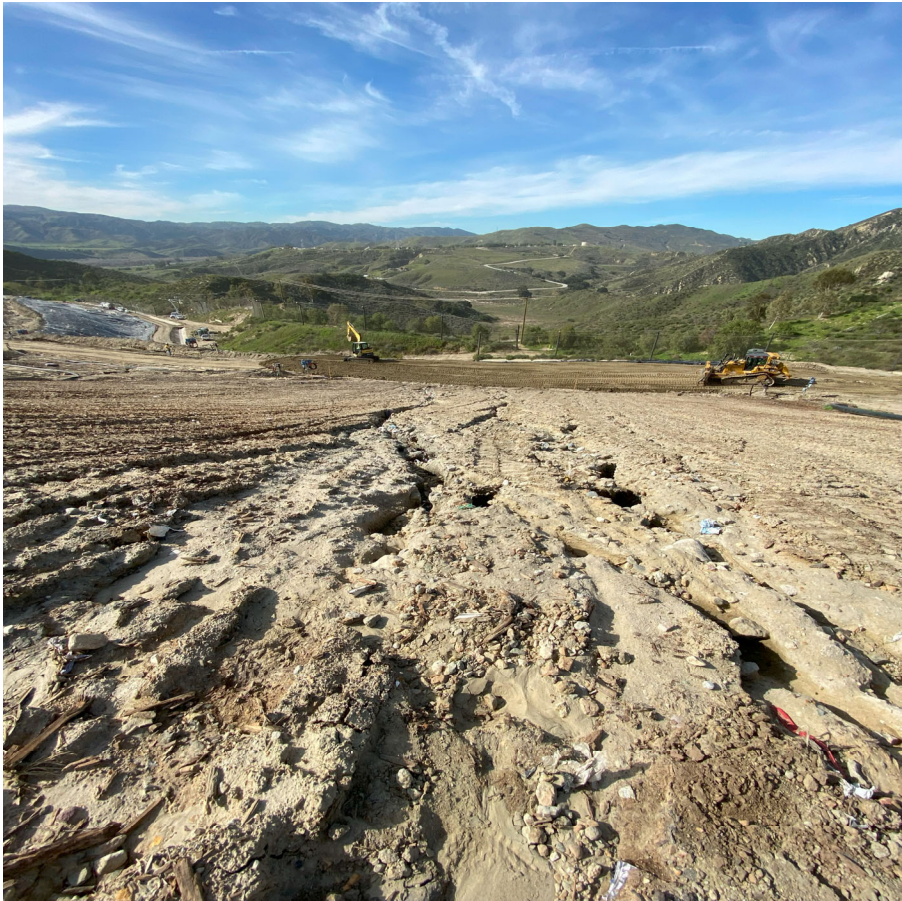
View of:	Heavy erosion looking down the slope located at the reaction area.
----------	--

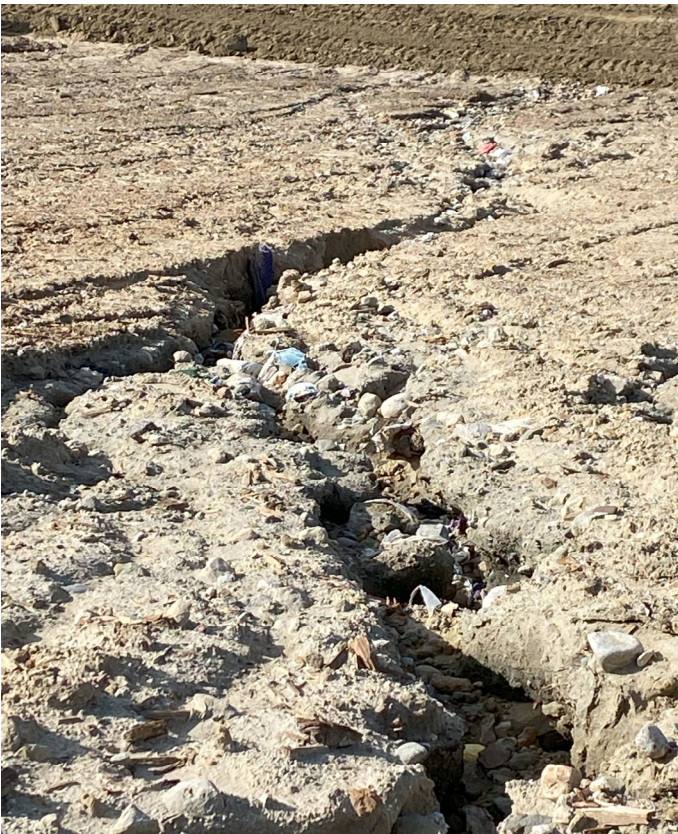
View of:	Heavy erosion observed on slope located in the reaction area.
----------	---
