GAIL FARBER, Director

# COUNTY OF LOS ANGELES

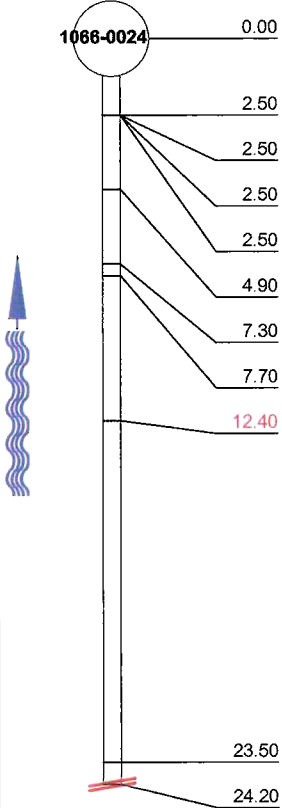
QSR	QMR	SPR	MPR	OPR	SPRI	MPRI	OPRI
5100	0000	5	0	5	5	0	5
