COUNTY OF LOS ANGELES

DEPARTMENT OF PUBLIC WORKS

CONSOLIDATED SEWER MAINTENANCE DISTRICT CONDITION ASSESSMENT PROGRAM REPORT PROJECT Y0TV0809B

**CONDITION ASSESSMENT REPORT
COUNTY OF LOS ANGELES DEPARTMENT OF PUBLIC WORKS
CONSOLIDATED SEWER MAINTENANCE DISTRICT**

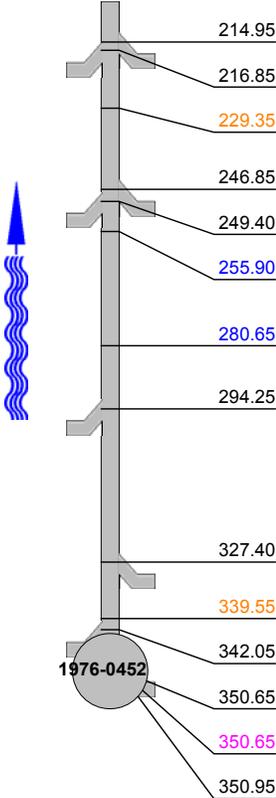
229.35	Crack Multiple, from 01 to 09 o'clock, within 8 inch: YES	00:15:03	319, b	S 3
	246.85	Tap Factory Made Capped, at 09 o'clock, 6", within 8 inch: YES	00:16:18	321

249.40	Tap Factory Made Capped, at 03 o'clock, 6", within 8 inch: YES	00:16:33	322	
	255.90	Crack Spiral, from 12 to 12 o'clock, within 8 inch: YES	00:16:58	323, b	S 2

280.65	Crack Spiral, from 11 to 05 o'clock, within 8 inch: YES	00:18:26	325, b	S 2
	294.25	Tap Factory Made Active, at 03 o'clock, 6", within 8 inch: YES	00:19:16	327

327.40	Tap Factory Made Active, at 09 o'clock, 6", within 8 inch: YES	00:24:46	328	
	339.55	Crack Multiple, from 01 to 08 o'clock, within 8 inch: YES	00:30:01	329	S 3

342.05	Tap Factory Made Active, at 03 o'clock, 6", within 8 inch: YES	00:30:48	330	
	350.65	Tap Factory Made Active, at 09 o'clock, 6", within 8 inch: YES	00:33:19	331

350.65	Fracture Multiple, from 09 to 03 o'clock, within 8 inch: YES	00:33:30	332, b	S 4
	350.95	Upstream Manhole, Survey Ends 1976-0452	00:37:37	334

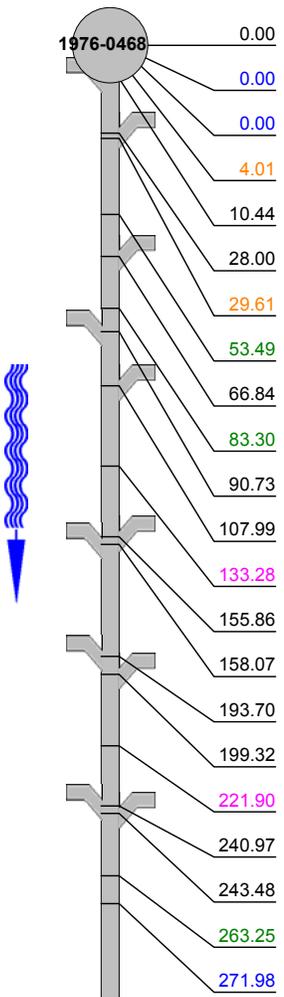
0.00	Water Mark, 5 % of cross sectional area	00:00:21		M 2
	4.01	Crack Multiple, from 12 to 12 o'clock, within 8 inch: YES	00:00:31	4234, b	S 3
	10.44	Tap Factory Made, at 02 o'clock, 4", within 8 inch: NO	00:01:09	4236

28.00	Tap Factory Made, at 10 o'clock, 4", within 8 inch: NO	00:01:58	4237	
	29.61	Crack Multiple, from 08 to 11 o'clock, within 8 inch: YES	00:02:21	4238, b	S 3

53.49	Crack Circumferential, from 07 to 11 o'clock, within 8 inch: YES	00:03:58	4240, b	S 1
	66.84	Tap Factory Made Capped, at 10 o'clock, 4", within 8 inch: NO	00:04:40	4242

83.30	Crack Circumferential, from 07 to 05 o'clock, within 8 inch: YES	00:05:28	4243, b	S 1
	90.73	Tap Factory Made, at 02 o'clock, 4", within 8 inch: NO	00:06:06	4245

107.99	Tap Factory Made, at 10 o'clock, 4", within 8 inch: NO	00:06:52	4246	
	133.28	Fracture Multiple, from 12 to 12 o'clock, within 8 inch: YES	00:07:54	4247, b	S 4

221.90	Fracture Multiple, from 12 to 12 o'clock, within 8 inch: YES	00:12:24	4253, b	S 4
	240.97	Tap Factory Made Capped, at 02 o'clock, 4", within 8 inch: NO	00:13:23	4255

243.48	Tap Factory Made, at 10 o'clock, 4", within 8 inch: NO	00:13:39	4256	
	263.25	Crack Circumferential, from 07 to 10 o'clock, within 8 inch: YES	00:14:31	4257, b	S 1

271.98	Crack Longitudinal, at 12 o'clock, within 8 inch: YES	00:15:01	4259, b	S 2

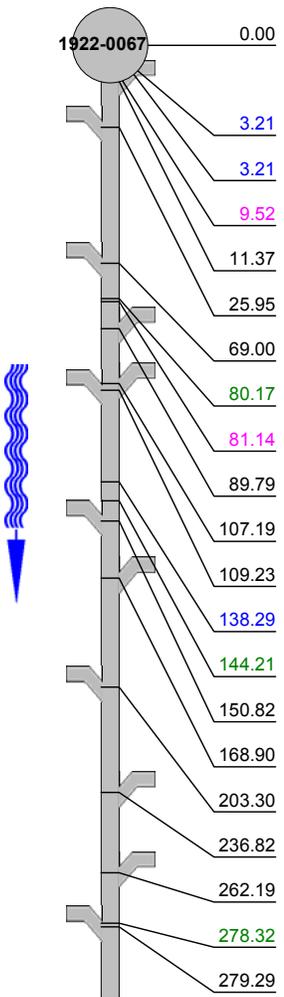
1:726	position	observation	MPEG	photo	grade
	0.00	Upstream Manhole, 1922-0068 Survey Begins	00:00:04	1895	
	<u>3.21</u>	Water Level, 10' of cross sectional area	00:00:21		M 2
	<u>3.21</u>	Water Mark, 10' of cross sectional area	00:00:21		M 2
	<u>9.52</u>	Fracture Multiple, from 08 to 04 o'clock, within 8 inch: YES	00:00:37	1896, b	S 4
	<u>11.37</u>	Tap Factory Made, at 10 o'clock, 4", within 8 inch: NO	00:01:00	1898	
	<u>25.95</u>	Tap Factory Made Capped, at 02 o'clock, 4", within 8 inch: NO	00:01:35	1899	
	<u>69.00</u>	Tap Factory Made, at 02 o'clock, 4", within 8 inch: NO	00:03:09	1900	
	<u>80.17</u>	Crack Circumferential, from 07 to 02 o'clock, within 8 inch: YES	00:03:41	1901, b	S 1
	<u>81.14</u>	Fracture Multiple, from 04 to 09 o'clock, within 8 inch: YES	00:03:56	1903, b	S 4
	<u>89.79</u>	Tap Factory Made, at 10 o'clock, 4", within 8 inch: NO	00:04:31	1905	
	<u>107.19</u>	Tap Factory Made, at 10 o'clock, 4", within 8 inch: NO	00:05:21	1906

<u>109.23</u>	Tap Factory Made, at 02 o'clock, 4", within 8 inch: NO	00:05:39	1907	
	<u>138.29</u>	Crack Longitudinal, at 03 o'clock, within 8 inch: YES	00:06:56	1908, b	S 2
	<u>144.21</u>	Crack Circumferential, from 10 to 02 o'clock, within 8 inch: YES	00:07:25	1910, b	S 1
	<u>150.82</u>	Tap Factory Made Capped, at 02 o'clock, 4", within 8 inch: NO	00:07:54	1912	
	<u>168.90</u>	Tap Factory Made, at 10 o'clock, 4", within 8 inch: NO	00:08:34	1913	
	<u>203.30</u>	Tap Factory Made, at 02 o'clock, 4", within 8 inch: NO	00:10:01	1914	
	<u>236.82</u>	Tap Factory Made Capped, at 10 o'clock, 4", within 8 inch: NO	00:11:21	1915	
	<u>262.19</u>	Tap Factory Made, at 10 o'clock, 4", within 8 inch: NO	00:12:44	1916	
	<u>278.32</u>	Crack Circumferential, from 08 to 04 o'clock, within 8 inch: YES	00:13:39	1917, b	S 1
	<u>279.29</u>	Tap Factory Made, at 02 o'clock, 4", within 8 inch: NO	00:13:54	1919

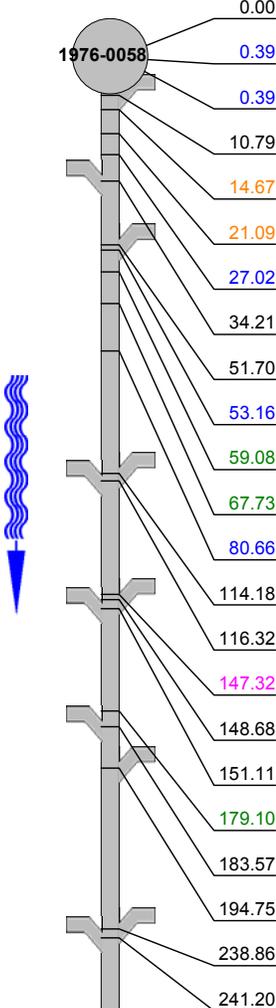
<u>67.73</u>	Crack Circumferential, from 07 to 10 o'clock, within 8 inch: YES	00:04:33	2327, b	S 1
	<u>80.66</u>	Crack Longitudinal, at 11 o'clock, within 8 inch: YES	00:05:07	2329, b	S 2
	<u>114.18</u>	Tap Factory Made, at 10 o'clock, 4", within 8 inch: NO	00:06:11	2331	
	<u>116.32</u>	Tap Factory Made, at 02 o'clock, 4", within 8 inch: NO	00:06:24	2332	
	<u>147.32</u>	Fracture Multiple, from 07 to 09 o'clock, within 8 inch: YES	00:07:21	2333, b	S 4
	<u>148.68</u>	Tap Factory Made, at 10 o'clock, 4", within 8 inch: NO	00:07:42	2335	
	<u>151.11</u>	Tap Factory Made, at 02 o'clock, 4", within 8 inch: NO	00:07:56	2336	
	<u>179.10</u>	Crack Circumferential, from 08 to 05 o'clock, within 8 inch: YES	00:08:49	2337, b	S 1
	<u>183.57</u>	Tap Factory Made, at 02 o'clock, 4", within 8 inch: NO	00:09:17	2339	
	<u>194.75</u>	Tap Factory Made, at 10 o'clock, 4", within 8 inch: NO	00:09:44	2340	
	<u>238.86</u>	Tap Factory Made Capped, at 10 o'clock, 4", within 8 inch: NO	00:10:59	2341

<u>241.20</u>	Tap Factory Made, at 02 o'clock, 4", within 8 inch: NO	00:11:13	2342

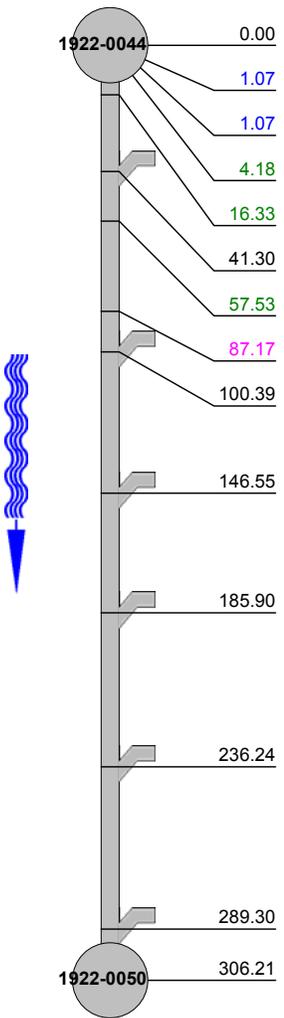
185.90	Tap Factory Made, at 10 o'clock, 4", within 8 inch: NO	00:06:53	3805	
	236.24	Tap Factory Made, at 10 o'clock, 4", within 8 inch: NO	00:08:15	3806

289.30	Tap Factory Made, at 10 o'clock, 4", within 8 inch: NO	00:09:42	3807	
	306.21	Downstream Manhole, 1922-0050 Survey Ends	00:11:20	3808
