# COUNTY OF LOS ANGELES

### **CONSOLIDATED SEWER MAINTENANCE DISTRICT CONDITION ASSESSMENT PROGRAM REPORT PROJECT NO. Y0TV0910C**

**CONDITION ASSESSMENT REPORT  
COUNTY OF LOS ANGELES DEPARTMENT OF PUBLIC WORKS  
CONSOLIDATED SEWER MAINTENANCE DISTRICT**

PROJECT NAME:	Y0TV0910C	PROJECT MGR:	Hanna Kebede
PROJECT DATE:	01/27/2011	CONTACT NO:	(626) 300-4686
SUP. DISTRICT(s):	4	MAP PAGE(S):	2347, 2348 & 2349
Report By:	Hanna Kebede	Report Date:	01/09/2013

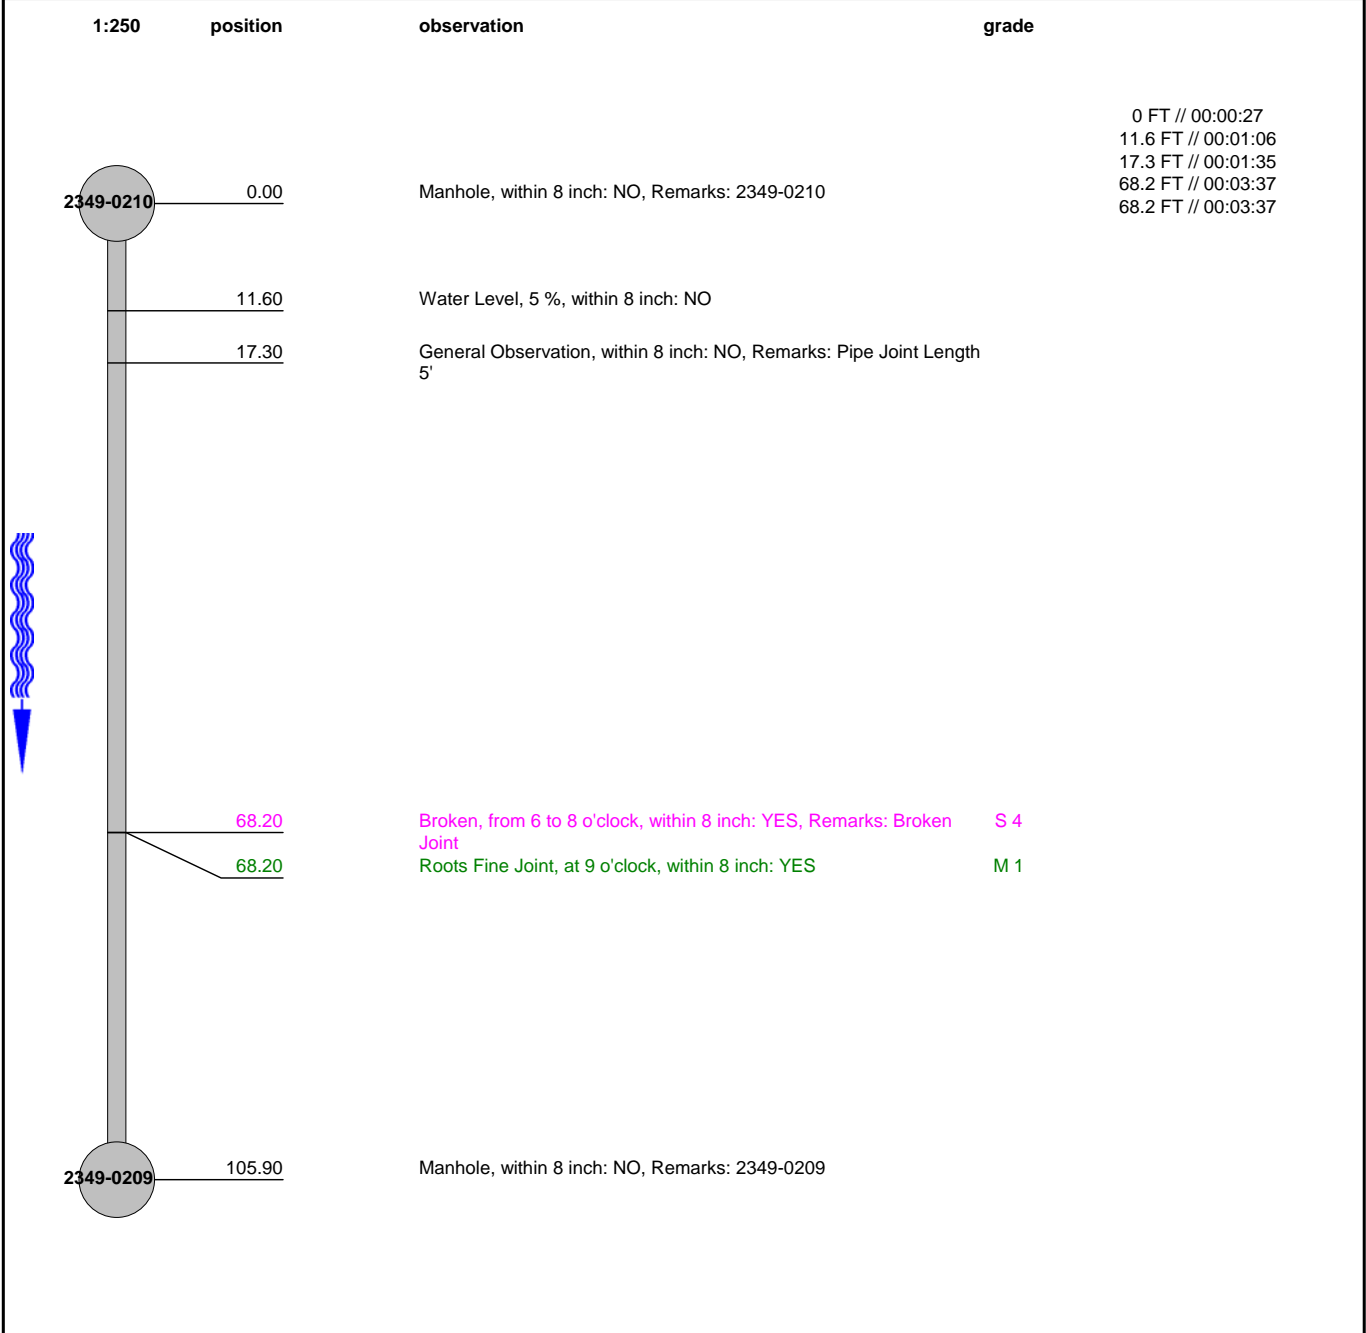
Reason for inspection: <b>Routine Assessment</b>	Dia/Height: <b>Circular 8"/8"</b>
Use of Sewer: <b>Sanitary</b>	Material: <b>Vitrified Clay Pipe</b> Pipe Length:
Drain. Area: <b>0209/2349-0210/2349</b>	Lining Method:
	Category:

QSR	QMR	SPR	MPR	OPR	SPRI	MPRI	OPRI
4100	1100	4	1	5	4	1	2.5

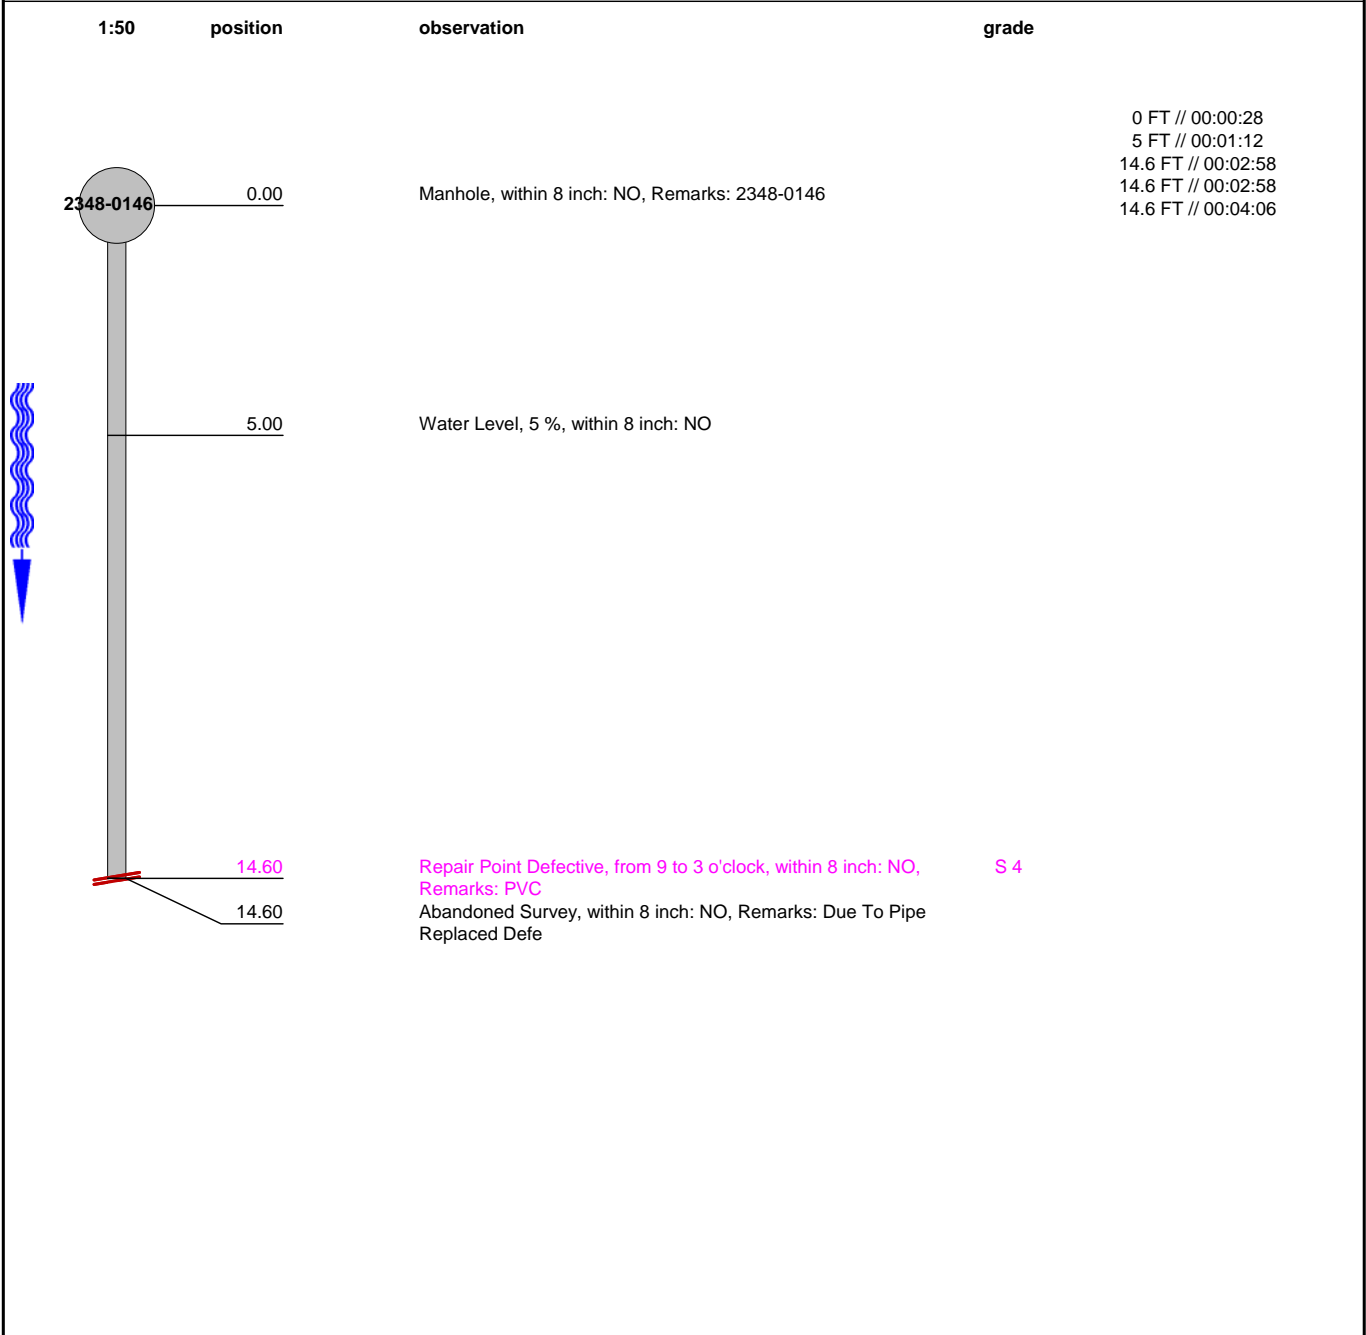
Reason for inspection: <b>Routine Assessment</b>	Dia/Height: <b>Circular 8"/8"</b>
Use of Sewer: <b>Sanitary</b>	Material: <b>Vitrified Clay Pipe</b> Pipe Length:
Drain. Area: <b>0145/2348-0146/2348</b>	Lining Method:
	Category:

QSR	QMR	SPR	MPR	OPR	SPRI	MPRI	OPRI
4100	0000	4	0	4	4	0	4

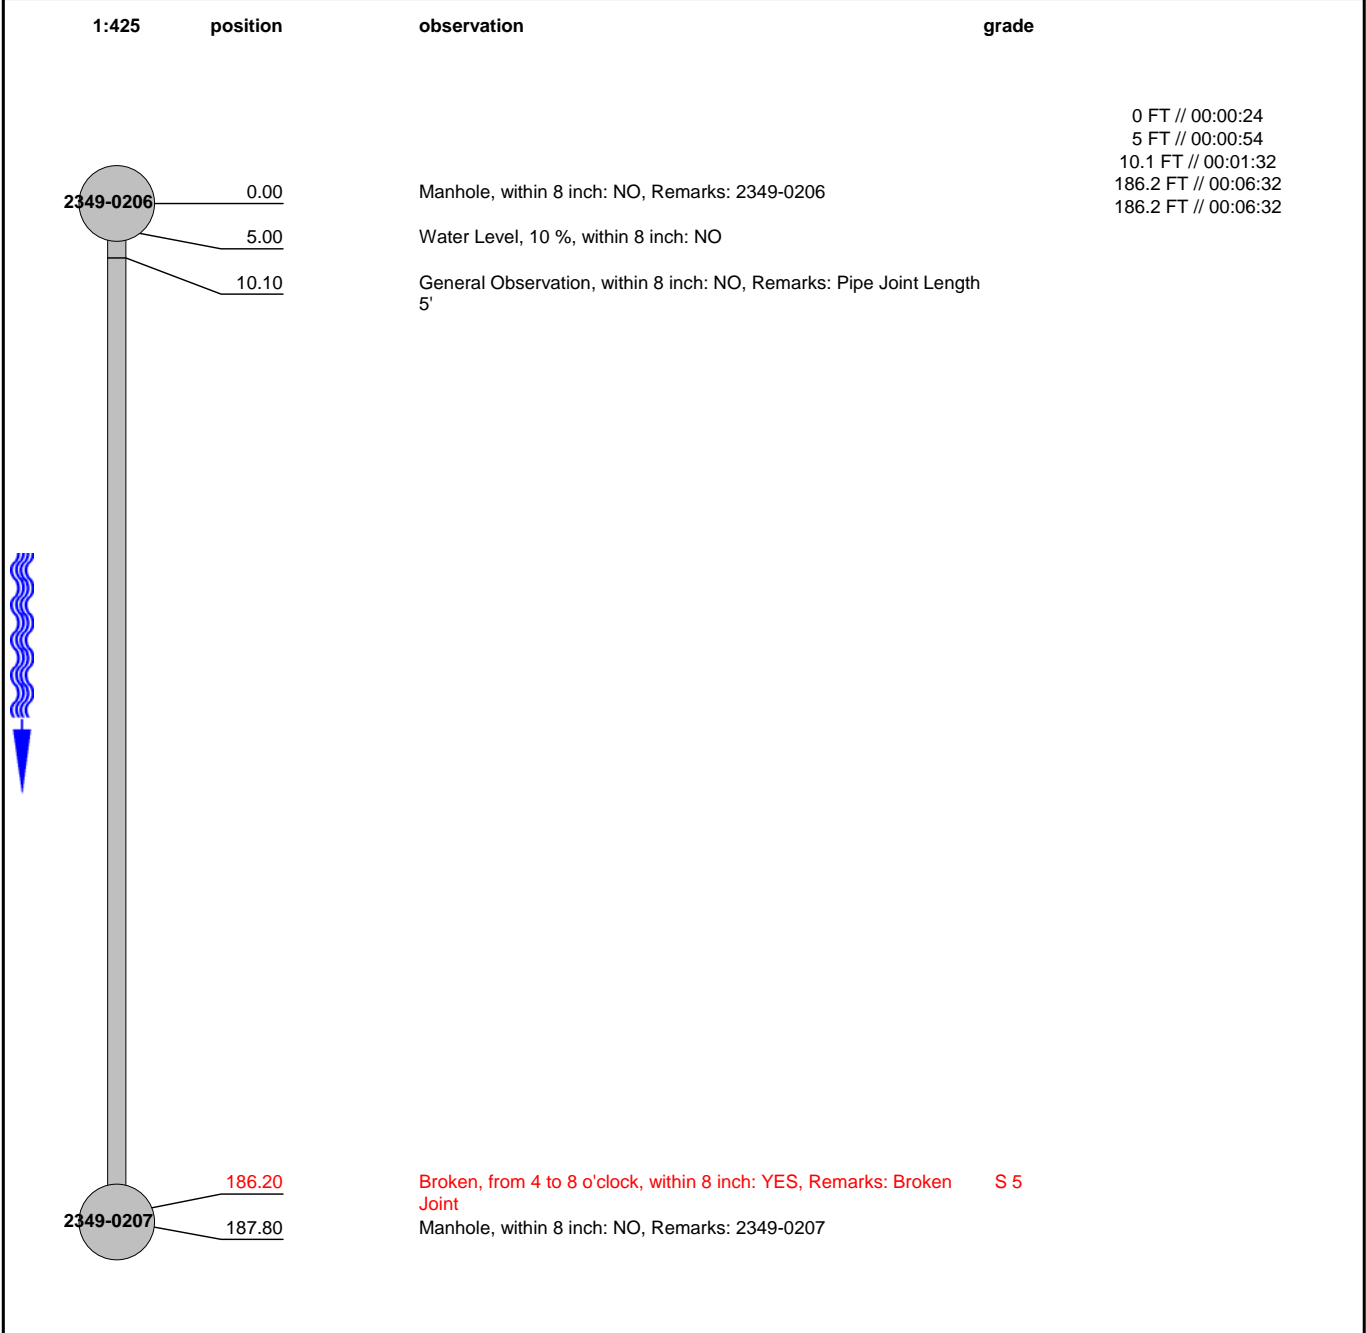
Reason for inspection: <b>Routine Assessment</b>	Dia/Height: <b>Circular 8"/8"</b>
Use of Sewer: <b>Sanitary</b>	Material: <b>Vitrified Clay Pipe</b> Pipe Length:
Drain. Area: <b>0206/2349-0207/2349</b>	Lining Method:
	Category:

QSR	QMR	SPR	MPR	OPR	SPRI	MPRI	OPRI
5100	0000	5	0	5	5	0	5

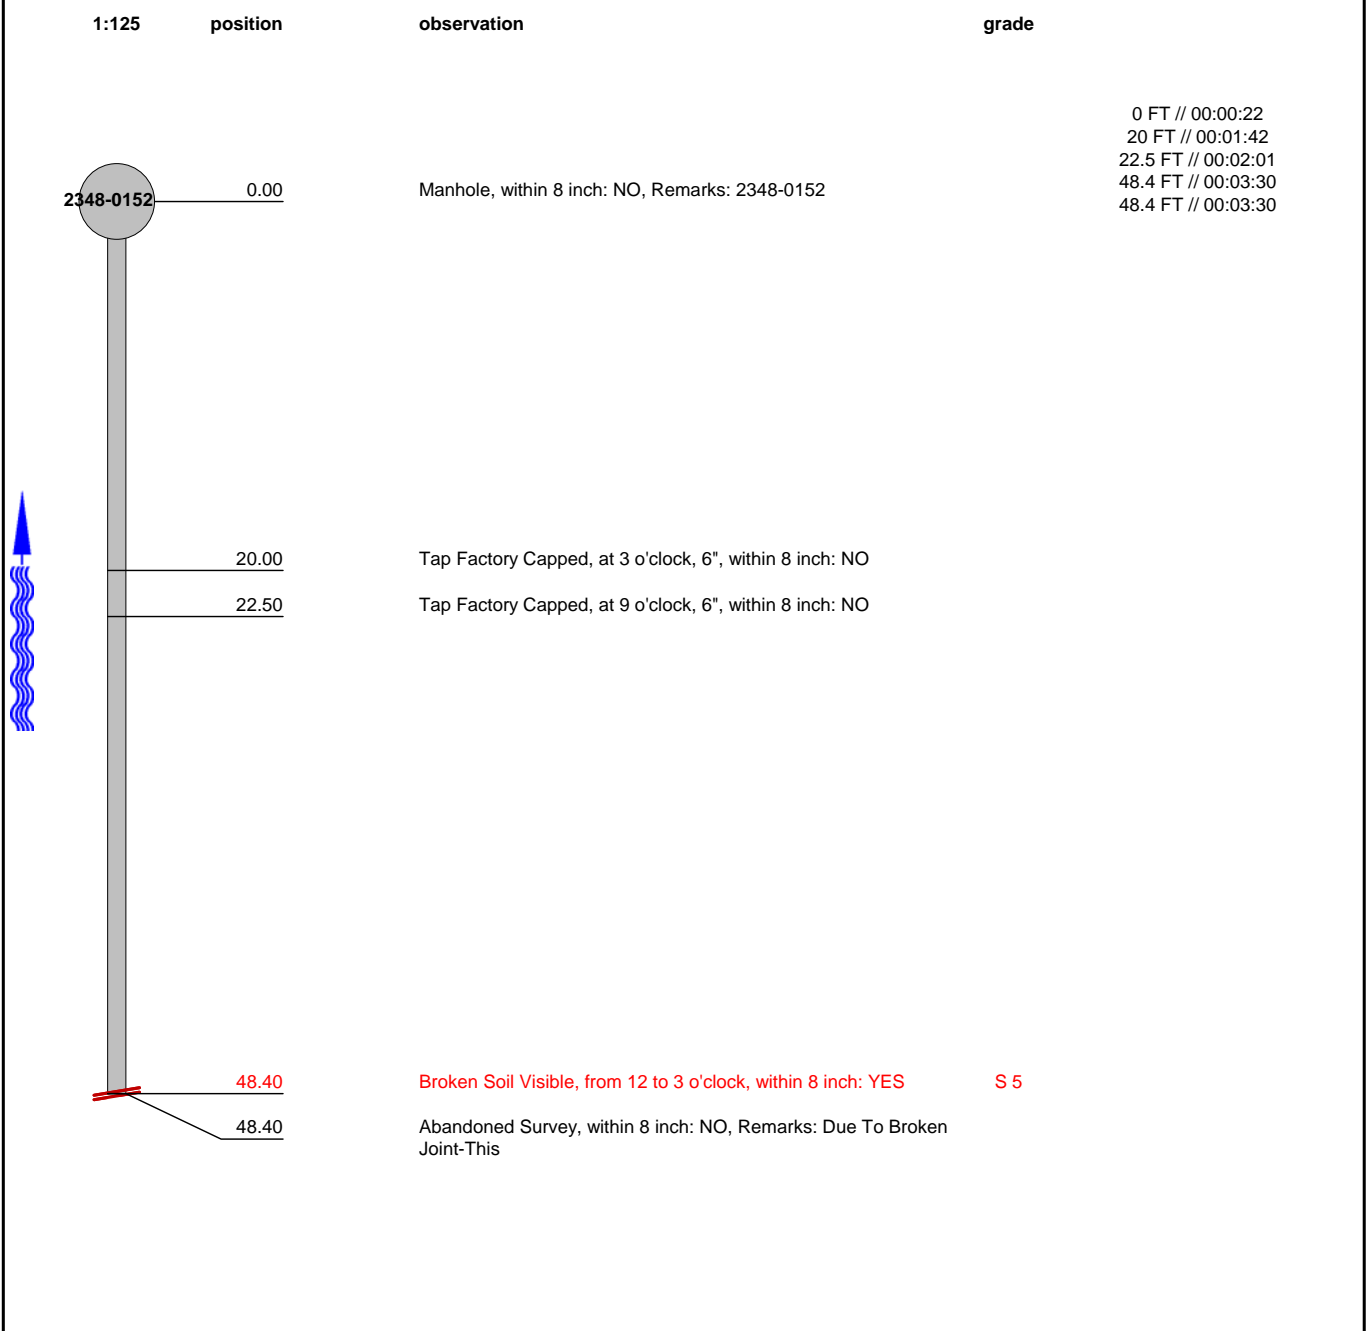
Reason for inspection: <b>Routine Assessment</b>	Dia/Height: <b>Circular 12"/12"</b>
Use of Sewer: <b>Sanitary</b>	Material: <b>Vitrified Clay Pipe</b> Pipe Length:
Drain. Area: <b>0152/2348-0153/2348</b>	Lining Method:
	Category:

QSR	QMR	SPR	MPR	OPR	SPRI	MPRI	OPRI
5100	0000	5	0	5	5	0	5
