**CONSOLIDATED SEWER MAINTENANCE DISTRICT
CONDITION ASSESSMENT PROGRAM REPORT
PROJECT NO. Y0TV0809B**

**CONDITION ASSESSMENT REPORT
COUNTY OF LOS ANGELES DEPARTMENT OF PUBLIC WORKS
CONSOLIDATED SEWER MAINTENANCE DISTRICT**

PROJECT NAME:	Y0TV0809B	PROJECT MGR:	Kari Eskridge
PROJECT DATE:	01/23/2009	CONTACT NO:	(626) 300-3369
SUP. DISTRICT(s):	4	MAP PAGE(S):	1867, 1921, 1912
Report By:	Eric Liu	Report Date:	10/25/2014

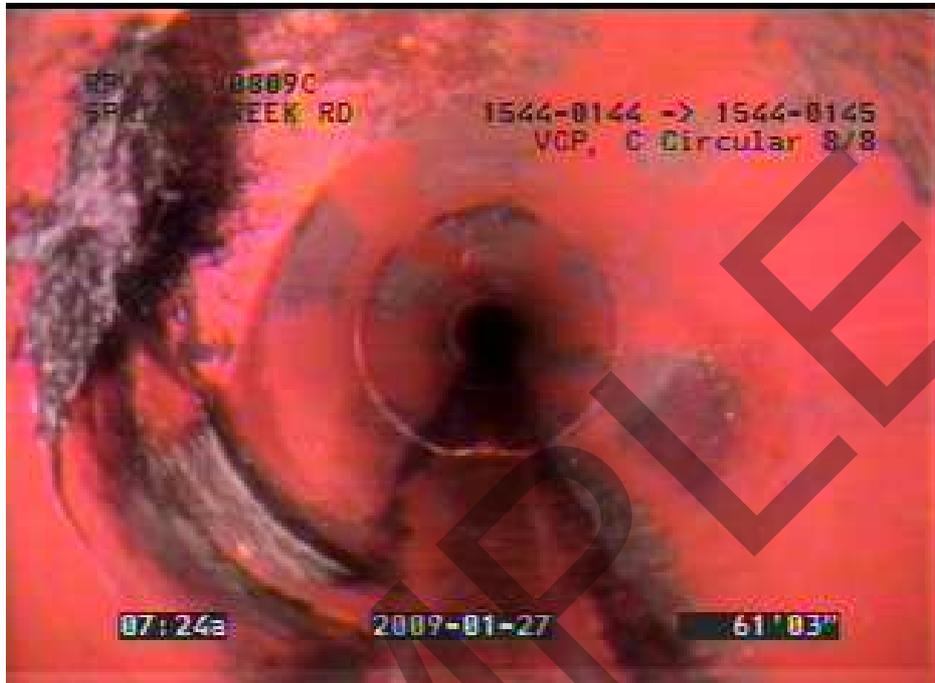
XXXX
Roots at Lateral Connection

Since the CCTV inspection, the sewer mainline has been cleaned and blockages from root growth have been removed; however, the roots blockage in your sewer lateral is still present. As the property owner, you are responsible for the entire length of the sewer lateral, which includes the portion that extends beyond the property line into the public right of way. We request that you contact a qualified plumbing contractor to service your sewer lateral within 90 days to remove roots and any other obstructions that may cause a sewage backup.

For your reference, we have enclosed photos of your lateral connection showing the presence of the root blockage. Also enclosed are some literature on ways of minimizing sewer overflows and damage to your home.
