DEPARTMENT OF PUBLIC WORKS

CONSOLIDATED SEWER MAINTENANCE DISTRICT CONDITION ASSESSMENT PROGRAM REPORT PROJECT NO. Y0TV0910A

**CONDITION ASSESSMENT REPORT
COUNTY OF LOS ANGELES DEPARTMENT OF PUBLIC WORKS
CONSOLIDATED SEWER MAINTENANCE DISTRICT**

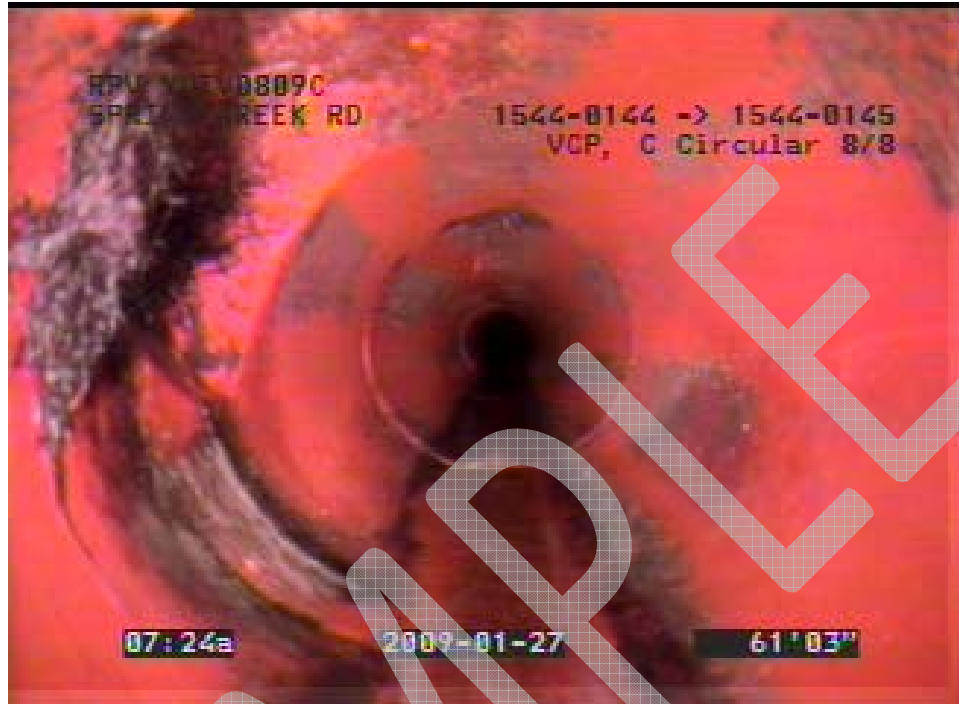
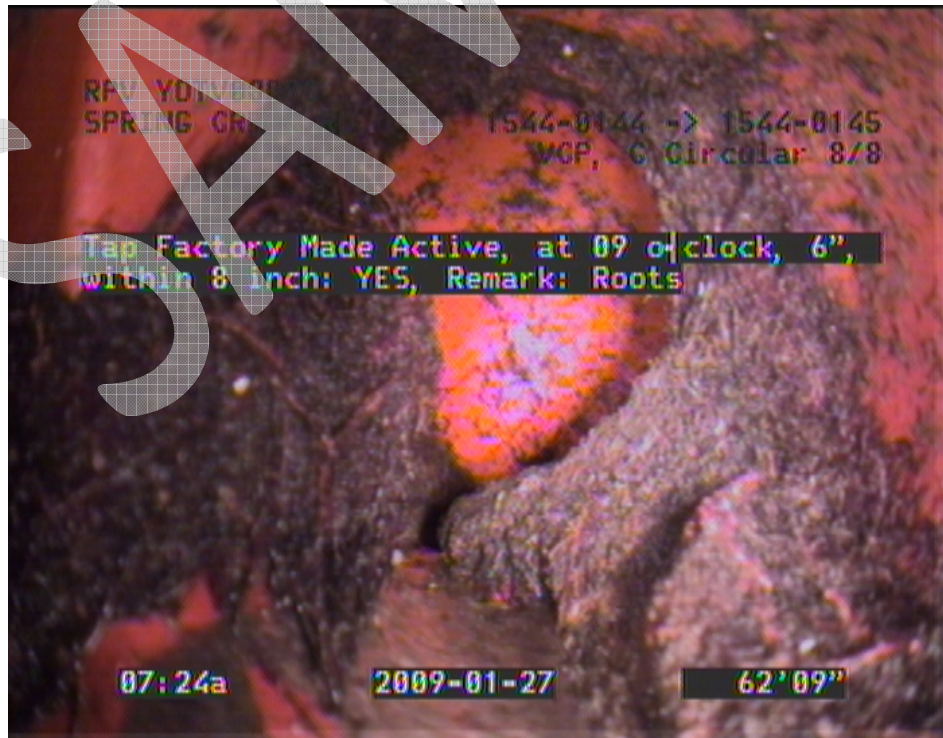
For your reference, we have enclosed photos of your lateral connection showing the presence of the root blockage. Also enclosed are some literature on ways of minimizing sewer overflows and damage to your home.

XXXX
Roots at Lateral Connection

Since the CCTV inspection, the sewer mainline has been cleaned and blockages from root growth have been removed; however, the root blockage in your sewer lateral is still present. As the property owner, you are responsible for the entire length of the sewer lateral, which includes the portion that extends beyond the property line into the public right of way. We request that you contact a qualified plumbing contractor to service your sewer lateral within 90 days to remove roots and any other obstructions that may cause a sewage backup.
