CONSOLIDATED SEWER MAINTENANCE DISTRICT CONDITION ASSESSMENT PROGRAM REPORT PROJECT Y0TV0607D

**CONDITION ASSESSMENT REPORT
COUNTY OF LOS ANGELES DEPARTMENT OF PUBLIC WORKS
CONSOLIDATED SEWER MAINTENANCE DISTRICT**

PROJECT NAME:	Y0TV0607D	PROJECT MGR:	Kari Eskridge
PROJECT DATE:	5/16/07-8/20/07	CONTACT NO:	(626) 300-3390
SUP. DISTRICT(s):	4	MAP PAGE(S):	1490, 1491, 1544, 1545
Report By:	Phyo Kyaw	Report Date:	07/29/09

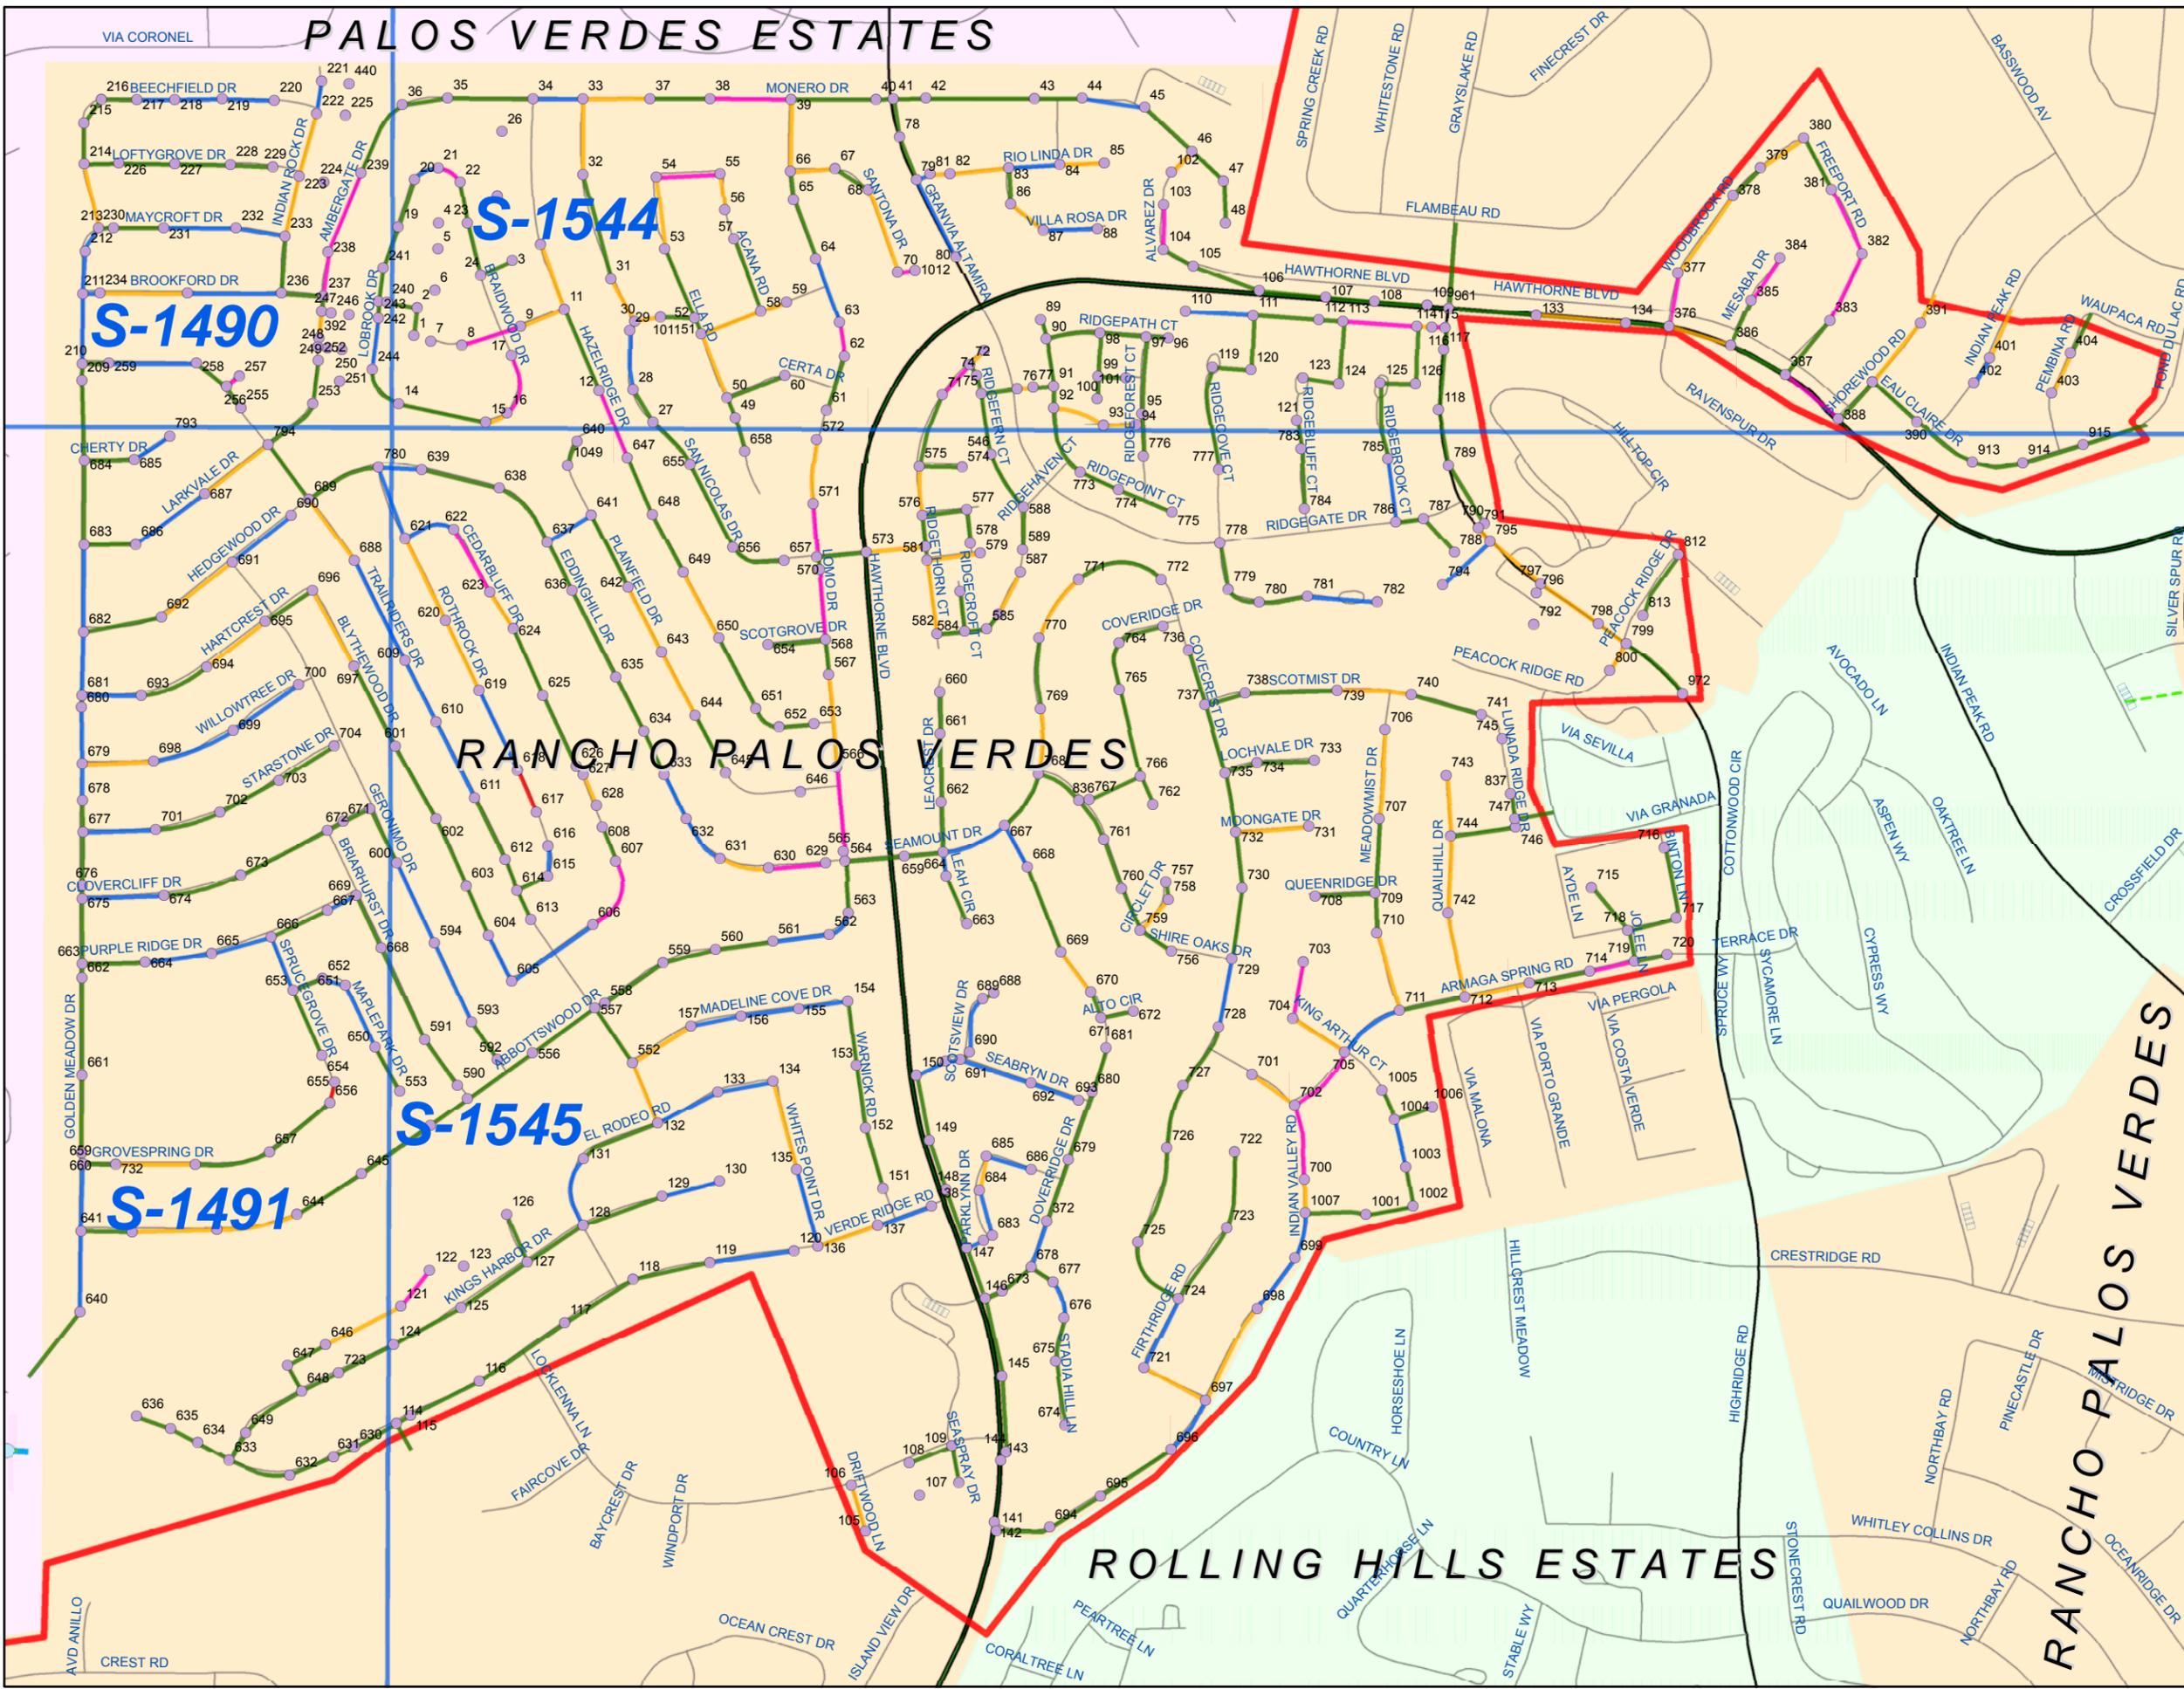
QUICK
 MAINTENANCE
 RATING
 (QMR)

Our inspection revealed that approximately 94.2 percent of the system televised was free of blockages or restrictions that would impede sewer flows. However, the remaining 5.8 percent of the inspected pipe segments within the City of Rancho Palos Verdes area had a PACP maintenance grade of 4 or 5 as indicated in the Quick Maintenance Rating Table shown below. These segments have been incorporated into our routine cleaning schedule with corrective action taken as noted on the Quick Maintenance Rating Report Priority List (Enclosure 2). Also included is a color-coded map showing the quick maintenance rating for each pipe segment.

Item No.	QMR	Start MH	End MH	Street	Observation: Location	Corrective Action Taken
1	5143	1545-0617	1545-0618	ROTHROCK DR	Roots	Rodder (Completed 1/26/09)
2	5141	1491-0656	1491-0655	SPRUCEGROVE DR	Roots; Deposits	Rodder; Hydrojet (Completed 1/27/09)
3	431B	1545-0571	1545-0572	LOMO DR	Roots	Rodder (Completed 1/26/09)
4	4236	1545-0703	1545-0704	KING ARTHUR CT	Roots	Rodder (Completed 1/26/09)
5	4236	1545-0702	1545-0700	INDIAN VALLEY RD	Roots	Rodder (Completed 1/26/09)
6	4232	1544-0084	1544-0085	RIO LINDA DR	Roots	Rodder (Completed 1/26/09)
7	4232	1545-0566	1545-0565	LOMO DR	Roots	Rodder (Completed 1/26/09)
8	4231	1544-0009	1544-0008	BIRCHMAN DR	Roots	Rodder (Completed 1/23/09)
9	4231	1490-0239	1490-0238	AMBERGATE DR	Roots	Rodder (Completed 1/27/09)
10	4200	1545-0623	1545-0622	CEDARBLUFF DR	Roots	Rodder (Completed 1/23/09)
11	4133	1544-0381	1544-0382	FREEPORT RD	Roots	Rodder (Completed 1/23/09)
12	4133	1544-0387	1544-0388	HAWTHORNE BVLD	Roots	Rodder (Completed 1/27/09)

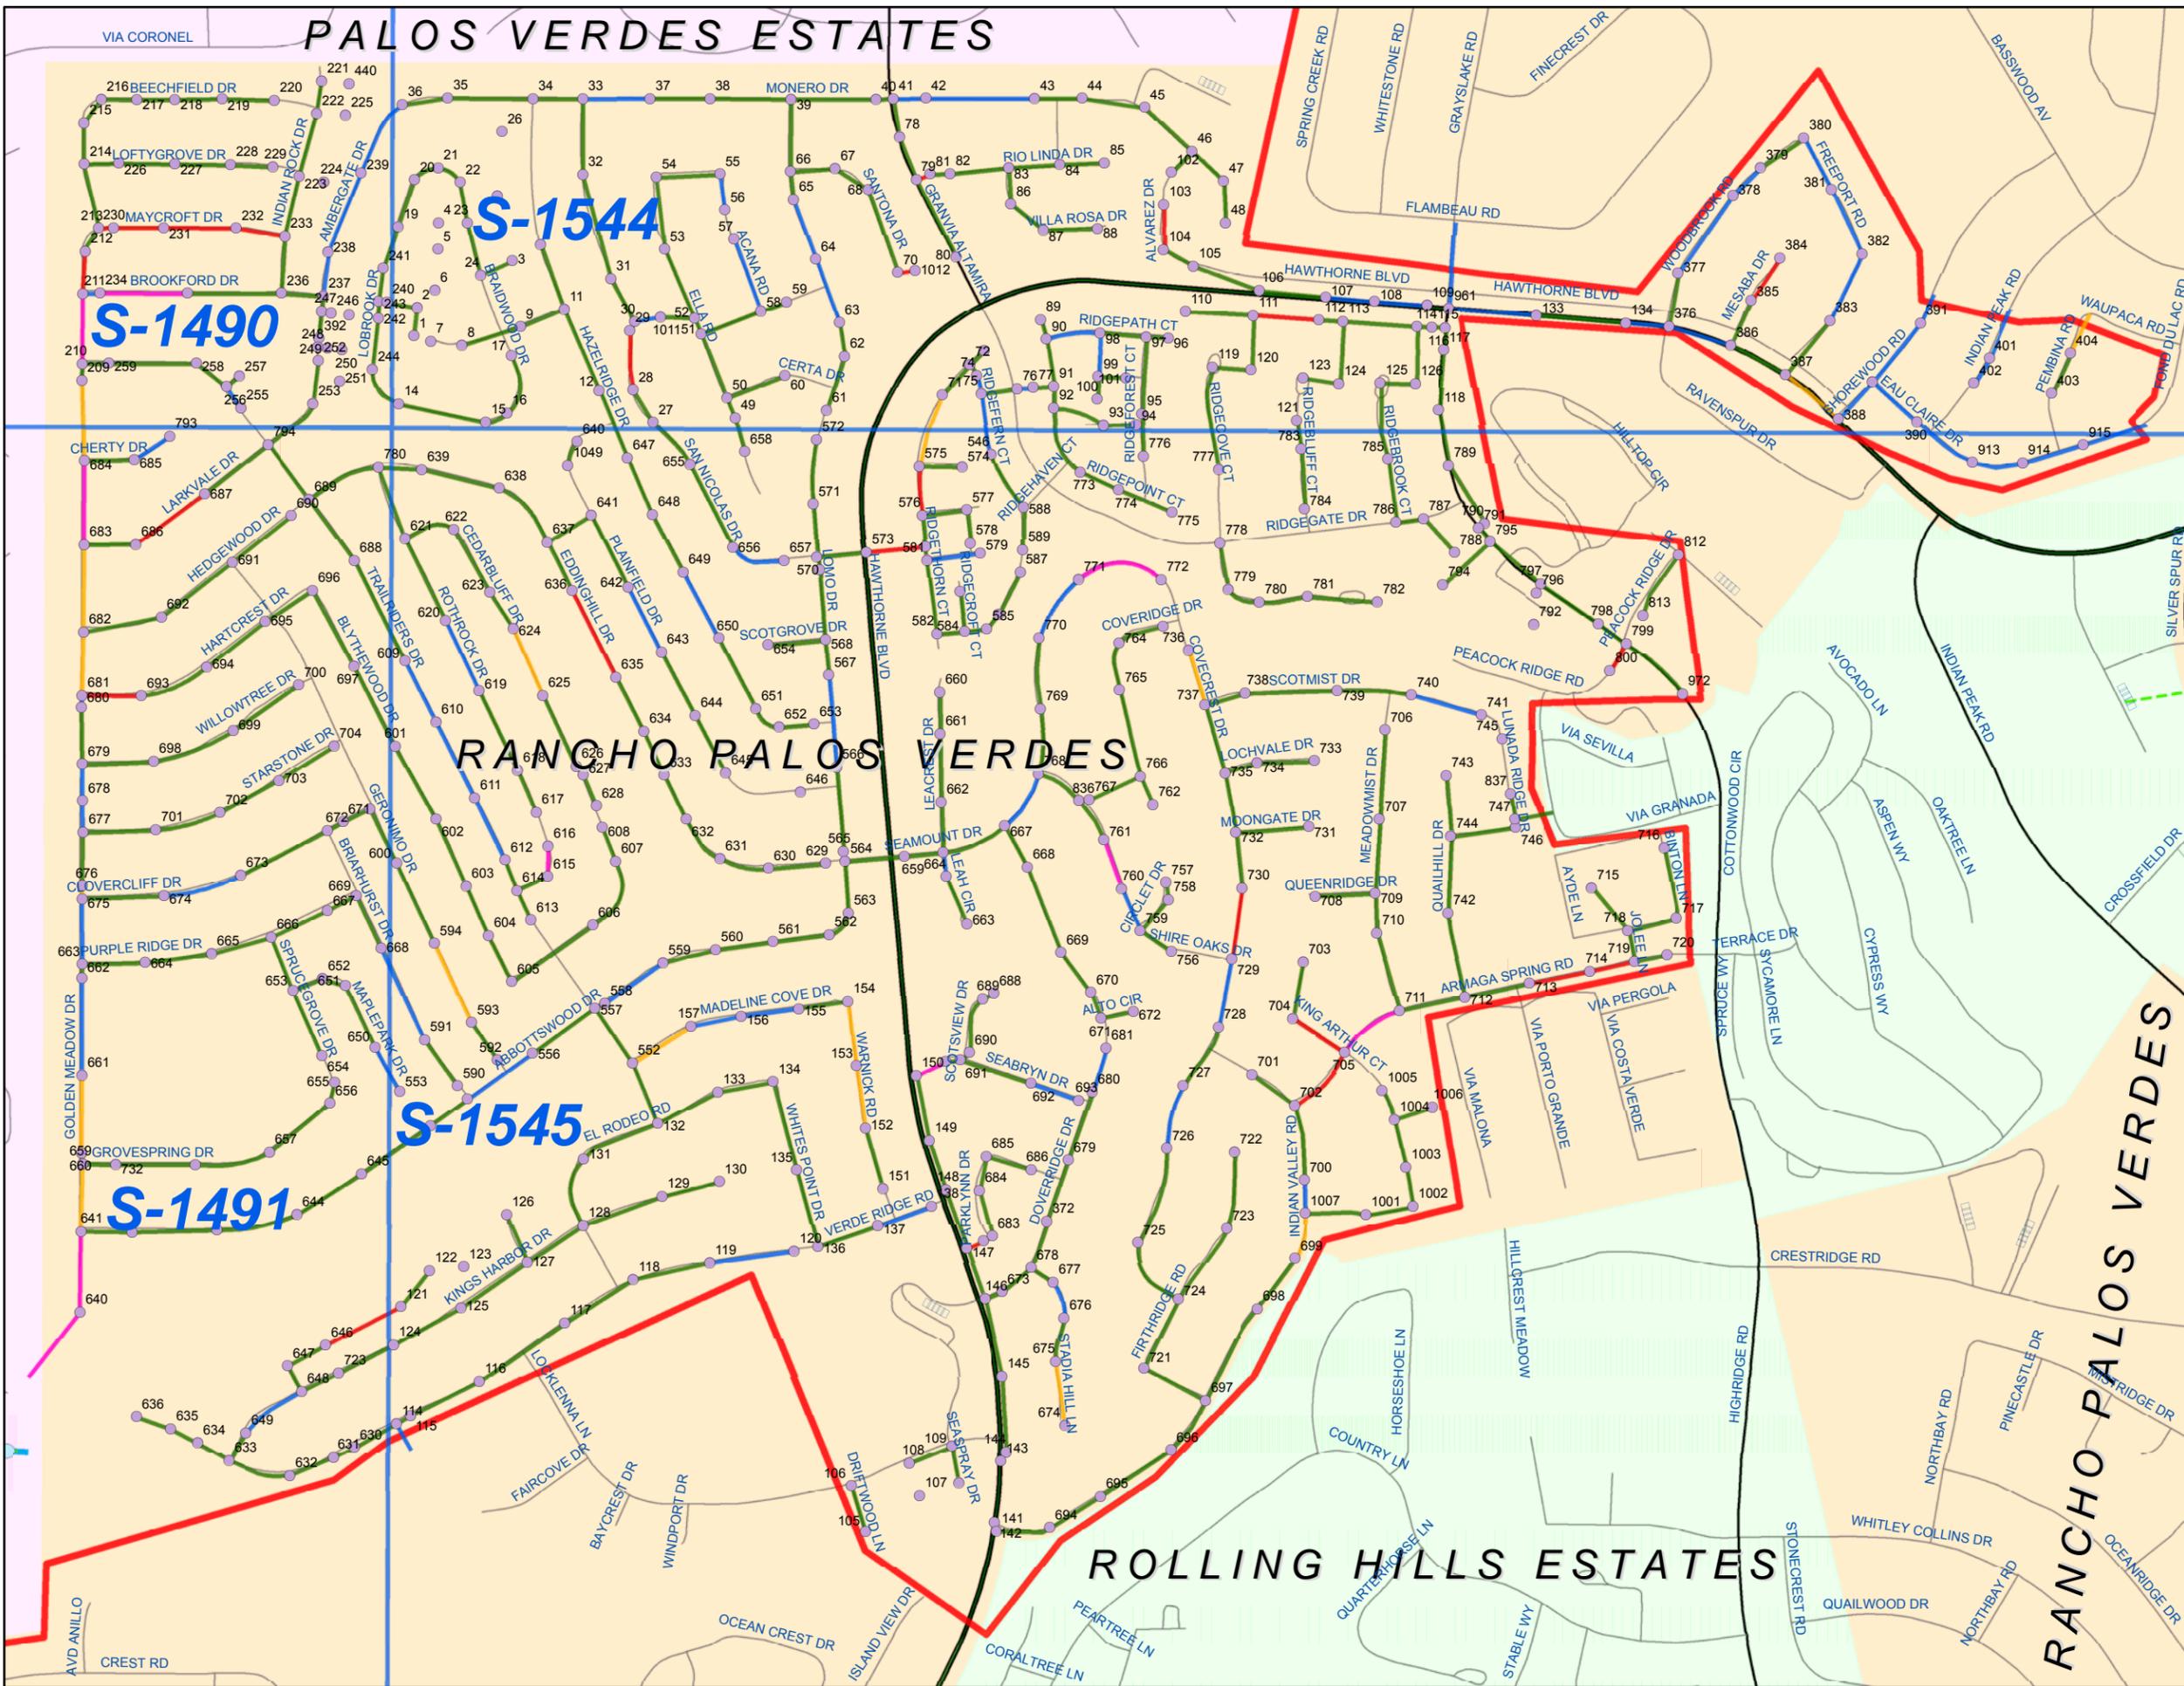
QUICK
 STRUCTURAL
 RATING
 (QSR)

Our inspection revealed that approximately 93.6 percent of the inspected pipe segments within the City of Rancho Palos Verdes were free of severe structural defects. However, the remaining 6.4 percent of the inspected pipe segments had a PACP structural grade of 4 as indicated in the Quick Structural Rating Table shown below. These segments have been placed on a priority list based on the severity and the need for action. For Items 1 through 34 in the Quick Structural Rating Report Priority List (Enclosure 3) which require a corrective action, the proposed corrective method will be scheduled in the next 24 months as part of the ongoing Accumulative Capital Outlay Project. A color-coded map showing the Quick Structural Rating for each pipe segment is located in Enclosure 3. Copies of the actual inspection report for these 34 segments are included in Enclosure 4.

Item No.	QSR	Start MH	End MH	Street	Observation: Location	Proposed Corrective Method	Length of Repair (FT)
1	5443	1545-0730	1545-0729	COVERCREST DR	Broken and deformed: 174'; multiple fractures: 68'	Lining: MH to MH	331
2	5442	1544-0081	1544-0079	GRANVIA ALTAMIRA	Broken: 14', 21'; fractures	Lining: MH to MH	59
3	5243	1491-0646	1545-0121	EASEMENT by KINGS HARBOR and ROCK PARK	Fracture: 223'; broken and multiple fractures: 229'; multiple fractures: 313'; joint offset (large): 159'	Lining: MH to MH	350
4	5223	1545-0580	1545-0573	EASEMENT by RIDGEFALLS and RIDGETHORN	Broken: 188'; Fracture: 177', 197'	Lining: MH to MH	201
5	5223	1544-0384	1544-0385	MESABA DR	Hole: End MH 1544-0385	CSMD will repair MH base.	
6	5200	1490-0233	1490-0232	MAYCROFT DR	Hole at lateral: 219'; hole: End MH 1490-0232	Structural integrity in tact. No action needed. CSMD will repair MH base.	-
7	5200	1491-0687	1491-0686	LARKVALE DR	Hole: End MH 1491-0686	CSMD will repair MH base.
