**CONSOLIDATED SEWER MAINTENANCE DISTRICT
CONDITION ASSESSMENT PROGRAM REPORT
PROJECT NO. Y0TV0910A**

**CONDITION ASSESSMENT REPORT
COUNTY OF LOS ANGELES DEPARTMENT OF PUBLIC WORKS
CONSOLIDATED SEWER MAINTENANCE DISTRICT**

| PROJECT NAME: | Y0TV0910A | PROJECT MGR: | Eric Liu |

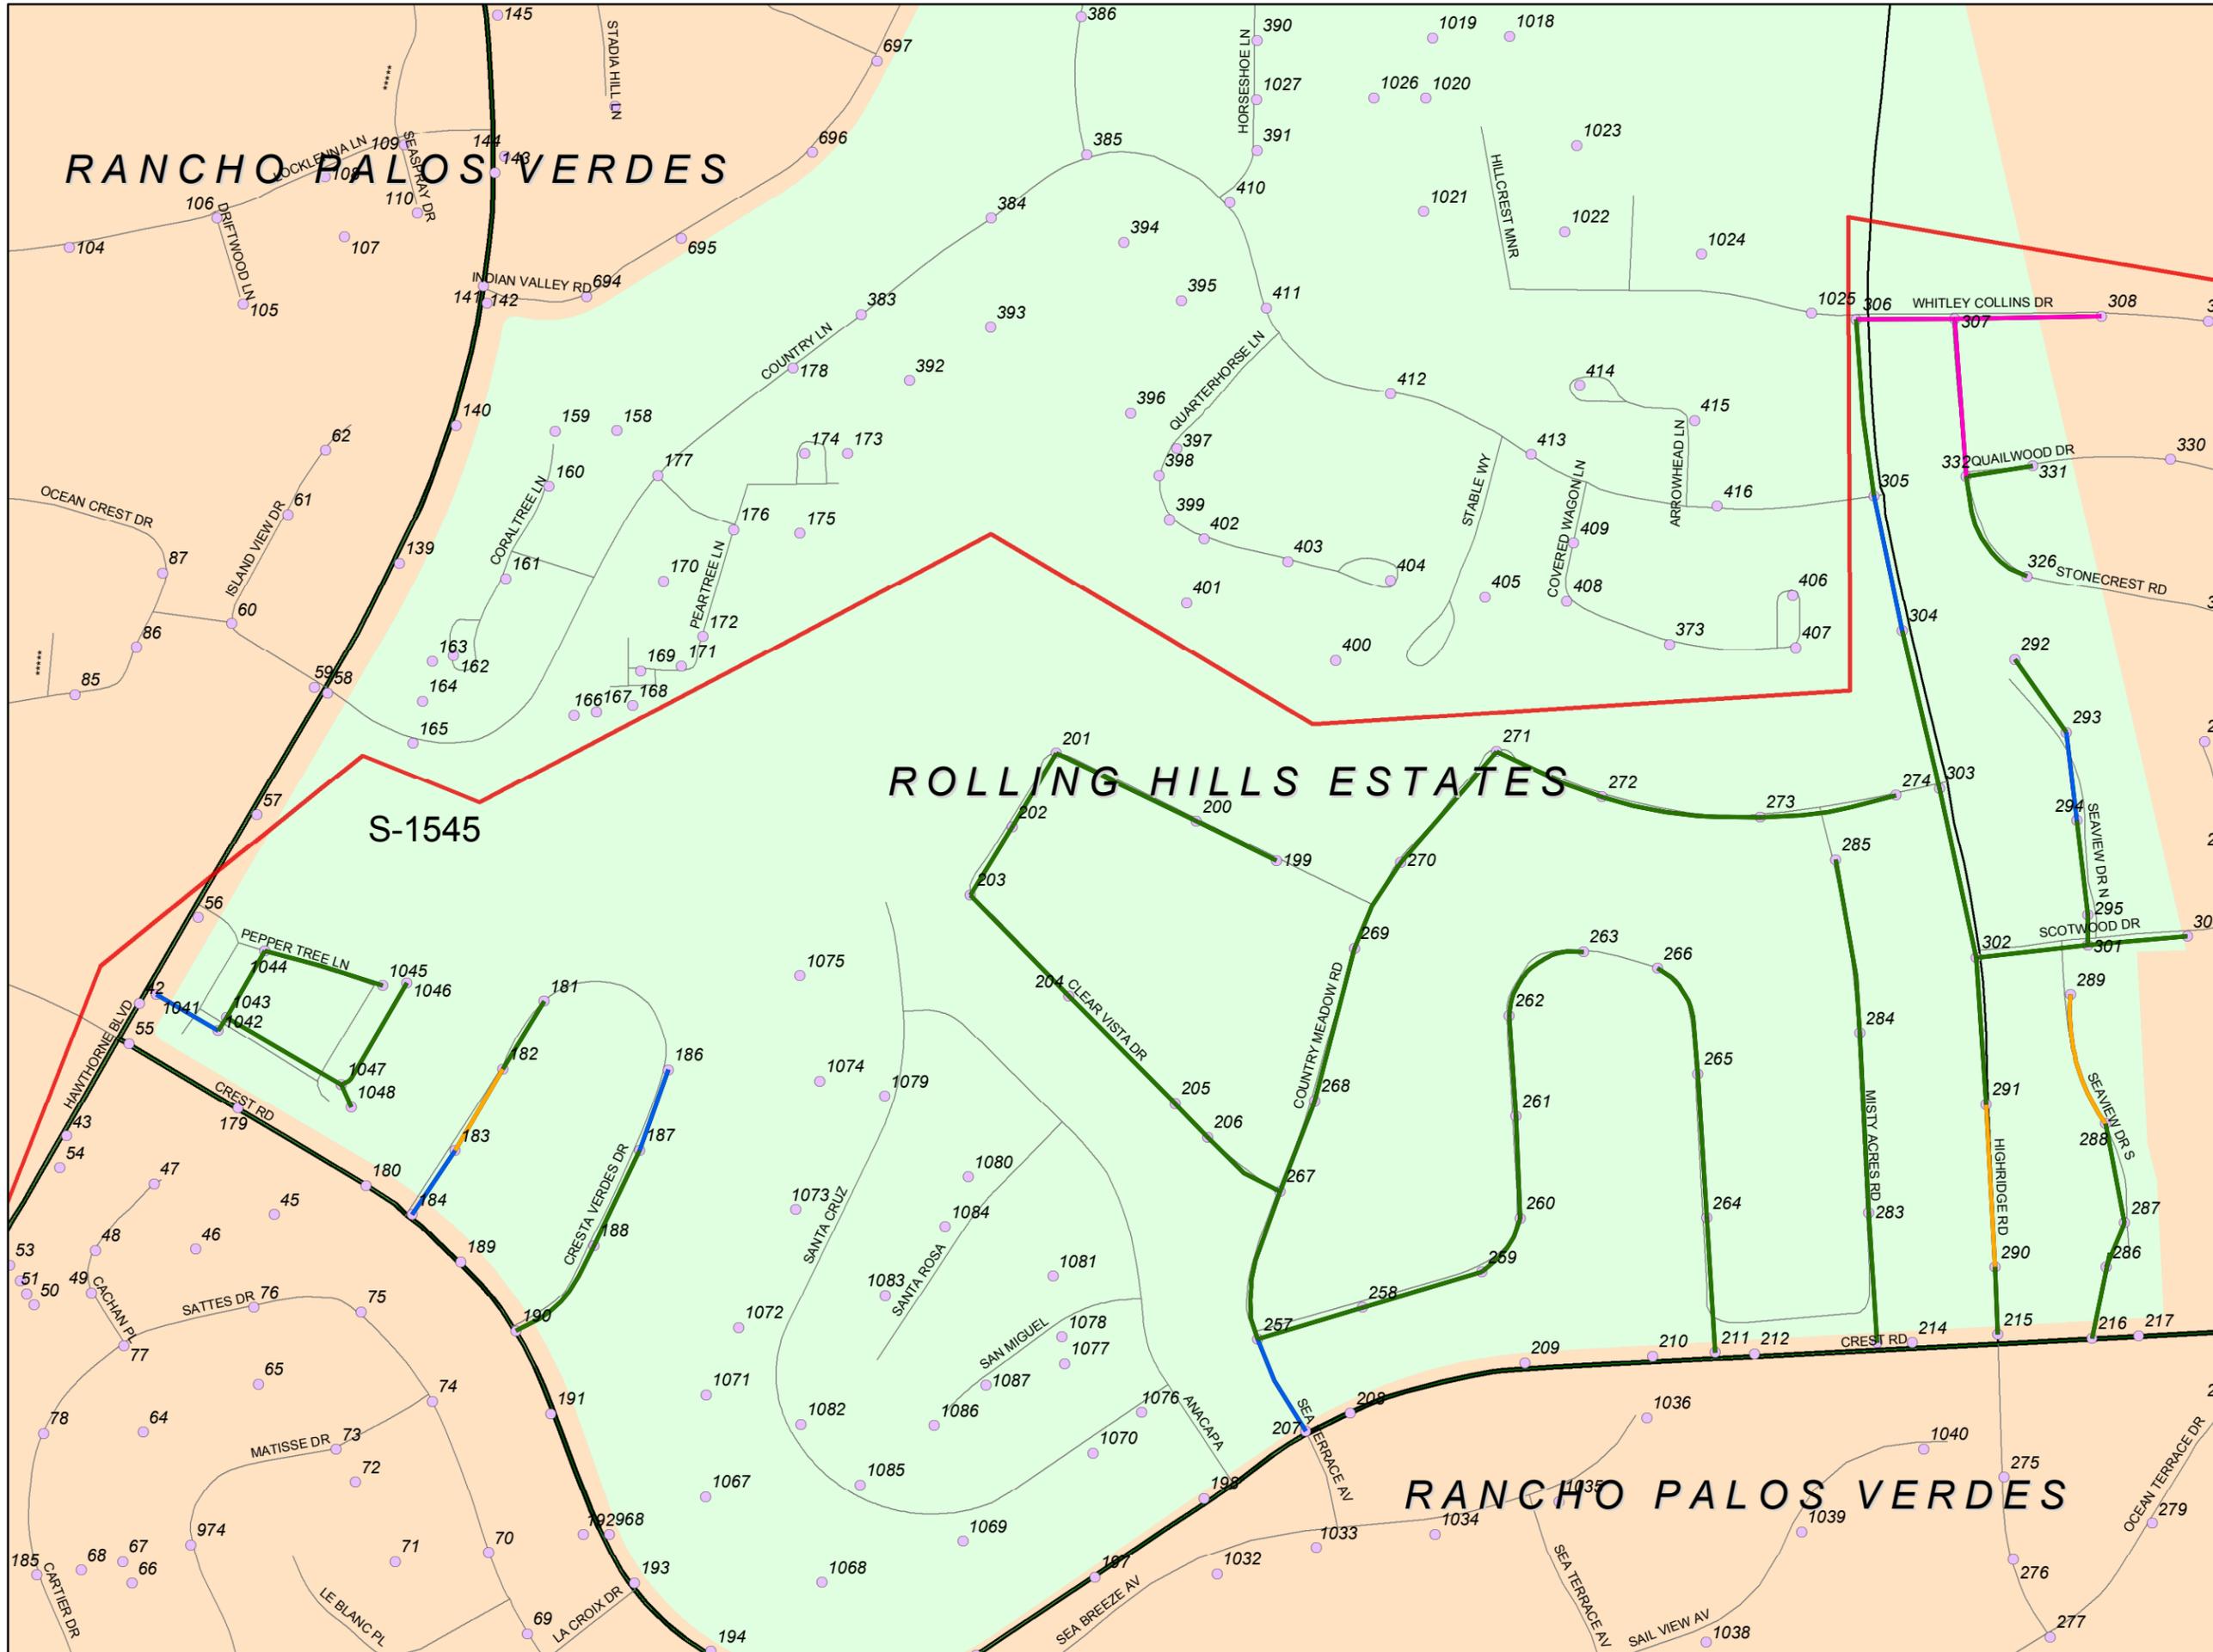
QUICK MAINTENANCE RATING (QMR)

ENCLOSURE 2
 QUICK MAINTENANCE RATING REPORT PRIORITY LIST
 CITY OF ROLLING HILLS ESTATES (Y0TV0910A)
 as of 07/10/09

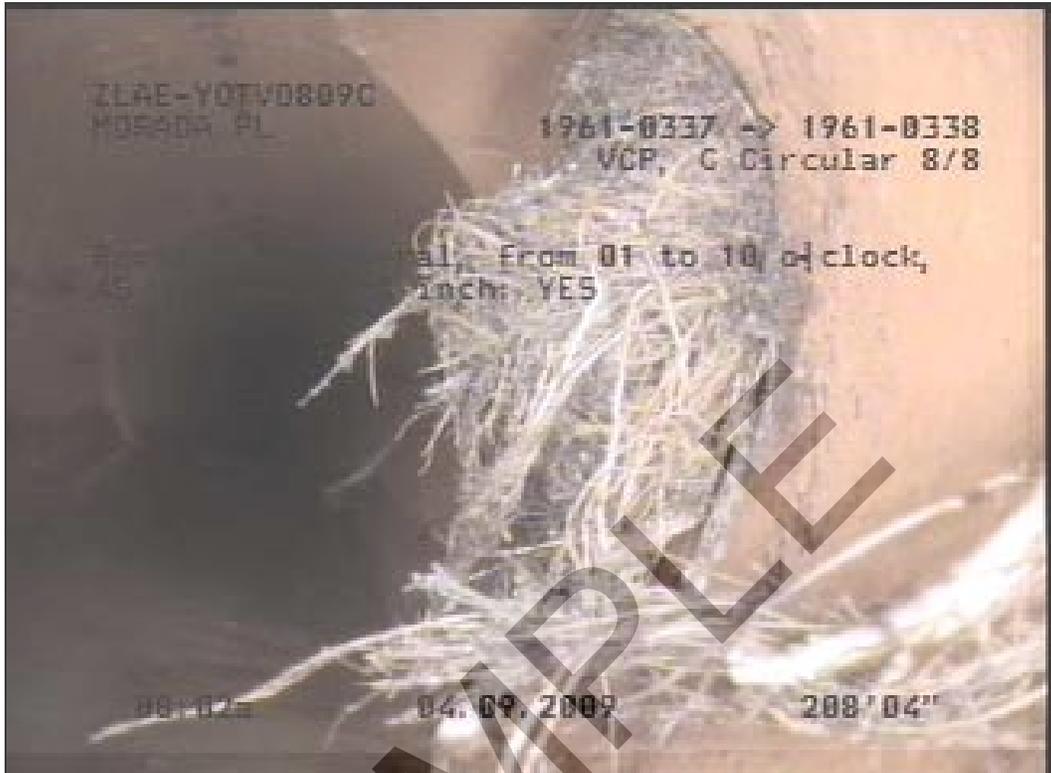
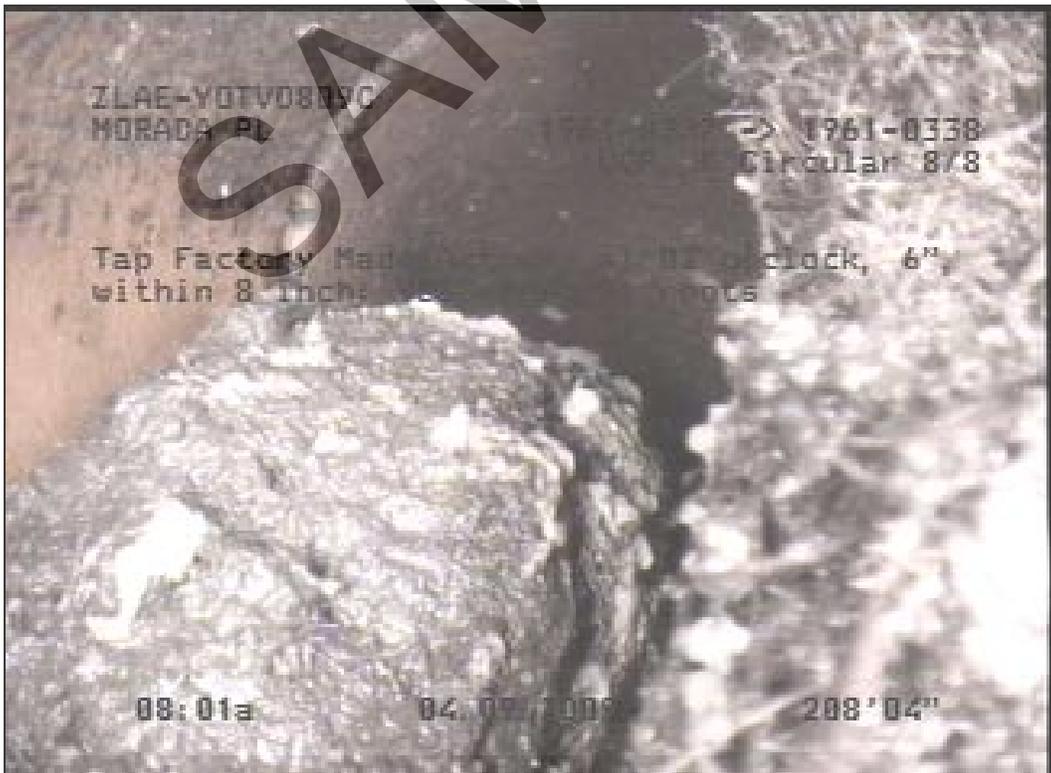
Using closed-circuit television (CCTV) camera technology, the District recently televised the sanitary sewer mainline and discovered the presence of roots in your sewer lateral connection. The intrusion of the roots from your lateral may block the flow of sewage in the mainline sewer causing a sanitary sewer overflow upstream of your property.

1570 MORADA PLACE
ALTADENA
Roots at Lateral Connection

your sewer lateral within 90 days to remove roots and any other obstructions that may cause a sewage backup.

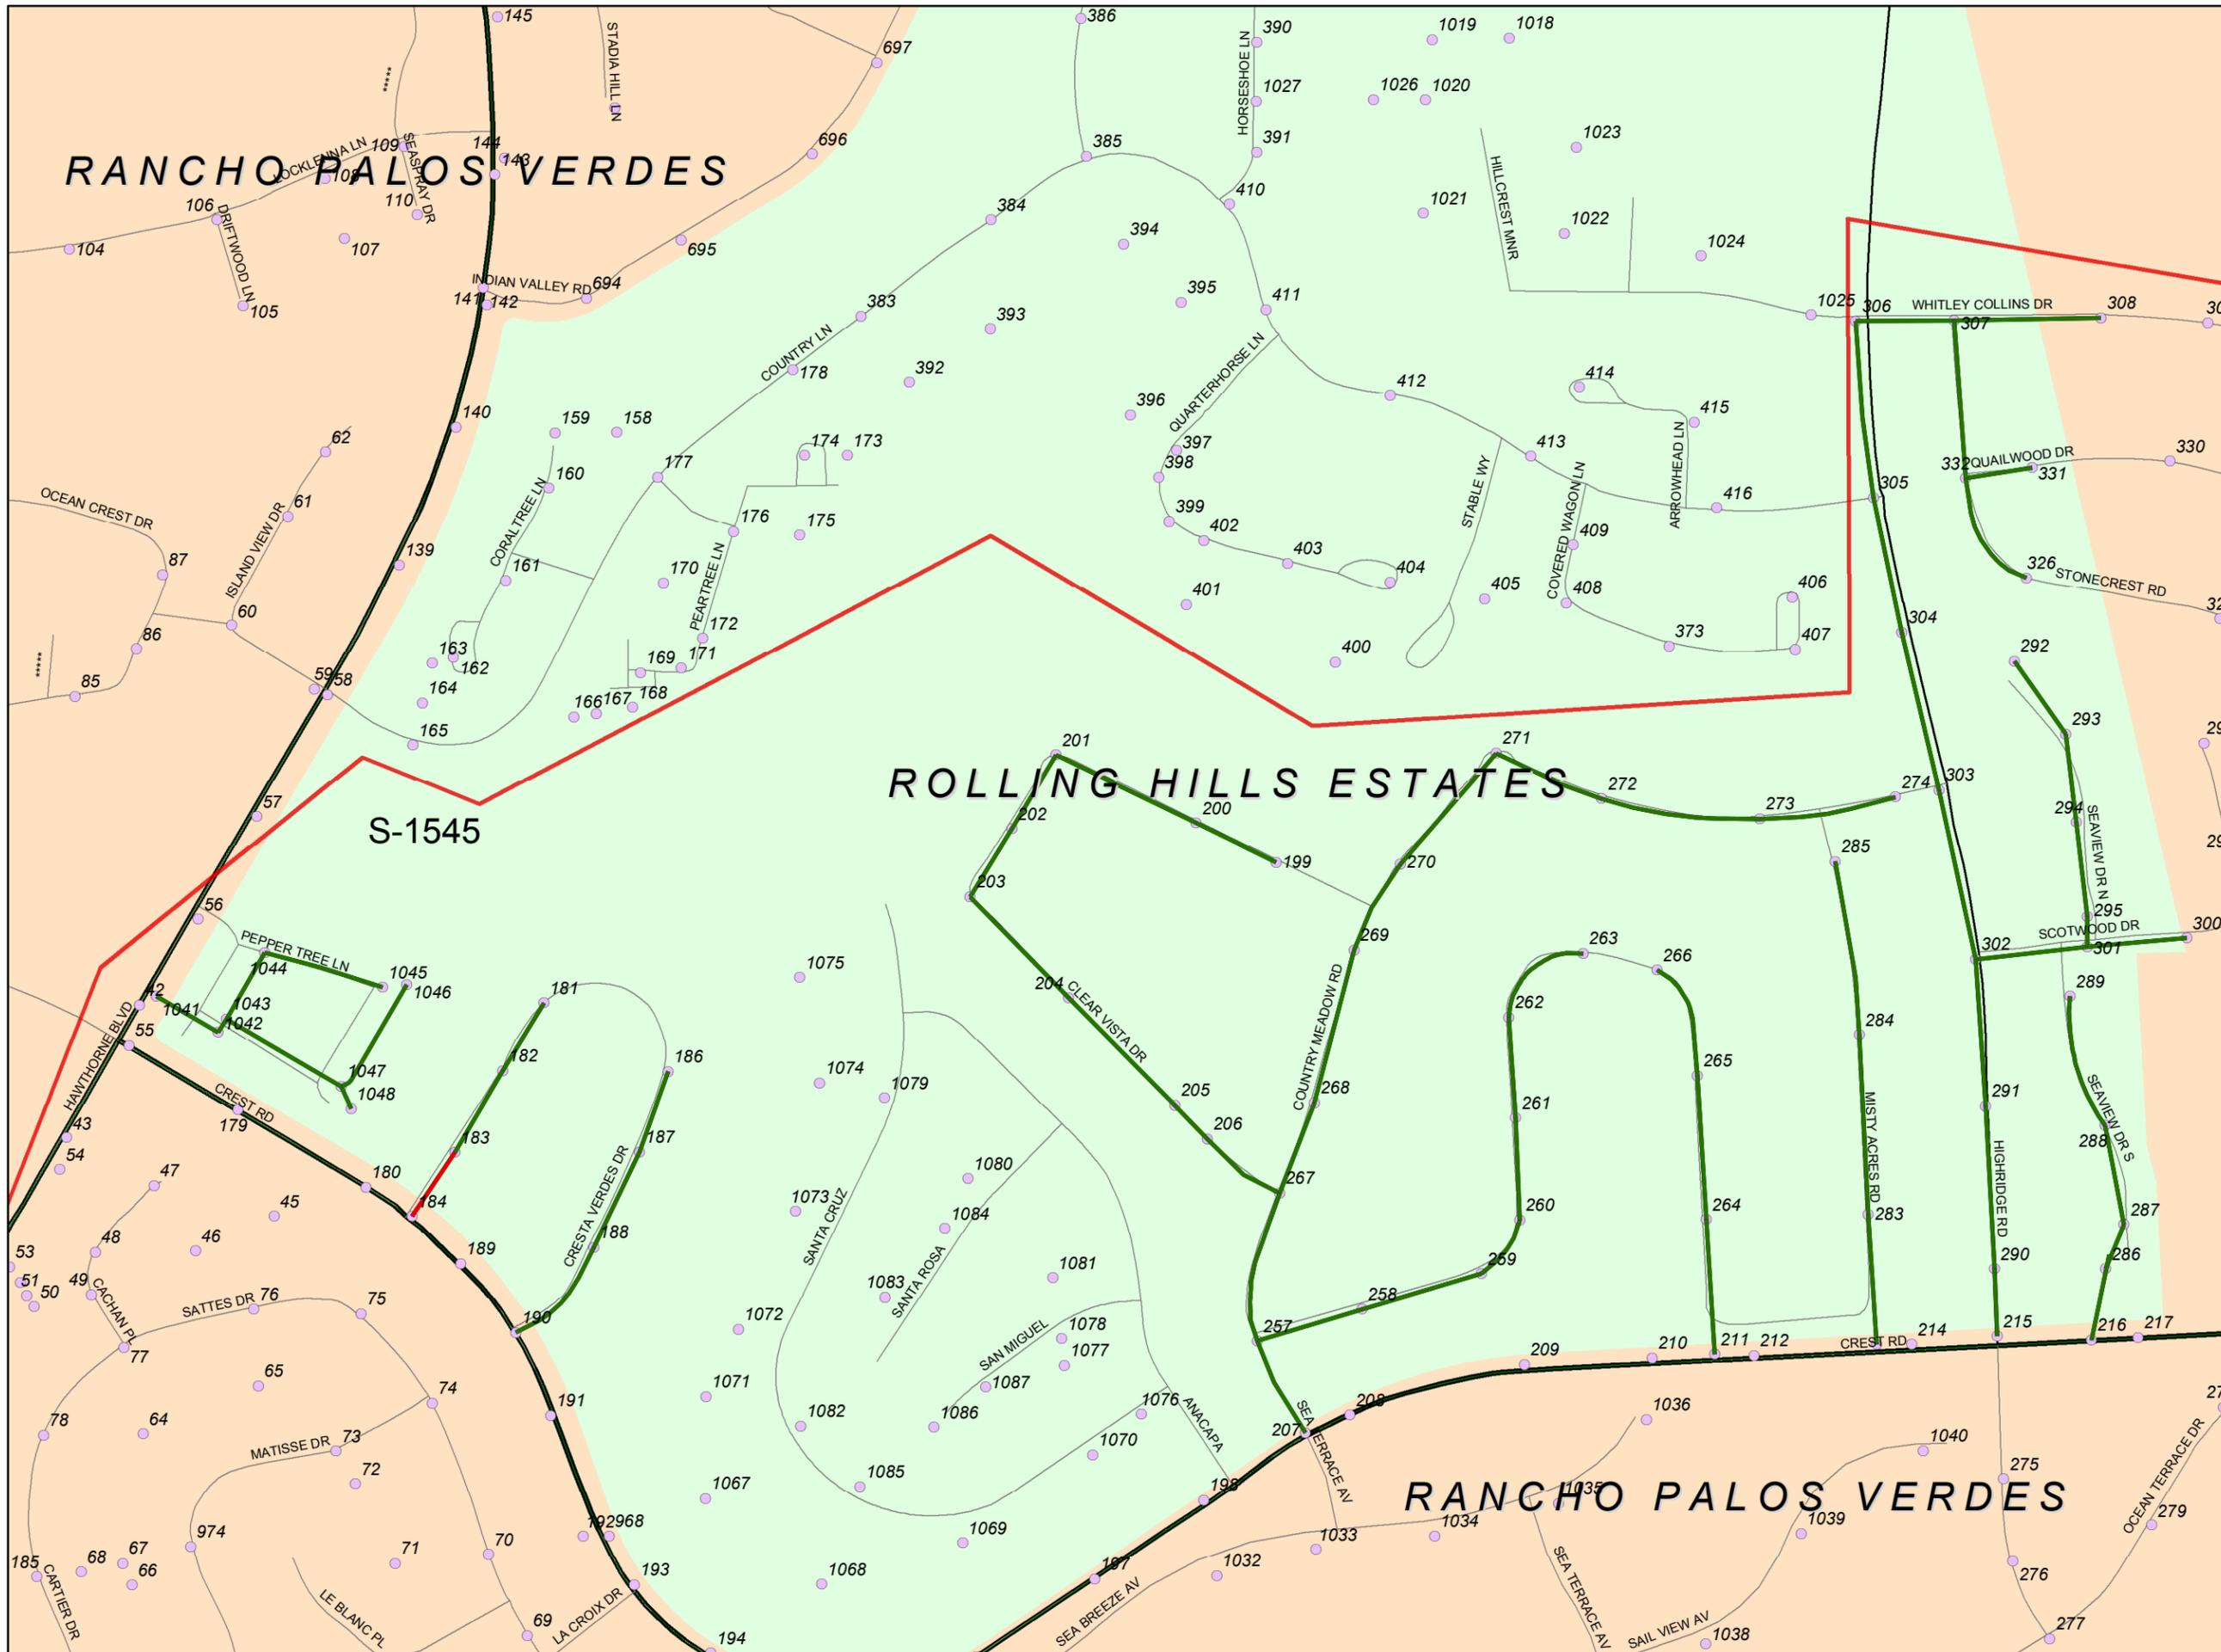
QUICK STRUCTURAL RATING (QSR)

| Item No. | QSR | Start MH | End MH | Street | Observation: Location | Proposed Corrective Method | Length of Repair (FT) |
|---|---|---|---|---|---|---|---|
| 1 | 5131 | 1545-0183 | 1545-0184 | Cresta Verdes Dr | Broken: 1' | Structural integrity in tact. No action needed. | |
