### **CONSOLIDATED SEWER MAINTENANCE DISTRICT CONDITION ASSESSMENT PROGRAM REPORTS PROJECTS Y0TV0708E AND Y0TV0809A**

**CONDITION ASSESSMENT REPORT  
COUNTY OF LOS ANGELES DEPARTMENT OF PUBLIC WORKS  
CONSOLIDATED SEWER MAINTENANCE DISTRICT**

PROJECT NAME:	Y0TV0809A	PROJECT MGR:	Kari Eskridge
PROJECT DATE:	August 2008	CONTACT NO:	(626) 300-3390
SUP. DISTRICT(s):	1	MAP PAGE(S):	T.G. 636, 596
Report By:	Kari Eskridge	Report Date:	05/27/2009

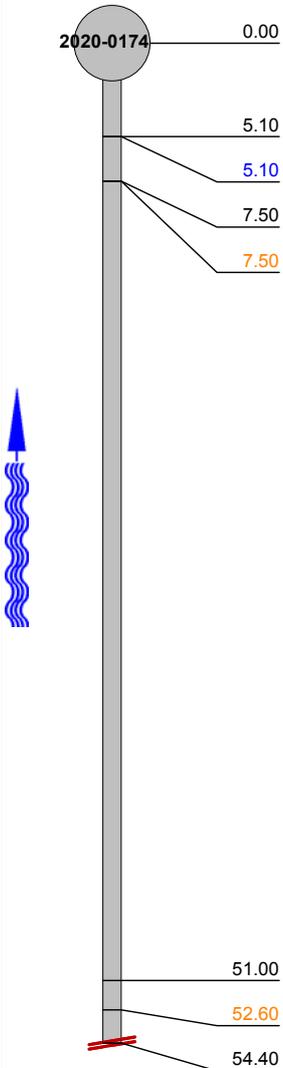
1:125	position	observation	MPEG	photo	grade
	0.00	Manhole, within 8 inch: NO, Remarks: 2020-0174	00:00:40	4080	
	5.10	Tap Factory Active, at 9 o'clock, 4", within 8 inch: NO	00:01:06	4081	
	5.10	Water Level, 5 %, within 8 inch: NO	00:01:21	4082	M 2
	7.50	Tap Factory Active, at 3 o'clock, 4", within 8 inch: NO	00:01:39	4083	
	7.50	Roots Medium Lateral, at 3 o'clock, 30 %, within 8 inch: NO	00:01:56	4084	M 3
	51.00	Roots Fine Joint, from 4 to 8 o'clock, within 8 inch: YES	00:03:55	4085, b	
	52.60	Obstacle Intruding Thru Wall, from 7 to 11 o'clock, 15 %, within 8 inch: NO	00:04:58	4087, b	M 3
	54.40	Abandoned Survey, within 8 inch: NO, Remarks: UNABLE TO PASS OBSTACLE	00:06:14	4090

QSR	QMR	SPR	MPR	OPR	SPRI	MPRI	OPRI
0000	3221	0	8	8	0	2.67	2.67

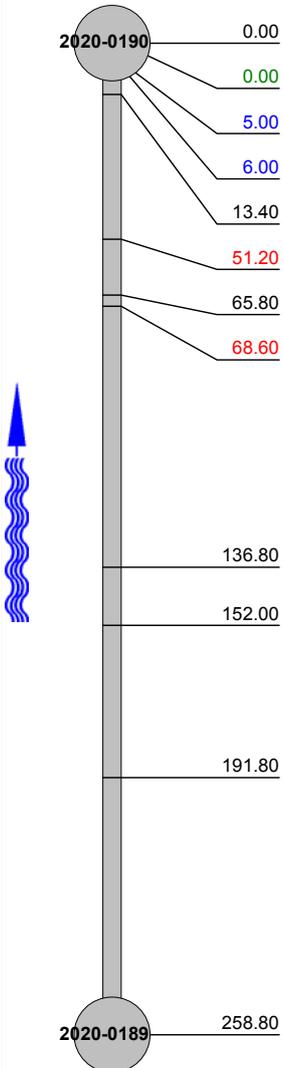
191.80	Tap Factory Capped, at 3 o'clock, 6", within 8 inch: NO	00:16:24	3829	
	258.80	Manhole, within 8 inch: NO, Remarks: 2020-0189	00:19:01	3830

QSR	QMR	SPR	MPR	OPR	SPRI	MPRI	OPRI
5200	2211	10	5	15	5	1.67	3
