March 27, 2023
2017-116.006

Re: *Devil's Gate Reservoir Restoration Project – Phase 2 Restoration Qualitative Monitoring Conducted on February 10, 2023*

1.0 INTRODUCTION

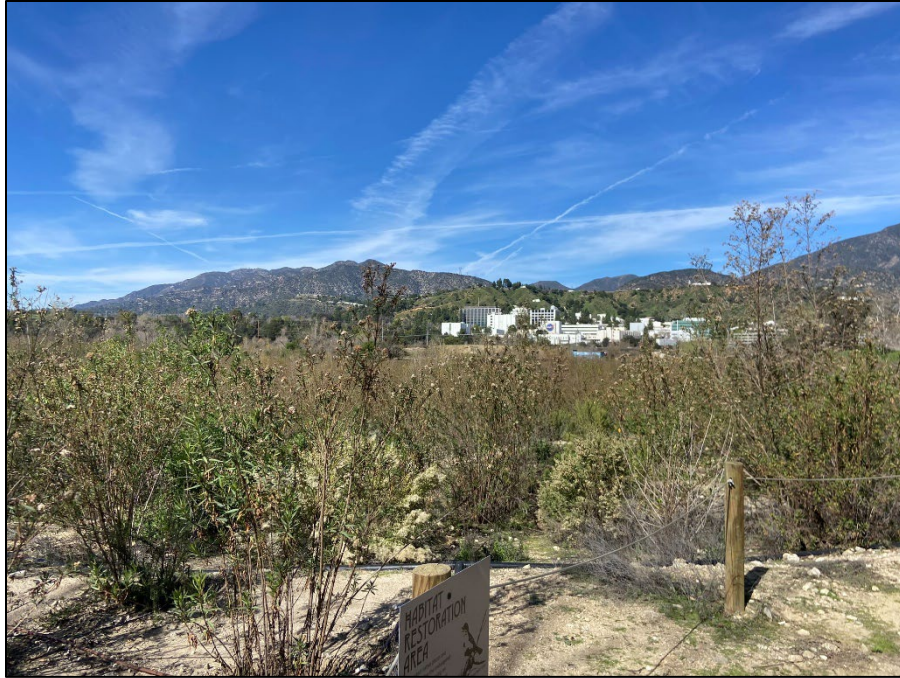
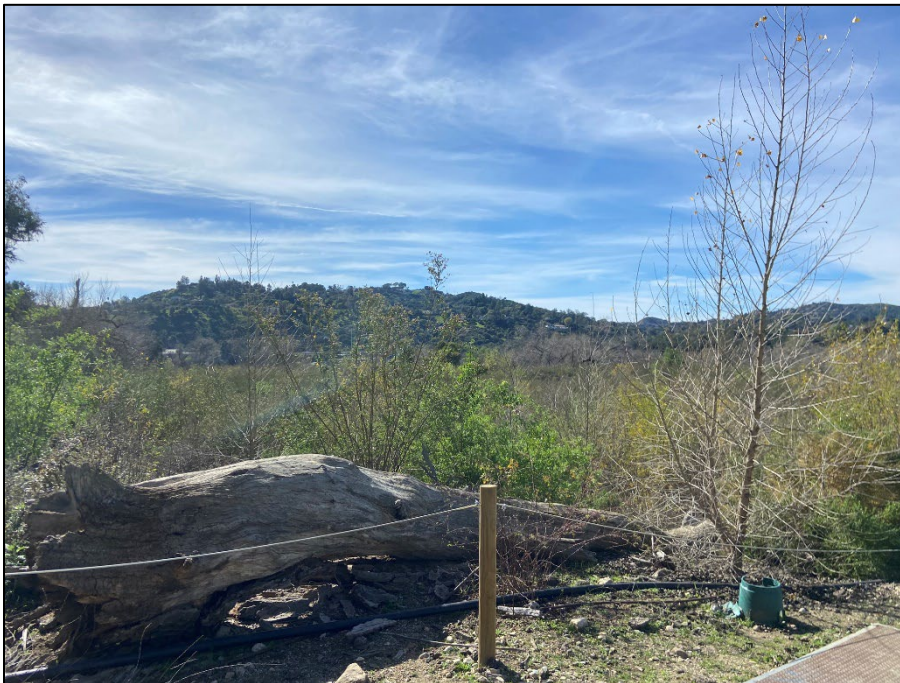
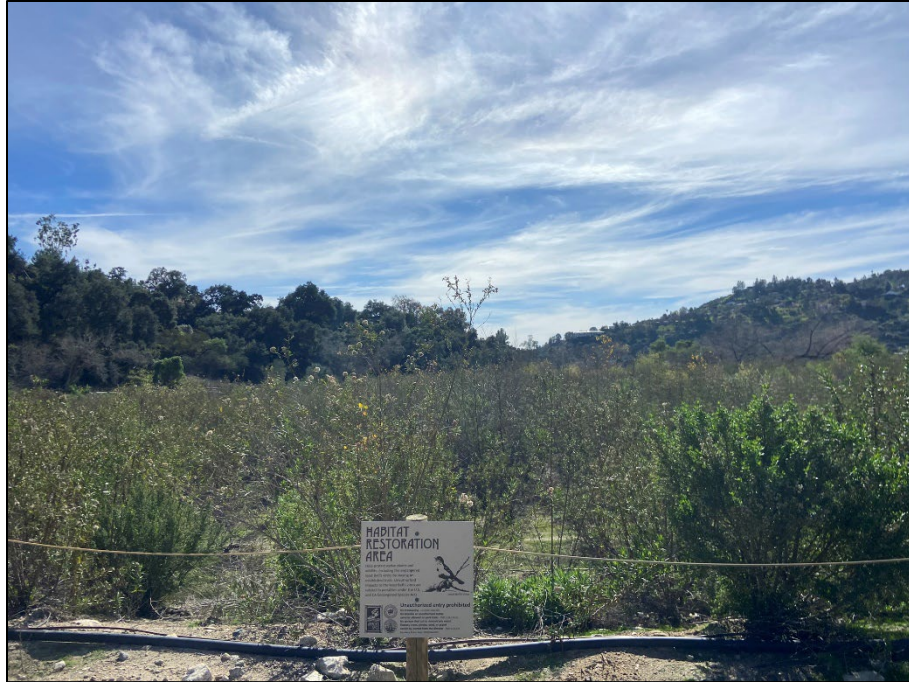
The overall health of the container plants in DG-W-1 was noted as being good. Approximately 5 to 10 percent of the container plants in DG-W-1 were noted as showing varied levels of stress and a negligible number were noted as being dead or missing. This is approximately the same percentage of plants that were showing stress during the last monitoring event. Stress may be occurring as a result of 1) competition from nonnative and invasive weeds, 2) misplaced emitters, or 3) recreational traffic through the mitigation areas. In addition, some of the mulefat in this mitigation area were showing signs of minor dieback that appeared to be the result of *Baccharis* leaf blister and some of the willows were showing signs of dieback from rust fungus (*Melampsora* sp.). A handful of Fremont's cottonwoods (*Populus fremontii*) were also showing minor dieback which appeared to be the result of natural recruitment of mulefat within their basins. Evidence of dieback from *Phytophthora cactorum*, including wilting, stunted growth, leaf spotting, and/or browning along leaf margins and tips, was not observed on any of the container plants. The willows and Fremont's cottonwoods in this mitigation area were showing seasonal dieback during the monitoring visit. Formal mortality counts were taken for DG-W-1 during the 2021 and 2022 quantitative monitoring events. Some of the container plants were noted as lacking well defined basins and should have their basins properly constructed and/or repaired. The irrigation line appeared to be functioning properly for the mitigation area during the monitoring visit. The installation of plants in the DG-W-1 mitigation area appears to have been completed successfully. The current issues identified during the monitoring visit are not expected to have an effect on the continued growth of the plants in the mitigation area. Photos 1 through 3 in Attachment B document the mitigation area during the monitoring visit.

Photo 1: Overview Mitigation Area DG-W-1 (Johnson Field)

Photo 2: Overview Mitigation Area Overview Mitigation Area DG-W-1 (Johnson Field)

Photo 3: Overview Mitigation Area Overview Mitigation Area DG-W-1 (Johnson Field)

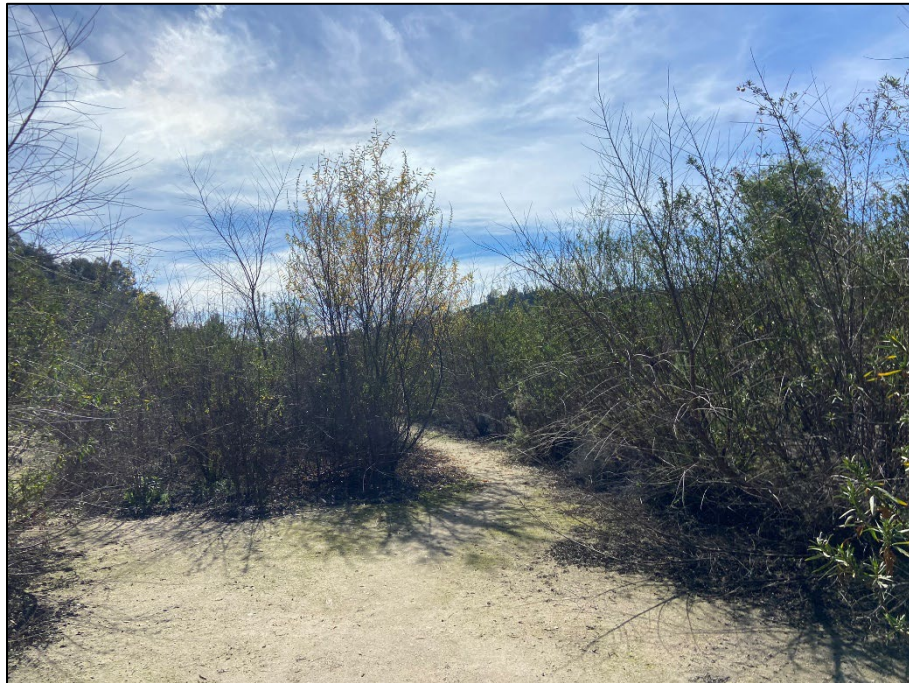
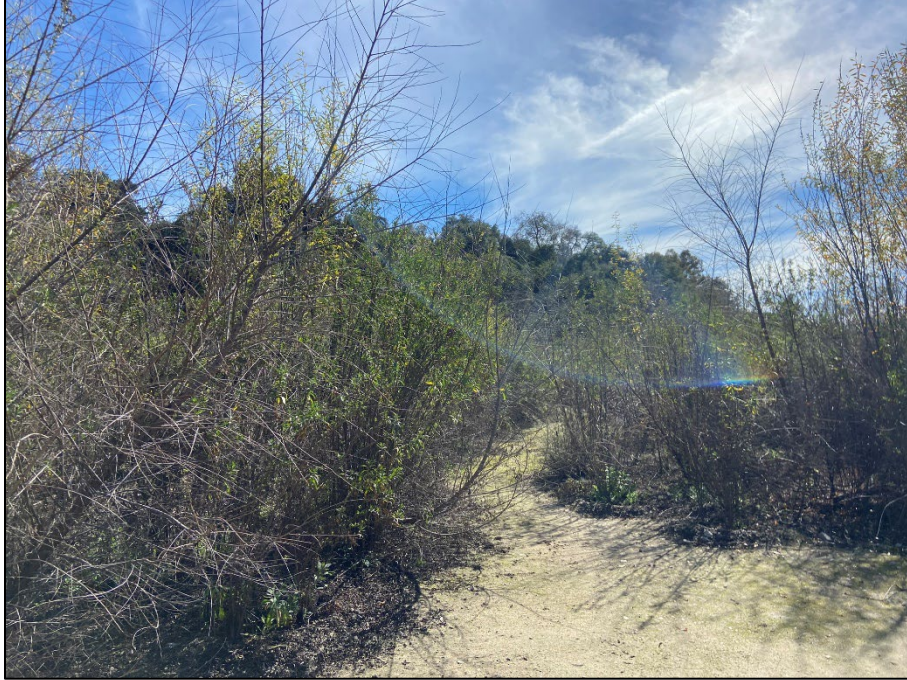
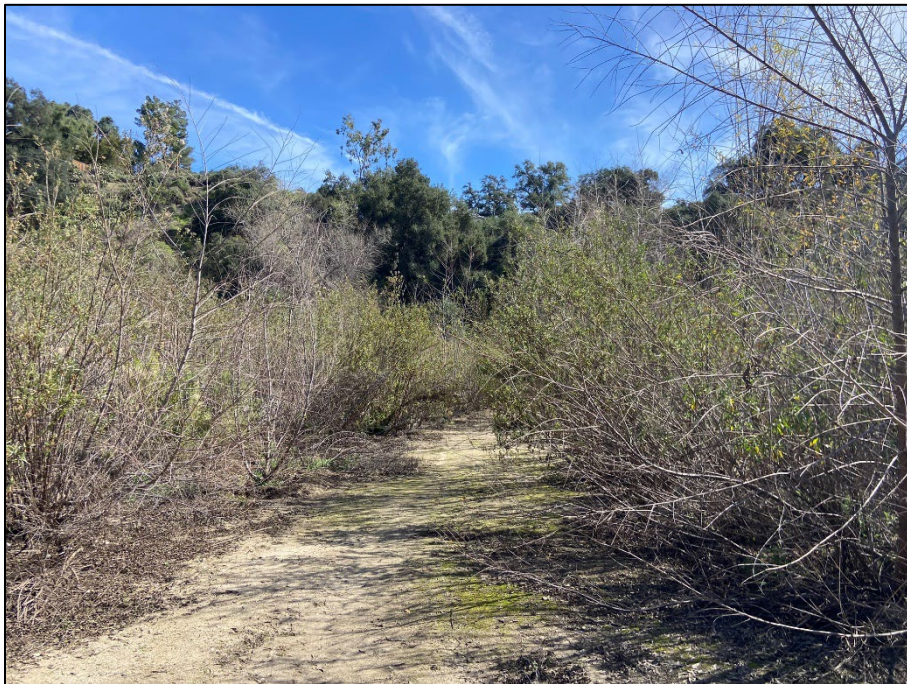
The overall health of the container plants in DG-2, DG-2 New Channels, and DG-2 WOUS was noted as being good. Approximately less than five percent of the container plants were noted as showing varied levels of stress and a negligible number were noted as being dead or missing. This is approximately the same percentage of plants that were showing stress during the last monitoring event. Stress may be occurring due to similar reasons described for DG-W-1. Evidence of dieback from *Phytophthora cactorum*, including wilting, stunted growth, leaf spotting, and/or browning along leaf margins and tips, was not observed on any of the container plants. Similar to DG-W-1, the willows and Fremont's cottonwoods in this mitigation area were continuing to show signs of seasonal dieback. Formal mortality counts were taken for DG-2, DG-2 New Channels, and DG-2 WOUS during the 2021 and 2022 quantitative monitoring events. Some of the container plants were noted as lacking well defined basins and should have their basins properly constructed and/or repaired. The irrigation line appeared to be functioning properly during the monitoring visit. During the monitoring visit, the grade control structure that was installed at the northern end of DG-2 New Channels where the channels connect to DG-W-1 was inspected for erosion. Minor erosion was observed, mostly towards the western end of the structure; however, no major erosion issues were observed, and the structure appears to be functioning properly. The installation of plants in the DG-2, DG-2 New Channels, and DG-2 WOUS mitigation areas appears to have been completed successfully. The current issues identified during the monitoring visit are not expected to have an effect on the continued growth of the plants in the mitigation area. Photos 4 through 6 in Attachment B document the mitigation areas during the monitoring visit. Photos 15 and 16 in Attachment B document the condition of the grade control structure during the monitoring visit.

Photo 4: Overview Mitigation Area DG-2 & DG-2 New Channels

Photo 5: Overview Mitigation Area DG-2 & DG-2 New Channels

Photo 6: Overview Mitigation Area DG-2 & DG-2 WOUS

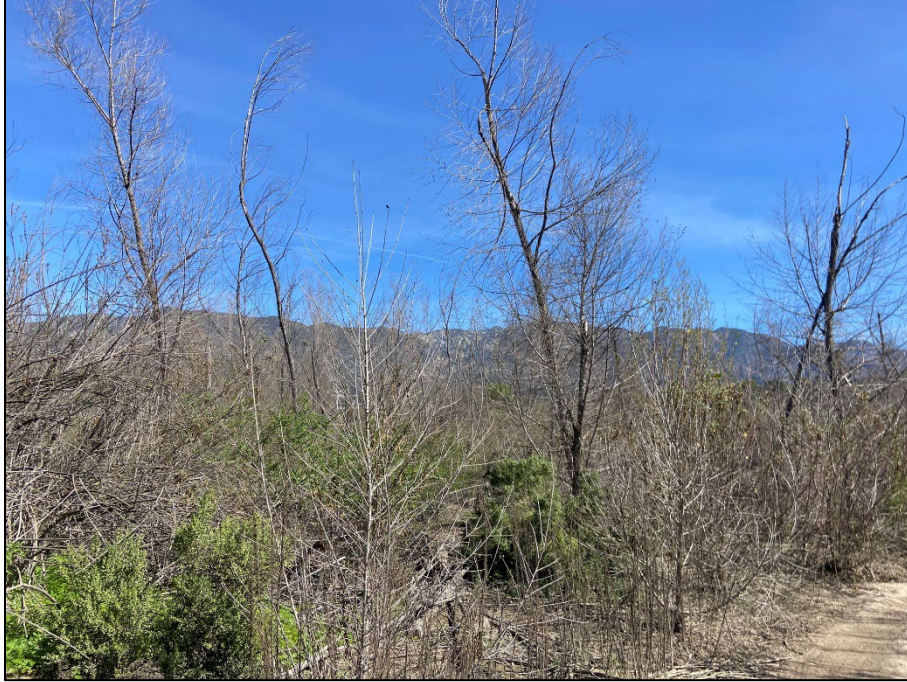
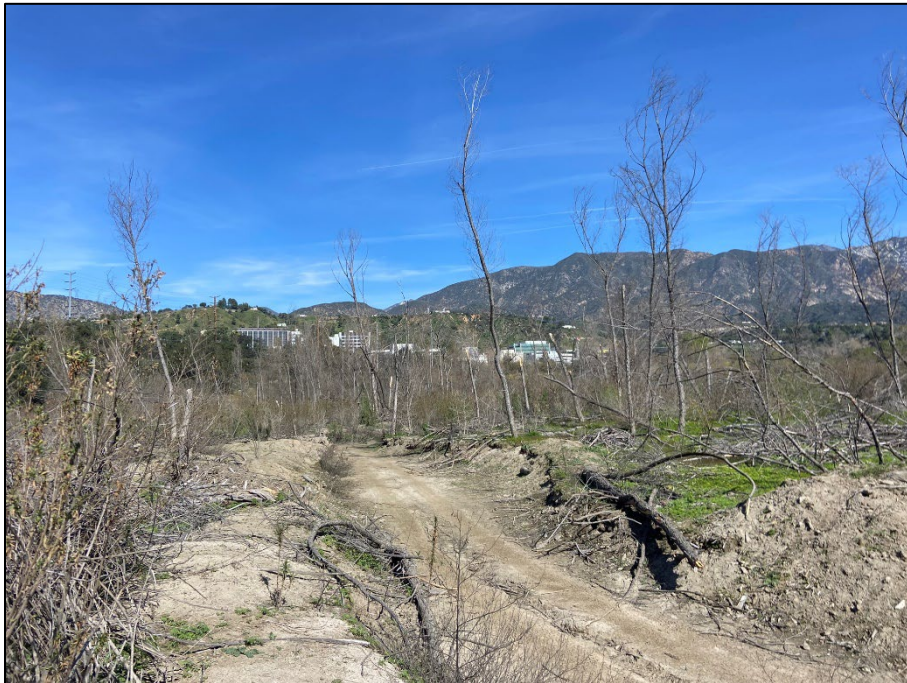
The overall health of the container plants in mitigation area DG-W-2 was noted as being good. Approximately 10 to 15 percent of the container plants were noted as showing varied levels of stress and a negligible number were noted as being dead or missing. This is approximately the same percentage of plants that were showing stress during the last monitoring event. Stress may be occurring due to similar reasons described for DG-W-1. Evidence of dieback from *Phytophthora cactorum*, including wilting, stunted growth, leaf spotting, and/or browning along leaf margins and tips, was not observed on any of the container plants. Similar to DG-W-1, the willows and Fremont's cottonwoods in this mitigation area were continuing to show signs of seasonal dieback. Formal mortality counts were taken for DG-W-2 during the 2021 and 2022 quantitative monitoring events. Some of the container plants were noted as lacking well defined basins and should have their basins properly constructed and/or repaired. The irrigation line appeared to be functioning properly for most areas of the mitigation area during the monitoring visit; however, some basins appeared to be dry and should be inspected for functionality. The installation of plants in the DG-W-2 mitigation area appears to have been completed successfully and the issues noted during the monitoring are not expected to have an impact on the continued growth of the plants. Photos 7 and 8 in Attachment B document the mitigation area during the monitoring visit.

During the monitoring visit, it was noted that many of the remaining mature black willows (*Salix gooddingii*) in this mitigation area were continuing to show dieback and most were not showing signs of recovery from the polyphagous shot-hole borer (PSHB) infestation that was confirmed by the Los Angeles County Department of Agricultural Commissioner/Weights & Measures in December of 2021; however, some of the dieback may be seasonal. The majority of the dead and hazardous black willows in this mitigation area were removed in October of 2022. Black willows that were determined to have the potential to recover were left in place and will be monitored during the qualitative monitoring visits.

Photo 7: Overview Mitigation Area DG-W-2 (Mining Pit)

Photo 8: Overview Mitigation Area DG-W-2 (Mining Pit)

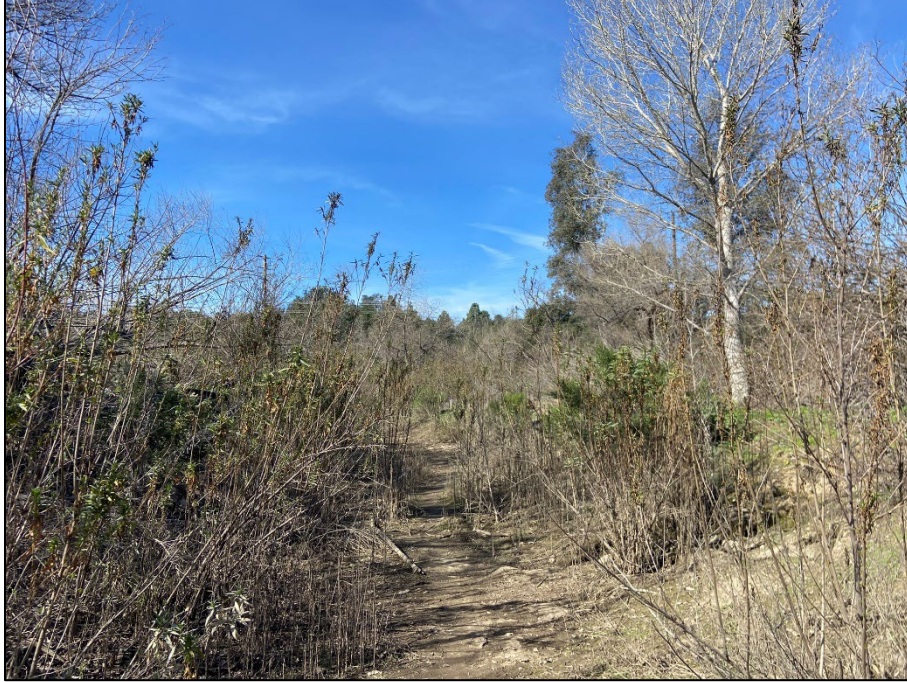
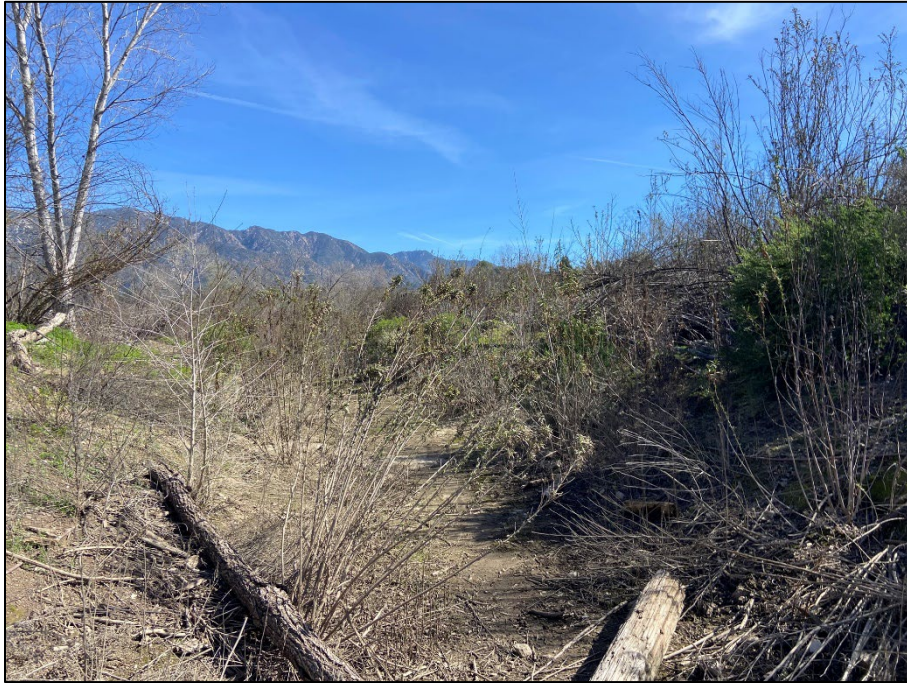
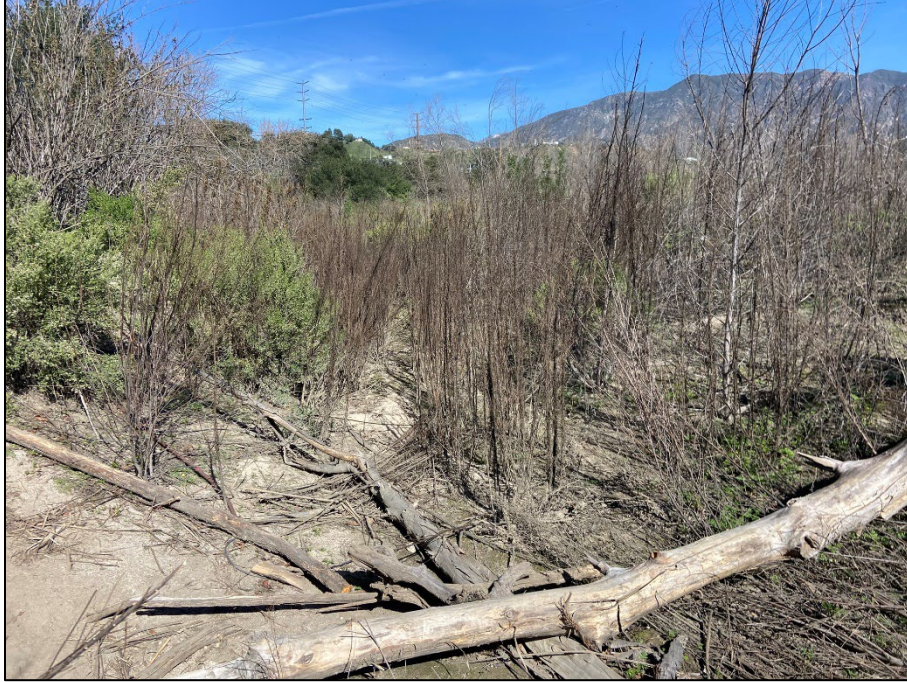
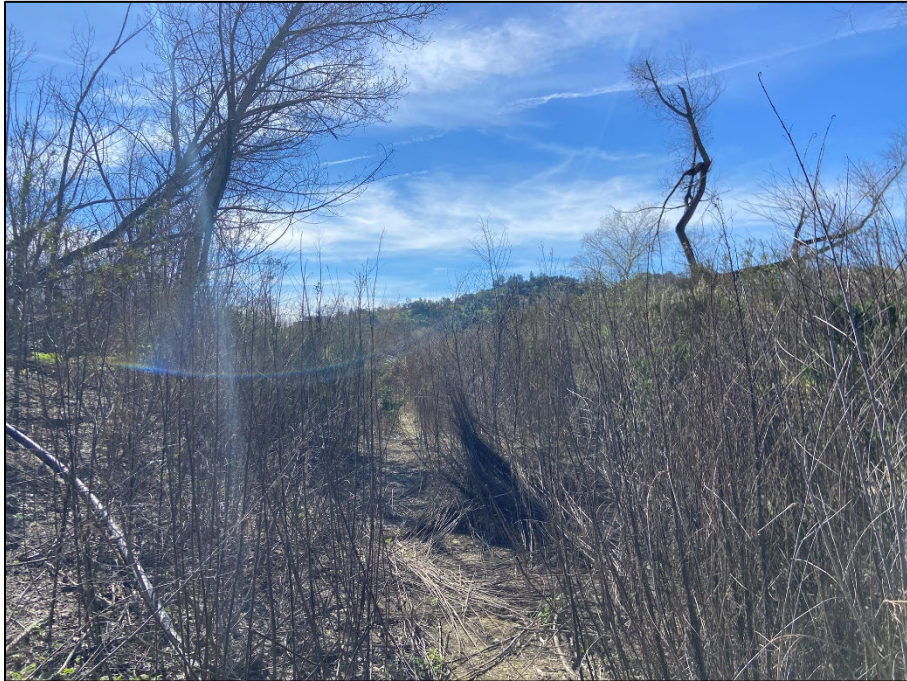
The overall health of the container plants in mitigation area DG-W-2 Outlet was noted as being good. Approximately 10 to 15 percent of the container plants were noted as showing varied levels of stress and a negligible number were noted as being dead or missing. This is approximately the same percentage of plants that were showing stress during the last monitoring event. Stress may be occurring due to similar reasons described for DG-W-1. Evidence of dieback from *Phytophthora cactorum*, including wilting, stunted growth, leaf spotting, and/or browning along leaf margins and tips, was not observed on any of the container plants. Similar to DG-W-1, the willows and Fremont's cottonwoods in this mitigation area were continuing to show signs of seasonal dieback. Formal mortality counts were taken for DG-W-2 Outlet during the 2021 and 2022 quantitative monitoring events. Some of the container plants were noted as lacking well defined basins and should have their basins properly constructed and/or repaired. The irrigation line appeared to be functioning properly for most areas of the mitigation area during the monitoring visit; however, some basins appeared to be dry and should be inspected for functionality. The installation of plants in the DG-W-2 Outlet mitigation area appears to have been completed successfully and the issues noted during the monitoring are not expected to have an impact on the continued growth of the plants. Photos 9 through 12 in Attachment B document the mitigation area during the monitoring visit.

Photo 9: Overview Mitigation Area DG-W-2 (Mining Pit Outlet)

Photo 10: Overview Mitigation Area DG-W-2 (Mining Pit Outlet)

Photo 11: Overview Mitigation Area DG-W-2 (Mining Pit Outlet)

Photo 12: Overview Mitigation Area DG-W-2 (Mining Pit Outlet)

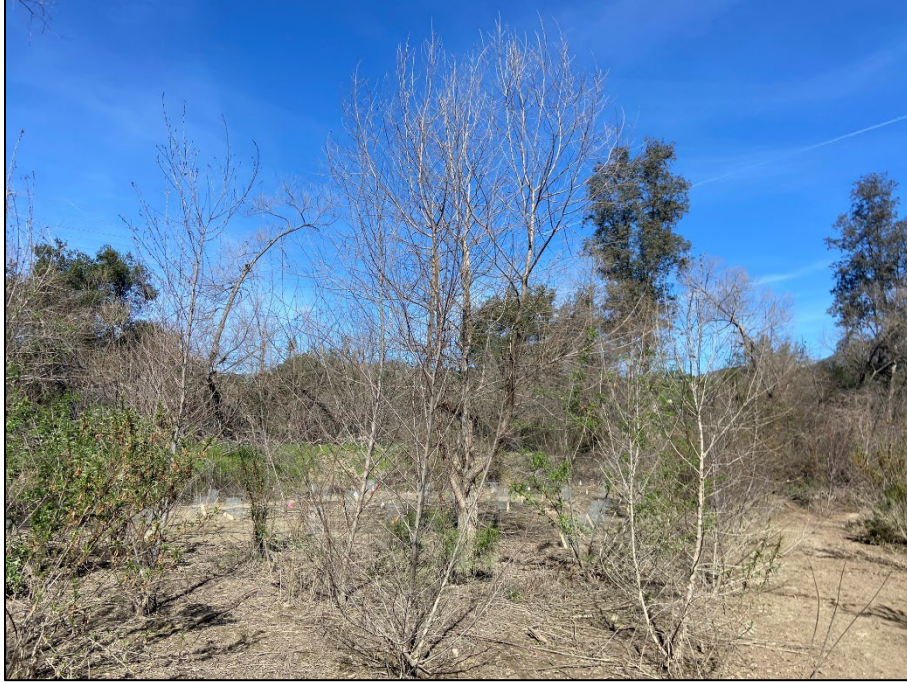
The overall health of the container plants in mitigation areas DG-4 Sheet Flow (northern) and DG-SF-1 was noted as being good. Approximately 10 percent of container plants were showing varied levels of stress which is approximately 10 percent more than the percentage of container plants that were showing stress during the previous monitoring event. Stress may be occurring due to similar reasons described for DG-W-1; however, the increased level of stress appears to be the result of prolonged inundation that occurred in January 2023. Evidence of dieback from *Phytophthora cactorum*, including wilting, stunted growth, leaf spotting, and/or browning along leaf margins and tips, was not observed on any of the container plants. Similar to DG-W-1, the willows and Fremont's cottonwoods in this mitigation area were starting to show minor seasonal dieback. Formal mortality counts were taken during the 2021 and 2022 quantitative monitoring events. Some of the container plants were noted as lacking well defined basins and should

have their basins properly constructed and/or repaired. In addition, minor herbivory of young plants was observed within the DG-4 Sheet Flow and DG-SF-1 areas and should continue to be monitored. The irrigation line appeared to be functioning properly during the monitoring visit. The installation of plants in the DG-4 Sheet Flow and DG-SF-1 mitigation areas appears to have been completed successfully and the issues noted during the monitoring are not expected to have an impact on the continued growth of the plants. Photo 13 in Attachment B document the mitigation area during the monitoring visit.

Photo 13: Overview Mitigation Area DG-4 Sheet Flow/Sheet Flow-1
