Bulk Asbestos, Lead Metal, Lead-Based Paint, Limited Hexavalent Chromium,
and Poly Chlorinated Biphenyls Survey

Los Angeles County Department Of Public Works
Morris Dam
Located Five Miles North of Azuza

HSA Project Number 99LA018

May 19, 1999

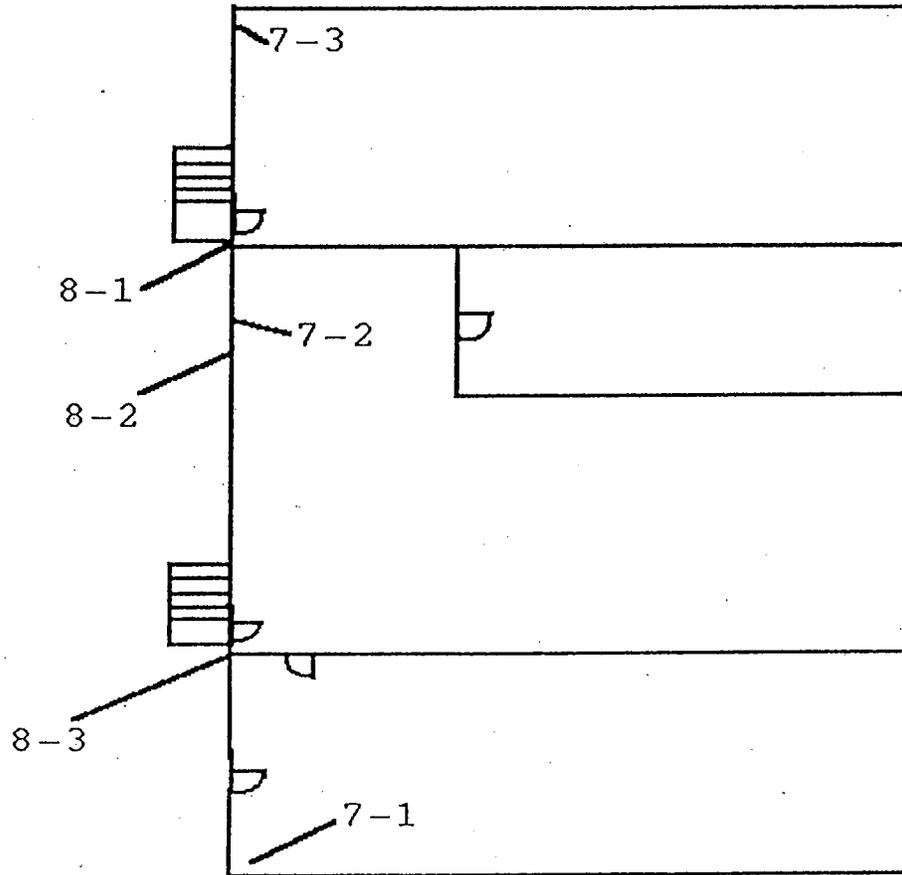
Morris Dam
Trailer
ACM Sample Locations

The roof mastics on the Temporary Trailer were determined to be ACM. These roof materials were observed to be non-friable and in good condition on the date of the survey. No other ACMs were located at the Temporary Trailer during our survey.

Roof
gr. for moisture
15% ACM

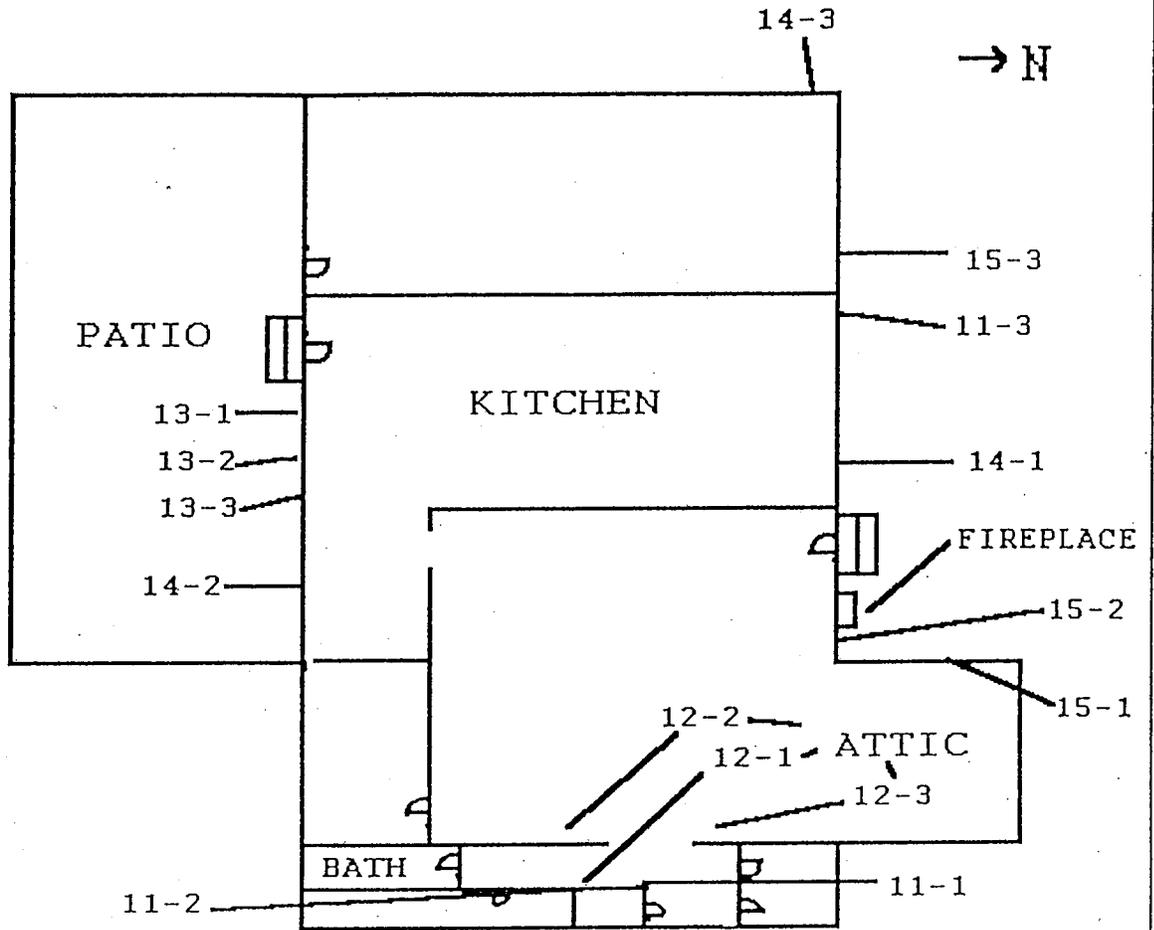
Morris Dam
ACM Sample Locations

The exterior stucco at the Dam Operator's house was determined to be ACM. The stucco materials were observed to be non-friable and in good condition on the date of the survey. It was reported to HSA that the flooring located inside the residence was installed less than three years ago; therefore, HSA did not sample the flooring materials as it is unlikely that these newly installed flooring materials contain asbestos.

*Exterior Stucco
ACM 2%*

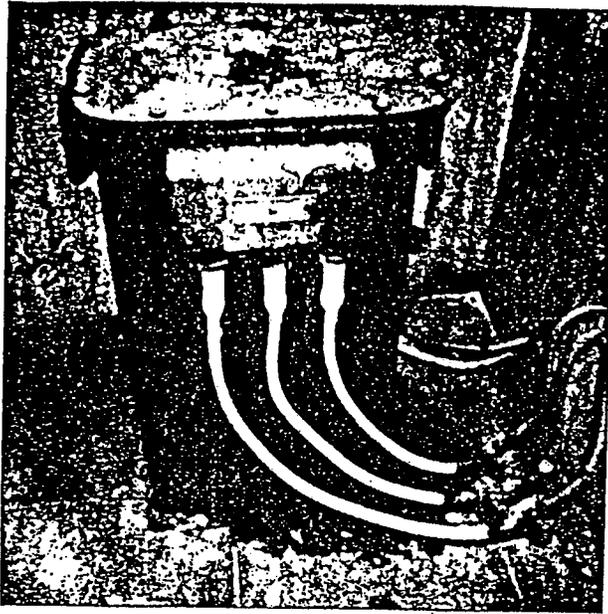
A LIGHTING TRANSFORMER

The oil (maximum result = 45 ppm) in the transformers is not considered a hazardous waste based on the TTLC (EPA Method 8081 - toxicity characteristic) sampling results; however, they should be managed appropriately through internal procedures in effect by way of the county's hazardous waste compliance program, as concentrations approaching the regulatory level were detected in the transformer oil. Wipe samples indicated that oil which contains PCBs has leaked to the floor. The extent of possible contamination is not known, but is probably only limited to the

Any DPW workers that are required to work near or on the transformers should be qualified with respect to occupational regulations regarding PCBs and associated hazards.

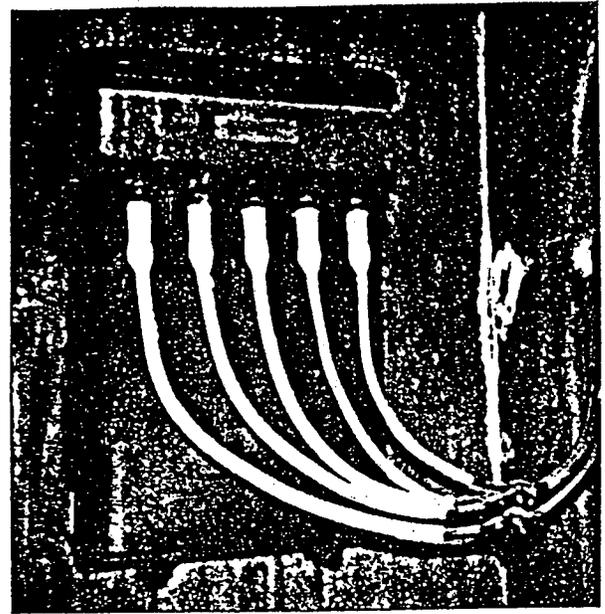
B - EMERGENCY LIGHTING TRANSFORMER

- The West Abutment Shaft J. B. To Pump House: Lead metal 2/O conductor wire and 3/O conductor wire conduit.
- Emergency & Lighting Transformers: Lead metal sheath.
- Emergency Pump Room: Lead conduit from dom-pumps.

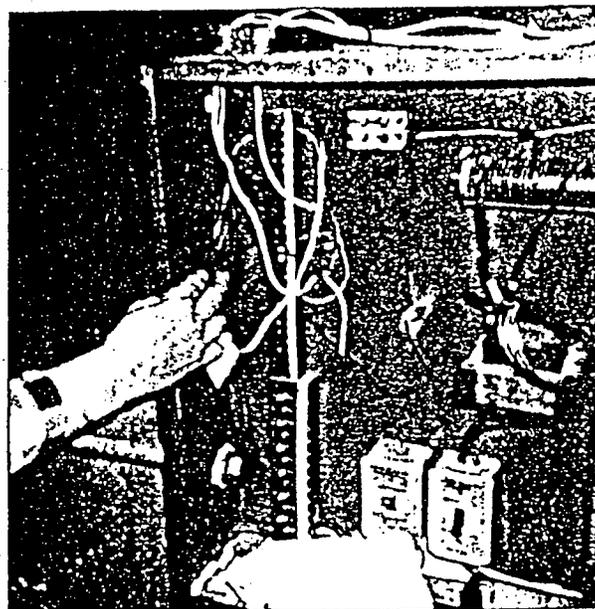
F - SOUTH WEST Pylon
PHONE

The electrical conduit wiring systems located in the Southwest Pylon Phone System, F, and the Emergency Valve Chamber Packings, K, were determined to be ACM. The Entrance Upper Gate System, I, was determined by LACDPW's to be the same type of electrical wiring system as the Southwest Pylon Phone System. These wiring systems were observed to be non-friable and were encased in braided silver painted metal mesh on the date of the survey.
