**2022-23 ANNUAL MAINTENANCE AND MONITORING REPORT
SOFT-BOTTOM CHANNEL MAINTENANCE PROGRAM
SECTION 401 WATER QUALITY CERTIFICATION ORDER NOS. 99-011 (2018 WDR)
AND 15-038**

The Los Angeles County Flood Control District (LACFCD) is pleased to submit the enclosed 2022-233700-1600 Annual Maintenance and Monitoring Report for the Soft-Bottom Channel (SBC) Maintenance Program, per the requirements of the Section 401 Water Quality Certification Order No. 99-011 and 15-038.

SUMMARY OF 2022-23 MAINTENANCE ACTIVITIES

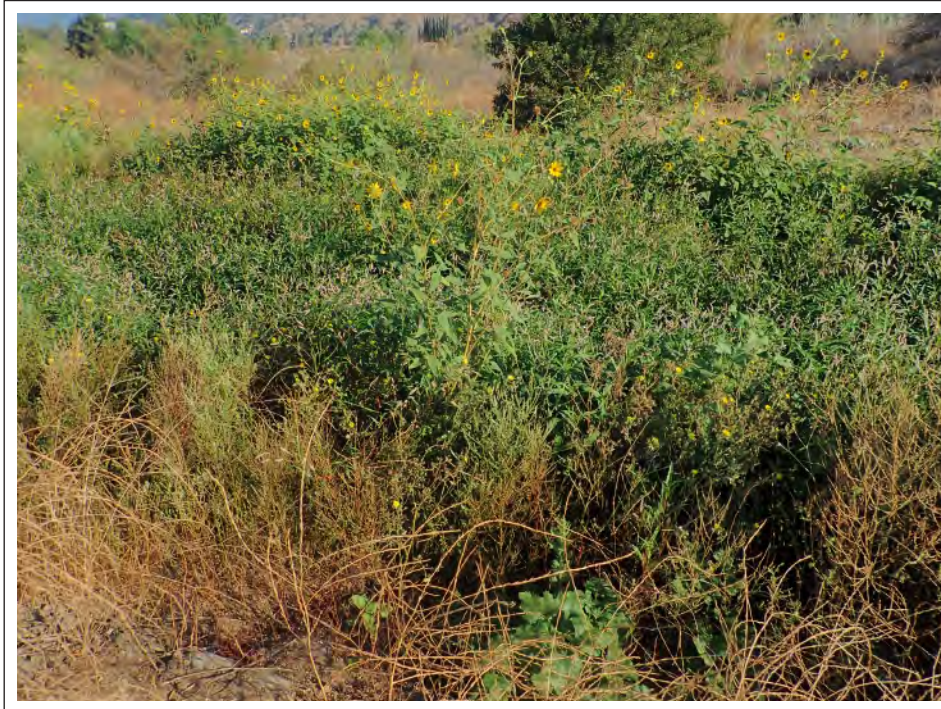
View of the center of Reach 39 facing downstream (northwest); showing dense herbaceous vegetation such as white sweetclover, rough cocklebur, common sunflower, and swamp smartweed growing in channel. Current conditions in this Reach are not suitable for SAS.

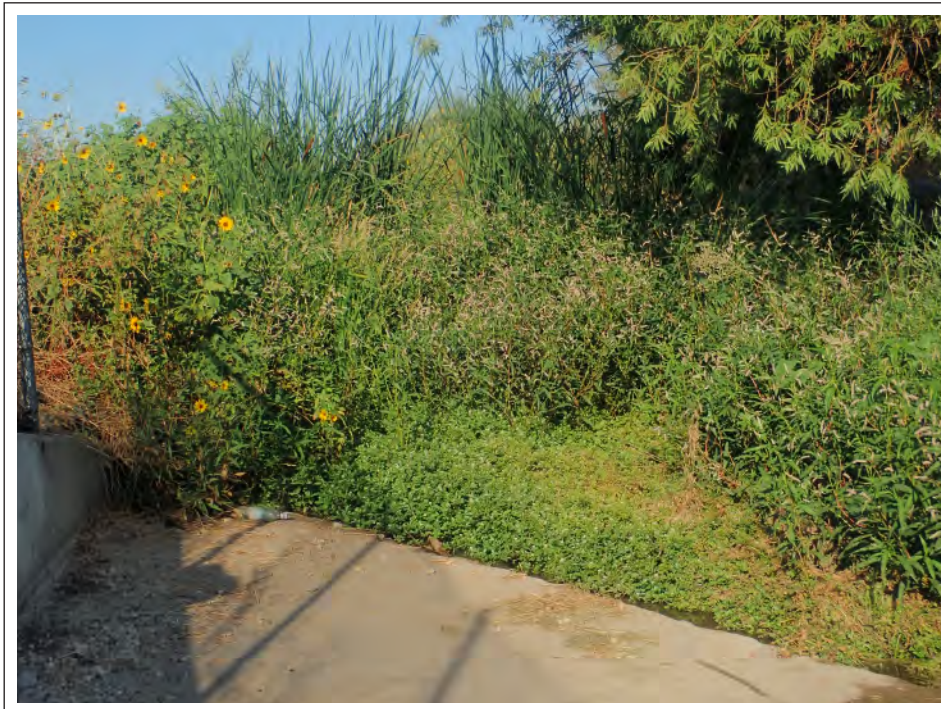
View of the upstream portion of Reach 39 facing downstream (west); showing more dense herbaceous vegetation growing in channel such as duckweed, cattails, common sunflower, and swamp smartweed. Current conditions in this Reach are not suitable for SAS.

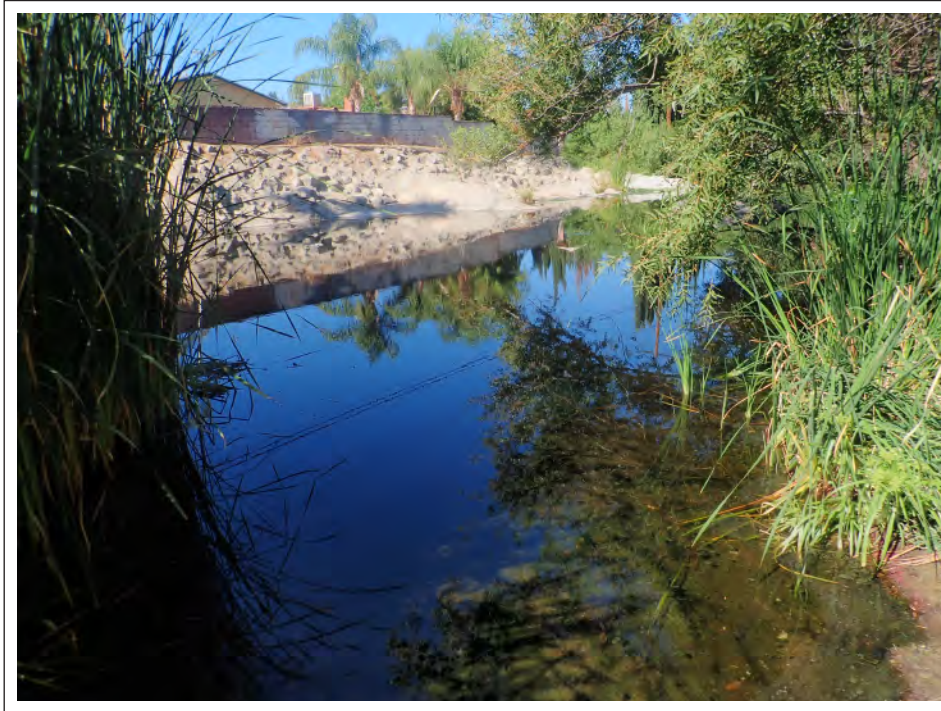
View of the upstream portion of Reach 12 facing downstream (west); showing pool of clear water and riparian vegetation such as cattails and black willow. Current conditions in this Reach are not suitable for SAS.

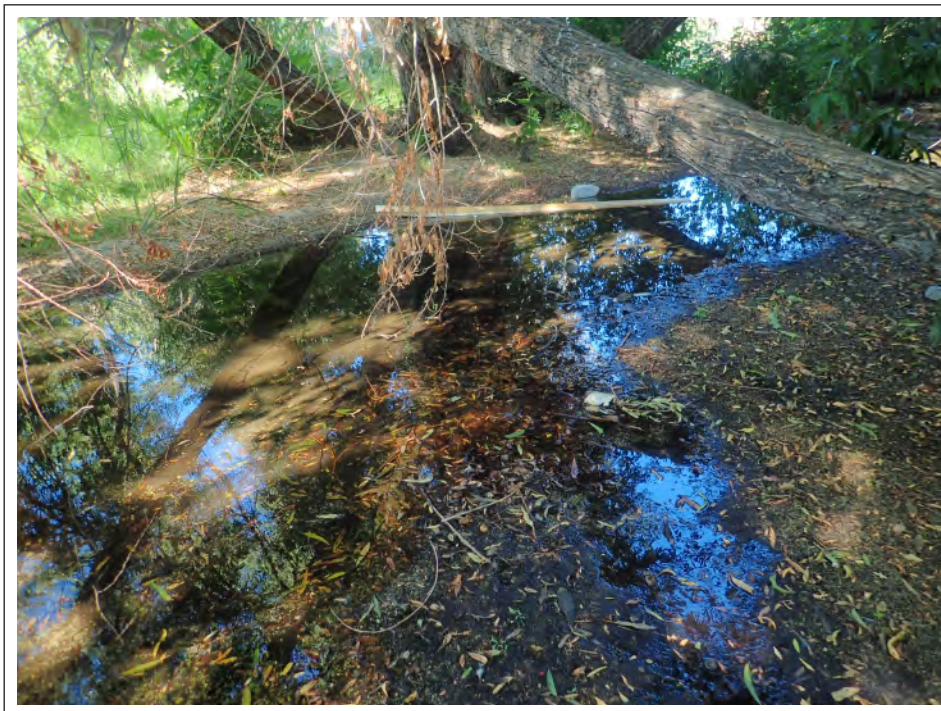
View of center portion of Reach 12 facing downstream (southwest); showing miscellaneous trash within shallow, slow moving water. Current conditions in this Reach are not suitable for SAS.

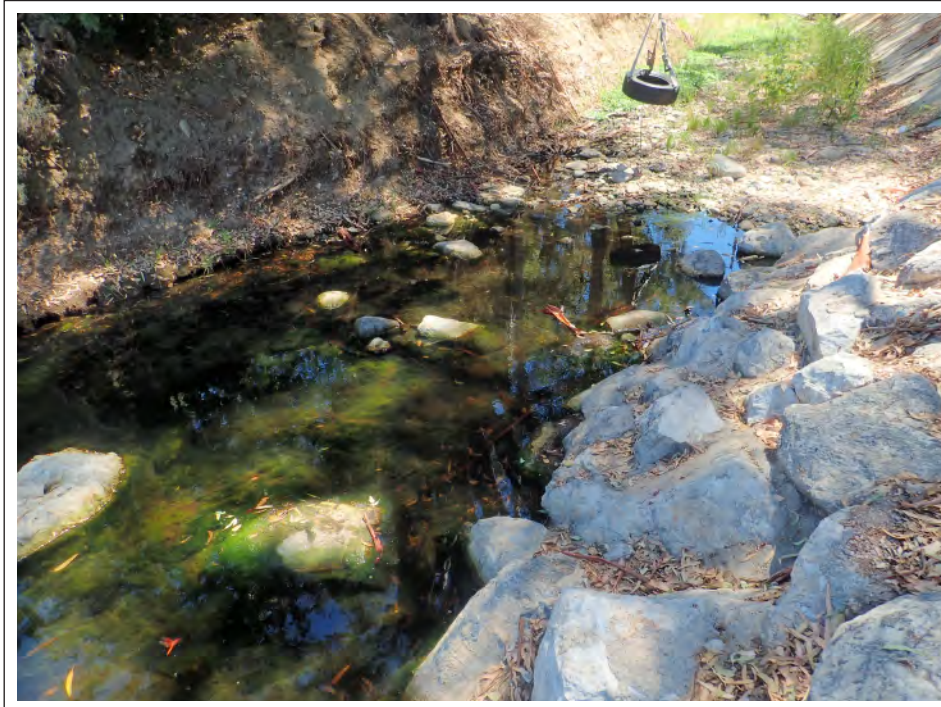
View of the center portion of Reach 54 facing upstream (southeast); showing clear water with algae mat on the channel bottom, and sparse vegetation growing in the upstream dry portion of the channel. Current conditions in this Reach are not suitable for UTS.

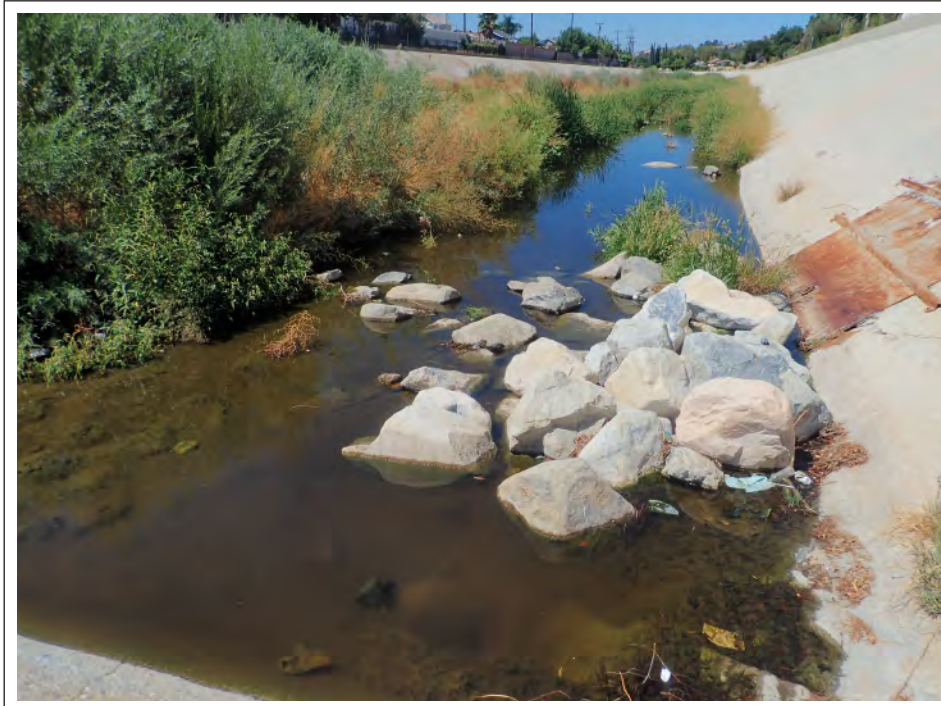
View of the downstream portion of Reach 67 facing downstream (southwest); showing cloudy pooled water with miscellaneous trash, rip-rap, and riparian vegetation such as sandbar willow and cattails. Current conditions in this Reach are not suitable for UTS.

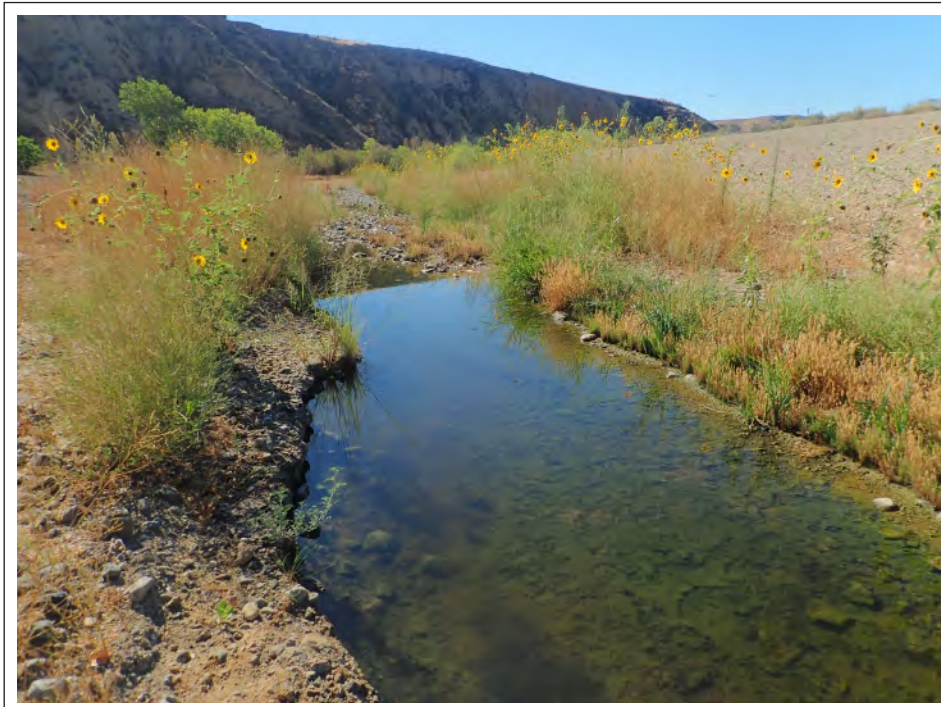
View of the upstream portion of Reach 86 facing downstream (southeast); showing clear water with an algae mat on bottom of channel and adjacent herbaceous vegetation such as common sunflower, white sweetclover, and cheat grass. Current conditions in this Reach are not suitable for UTS.

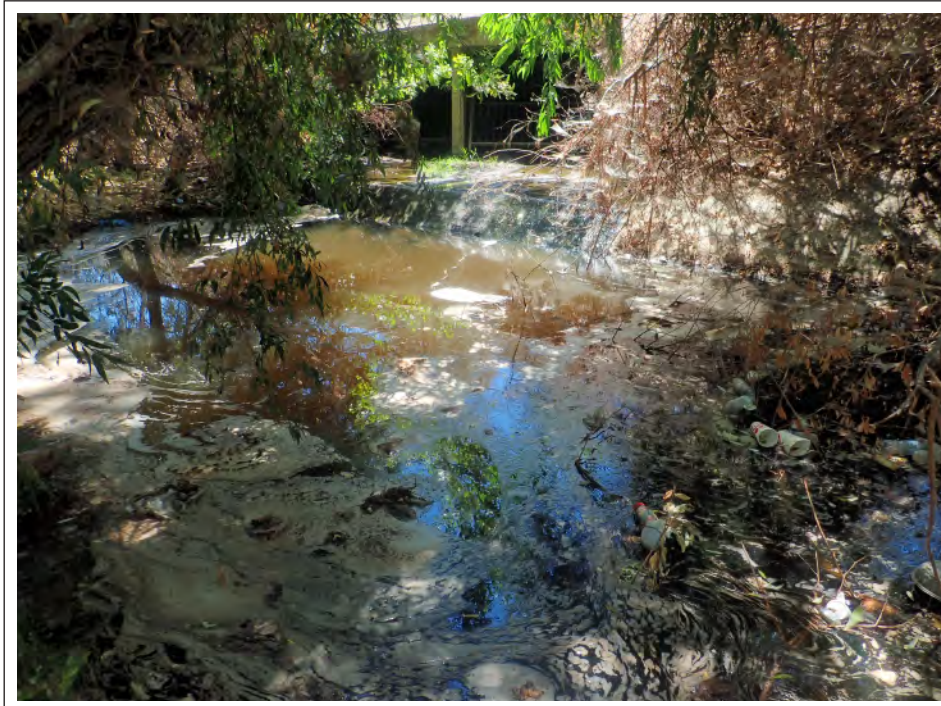
View of the upstream portion of Reach 109 facing upstream (southeast); showing pooled water with poor water quality conditions such as white foam, trash, and dissolved solids creating a cloudy appearance. Current conditions in this Reach are not suitable for UTS.

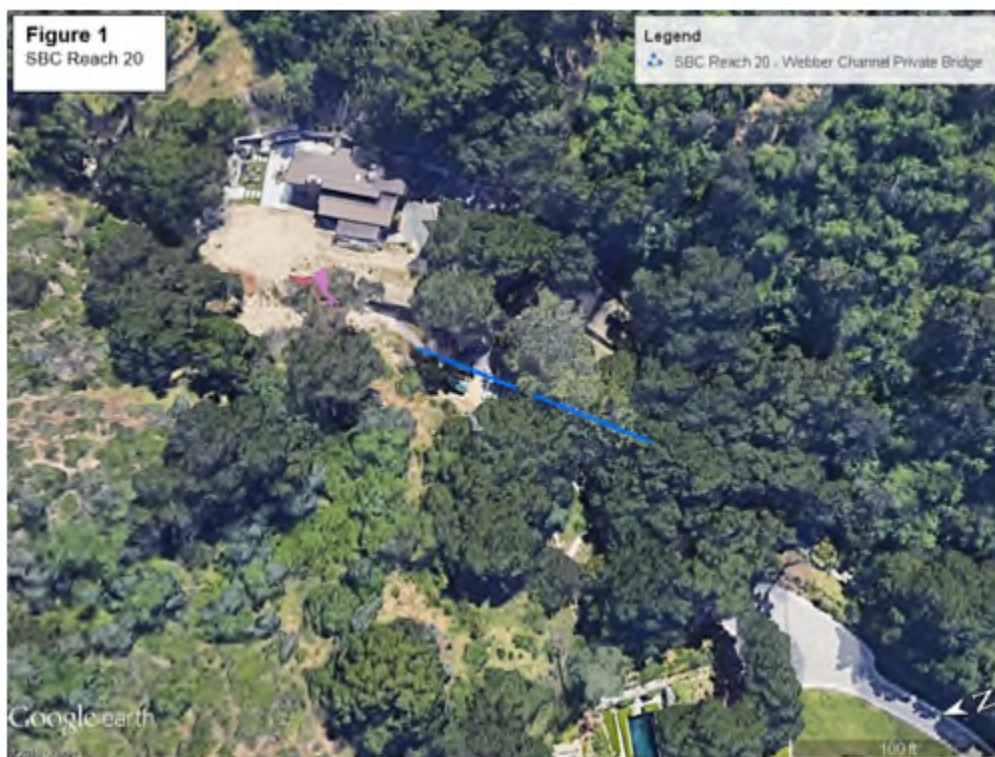
P S O M A S

Webber Channel is in the Angeles National Forest and discharges into the Verdugo Wash. Two soft-bottom sections of the channel are being investigated in this MMPP. Reach 20 is a stream at a private bridge that is about 115 feet in length and 25 feet in width (0.13 acres). Reach 20 spans from 861 feet upstream of Los Amigos Street to 746 feet upstream of Los Amigos Street (see Figure 1). Reach 21 is a stream that is 25 feet in length and 25 feet in width (0.03 acres). It serves as the main channel inlet downstream of the private bridge. Reach 21 spans from 496 feet upstream of Los Amigos Street to 471 feet upstream of Los Amigos Street (see Figure 2).
