Las Virgenes Gateway

MASTER PLAN

December 2, 1998

Prepared for the City of Calabasas
by
Mainstreet Architects & Planners, Inc.
with
Stephanie Diaz, Land Use Planner

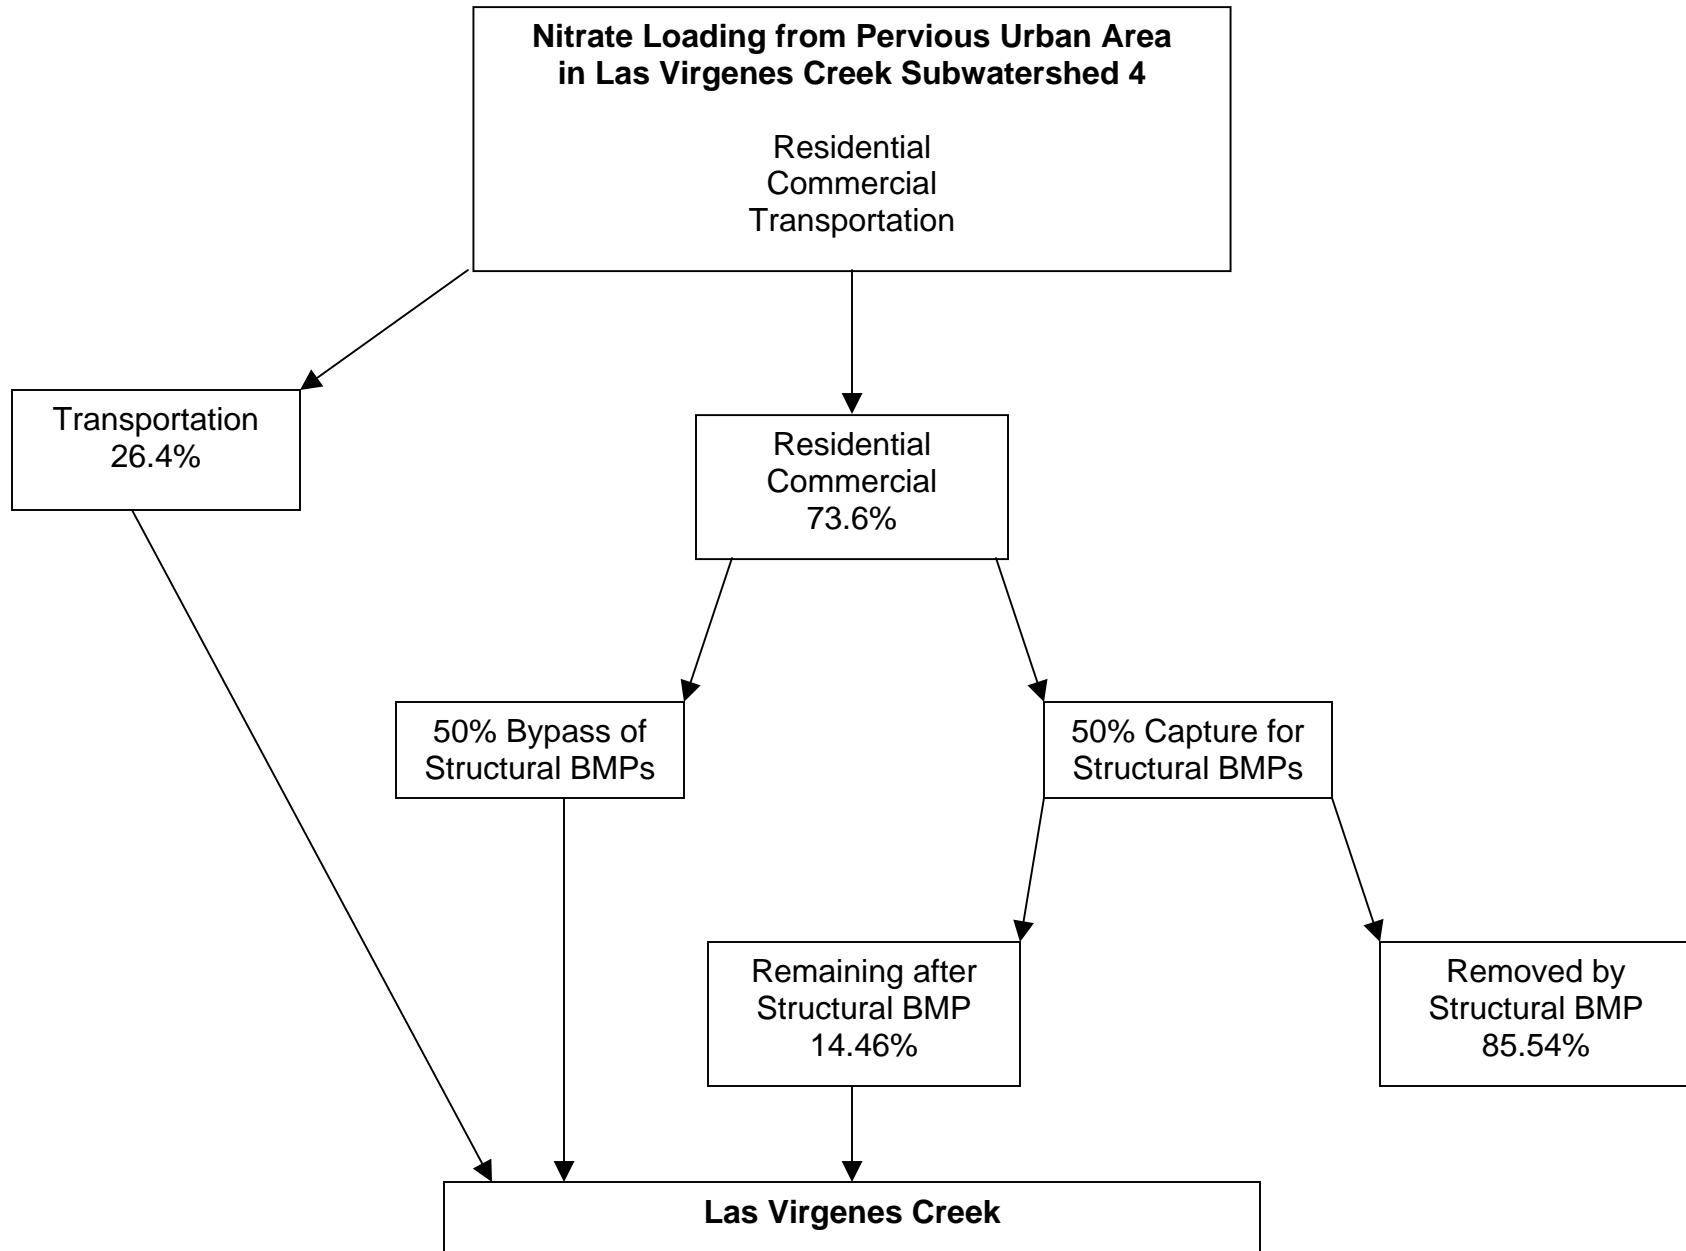
Figure 4.4 Example Flow Chart for Watershed Management Alternative 1A - Structural BMPs
