# Leachate Collected and Number of Odor Complaints - Sunshine Canyon Landfill

# Surface Gas Emissions and Number of Odor Complaints - Sunshine Canyon Landfill

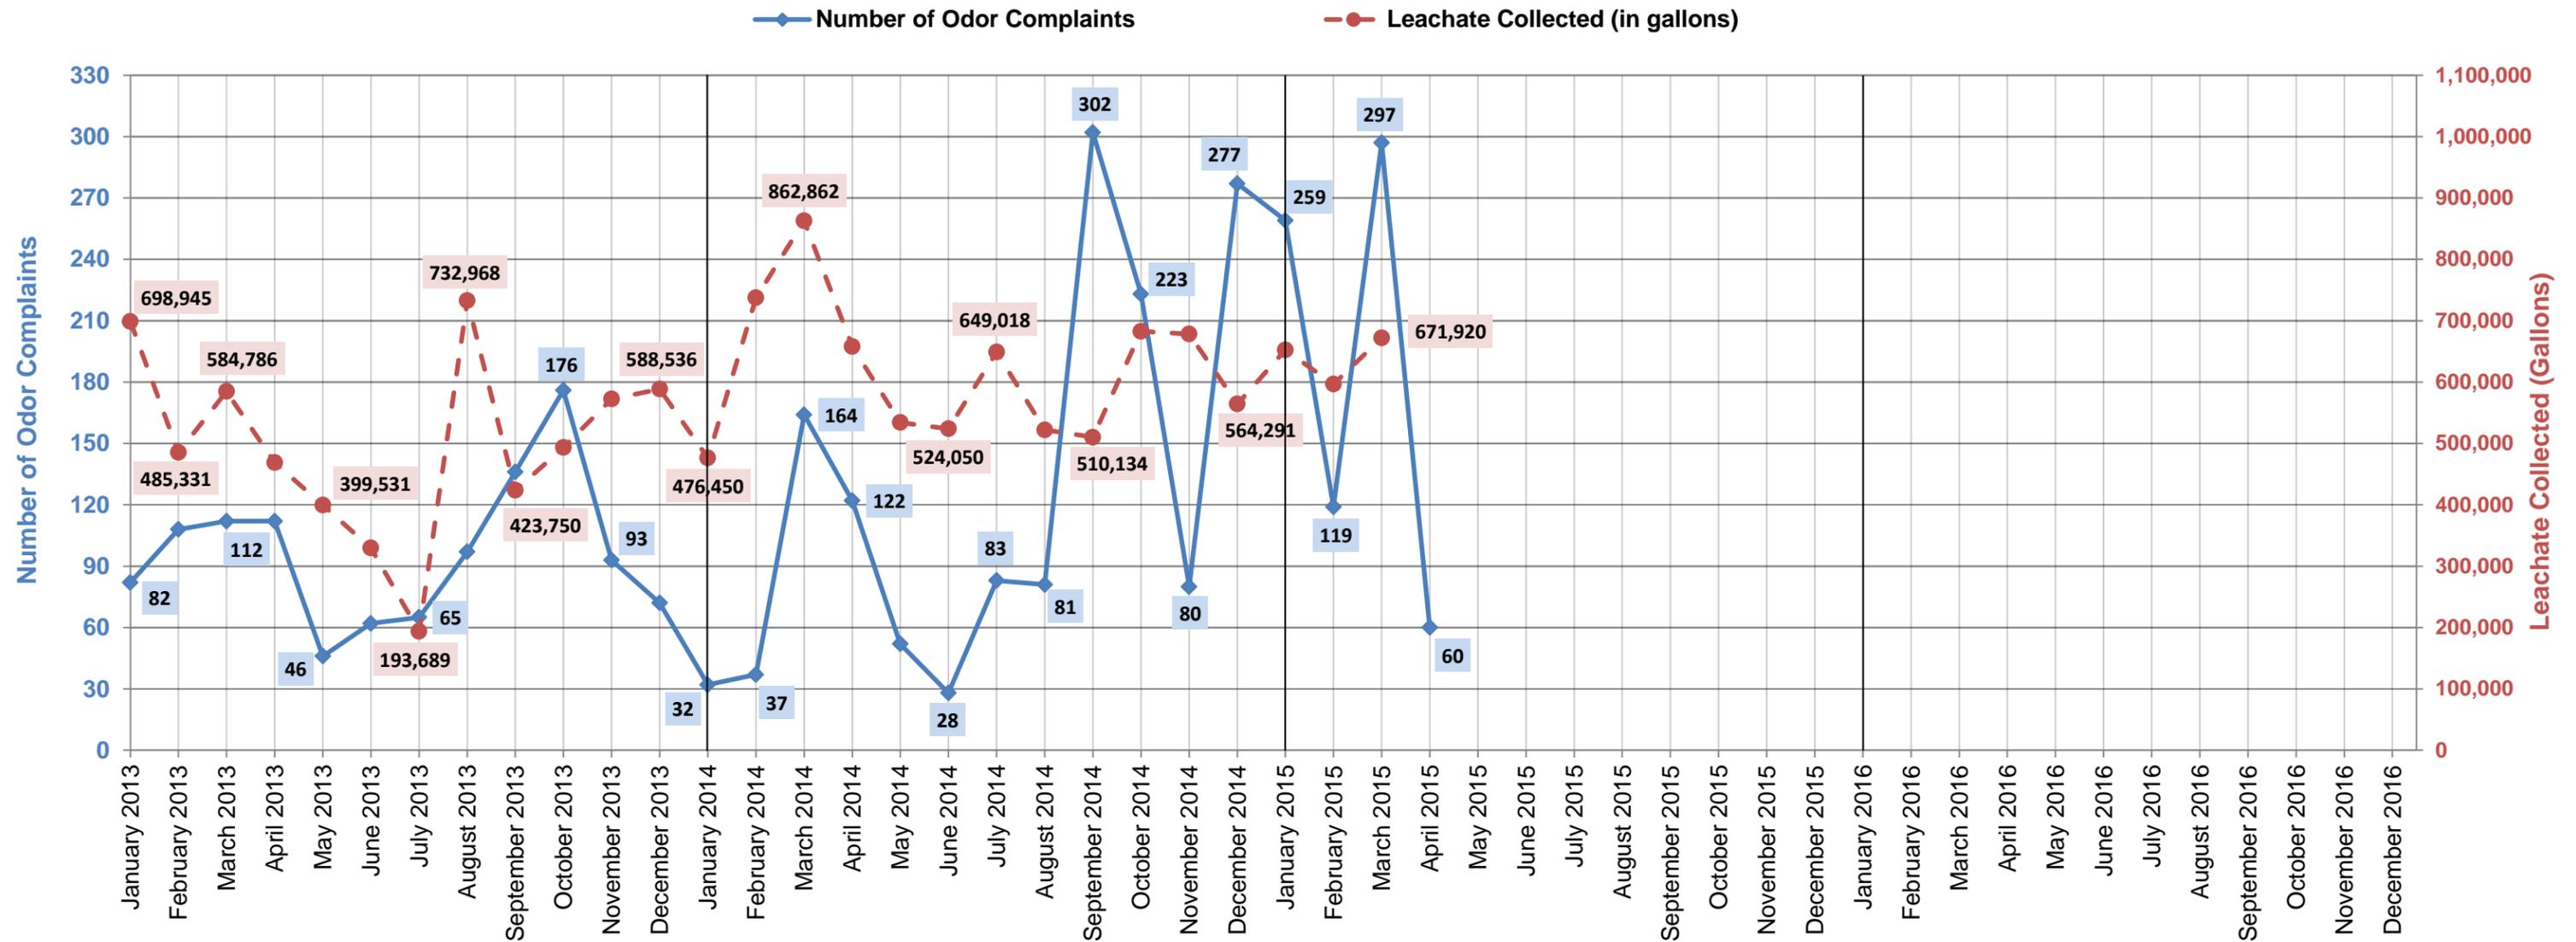
60 vertical gas wells and 27 pumps were installed.

14 vertical gas wells installed.

Flare 10 became operational.

Gas well was damaged.

14 vertical gas wells were installed.

Ponded water, erosional rills, damaged protective soil layer, and trash exposure from a storm event were observed.

From Dec. 2013 to April 2014, 30 vertical gas wells and 25 pumps were installed.

9,500 linear feet of gas lines and 1,900 linear feet of header lines were installed.

24 vertical gas wells were installed.

July 21 - startup of the Gas-to-Energy facility commenced.

September 1 - Gas-to-Energy facility became fully operational.

September 16 - approximately 100' x 100' area of settlement within the existing refuse area on the City South portion was observed. Remediation of the area was completed the next day.

Nov. 3 - trash exposure was observed due to improper covering of trash from the previous Saturday evening.

Dec. 2 & 12 - trash exposure was observed due to stormwater runoff.

Dec. 19 - 10 to 15 acres of trash was exposed due to heavy rain.

Dec. 26 - trash exposure was observed due to heavy rain.

Note: 1.) Number of complaints are based on AQMD's Complaint Summary Monthly Reports.  
 2.) Leachate collected is based on Republic Services' Summary of Water Sources Quarterly Reports to the SCL-LEA.

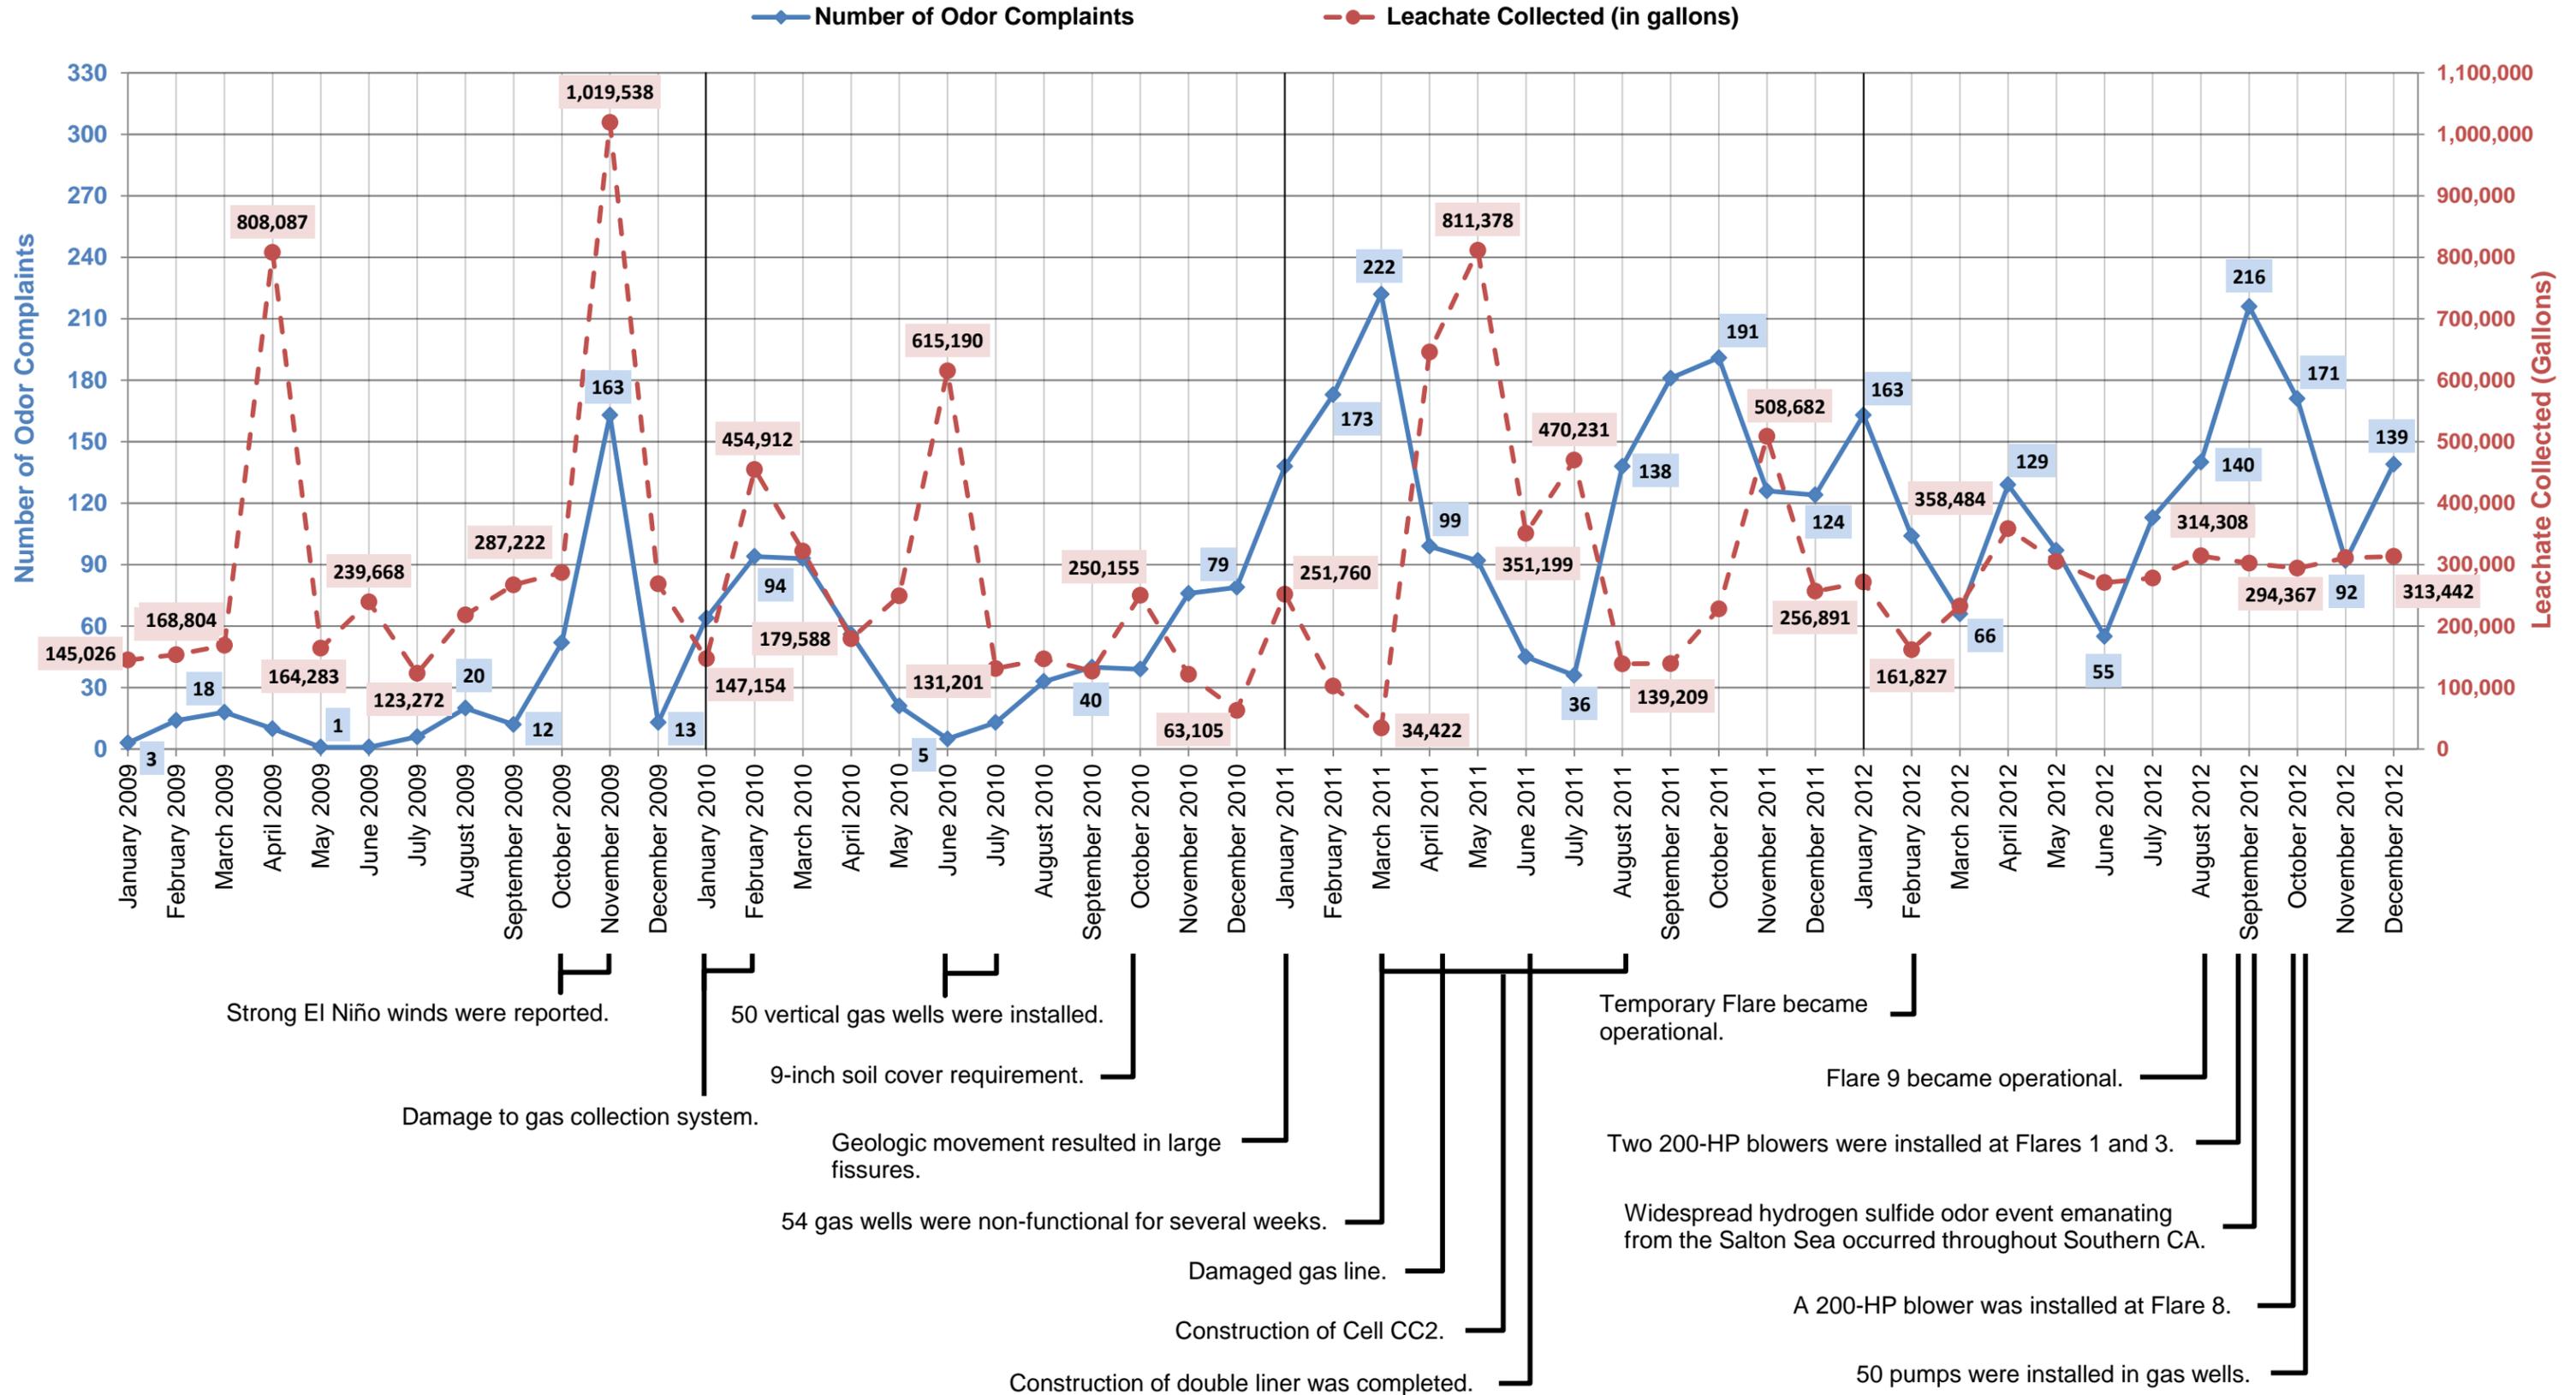
# Leachate Collected and Number of Odor Complaints - Sunshine Canyon Landfill

Note: 1.) Number of complaints are based on AQMD's Complaint Summary Monthly Reports.  
 2.) Leachate collected is based on Republic Services' Summary of Water Sources Quarterly Reports to the SCL-LEA.

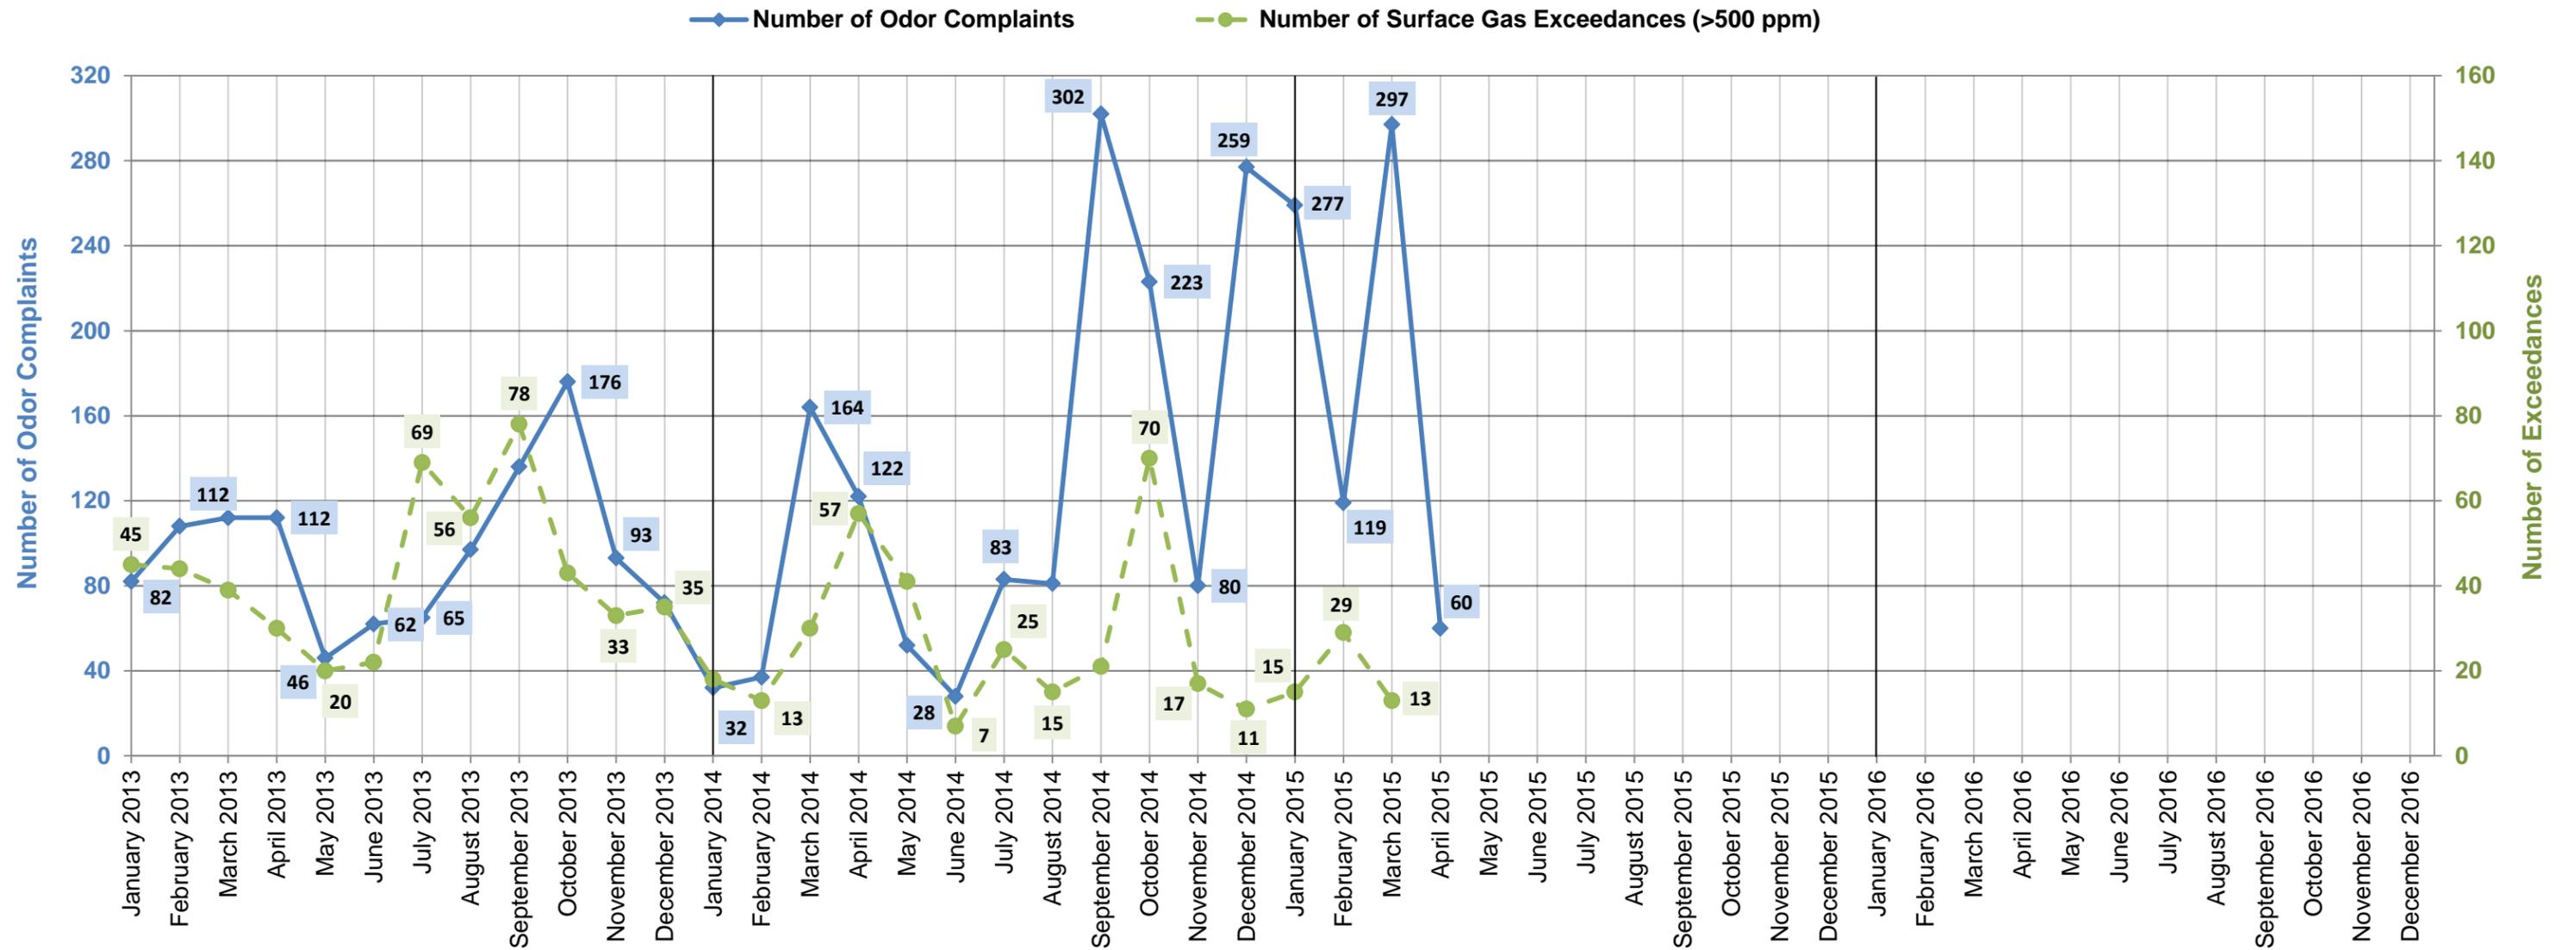
60 vertical gas wells and 27 pumps were installed.

14 vertical gas wells installed.

Flare 10 became operational.

Gas well was damaged.

14 vertical gas wells were installed.

Ponded water, erosional rills, damaged protective soil layer, and trash exposure from a storm event were observed.

From Dec. 2013 to April 2014, 30 vertical gas wells and 25 pumps were installed.

9,500 linear feet of gas lines and 1,900 linear feet of header lines were installed.

24 vertical gas wells were installed.

July 21 - startup of the Gas-to-Energy facility commenced.

September 1 - Gas-to-Energy facility became fully operational.

September 16 - approximately 100' x 100' area of settlement within the existing refuse area on the City South portion was observed. Remediation of the area was completed the next day.

Nov. 3 - trash exposure was observed due to improper covering of trash from the previous Saturday evening.

Dec. 2 & 12 - trash exposure was observed due to stormwater runoff.

Dec. 19 - 10 to 15 acres of trash was exposed due to heavy rain.

Dec. 26 - trash exposure was observed due to heavy rain.

Note: 1.) Number of complaints are based on AQMD's Complaint Summary Monthly Reports.  
 2.) Number of surface gas exceedances is based on Republic Services' Rule 1150.1 Quarterly Monitoring Reports

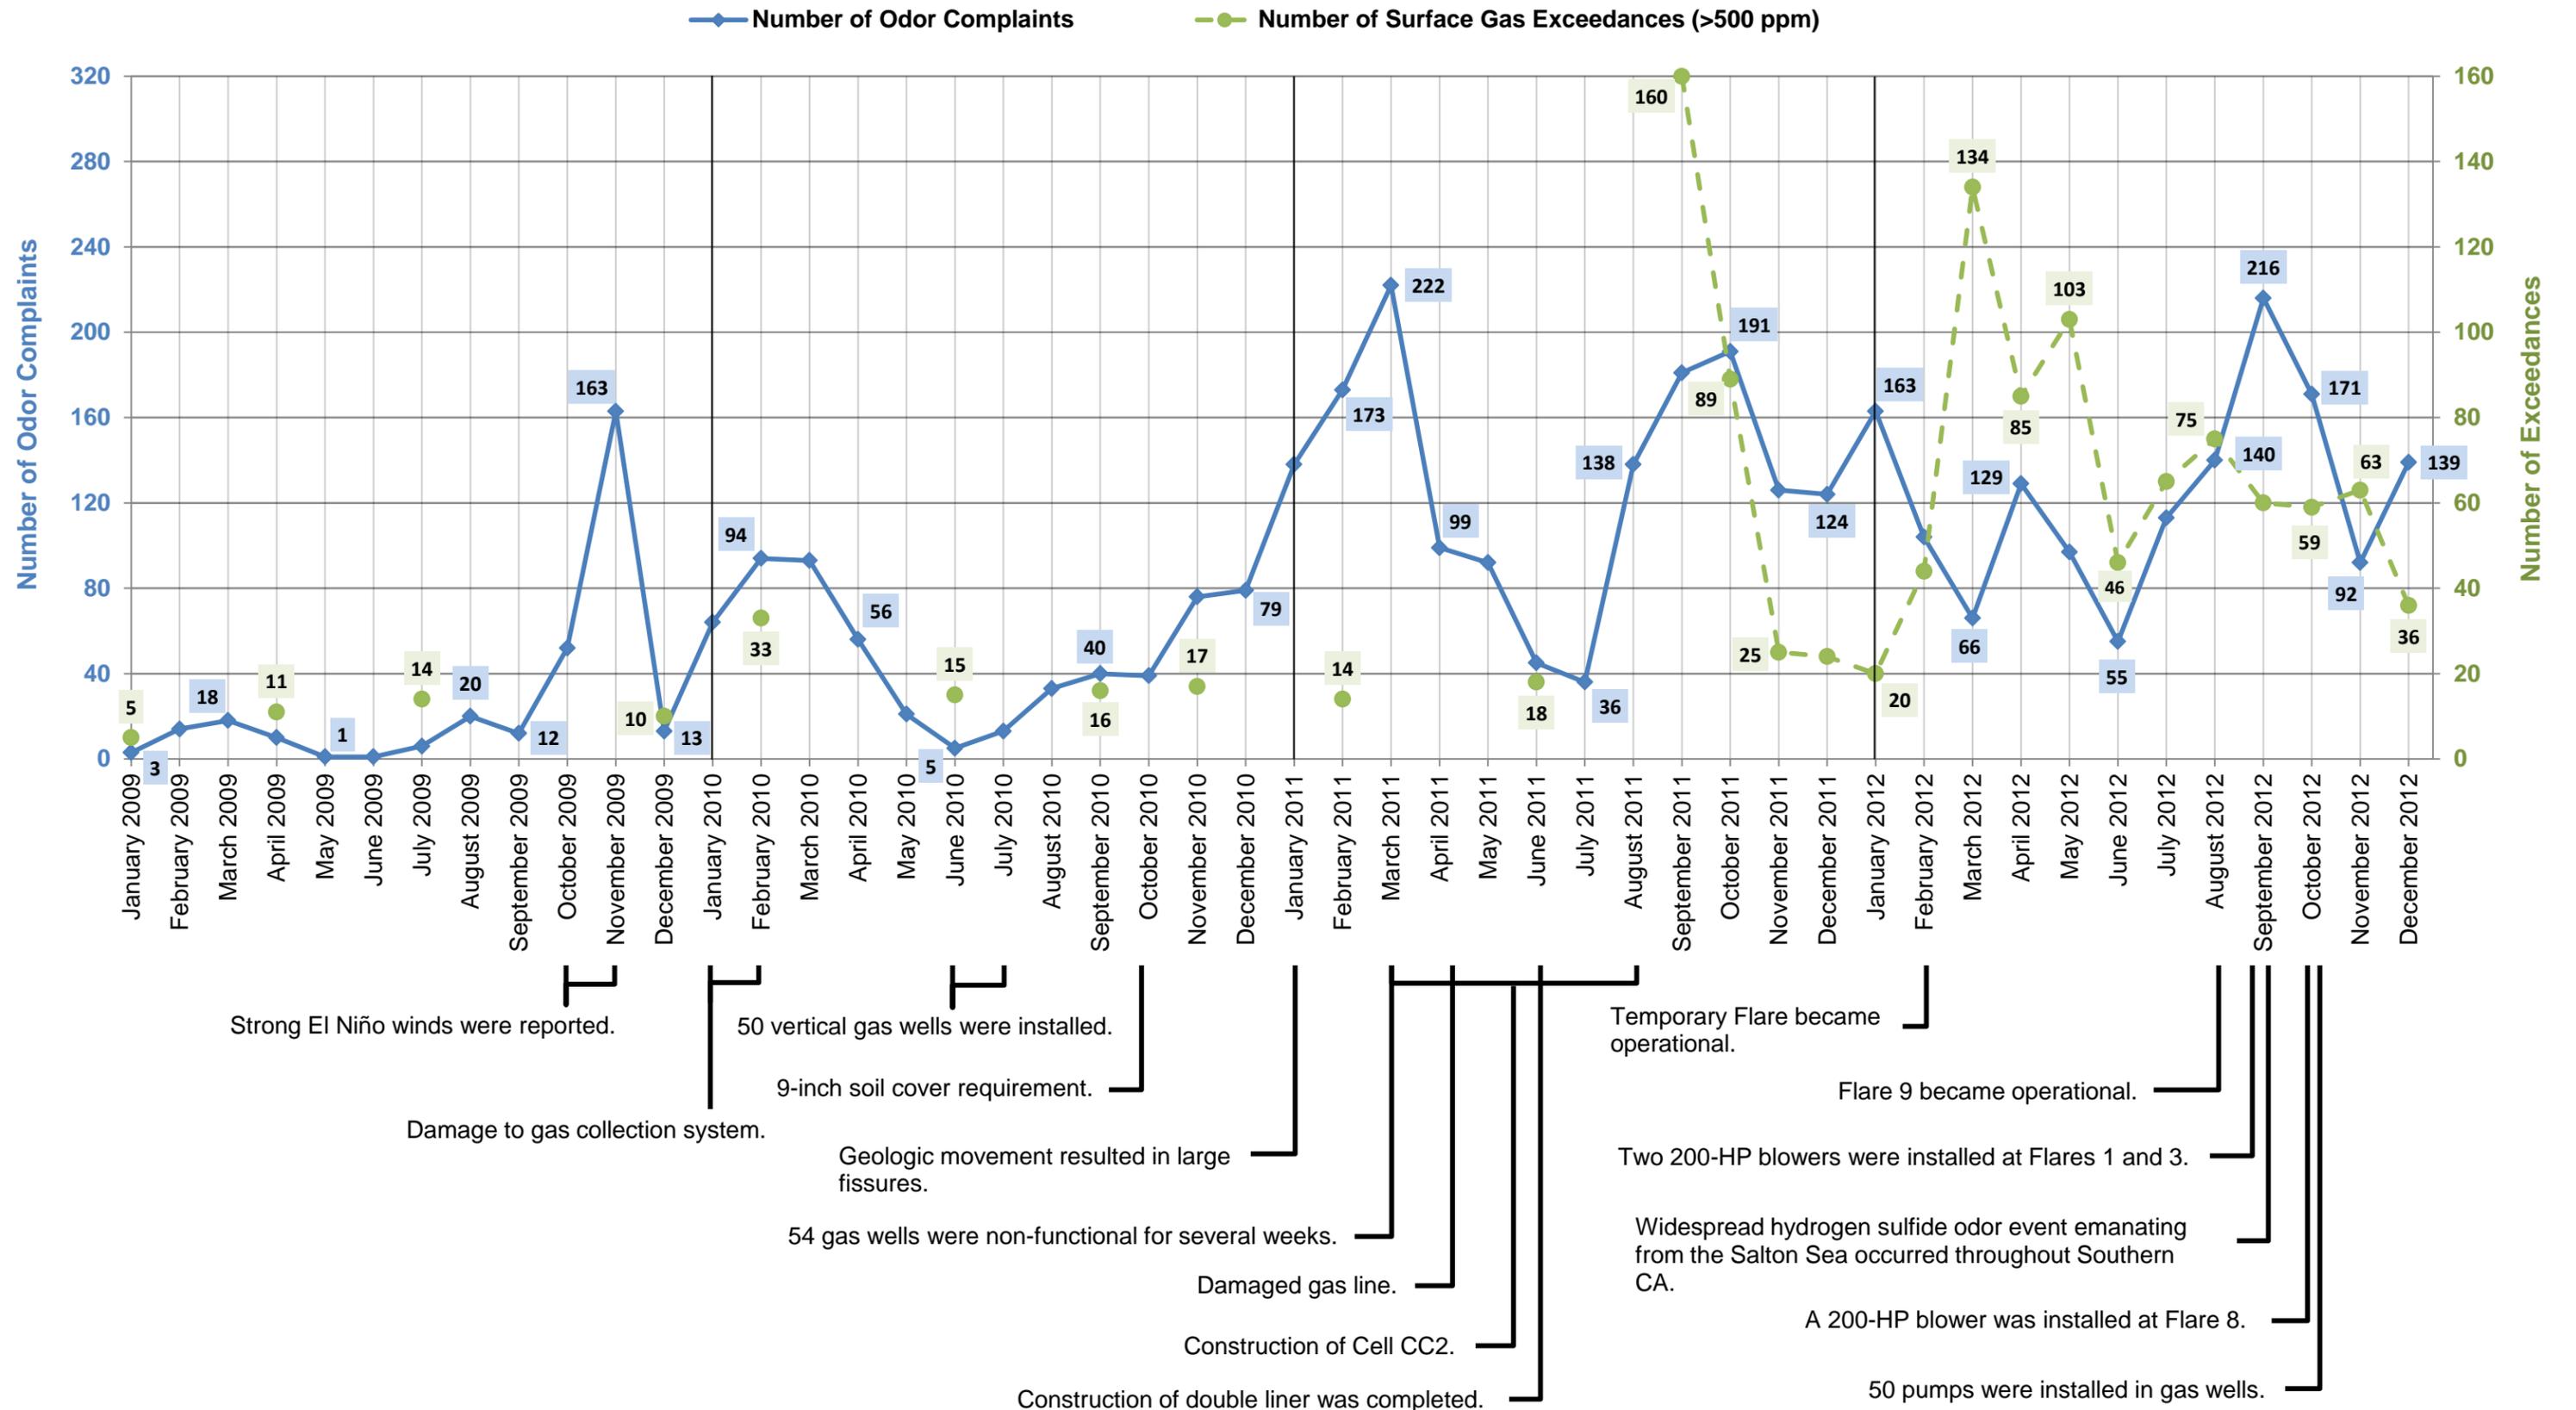
# Surface Gas Emissions and Number of Odor Complaints - Sunshine Canyon Landfill

Note: 1.) Number of complaints are based on AQMD's Complaint Summary Monthly Reports.  
 2.) Number of surface gas exceedances is based on Republic Services' Rule 1150.1 Quarterly Monitoring Reports
