**STAFF REPORT  
SECOND QUARTER 2015 VEGETATION PROJECT STATUS REPORT  
AT SUNSHINE CANYON CITY/COUNTY LANDFILL**

# SUNSHINE CANYON LANDFILL

Subject: Sunshine Canyon Landfill, Quarterly Vegetation Report – REVISED  
Second Quarter 2015 Vegetation Report

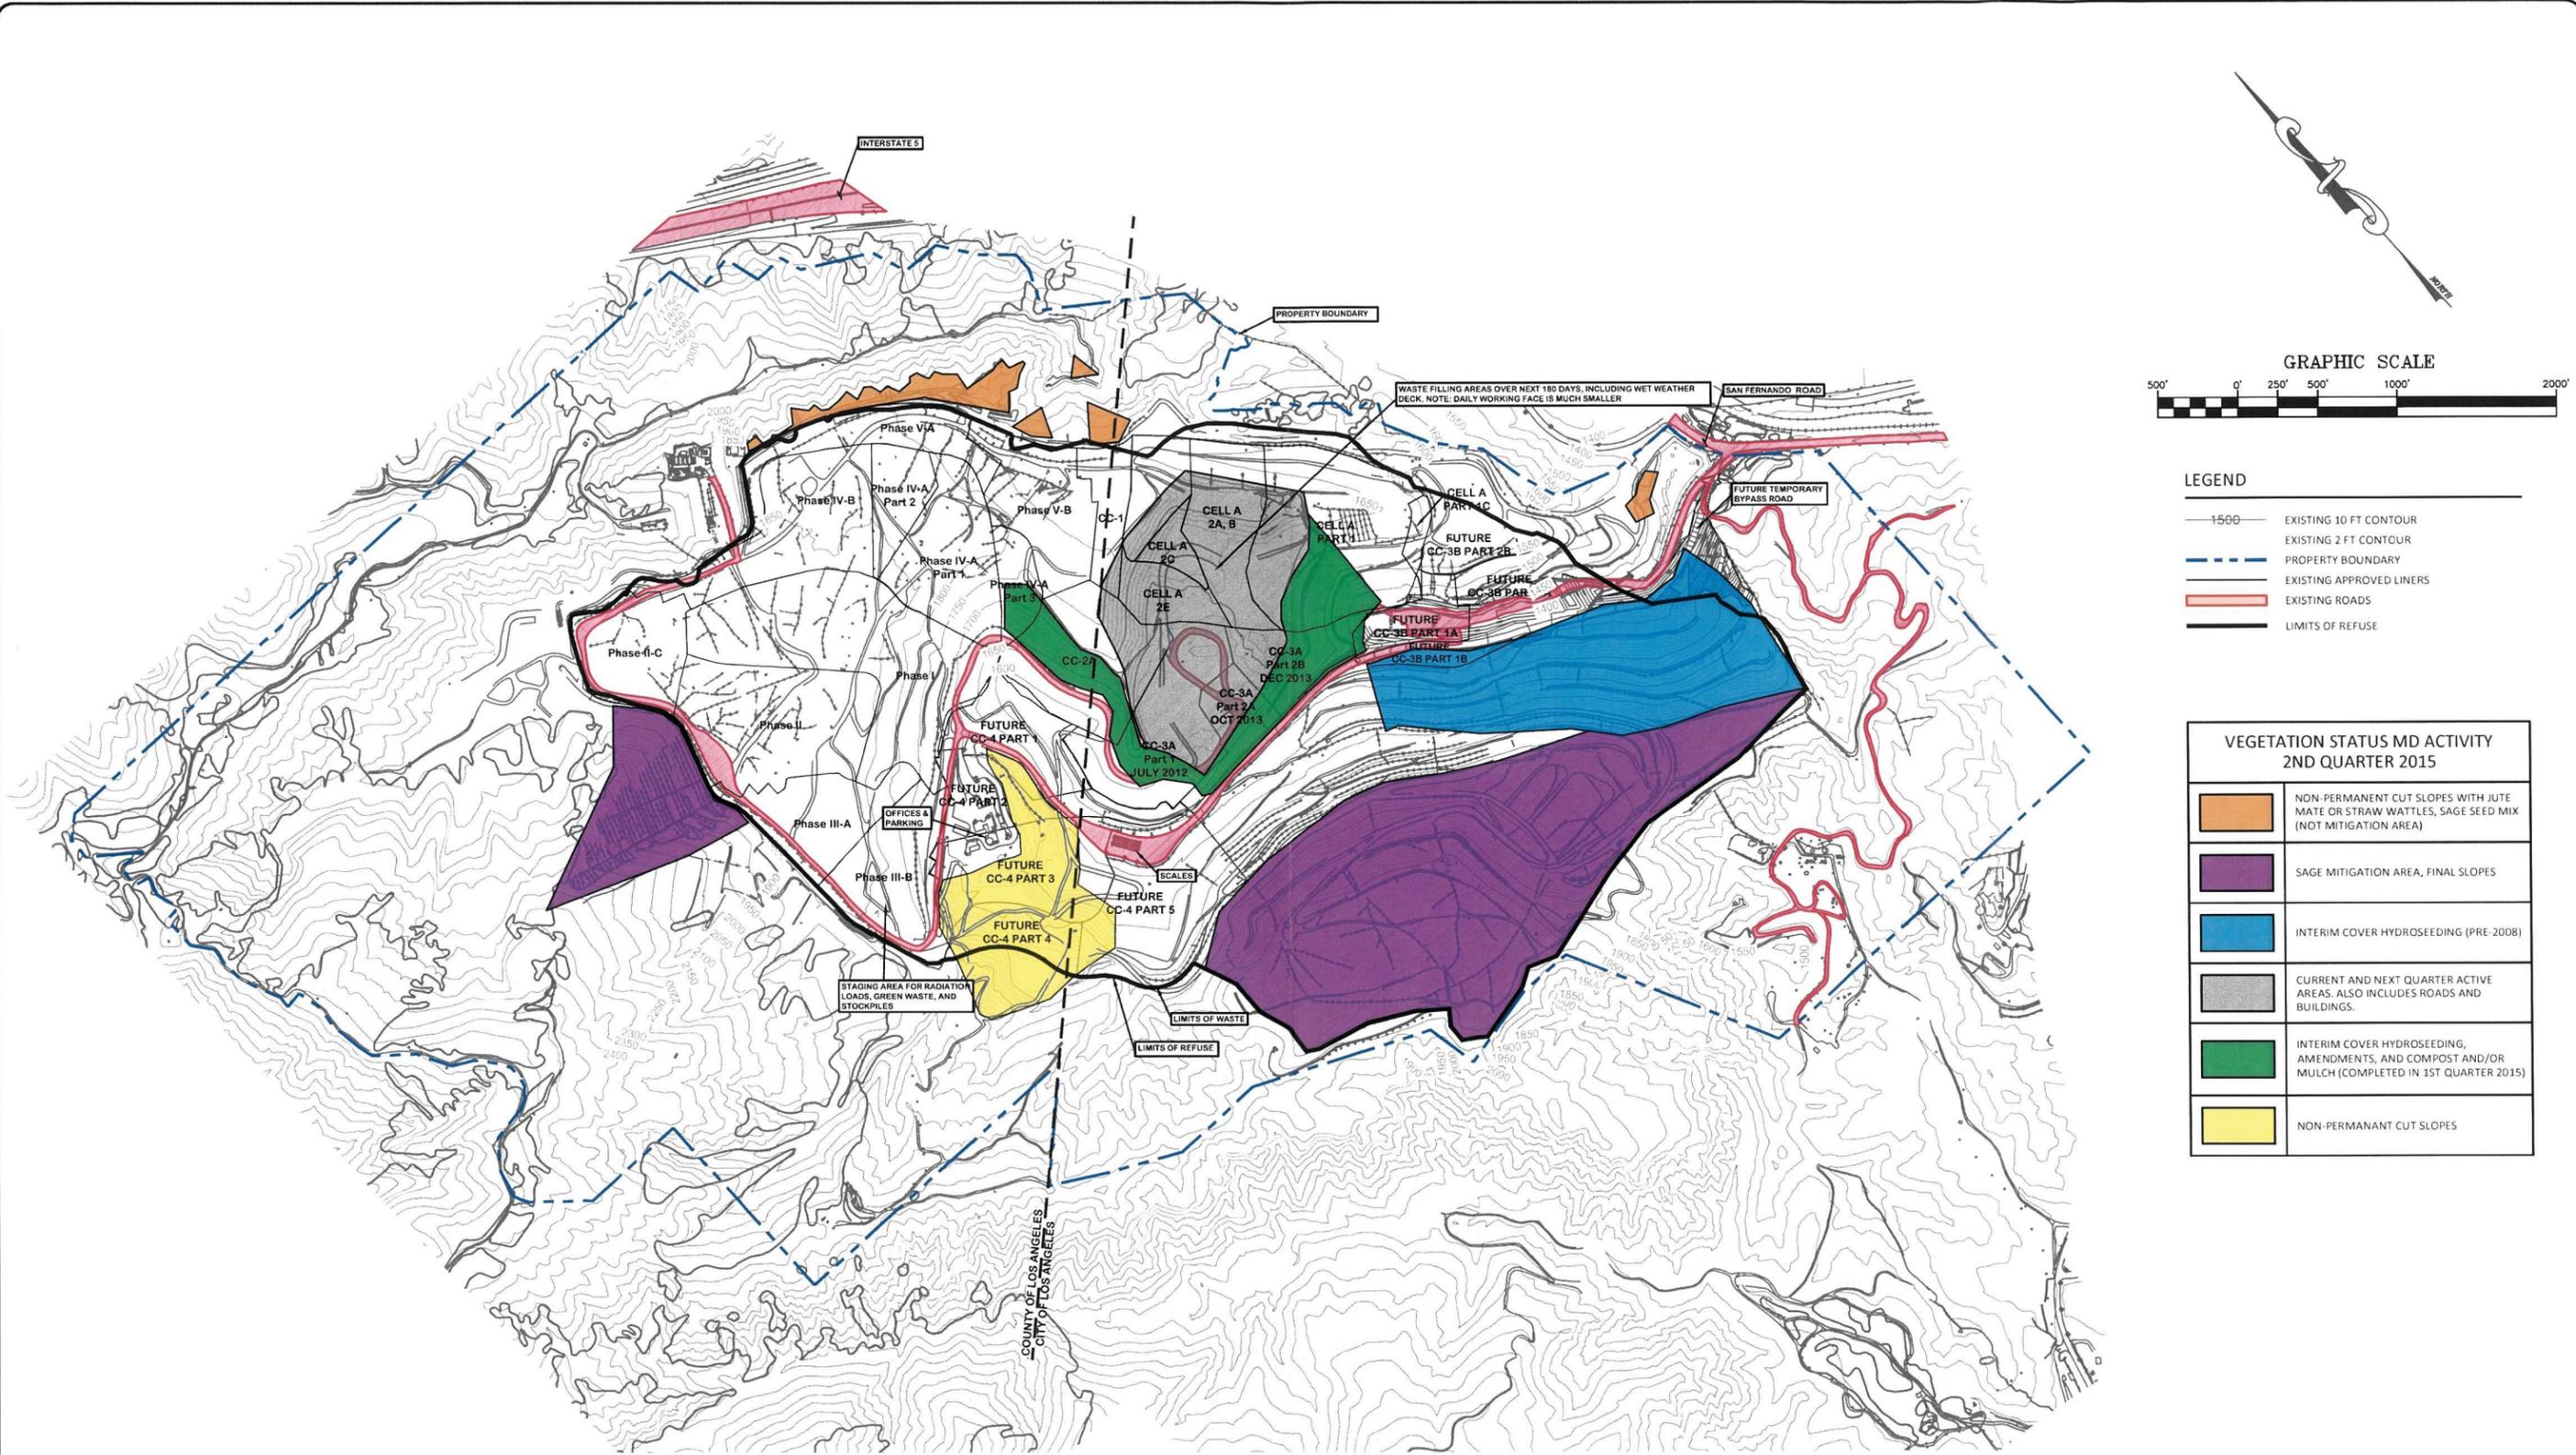
Drawing 1	2Q2015 Site Vegetation Areas
-----------	------------------------------

As reported in the vegetation report for the first quarter of 2015, hydroseeding activities were conducted on approximately 12 acres of interim slopes (Drawing 1).

Prior quarterly vegetation reports have illustrated areas located just north of the County portion of the site and one area above the front terminal sedimentation basin as “non-permanent cut slopes”. An evaluation of these areas will be conducted to determine if these areas have been categorized correctly, and what, if any vegetation activities are appropriate for these areas. Non-permanent cut slopes are shown on Drawing 1.

The County sage mitigation area is located on the western side of the County portion of Sunshine Canyon Landfill (Drawing 1). No revegetation activities were conducted in this area during the second quarter of 2015, and, as noted in multiple JMA progress reports, the conditions in this mitigation area have remained unchanged for some time.

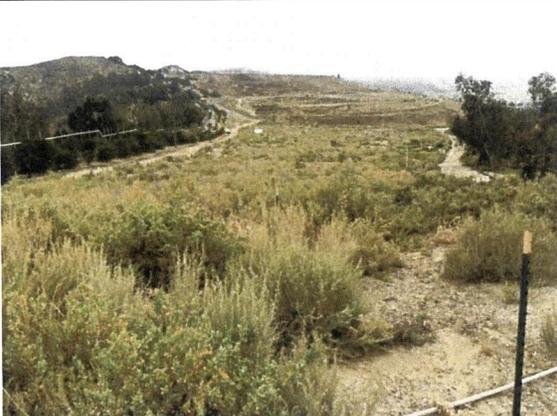
Photo 1. Facing west at lower deck. View of *Atriplex* species that dominate the vegetation cover and distribution within the pilot study area.

- **Selectively thin Atriplex vegetation where coastal sage scrub seedlings are present.** Closely monitor the seedlings that are growing within the understory of the Atriplex plants. Currently, the Atriplex plants are providing shade and good growing conditions for seedlings of coastal sage scrub species to become established. However, as the seedlings grow, the Atriplex plants should be thinned to reduce competition for space, water and available nutrients and to allow sunlight to reach the seedlings to increase photosynthesis.

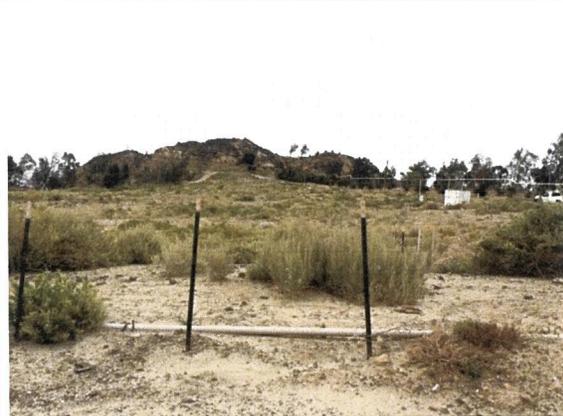
Photo 2. Facing east at lower deck. The vegetation seen in this photo is dominated by *Atriplex lentiformis* and *A. polycarpa*.

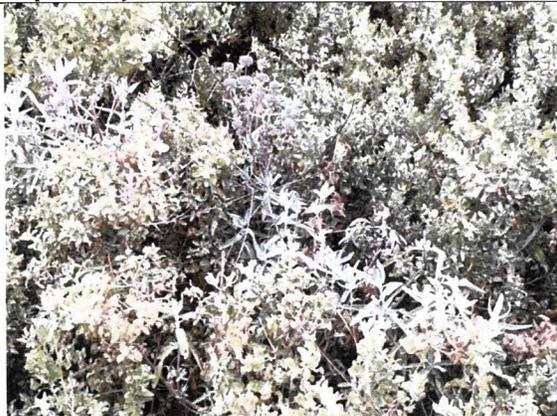
Photo 3. Example of dense *Atriplex* out-competing purple sage (*Salvia leucophylla*).

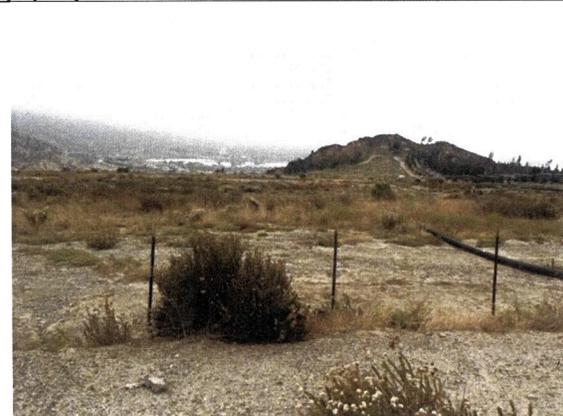
Photo 4. Facing east at middle deck with lower deck visible in background. View of non-native and native plant composition with areas of bare ground in the foreground. It is evident in this photos that the herbaceous non-natives (grasses) dominate the vegetation cover in the middle deck with patches of native interspersed in varying densities.

- **Plant Natives in Areas Dominated with Non-natives.** The vegetated areas on the middle deck that are currently dominated with annual, non-native species have decent soil-texture conditions. These areas are not near as compacted as adjacent areas that are gravelly and mostly void of vegetation. In general, the soil texture within the vegetated areas with non-native vegetation is friable down to approximately 8-12 inches in depth. Various planting methods (i.e., planting container plants and hydroseeding) may be used to re-establish native plants on the middle and upper decks where non-natives currently dominate. A temporary irrigation source would aid in establishing container plants and a consistent weed abatement program is important to control non-native species so that native can thrive and regenerate.

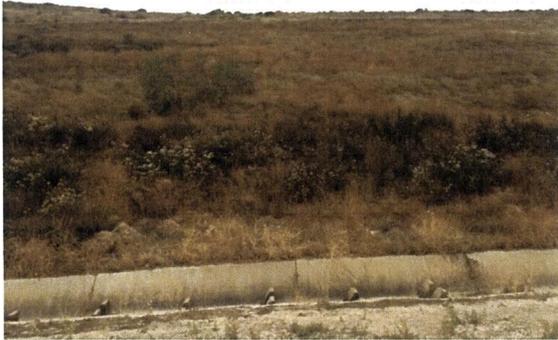
**Photo 4.** Facing west at the easterly-facing slope located between middle and upper decks. The vegetation on this slope (as well as all slopes below the upper deck) is dominated with mustard and brome grasses. CA buckwheat is present in patches as depicted in the foreground of this photograph.

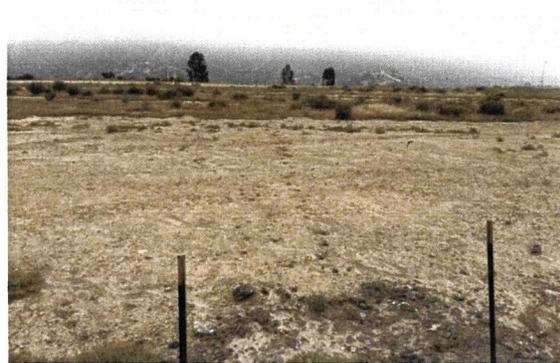
**Photo 5.** Facing northeast at upper deck. This area is compacted and gravelly and continues to be problematic for supporting vegetation. Non-native grasses and some CA buckwheat shrubs are evident in the background.

- **Improve root zone and soil conditions.** Continue to investigate ways to import the soil layer to improve the root penetration and saturation zone to enable plant growth in heavily compacted areas. Consider applying soil in random undulations or uneven mounds to improve soil porosity and filtration and to control soluble salts from leaching from existing layer.

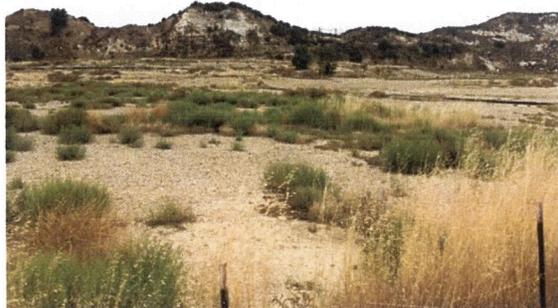
**Photo 6.** Facing southwest at upper deck. The area shown in this photo is dominated by annual non-native grasses.

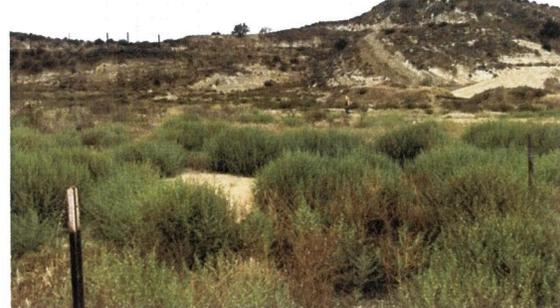
**Photo 7.** Facing south at the upper deck at the disturbed area that is currently dominated with Russian thistle, mustard and brome grasses.

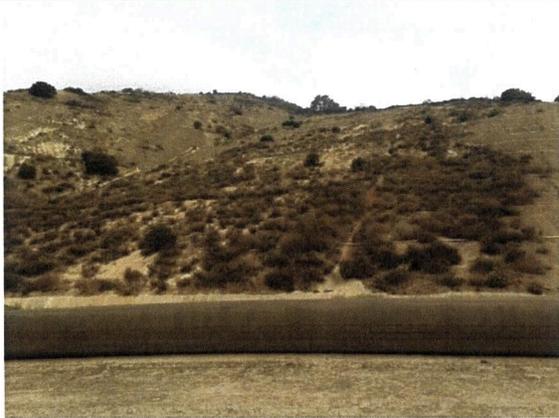
**Photo 1.** Facing west at established sage scrub on the southern half of the county-side mitigation area. Vegetation is dominated with CA buckwheat, with scattered California sunflower (*Encelia californica*). Annual, non-native grasses and forbs dominate the ground cover, as well as Russian thistle.

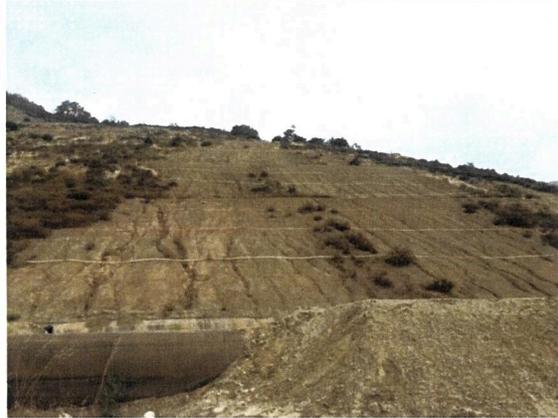
**Photo 2.** Facing west at the bare slope on the northern-half of the county-sage mitigation area. Plant growth remains to be problematic due to erosion, a hard soil surface layer, and boron toxicity.

- **Create benches.** Consider creation of benches throughout the mitigation area to control soil erosion and to improve soil conditions to improve plant establishment and seed dispersal. This technique has been widely used on steep slopes and in areas where soil erosion is problematic. This technique also allows for opportunities to introduce a high quality soil layer above the poor soils that exist.

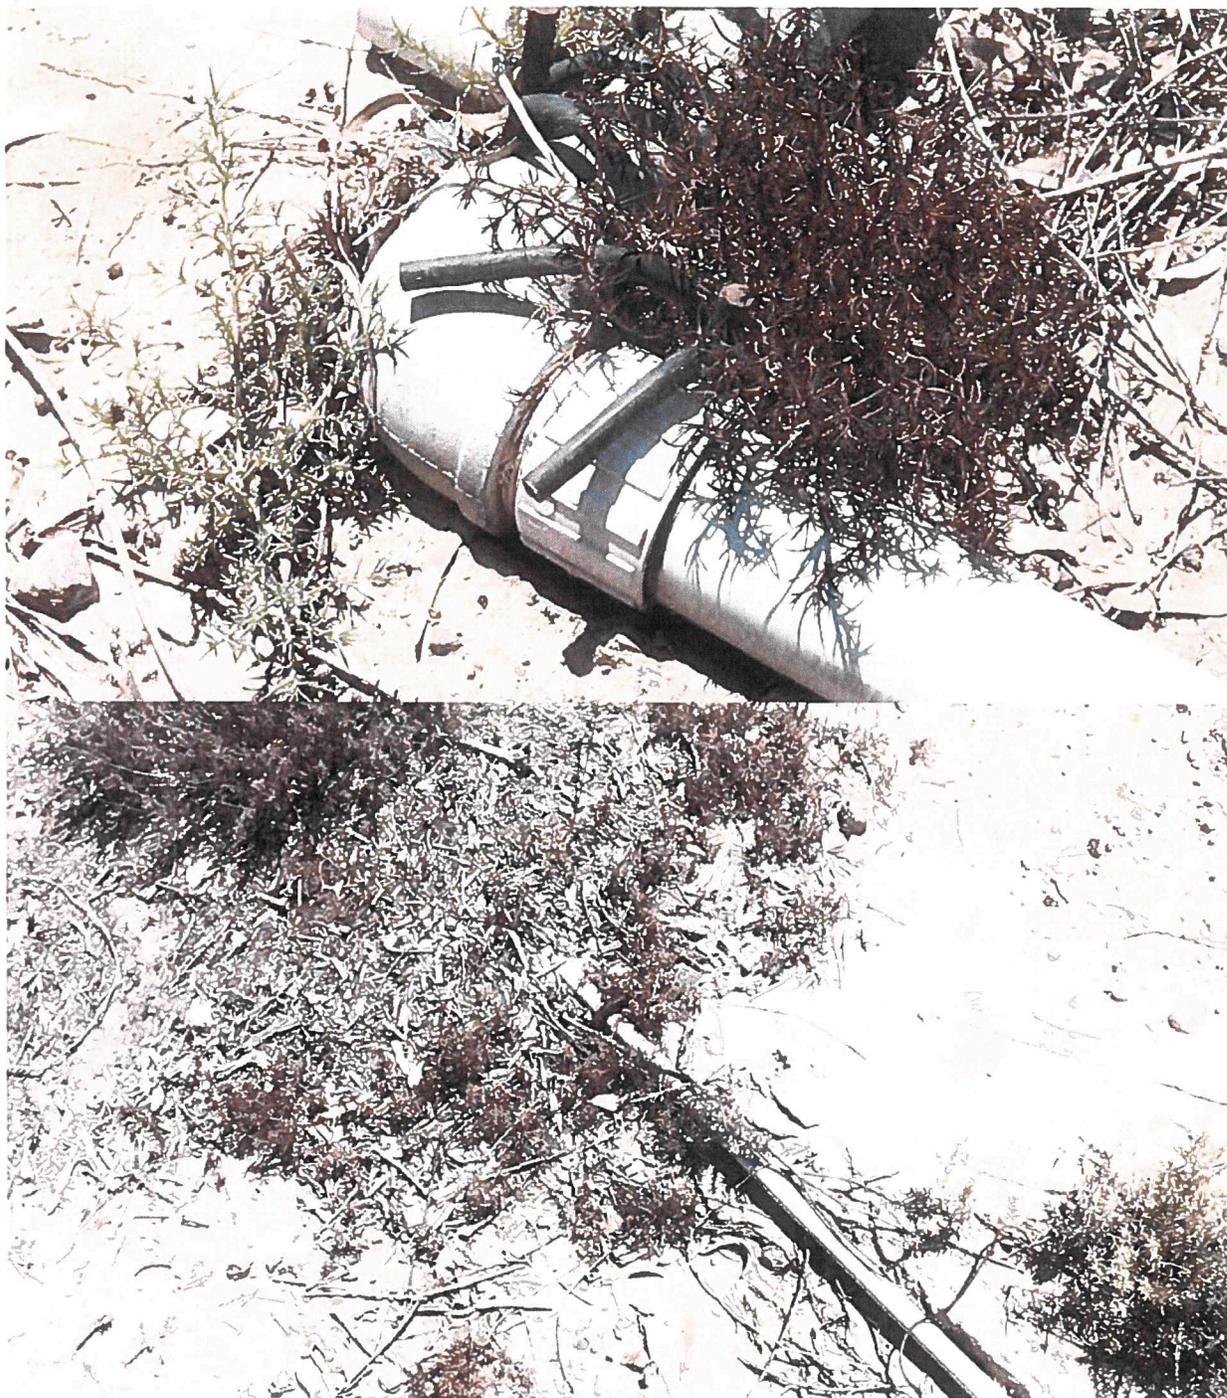
- There are still a lot of juvenile Russian Thistle (*Salsola* spp.) and spraying is evident, but new seedlings are spouting up quickly with heat and additional moisture. This is an on-going issue and will need to be managed to eliminate infestation.

Evidence of chemically sprayed Russian Thistle with new germinated seedlings adjacent to it. This will be an on-going maintenance issue to keep it from establishing and taking over areas where planting mosaic is more open.

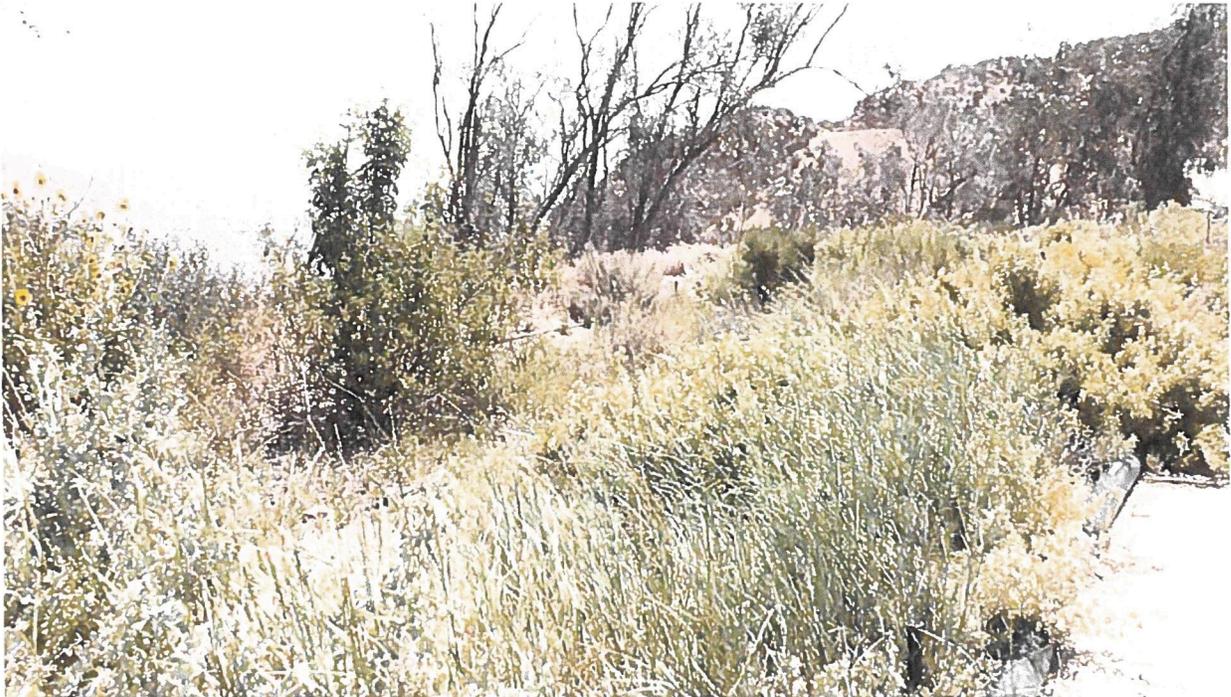
Healthy stand and mix of natives. Mexican Elderberry - *Sambucus Mexicana* are performing much better within the northern area of the Trial Site versus other areas where it was planted as a containerized plant.

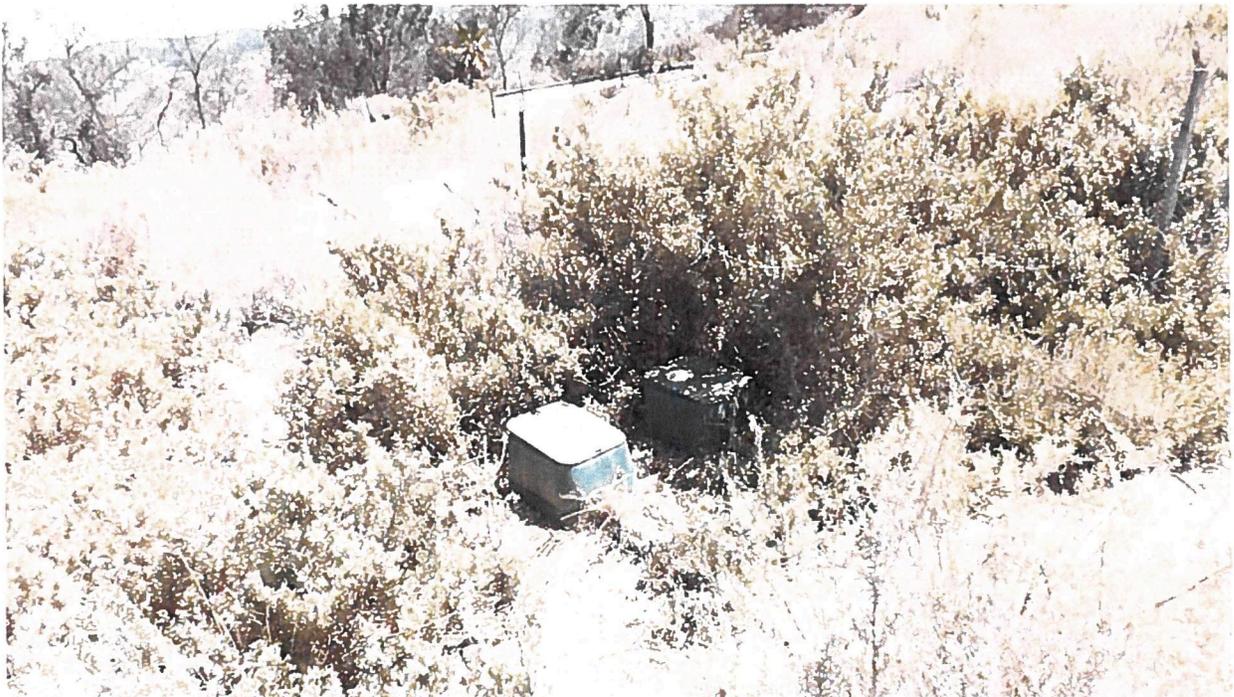
Removals of Salt Bush to unveil irrigation valves boxes and gate valves.
