**STAFF REPORT  
UPDATE ON RE-VEGETATION AT SUNSHINE CANYON CITY/COUNTY LANDFILL**

**Quarterly Vegetation Report**

**First Quarter 2013**

# SUNSHINE CANYON LANDFILL MITIGATION SITES

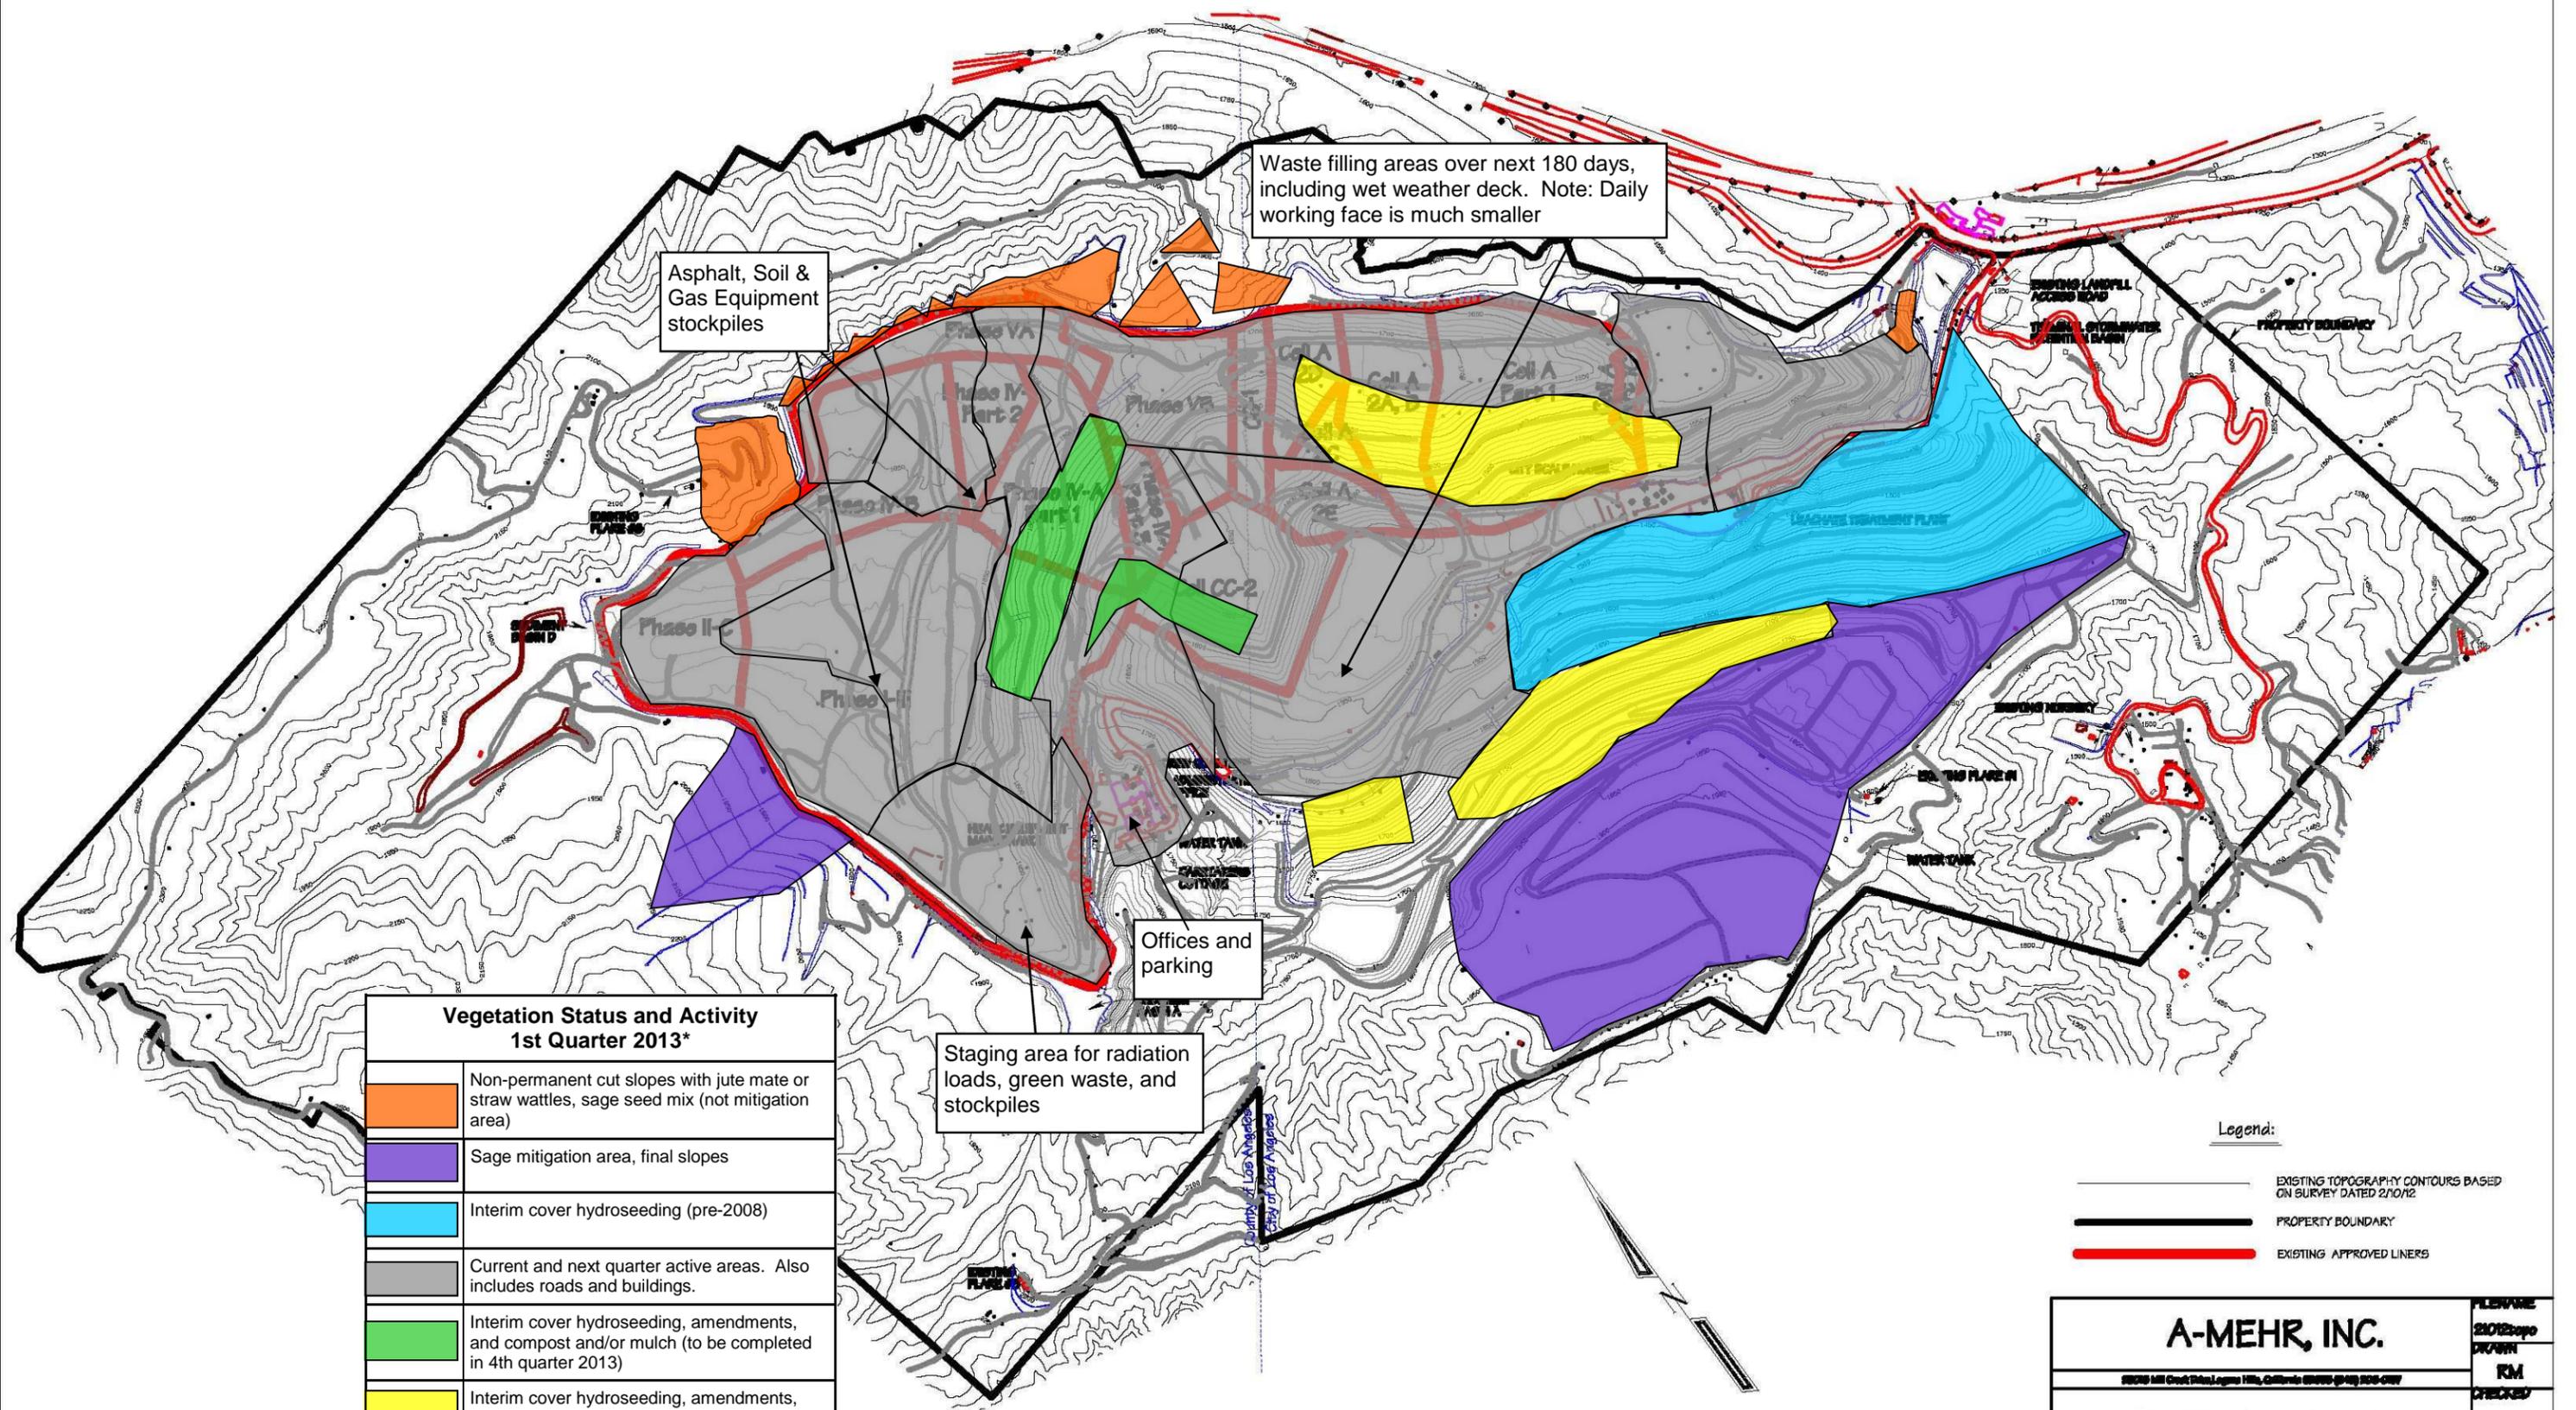
Vegetation Status and Activity 1st Quarter 2013*

In the first quarter of 2013, interim areas on the City and County of the landfill were not seeded, amended or mulched. See Figure 1 in Appendix A.

Figure 1 (Appendix A) shows areas of the landfill that have been vegetated with the exception of the active areas, roadways, and areas where buildings are located. Vegetative treatments meet the vegetation plans that were in place at the time plantings were conducted. Current and planned activities are described in previous sections of this report.

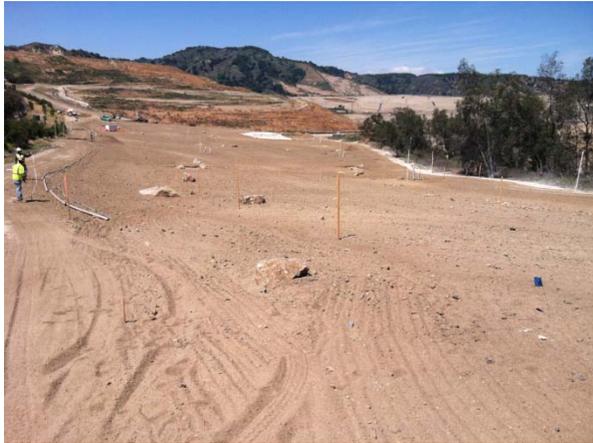
**Photo 1. Facing west at lower deck. This area was recently disked for planting sage scrub vegetation. Crews were installing temporary irrigation during the inspection.**

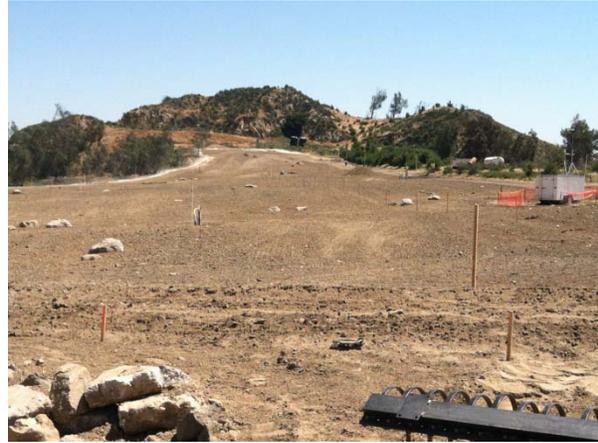
**Photo 2. Facing east at lower deck where sage scrub is soon to be planted.**

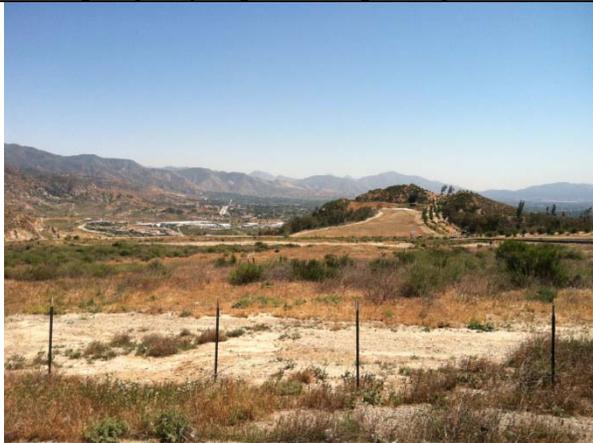
**Photo 3. Facing east at middle deck with lower deck visible in background. View of non-native and native plant composition. Natives visible in this photo primarily include buckwheat and non-natives include desiccant and new sprouts of shortpod mustard and other annual, non-natives of including brome grasses.**

• **Plant Natives in Areas Dominated with Non-natives.** The vegetated areas on the lower and middle deck that are currently dominated with annual, non-native species have decent soil conditions. These areas are not near as compacted as adjacent areas that are gravelly and mostly void of vegetation. In general, the soil texture within the vegetated areas with non-native vegetation is friable down to approximately 8-12 inches in depth. Various planting methods (i.e., planting container plants and hydroseeding) may be used to re-establish native plants on the middle and upper decks where non-natives currently dominate. A temporary irrigation source would aid in establishing container plants and a consistent weed abatement program is important to control non-native species so that native can thrive and regenerate.

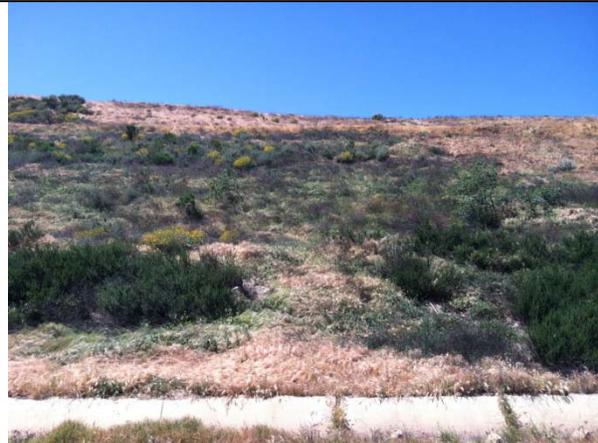
**Photo 4. Facing northwest at slope between upper and middle decks. Buckwheat is evident in the foreground and new sprouts of annual, non-native are evident throughout these slopes. Brome grasses and mustard have created a mat that is making it problematic for regeneration of native species to occur.**

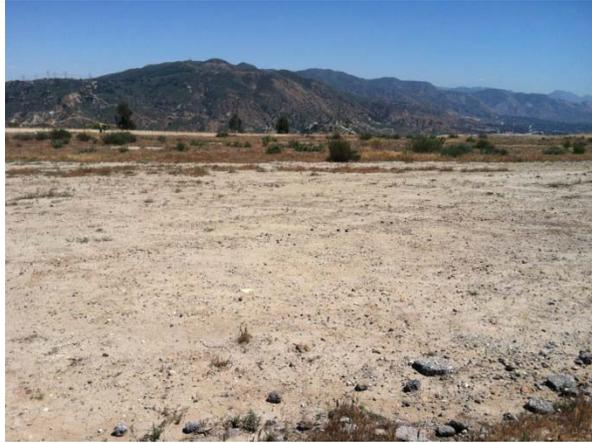
**Photo 5.** Facing northeast at upper deck. The area shown in this photo consists of compacted and gravelly soils. New sprouts of annual, non-native grasses dominate the vegetative cover in the background.

- **Improve root zone and soil conditions.** Continue to investigate ways to import the soil layer to improve the root penetration and saturation zone to enable plant growth in heavily compacted areas. Consider applying soil in random undulations or uneven mounds to improve soil porosity and filtration and to control soluble salts from leaching from existing layer.

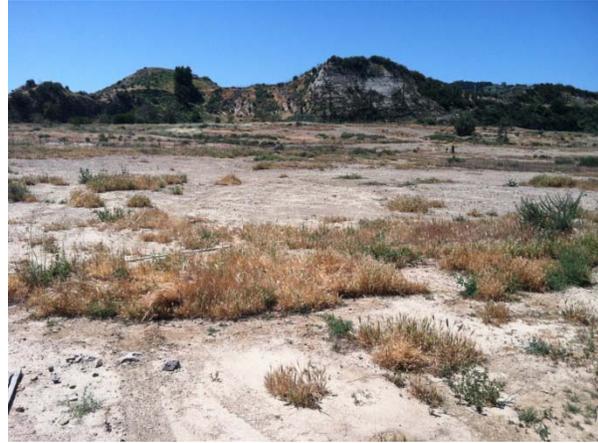
**Photo 6.** Facing southwest at upper deck. The area shown in this photo is dominated by brome grasses and bare ground.

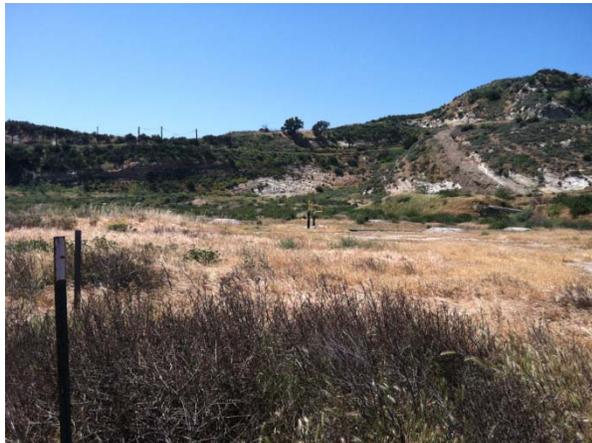
**Photo 7.** Facing southwest at upper deck. This area has the greatest amount of vegetation, including establishment of native species, mostly buckwheat. Desiccant mustard plants and brome grasses are visible in the foreground.

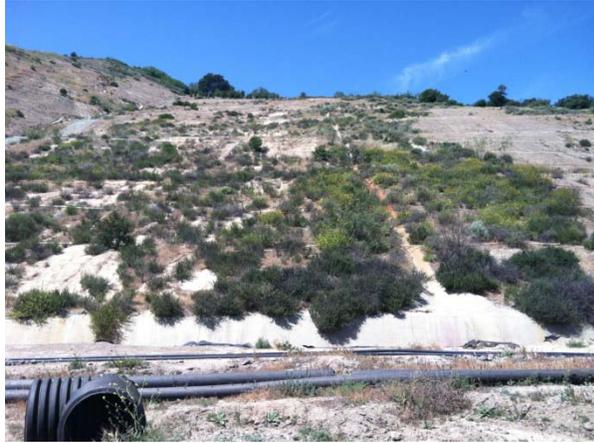
Photo 1. Facing west at established coastal sage scrub on "County sage hill". Vegetation dominated with buckwheat and California sunflower (*Encelia californica*). *E. californica* can be seen in flower in this photo. Annual, non-native grasses and forbs dominate the ground cover.

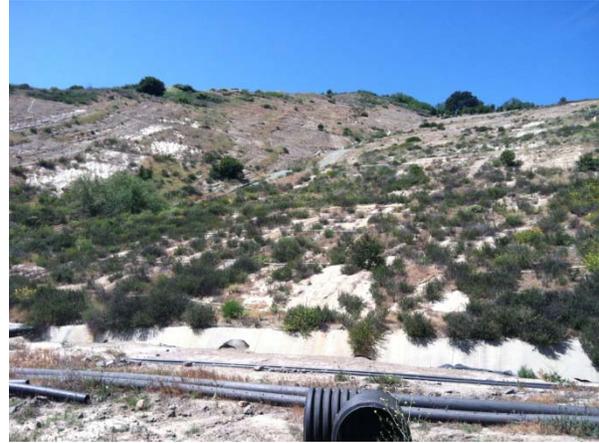
Photo 2. Facing southwest at coastal sage scrub dominated with California buckwheat. Southern-most area of steep slopes continues to remain mostly bare.

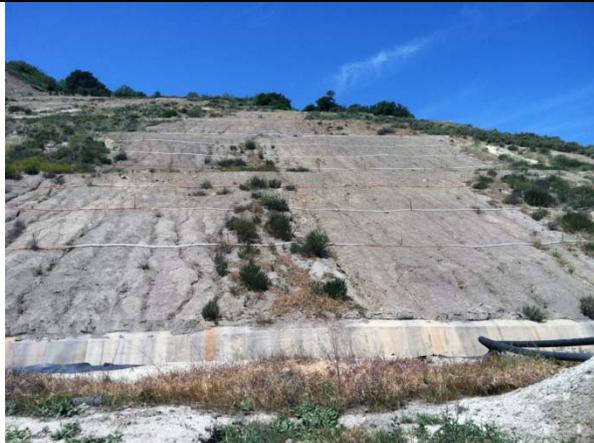
Photo 3. Facing west at bare slope on "County sage hill". Plant growth remains to be problematic due to erosion and a hard soil layer.

- Consider creation of benches throughout the mitigation area to control soil erosion and to improve soil conditions to improve plant establishment and seed dispersal. This technique has been widely used on steep slopes and in areas where soil erosion is problematic. This technique also allows for opportunities to introduce a high quality soil layer above the poor soils that exist.
