**NOTICE OF INTENT TO ADOPT A MITIGATED
NEGATIVE DECLARATION**

BOUQUET CANYON CREEK RESTORATION PROJECT

Bouquet Canyon Creek Restoration Project

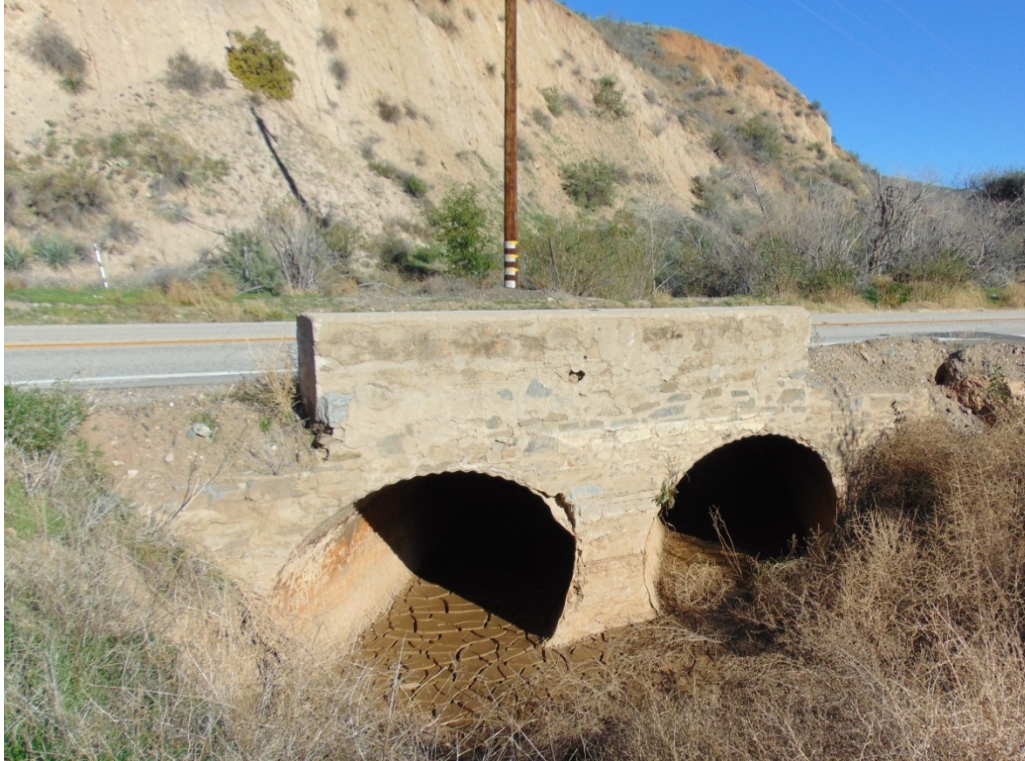
One archaeological resource was observed in this area. Recorded as MAB20160208-1, this resource consists of a multiple pipe culvert built by the Los Angeles County Flood Control District in 1964 (Plate 2). This culvert has two 5-foot-diameter, corrugated metal pipes that extend northwest to southeast under Bouquet Canyon Road near MM 15.89, allowing Bouquet Creek to flow beneath the road. A multiple-course concrete and local stone wall stands on the east side of the road encasing the culvert pipes. A metal benchmark stamped with the year 1964 is embedded in the center top of the wall. The monument reads in full: “LOS ANGELES COUNTY FLOOD CONTROL DISTRICT 1964 / 500 DOLLARS FINE FOR DISTURBING THIS MARK / BM – 144 01 700.” The western side of the culvert also appears to have once had a wall, no longer extant, that may have been washed away due to flood damage (Plate 3).

Plate 2. MAB20160208-1, Culvert, East Side, View Northwest

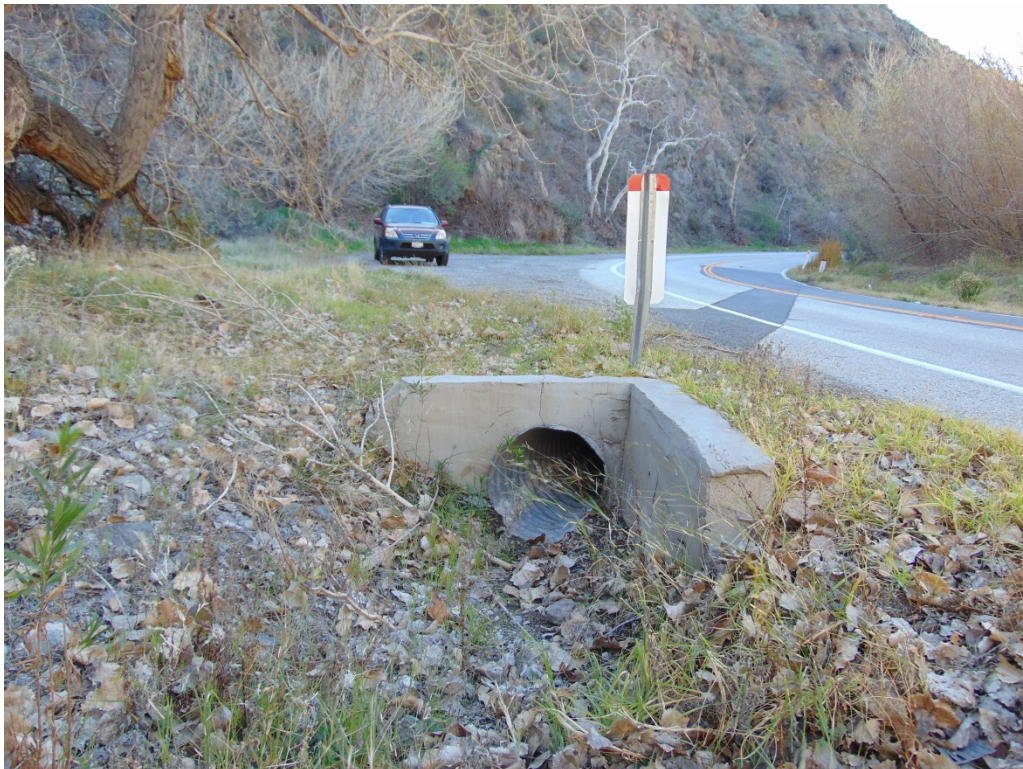
Site 3 is a short segment of the APE located in a moderately narrow portion of the canyon (Plate 4). The eastern extent of the APE has been modified, likely in association with road construction and maintenance activities. Again, ground visibility was low, approximately 5 percent, due to high amounts of vegetation, duff, and the water in Bouquet Creek. Vegetation observed was similar to other locations and included willow, mule fat, yucca, oak, sycamore, invasive grasses, buckwheat, sage, wild rye, and cottonwood trees.

Plate 4. Overview of Modern Culvert in Project Site 3, View Southeast

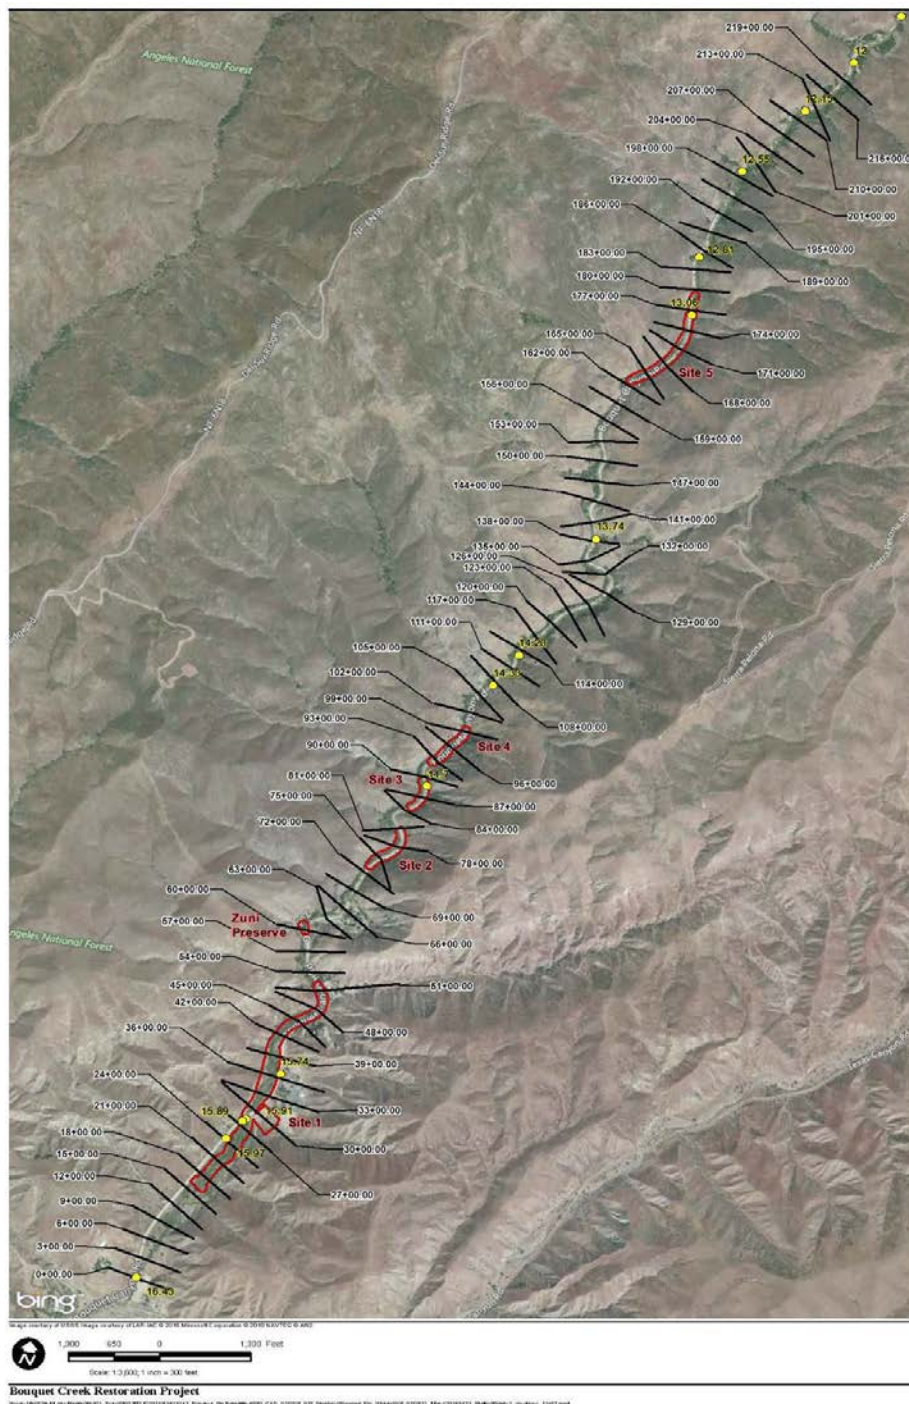
Figure 3. Study Reach Hydraulic Analysis Cross-Sections Location Map

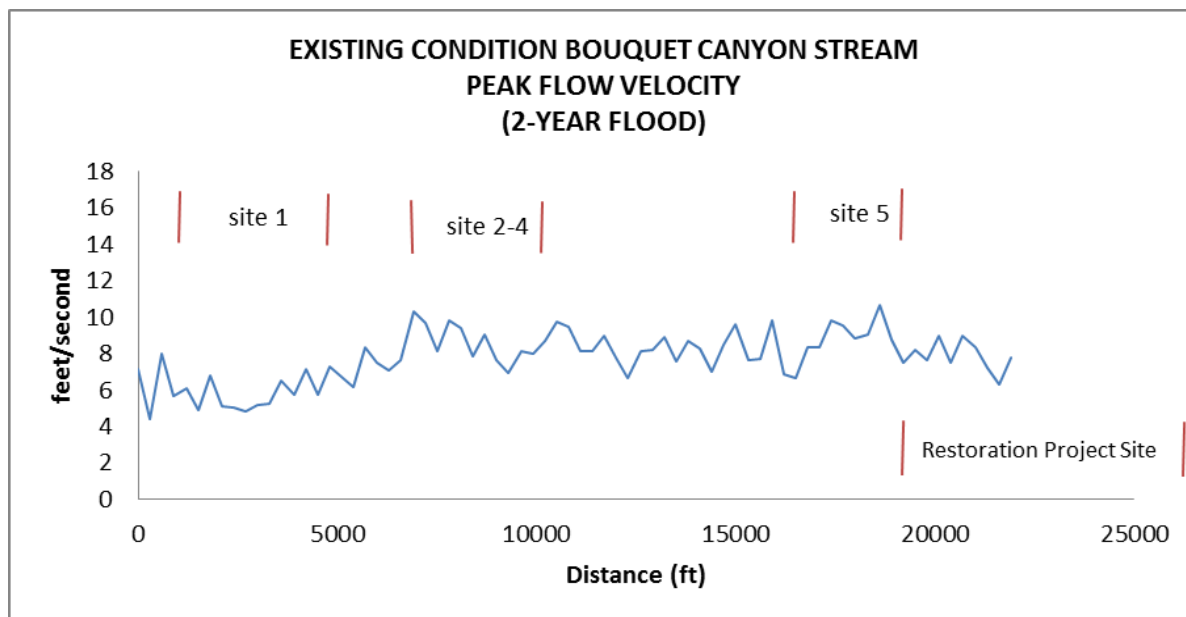
Figure 4. Bouquet Canyon Creek 2-year Flood Flow Velocity Profile under Existing Conditions

The U.S. Army Corps of Engineers' HEC-RAS backwater model was used to evaluate the hydraulic characteristics. Flow velocity and water surface elevations were computed for each of the 2-, 5-, 10-, 25-, and 50-year storm events. The flow velocity results were plotted and are shown in Figures 4 through 8.

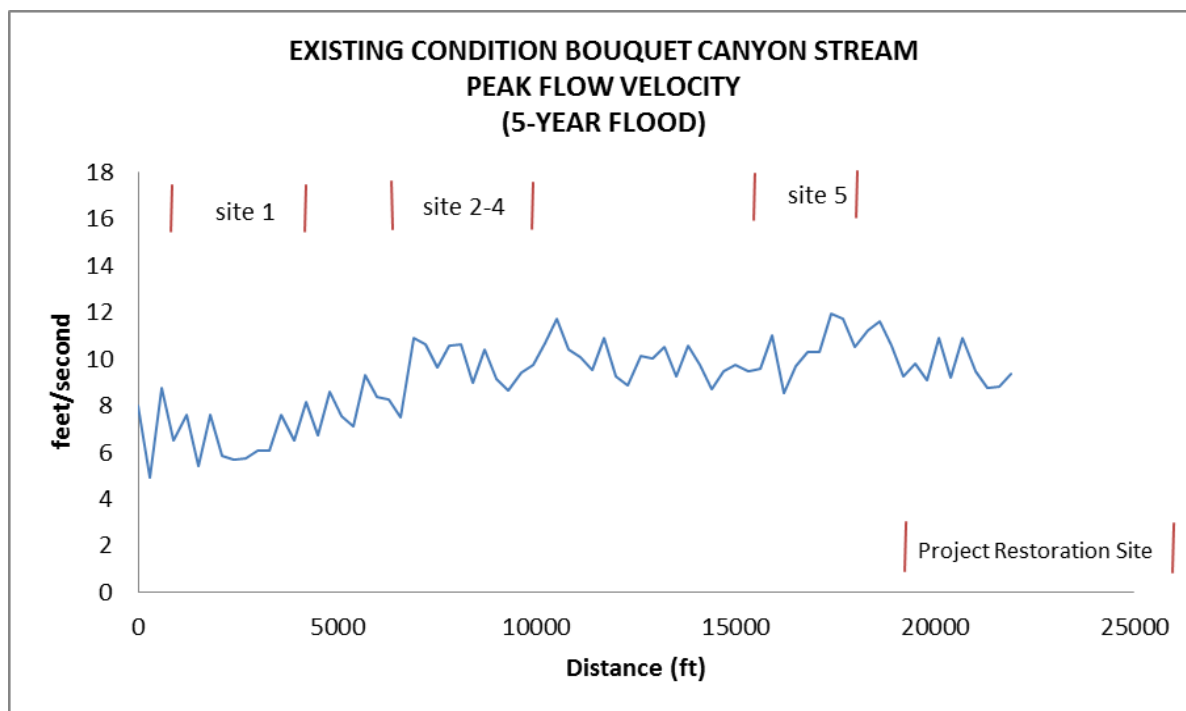
Figure 5. Bouquet Canyon Creek 5-year Flood Flow Velocity Profile under Existing Conditions

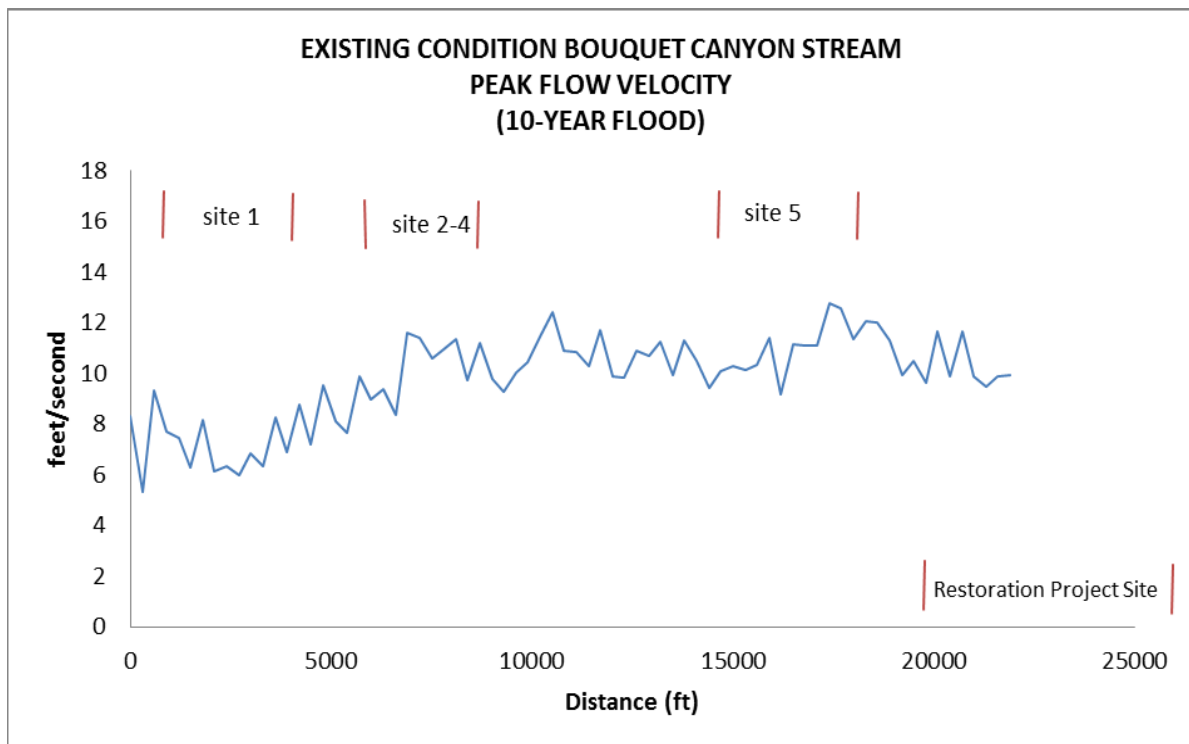
Figure 6. Bouquet Canyon Creek 10-year Flood Flow Velocity Profile under Existing Conditions

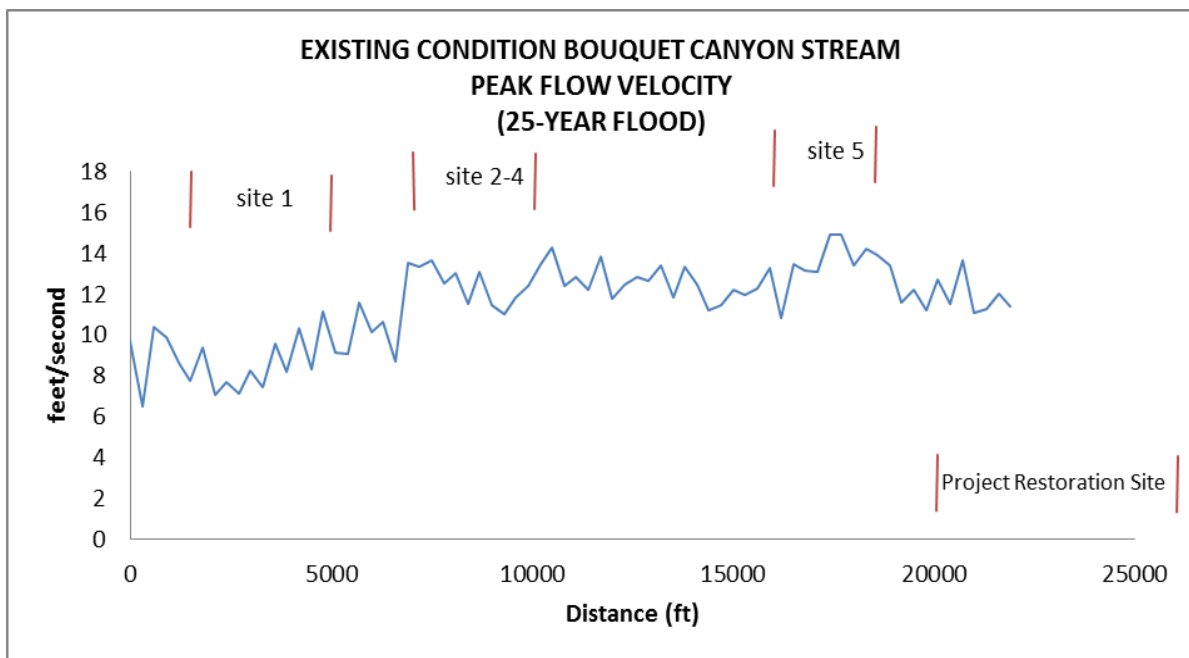
Figure 7. Bouquet Canyon Creek 25-year Flood Flow Velocity Profile under Existing Conditions

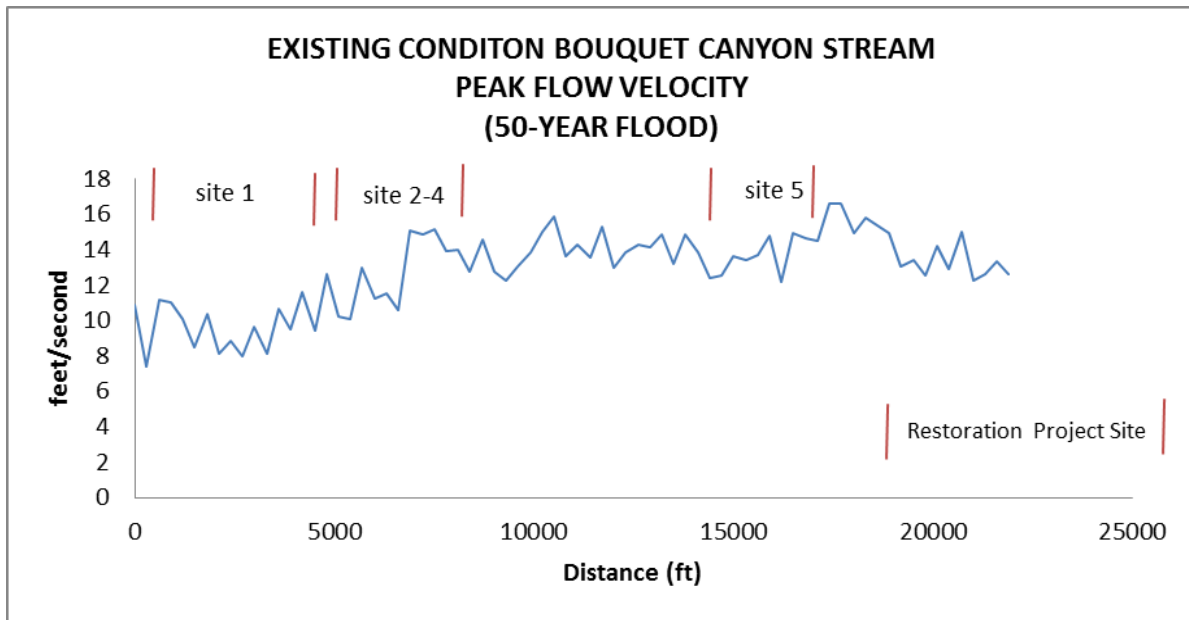
Figure 8. Bouquet Canyon Creek 50-year Flood Flow Velocity Profile under Existing Conditions

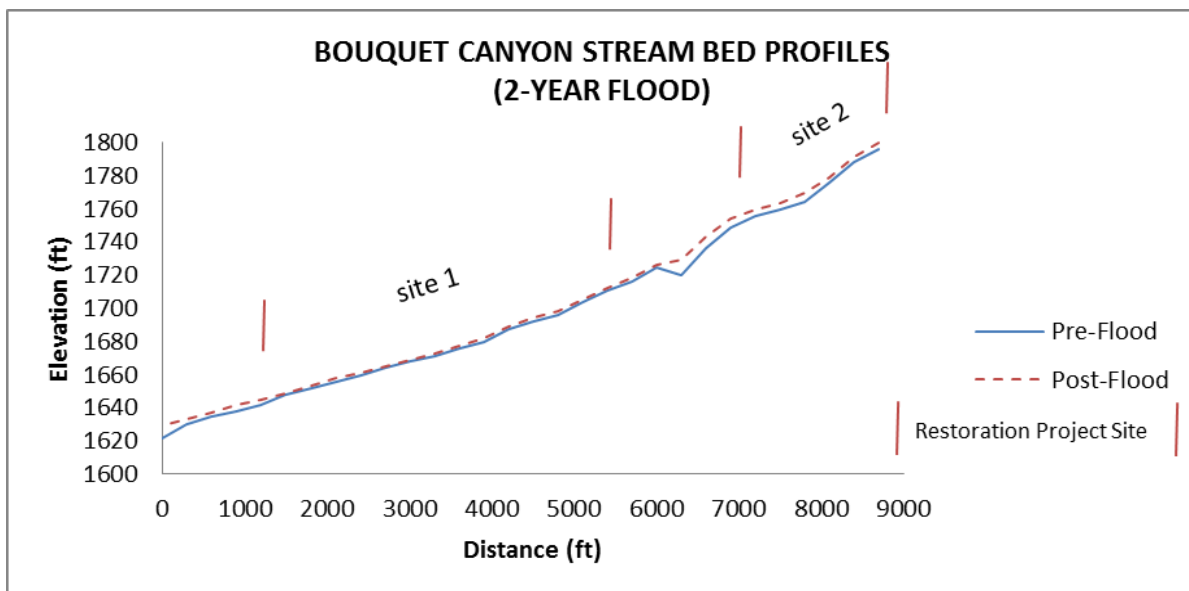
Figure 9. Bouquet Canyon Creek 2-year Flood Water Surface Profile under Existing Conditions (Sites 1 and 2)

Profiles of water surface elevations computed along Bouquet Canyon Creek were also plotted under each flood event and are shown in Figures 9 through 23.

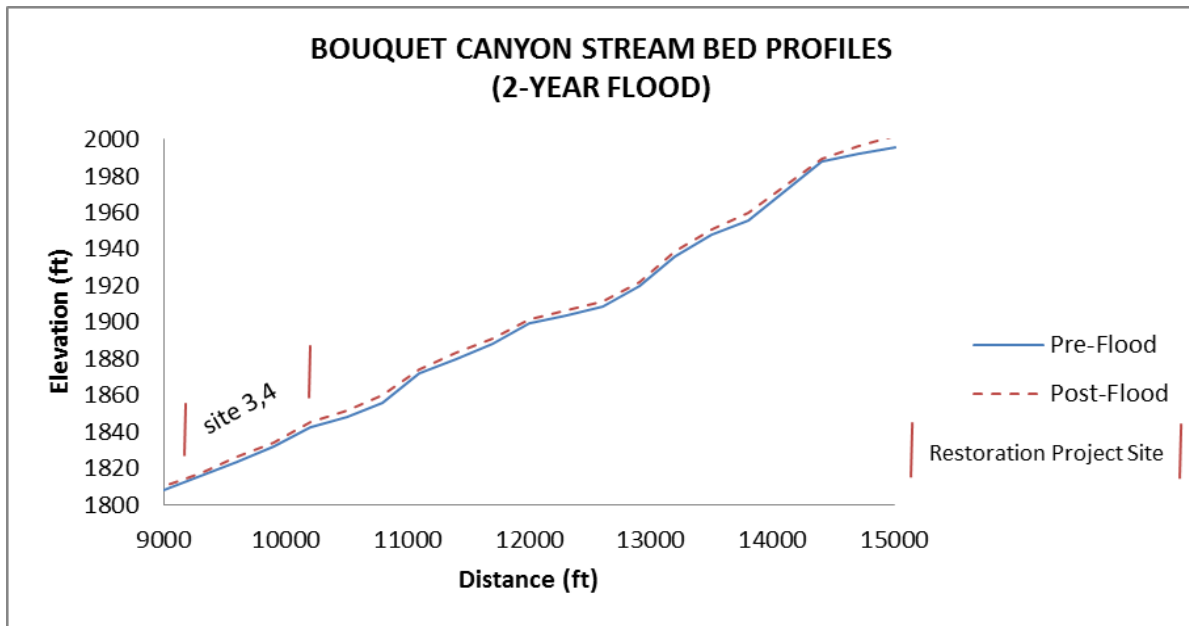
Figure 10. Bouquet Canyon Creek 2-year Flood Water Surface Profile under Existing Conditions (Sites 3 and 4)

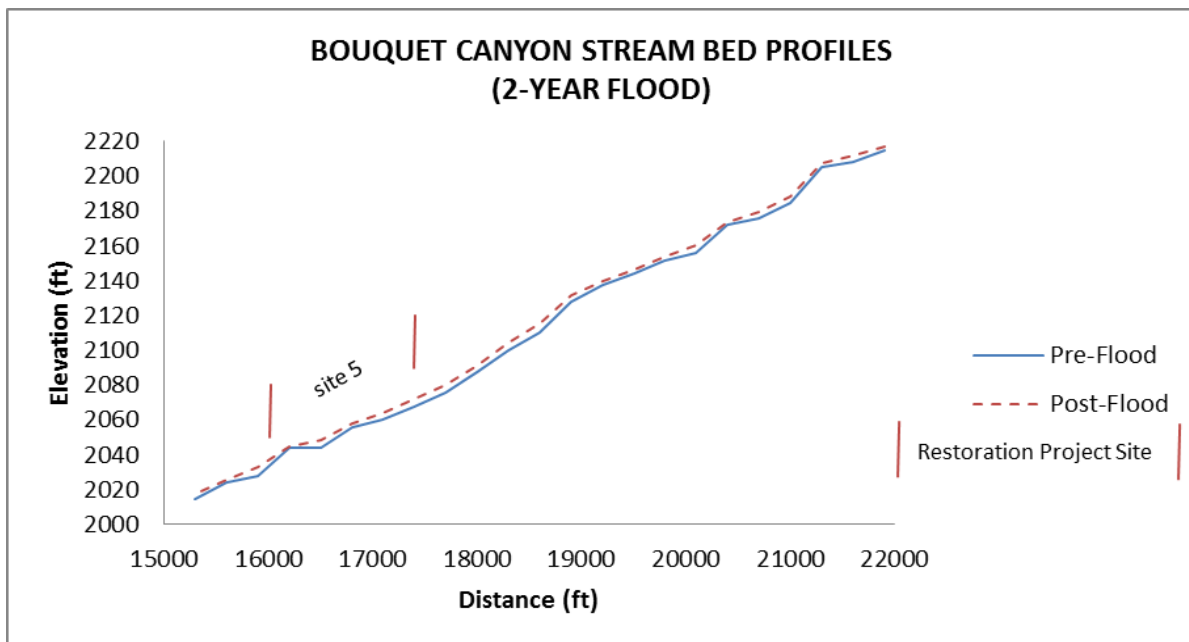
Figure 11. Bouquet Canyon Creek 2-year Flood Water Surface Profile under Existing Conditions (Site 5)

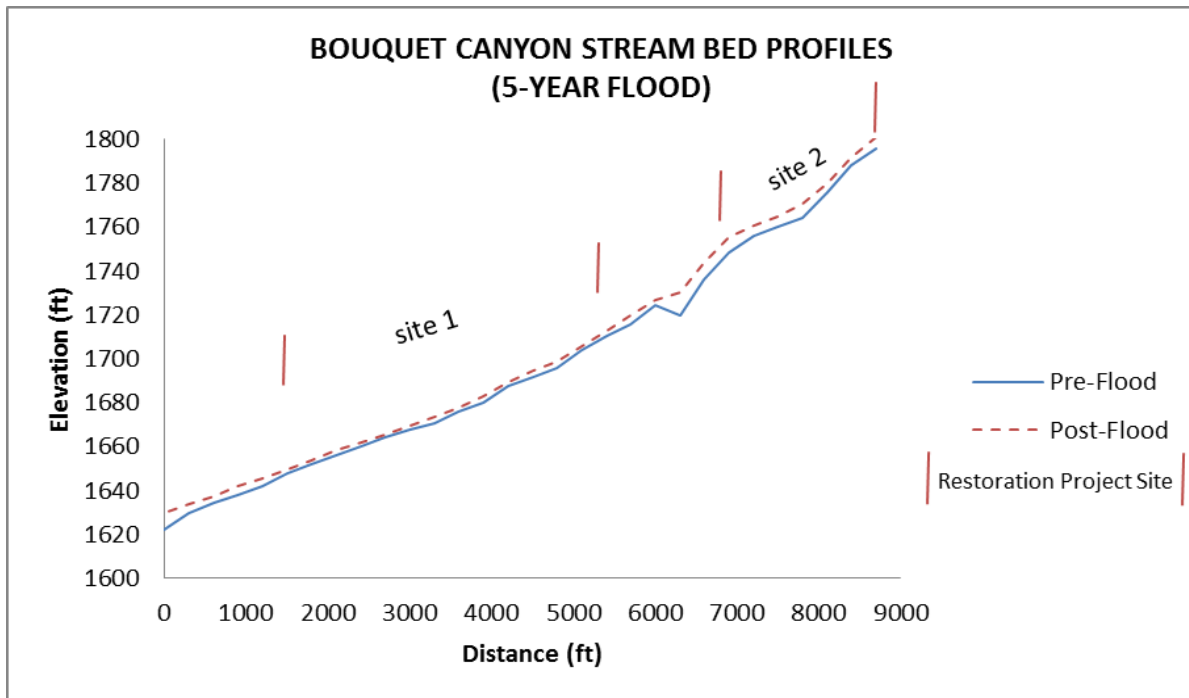
Figure 12. Bouquet Canyon Creek 5-year Flood Water Surface Profile under Existing Conditions (Sites 1 and 2)

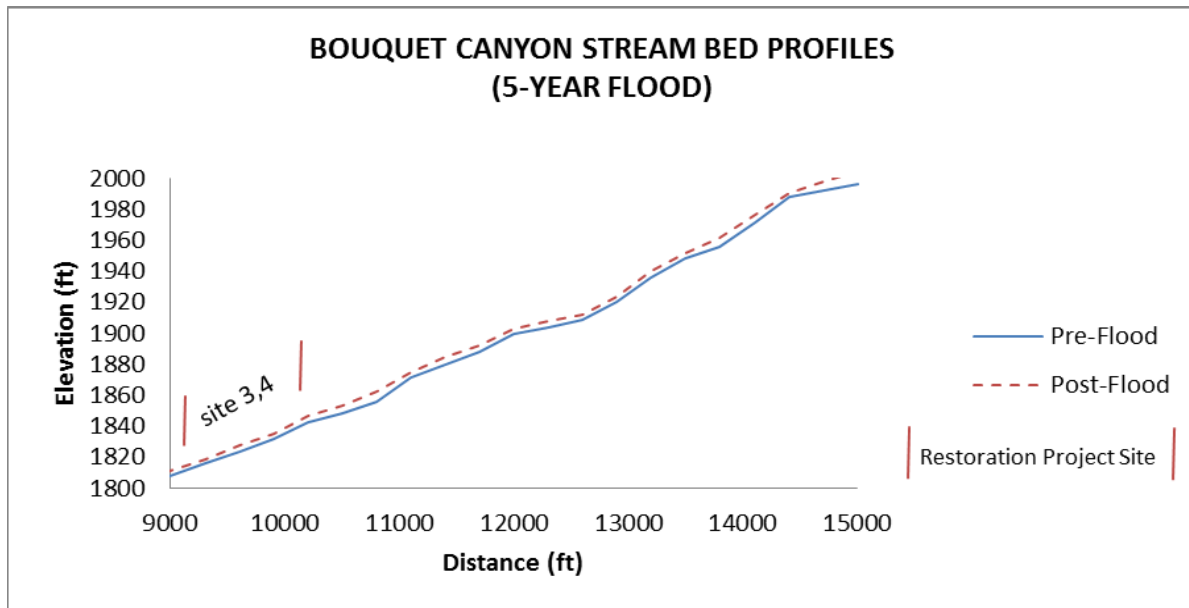
Figure 13. Bouquet Canyon Creek 5-year Flood Water Surface Profile under Existing Conditions (Sites 3 and 4)

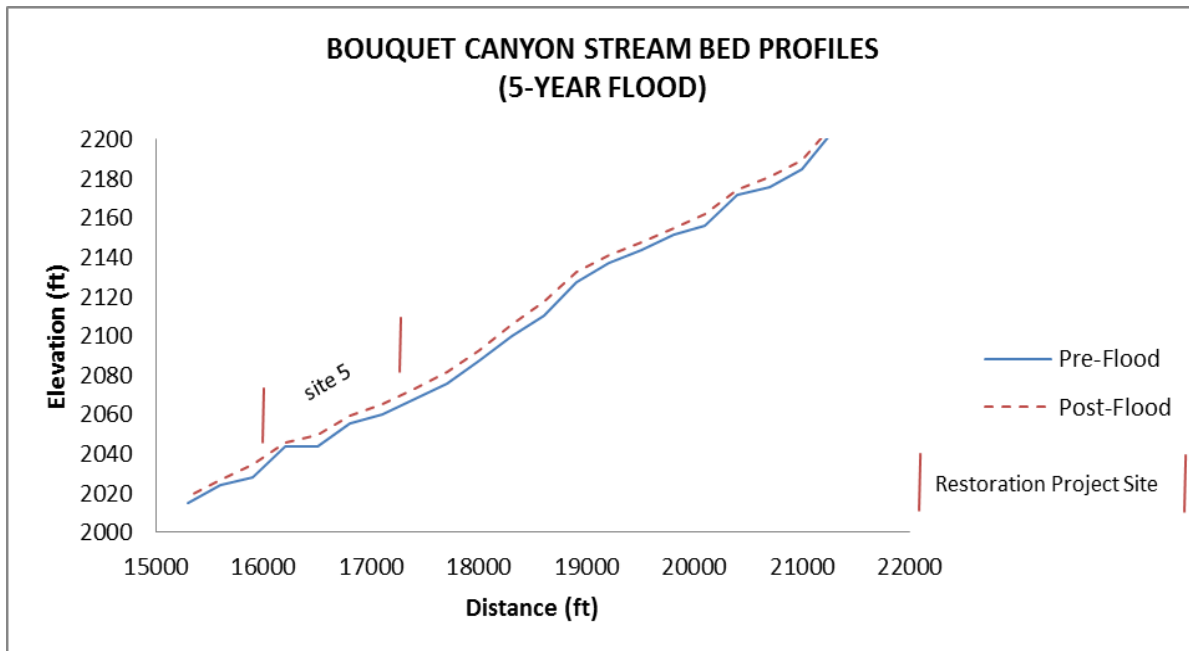
Figure 14. Bouquet Canyon Creek 5-year Flood Water Surface Profile under Existing Conditions (Site 5)

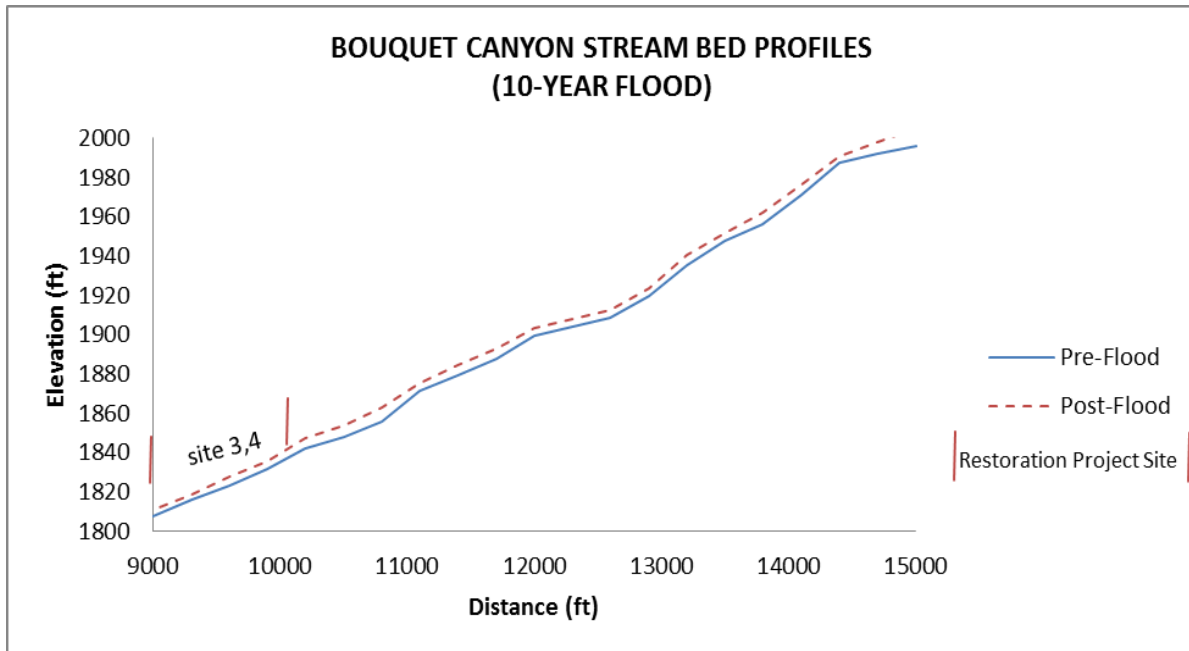
Figure 16. Bouquet Canyon Creek 10-year Flood Water Surface Profile under Existing Conditions (Sites 3 and 4)

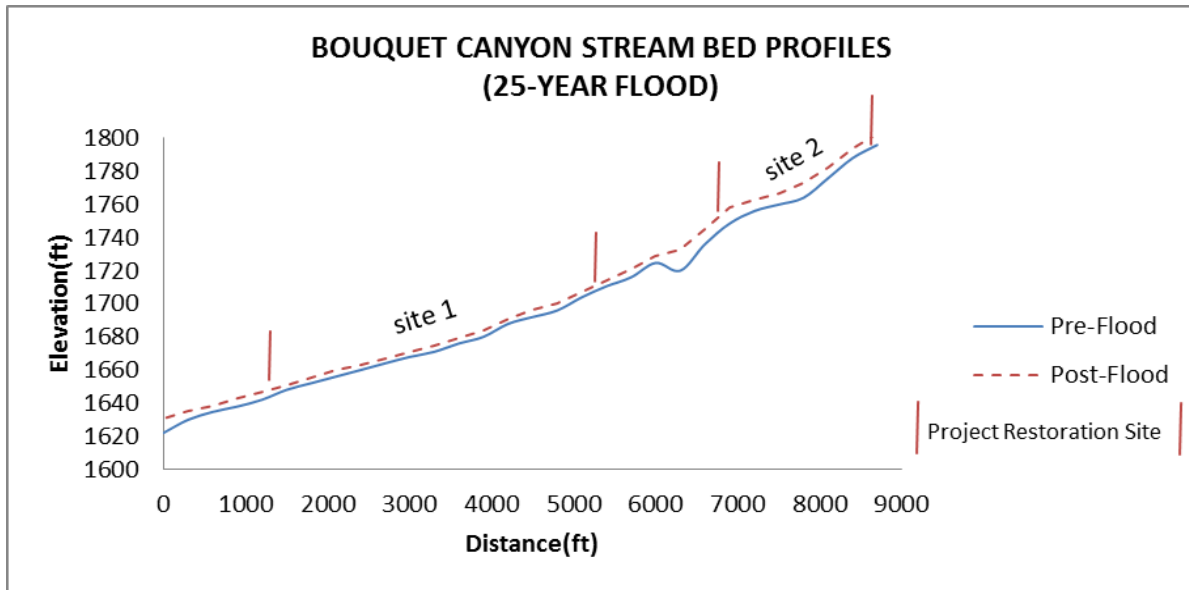
Figure 18. Bouquet Canyon Creek 25-year Flood Water Surface Profile under Existing Conditions (Sites 1 and 2)

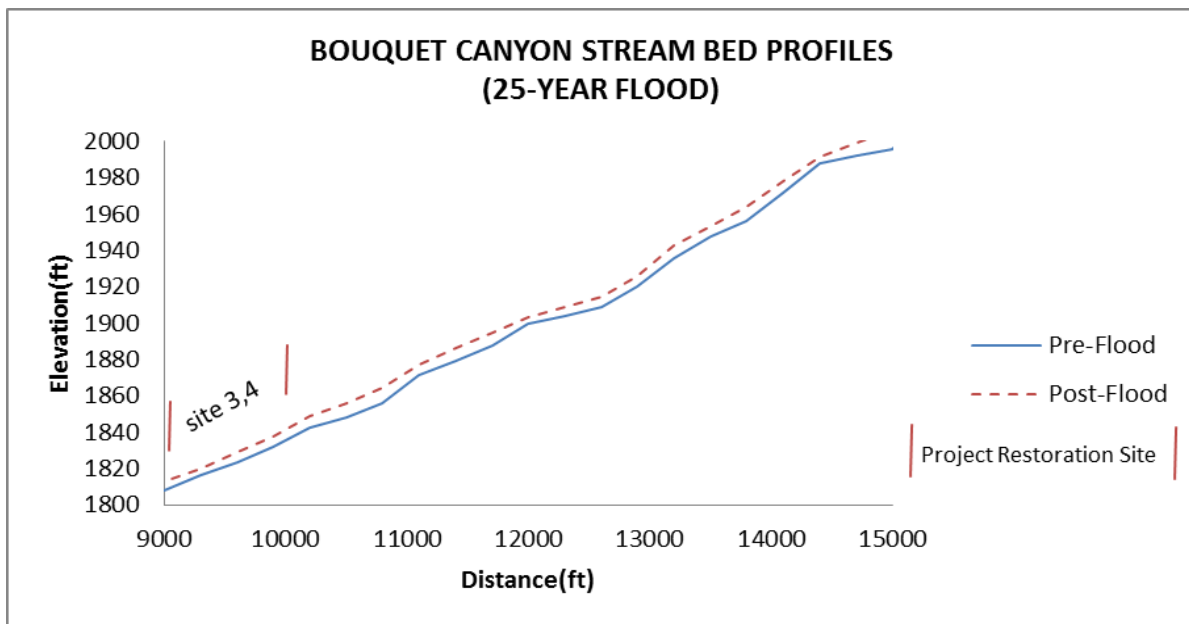
Figure 19. Bouquet Canyon Creek 25-year Flood Water Surface Profile under Existing Conditions (Sites 3 and 4)

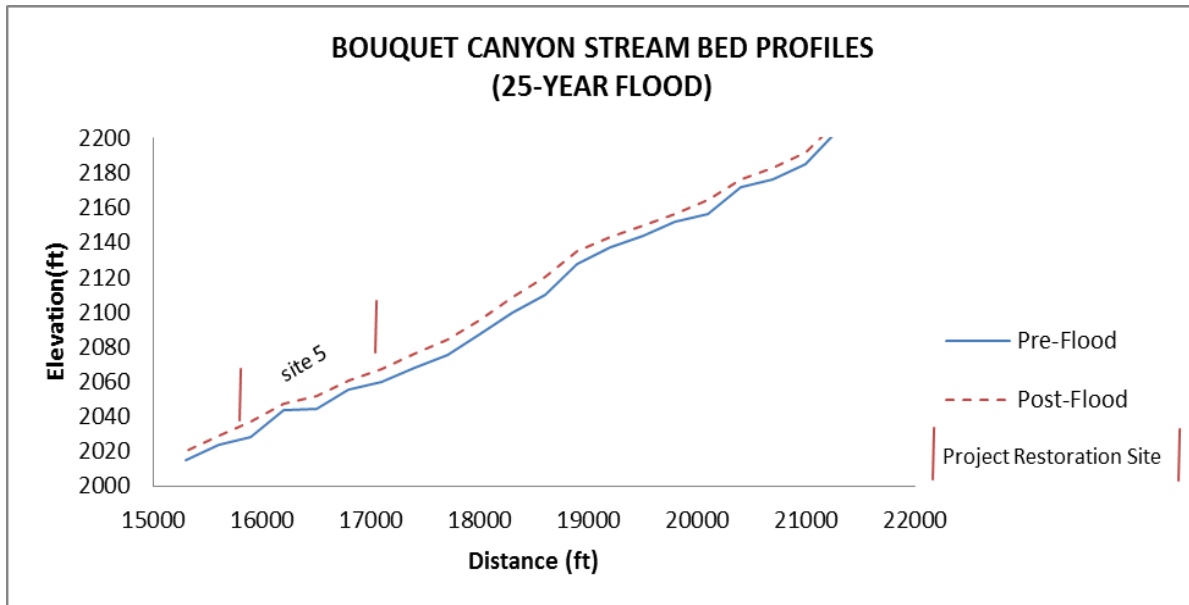
Figure 20. Bouquet Canyon Creek 25-year Flood Water Surface Profile under Existing Conditions (Site 5)

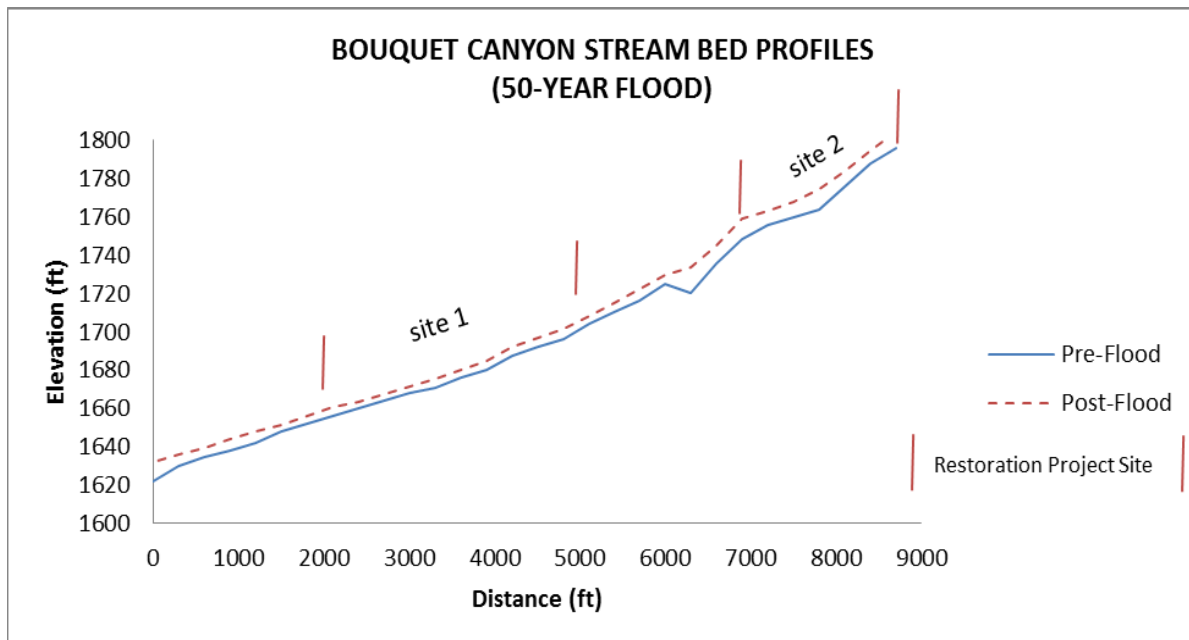
Figure 21. Bouquet Canyon Creek 50-year Flood Water Surface Profile under Existing Conditions (Sites 1 and 2)

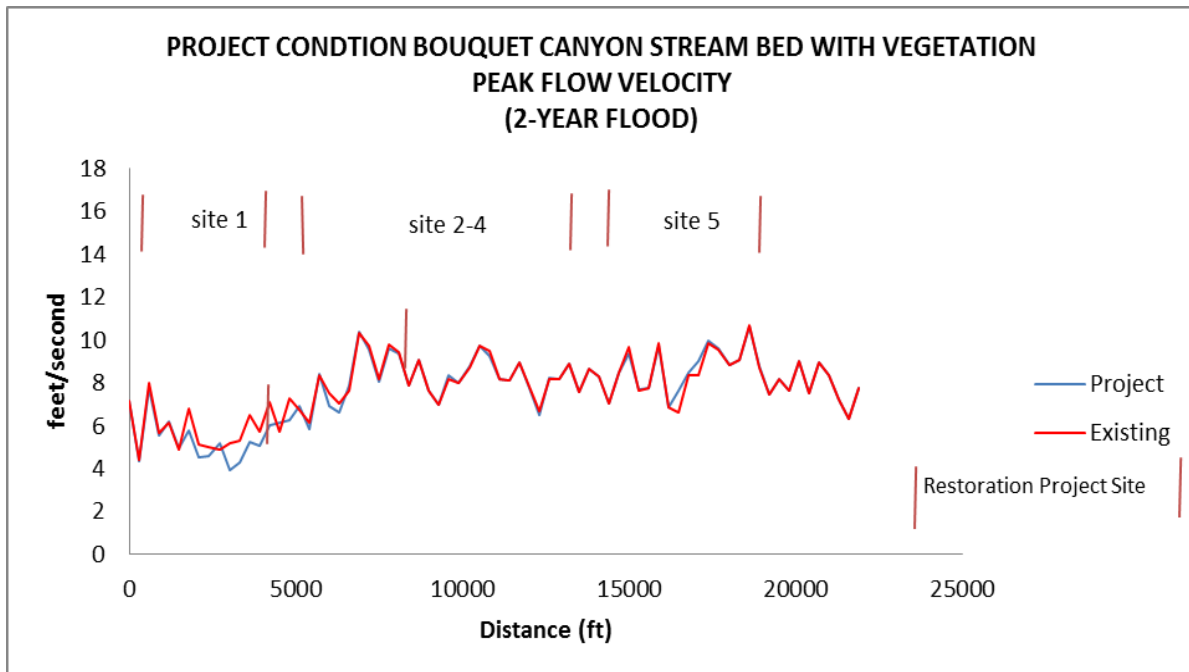
Figure 24. Bouquet Canyon Creek 2-year Flood Flow Velocity Profile under Project Conditions

With implementation of the project, the Bouquet Canyon Creek stream would be modified in the five project sites with stabilized slopes and greater conveyance capacities. For comparison, the computed project conditions flow velocity profiles were plotted together with those generated for the existing conditions and they are shown in Figures 24 through 28.

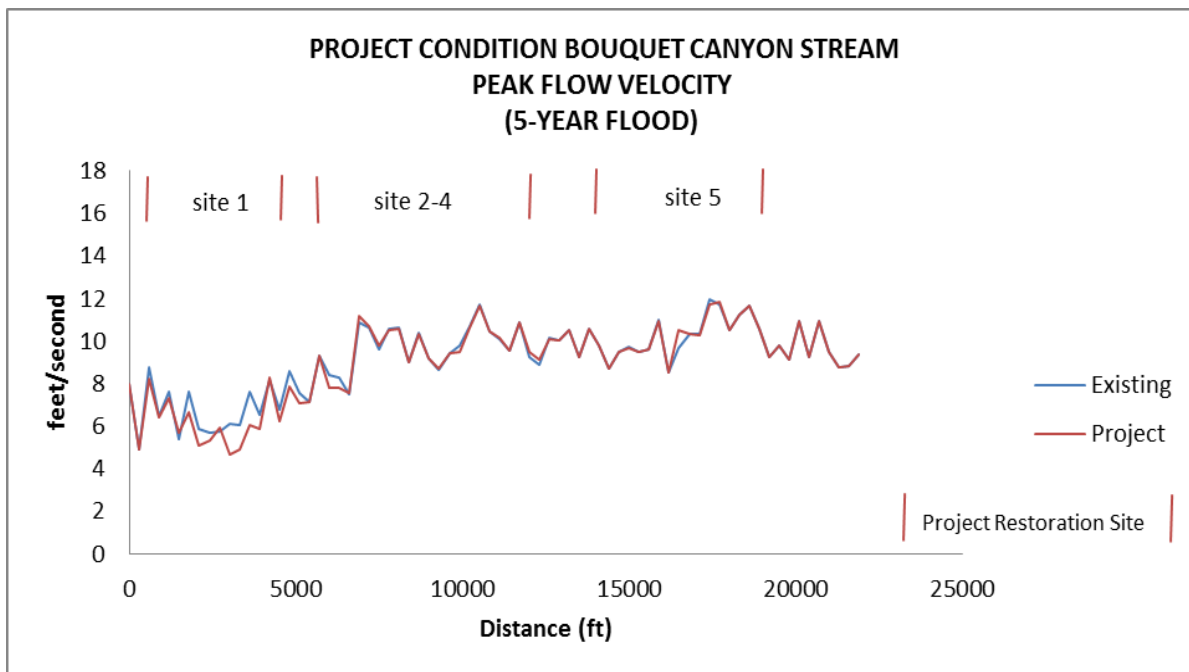
Figure 25. Bouquet Canyon Creek 5-year Flood Flow Velocity Profile under Project Conditions

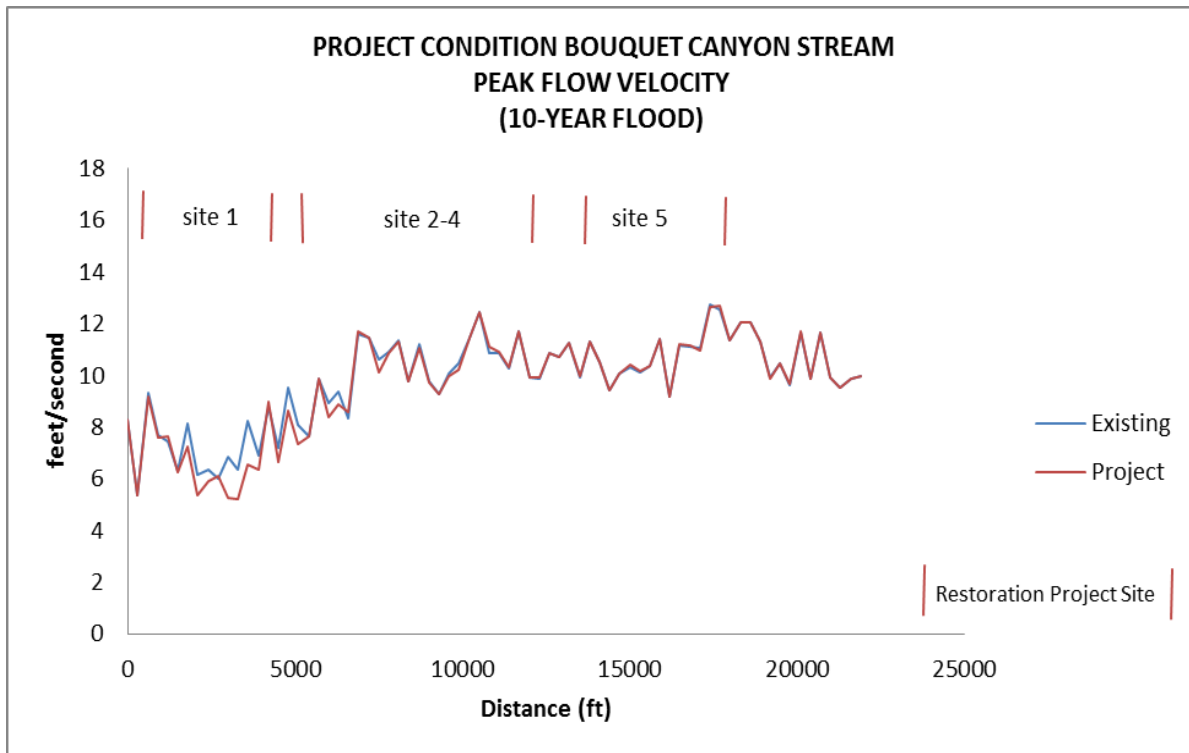
Figure 26. Bouquet Canyon Creek 10-year Flood Flow Velocity Profile under Project Conditions

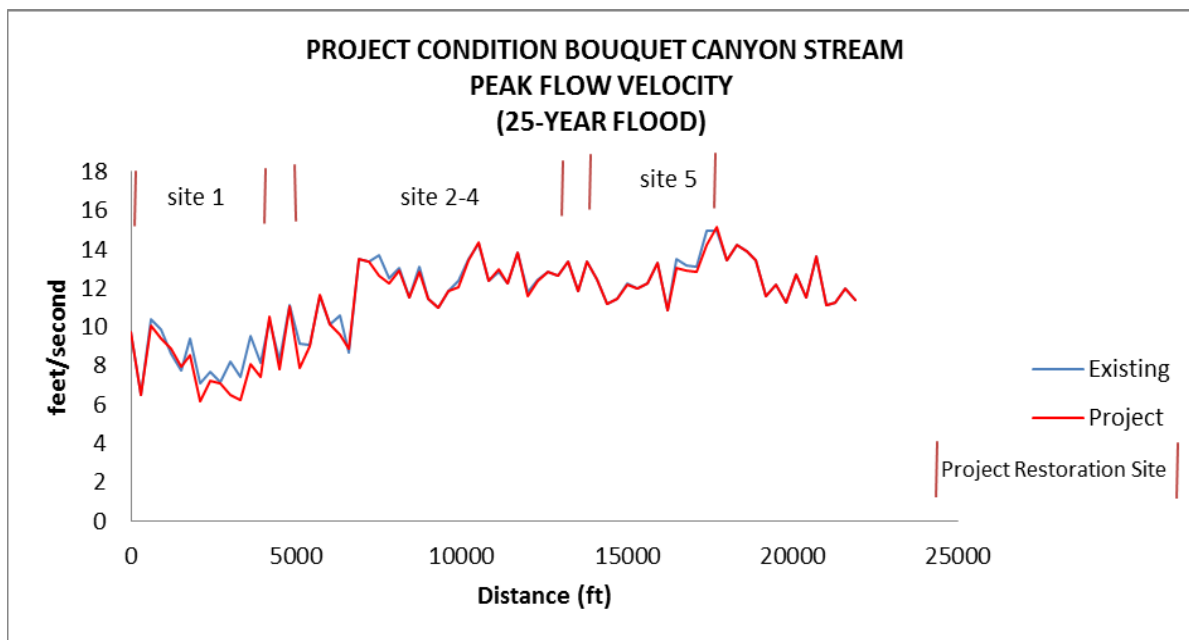
Figure 27. Bouquet Canyon Creek 25-year Flood Flow Velocity Profile under Project Conditions

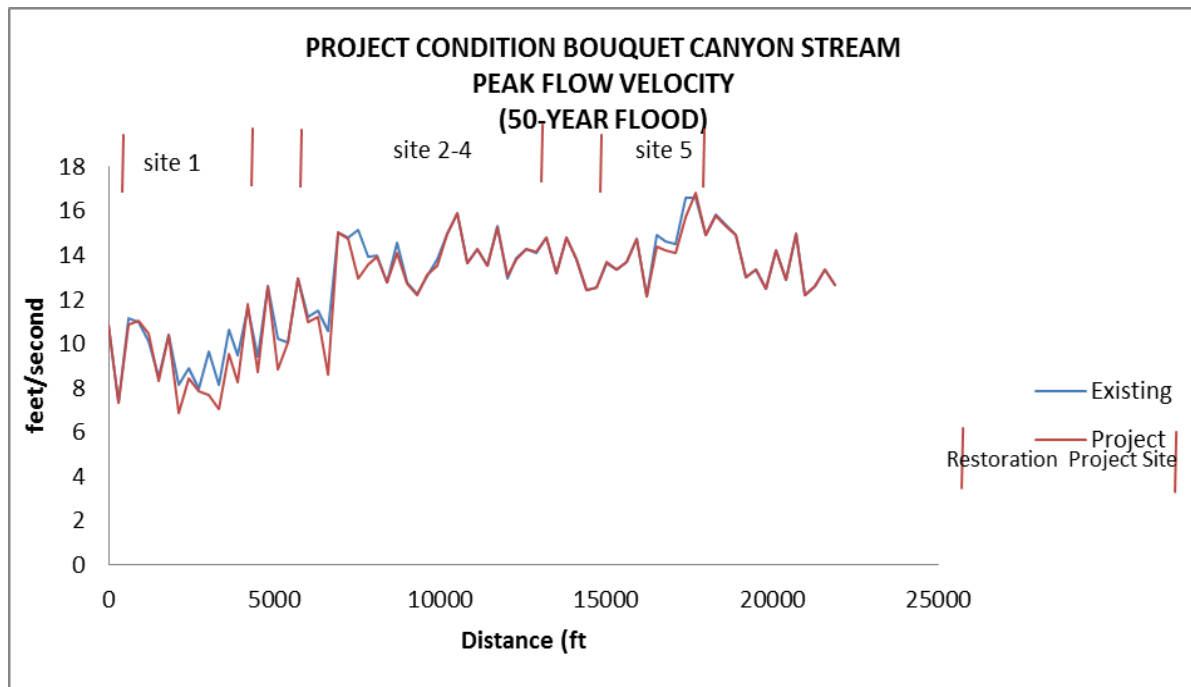
Figure 28. Bouquet Canyon Creek 50-year Flood Flow Velocity Profile under Project Conditions

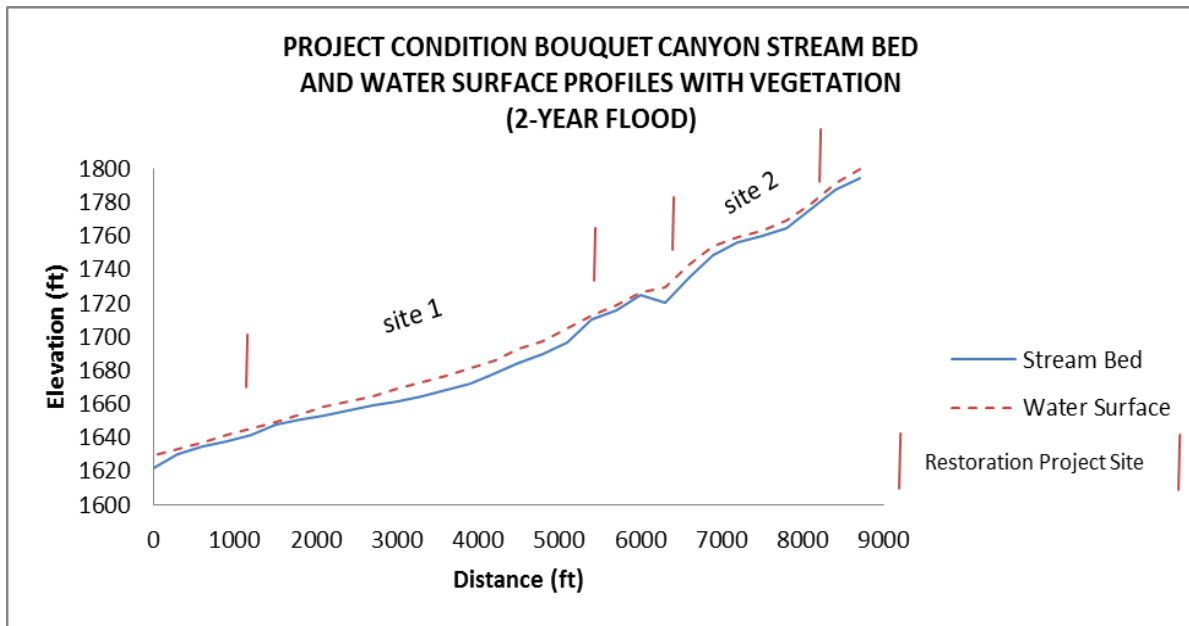
Figure 29 Bouquet Canyon Creek 2-year Flood Water Surface Profile under Project Conditions (Sites 1 and 2)

The project condition water surface profiles were plotted and are shown in Figures 29 through 43.

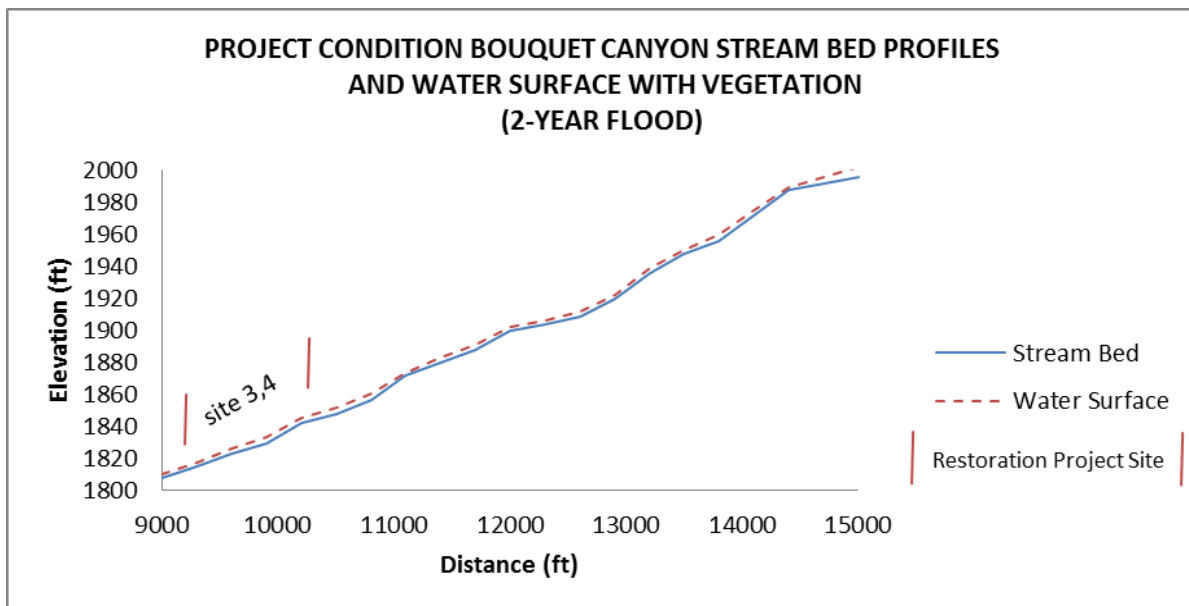
Figure 30. Bouquet Canyon Creek 2-year Flood Water Surface Profile under Project Conditions (Sites 3 and 4)

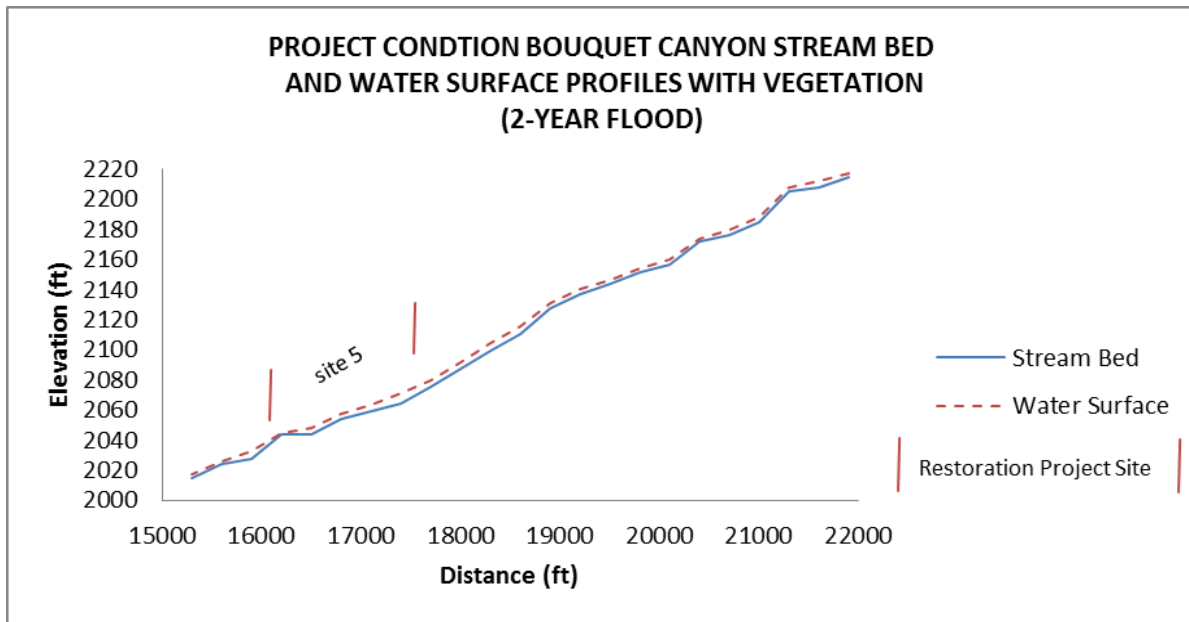
Figure 31. Bouquet Canyon Creek 2-year Flood Water Surface Profile under Project Conditions (Site 5)
