**NOTICE OF INTENT TO ADOPT A MITIGATED
NEGATIVE DECLARATION**

BOUQUET CANYON CREEK RESTORATION PROJECT

Bouquet Canyon Creek Restoration Project

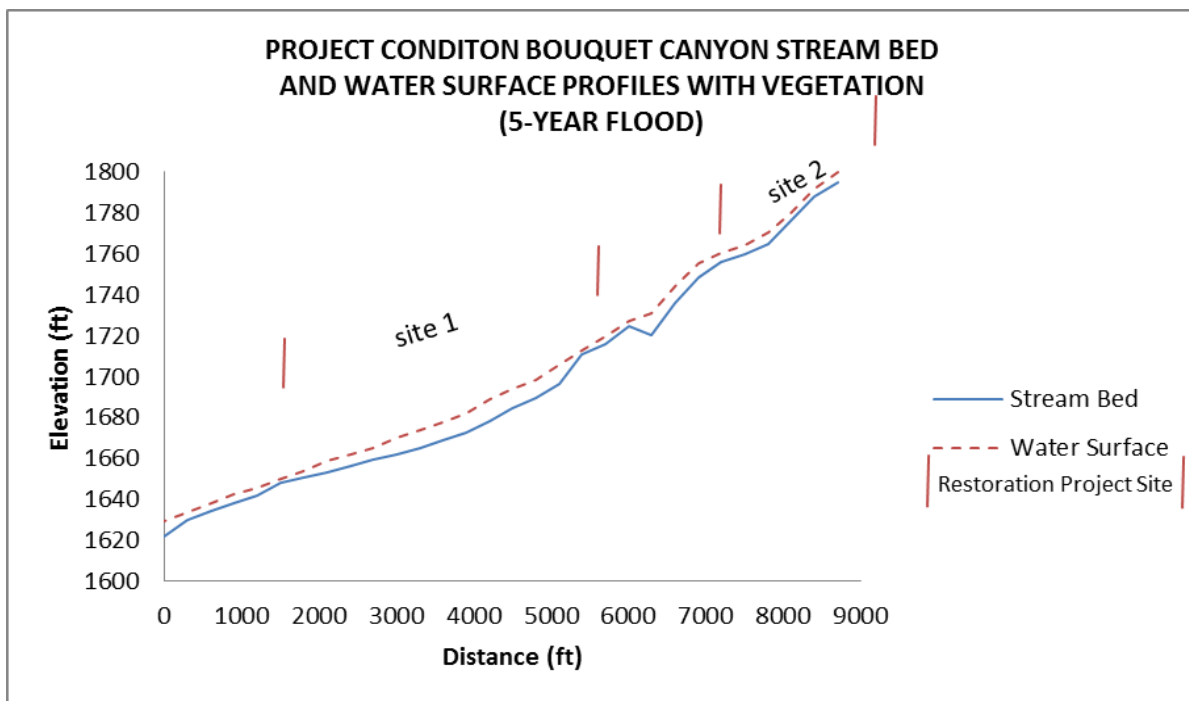
Figure 32. Bouquet Canyon Creek 5-year Flood Water Surface Profile under Project Conditions (Sites 1 and 2)

The project condition water surface profiles were plotted and are shown in Figures 29 through 43.

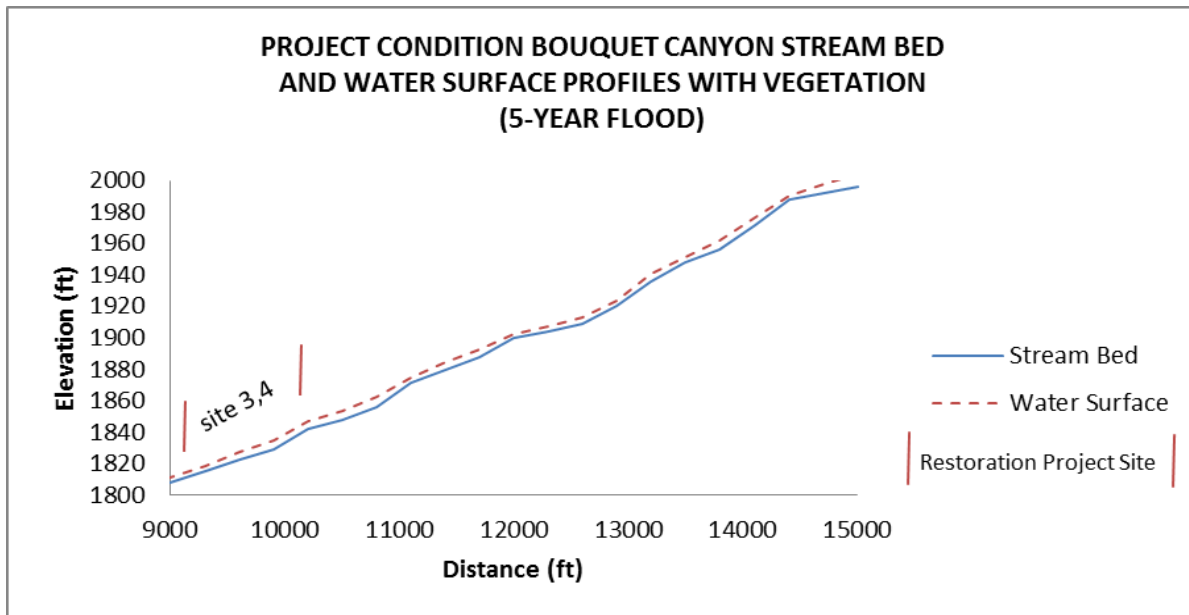
Figure 33. Bouquet Canyon Creek 5-year Flood Water Surface Profile under Project Conditions (Sites 3 and 4)

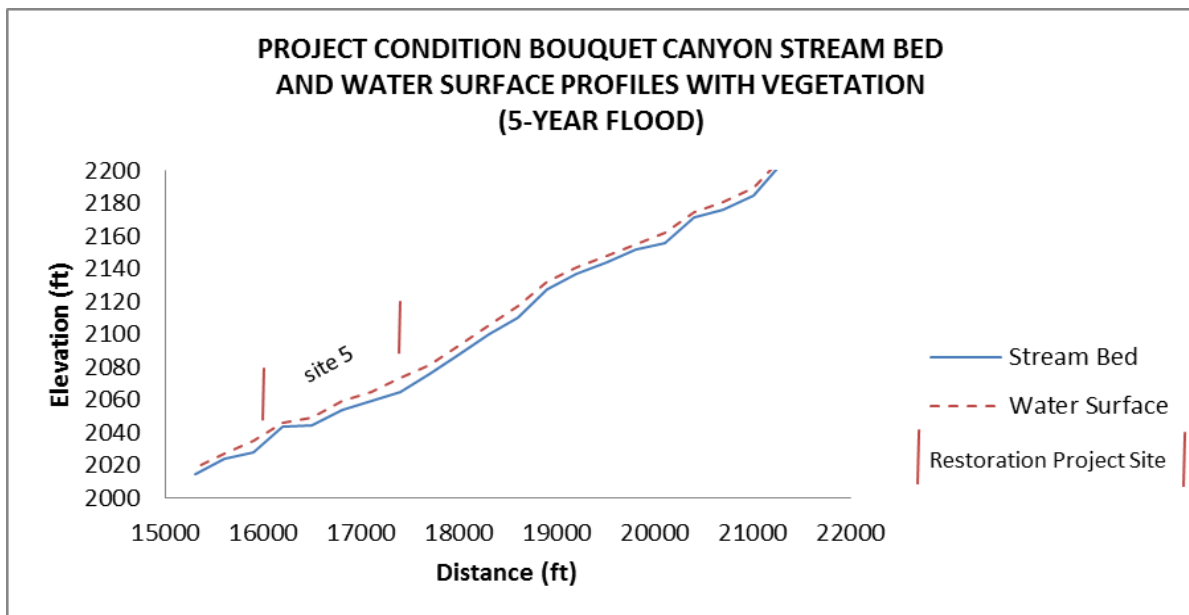
Figure 34. Bouquet Canyon Creek 5-year Flood Water Surface Profile under Proposed Conditions (Site 5)

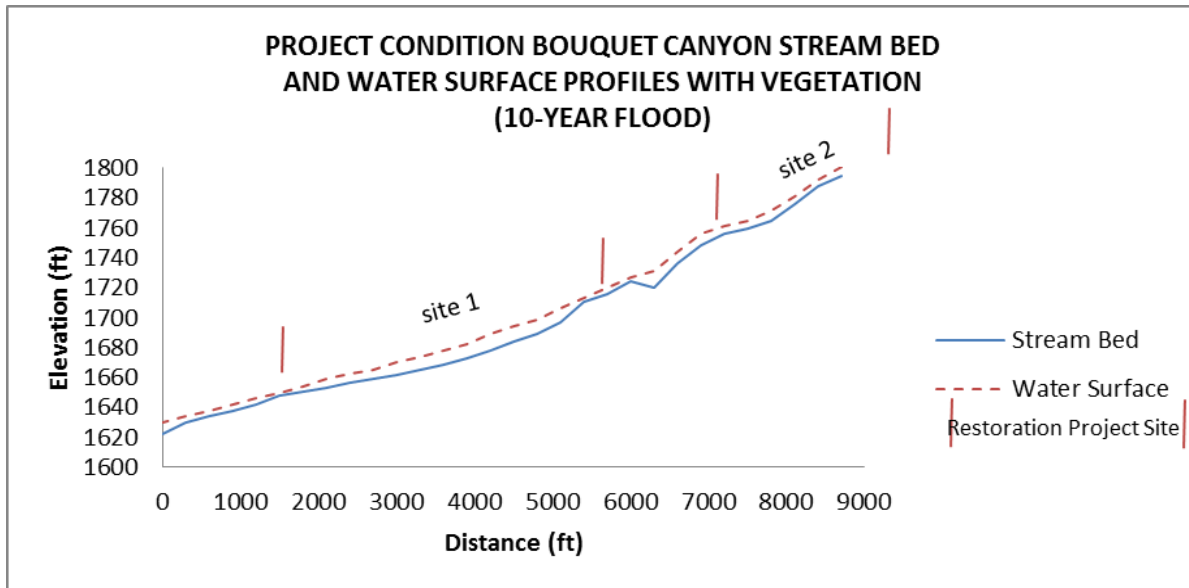
Figure 35. Bouquet Canyon Creek 10-year Flood Water Surface Profile under Project Conditions (Sites 1 and 2)

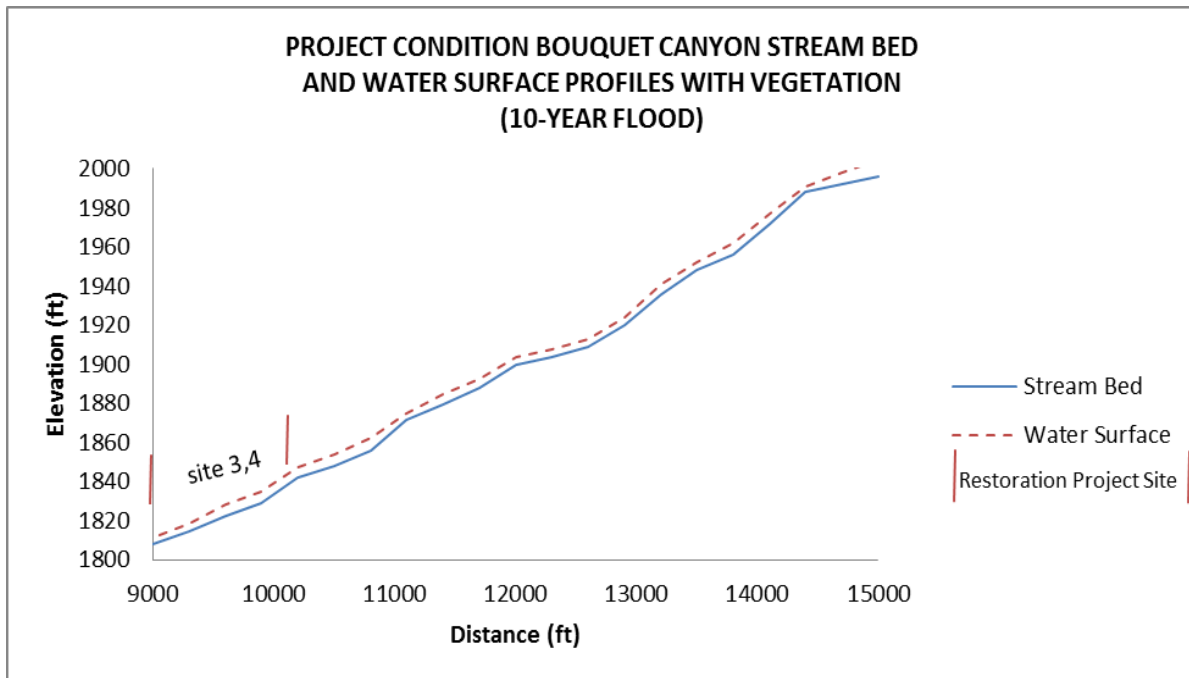
Figure 36. Bouquet Canyon Creek 10-year Flood Water Surface Profile under Project Conditions (Sites 3 and 4)

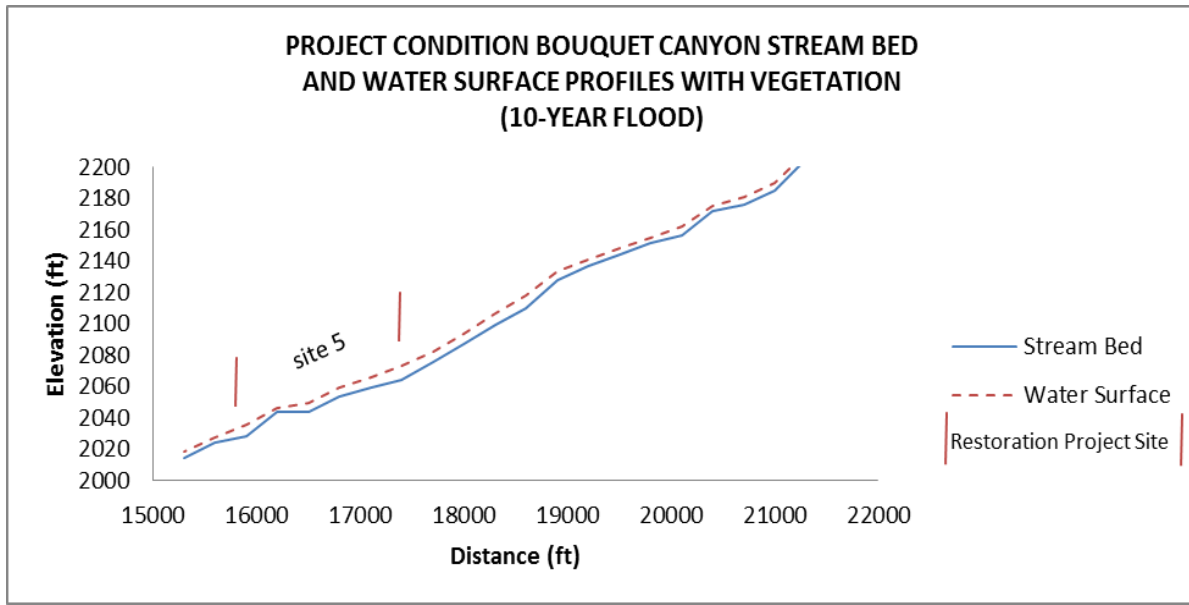
Figure 37. Bouquet Canyon Creek 10-year Flood Water Surface Profile under Project Conditions (Site 5)

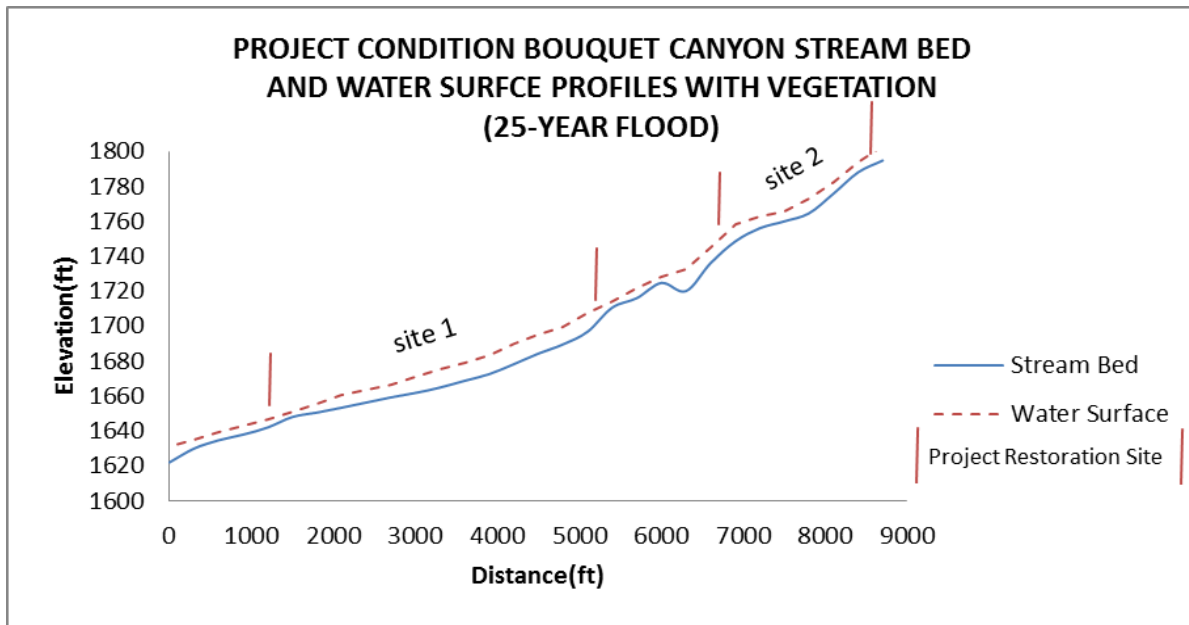
Figure 38. Bouquet Canyon Creek 25-year Flood Water Surface Profile under Project Conditions (Sites 1 and 2)

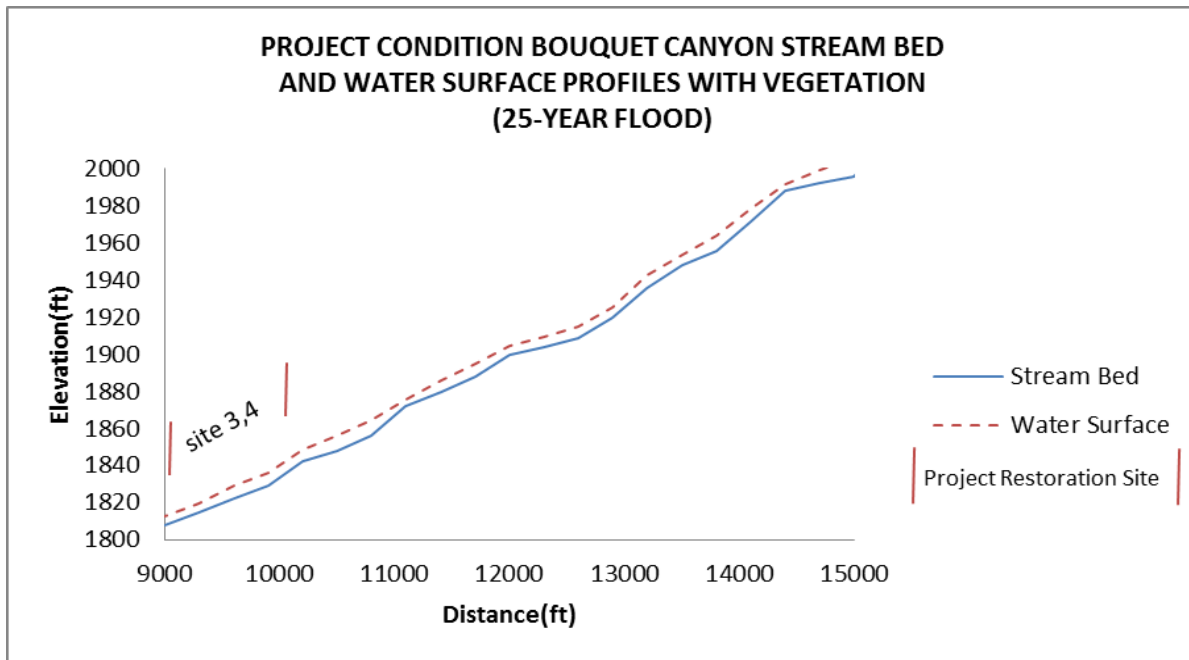
Figure 39. Bouquet Canyon Creek 25-year Flood Water Surface Profile under Project Conditions (Sites 3 and 4)

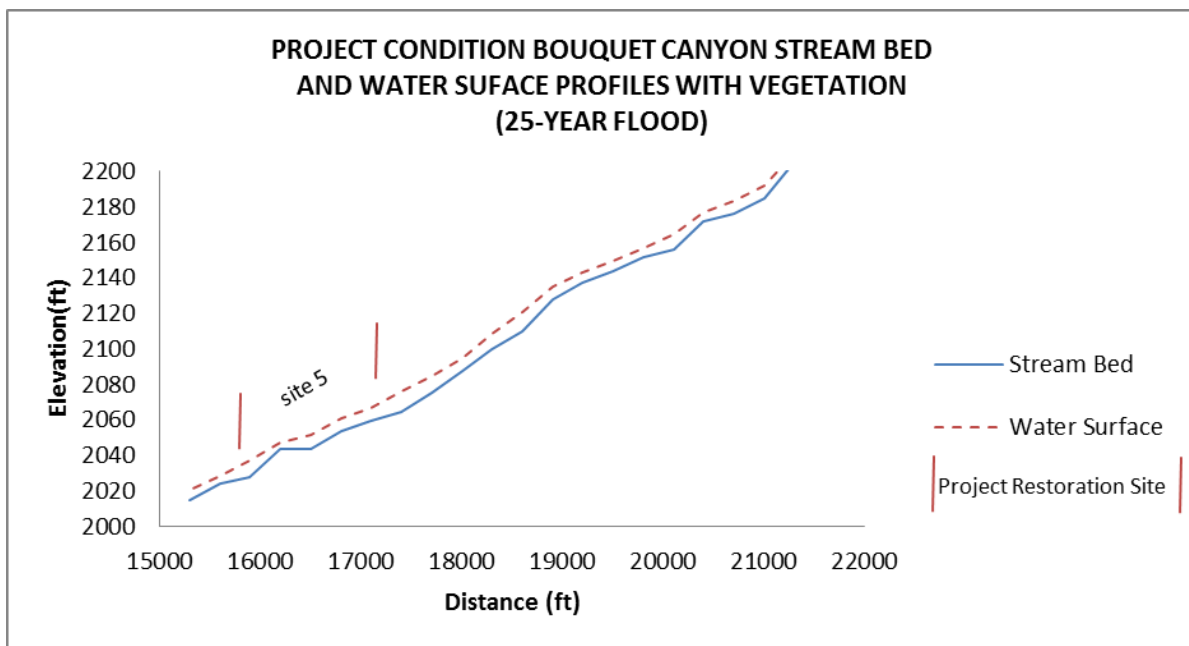
Figure 40. Bouquet Canyon Creek 25-year Flood Water Surface Profile under Project Conditions (Site 5)

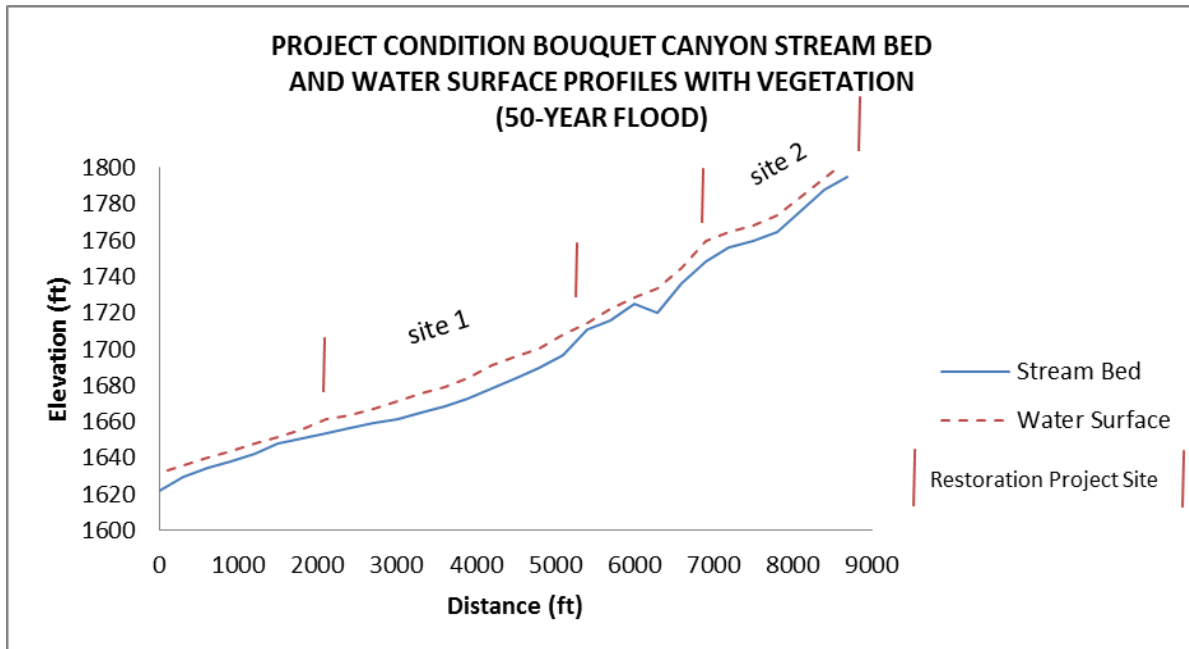
Figure 41. Bouquet Canyon Creek 50-year Flood Water Surface Profile under Project Conditions (Sites 1 and 2)

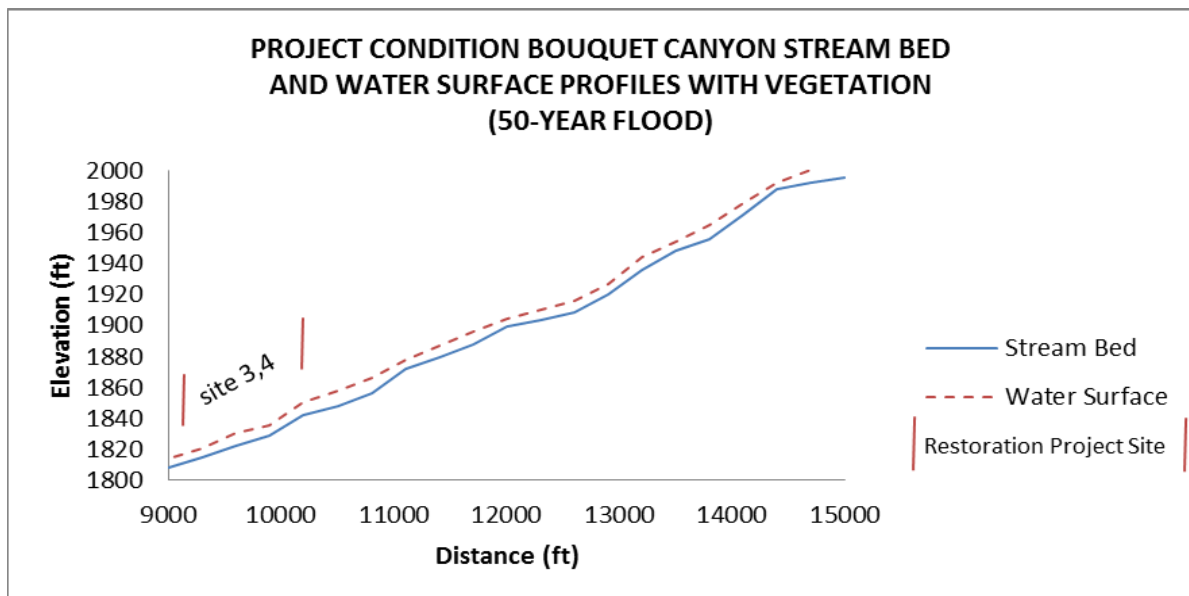
Figure 42. Bouquet Canyon Creek 50-year Flood Water Surface Profile under Project Conditions (Sites 3 and 4)

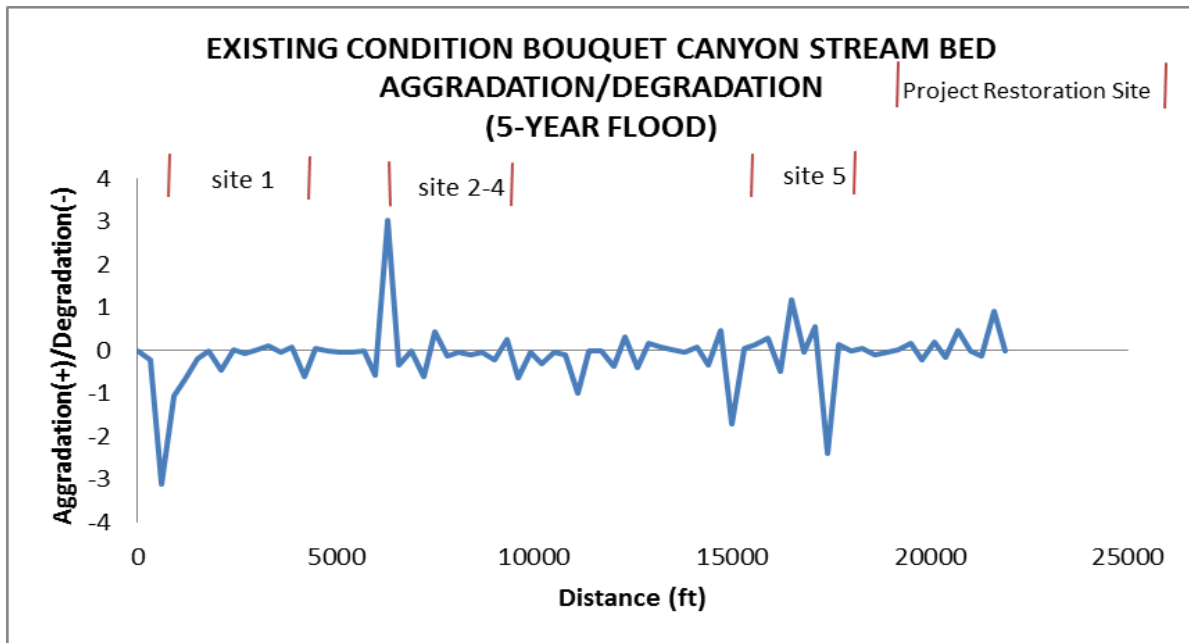
Figure 51. Bouquet Canyon Creek 5-year Flood Bed Aggradation/Degradation Depths under Existing Conditions

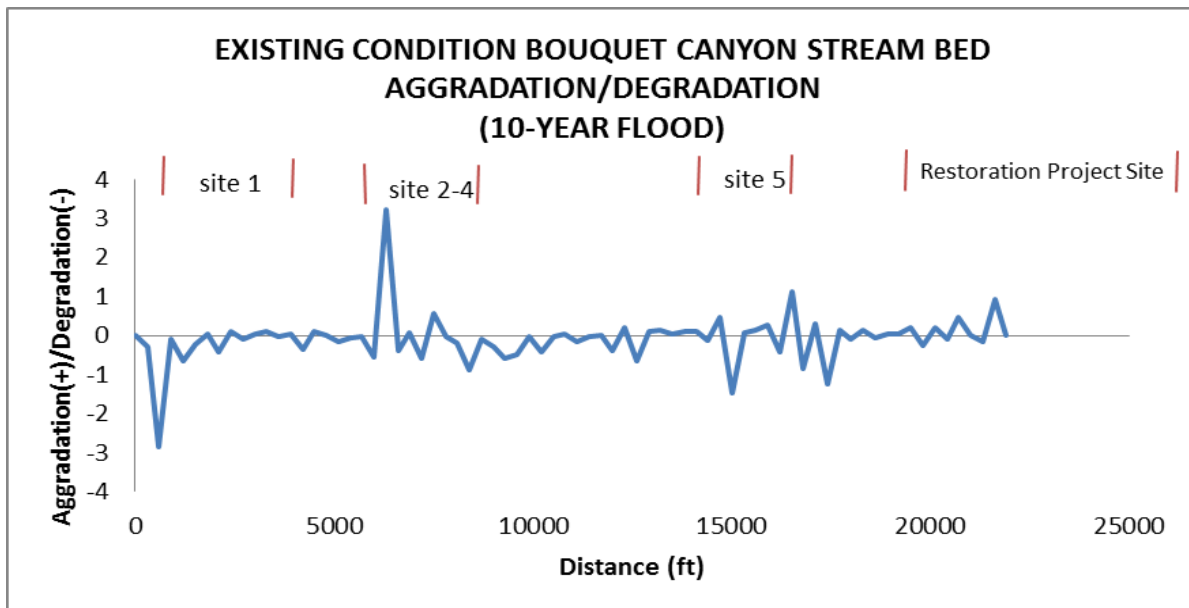
Figure 52. Bouquet Canyon Creek 10-year Flood Bed Aggradation/Degradation Depths under Existing Conditions

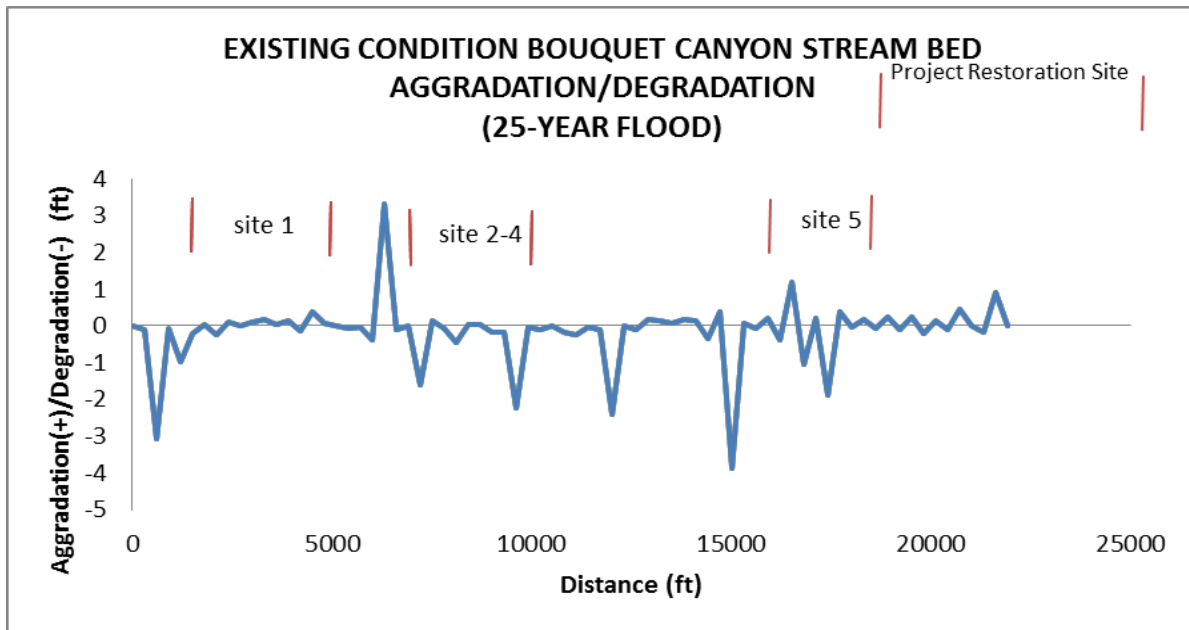
Figure 53. Bouquet Canyon Creek 25-year Flood Bed Aggradation/Degradation Depths under Existing Conditions

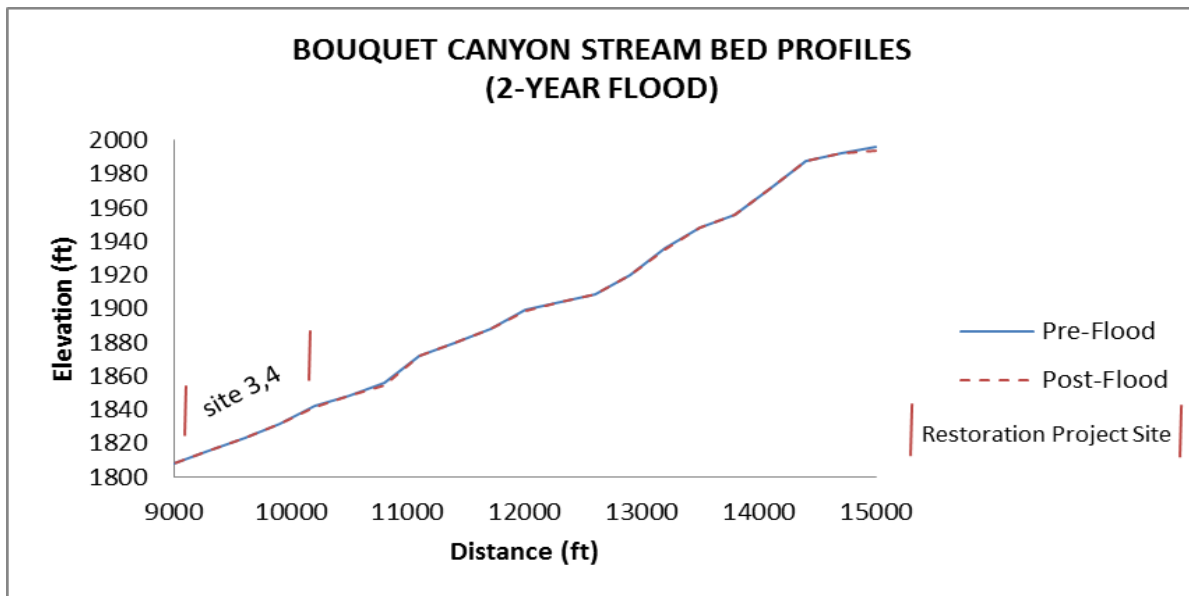
Figure 56. Bouquet Canyon Creek 2-year Flood Stream Bed Profiles under Existing Conditions (Sites 3 and 4)

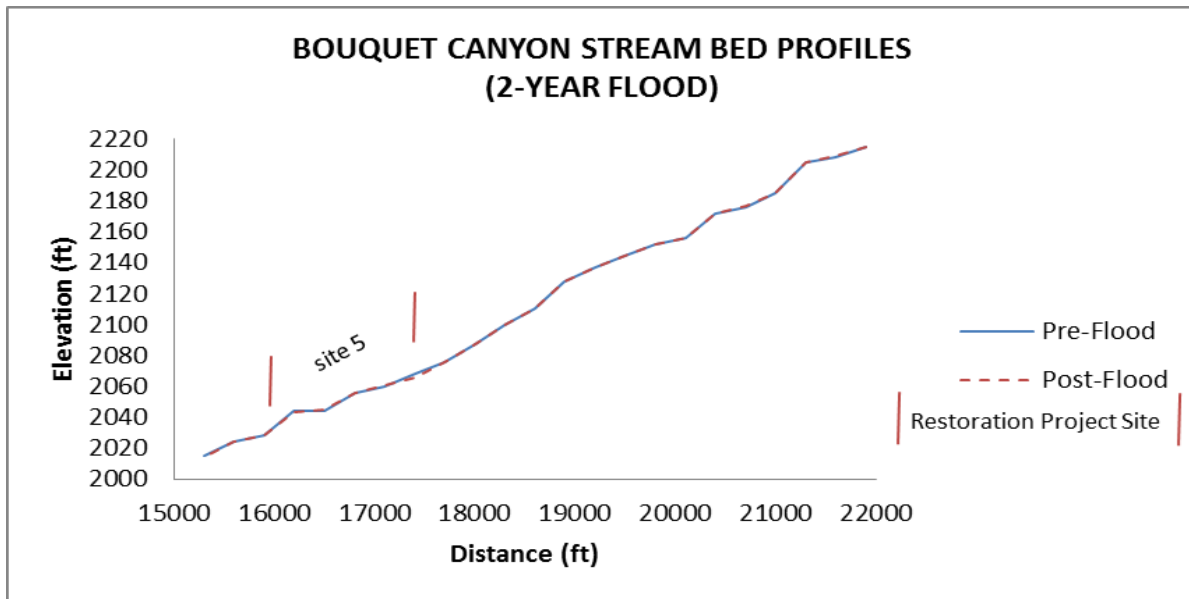
Figure 57. Bouquet Canyon Creek 2-year Flood Stream Bed Profiles under Existing Conditions (Site 5)

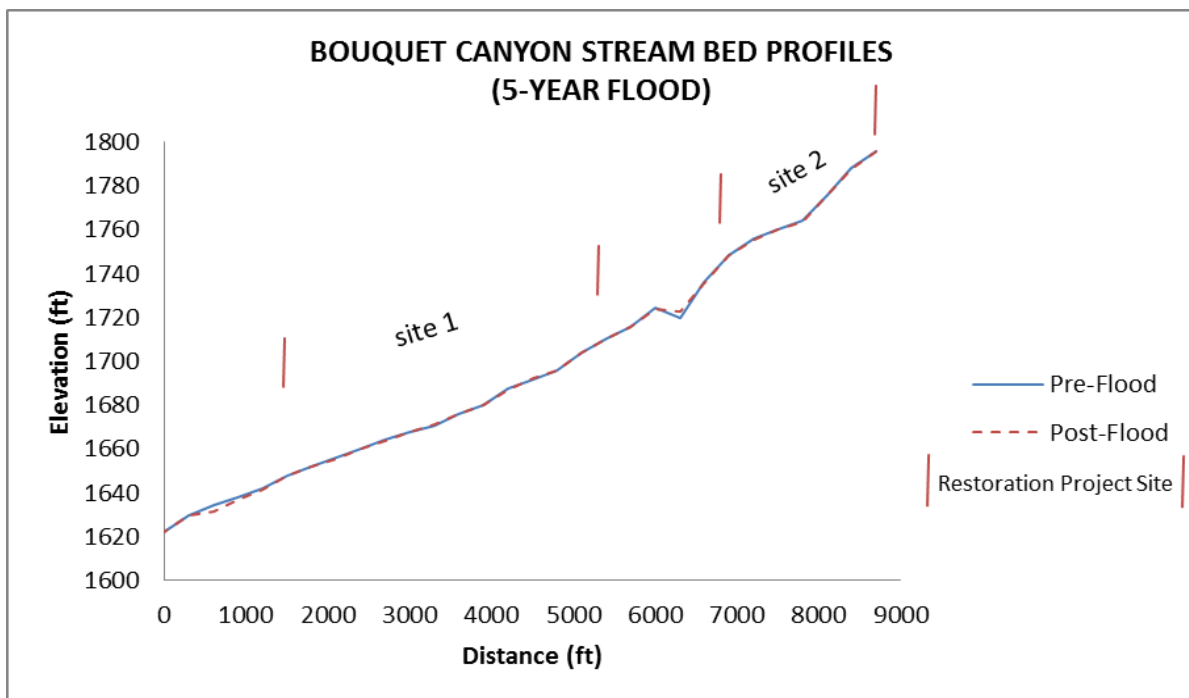
Figure 58. Bouquet Canyon Creek 5-year Flood Stream Bed Profiles under Existing Conditions (Sites 1 and 2)

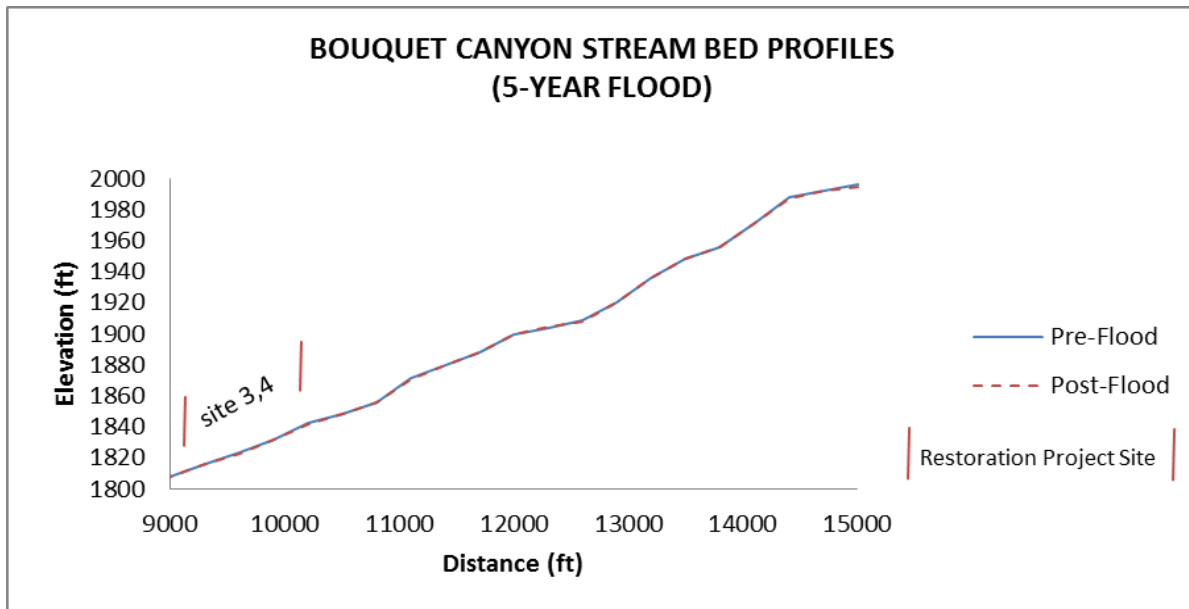
Figure 59. Bouquet Canyon Creek 5-year Flood Stream Bed Profiles under Existing Conditions (Sites 3 and 4)

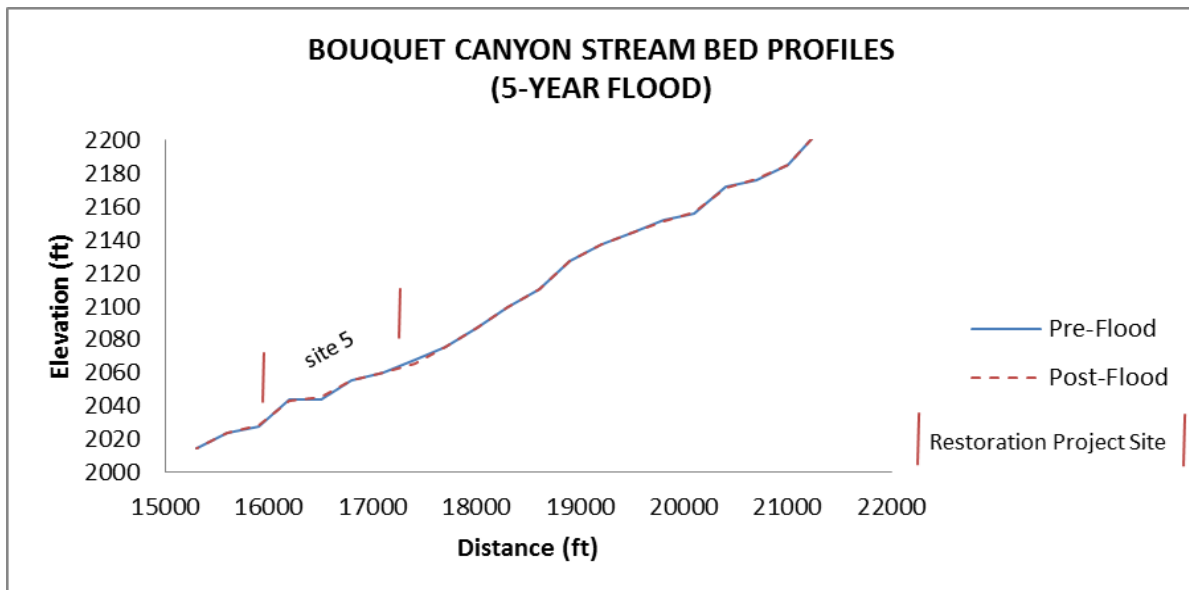
Figure 60. Bouquet Canyon Creek 5-year Flood Stream Bed Profiles under Existing Conditions (Site 5)

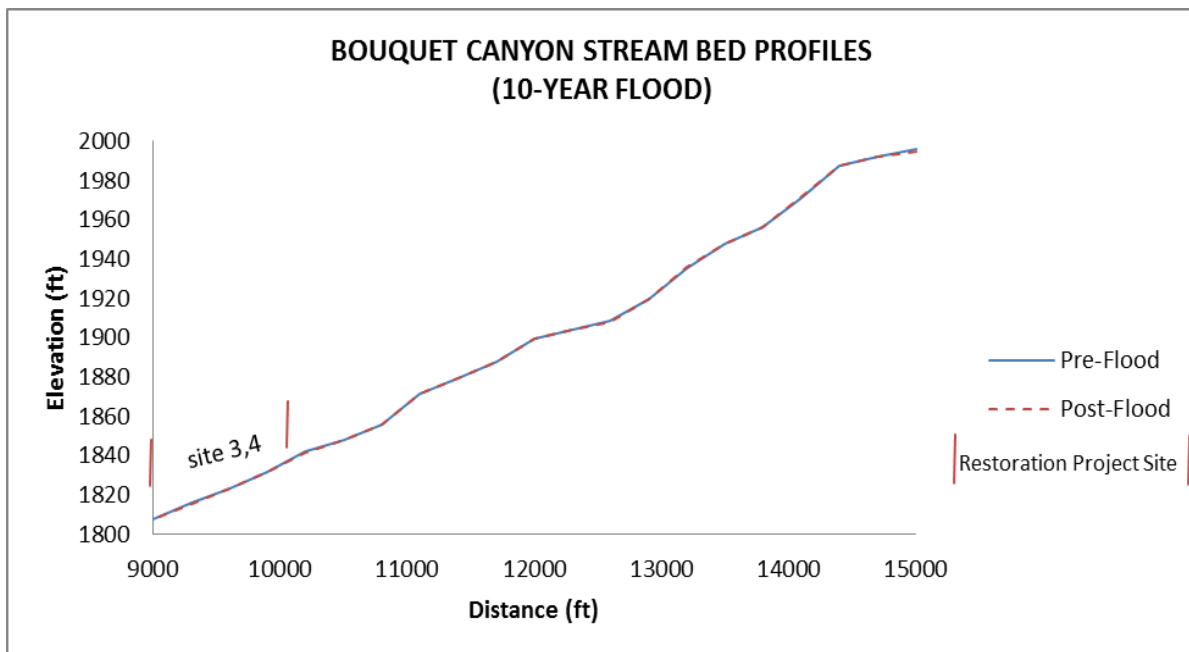
Figure 62. Bouquet Canyon Creek 10-year Flood Stream Bed Profiles under Existing Conditions (Sites 3 and 4)

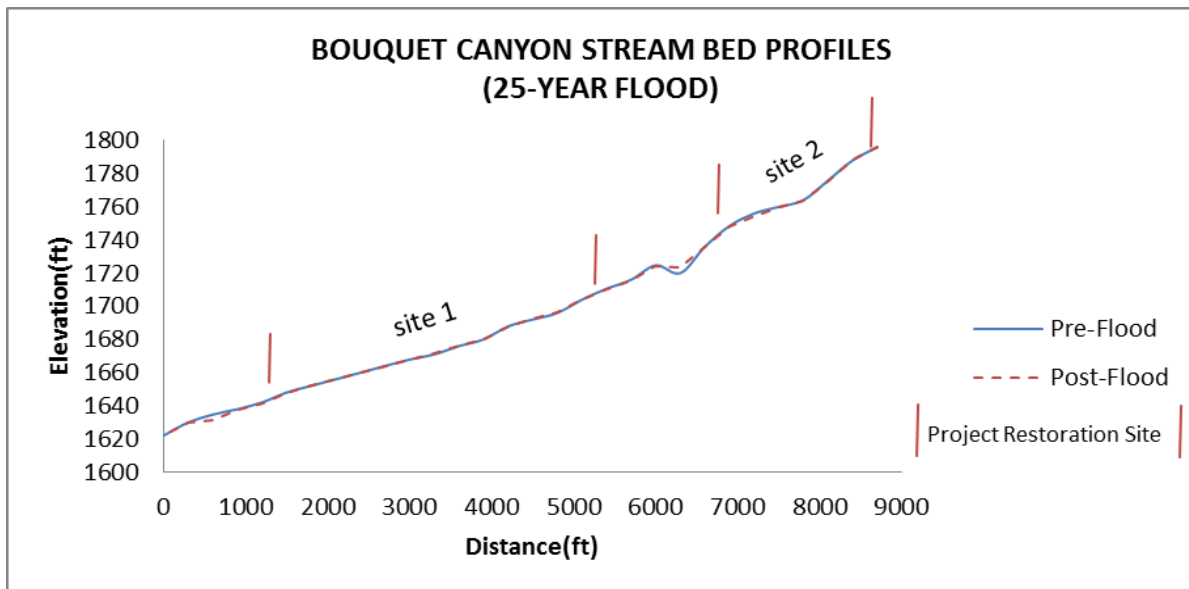
Figure 64. Bouquet Canyon Creek 25-year Flood Stream Bed Profiles under Existing Conditions (Sites 1 and 2)

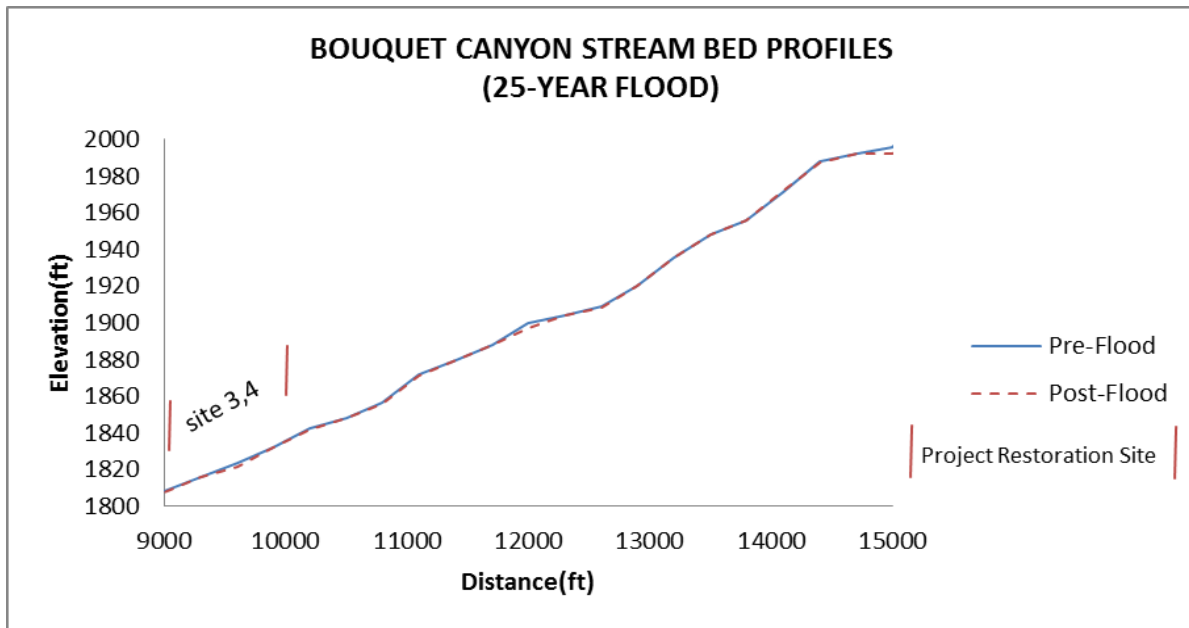
Figure 65. Bouquet Canyon Creek 25-year Flood Stream Bed Profiles under Existing Conditions (Sites 3 and 4)

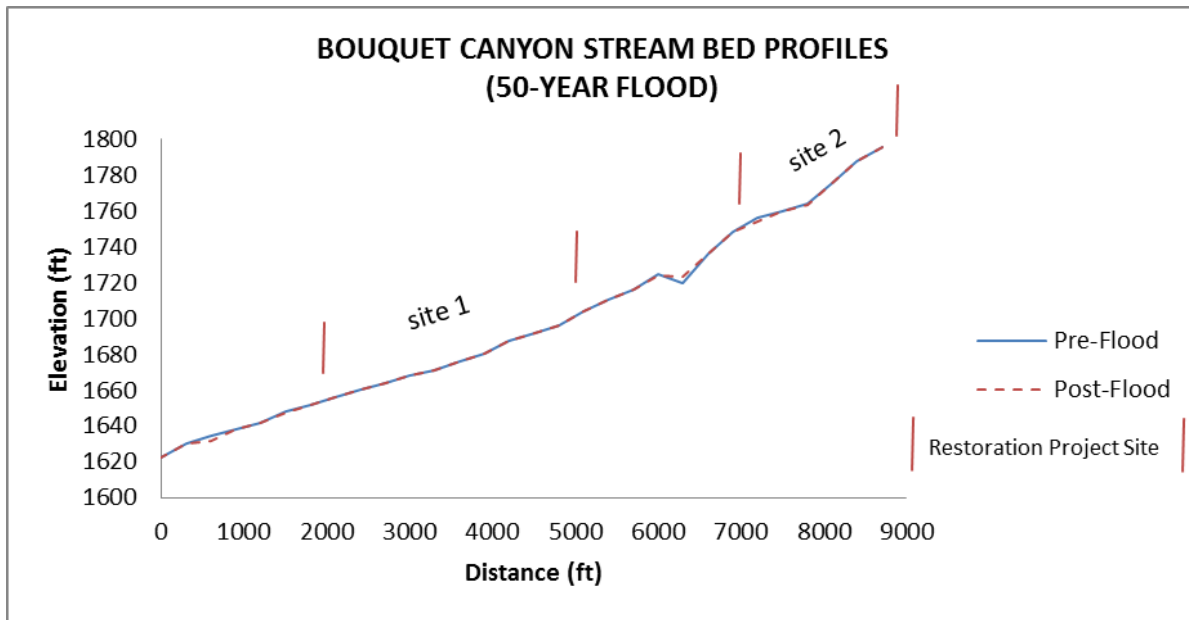
Figure 67. Bouquet Canyon Creek 50-year Flood Stream Bed Profiles under Existing Conditions (Sites 1 and 2)

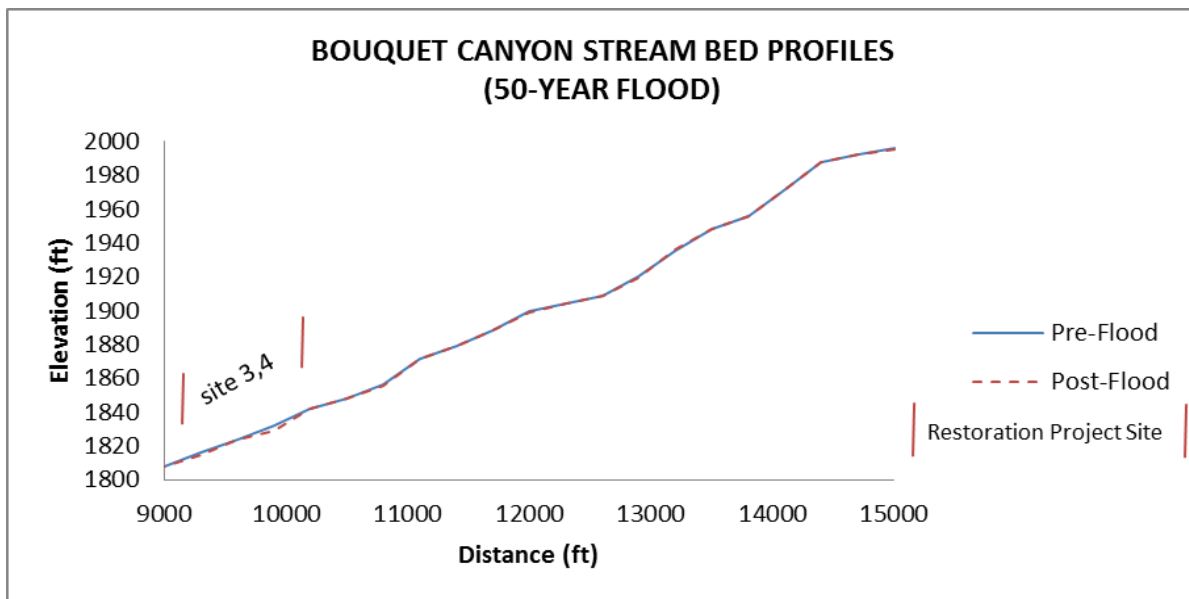
Figure 68. Bouquet Canyon Creek 50-year Flood Stream Bed Profiles under Existing Conditions (Sites 3 and 4)

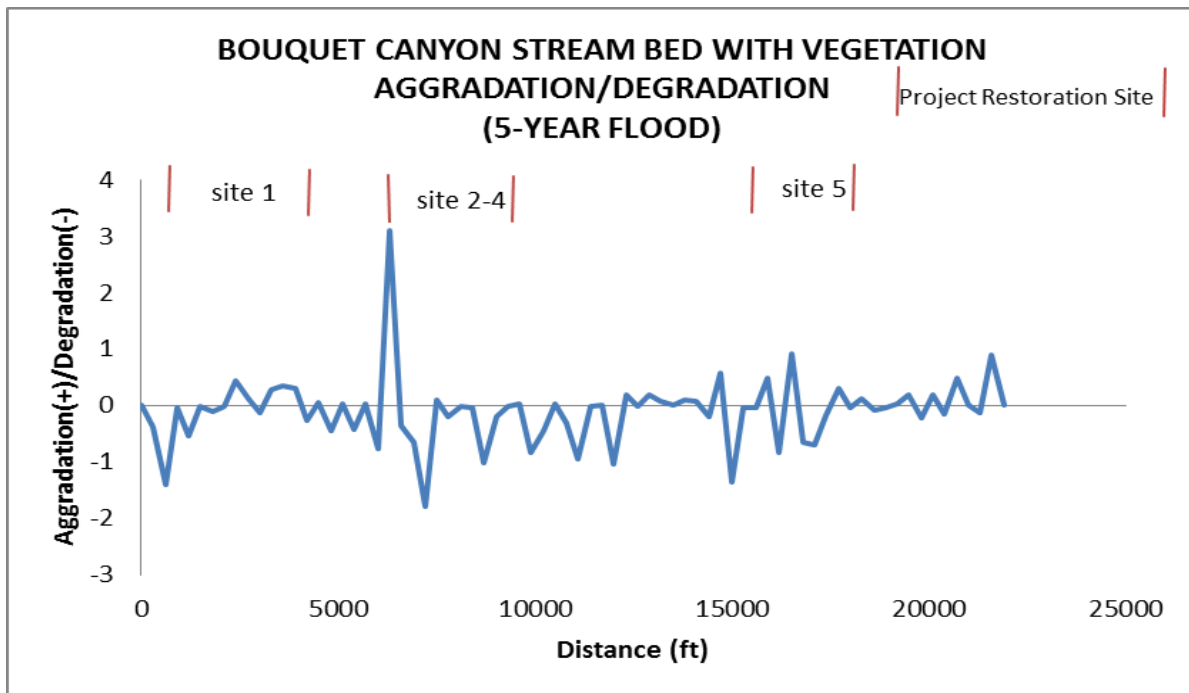
Figure 71. Bouquet Canyon Creek 5-year Flood Bed Aggradation/Degradation Depths under Project Conditions

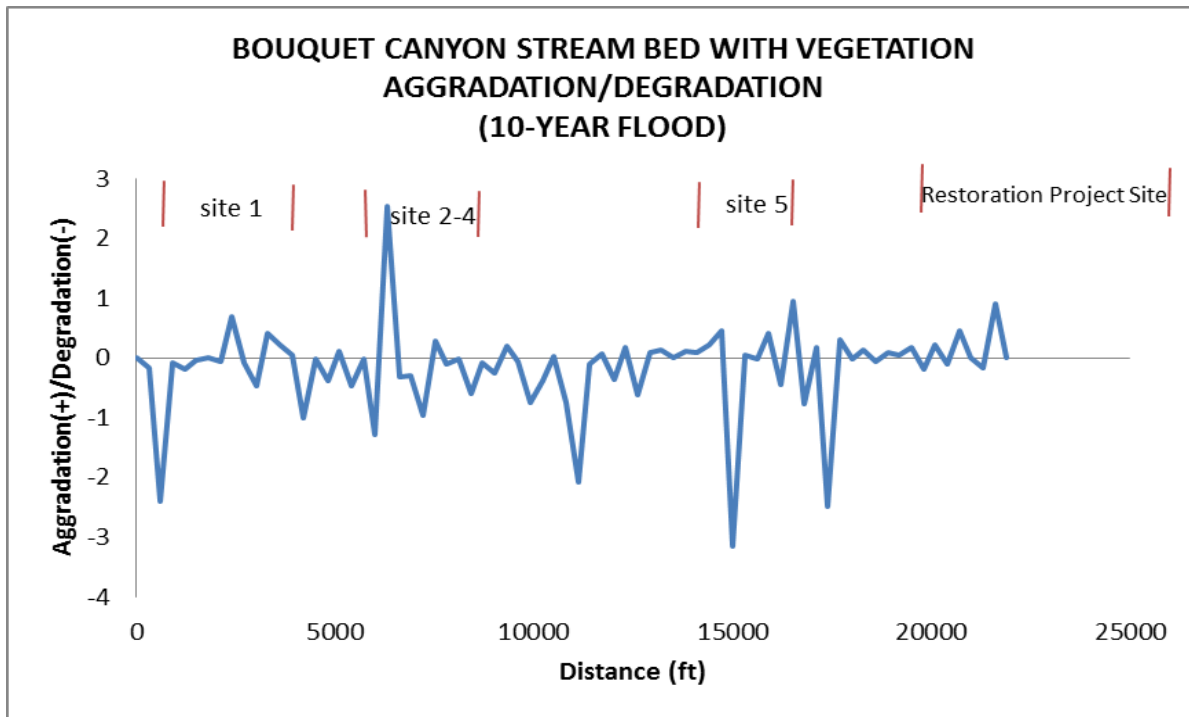
Figure 72. Bouquet Creek Canyon 10-year Flood Bed Aggradation/Degradation Depths under Project Conditions

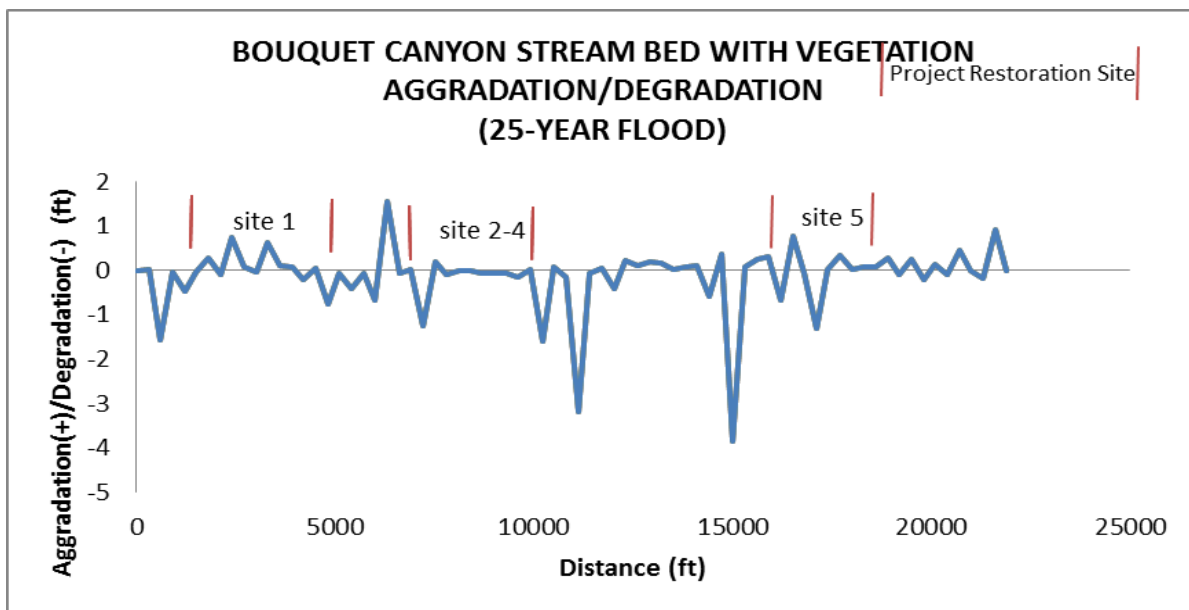
Figure 73. Bouquet Creek Canyon 25-year Flood Bed Aggradation/Degradation Depths under Project Conditions

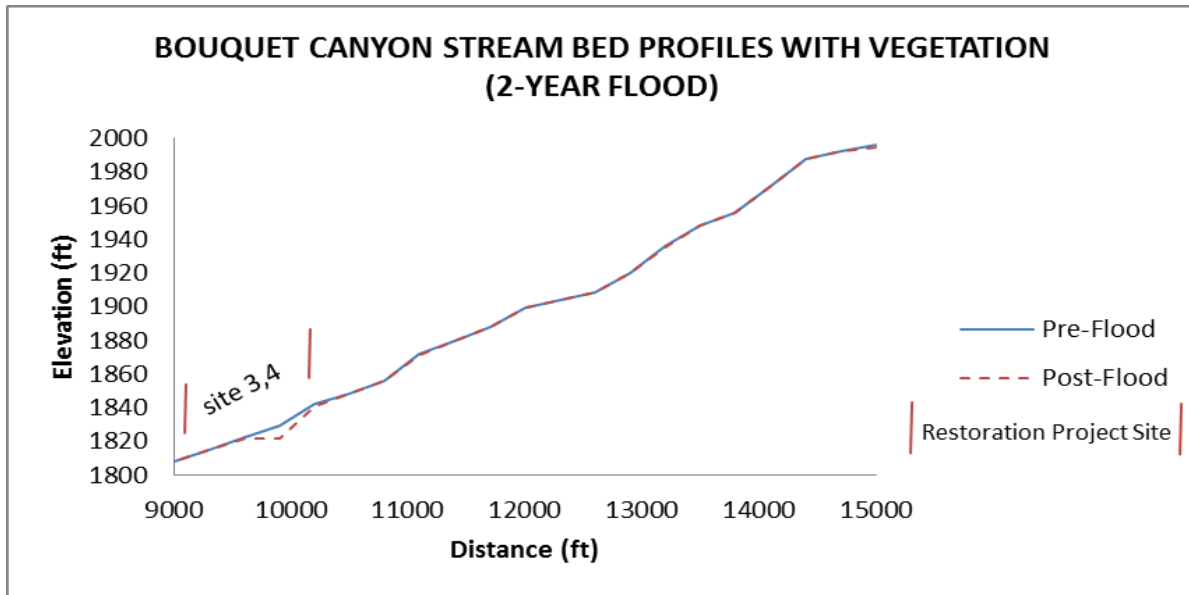
Figure 76. Bouquet Canyon Creek 2-year Flood Stream Bed Profiles under Project Conditions (Sites 3 and 4)

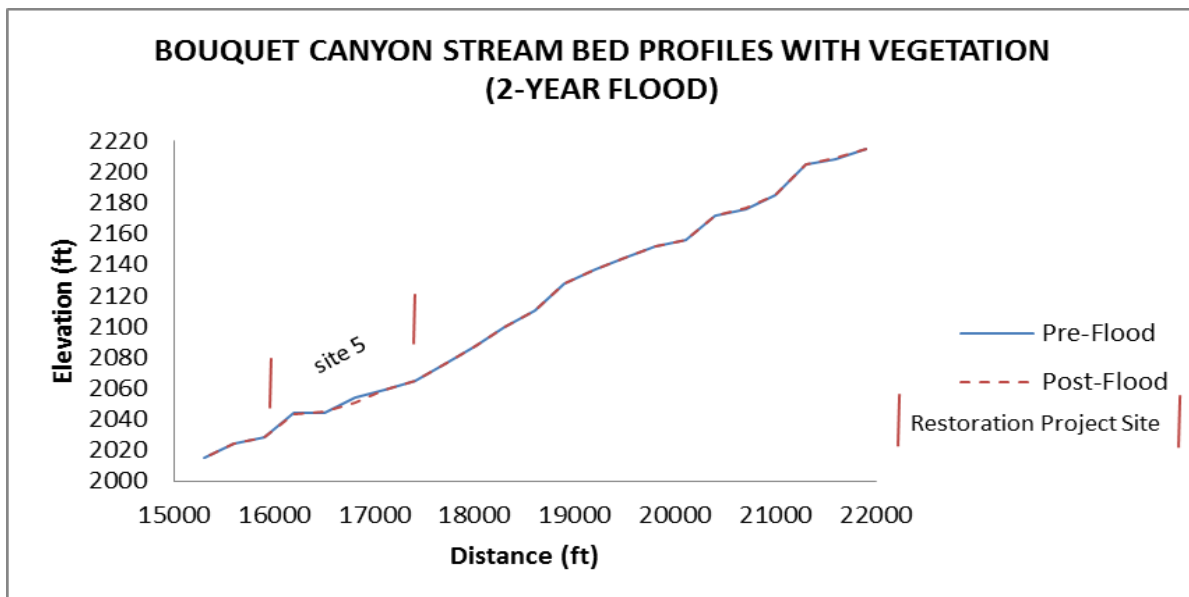
Figure 77. Bouquet Canyon Creek 2-year Flood Stream Bed Profiles under Project Conditions (Site 5)
