**NOTICE OF INTENT TO ADOPT A MITIGATED
NEGATIVE DECLARATION**

BOUQUET CANYON CREEK RESTORATION PROJECT

Bouquet Canyon Creek Restoration Project

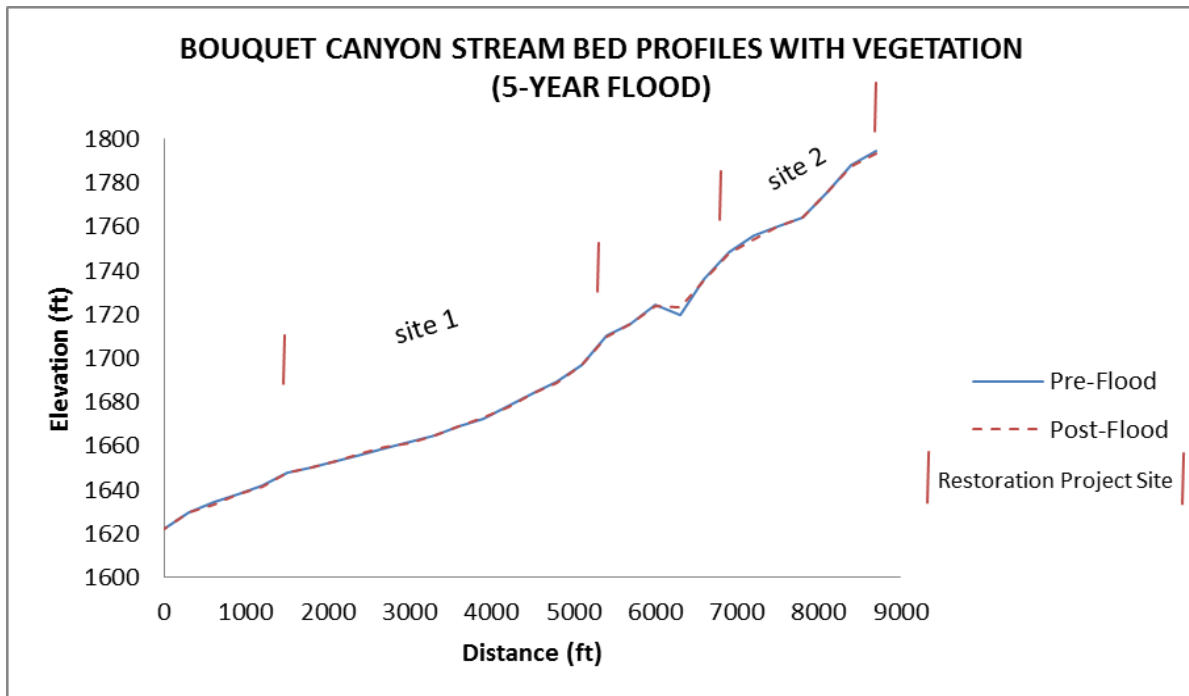
Figure 78. Bouquet Canyon Creek 5-year Flood Stream Bed Profiles under Project Conditions (Sites 1 and 2)

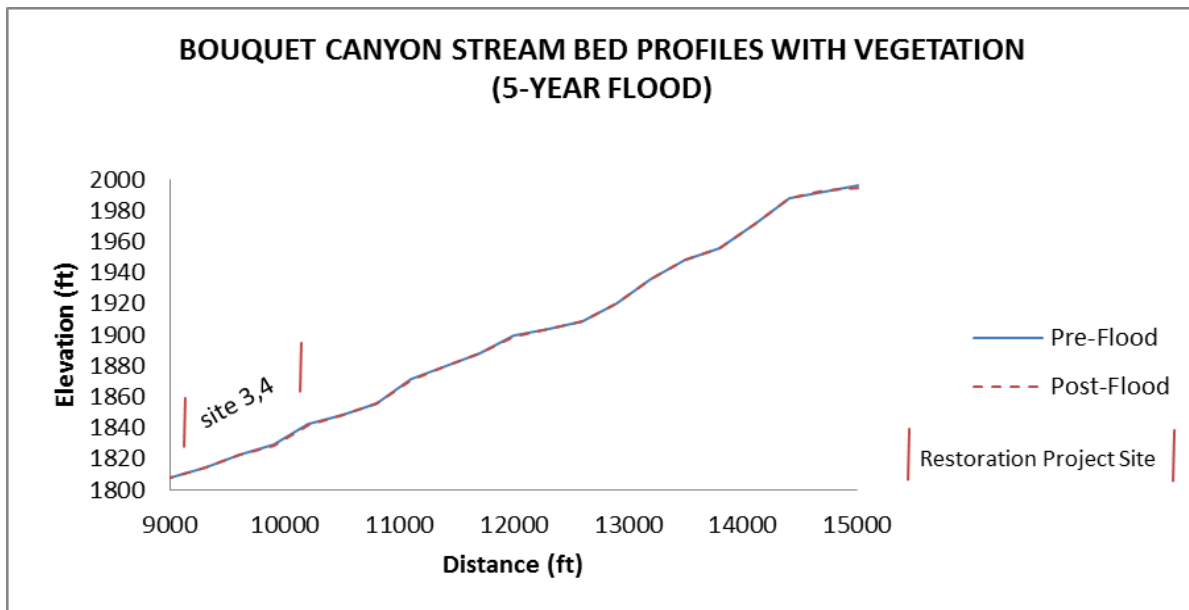
Figure 79. Bouquet Canyon Creek 5-year Flood Stream Bed Profiles under Project Conditions (Sites 3 and 4)

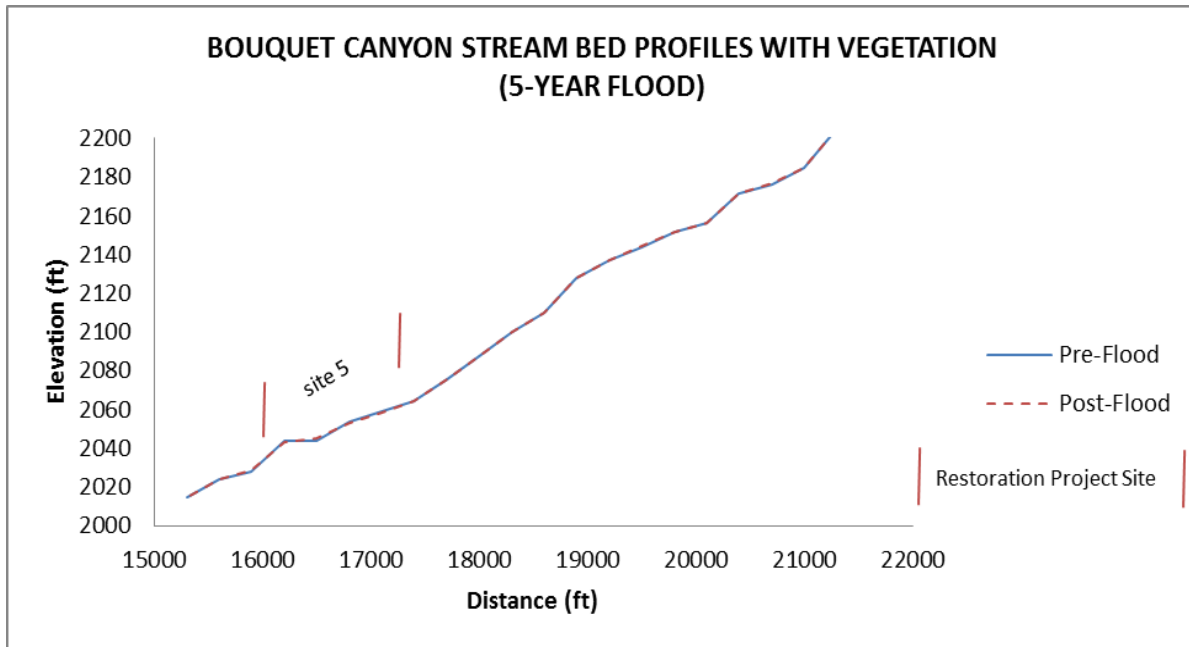
Figure 80. Bouquet Canyon Creek 5-year Flood Stream Bed Profiles under Project Conditions (Site 5)

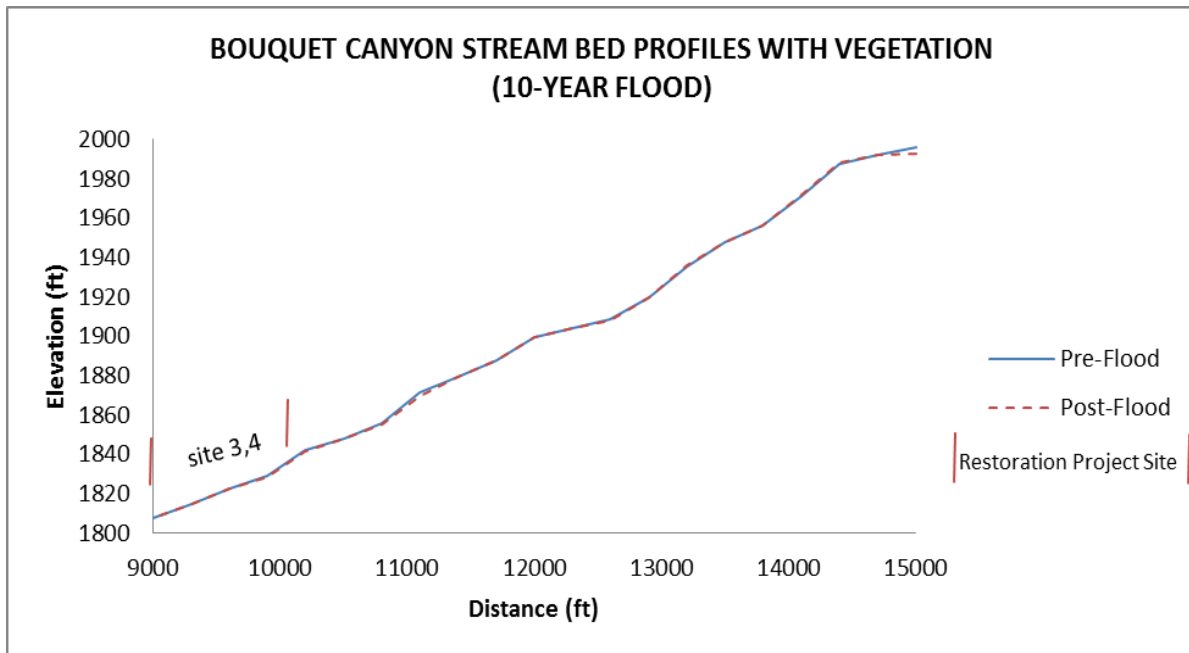
Figure 82. Bouquet Canyon Creek 10-year Flood Stream Bed Profiles under Project Conditions (Sites 3 and 4)

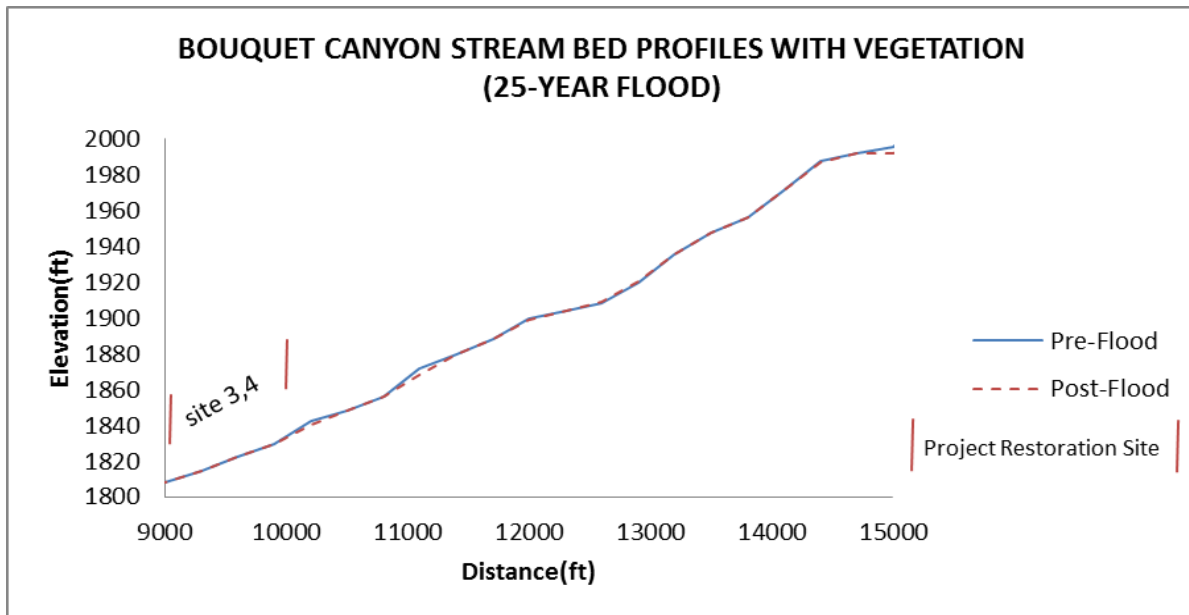
Figure 85. Bouquet Canyon Creek 25-year Flood Stream Bed Profiles under Project Conditions (Sites 3 and 4)

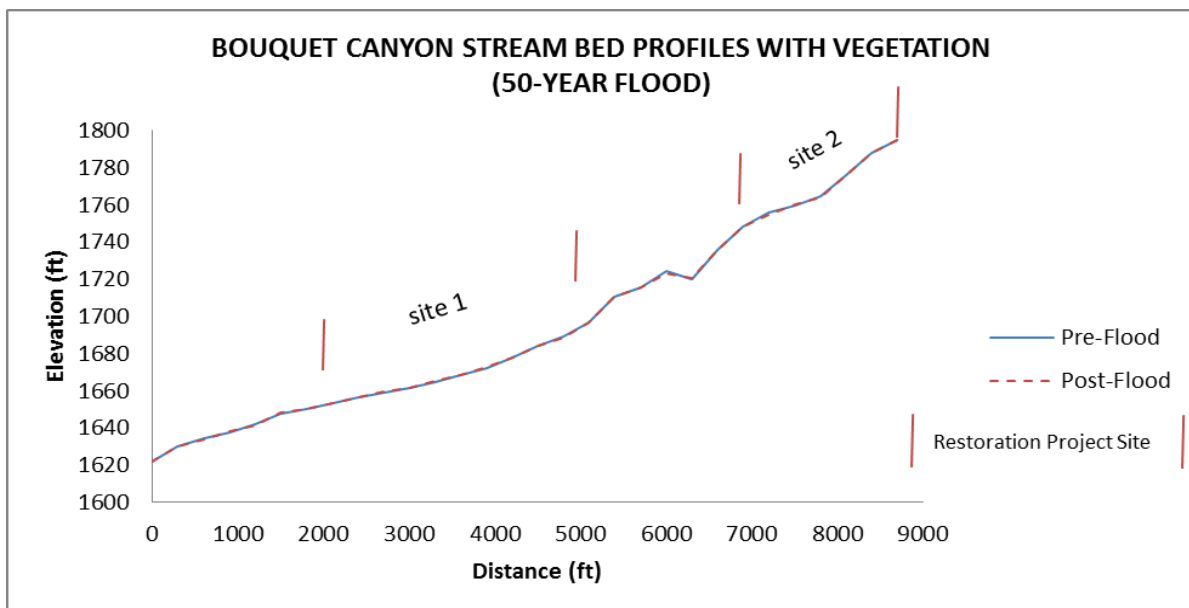
Figure 87. Bouquet Canyon Creek 50-year Flood Stream Bed Profiles under Project Conditions (Sites 1 and 2)

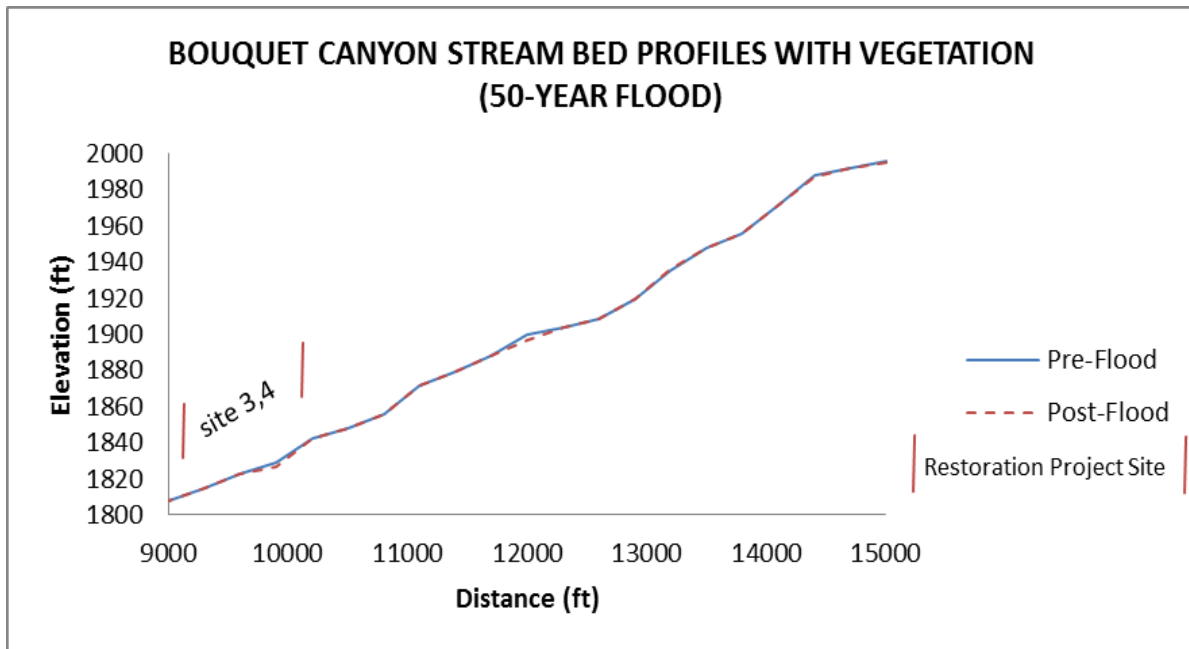
Figure 88. Bouquet Canyon Creek 50-year Flood Stream Bed Profiles under Project Conditions (Sites 3 and 4)

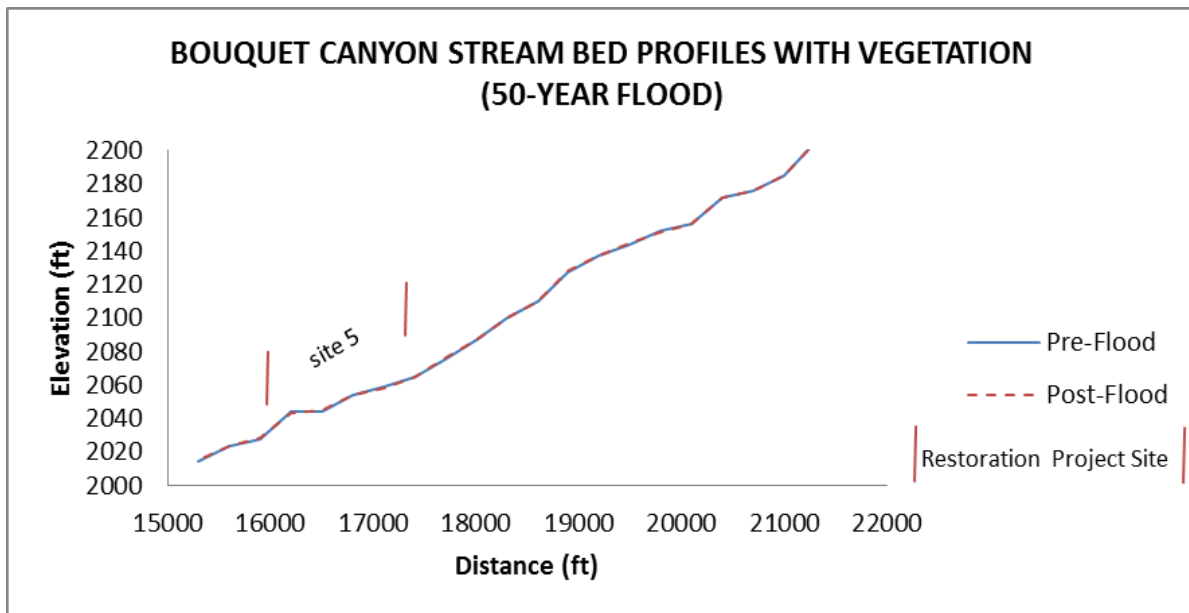
Figure 89. Bouquet Canyon Creek 50-year Flood Stream Bed Profiles under Project Conditions (Site 5)
