INITIAL STUDY

HARBOR-UCLA MEDICAL CENTER CAMPUS MASTER PLAN PROJECT

CITY OF TORRANCE, CALIFORNIA

NOVEMBER 2014

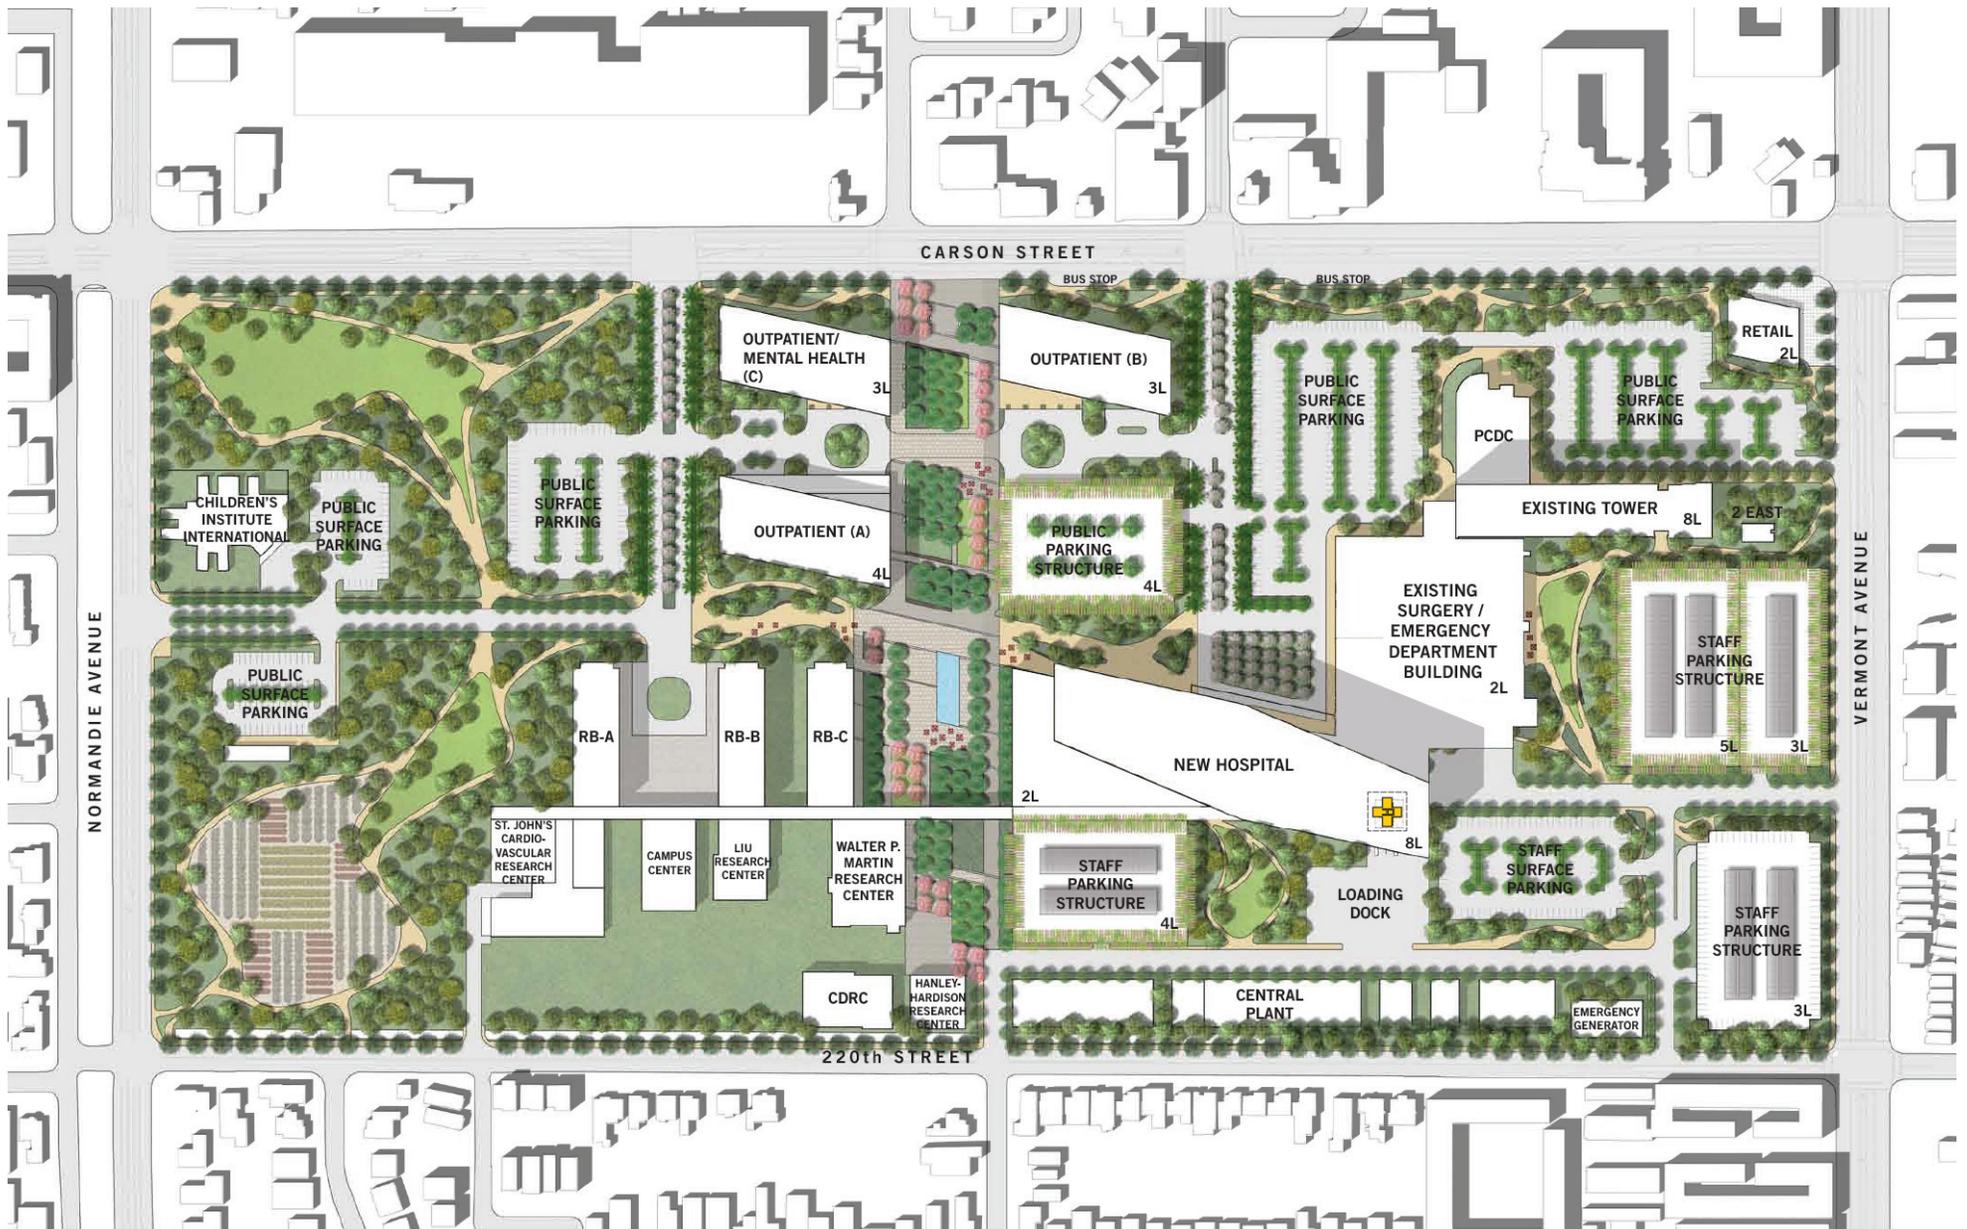
Note: Plans are conceptual and representative of planned buildout of the Harbor-UCLA Medical Center Campus, subject to refinement during design development for specific building sites.

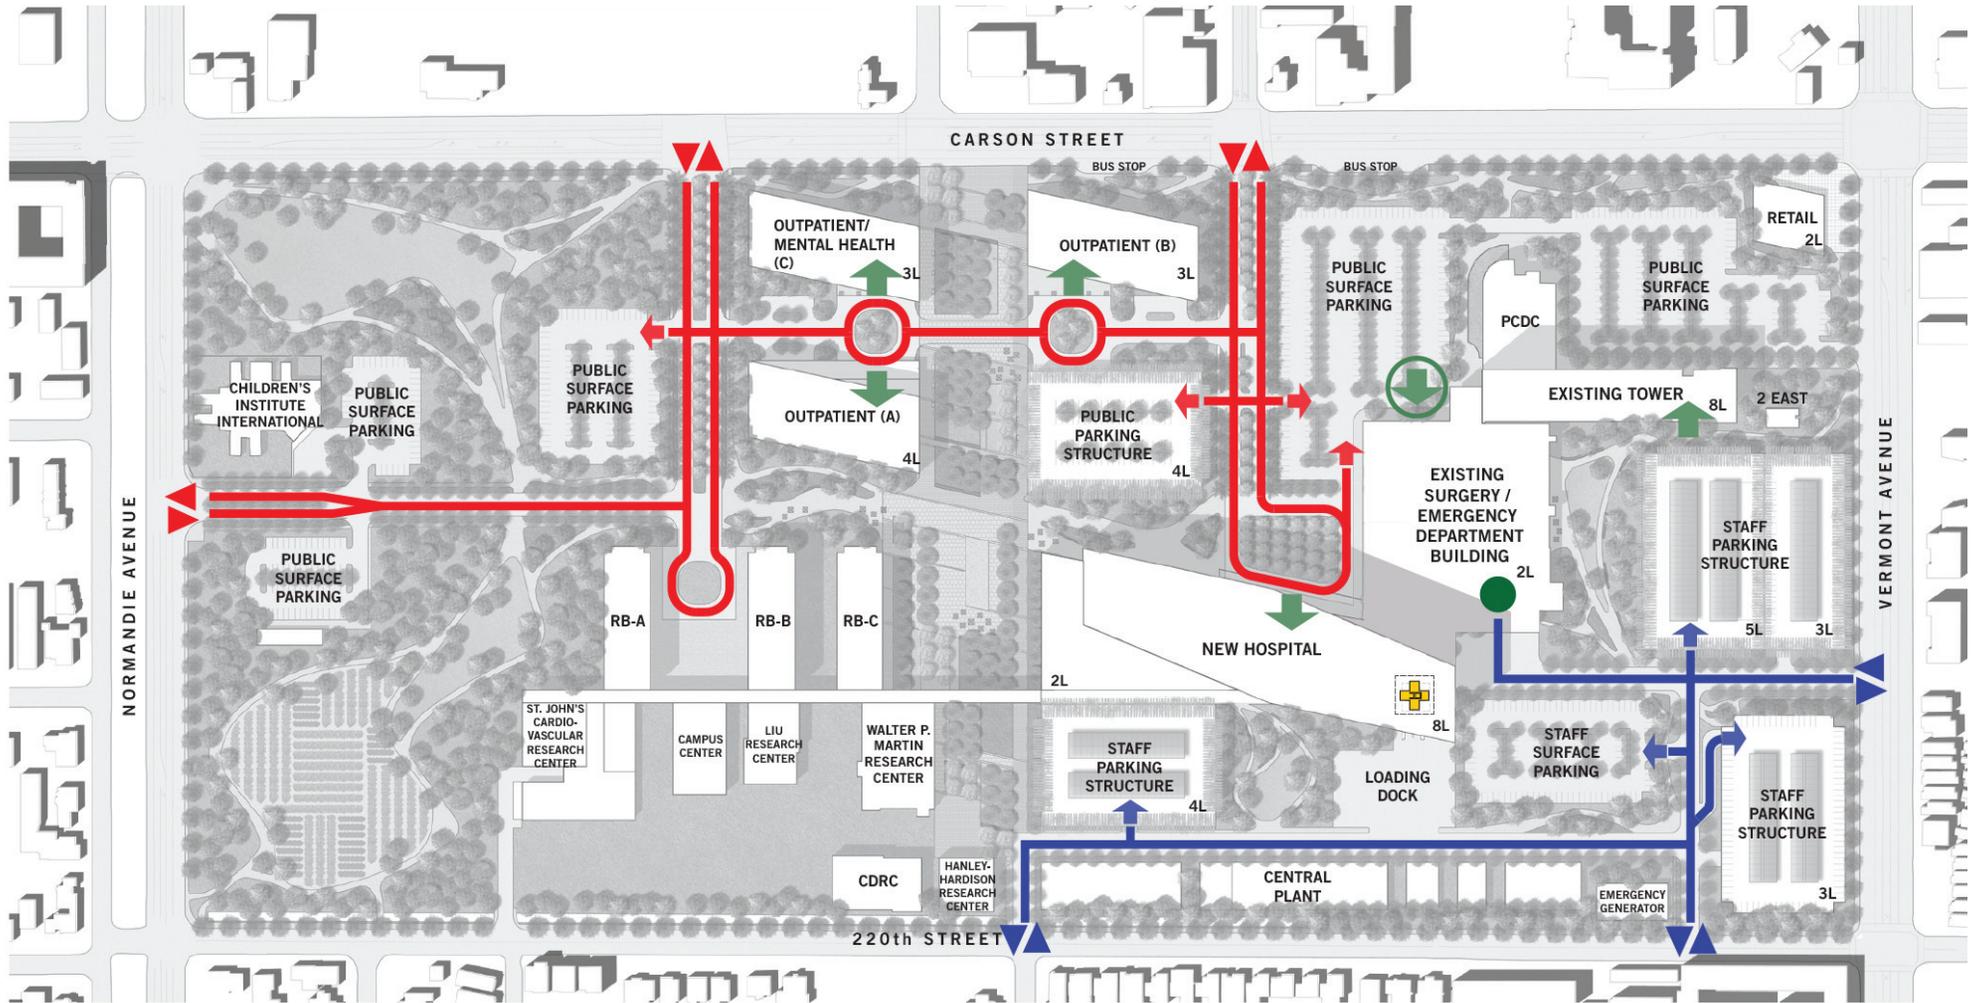
- ▶ PUBLIC ENTRY/EXIT TO CAMPUS ➡ STAFF ENTRY/EXIT TO PARKING — PRIMARY PUBLIC VEHICULAR CIRC.
- ▶ STAFF ENTRY/EXIT TO CAMPUS ➡ MAIN BUILDING ENTRANCE — PRIMARY STAFF VEHICULAR CIRC.
- ▶ PUBLIC ENTRY/EXIT TO PARKING ➡ PUBLIC EMERGENCY ENTRANCE ● AMBULANCE EMERGENCY ENTRY

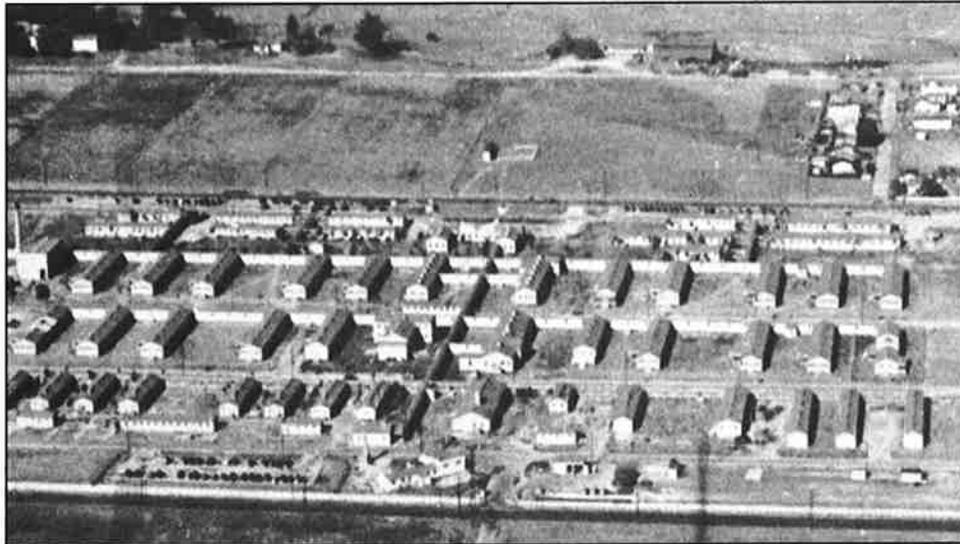
Figure 2: Photograph of the site in 1943. Source: www.labiomed.org.

The site consisted primarily of one-story rectangular buildings with gabled roofs and wood clapboard siding. The barracks had multi-light double-hung windows and partially-glazed paneled doors. The majority of the long, thin buildings were oriented facing north-south with covered walkways that connected the buildings running east to west. At the

west end of the site, there was a grouping of small cottages: single-story, square buildings with gabled roofs that were likely used for staff housing.

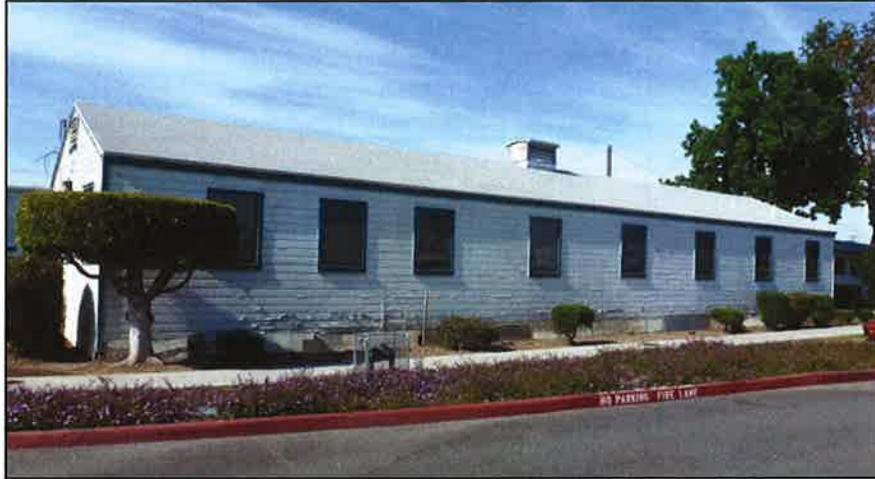
Figure 3: Building N6, north elevation, view looking southwest. Source: GPA.

The most intact building that remains is Building N6, at the north end of the site. Although it is in generally poor condition, it provides the most insight into how the original buildings appeared in 1943. Building N6 is a rectangular building with a gabled roof and flush eaves. The original roof material is not known and has been replaced with a composition shingle. There are louvered attic vents at the gable ends. At the center of the gable ridge is a wood cupola; the cupola has a gabled roof and is clad in horizontal clapboard with louvered vents on its north- and south-facing sides. The exterior of the building is clad in wide, horizontal clapboards with simple wood corner boards and trim. The building has no foundation and is elevated above ground level by concrete piers. A plywood skirt now encloses the open space beneath the building. The original entrances, based on evidence from Buildings N14 and N6, were partially glazed wood panel doors with sidelights, accessed by wood steps. The windows on Building N6 are eight-over-eight double-hung wood windows surrounded by simple wood trim. Portions of original buildings were identified by the GPA project team based on these characteristics. For descriptions of the other buildings on the site, please see the state historic resource inventory forms (DPR 523 forms) located in Appendix I. For a list of buildings on the site over 50 years of age, please see Table I on the following pages.

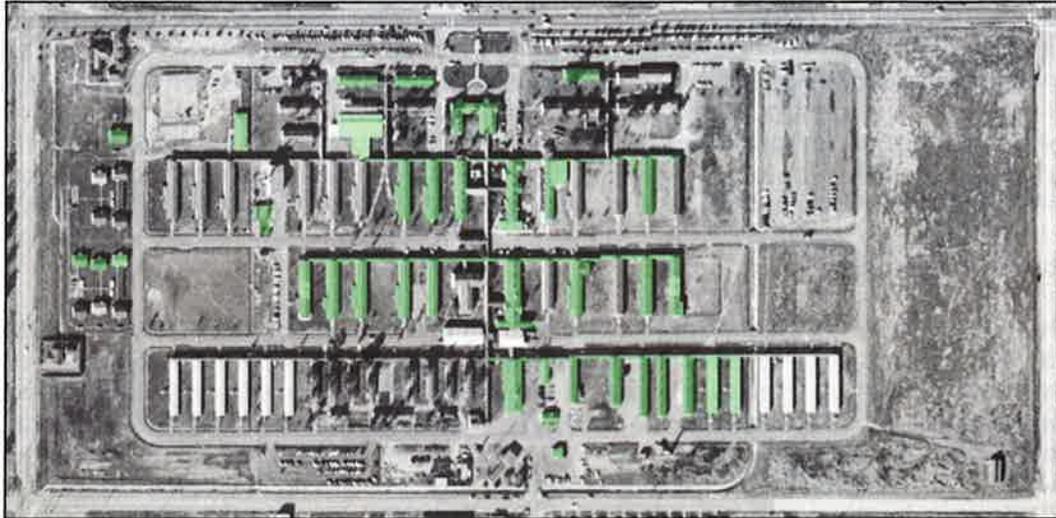
Figure 7: Original buildings that remain, in whole or in part, are shaded green. Source: *Historicaerials.com*.

Some remaining buildings are freestanding, such as Building N14, while others in the B, C, D, E, and F blocks are connected by the original covered walkways. However, some buildings connected to these walkways have been demolished, leaving crude scars such as exposed framing or gable remnants. Thus, the once regular pattern of barracks now has missing pieces, and new buildings have filled some of the gaps.

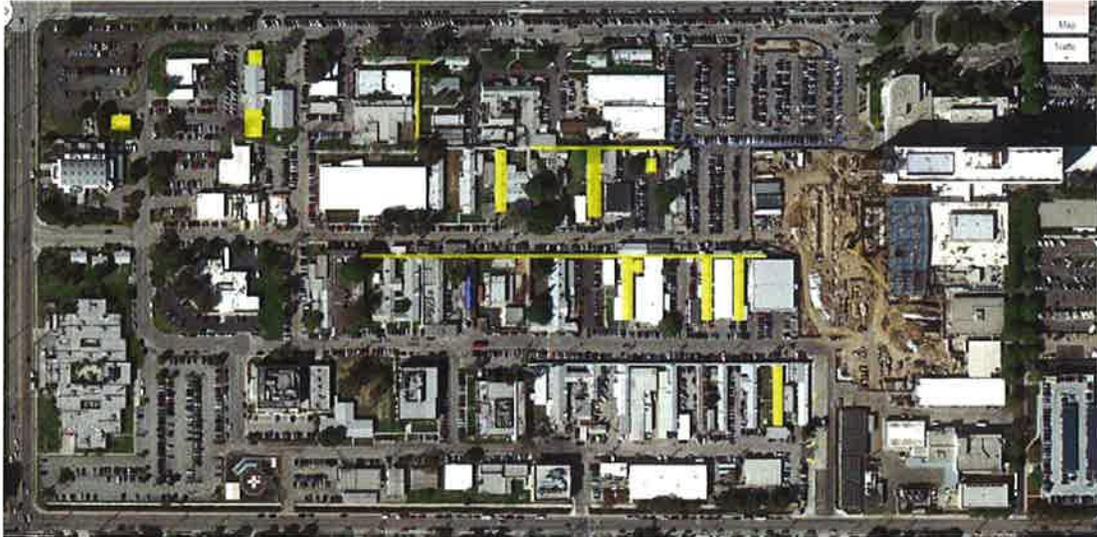
Figure 8: Would-be contributing buildings are shaded yellow. Source: Google Maps.

As illustrated in Table II and Figure 8 on the following page, of the 42 buildings remaining from the period of significance, only 14 retain sufficient integrity to be considered contributing to the potential historic district. These buildings are generally scattered throughout the property, and they have been joined by new buildings that were constructed on the campus beginning in the early 1980s. Indeed, so many buildings have been added to the campus that it no longer conveys its sense as an historic environment. (Select photographs of the buildings on the property are located in Section 7: Additional Figures).

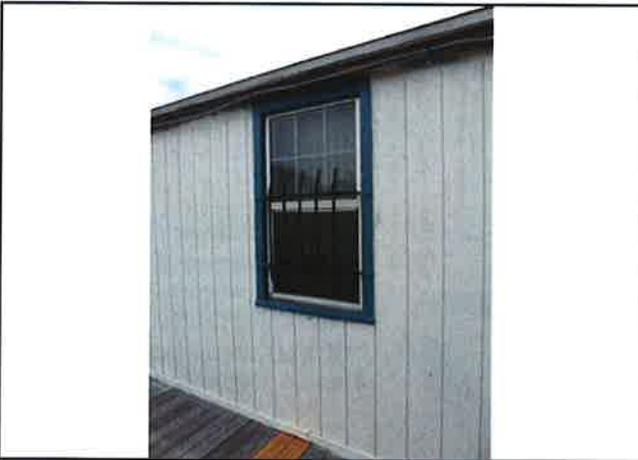
Replacement window and security bars, east elevation. 6/11/13.

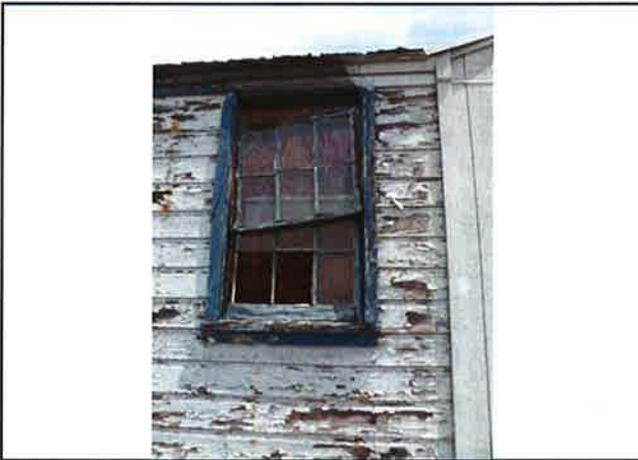
South elevation, severe window deterioration. 6/11/13.

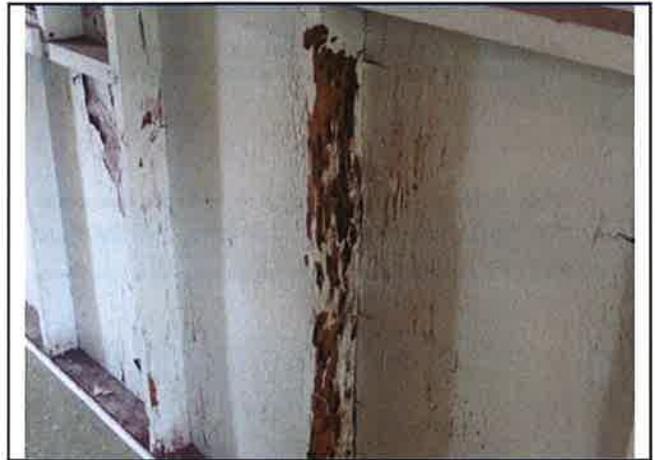
Interior, severe termite damage. 6/11/13.

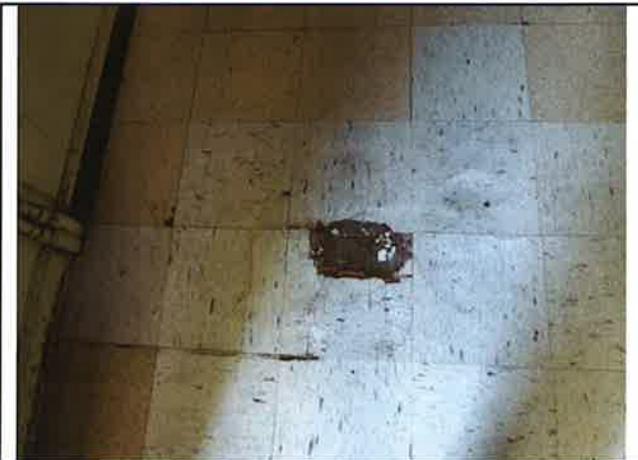
Interior, floor damage. 6/11/13.

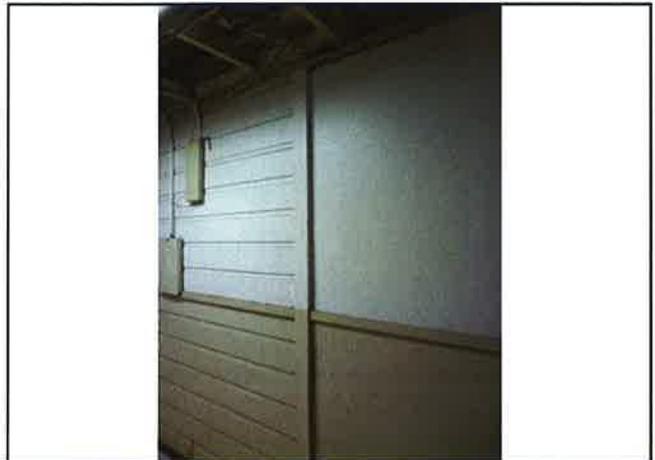
Interior wall materials. 6/11/13.
