LA COUNTY PUBLIC WORKS

1900 NORTH SYCAMORE CANYON ROAD
SAN DIMAS, CA 91773

GLENN ROCKEY CAMP CCTV SYSTEM
LA DPW PROJECT NO. P9700149
BID SET

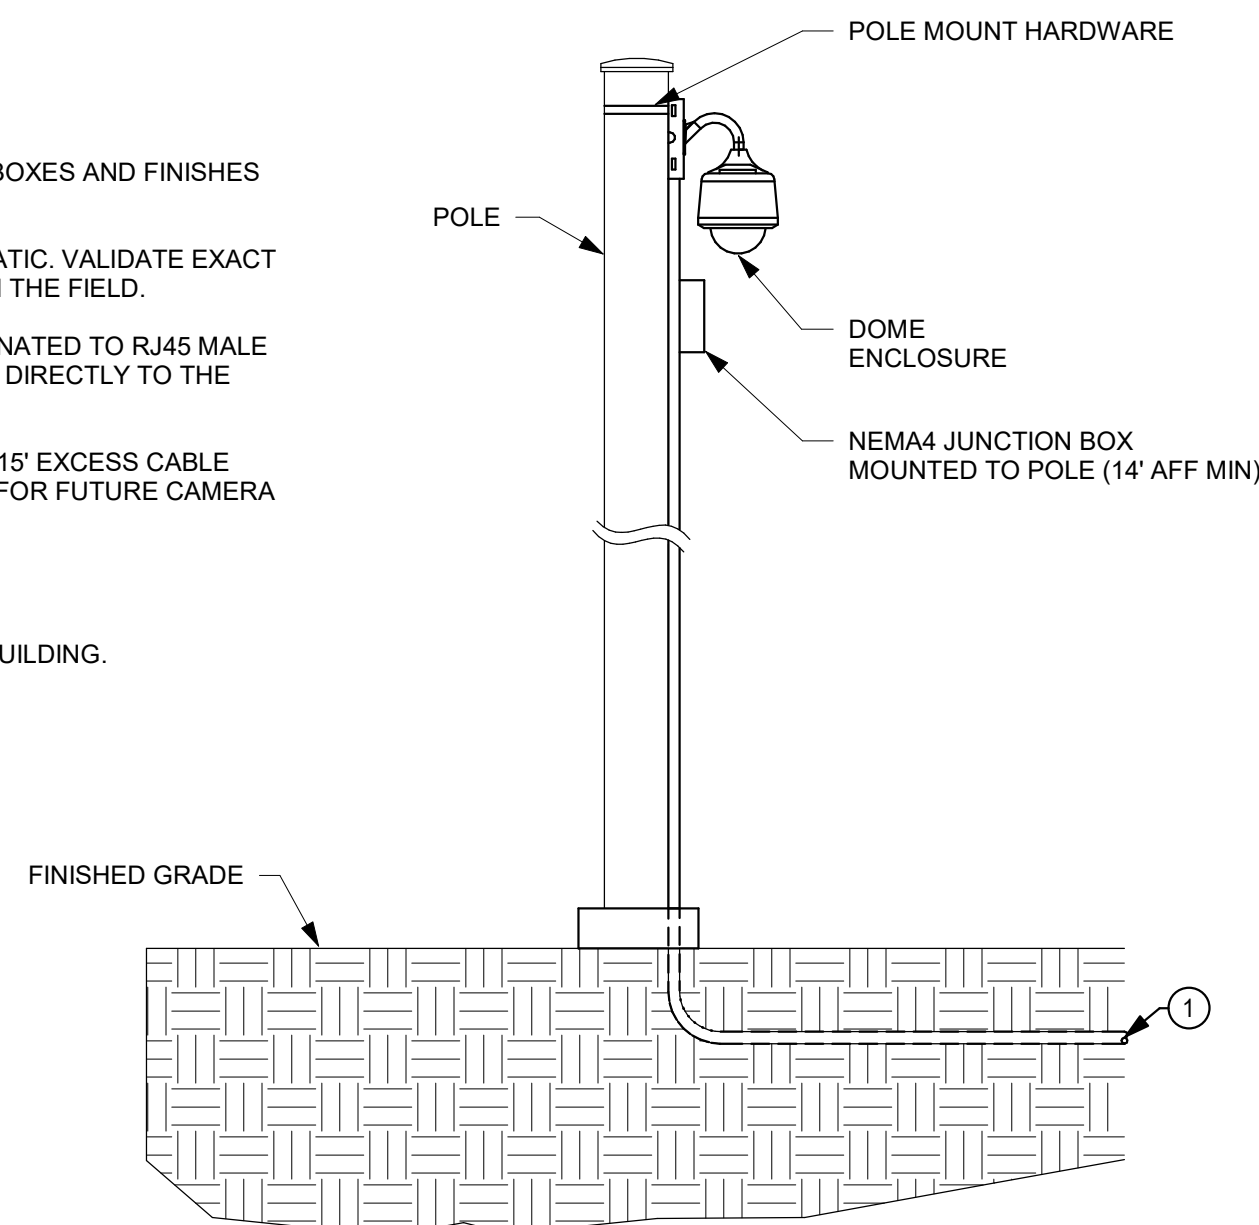
7 POLE MOUNT GOOSENECK NTS

- GENERAL NOTES:**
- A. PROVIDE WEATHER PROOF ENCLOSURE, FITTING, BACKBOX, CONDUIT, AND FINISHES.
 - B. MOUNTING DETAIL IS DIAGRAMATIC. VALIDATE EXACT MOUNTING CONDITIONS WITHIN THE FIELD.
 - C. NETWORK CONNECTION TERMINATED TO RJ45 MALE CONNECTOR AND TERMINATED DIRECTLY TO THE CAMERA.
 - D. CONTRACTOR SHALL PROVIDE 15' EXCESS CABLE COILED AT CAMERA LOCATION FOR FUTURE CAMERA FLEXIBILITY.

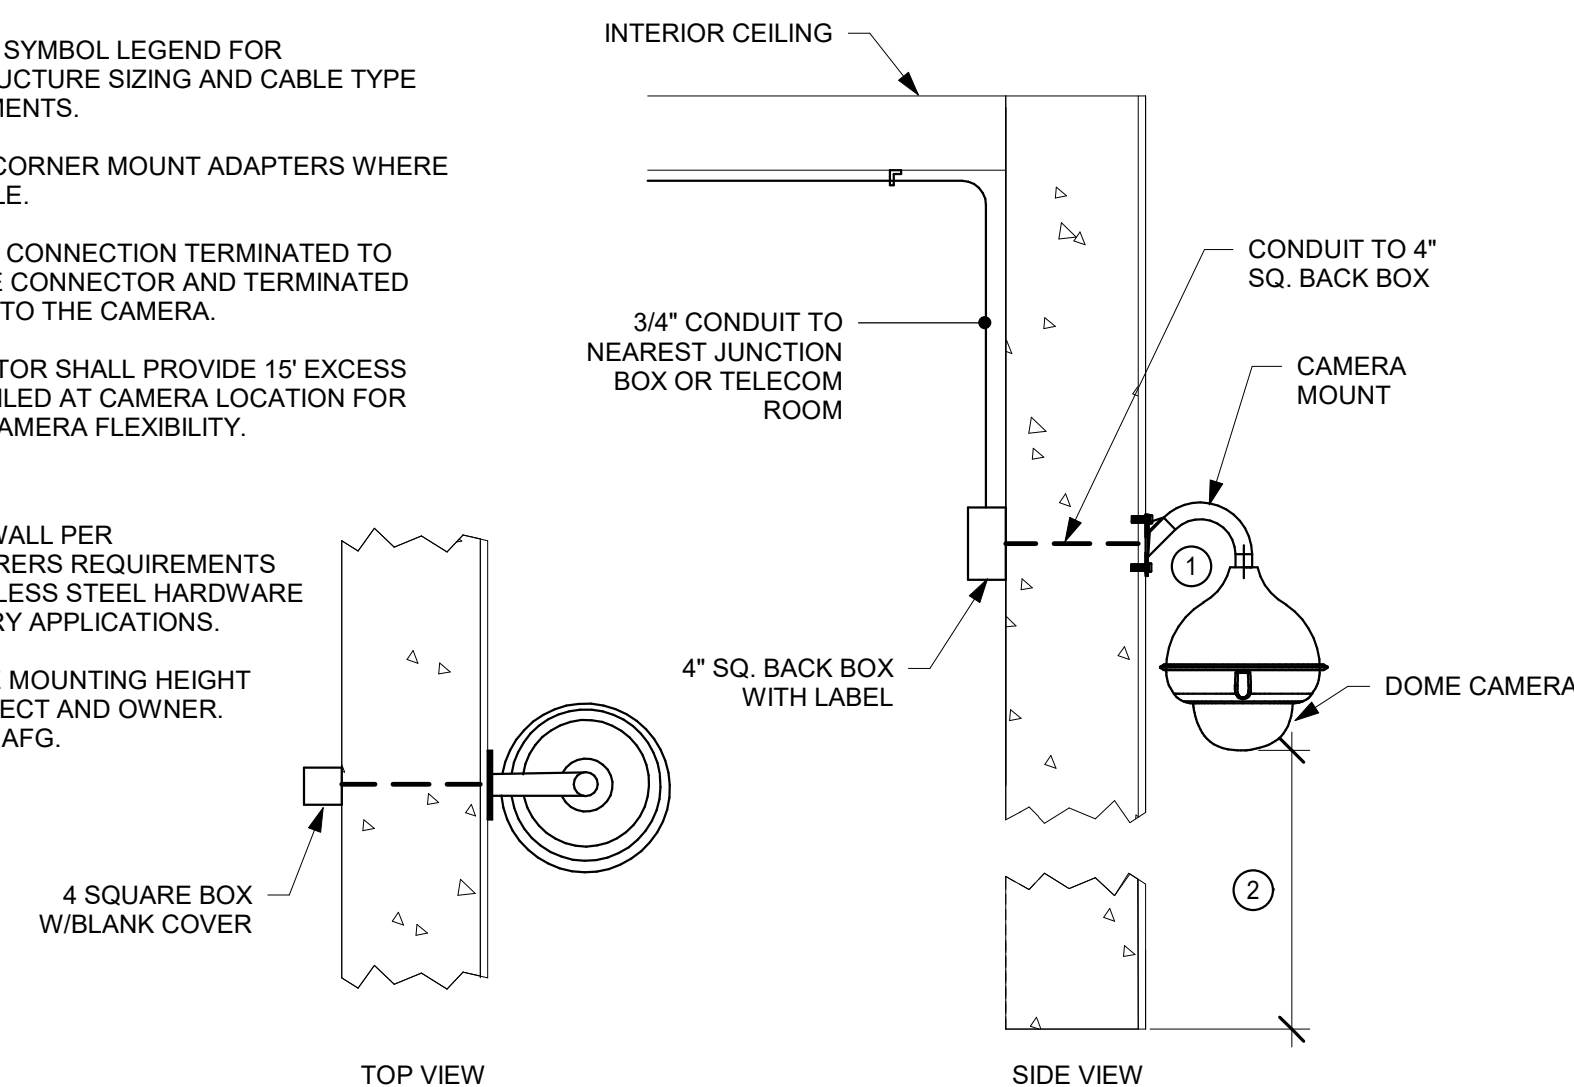
5 CAMERA - EXTERIOR WALL MOUNT NTS

- GENERAL NOTES:**
- A. REFER TO SYMBOL LEGEND FOR INFRASTRUCTURE SIZING AND CABLE TYPE REQUIREMENTS.
 - B. NETWORK CONNECTION TERMINATED TO RJ45 MALE CONNECTOR AND TERMINATED DIRECTLY TO THE CAMERA.
 - C. CONTRACTOR SHALL PROVIDE 15' EXCESS CABLE COILED AT CAMERA LOCATION FOR FUTURE CAMERA FLEXIBILITY.
- DRY WALL :** INSTALL BACKBOX AND ENSURE BACKBOX IS ANCHORED WITH #8 SCREWS.
- CONCRETE RATED WALL :** INSTALL BACKBOX AND ENSURE BACKBOX IS ANCHORED WITH 3/8" HILTI TZ EXPANSION ANCHOR WITH 2" EMBED (MIN.).
