**FINDING OF CONFORMANCE  
SUNSHINE CANYON LANDFILL—CITY/COUNTY PROJECT**

Quarterly  
Vegetation  
Project Status Report  
2nd Quarter 2009

## **Quarterly Vegetation Project Status Report**

**Second Quarter 2009**

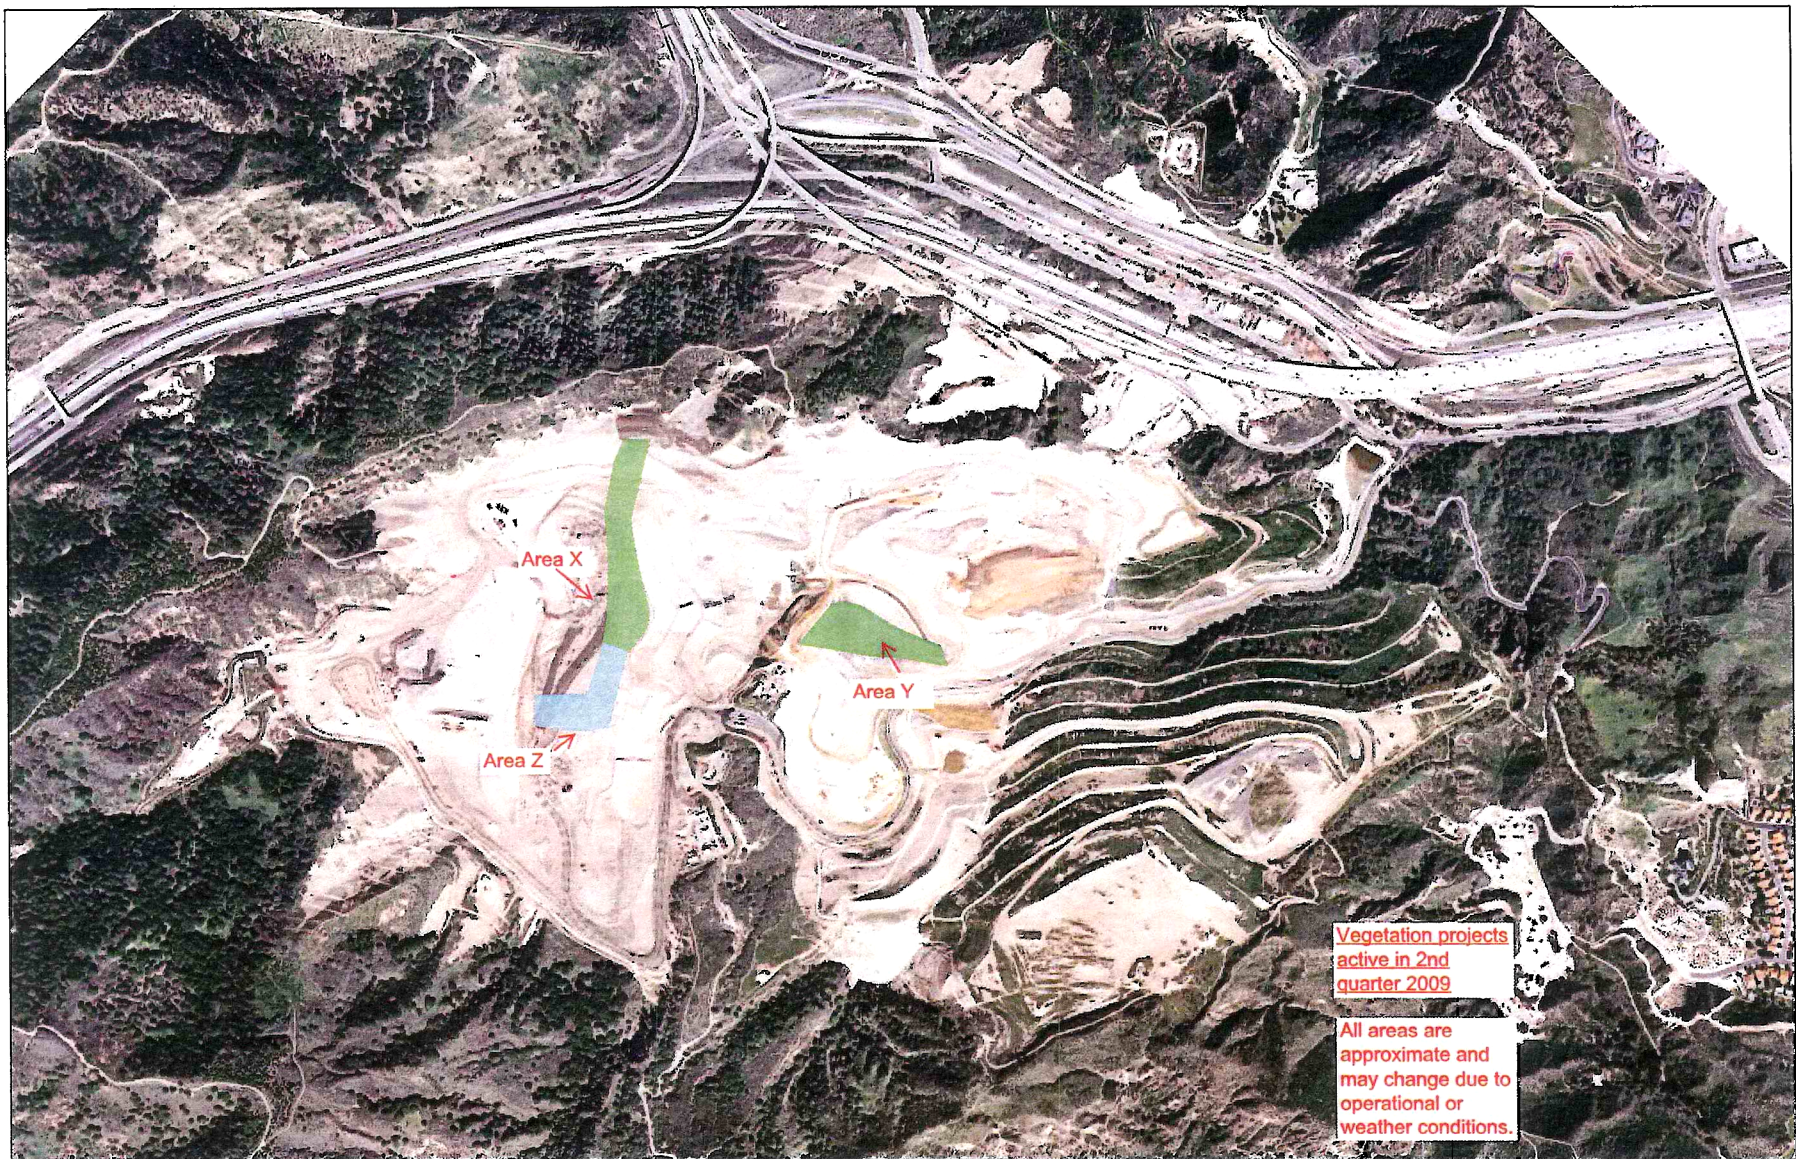
Area	Color Code	Installed By	Details	Status
X, Y		BFI	Interim Slopes. Two pass amendment and seed hydroseeding per Chamber's Plan, followed by greenwaste layer.	Completed July 2009.
Z		BFI	Interim Slopes. Greenwaste applied over previously seeded slopes.	Completed June 2009.

Vegetation projects  
active in 2nd  
quarter 2009

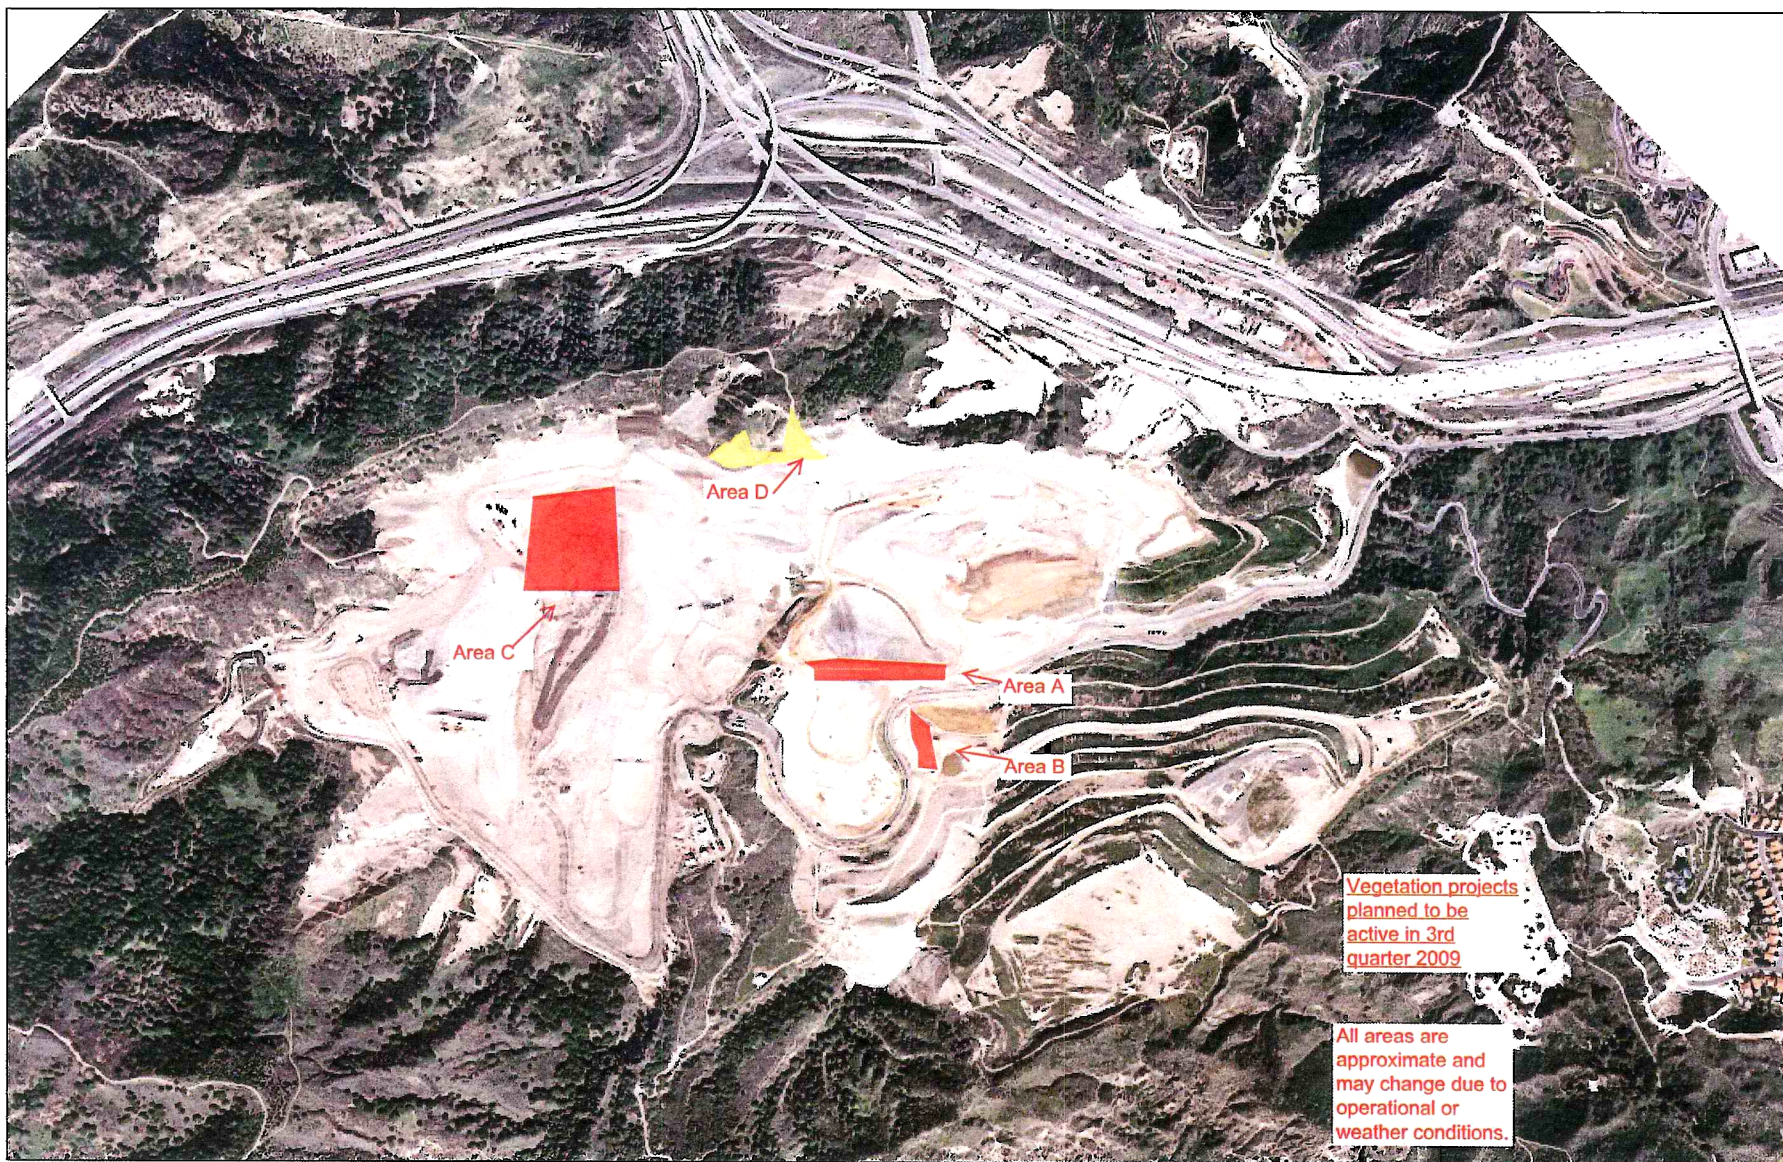
Area	Color Code	To be Installed by	Details	Status
A, B, C		BFI	Interim Slopes. Two pass amendment and seed hydroseeding per Chamber's Plan, followed by greenwaste layer.	Pending operations and weather conditions.
D		Contractor	Final cut slopes to be stabilized and seeded similar to Phase V area.	Develop scope of work and hire installation contractor in 3rd Quarter. Time permitting, begin installation.

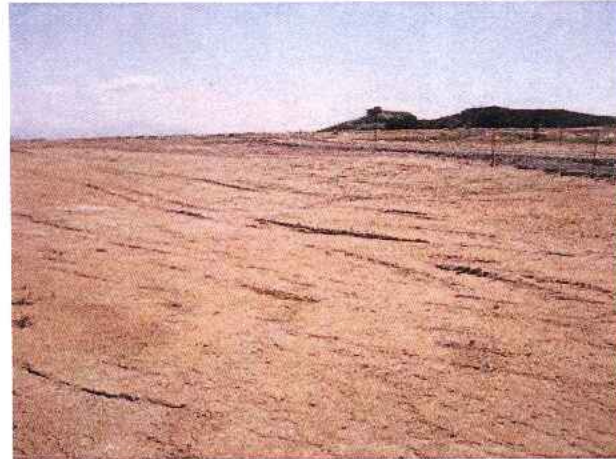
The seeds in the hydroseed mix are germinating. Seedlings of California poppy (*Eschscholzia californica*), goldfields (*Lasthenia californica*), California goldenbush (*Isocoma menziesii*) and milkvetch (*Astragalus* sp.) were observed on almost all the slopes and most areas of the top deck. Less germination was observed in areas on the top deck where soil is compacted.

Less germination was observed on the compacted soil on the top deck.

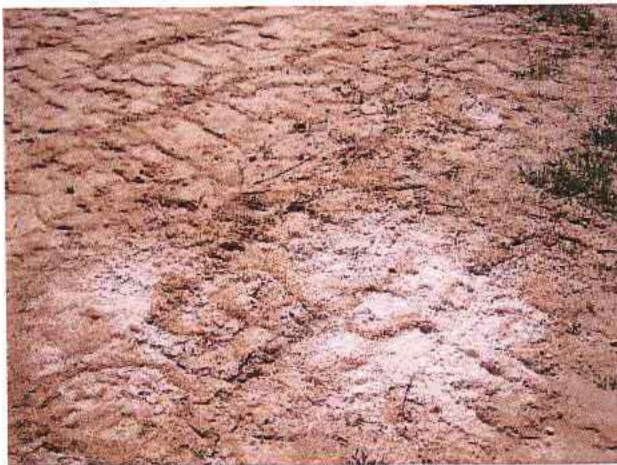
OVERALL NATIVE PLANT CONDITIONS			
<b>PLANT COVER:</b> <input type="checkbox"/> Dense <input checked="" type="checkbox"/> Moderate <input checked="" type="checkbox"/> Minimal	<b>PLANT HEALTH ISSUES</b> <input type="checkbox"/> Disease/pests <input type="checkbox"/> Plant stress <input type="checkbox"/> Excessive herbivory	<b>HEIGHT</b> <input type="checkbox"/> 0" – 12" <input checked="" type="checkbox"/> 12" – 24" <input type="checkbox"/> 24" +	<b>SPECIES RICHNESS</b> <input checked="" type="checkbox"/> Low <input type="checkbox"/> Medium <input type="checkbox"/> High
<b>COMMENTS:</b> <p>Pre-existing natives such as California sagebrush (<i>Artemisia californica</i>) and California goldenbush provided moderate cover of native plants on both the hillside and the top deck.</p> <p>Less germination and sparse growth of natives were observed on the top where soil is compacted. White deposits of salt were observed on some areas on the top deck.</p>

Salt deposits observed on the top deck.

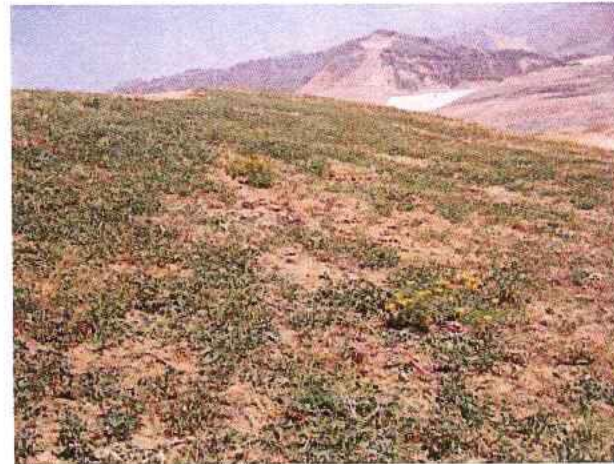
The slope that has been recently weeded is cleared of mature lamb's quarters (*Chenopodium album*).

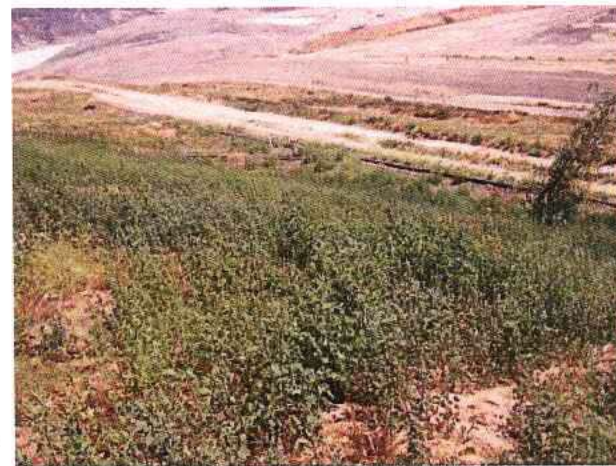
The slope that has not been recently weeded has abundant growth of lamb's quarters.

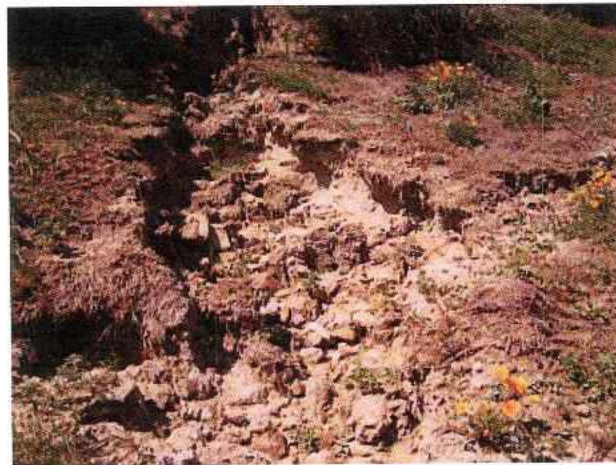
MISCELLANEOUS			
<b>CONDITIONS:</b> <input checked="" type="checkbox"/> Trash <input type="checkbox"/> Vandalism <input checked="" type="checkbox"/> Erosion			
<b>COMMENTS:</b> Two small gullies developed on one of the slopes. Several plastic bags were observed.

A gully was observed on one of the upper slopes.

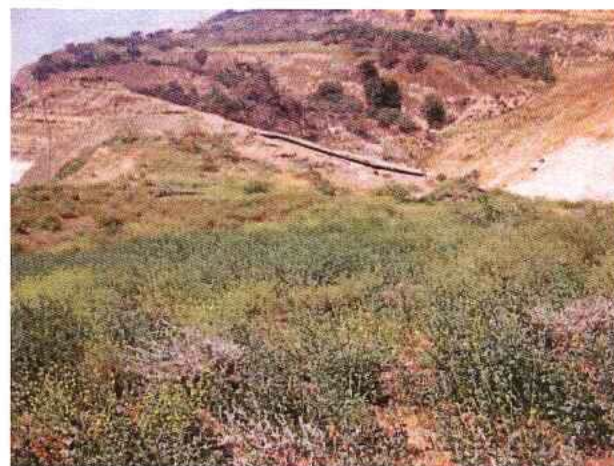
The slopes facing the office were infested with lamb's quarters and short-pod mustard (*Hirschfeldia incana*)

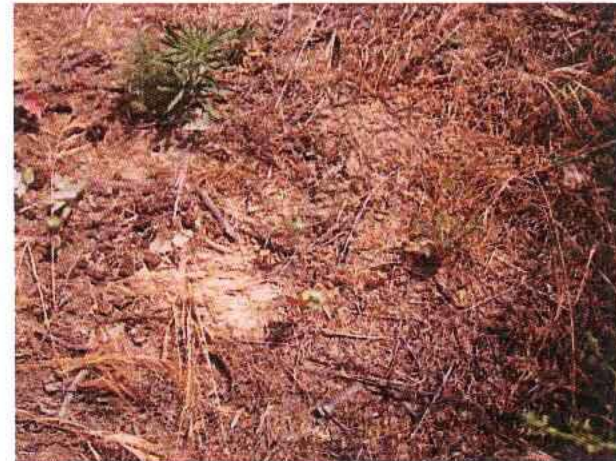
OVERALL NATIVE PLANT CONDITIONS			
<b>PLANT COVER:</b> <input type="checkbox"/> Dense <input checked="" type="checkbox"/> Moderate <input checked="" type="checkbox"/> Minimal	<b>PLANT HEALTH ISSUES</b> <input type="checkbox"/> Disease/pests <input type="checkbox"/> Plant stress <input type="checkbox"/> Excessive herbivory	<b>HEIGHT</b> <input type="checkbox"/> 0" – 12" <input checked="" type="checkbox"/> 12" – 24" <input type="checkbox"/> 24" +	<b>SPECIES RICHNESS</b> <input checked="" type="checkbox"/> Low <input type="checkbox"/> Medium <input type="checkbox"/> High
<b>COMMENTS:</b> Pre-existing natives looks healthy. California sagebrush ( <i>Artemisia californica</i> ) is turning grayish. Pre-existing deerweed ( <i>Lotus scoparius</i> ) and California buckwheat ( <i>Eriogonum fasciculatum</i> ), black sage ( <i>Salvia mellifera</i> ) and white sage ( <i>Salvia apiana</i> ) are flowering. Lots of horse weed ( <i>Conyza sp.</i> ) seedlings were observed. Dove weed ( <i>Eremocarpus setigerus</i> ) obtained noticeable growth since last visit. Most native plants from seedlings are healthy. However, several California poppy was chewed by animals.

A California poppy (*Eschscholzia californica*) was chewed by rabbits.

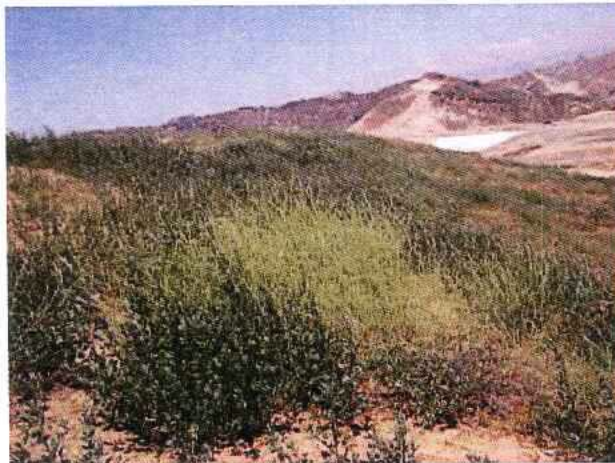
Lamb's quarters (*Chenopodium album*) and mustard (*Hirschfeldia incana*) that are out of control on one of the slopes.

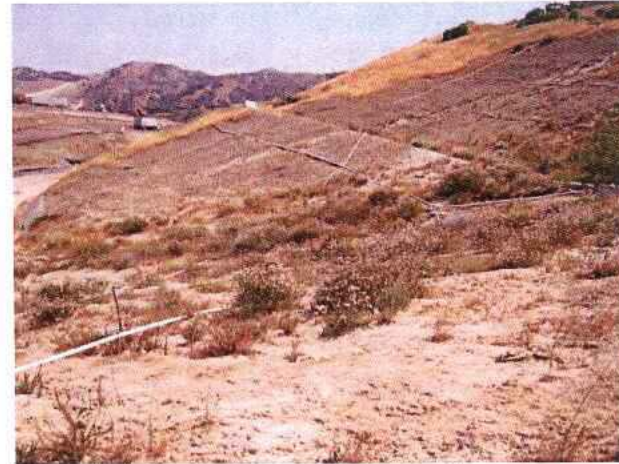
Substantial die-backs were observed in toxic soils that are located mainly on the southern and northern slopes. Several laurel sumac (*Malosma laurina*), needle grasses (*Nassella sp.*), and giant wild rye (*Leymus condensatus*) survived, but none of them has shown noticeable growth since the previous visit.

Southern slopes with toxic soils and minimal vegetation cover

OVERALL NATIVE PLANT CONDITIONS			
<b>PLANT COVER:</b> <input type="checkbox"/> Dense <input checked="" type="checkbox"/> Moderate <input checked="" type="checkbox"/> Minimal	<b>PLANT HEALTH ISSUES</b> <input type="checkbox"/> Disease/pests <input checked="" type="checkbox"/> Plant stress <input type="checkbox"/> Excessive herbivory	<b>HEIGHT</b> <input checked="" type="checkbox"/> 0" – 12" <input checked="" type="checkbox"/> 12" – 24" <input type="checkbox"/> 24" +	<b>SPECIES RICHNESS</b> <input type="checkbox"/> Low <input checked="" type="checkbox"/> Medium <input type="checkbox"/> High
<b>COMMENTS:</b> <p>The native plant cover was medium to high on the lower slope near the center. Deer weed (<i>Lotus scoparius</i>), California buckwheat (<i>Eriogonum fasciculatum</i>), and California poppy (<i>Eschscholzia californica</i>) are flowering.</p> <p>The native plant cover was minimal on the southern and northern slopes. Plants that established in erosion rills, flat areas, and areas around sprinklers are mature now. These areas have received enough water for sufficient leaching of excessive salts which prevents plants from germination and growth. A field trial of soil amendments is recommended on those barren slopes to help native plants establish themselves.</p>

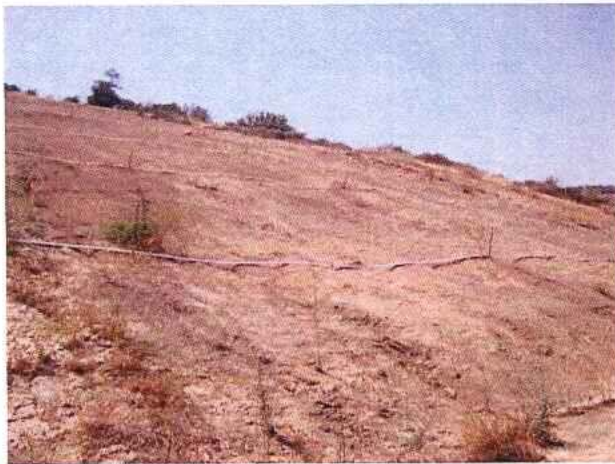
Northern slopes with toxic soils and minimal vegetation cover

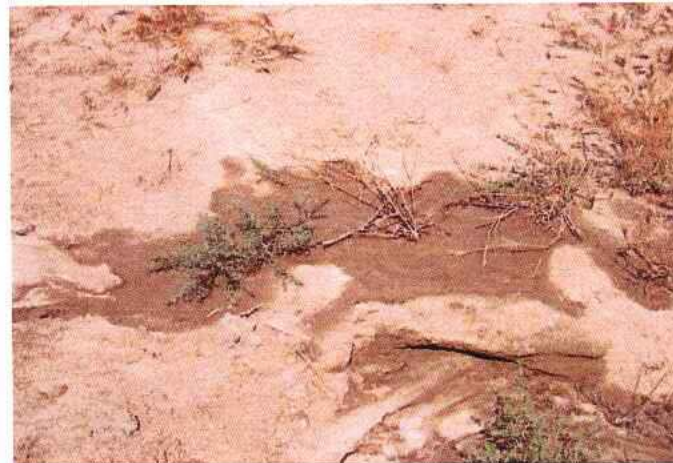
Wet spots caused by leaking pipes or sprinklers

<b>IRRIGATION SYSTEM</b>	
<b>REPAIRS NEEDED:</b>  <div style="display: flex; justify-content: space-between;"> <div style="width: 45%;"> <input type="checkbox"/> Over-irrigation  <input type="checkbox"/> Under-irrigation (last 2-3 weeks)  <input type="checkbox"/> Inoperative head </div> <div style="width: 45%;"> <input checked="" type="checkbox"/> Inoperative controller  <input checked="" type="checkbox"/> Leaking components  <input type="checkbox"/> Damaged components </div> </div>	<b>WAYPOINTS:</b>  
<b>COMMENTS:</b> The irrigation system was not working well during this site visit. Some leakage was observed.	
<b>MISCELLANEOUS</b>	
<b>CONDITIONS:</b>  <input type="checkbox"/> Trash <input type="checkbox"/> Vandalism <input checked="" type="checkbox"/> Erosion	
<b>COMMENTS:</b> Erosion problems mentioned in several previous reports are still threatening to become worse during the next rainy season.  Erosion rills developed around the leaking pipes and sprinklers. Application of wood chips, compost, or erosion blanket will help to decrease the velocity of water flow, increase water infiltration rate, and boost leaching of excessive salts, which will potentially improve soil properties for plant growth.  No vandalism and minimal trash was observed.

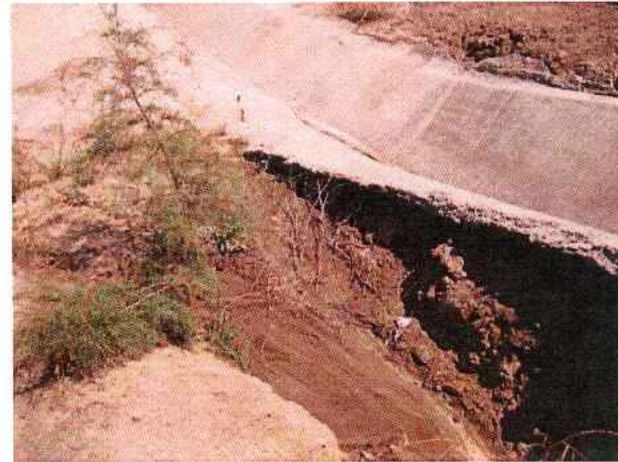
A fennel (*Foeniculum vulgare*) is growing on the erosion ridge caused by the leaking sprinklers or pipes
