SUNSHINE CANYON LANDFILL

Re: BFI Sunshine Canyon Landfill Status Report, 2nd Quarter 2010

Quarterly Vegetation Project Status Report

Second Quarter 2010

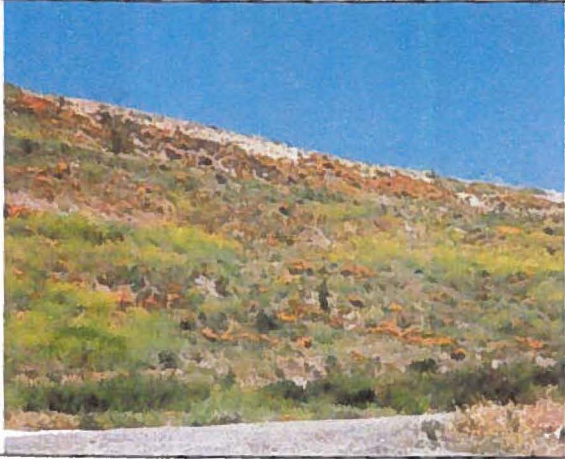
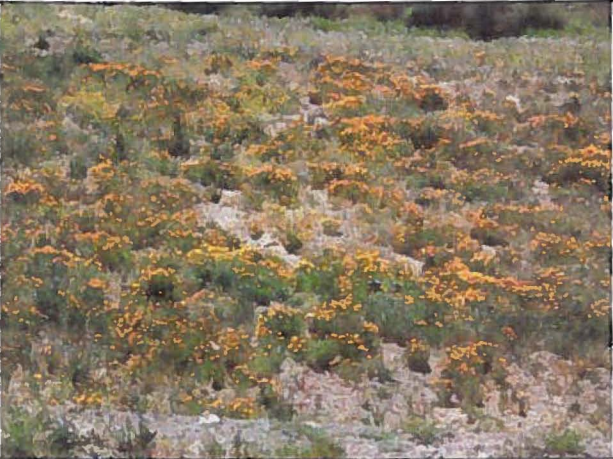
<p>Native plants are becoming increasingly evident on city-side slopes .</p>	<p>Native patches include several species but are visually dominated by California poppy.</p>

I recommend regular mowing during the next rainy season to allow natives to spread further. If the current program is applied faithfully there is every reason to expect that the city-side slope will become dominated by natives rather than weeds.

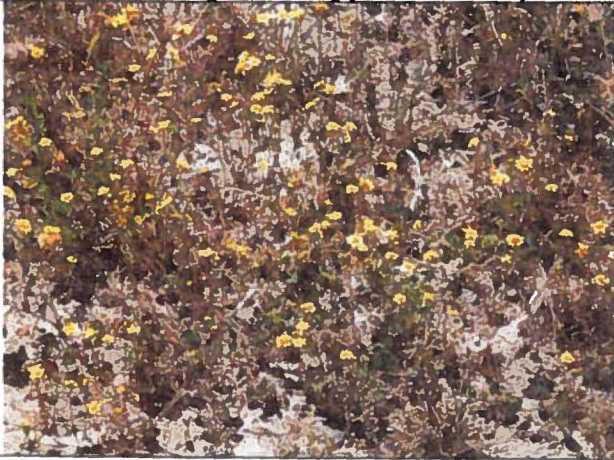
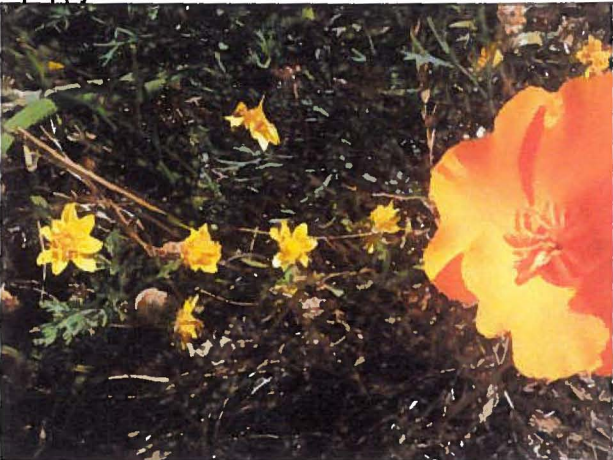
<p>An area of the top deck is shown here with native wildflowers getting ready to set seed. Most of the native vegetation on the top deck consisted of annuals rather than shrubs.</p>	<p>Native plant patches on the slopes have become mycorrhizal, apparently aided by extensive weed trimming.</p>

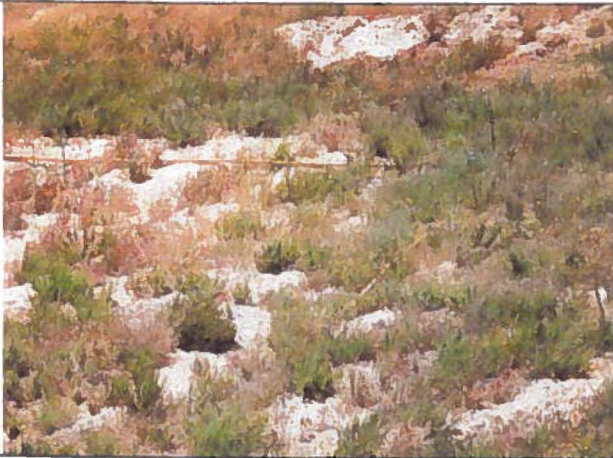
There has been little change since March on the county-side slopes except that some annual weeds have died for the season.

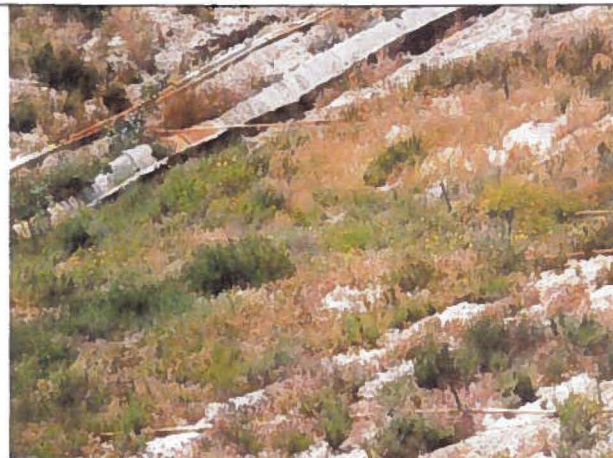
Within vegetation patches native vegetation appears destined to thoroughly replace the remaining weeds.

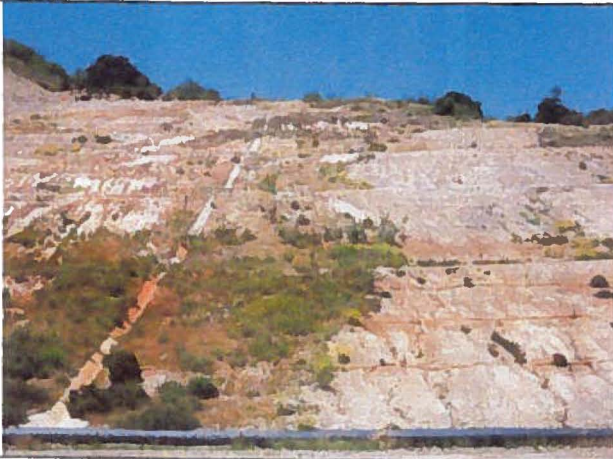
Some portions of the hillside appear to be absolutely resistant to plant growth of any kind.

County: As noted, test plots are installed and work continues to find a solution, if possible, to the difficult soil areas on the slope.

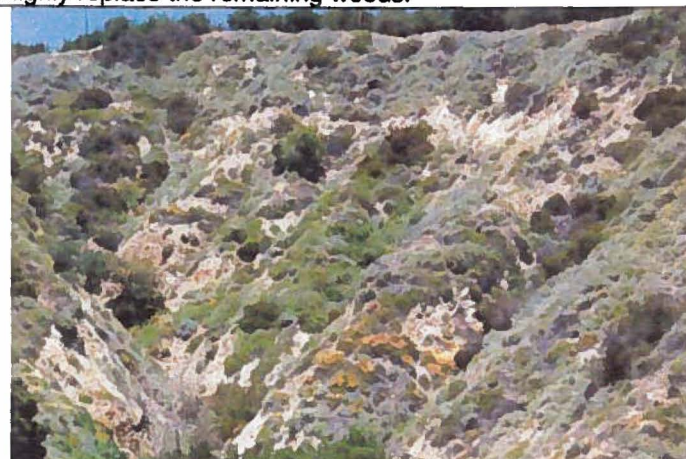
The exposed areas of unvegetated soil appear not only on cut slopes, but also on nearby undisturbed slopes.

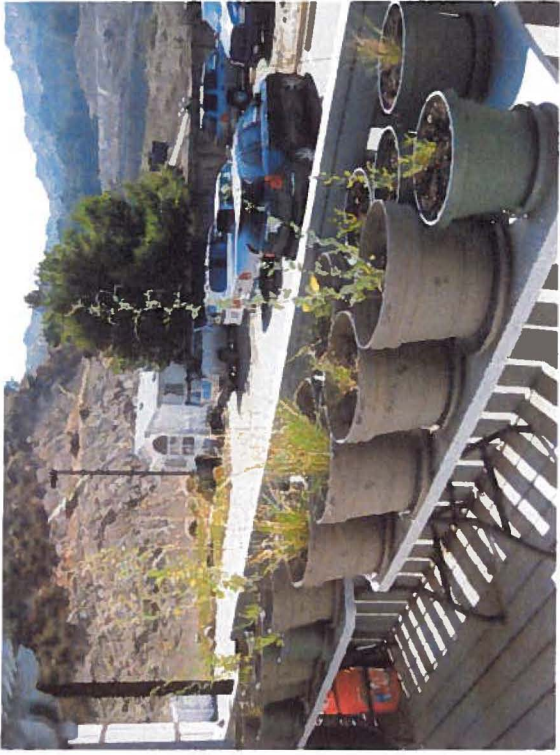
Test Pots

In addition, the site began testing some salt-tolerant plants in pots of the difficult soil from the County Sage Slope. Some of the pots were left untreated, and some were treated with amendments. The plants will be monitored to see if a certain sage-compatible species does well in the soil that has presented challenges so far.

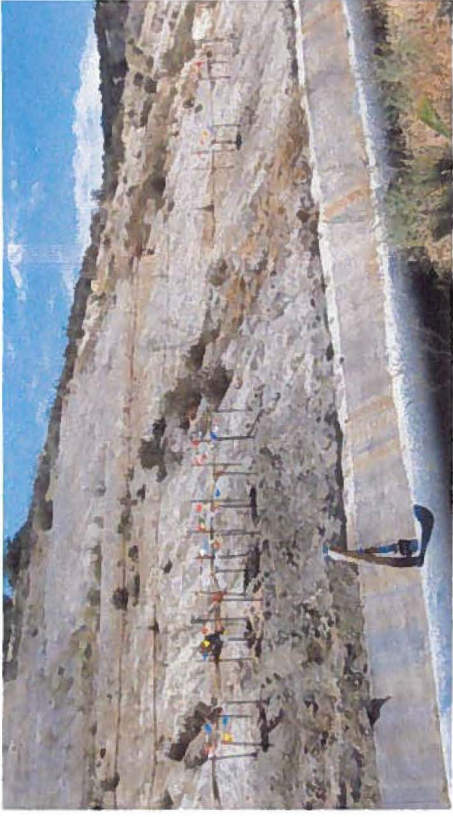
Test Plots on Slope

On the County Sage Slope, test plots were installed in areas of problematic soils. These plots were designed by Dr. Ted St. John of AECOM, and were described in a May 4, 2010 letter report from AECOM (see Appendix B.) The plots were physically treated in three different ways that may help mitigate for the salts occurring in the soils:

- 1) Wood chips under jute mat
- 2) Trench to catch washed soil
- 3) Ridges to facilitate salt wicking

There are three replicates of each treatment on the slope. Soil monitoring will occur quarterly for one year to determine the effects on salinity.
