SUNSHINE CANYON LANDFILL

Re: Sunshine Canyon Landfill Status Report, 3rd Quarter 2010

Quarterly Vegetation Project Status Report

Third Quarter 2010

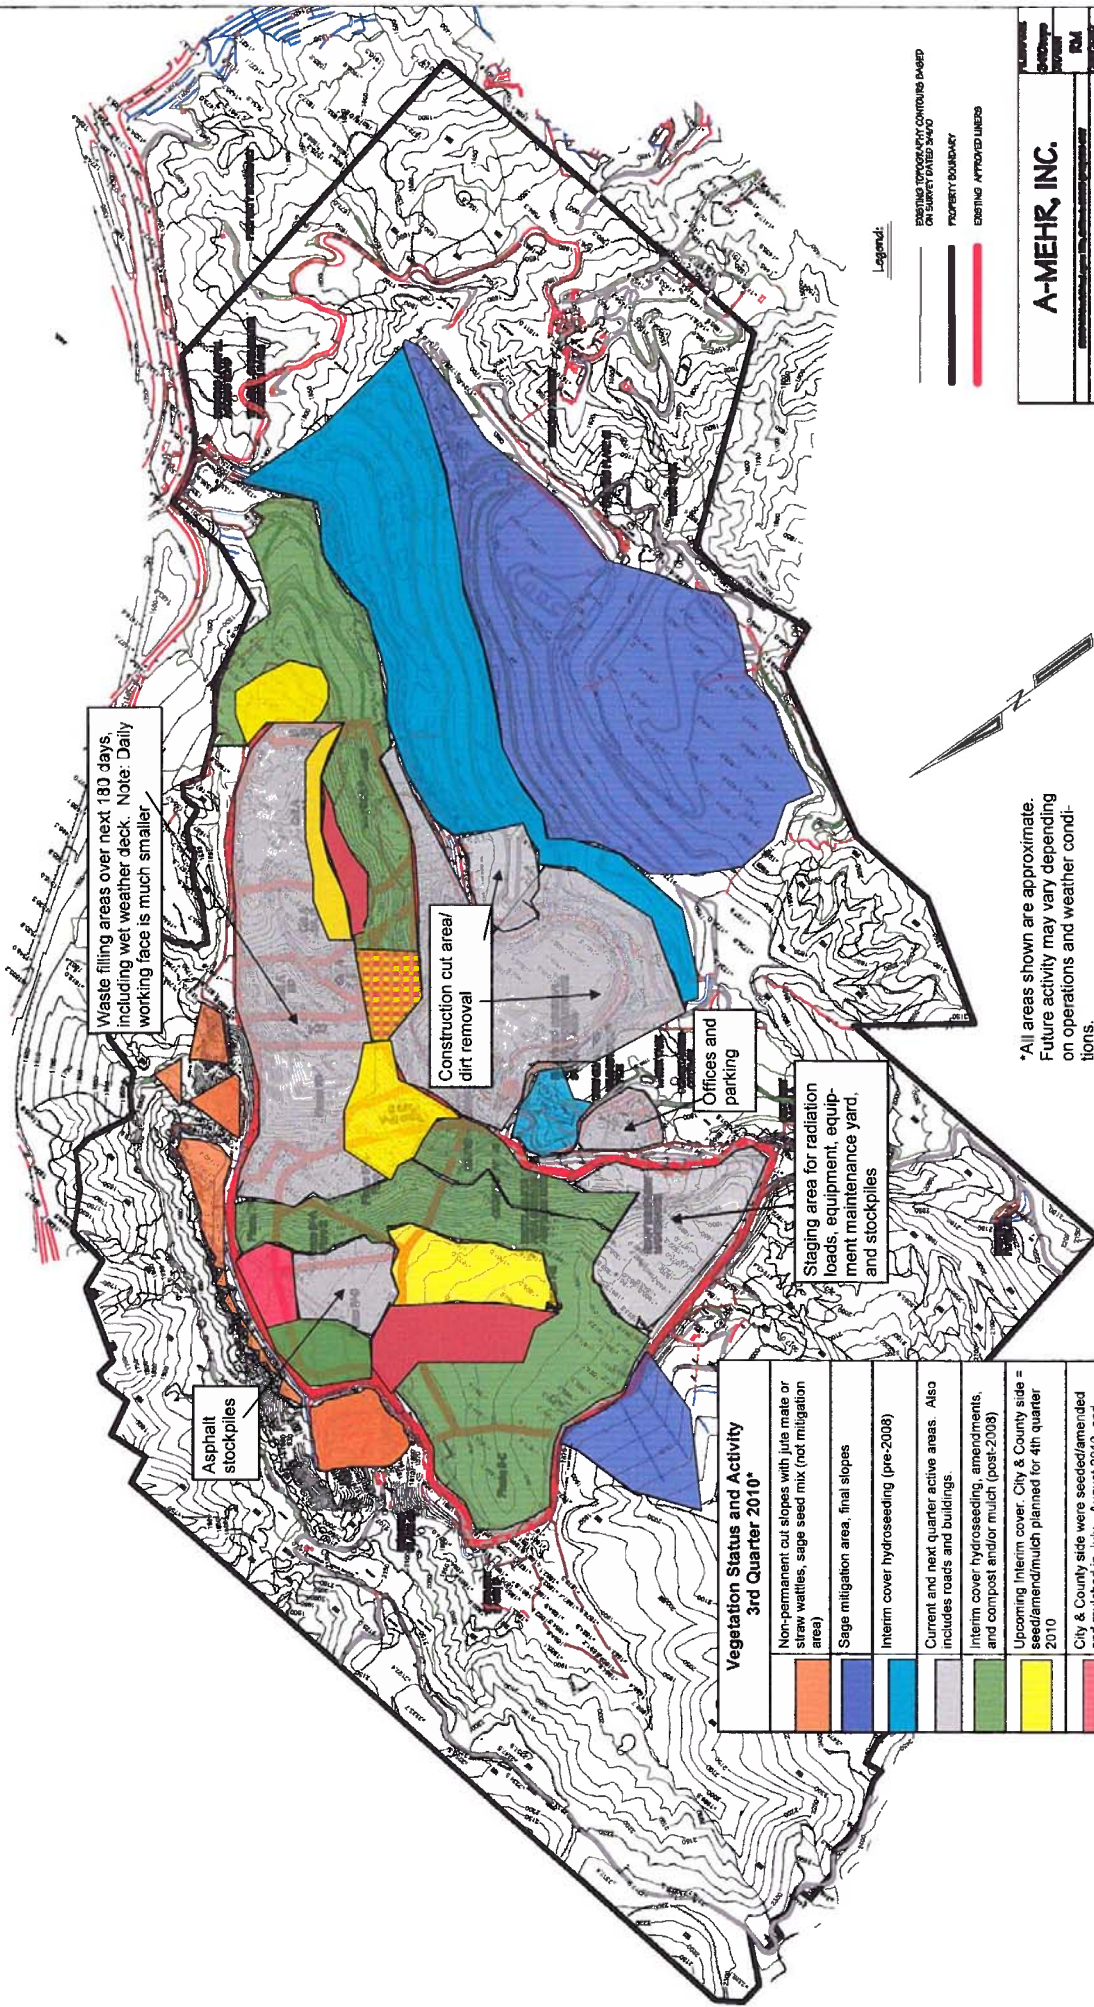
Appendix A

The site seeded, amended and mulched the areas shown in pink (see map in Appendix A) on the City and County side in July – August 2010, with the exception of one area that is close to the City-County boundary line, that was only seeded (pink/yellow-checker). This is currently being amended and mulched (October 2010). The areas shown in green were seeded, amended and mulched again during the 3rd Quarter 2010.

The site is projecting that the areas shown in yellow (see map in Appendix A) on the City and County side are the only unvegetated slopes that will be inactive for greater than 180 days. In the 4th quarter of 2010 these slopes will be seeded, amended and mulched per Chambers' 1/08 plan. As stated above, the area shown in pink/yellow-checker, on the City Side, has already been seeded, and will be amended and mulched in the 3rd Quarter 2010.

As shown on the map in Appendix A, all areas of the landfill have been vegetated with the exception of the active areas, roadways, and buildings. Vegetative treatments meet both industry standards and the vegetation plans in place at the time plantings were conducted. Due to the dry conditions, at the present time most vegetation is dormant and will likely remain so except when winter rains are plentiful. Current and planned activities are described in previous sections of this report.

Vegetation Status and Activity 3rd Quarter 2010*	
	Non-permanent cut slopes with jute mat or straw wattles, sage seed mix (not mitigation area)
	Sage mitigation area, final slopes
	Interim cover hydroseeding (pre-2008)
	Current and next quarter active areas. Also includes roads and buildings.
	Interim cover hydroseeding, amendments, and compost and/or mulch (post-2008)
	Upcoming interim cover. City & County side = seed/amend/mulch planned for 4th quarter 2010
	City & County side were seeded/amended and mulched in July–August 2010, and mulch was added in the 3rd quarter 2010.
	City & County side was seeded in the 3rd quarter 2010, and will be amended and mulched in the 4th quarter 2010
Note: Balance of property is native and/or mitigation tree plantings.

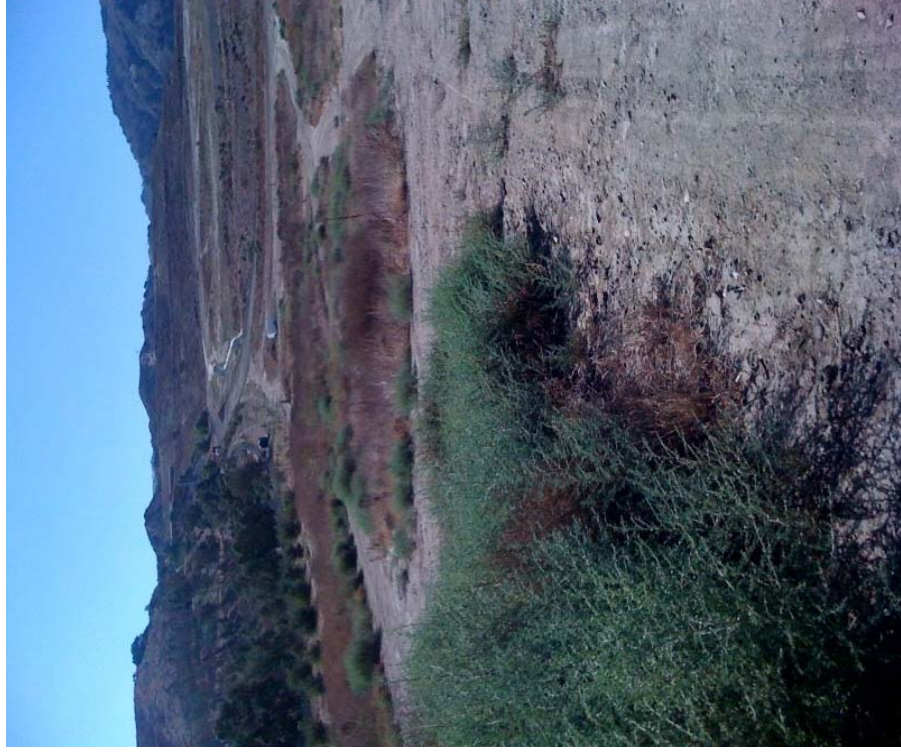
Photo 1. Facing west at lower deck of vegetated areas dominated by non-natives weeds and barron areas consisting of compacted and heavily disturbed soils.

Comments:	
RECOMMENDATIONS	
<p>Maintain a regular weed control program to control and eventually reduce weed species. Weed control should occur quarterly at minimum and always prior to flowering or setting seed. Weed control should be initiated immediately to remove Russian thistle and other non-natives that are in a vegetative state (those that are green as opposed to dormant) and shading small natives. Hand weeding methods should be performed around native species to reduce potential of impacting natives and to reduce shading and competition. Initial weeding activities should be monitored by a biologist and representative sample of natives to be preserved should be flagged by a biologist.</p> <p>Incorporate a soil amendment or mulch with high organic content by tilling into the top 6 inches of the existing compacted soils to improve soil texture, drainage, porosity, and aerobic conditions. Analyze existing soil for nutrient content and any toxins and identify amendment needs. Apply seed (by means of broadcast seeding or hydroseeding) to amended/mulched areas, slopes, and within existing vegetated areas prior to seasonal rains. Amend seed mix with species tolerant of disturbed and poor soil conditions. Install erosion control measures (such as mulches, blankets, jute netting, flexible growth medium, straw waddles) on slopes to reduce soil erosion, retain native seed coverage, and improve the native germination rate. Install fencing with appropriate signage and conduct an</p>

- 1) Weed Control: A contract has been set up with a vendor for on-call weed abatement services to be conducted by crews trained to work amongst the native plants.

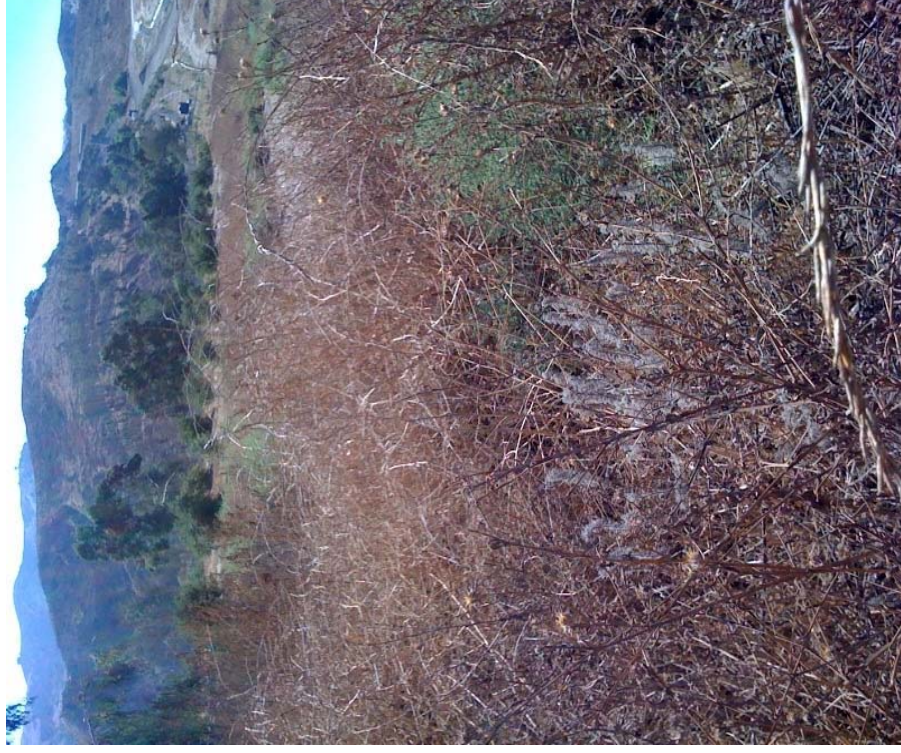
Photo 2. View of native *Phacelia* sp. within the lower deck that is surrounded by non-native mustard and Russian thistle.

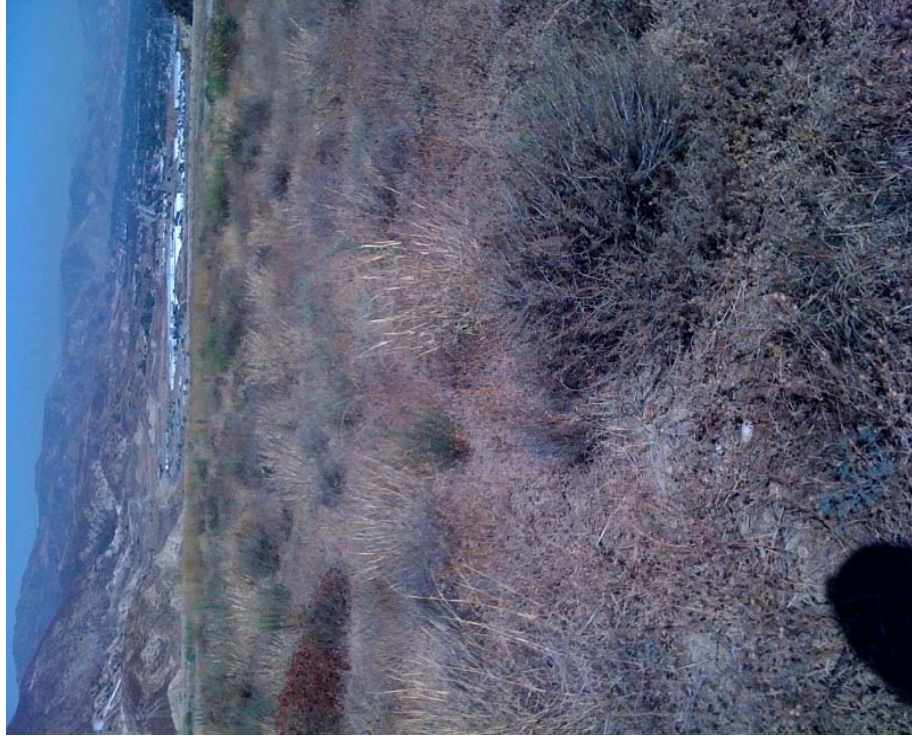
Photo 3. Facing east at middle deck of vegetated areas consisting of good native species composition. Presence of non-native species is less at middle deck compared to the lower and upper decks.

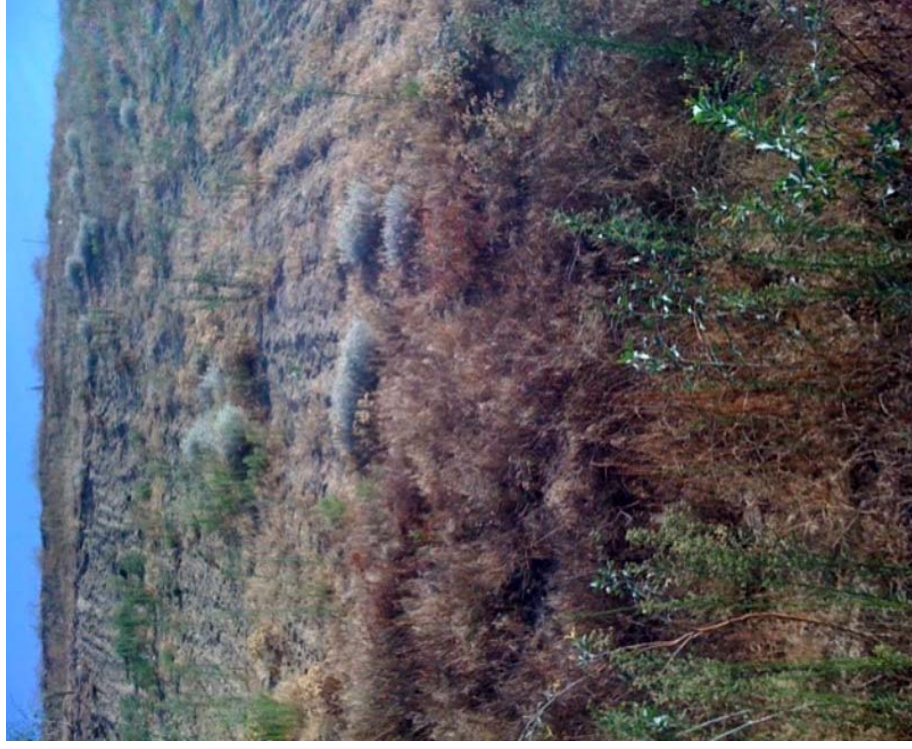
Photo 4. Facing south at north-facing bench below upper deck. Native plants have established and are often taller than non-natives; however, brome grasses and other weeds are co-dominant.

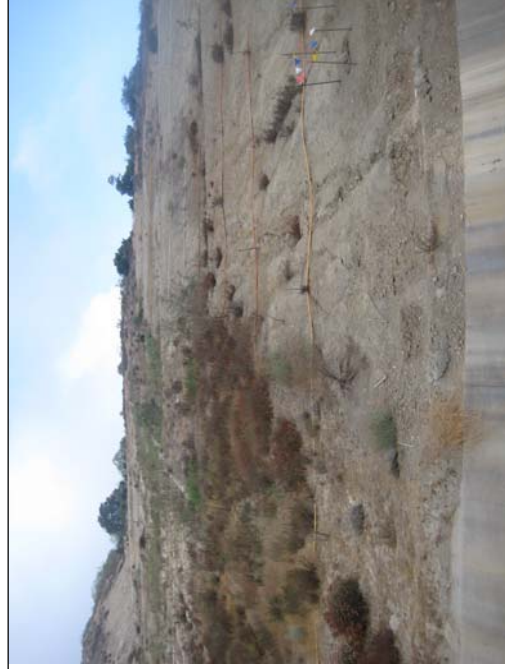
Photo 1. Facing west at established coastal sage scrub and adjacent areas where germination and establishment has been problematic.

MISCELLANEOUS		
Conditions:	<input type="checkbox"/> Trash	<input type="checkbox"/> Vandalism
Comments:	<input type="checkbox"/> Erosion	
<p>RECOMMENDATIONS</p> <p>Maintain a regular weed control program to control and eventually reduce weed species. Weed control should occur quarterly at minimum and always prior to flowering or setting seed. Weed control should be initiated immediately to remove Russian thistle and other non-natives that are in a vegetative state (those that are green as opposed to dormant) and shading small natives. Hand weeding methods should be performed around native species to reduce potential of impacting natives and to reduce shading and competition. Initial weeding activities should be monitored by a biologist and representative sample of natives to be preserved should be flagged by a biologist.</p> <p>Incorporate a soil amendment or mulch with high organic content in select areas as determined by the restoration specialist (avoid rocky areas that are hydrophobic). If feasible, identify areas that are visible from public view sheds. Apply seed (by means of broadcast seeding or hydroseeding) to amended/mulched areas and within existing vegetated areas prior to seasonal rains. Amend seed mix with species tolerant of disturbed and poor soil conditions. Install erosion control measures (such as mulches, blankets, burlap netting, flexible growth medium, straw waddles) on slopes to reduce soil erosion, retain native seed coverage, and improve the native germination rate. Install signage and conduct an employee awareness program to inform staff on the importance of preserving restoration areas.</p>

- 3) Erosion Control: SCL has contracted a landscaping company to install physical erosion control improvements to the County Sage slope beginning on October 14, 2010. The landscape company will be using a combination of sand bags, straw wattles and re-grading the benches to direct run-off into the concrete drainage channel. Disturbed areas will be re-seeded if necessary.

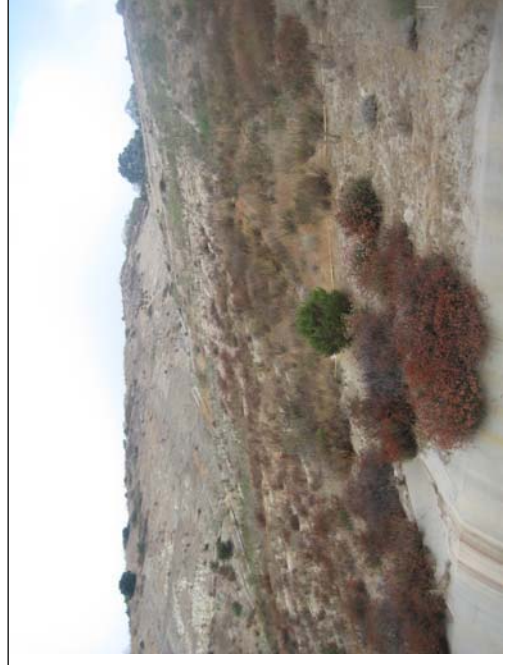
Photo 2. Facing southwest at coastal sage scrub dominated with California buckwheat on the County sage slopes.

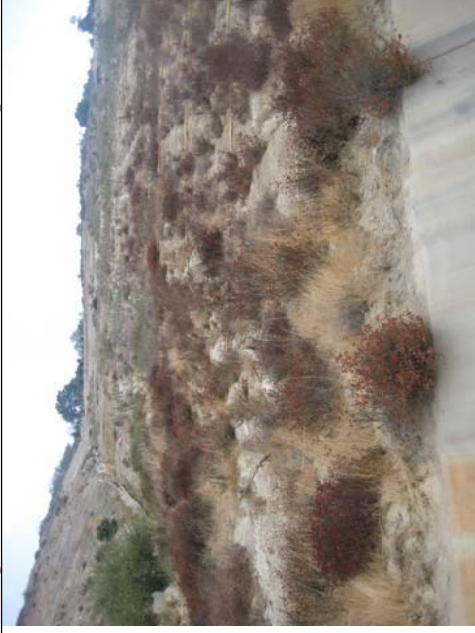
Photo 3. Facing west at coastal sage scrub dominated with California buckwheat on the county sage slopes.

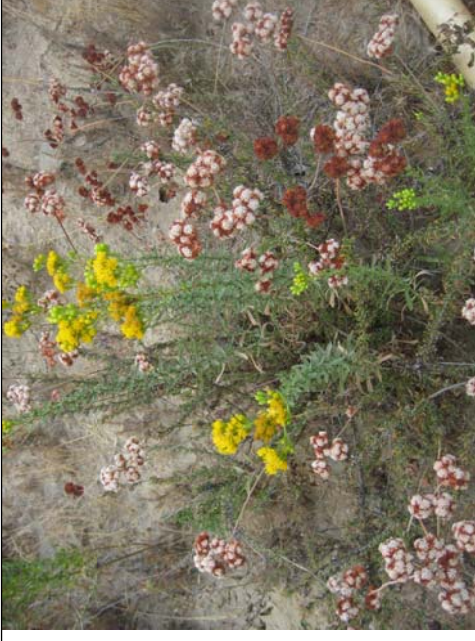
Photo 4. View of native species that have successfully established on the county sage slopes.

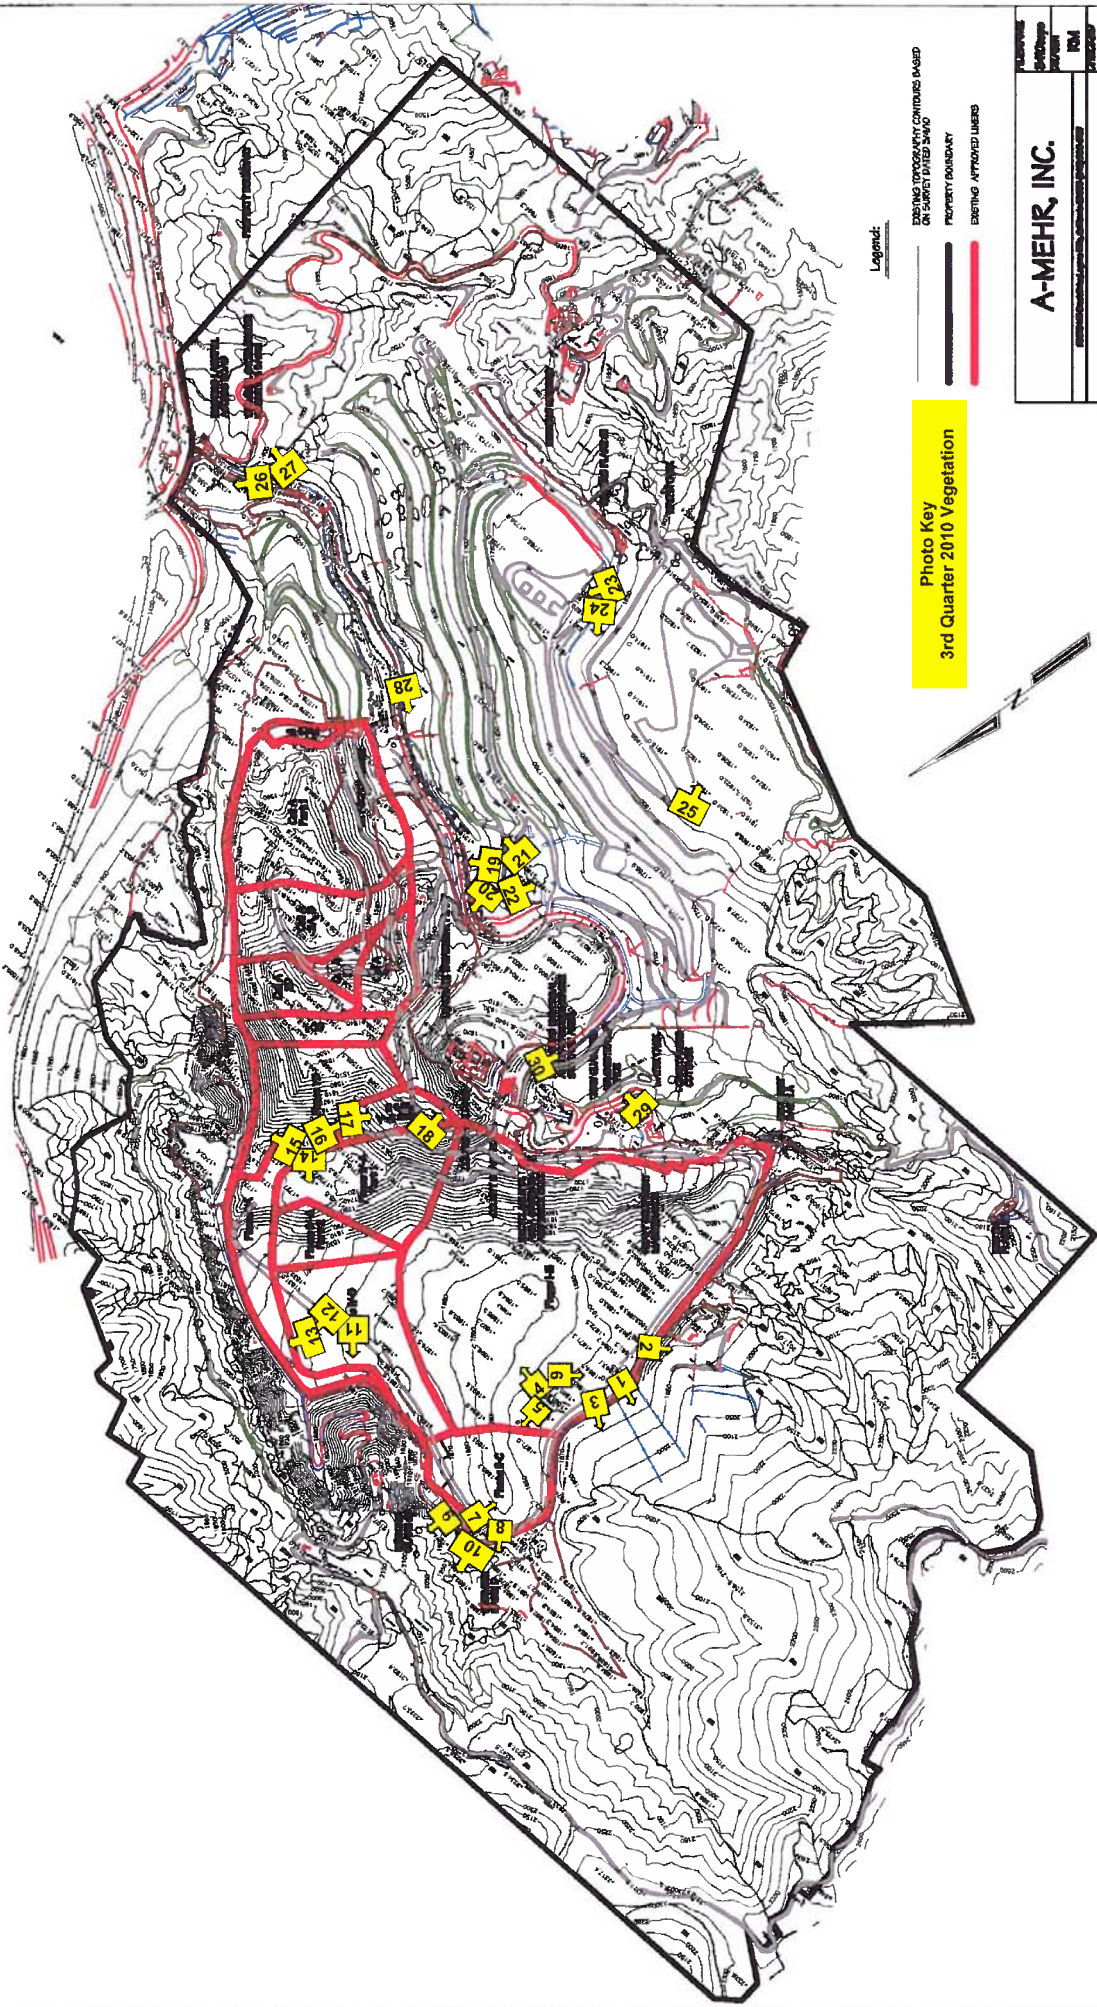
Photo Key
3rd Quarter 2010 Vegetation

Pictures illustrating samples of the different vegetated areas on site are provided in Appendix E.
