Re: BFI Sunshine Canyon Landfill Status Report, 1st Quarter 2010

Quarterly
Vegetation
Project Status Report

First Quarter 2010

PROGRESS REPORT
for the Sunshine Canyon Landfill Mitigation Sites
City Side Mitigation Area
Prepared by AECOM
on behalf of Browning-Ferris Industries and Compliance Plus.

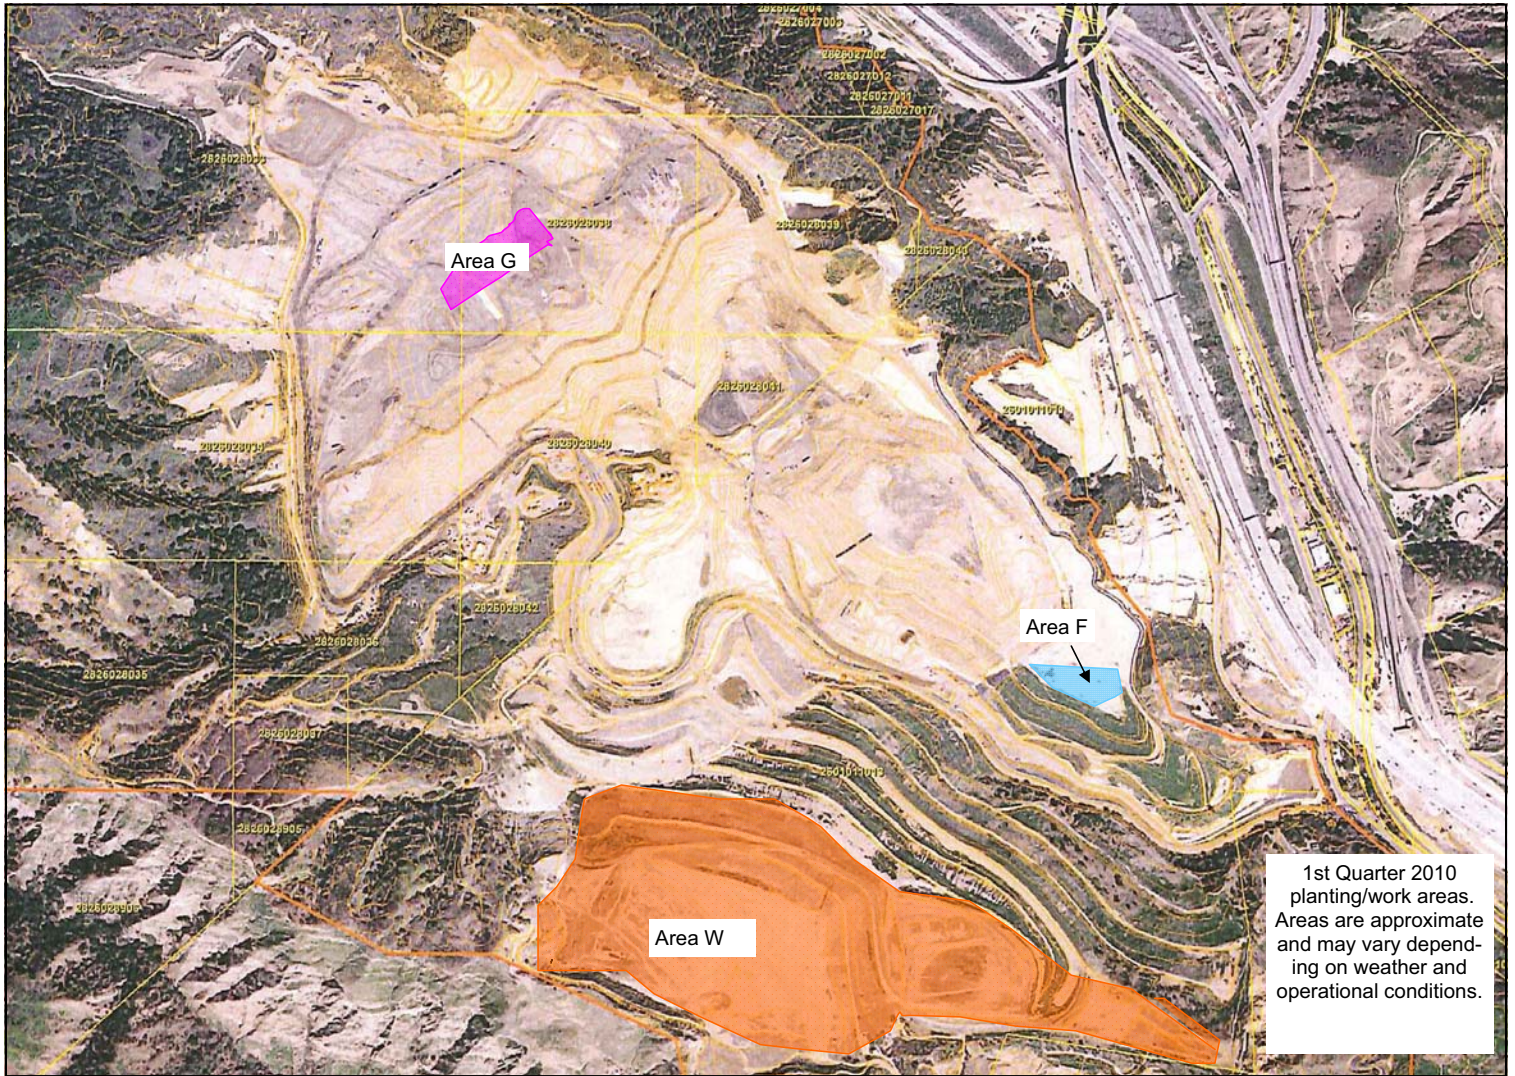
Area	Color Code	Completed By	Details	Status
F		SCL	Interim Slopes. Previously seeded. Greenwaste mulch applied.	Completed
G		SCL	Interim Slopes. Greenwaste mulch applied.	Completed
W		LDI	Sage Slopes. Non-native weed abatement.	Completed

1st Quarter 2010
planting/work areas.
Areas are approximate
and may vary depend-
ing on weather and
operational conditions.

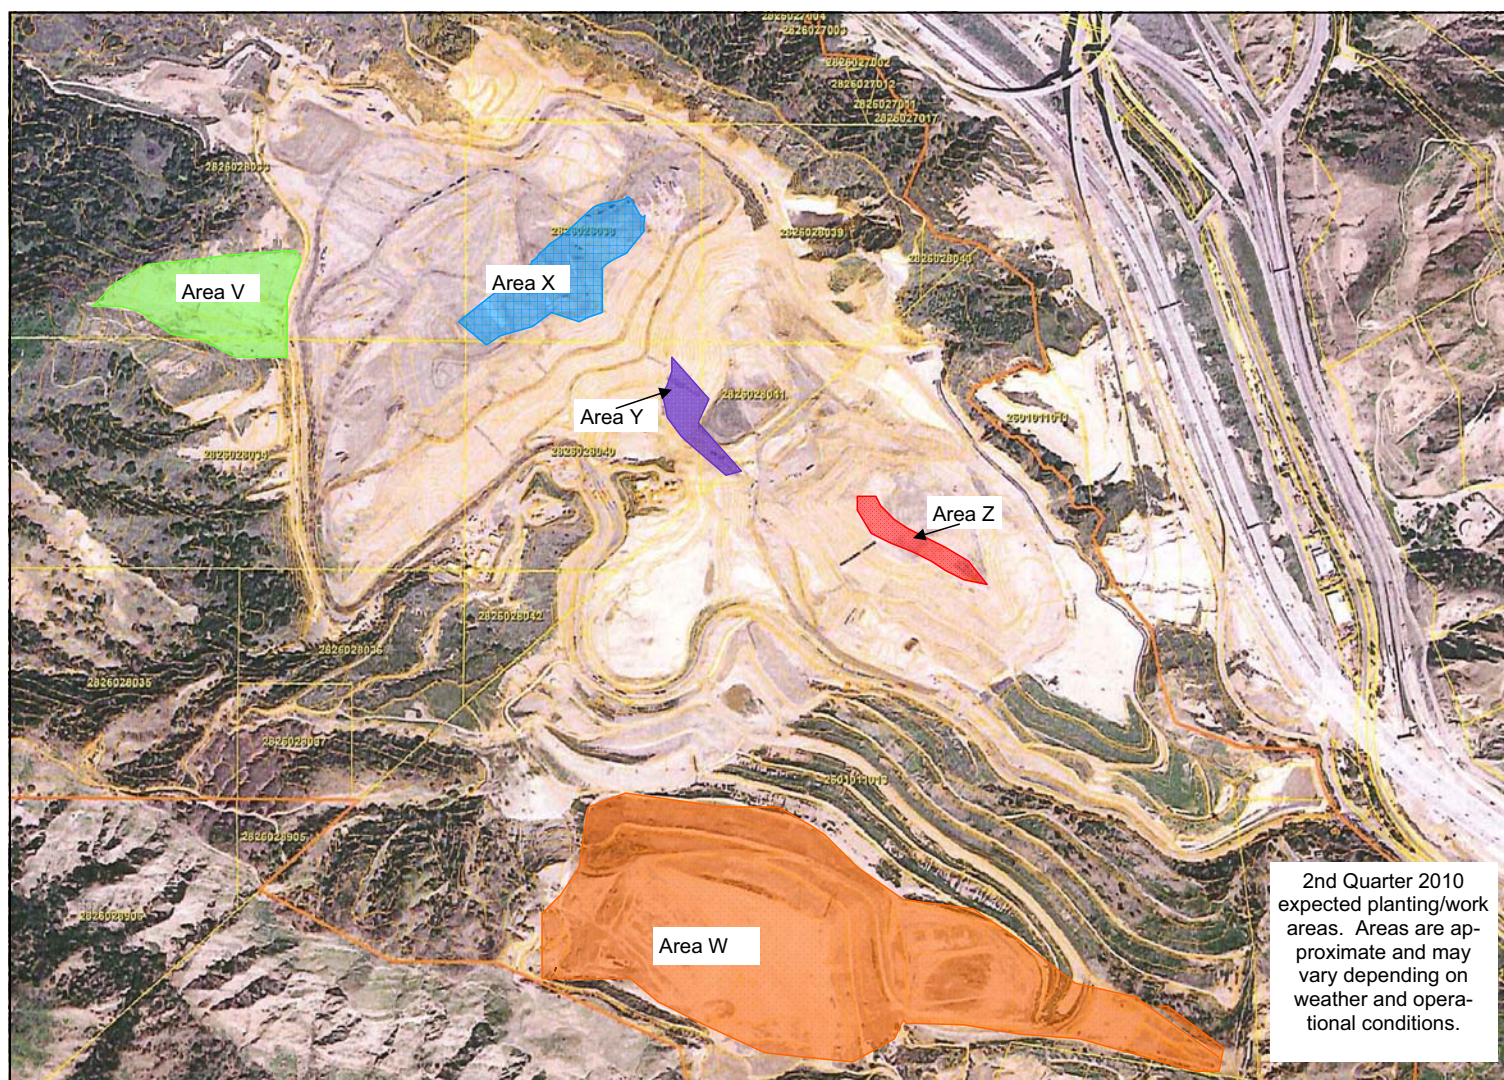
Planned for 2nd Quarter 2010

Area	Color Code	To Be Installed by	Details	Status
V		SCL or contractor	Test plots for problematic soils from this area will be installed in planter beds to facilitate observation and maintenance through the summer	Design underway by Dr. Ted St. John, AECOM
W		Contractor	Sage Area. Second round of spring weed removal will be done if directed by restoration specialist.	Pending observation following spring rains.
X		SCL or contractor	Interim Slopes. Interim seed mix, amendments, and greenwaste mulch applied.	To be completed by end of quarter, depending on fill sequencing.
Y		SCL or contractor	Interim Slopes. Interim seed mix, amendments, and greenwaste mulch applied.	To be completed by end of quarter, depending on fill sequencing.
Z		SCL or contractor	Interim Slopes. Interim seed mix, amendments, and greenwaste mulch applied.	To be completed by end of quarter, depending on fill sequencing.

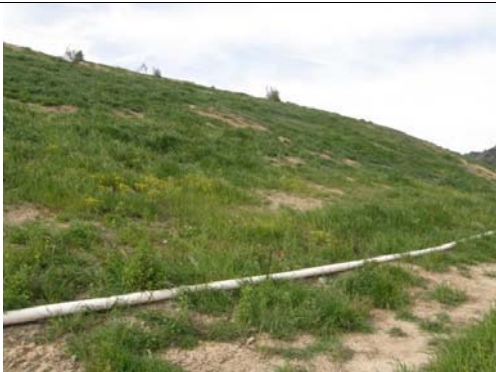
City-side slopes are a mixture of weedy grasses with bare patches and some native plants.

MISCELLANEOUS	
CONDITIONS: <input type="checkbox"/> Trash <input type="checkbox"/> Vandalism <input type="checkbox"/> Erosion	
COMMENTS:	
RECOMMENDATIONS	
The urgent matter on these slopes is weed control. AECOM recommends trimming rather than herbicide, pulling, or hoeing of weeds. It is important to avoid mechanical disturbance of the soil, which disrupts formation of the mycorrhizal network needed by natives. Trimming allows penetration of sunlight and continued development of natives. As the natives grow and form a mycorrhizal network weed growth will steadily diminish.

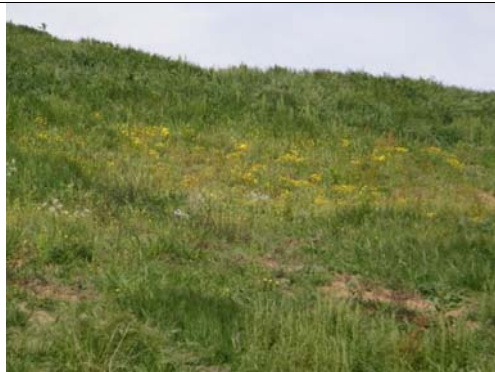
A few areas are dominated by native plants that have locally excluded weedy plant species.

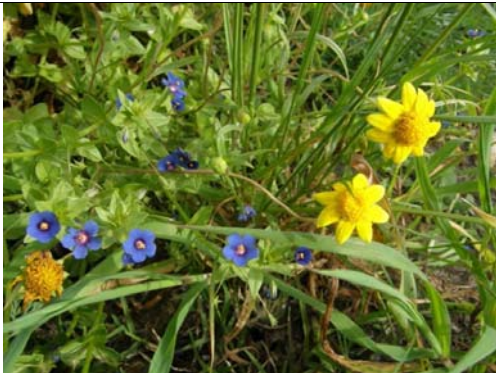
Native patches in some cases include a diverse mix of natives with very few weeds.

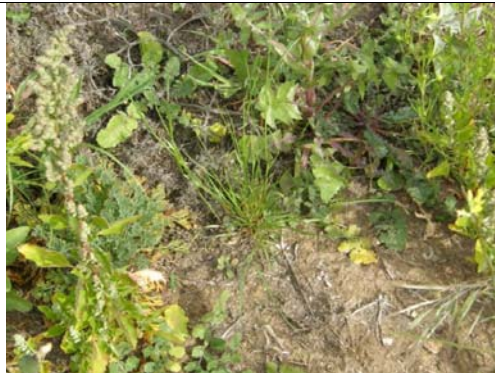
Most of the area consists of isolated natives under heavy weed growth. Prompt trimming of the weeds would allow penetration of sunlight and development of native vegetation.

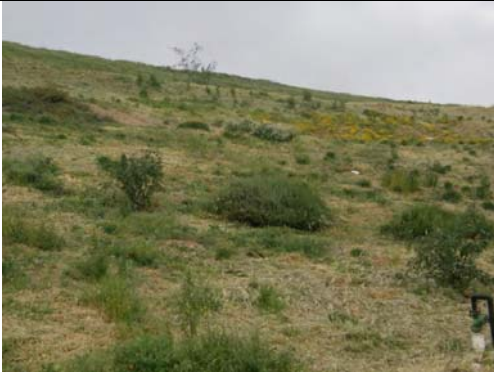
City-side slopes show a patchwork of weedy grasses and native plants. A few spots with imported soil remain bare.

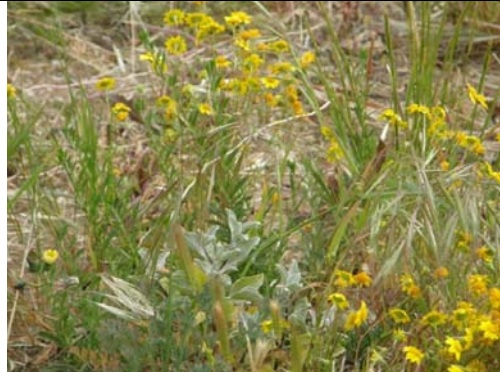
Native patches include a diversity of native plant species.

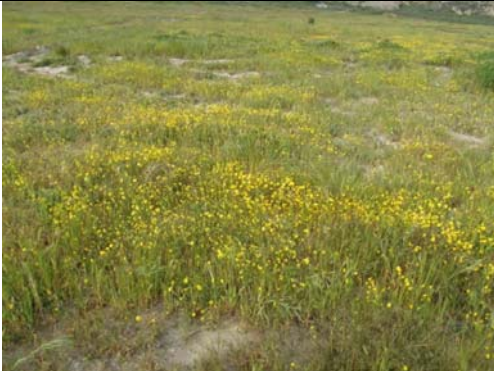
Native annuals have performed well on the top deck. However, the soil is probably too thin and too compacted for shrubs to persist.

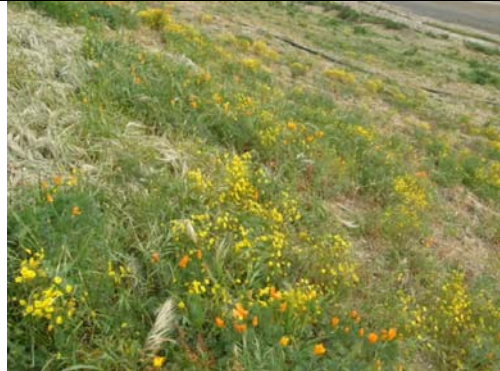
Native plant patches appear to have expanded during the previous month, perhaps helped by extensive weed trimming.

MISCELLANEOUS	
CONDITIONS: <input type="checkbox"/> Trash <input type="checkbox"/> Vandalism <input type="checkbox"/> Erosion	
COMMENTS:	
RECOMMENDATIONS	
Continue weed control until the exotic annual plants (mostly grasses) turn color and stop growth for the season. AECOM recommends trimming rather than herbicide, pulling, or hoeing of weeds.

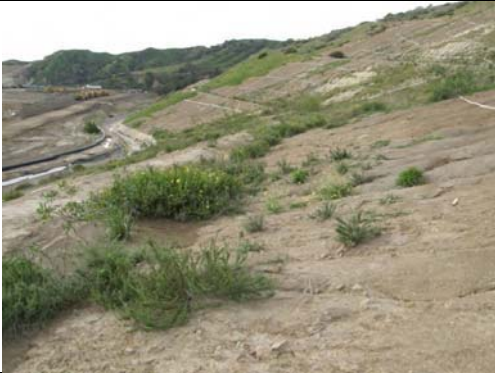
Vegetation remains patchy with large bare areas that have always been bare of either weeds or natives. The bare areas conform to soil types or soil depth, with patches of vegetation always found on spots where the soil is soft and able to support root growth. Aerial photos make it clear that the soil types are associated with alternating beds of different Towsley Formation subtypes. The areas dominated by native plant species are stable or improving, and are found on the conglomerate subtype of the Towsley formation. The failure of all vegetative growth, including weeds, is seen on the

Vegetation is patchy on the County-side slopes. Growth is related to soil loose enough to allow root growth and to soil types as indicated by testing and by soil color.

Our most pressing need in this area is to move forward with trials of soil treatments so we can determine the best strategy for the long term. Those trials have been authorized and detailed design of the trials is under way. Replanting next rainy season will make use of the findings of the trials.

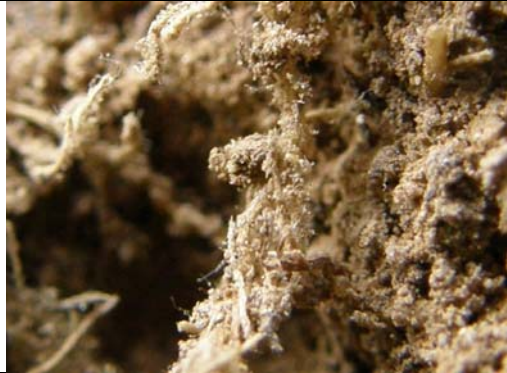
Within vegetation patches it is possible to see mycorrhizal fungi. The fungal filaments are visible as glassy threads near the roots.

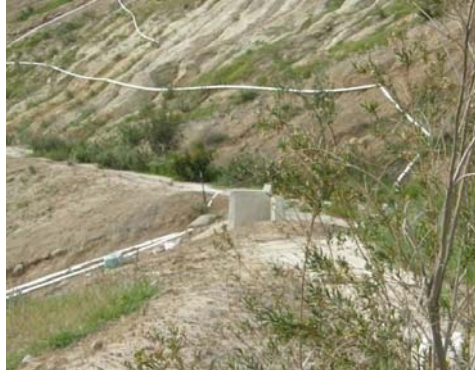
There has been overflow of runoff spilling from the horizontal terraces and some storm flow has bypassed the V-ditches. In other places water that spills from above has created locally favorable conditions where native plants thrive along with a rich biological soil crust. The best plant growth continues to be in the low spots where sediment has accumulated after having been washed free of salts.

Terraces on the slope should channel water to the V-ditches. However the water has breached the berms at several points.

In response to the findings from this quarter's monitoring visit, SCL will be installing erosion control devices to better route water to existing v-ditches. This will be completed by the end of the third quarter 2010, prior to the rainy season.

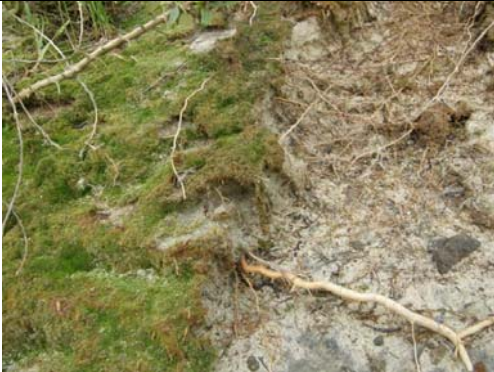
Surface flows of water have created local wet spots where native plants thrive and the soil has become covered with moss. This photo shows exposed roots where the moss cover failed.

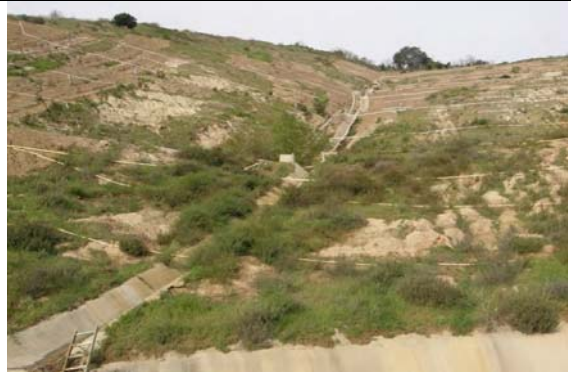
Some of the best plant growth has been where lime was applied in 2007, but it is unclear whether the lime caused the success.

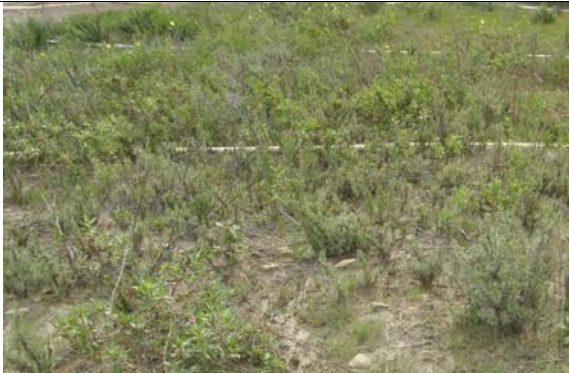
The best soils show considerable success, with relatively weed-free patches and several species of native shrubs.

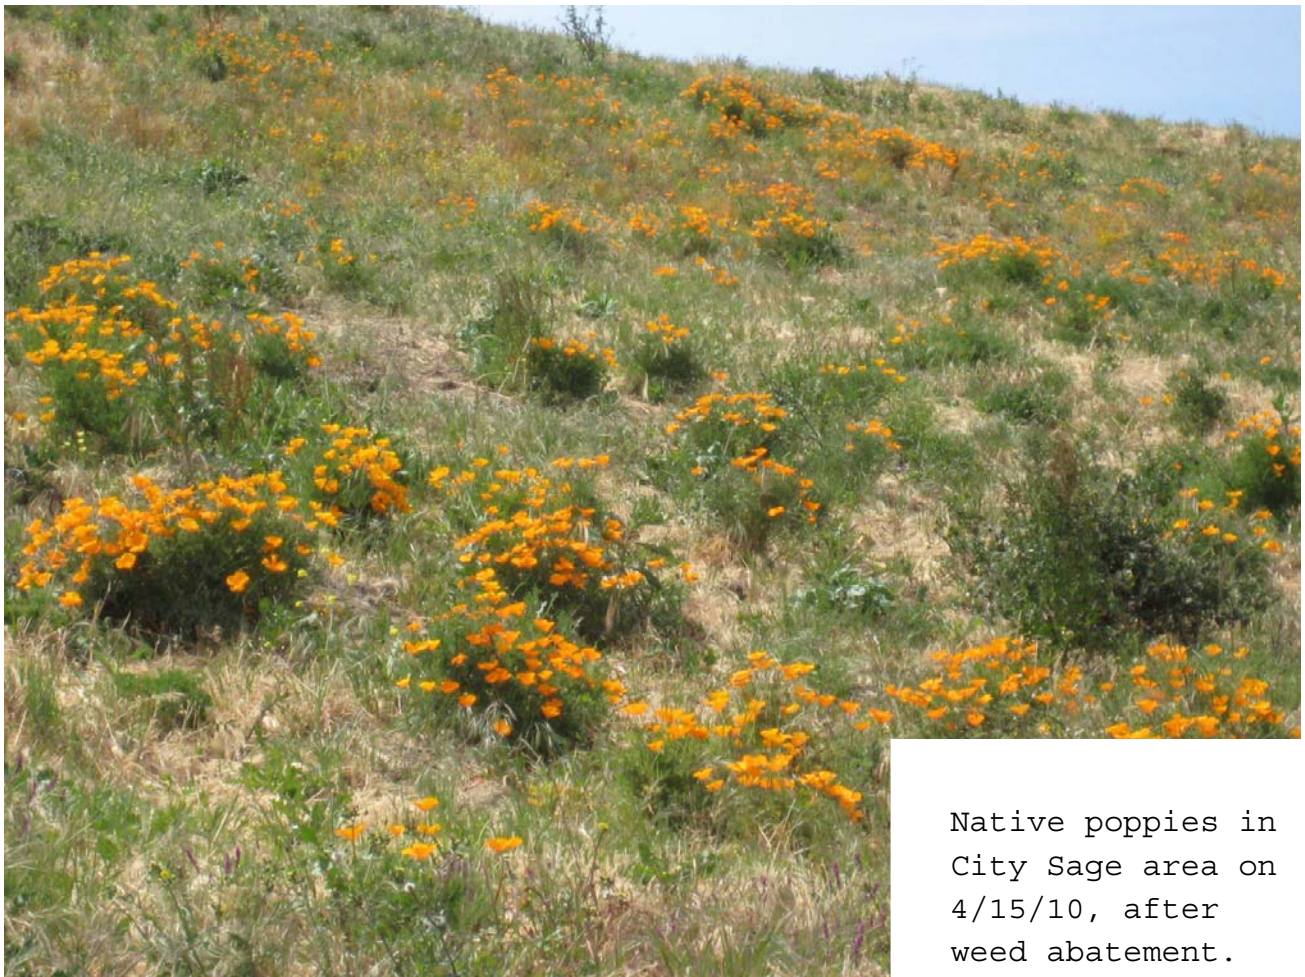
Native poppies in
City Sage area on
4/15/10, after
weed abatement.

The City sage mitigation area (Area W on map) experienced rapid plant growth after winter rains. Non-native plants were shading the slower growing natives, as observed by restoration specialist Dr. Ted St. John. A trained crew from Landscape Development, Inc. (LDI) was retained to cut down non-native plants from March 17th through April 2nd. Photos of this area that show extensive growth of native poppies after weed abatement are included in Appendix D.
