Subject: Sunshine Canyon Landfill, Quarterly Vegetation Report
First Quarter 2019 Vegetation Report

This report presents the progress of the site's landscaping and revegetation activities for the first quarter of 2019. The intent of these reports is to provide detailed information regarding the site's efforts related to vegetation including vegetation of interim and permanent slopes and activities conducted for the on-site sage mitigation areas.

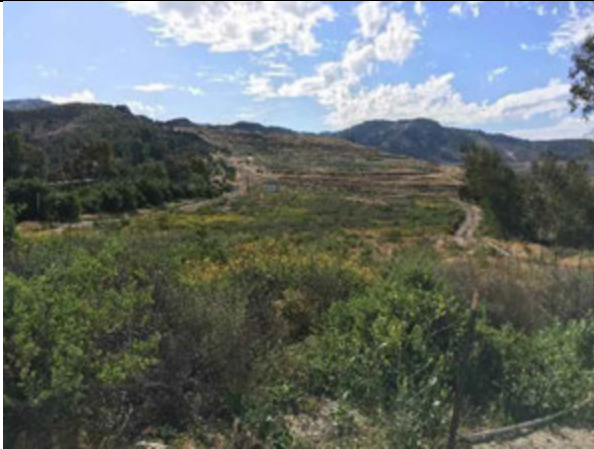
Photo 1. Facing west at lower deck. View of *Atriplex* species and California sunflower (*Encelia californica*) that dominate the vegetation cover.

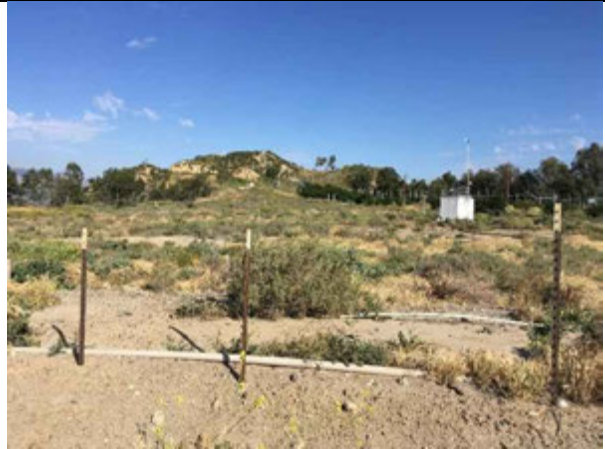
Photo 2. Facing east at lower deck from western boundary.

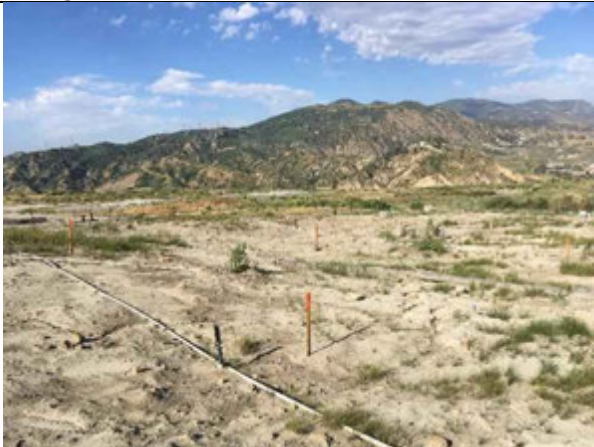
Photo 3. Facing northeast at recently planted coastal sage scrub pilot study within the Middle Deck.

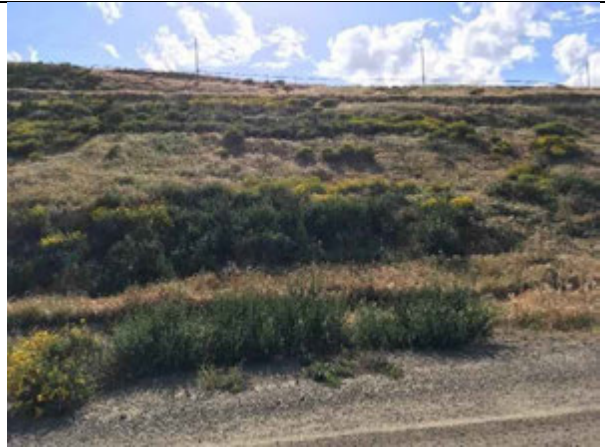
Photo 4. Facing west at the easterly-facing slope located between middle and upper decks. The vegetation on the slopes below the upper deck is dominated with mustard and brome grasses. The dark areas of vegetation consist of California buckwheat.

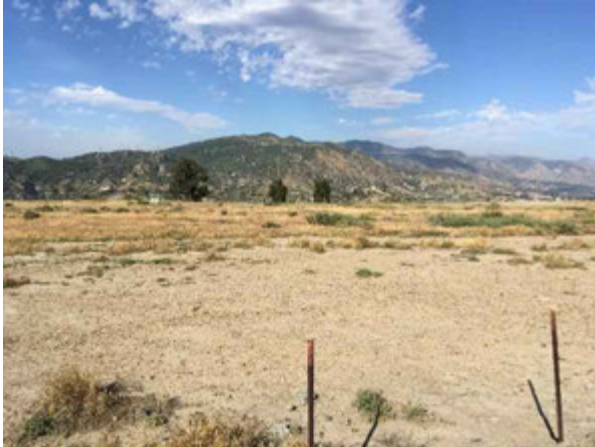
Photo 5. Facing northeast at upper deck. This area is compacted and gravelly and continues to be problematic for supporting vegetation. Non-native grasses and some CA buckwheat shrubs are evident in the background.

- **Improve root zone and soil conditions.** Continue to investigate ways to import the soil layer to improve the root penetration and saturation zone to enable plant growth in heavily compacted areas. Consider applying soil in random undulations or uneven mounds to improve soil porosity and filtration and to control soluble salts from leaching from existing layer.

If permissible, prior to seeding (broadcast, hydroseeding, or drilling) native species, incorporate a soil amendment or mulch with high organic content by tilling into the top 12 inches of the existing compacted soils to improve soil texture, drainage, porosity, and aerobic conditions. If an organic mulch or soil amendment is not feasible or available, incorporate available soil from on-borrow sites within the landfill that have the appropriate, so long as these borrowed soils have been determined to not have toxic conditions such as boron or high salinity.

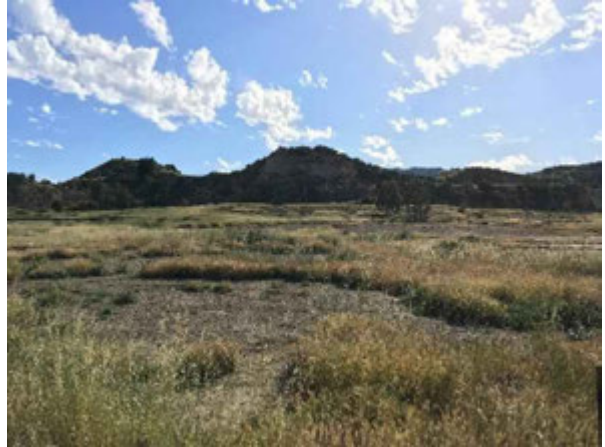
Photo 6. Facing southwest at upper deck. The area shown in this photo is dominated by brome grasses and wild oats; however, some natives such as California buckwheat are present.

- **Plant natives in areas dominated with non-natives.** The vegetated areas on the middle deck that are currently dominated with annual, non-native species have decent soil-texture conditions. These areas are not near as compacted as adjacent areas that are gravelly and mostly void of vegetation. In general, the soil texture within the vegetated areas with non-native vegetation is

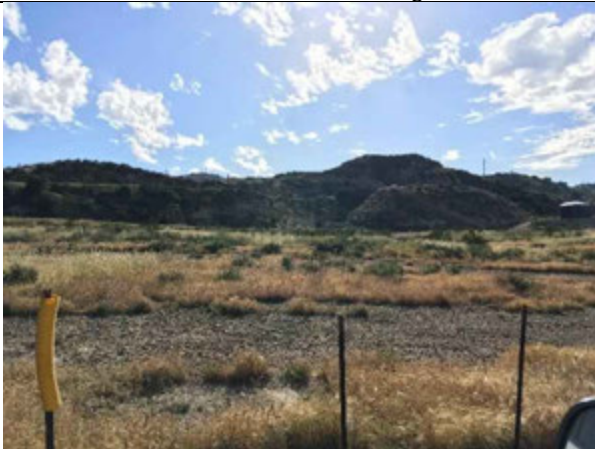
Photo 7. Facing southeast at the upper deck at the disturbed area that is currently dominated with desiccant brome grasses.

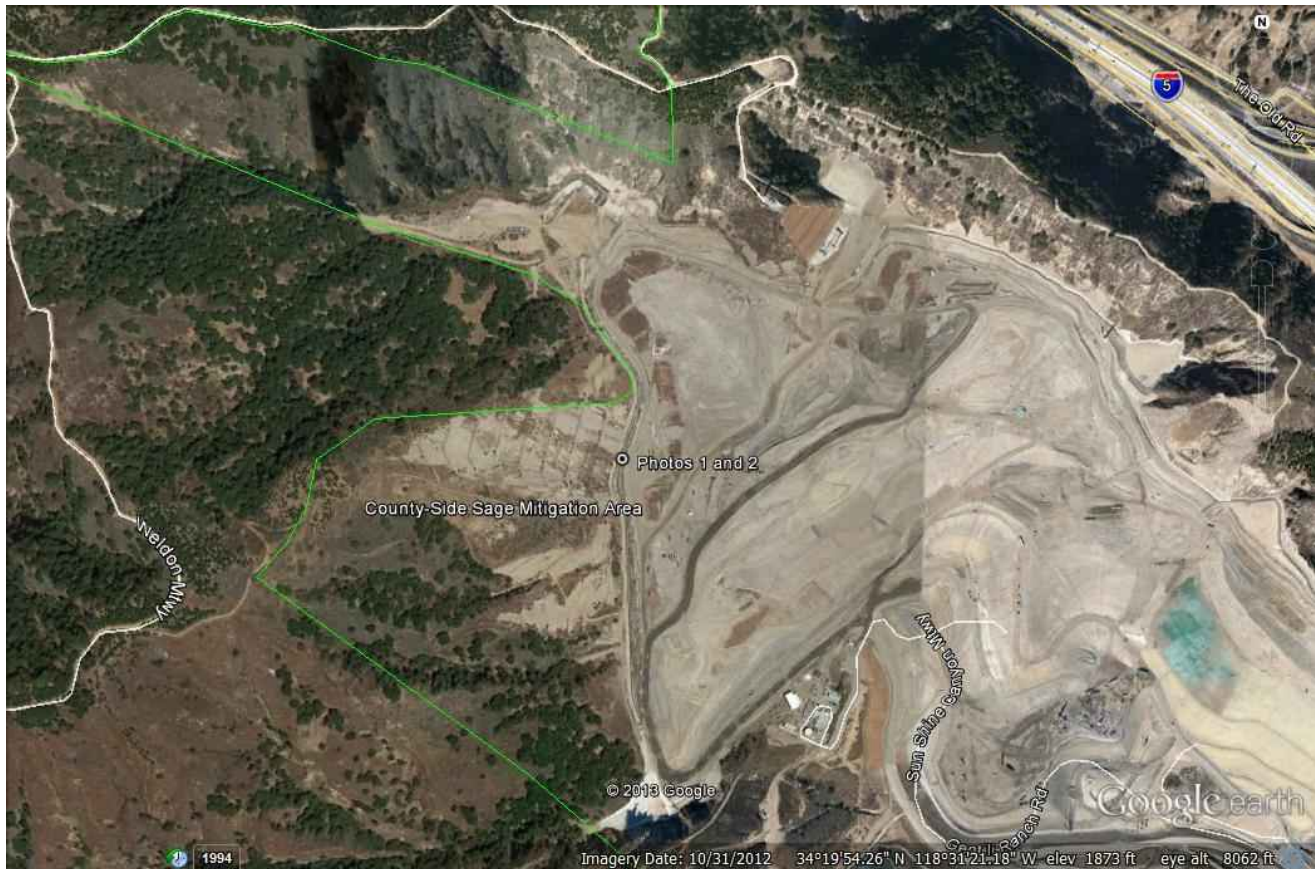
Photo Locations

It should be noted that the plant cover rating above applies where vegetation is dominant in the southeastern portion of the mitigation area. Vegetation cover is moderate in the southeastern portion of the county-sage mitigation area and sparser along the upper slopes where rocky conditions occur. The majority of the northern and upper portions of the mitigation area continue to have minimal coverage. Bare areas and non-native annual grasses are intermixed; however, the northern and upper areas continue to be mostly bare where erosion and rocks are apparent. Native vegetation coverage is good in vegetated areas and the amount of non-native grasses that are present is expected when compared to sparsely covered areas of California buckwheat in the region.

Annual, non-native weed species consist primarily of brome grasses and wild oats, which are currently desiccant, as well as patches of short-pod mustard. Other established weeds that were observed include red-stemmed filaree (*Erodium cicutarium*) and (native) telegraph weed (*Heterotheca grandiflora*). Russian thistle (*Salsola kali*) and tree tobacco (*Nicotiana glauca*) are scattered within the vegetated areas, but in less densities than the other non-native species noted above.

- **Create benches.** Consider creation of benches throughout the mitigation area to control soil erosion and to improve soil conditions to improve plant establishment and seed dispersal. This technique has been widely used on steep slopes and in areas where soil erosion is problematic. This technique also allows for opportunities to introduce a high quality soil layer above the poor soils that exist.

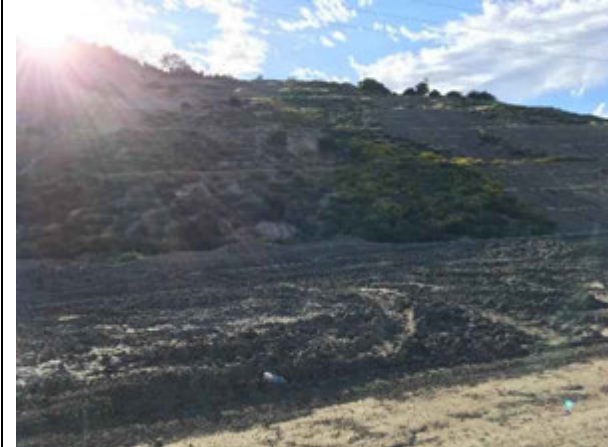
Photo 1. Facing west at the county sage slope. Blooming California sunflower can be seen in this photos and a denser cover of native species that include sunflower and California buckwheat is present.

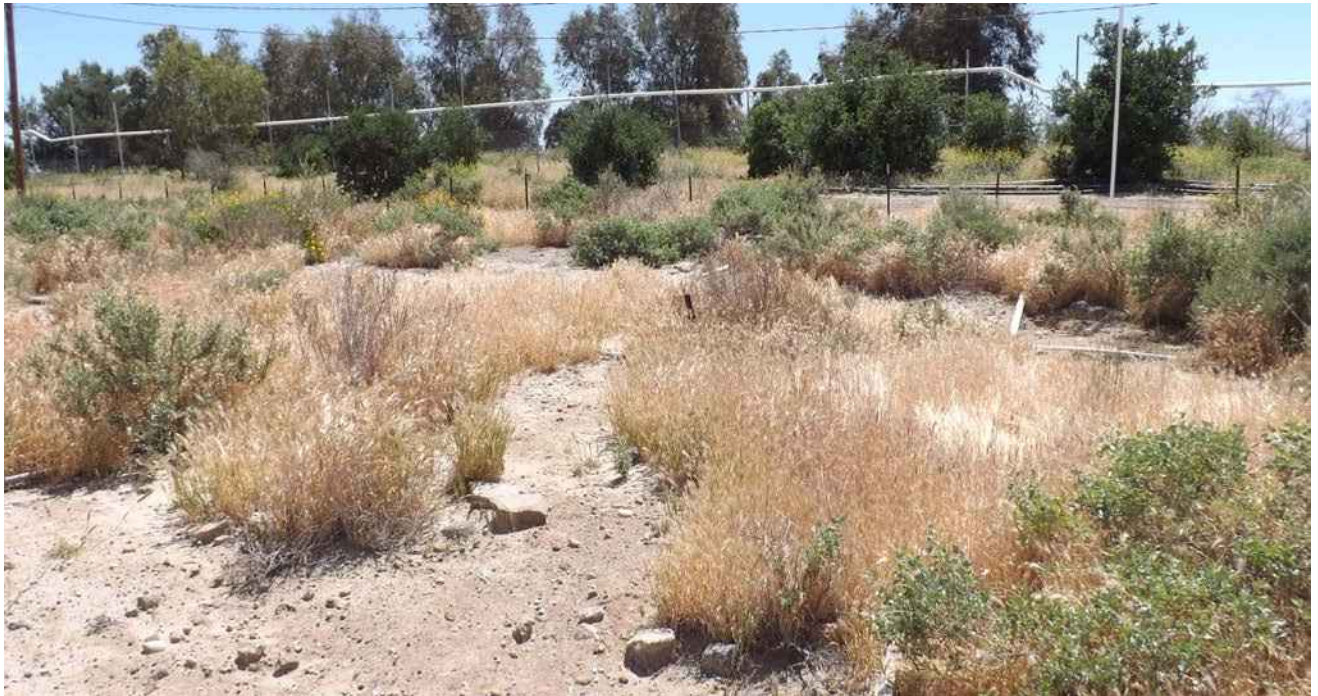
Red Brome Grass has established and produced an abundance of weed seed.

- After a robust winter of rains, several weed species have emerged over just the last few weeks and are flowering/going to seed. These include: Russian Thistle (*Salsola* ssp.), Shortpod Mustard (*Hirshfeldia incana*), Red Brome Grass (*Bromus madritensis*), False Barley (*Hordeum murinum*). Architerra Design Group, Inc. recommends that the maintenance contractor immediately begin removal of these invasive species and weed abatement. The weeds should be bagged/wrapped prior to removal so that the weed seeds do not spread. Contractor should target the species above and take care to not remove/damage new seedlings intermixed amongst the weeds. In addition to the deck, the understory of the PM10 Berm is loaded with Mustard and Brome Grass. This area should also be cleared of weeds to prevent wind dispersion of weed seed into the deck.

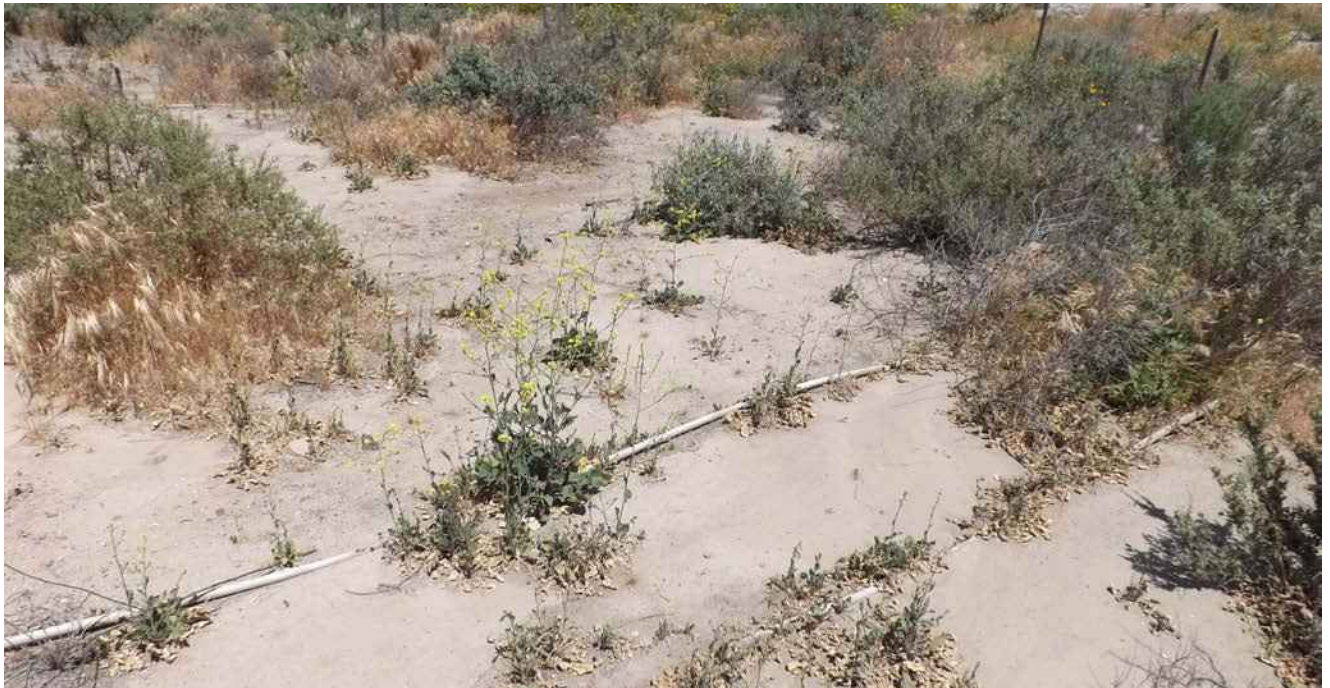
Shortpod Mustard germinating along original irrigation laterals where soil erosion collects.

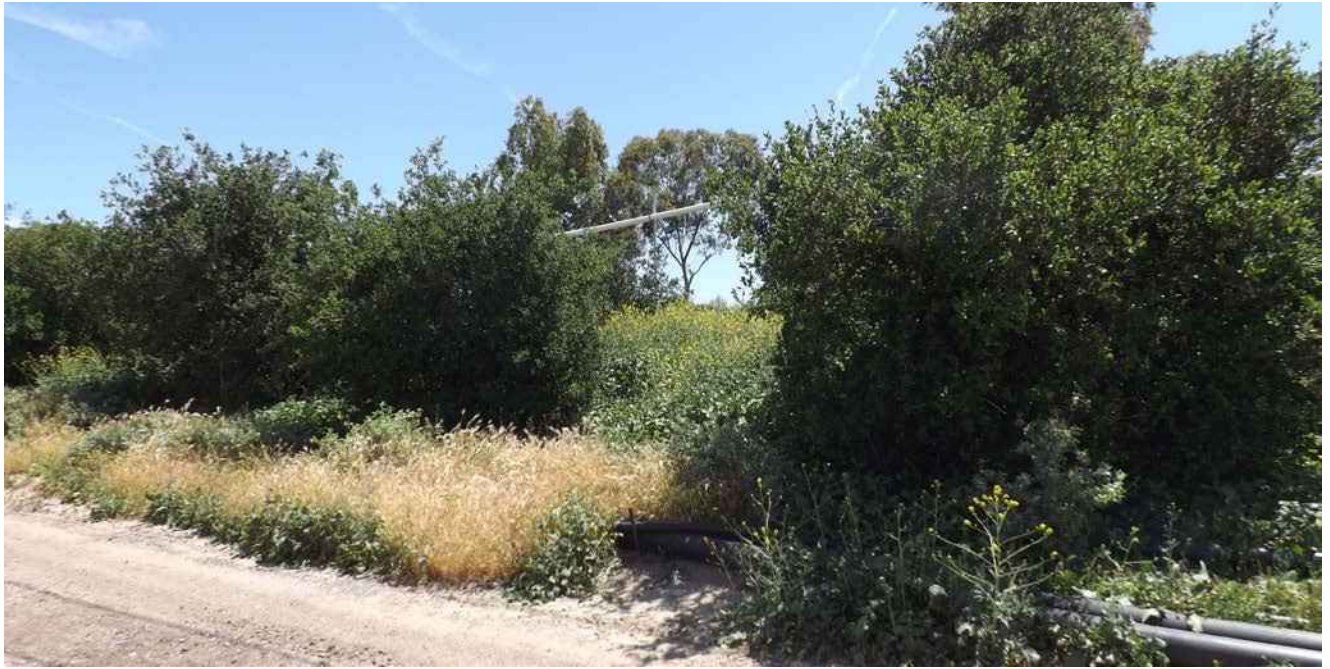
Invasive Shortpod Mustard blooming on PM10 Berm

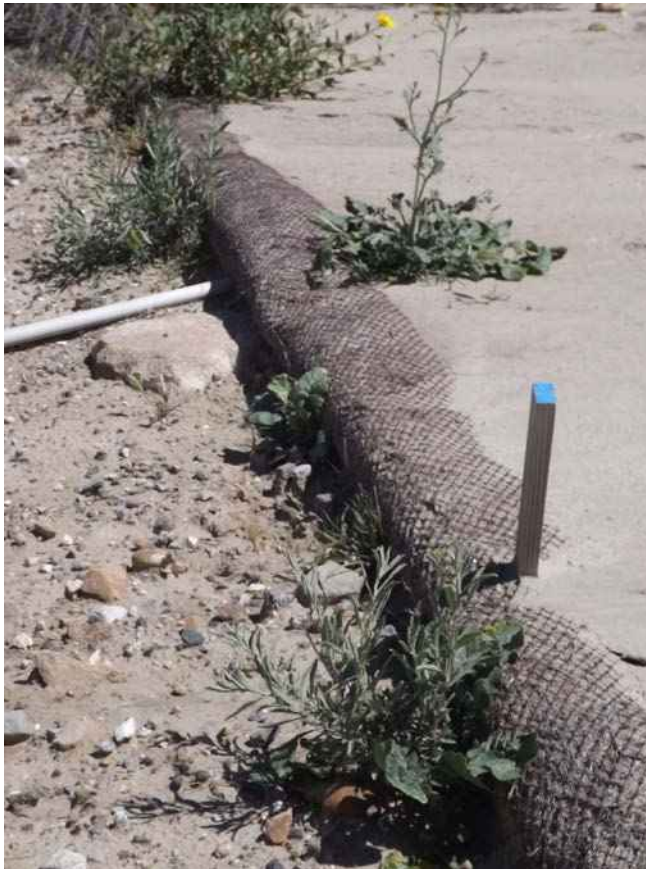
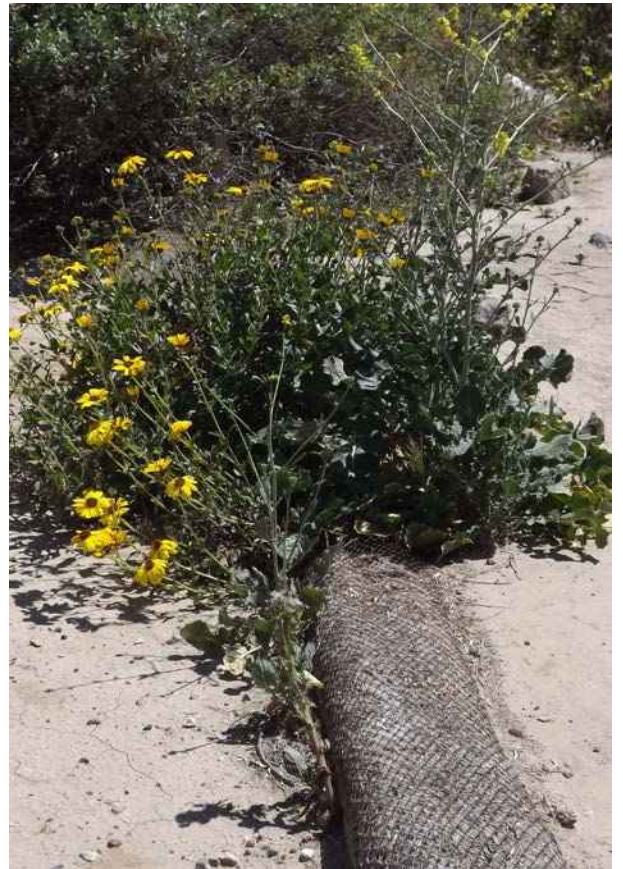
- The straw wattles that were installed in 2017 now show signs of holding back soil fines and new plants (including weeds) have begun to establish were moisture is more available.

Seedlings of Coast Sunflower (*Encelia californica*) and Salt Bush establishing within straw wattles placed in 2017

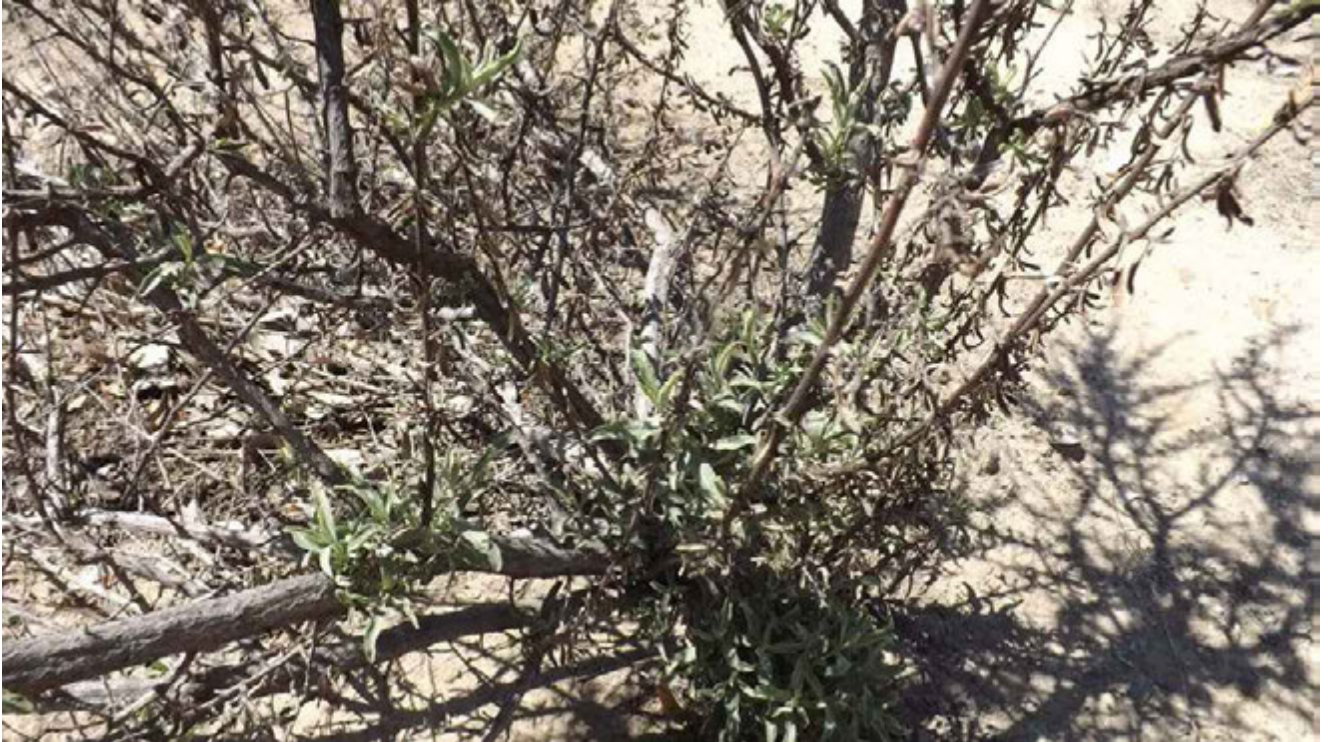
New emerging foliage from Saltbush that was devoid of vegetation

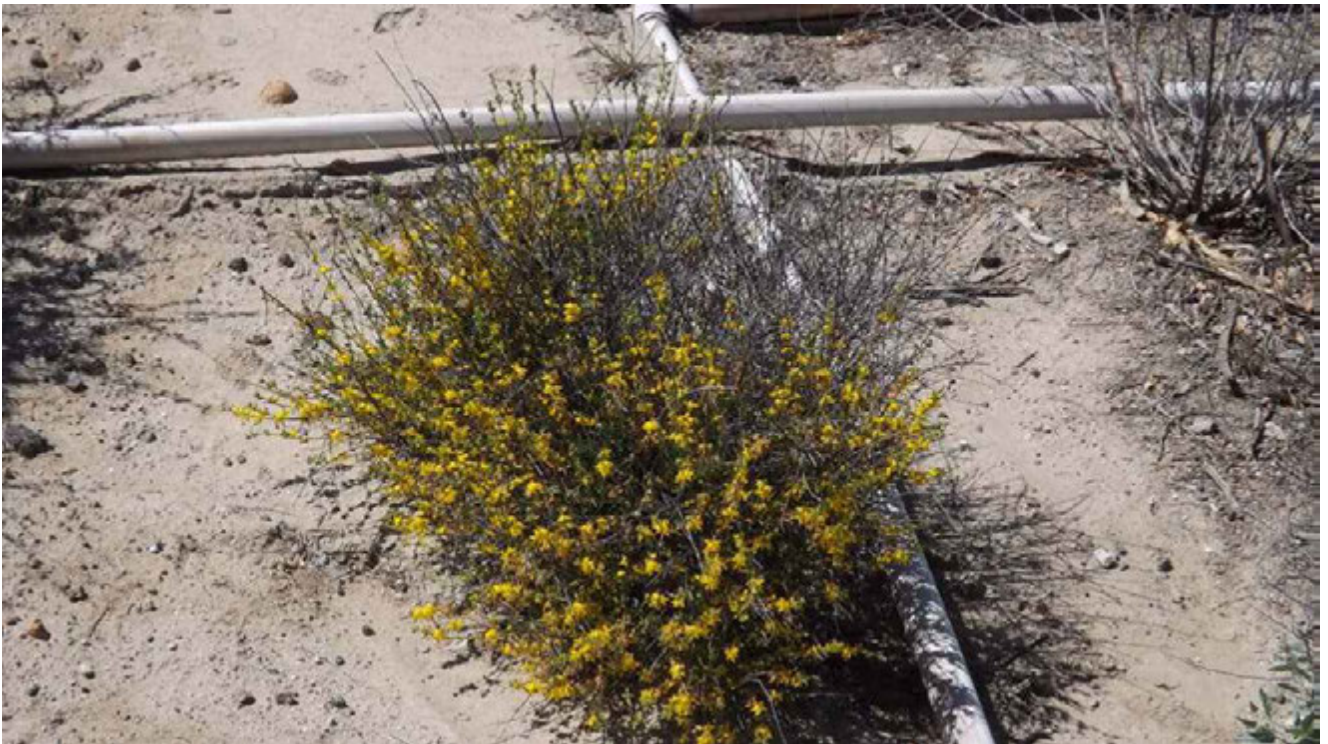
New foliage and flowers emerge from dried branches of the Deerweed (*Lotus scoparius*)

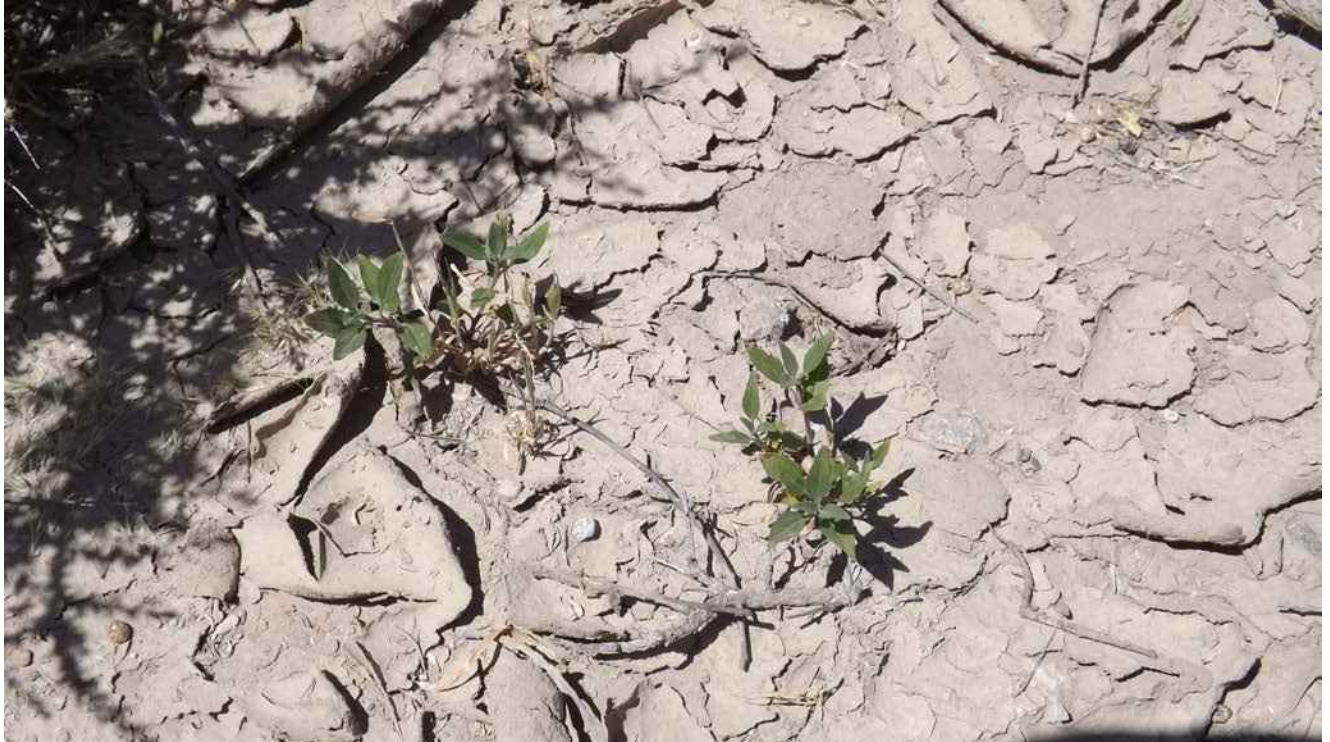
Seedlings of Coast Sunflower (*Encelia californica*) germinate from an area that temporarily held moisture during the winter rains

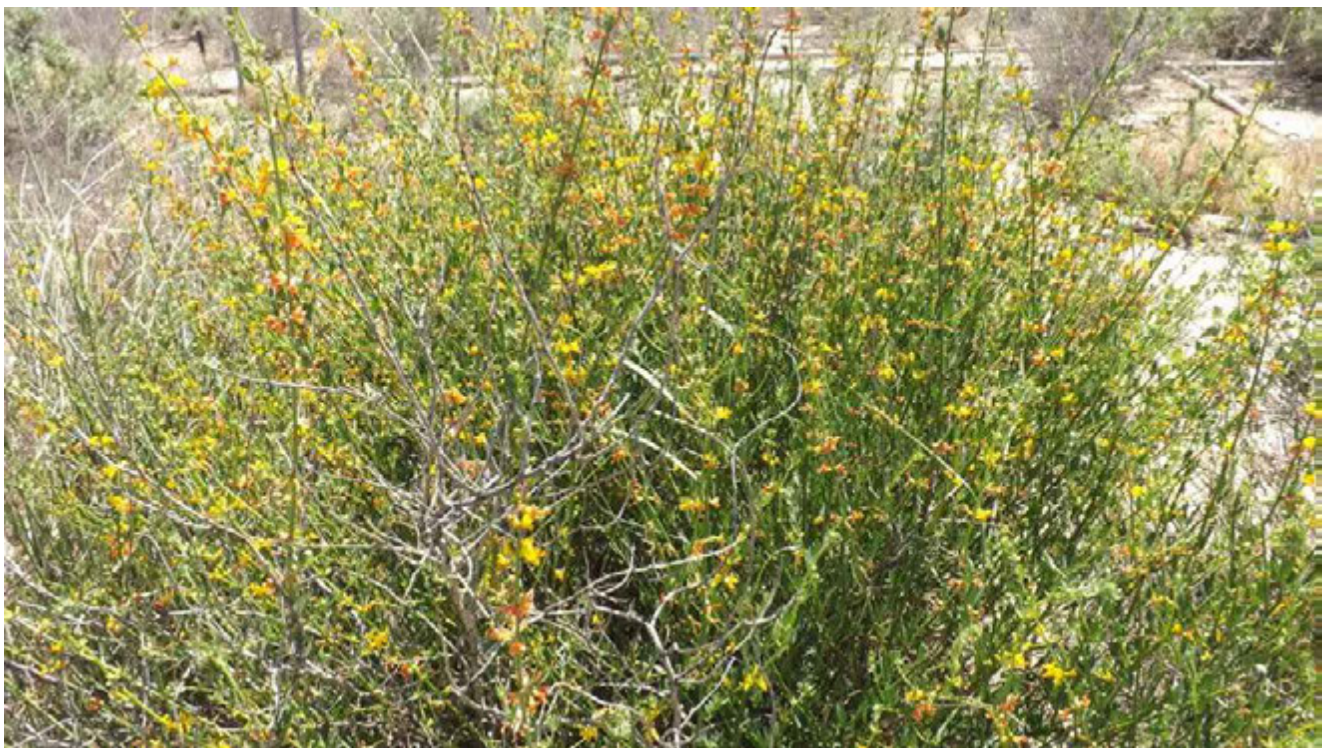
Large and healthy flowering Deerweed perennial

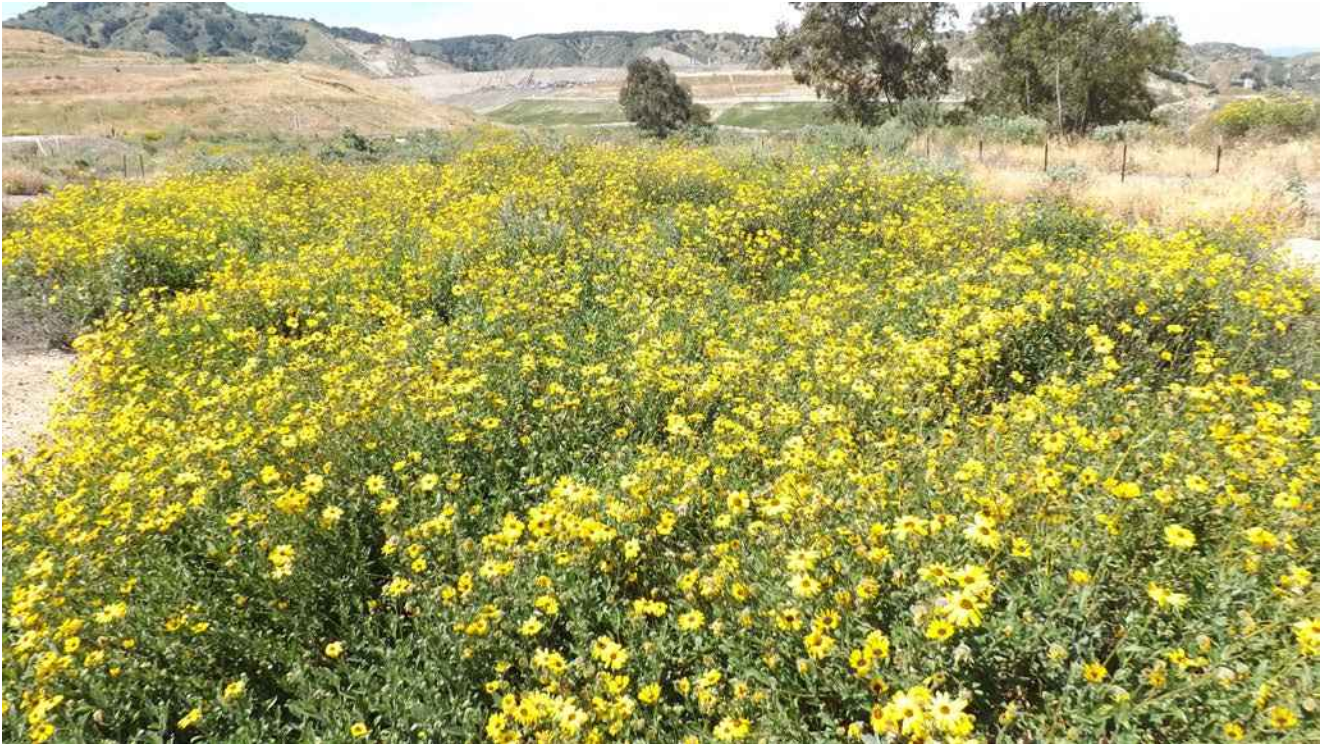
Lower swale at north side of deck blooming with Coast Sunflower. This swale was Slatbush dominant and thinned back a few years to allow new species to take over

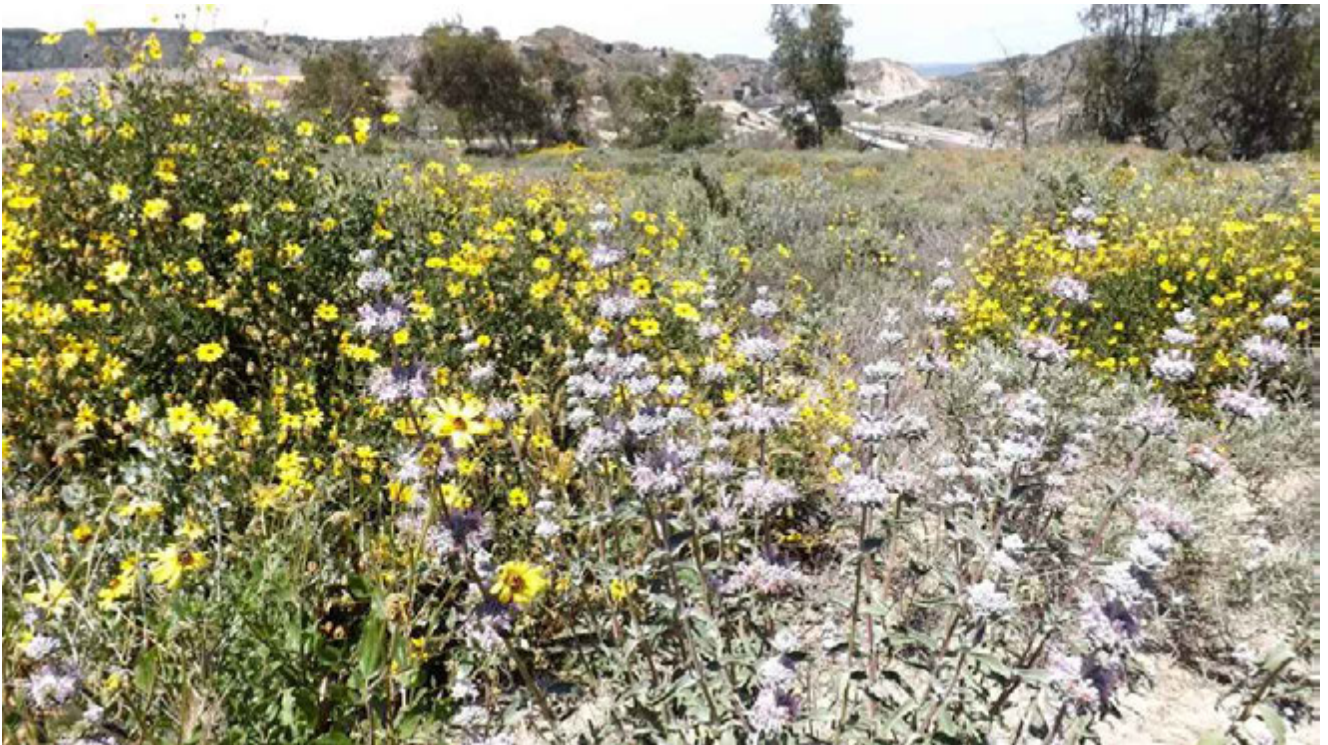
Blooming Purple Sage and Coast Sunflower

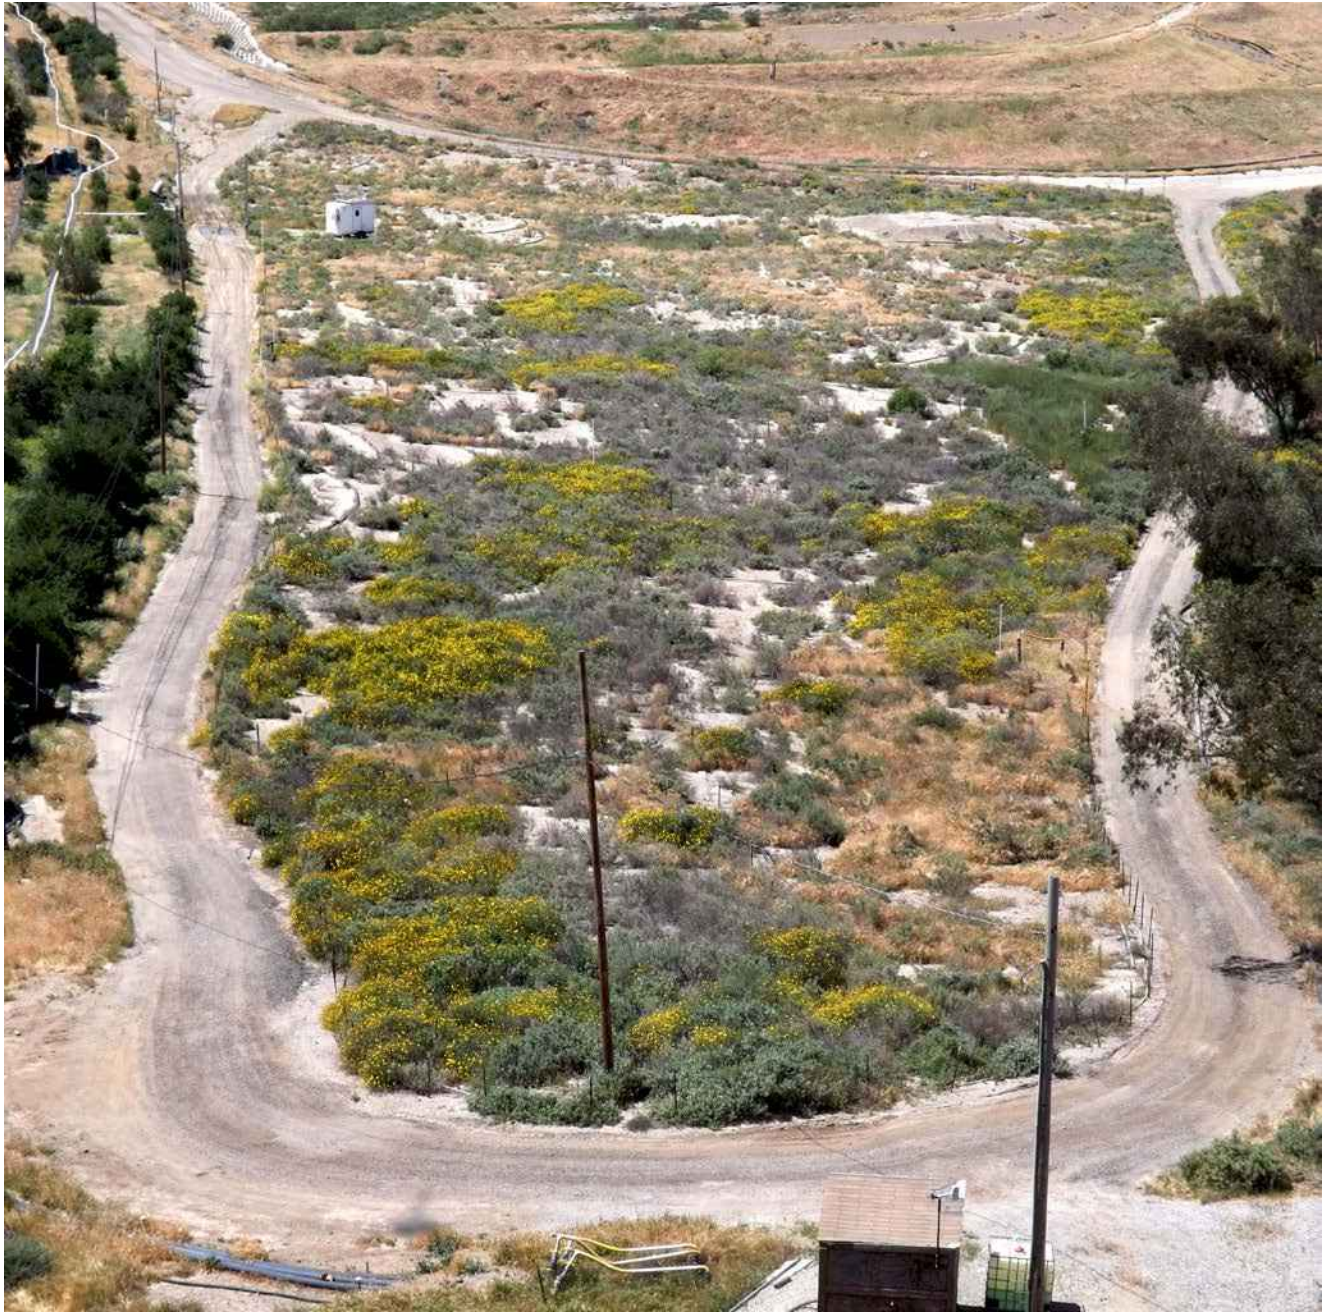
Overall View of Deck C (Looking West)

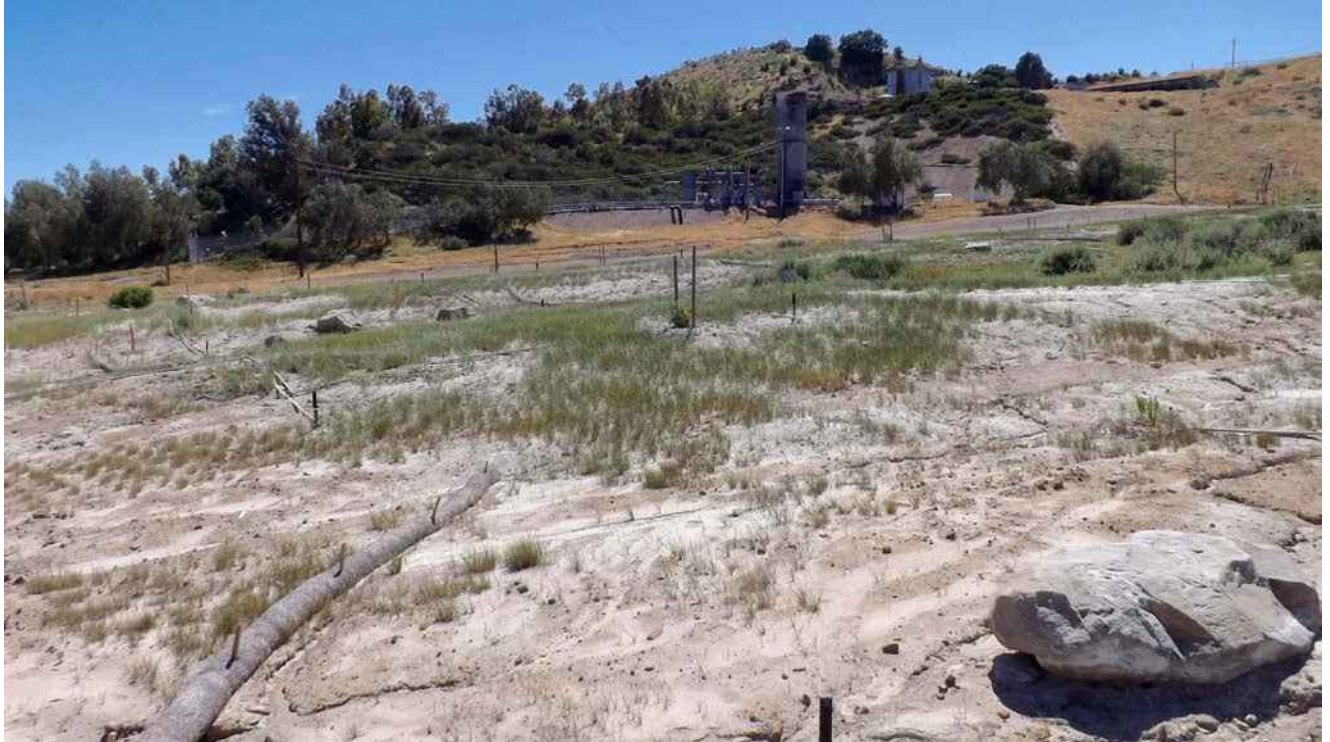
- Deck B has really started to germinate over the last few weeks. When observed in February, there was little germination, but now several annuals and grasses have established.
- In many portions of the deck you can see the evidence of the seed imprinting performed last year, mostly by the germination of native grasses and annuals. With the heavy rains that occurred, much of the dimpled pattern evident in the fall has vanished.

Leymus triticoides (Creeping Wild Rye) evident in spaced out dimpled pattern made from soil imprinting technique

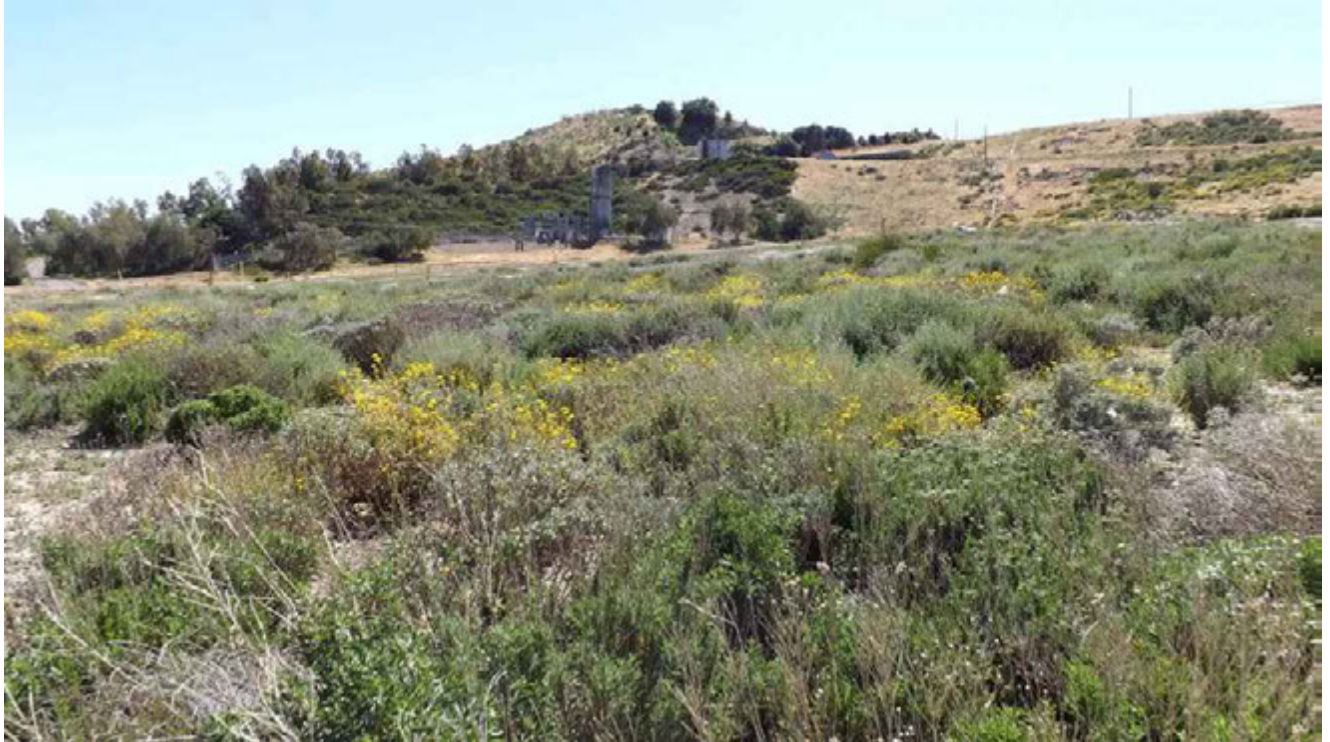
Existing CSS vegetation along north side of Deck B

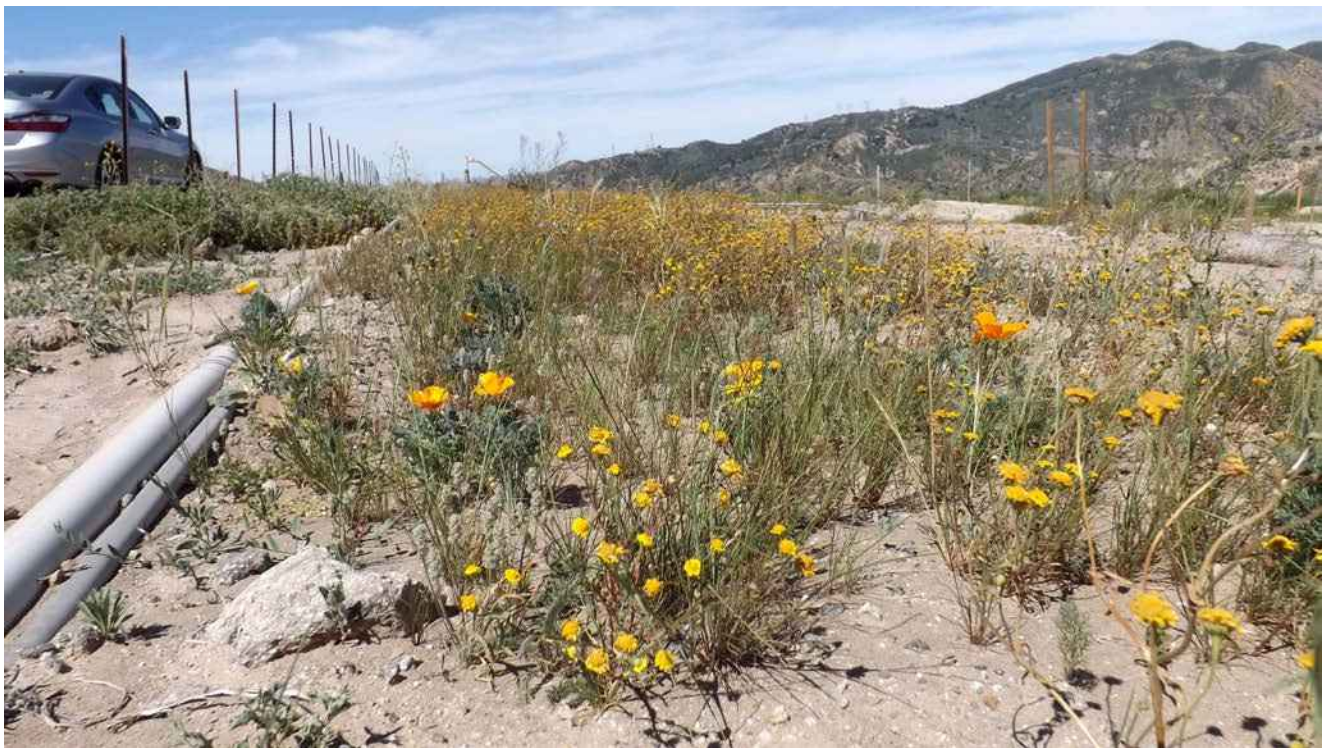
California Goldfields and California Poppy bloom on west side of Deck B

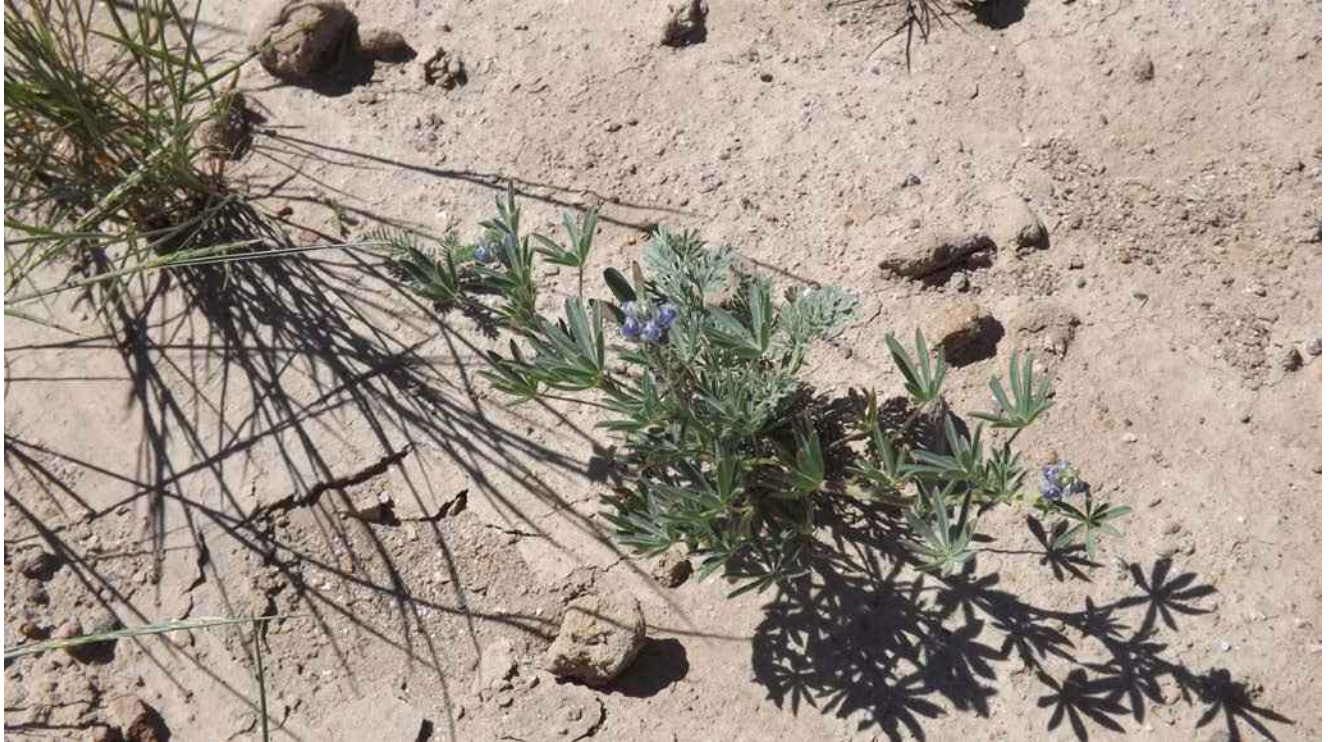
Annual Lupine beginning to bloom

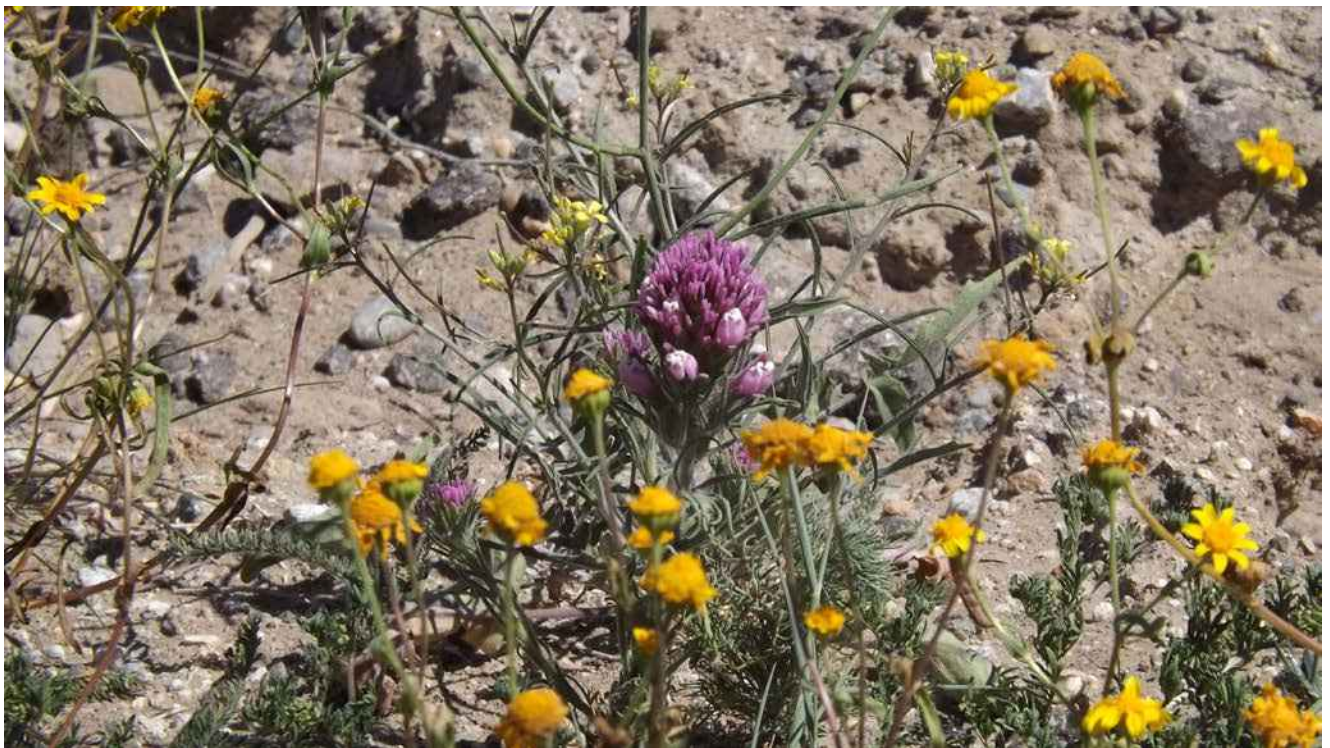
Owls Clover and California Goldfields blooming along entire deck area

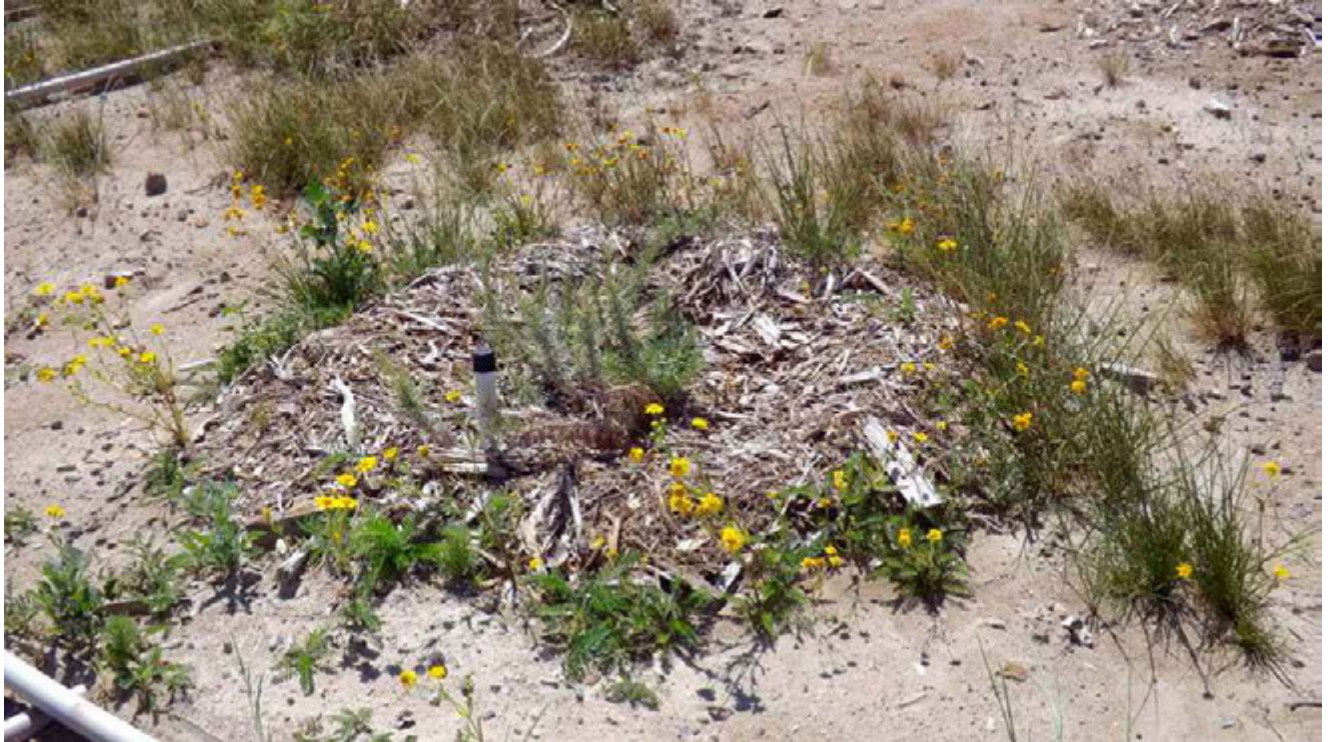
California Goldfields, Yarrow and Creeping Wild Rye within mulch at California Sagebrush
