Subject: Sunshine Canyon Landfill, Quarterly Vegetation Report
First Quarter 2019 Vegetation Report

This report presents the progress of the site's landscaping and revegetation activities for the first quarter of 2019. The intent of these reports is to provide detailed information regarding the site's efforts related to vegetation including vegetation of interim and permanent slopes and activities conducted for the on-site sage mitigation areas.

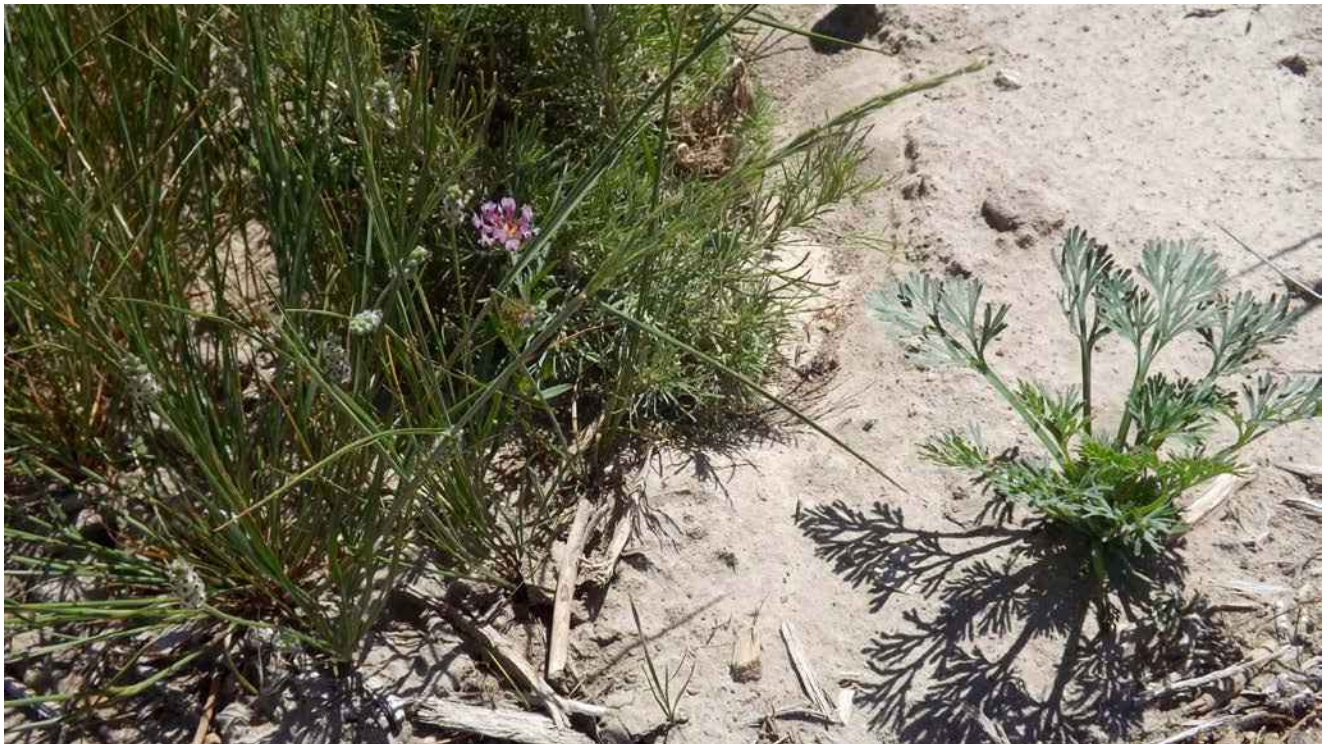
California Poppy, California Plantain and Tomcat Clover seedlings

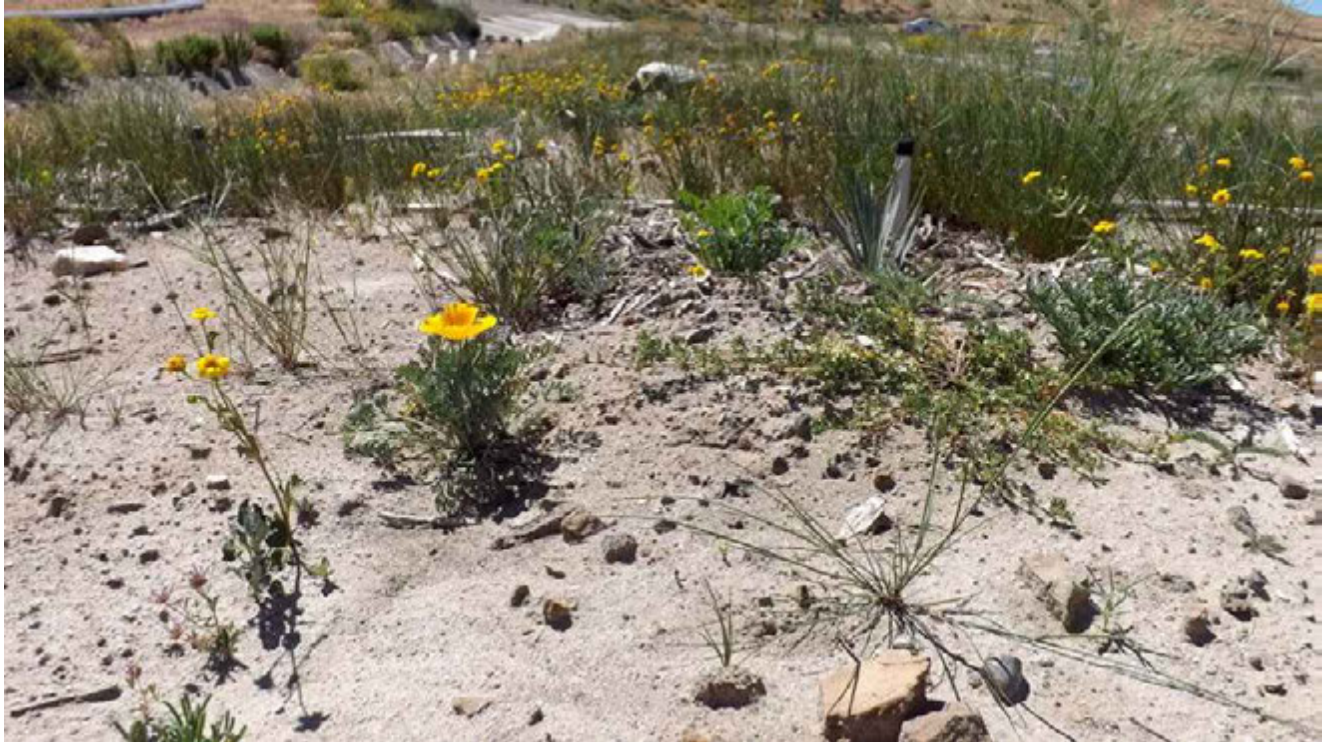
California Poppy, California Goldfields and Wild Rye establishing on deck near container
planted Yucca whipplei

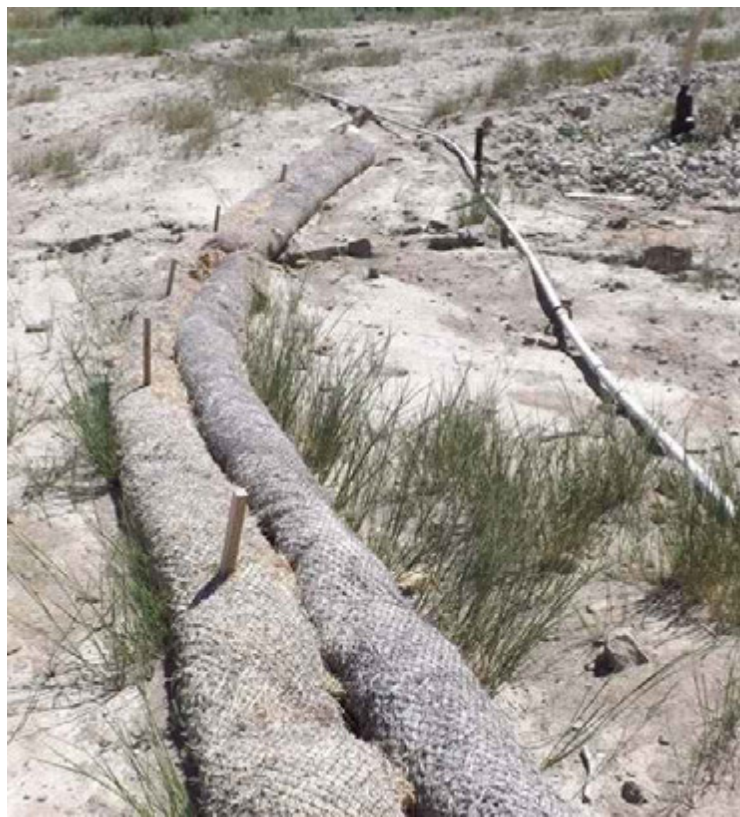
- The contractor has stayed on top of keeping the swales protected and has come back and regraded and reinforced the sediment erosion by installing new straw wattles behind existing ones.
- For the most part, PRG has kept the weeds to a minimum, but there are areas on the deck (adjacent to existing vegetation islands) where new weeds are emerging.
- During the last quarter, ADG staked the deck and established (9) nine random 50sq. meter quadrats for biological review and vegetation cover by Greg Ainsworth.

New straw wattle installation behind original to help eliminate erosion

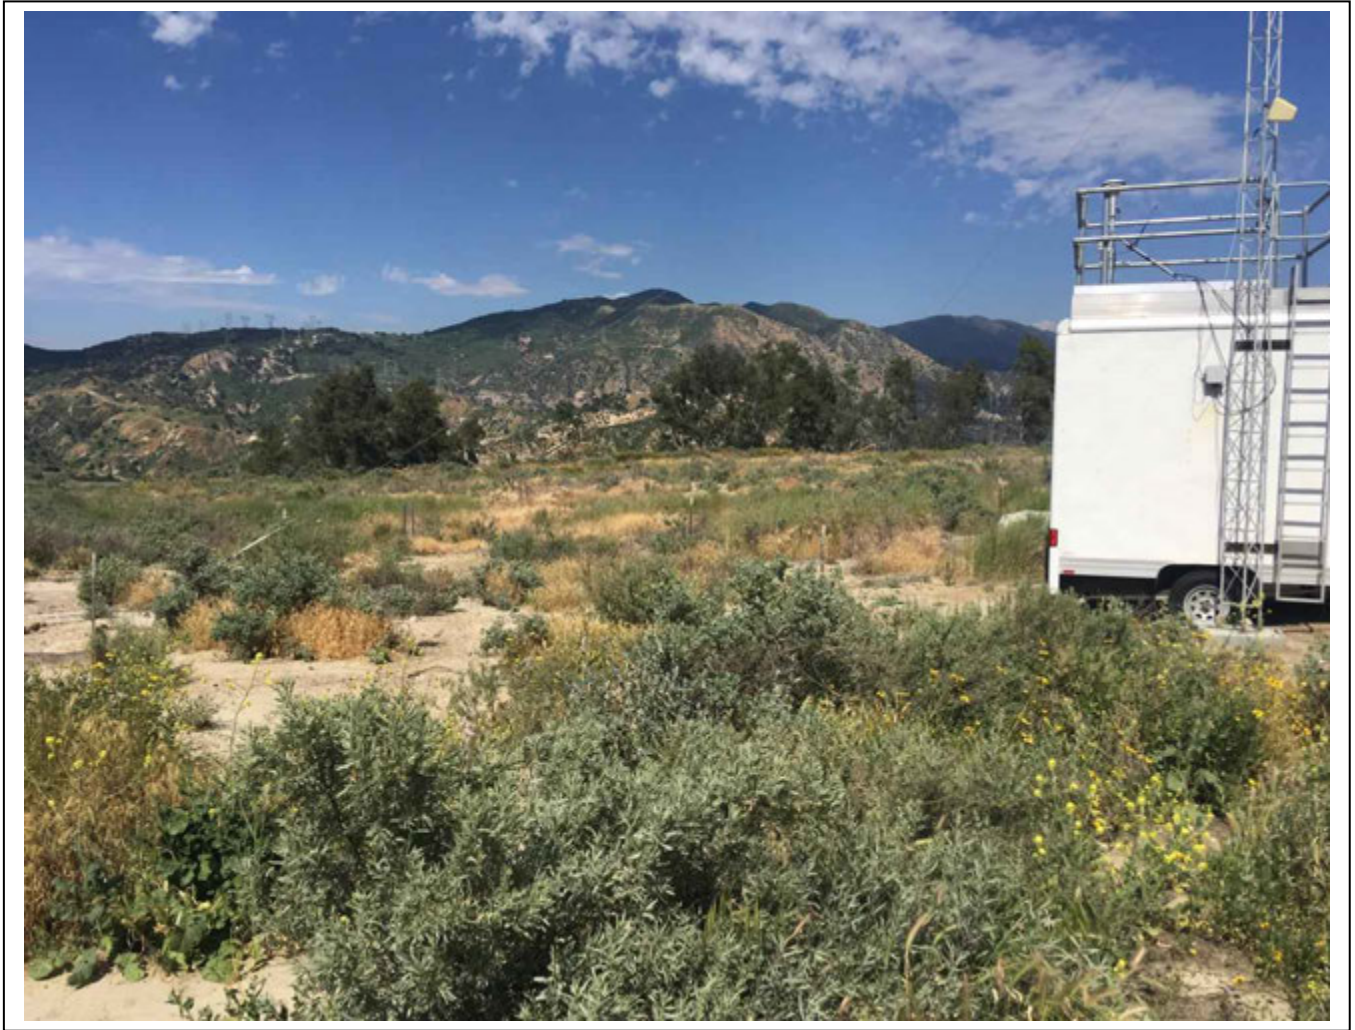
Quadrat B. Facing northeast from southwest corner.

Quadrat	Species	Size (sq. meters)	% basal (shrub)	% basal (herb.)	% Bare	% Rock/ unusable	% canopy (shrub)	% canopy (herb.)
B		50	2%	40%	30%	5%		
	CA Artemisia						1%	
	Encelia californica						4%	
	Sambucus nigra ssp. caerulea						1%	
	Hazardia squarosa						1%	
	Yucca whipplei						1%	
	Achillea millefolium							3%
	Mustard							30%
	Tocalote							20%
	Purple needlegrass							3%
	Lasthenia californica							7%
	Salvia apiana						1%

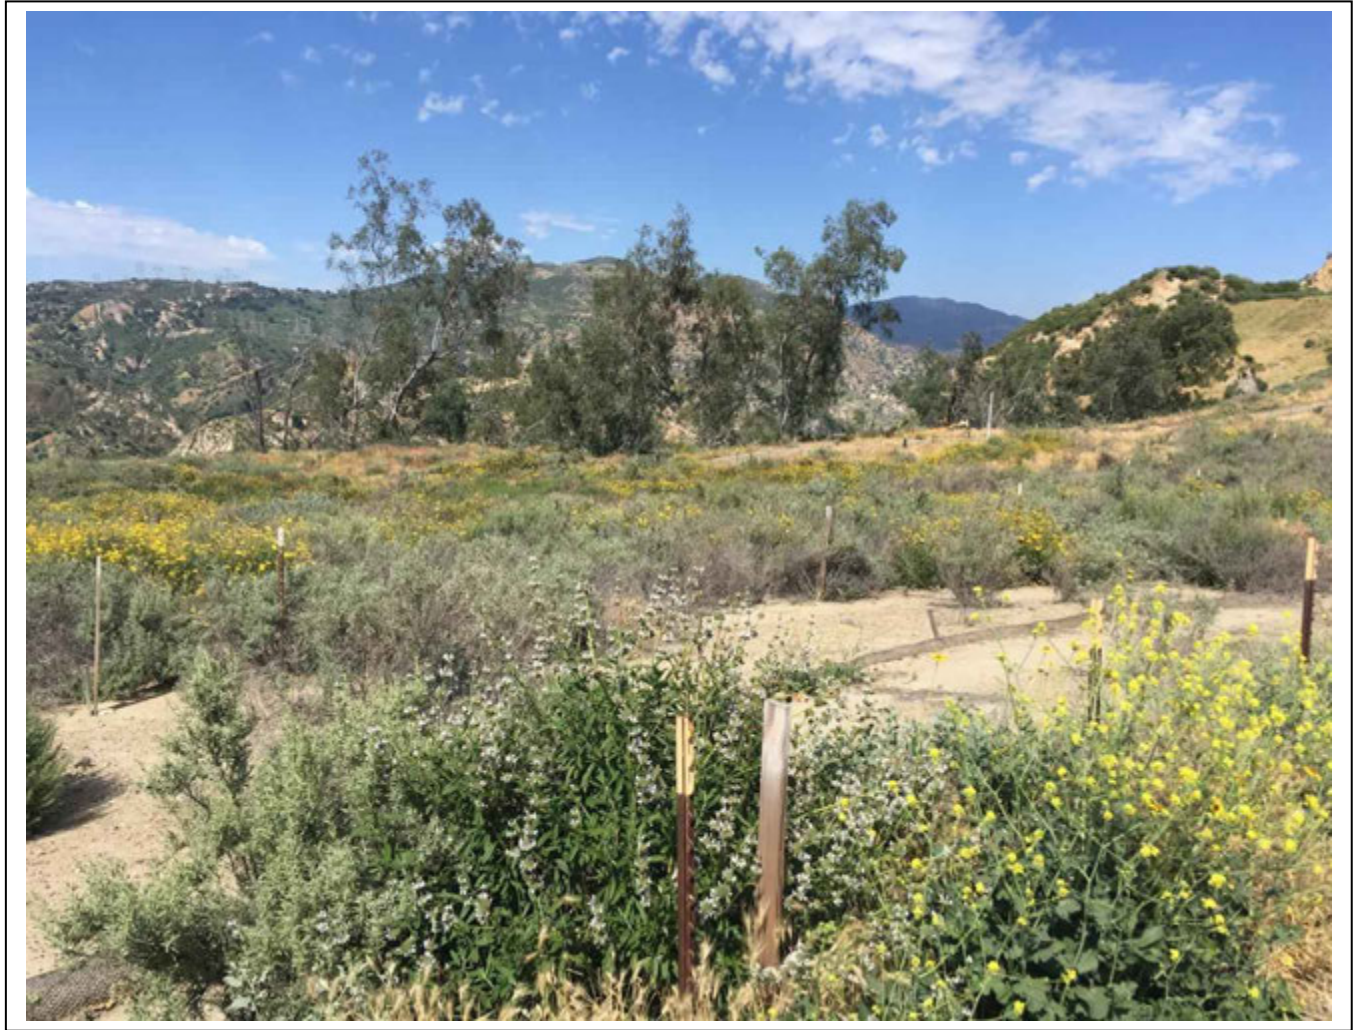
Quadrat C. Facing northeast from southwest corner.

Quadrat	Species	Size (sq. meters)	% basal (shrub)	% basal (herb.)	% Bare	% Rock/ unusable	% canopy (shrub)	% canopy (herb.)
C		50	2%	25%	40%	5%		
	Artemisia californica						2%	
	Salvia apiana						2%	
	Opuntia littoralis						1%	
	Baccharis sp.						2%	
	Mustard							1%
	Lasthenia californica							5%
	Vulpia microstachys							45%
	CA poppy							1%
	Achillea millefolium							4%
	Isocoma menziesii						1%

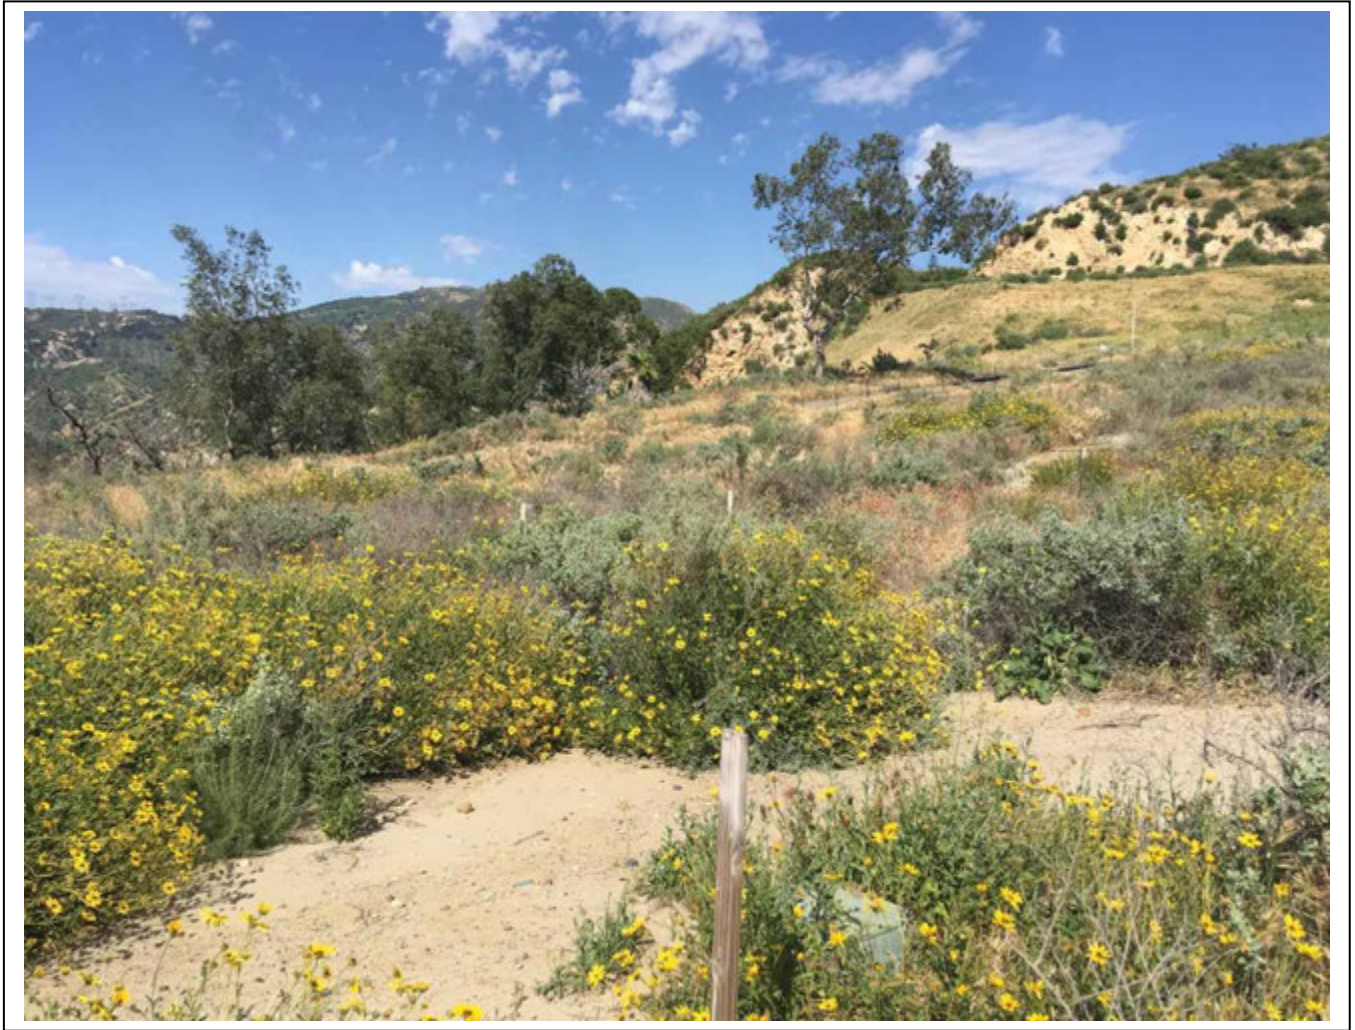
Quadrat D. Facing northeast from southwest corner.

Quadrat	Species	Size (sq. meters)	% basal (shrub)	% basal (herb.)	% Bare	% Rock/ unusable	% canopy (shrub)	% canopy (herb.)
D		50	1%	40%	20%	5%		
	Sambucas nigra ssp. caerulea						2%	
	Salvia apiana						1%	
	Achillea millefolium							6%
	Lasthenia californica							2%
	Mustard							2%
	Vulpia microstachys							50%

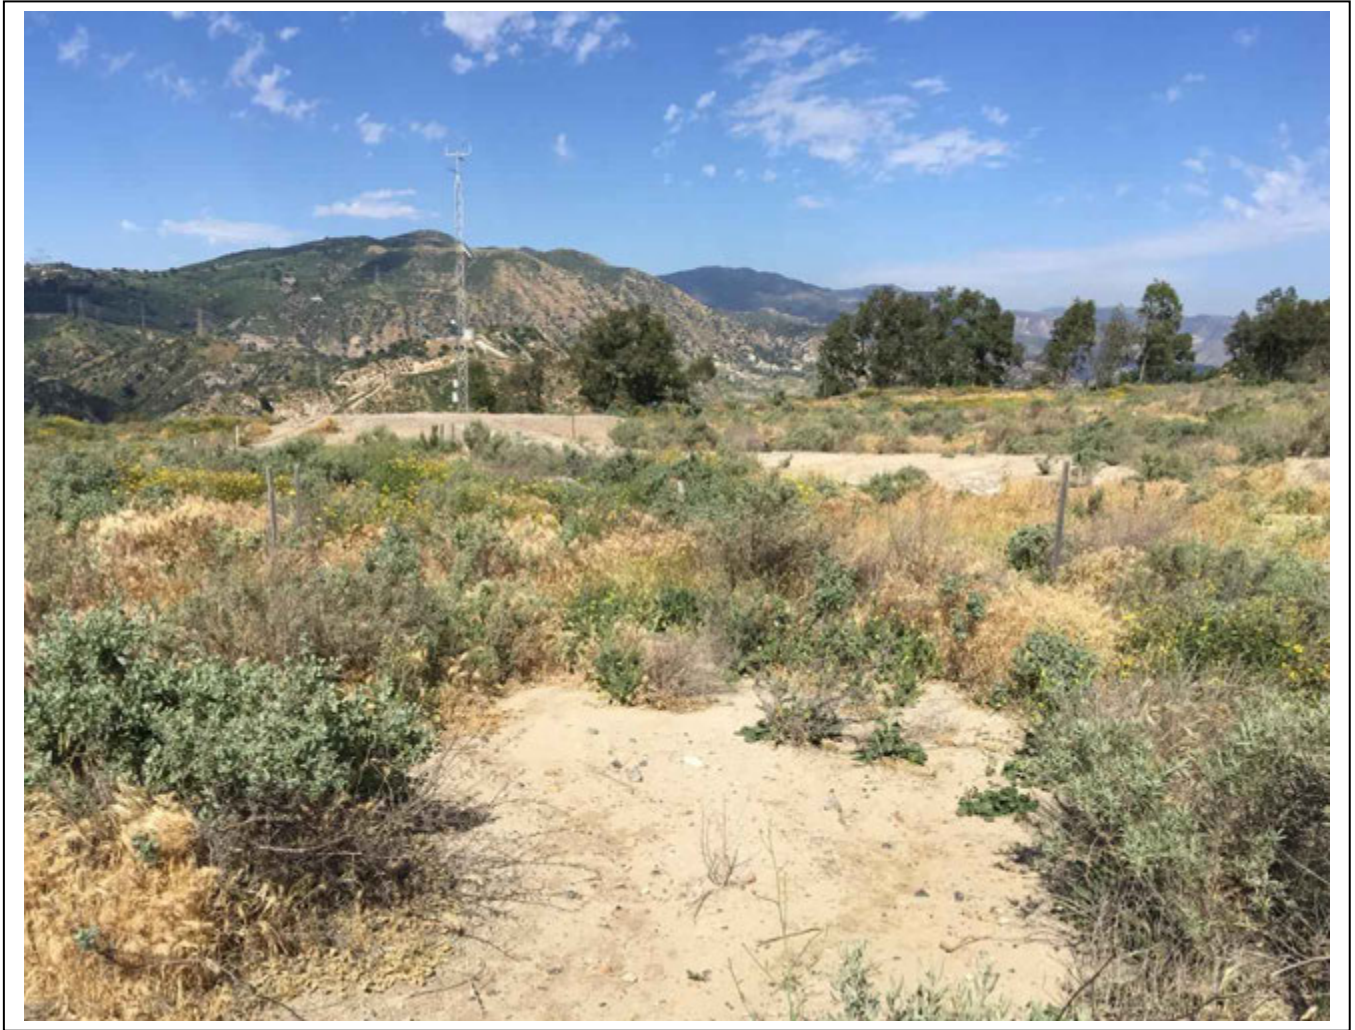
Quadrat E. Facing northeast from southwest corner.

Quadrat	Species	Size (sq. meters)	% basal (shrub)	% basal (herb.)	% Bare	% Rock/unusable	% canopy (shrub)	% canopy (herb.)
E		50	1%	15%	65%	7%		
	Eriogonum fasciculatum foliosium						1%	
	Vulpia microstachys							30%
	Achillea millefolium							2%

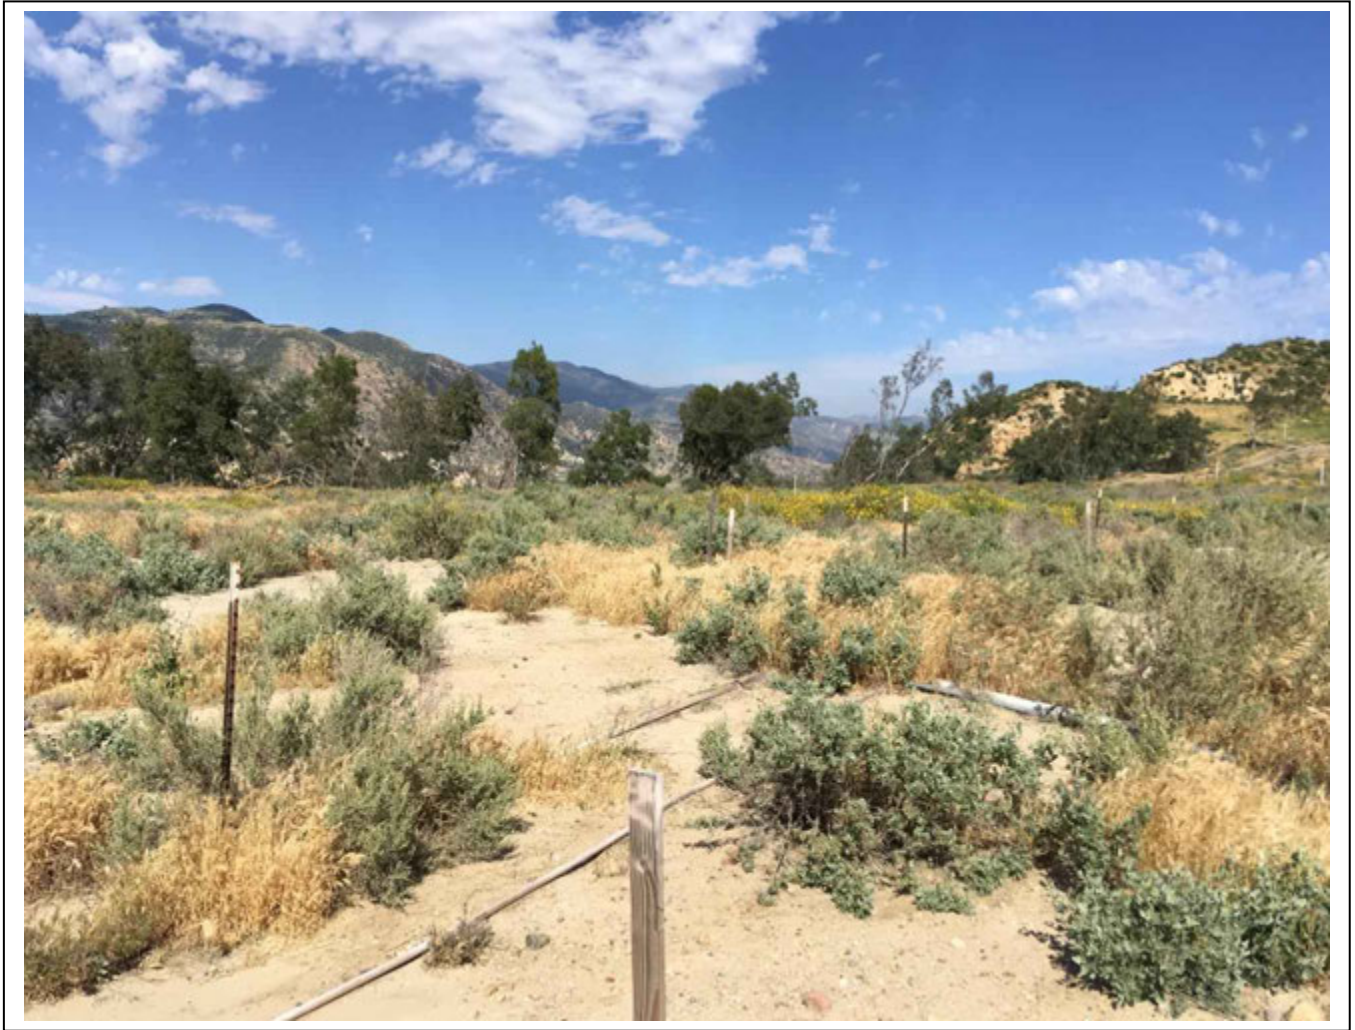
Quadrat F. Facing northeast from southwest corner.

Quadrat	Species	Size (sq. meters)	% basal (shrub)	% basal (herb.)	% Bare	% Rock/ unusable	% canopy (shrub)	% canopy (herb.)
F		50	2%	18%	55%	5%		
	Baccharis pilularis						2%	
	CA artemisia						1%	
	CA poppy							1%
	Vulpia microstachys							35%
	Achillea millefolium							5%
	Lasthenia californica							2%

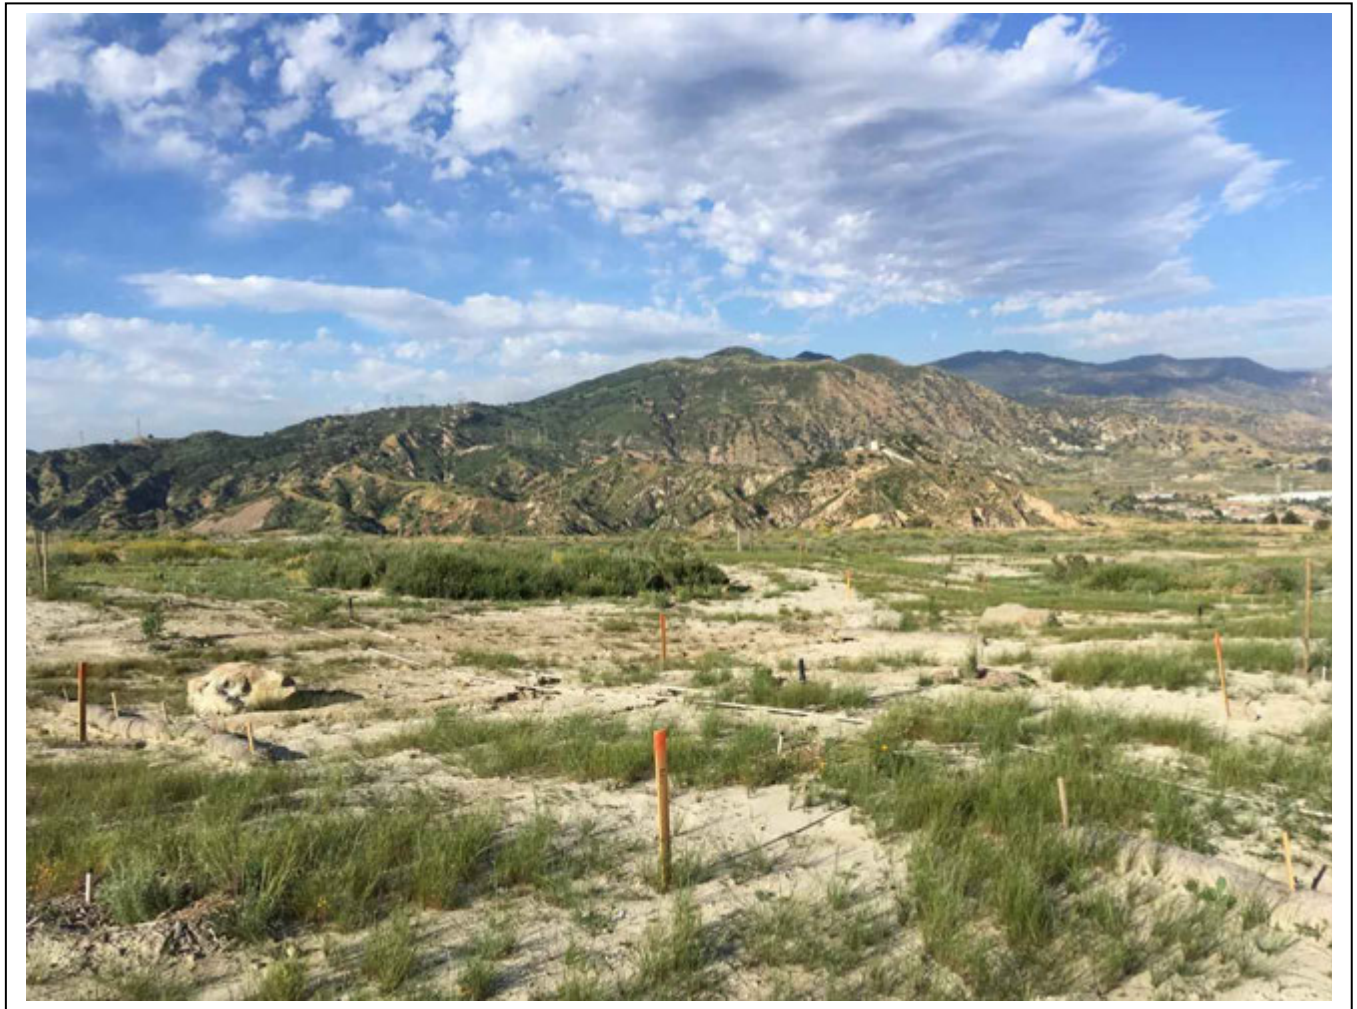
Quadrat F. Facing northeast from southwest corner.

Quadrat	Species	Size (sq. meters)	% basal (shrub)	% basal (herb.)	% Bare	% Rock/ unusable	% canopy (shrub)	% canopy (herb.)
G		50	2%	15%	50%	10%		
	Baccharis pilularis						1%	
	CA poppy						2%	
	Vulpia microstachys							30%
	Lasthenia californica							1%

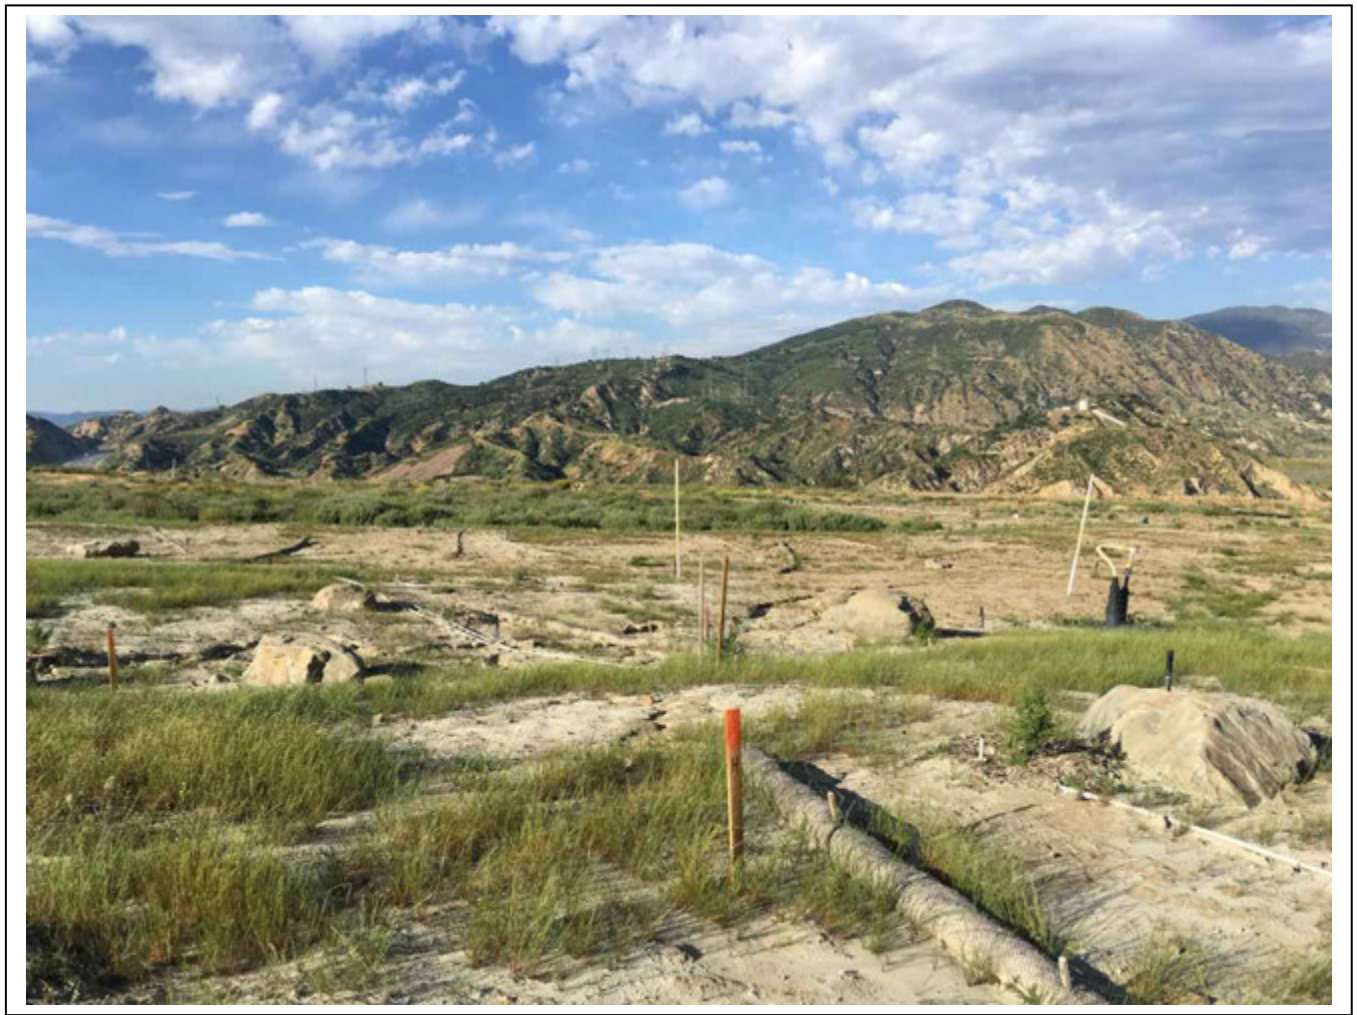
Quadrat H. Facing northeast from southwest corner.

Quadrat	Species	Size (sq. meters)	% basal (shrub)	% basal (herb.)	% Bare	% Rock/ unusable	% canopy (shrub)	% canopy (herb.)
I		50	2%	20%	65%	3%		
	Baccharis pilularis						1%	
	Atriplex lentiformis						2%	
	Foxtail barley							2%
	Vulpia microstachys							30%
	Achillea millefolium							2%
