Subject: Sunshine Canyon Landfill, Quarterly Vegetation Report  
First Quarter 2020 Vegetation Report

This report presents the progress of the site's landscaping and revegetation activities for the first quarter of 2020. The intent of these reports is to provide detailed information regarding the site's efforts related to vegetation including vegetation of interim and permanent slopes and activities conducted for the on-site sage mitigation areas.

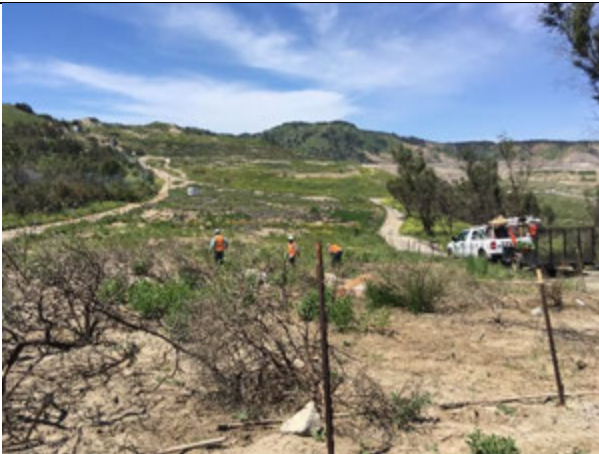
**Photo 1.** Facing west at lower deck. View of eastern limits that was dominated with *Atriplex* species and California sunflower (*Encelia californica*) prior to the October 2019 Saddleridge Fire. Maintenance crew can be seen removing shortpod mustard.

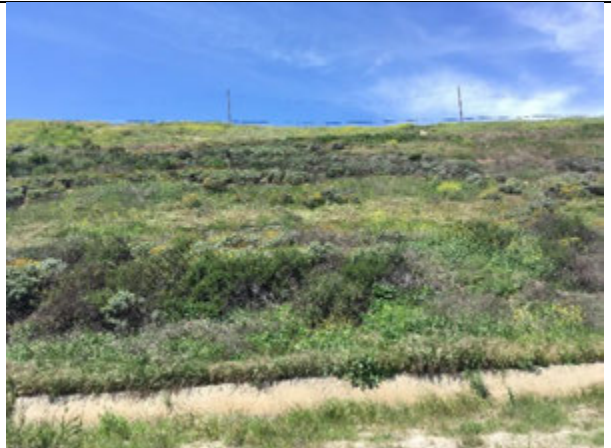
**Photo 4.** Facing west at the easterly-facing slope located between middle and upper decks. The vegetation on the slopes below the upper deck is dominated with CA buckwheat and annual non-native grasses.

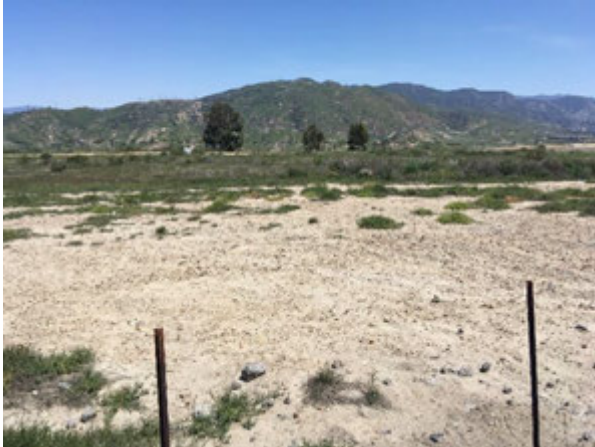
**Photo 5. Facing northeast at upper deck. This area is compacted and gravelly and continues to be problematic for supporting vegetation. Annual non-native grasses and some CA buckwheat shrubs are evident in the background.**

• **Improve root zone and soil conditions.** Continue to investigate ways to import the soil layer to improve the root penetration and saturation zone to enable plant growth in heavily compacted areas. Consider applying soil in random undulations or uneven mounds to improve soil porosity and filtration and to control soluble salts from leaching from existing layer.

If permissible, prior to seeding (broadcast, hydroseeding, or drilling) native species, incorporate a soil amendment or mulch with high organic content by tilling into the top 12 inches of the existing compacted soils to improve soil texture, drainage, porosity, and aerobic conditions. If an organic mulch or soil amendment is not feasible or available, incorporate available soil from on-borrow sites within the landfill that have the appropriate, so long as these borrowed soils have been determined to not have toxic conditions such as boron or high salinity.

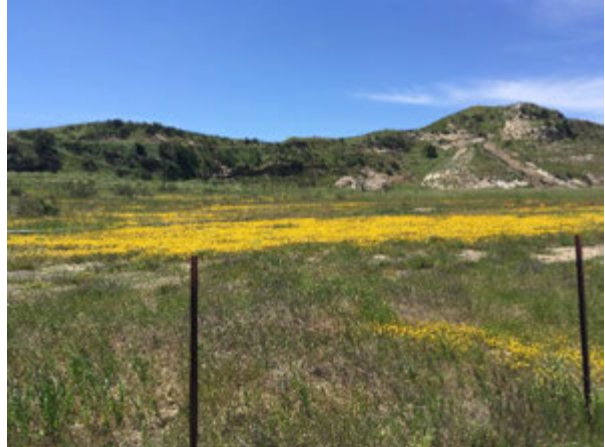
**Photo 6. Facing southwest at upper deck. The area shown in this photo is dominated by wild oats and California goldfields**

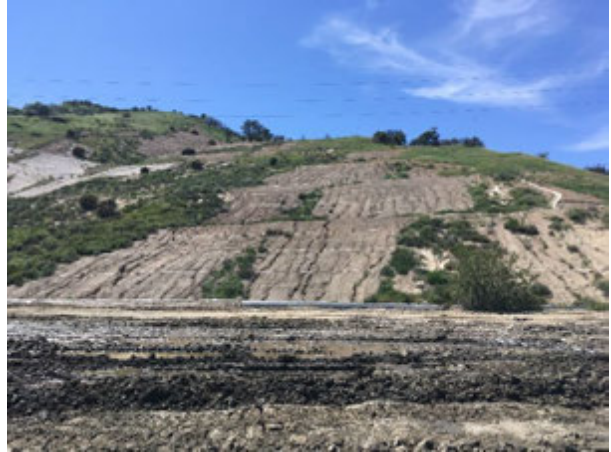
Photo 2. Facing west at the northern-half of the county sage hill, where plant growth has been problematic due to poor soil conditions.

- **Create benches.** Consider creation of benches throughout the mitigation area to control soil erosion and to improve soil conditions to improve plant establishment and seed dispersal. This technique has been widely used on steep slopes and in areas where soil erosion is problematic. This technique also allows for opportunities to introduce a high quality soil layer above the poor soils that exist.

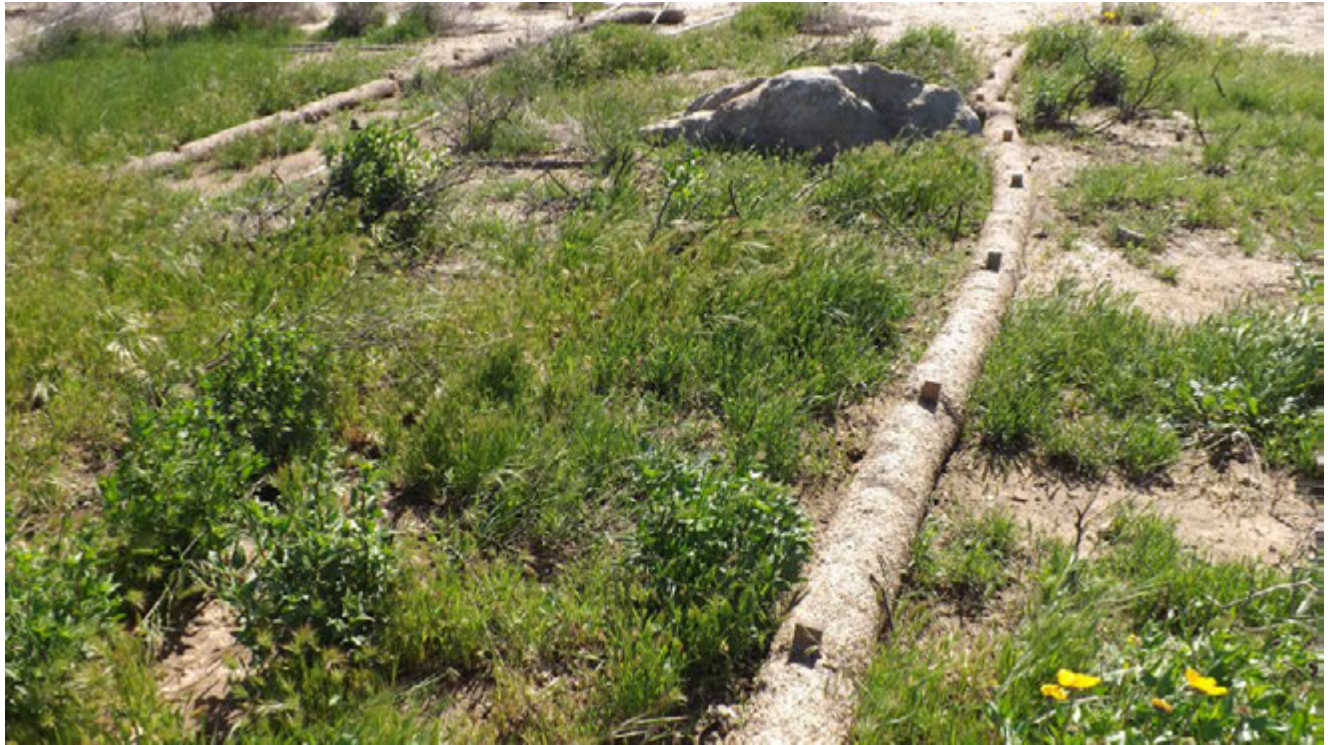
Flourishing mix of exotic weeds and CSS Venturan Species

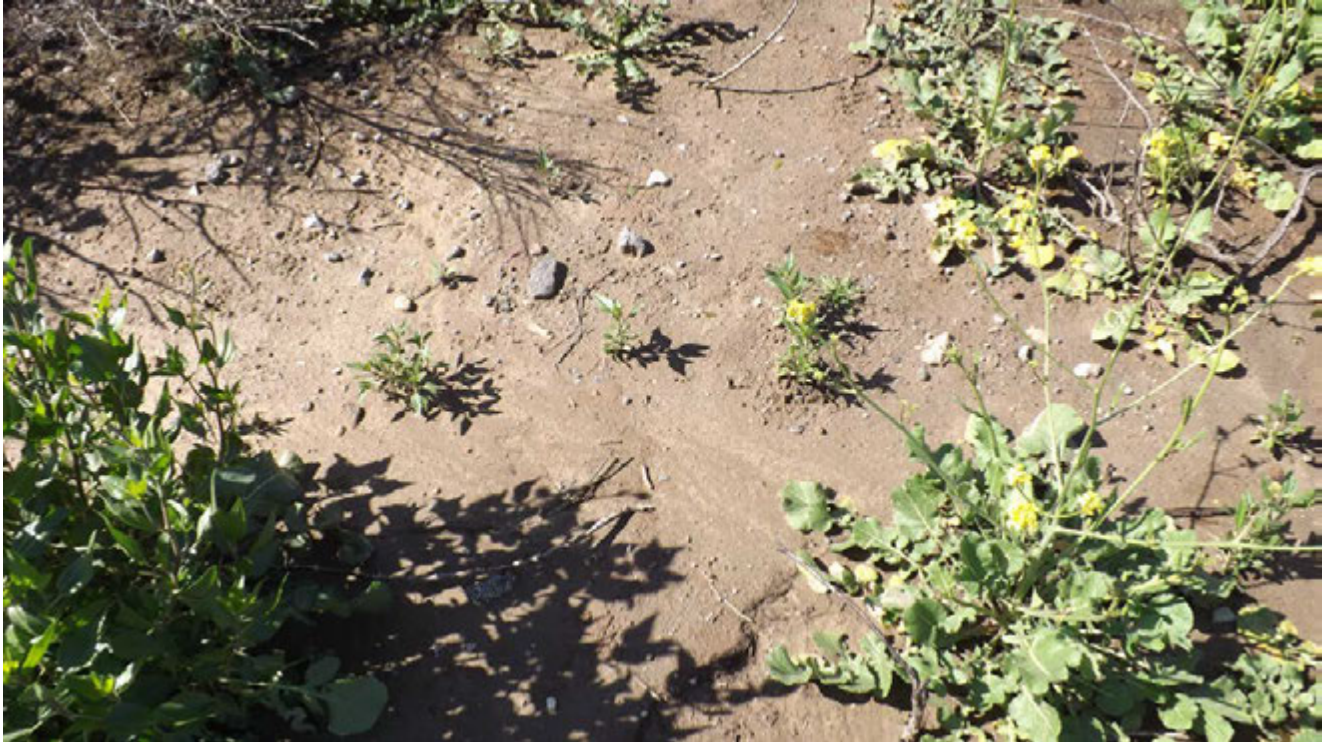
New Coast Sunflower establishing adjacent to Shortpod Mustard

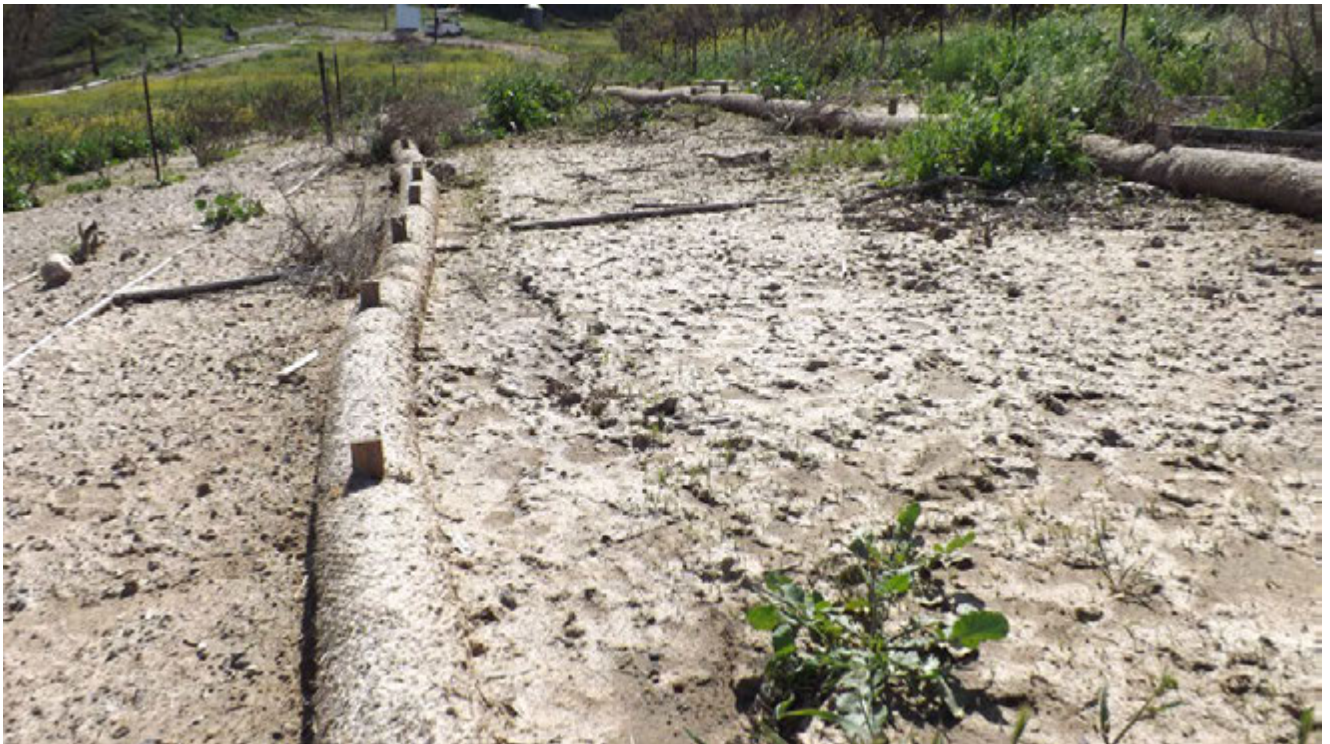
New Straw Wattles with emerging seedlings from recent hydroseeding

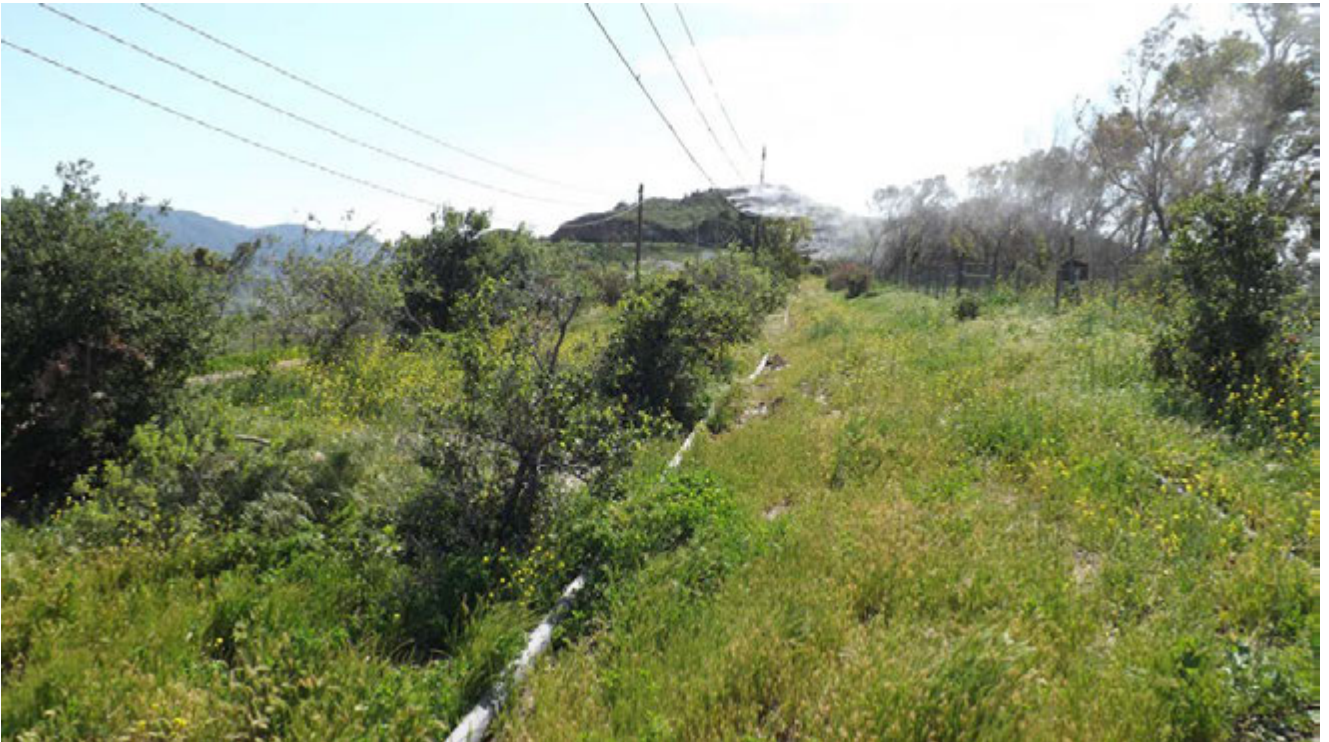
PM10 Berm covered in Red Brome Grass and Shortpod Mustard

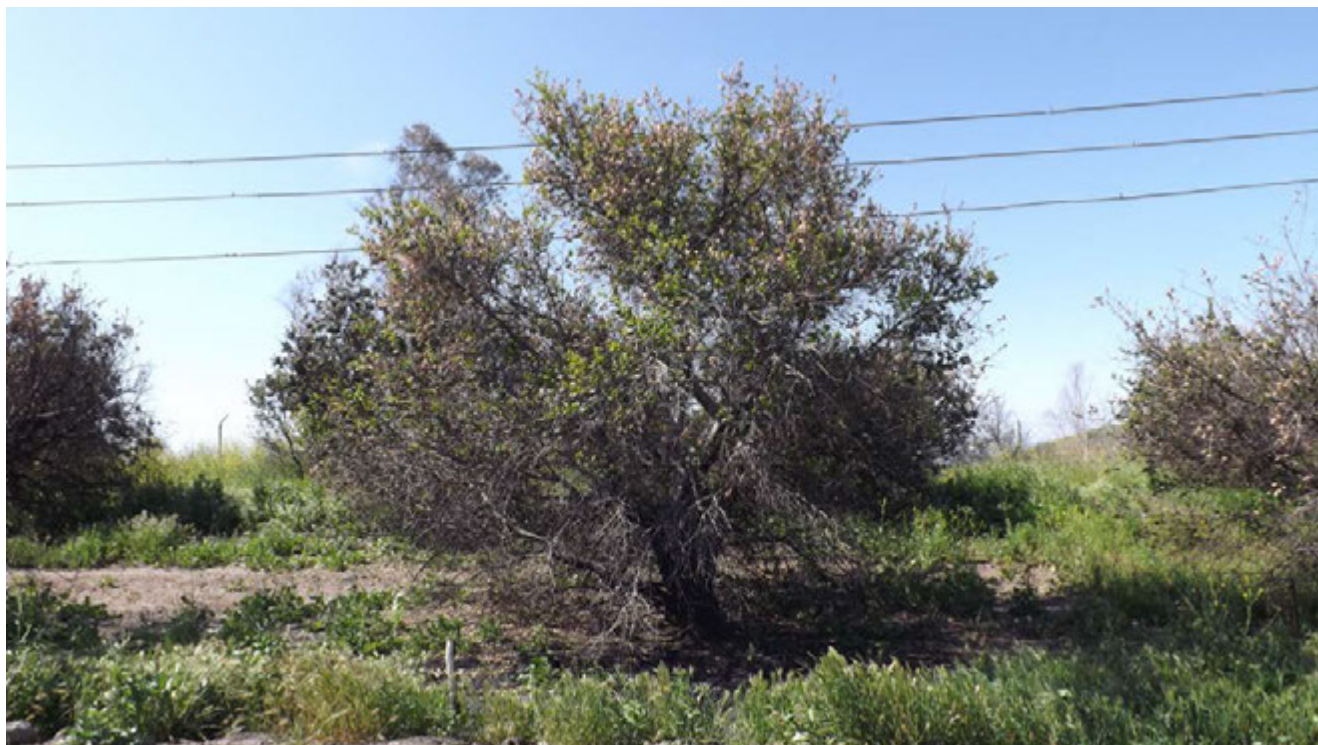
PM10 Berm Oak Tree recovering and beginning to flush new growth

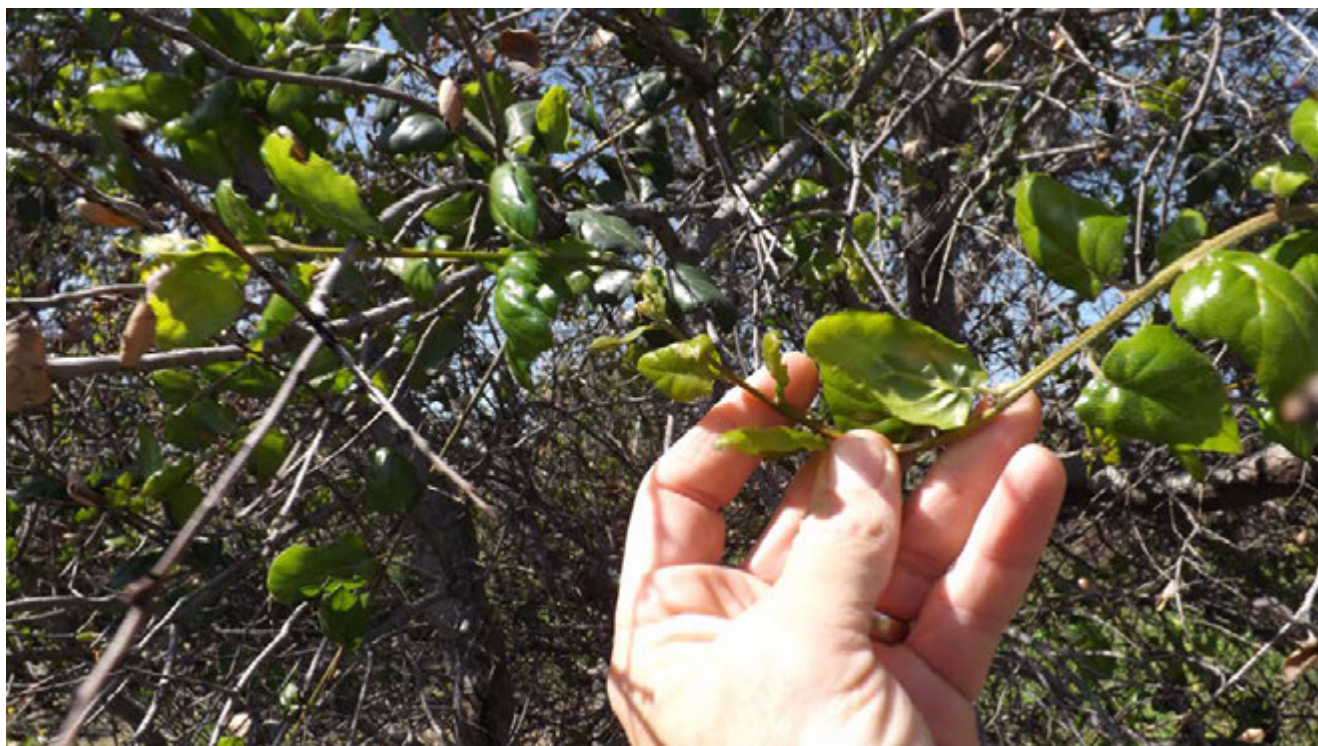
Close up showing recovery and new vegetative growth

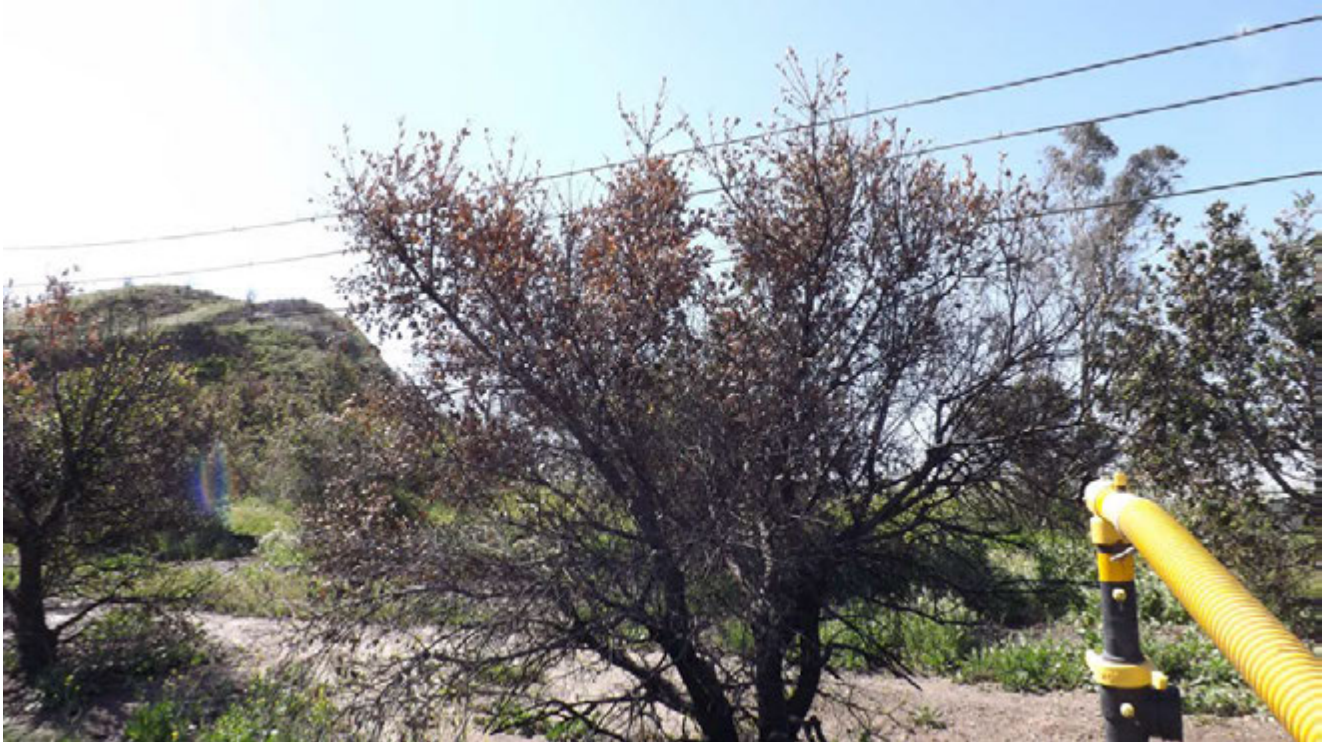
- PM10 Berm Oak Trees were severely damaged from the fire, but some early signs of new sprouting are evident on a number of trees. It will take time for these canopies to reestablish to the density of what they were prior to the fire, but active growth is seen in perhaps 75% of the trees. Some have not flushed new growth and have either crown spouted or are so severely damaged, they may not rebound. Undesirable invasive Shortpod Mustard has been quick to establish under the open canopies of the PM10 Berm and needs to be addressed. During my visit of the decks, Oakridge Landscape was present with several workers targeting the Mustard within Deck C. After the deck removals, we suggest removals or at a minimum brush clearance of this area to stubble.

Existing PM10 Berm Oak Tree not showing signs of recovery

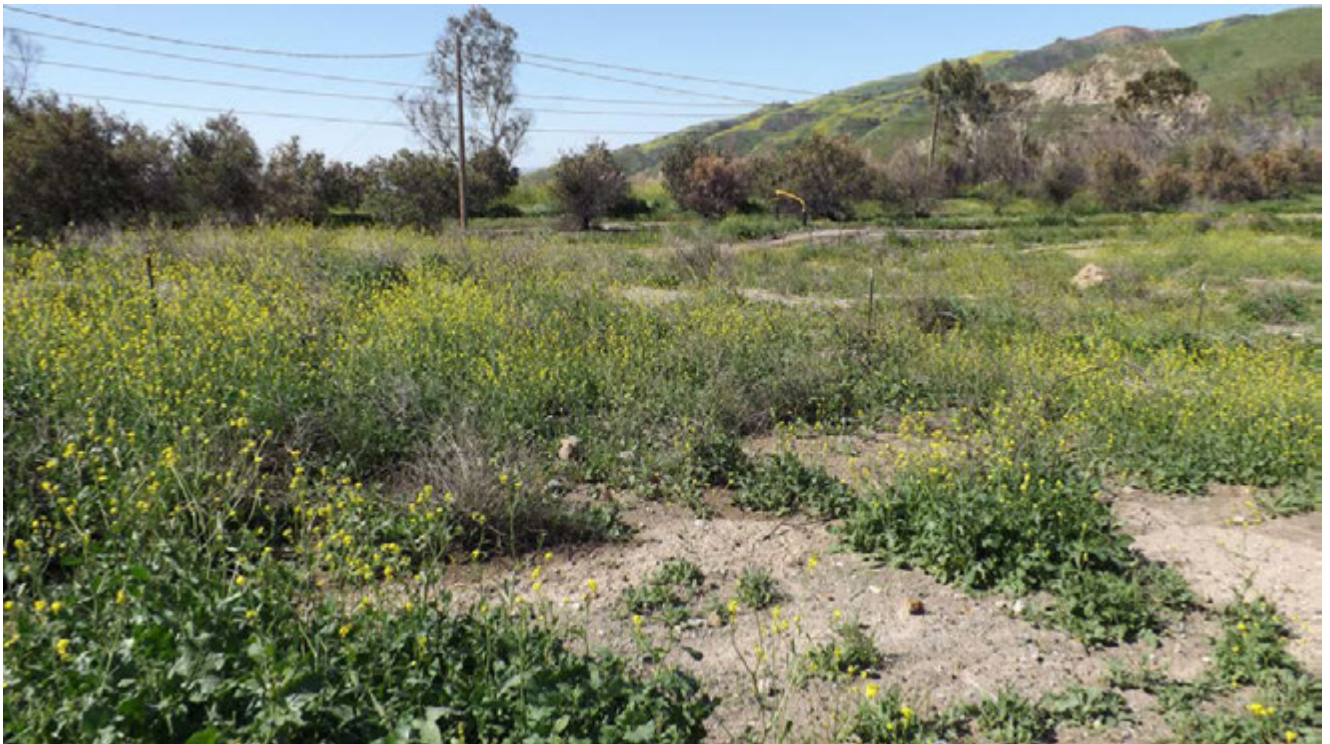
- Due to the burn, Deck C was left exposed and as a result, many new exotic weeds are beginning to establish. Oakridge Landscape needs to continue their weed abatement and remain aggressive during the spring to keep areas from being overrun. Active exotic weed growth on Deck C includes: Shortpod Mustard (*Hirschfeldia incana*), Yellow Star Thistle (*Centaurea solstitialis*) and Red Brome Grass (*Bromus madritensis*). With early spring heat arriving later this week, smaller seedlings of Russian Thistle (*Salsola ssp.*) will explode if not kept in check. Weed abatement within Deck C will need to be an on-going activity

East end of Deck C abundant with Shortpod Mustard

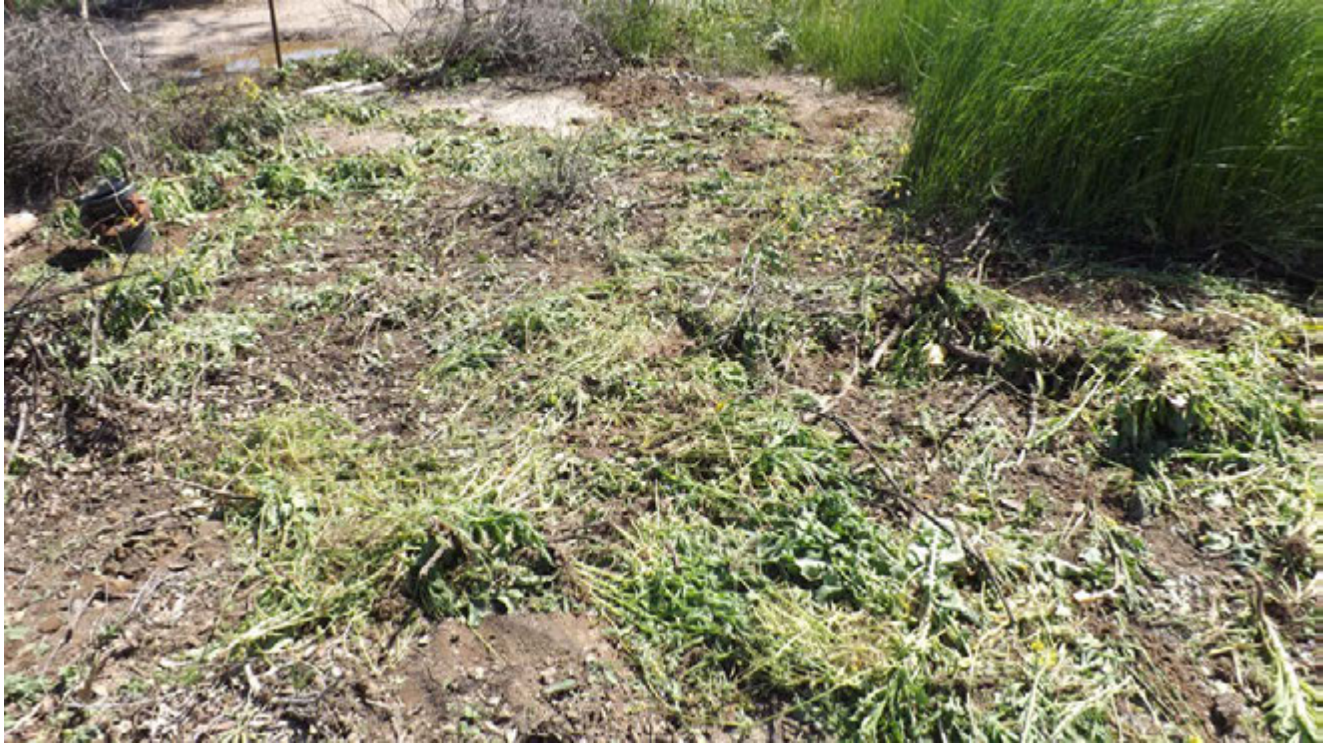
Weed abatement efforts focused on Shortpod Mustard

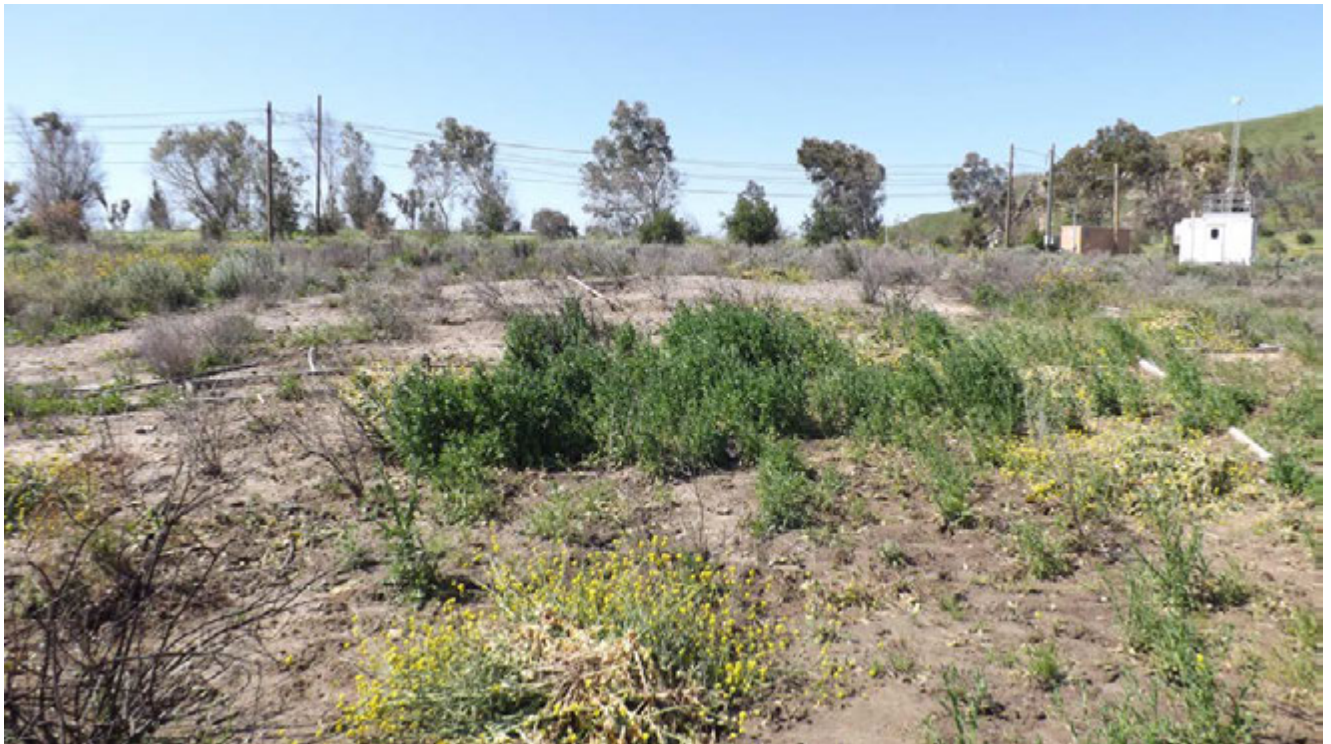
Large stand of Yellow Star Thistle

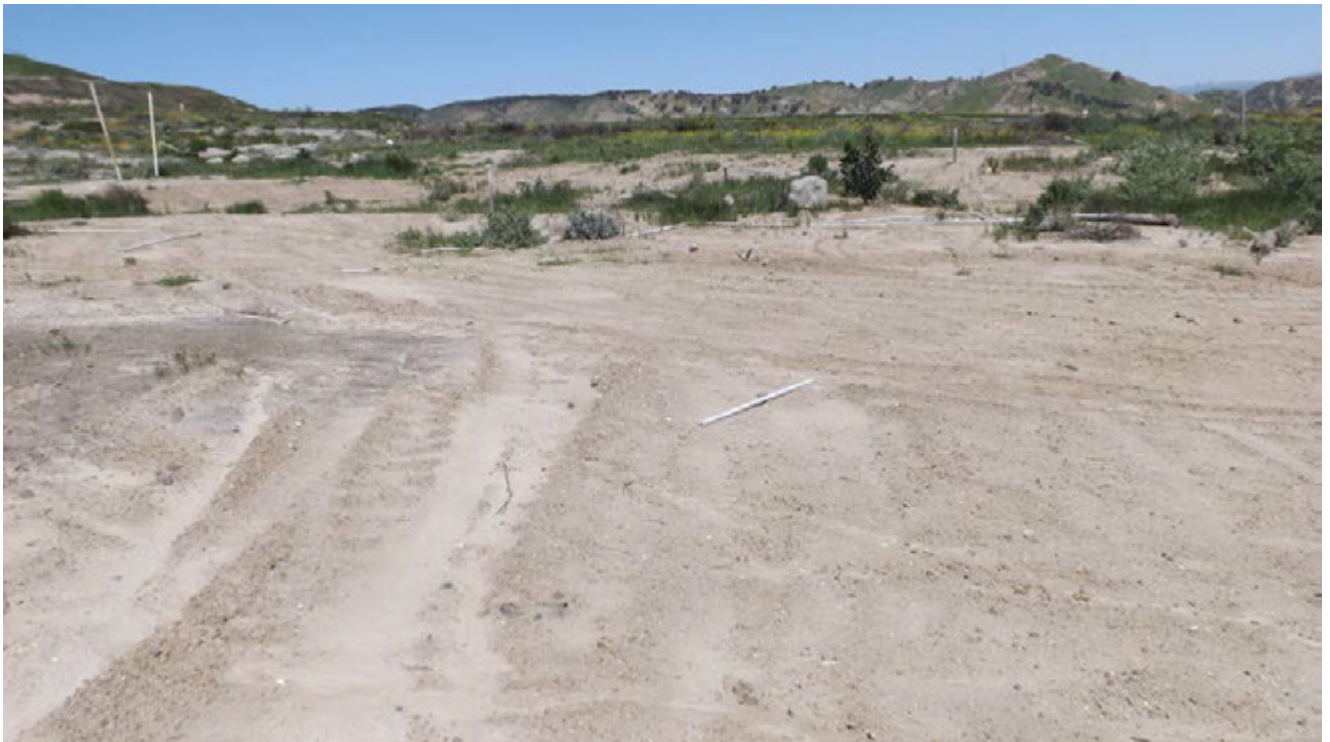
- Portions of Deck B burned during the Saddle Ridge Fire, but most of the damage came as a result of fire personnel vehicles driving onto the deck and breaking irrigation lines and moving dirt to fight the fire advancement. Surprisingly, Deck B has flourished with an abundance of new native seedlings. Areas that were mostly barren have now become covered with a variety of Venturan CSS species. The irrigation mainline and laterals are damaged and are not operational, however, due to the late winter and spring rains in March and April, vegetation that has established on the deck may not need irrigation to endure. Typically, irrigation would be dialed back during the spring and summer months after the third winter of growth, but after only two winters, it seems like the Deck B revegetation efforts may be able to persist, even without the additional year of irrigation. ADG will monitor the vegetation during the drier months to see how it responds.

Some areas remain barren do to fire vehicle damage and displacement of soils

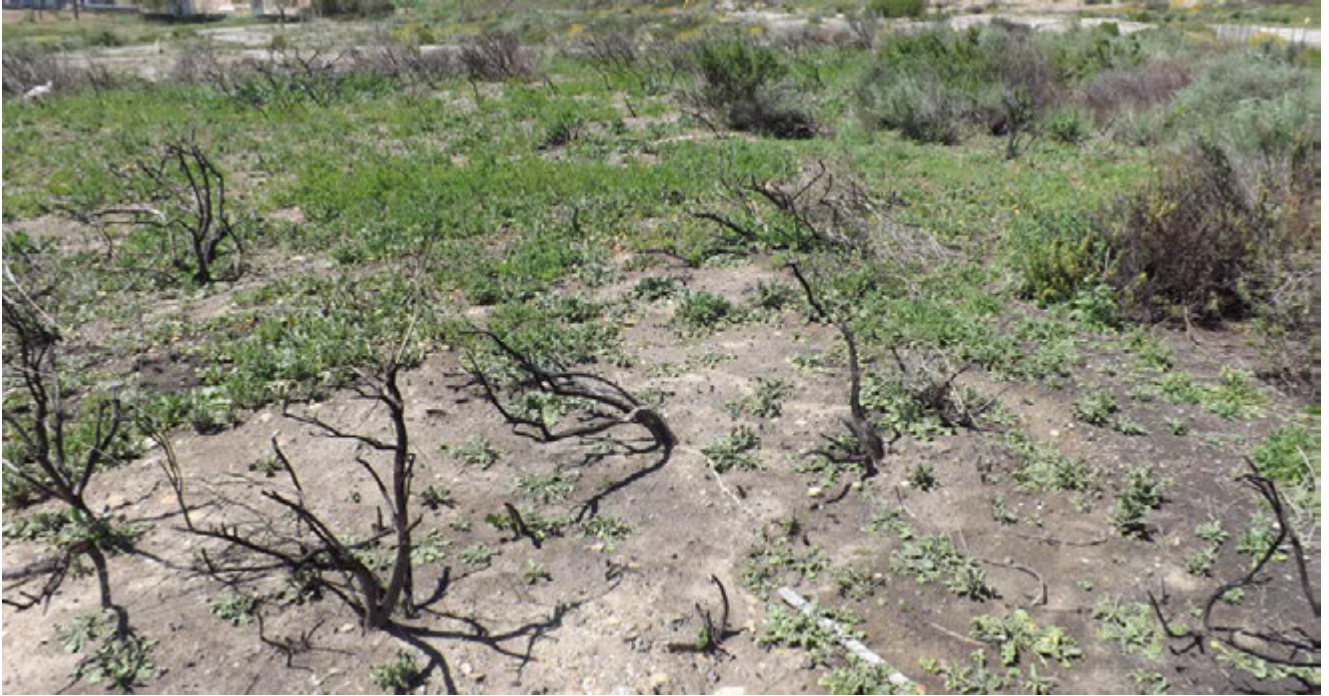
Abundance of Shortpod Mustard seedlings within existing stand of CSS at Deck B

- A good portion of the existing CSS stand that was within the middle of the deck burned. Unlike most of the newly revegetated deck area, this middle portion has the most intensive areas of exotic weed establishment. Weeding efforts should begin immediately and focus on removing as much as possible within this area so that the surrounding deck does not become overrun.

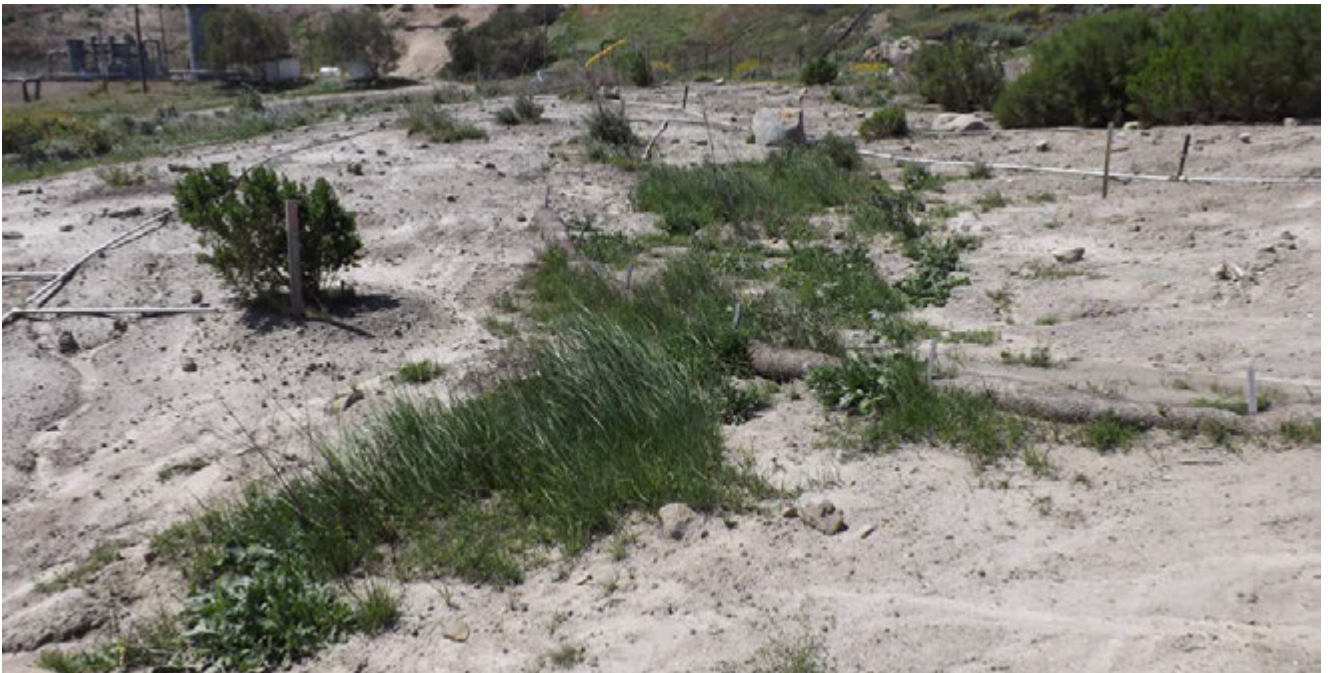
- New straw wattles were placed along swales to minimize erosion and for the most part it was successful.
- Openings along the perimeter edge need to be filled in with the T-Bar stakes to eliminate vehicular traffic onto the deck. Staking was damaged and/or removed during the fire.

Straw wattles holding back sediment with native grasses (*Leymus*) within swaleline
