Subject: Sunshine Canyon Landfill, Quarterly Vegetation Report

Third Quarter 2021 Vegetation Report

#### City-Side Sage Mitigation Area Qualitative Progress Report – 3rd Quarter, 2021

### **FIELD OBSERVATION REPORT**

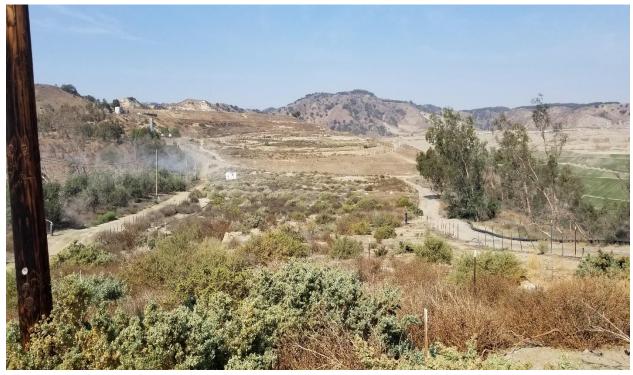
Photograph 1. Facing west at lower deck. View of eastern limits that was dominated by Atriplex sp. and California sunflower prior to the Saddleridge Fire (September 29, 2021).

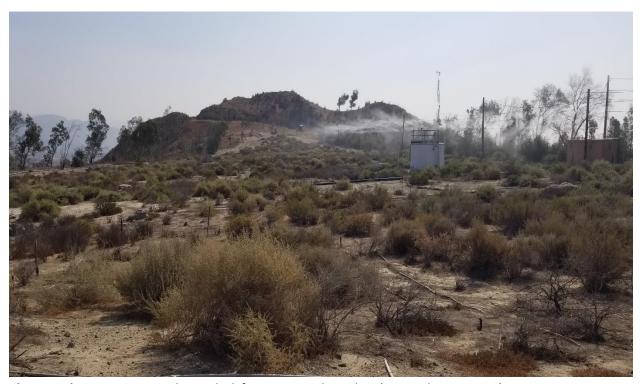
**Photograph 2.** Facing east at lower deck from western boundary (September 29, 2021).

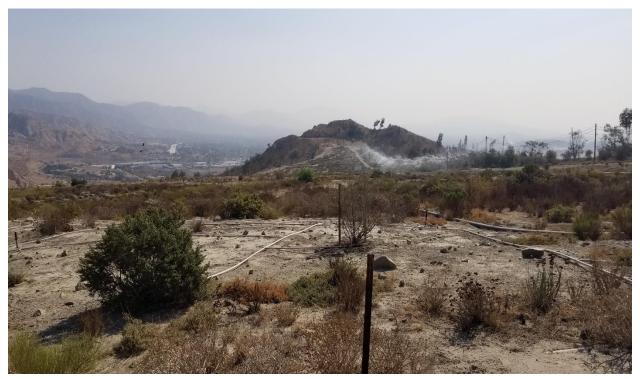
Photograph 3. Facing east at the Middle Deck from western boundary (September 29, 2021).

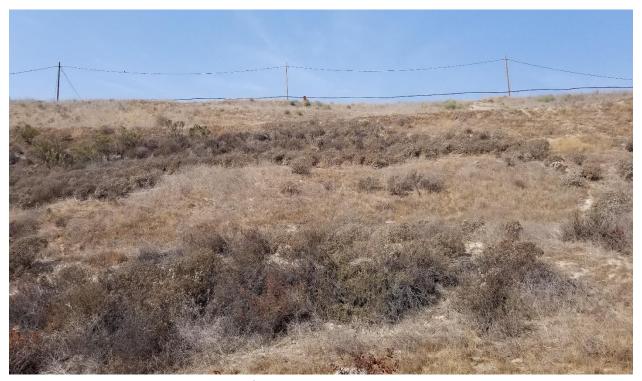
Photograph 4. Facing west at the easterly-facing slope located between the Middle and Upper Decks. The vegetation on the slopes between the Upper Deck is dominated by California buckwheat (currently in flower and setting seed) and non-native annual grasses (September 29, 2021).

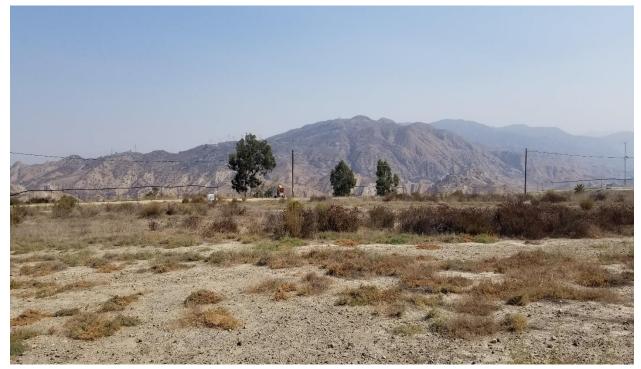
**Photograph 5.** Facing northeast at the Upper Deck. This area is compacted and gravelly and continues to be problematic for supporting vegetation. Non-native annual grasses and forbs, and California buckwheat shrubs are evident in the background (September 29, 2021).

• The vegetated areas on the Upper Deck that are currently dominated with non-native annual species have decent soil-texture conditions. These areas are less compacted than adjacent areas that are gravelly and mostly devoid of vegetation. In general, the soil texture within the vegetated areas with non-native vegetation is friable down to approximately 8-12 inches in depth. Various planting methods (i.e., planting container plants and hydroseeding) may be used to re-establish native plants on the Upper Deck where non-natives currently dominate.

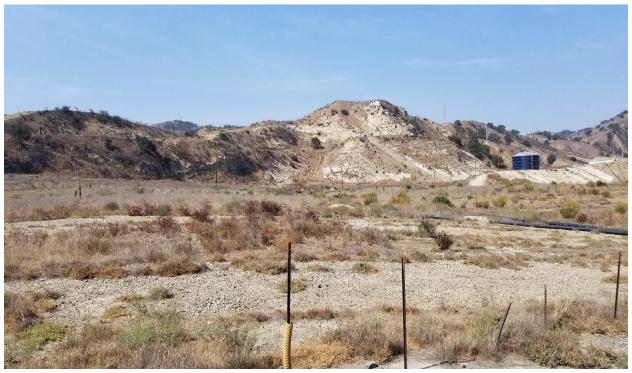
**Photograph 6.** Facing southwest at the Upper Deck. This area is dominated by wild oats and California buckwheat, which are currently flowering and setting seed (September 29, 2021).

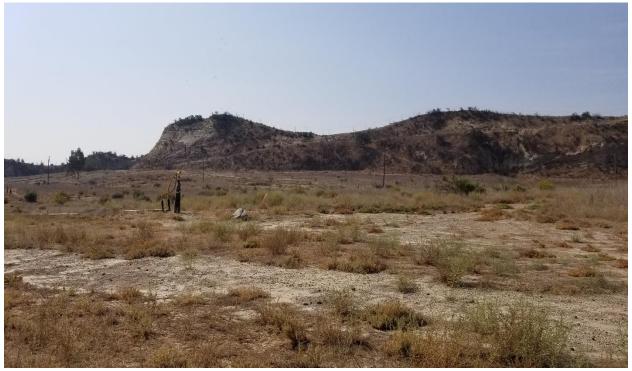
Photograph 7. Facing southeast at the western portion of the Upper Deck. This area is dominated by short podded mustard and Australian saltbush (September 29, 2021).

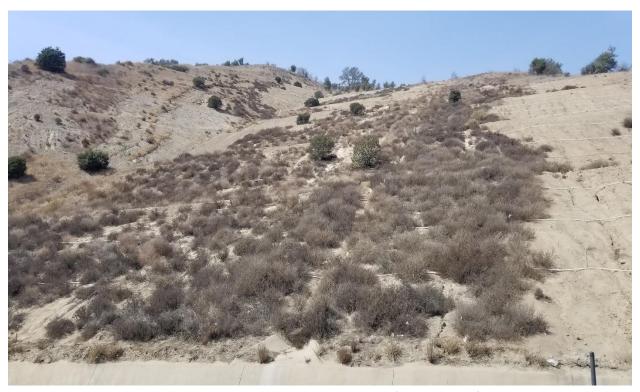
**Photograph 1.** Facing west at the County-Side Sage Mitigation Area (June 23, 2021).

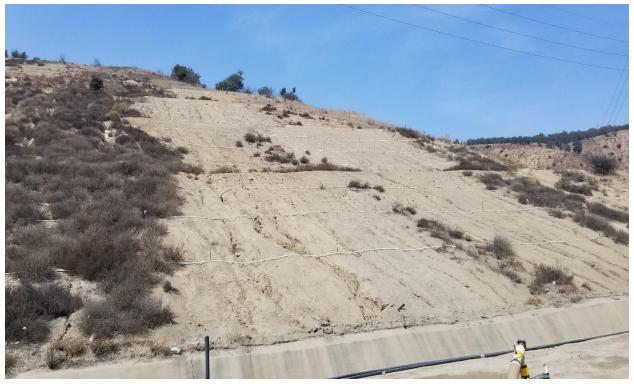
Photograph 2. Facing west at the northern portion of the County-Side Sage Mitigation Area where plant growth has been problematic due to poor soil conditions (June 23, 2021).

- Create benches. Consider creation of several benches throughout the mitigation area to control soil erosion and to improve soil conditions to improve plant establishment and seed dispersal. This technique has been widely used on steep slopes and in areas where soil erosion is problematic. This technique also allows for opportunities to introduce a high-quality soil layer above the poor soils that exist.

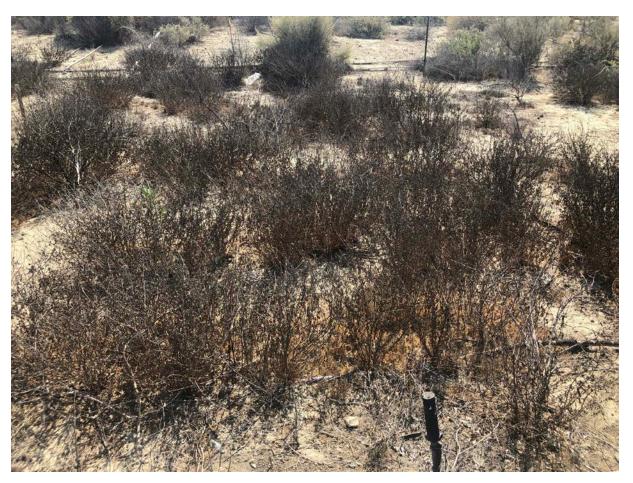
Side by Side - Native Plant Coast Sunflower (Summer/Fall dormant)

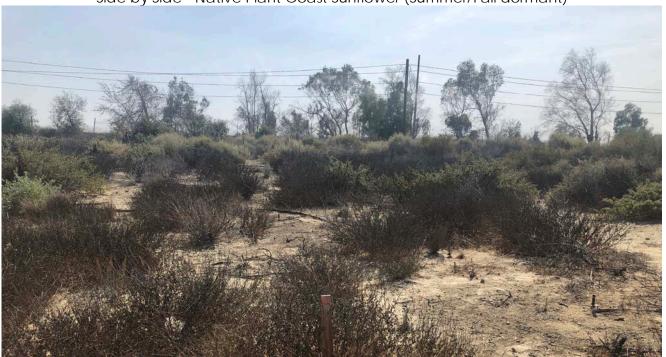
Dormant Coast Sunflower and Saltbush in the background

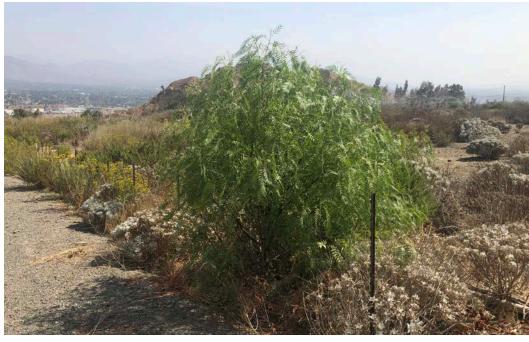
# Invasive California Pepper Trees on Deck B

• Weeding efforts on smaller herbaceous species have allowed the new growth of the Venturan Coastal Sage Scrub. However, three large California Peppers (*Schinus molle*), need to be removed from the center portion of the deck. These trees were identified in the last report and grow rapidly. Priority should be taken to remove as soon as possible.

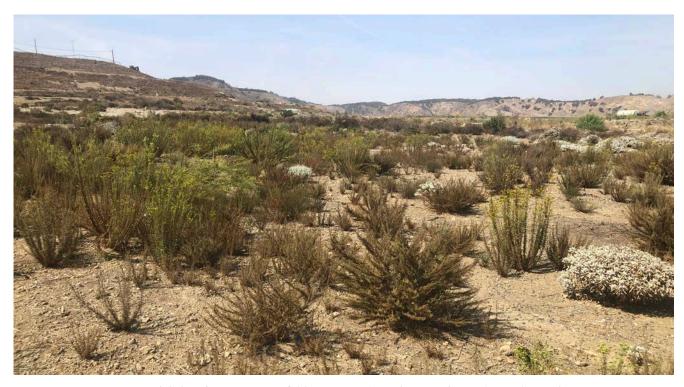
Reestablished Venturan CSS on previous burned portion of Deck B

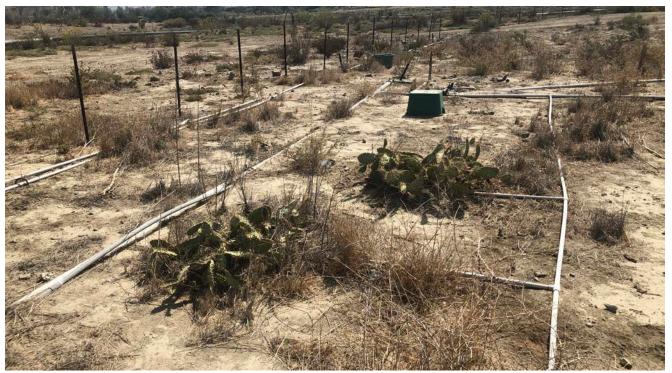
Coast Prickly Pear (Opuntia littoralis) that survived Saddle Ridge Fire
