March 10, 2021

Subject: Sunshine Canyon Landfill, Quarterly Vegetation Report  
Fourth Quarter 2020 Vegetation Report

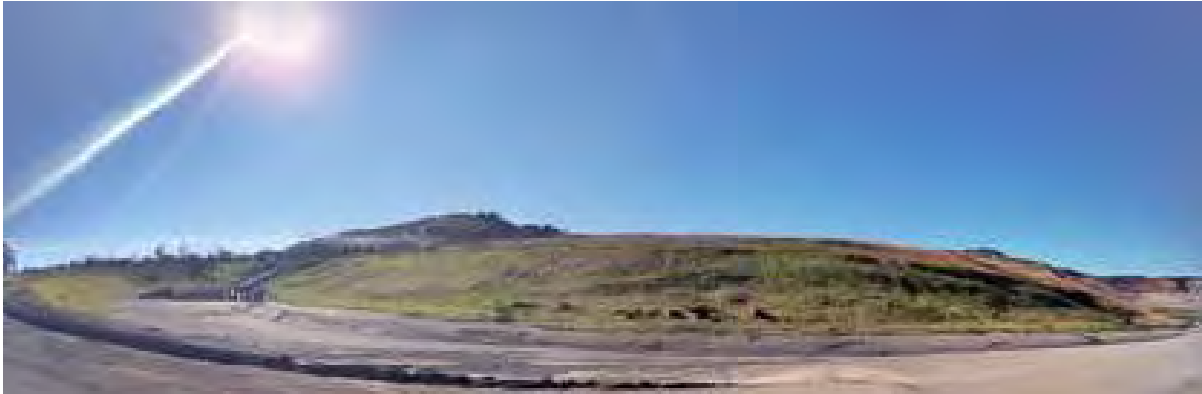
Deck B south slope panoramic view from Deck C entry road

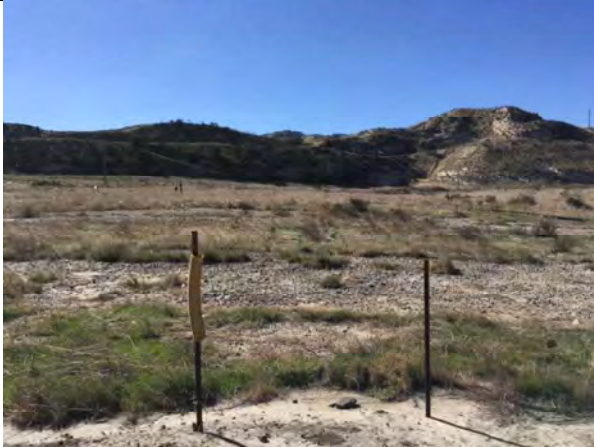
**Photo 6.** Facing southwest at upper deck. The area shown in this photo is dominated by Russian thistle in the foreground, and areas that burned during the Saddleridge Fire are visible in the background.

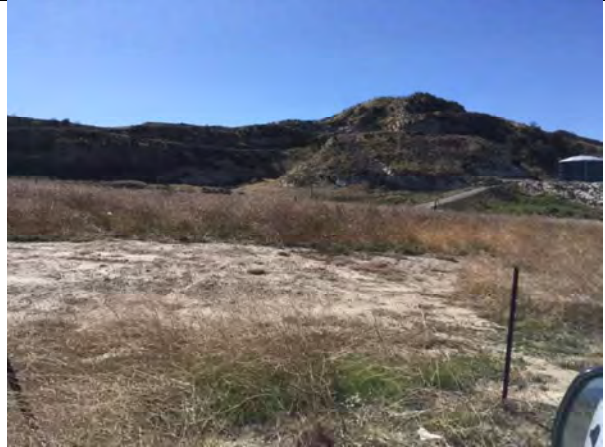
**Photo 7.** Facing southeast at the upper deck at the disturbed area that is currently dominated with desiccant brome grasses and Russian thistle.

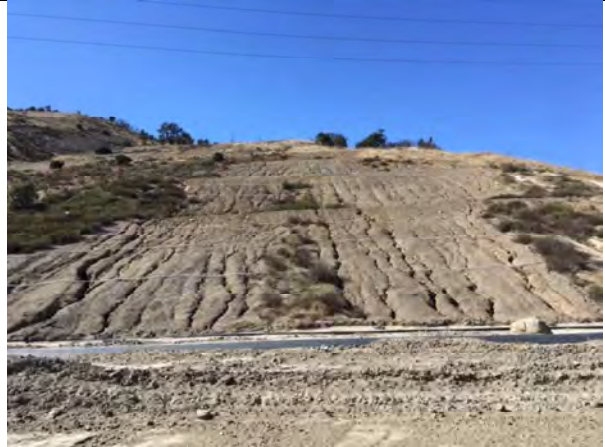
**Photo 2.** Facing west at the northern-half of the county sage hill, where plant growth has been problematic due to poor soil conditions.

- **Create benches.** Consider creation of benches throughout the mitigation area to control soil erosion and to improve soil conditions to improve plant establishment and seed dispersal. This technique has been widely used on steep slopes and in areas where soil erosion is problematic. This technique also allows for opportunities to introduce a high quality soil layer above the poor soils that exist.

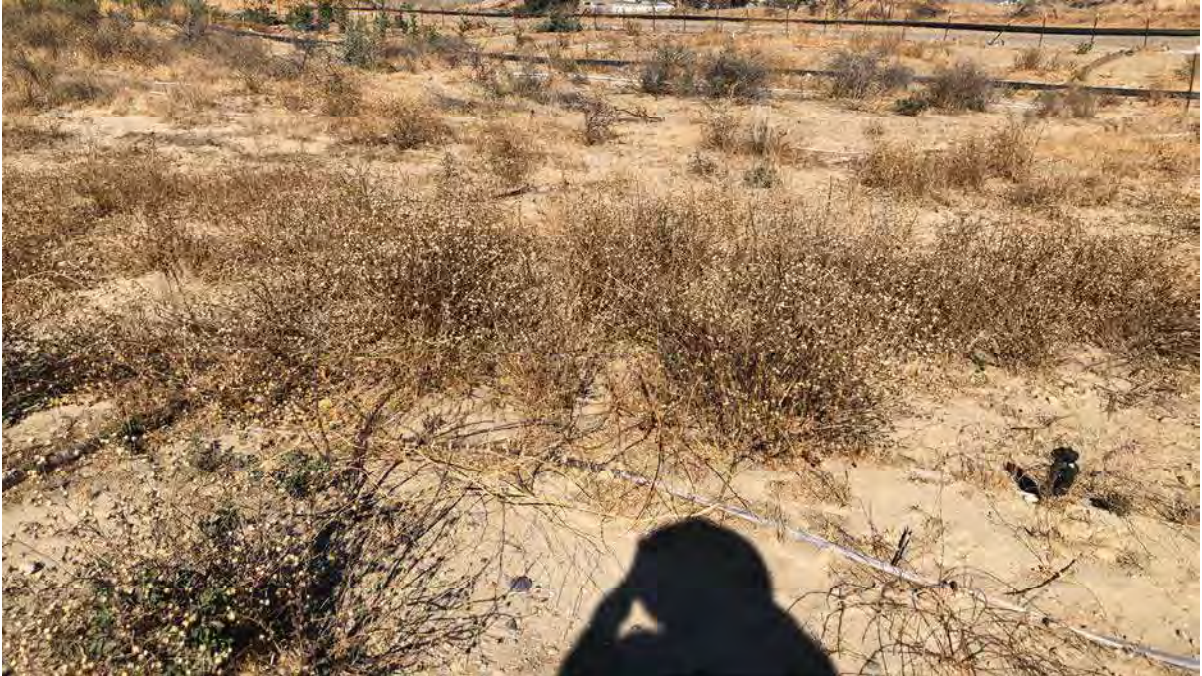
Section of Yellow Star Thistle (*Centaurea solstitialis*) still remaining on deck

- It will be important during these next 3-4 months to stay on top of the weeding efforts, as there are plenty of weed seeds in the existing soils. We would anticipate that the Brome Grass is already growing pretty aggressive and should be controlled using either mechanical removal or foliage spray applications, prior to the grass setting seed.

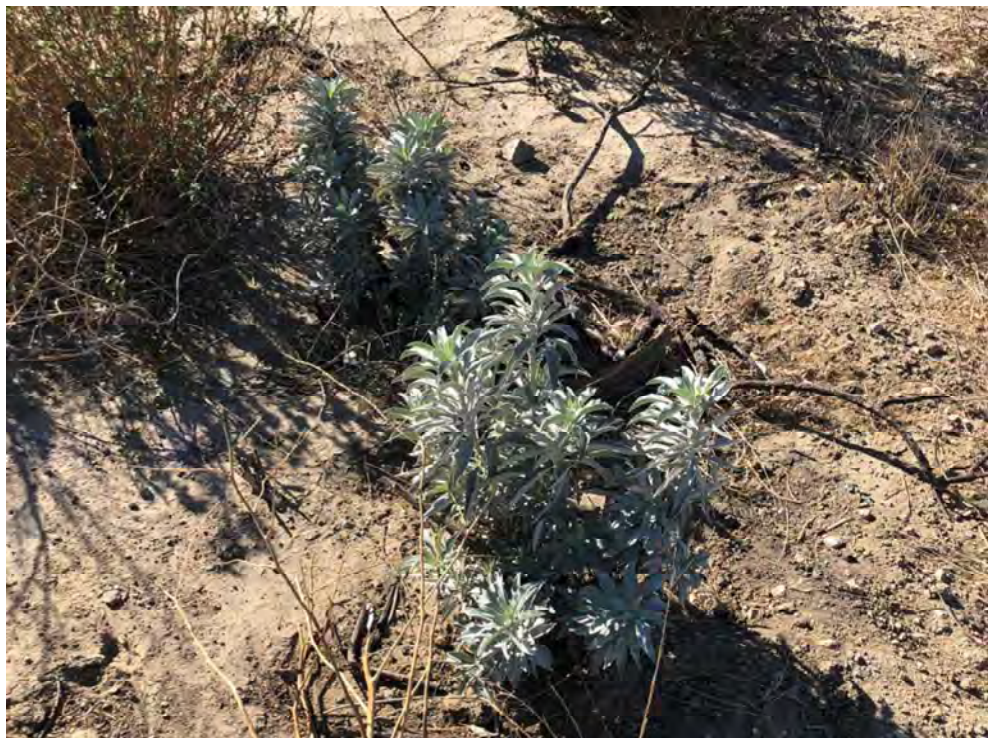
New White Sage (*Salvia apiana*) growing at burned area of deck

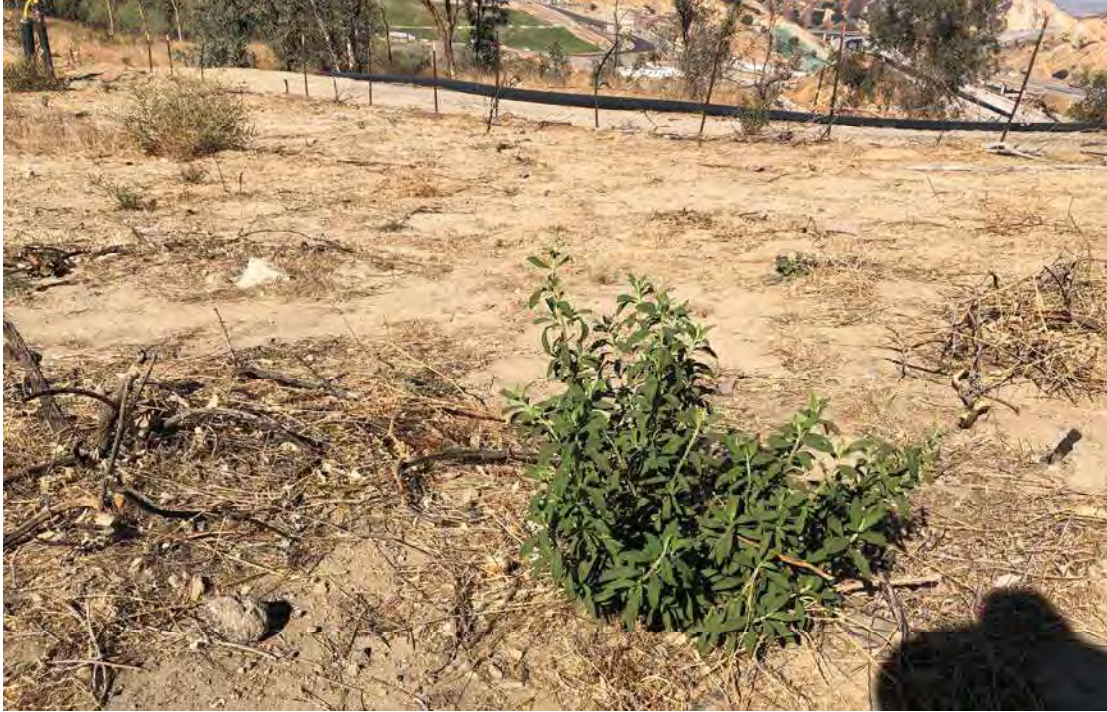
New Black Sage (*Salvia mellifera*) growing on burned area of deck

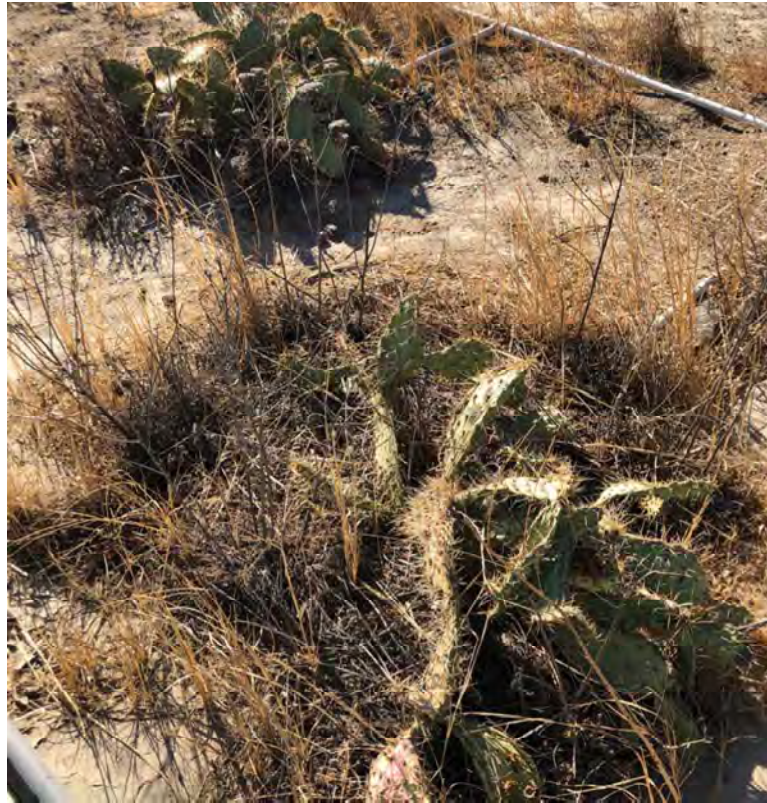
Coast Prickly Pear (*Opuntia littoralis*) managed to sustain fire damage but is regenerating new foliage.

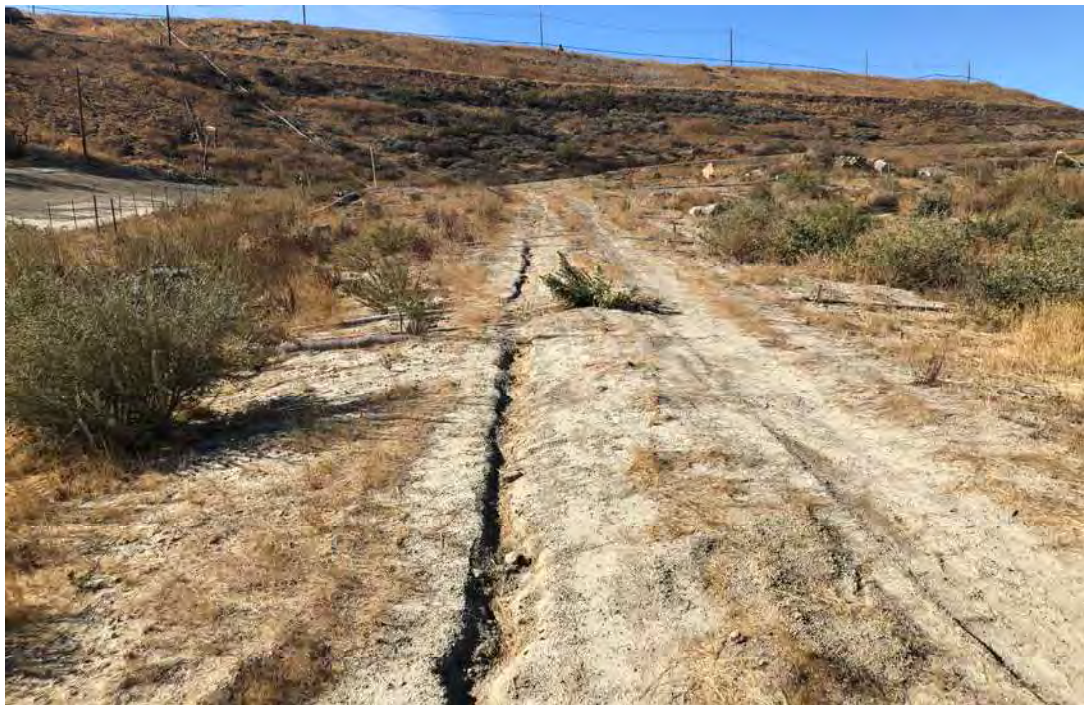
Rill erosion along access used during Fire. Recommend installing straw wattles to eliminate rill erosion (40' o.c.) and closing off west end of access road with T-Bar staking

- An access road was created during the fire running east to west. We recommend installing straw wattles along this roadway at 40' o.c. to minimize rill erosion. T-Bar staking should be repaired to discourage any future vehicular access onto the deck at this location.

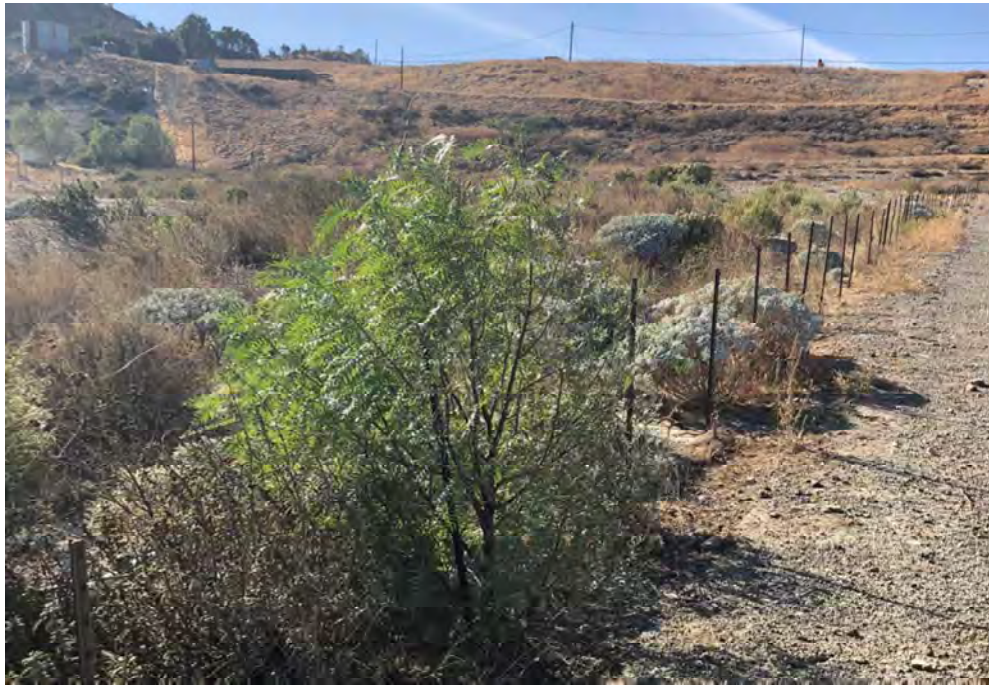
Invasive California Pepper Trees (*Schinis molle*) that should be removed.

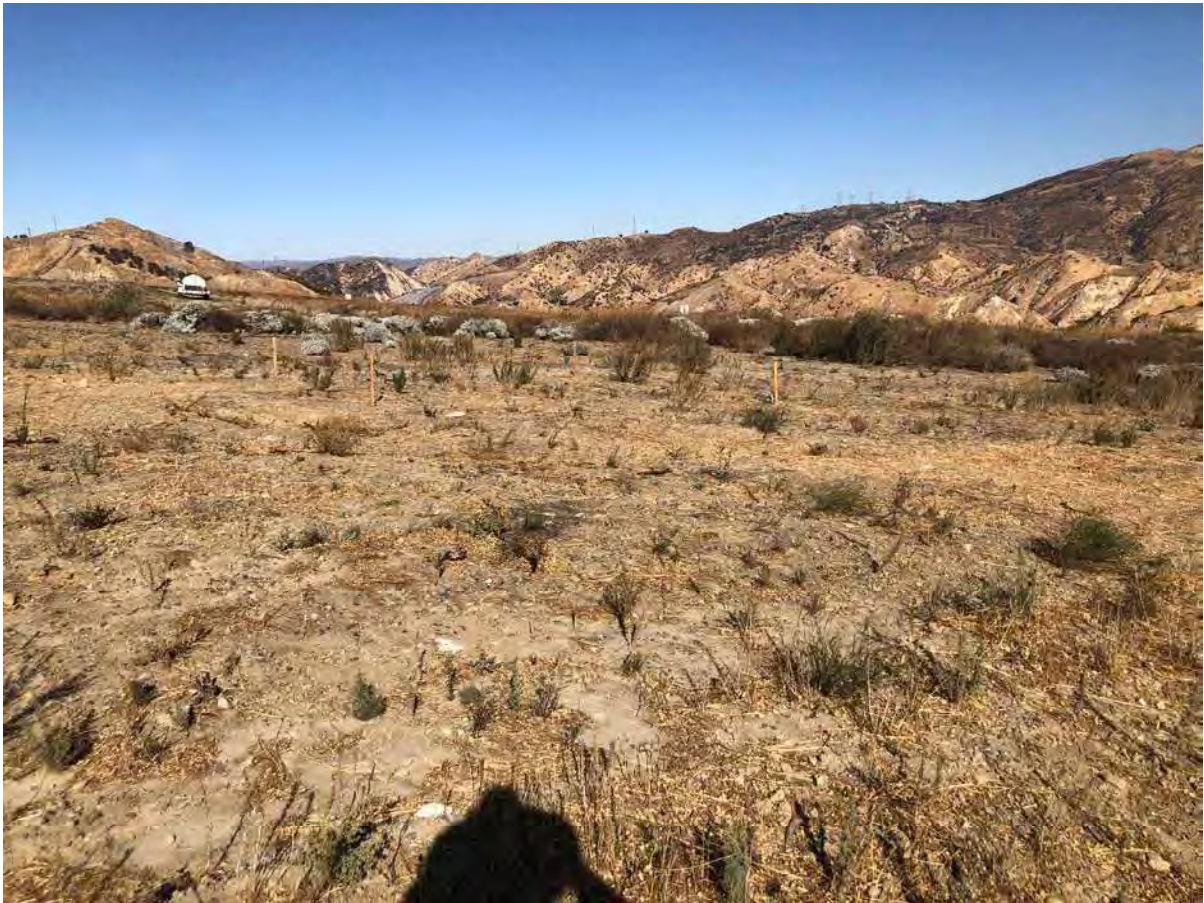
Large portion of previously existing Venturan Sage Scrub recovering from fire. Species include Deerweed (*Acmispon glaber*), California Sagebrush (*Artemesia californica*), California Buckwheat (*Eriogonum fasciculatum*), Black Sage (*Salvia mellifera*), Sawtooth Goldenbush (*Hazardia squarrosa*) and Telegraph Weed (*Heterotheca grandiflora*)
