STAFF REPORT
THIRD QUARTER 2024 VEGETATION PROJECT STATUS REPORT
AT SUNSHINE CANYON CITY/COUNTY LANDFILL

Republic Services, Inc. (Republic) submitted the Third Quarter 2024 Vegetation Project Status Report for the Sunshine Canyon City/County Landfill, received on October 31, 2024. The Status Report is a requirement of Conditional Use Permit Condition 44A, and Los Angeles City Condition [Q] C8 of Ordinance Number 172933, and Condition 18B of the Finding of Conformance granted to the Landfill by the Task Force on December 18, 2008. This report presents the progress of the site's landscaping and revegetation activities for the third quarter of 2024.

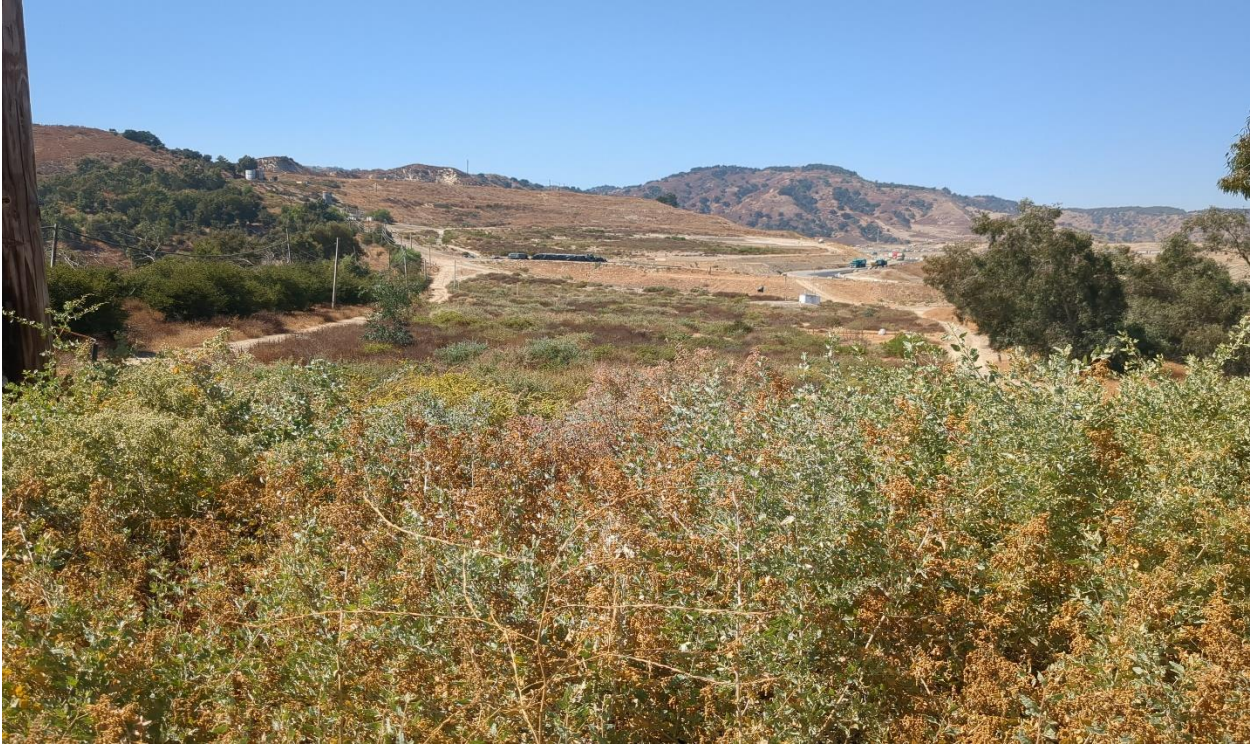
Photograph 1. Facing west at Lower Deck. View of eastern limits dominated by *Atriplex* spp. and California sunflower (September 27, 2024).

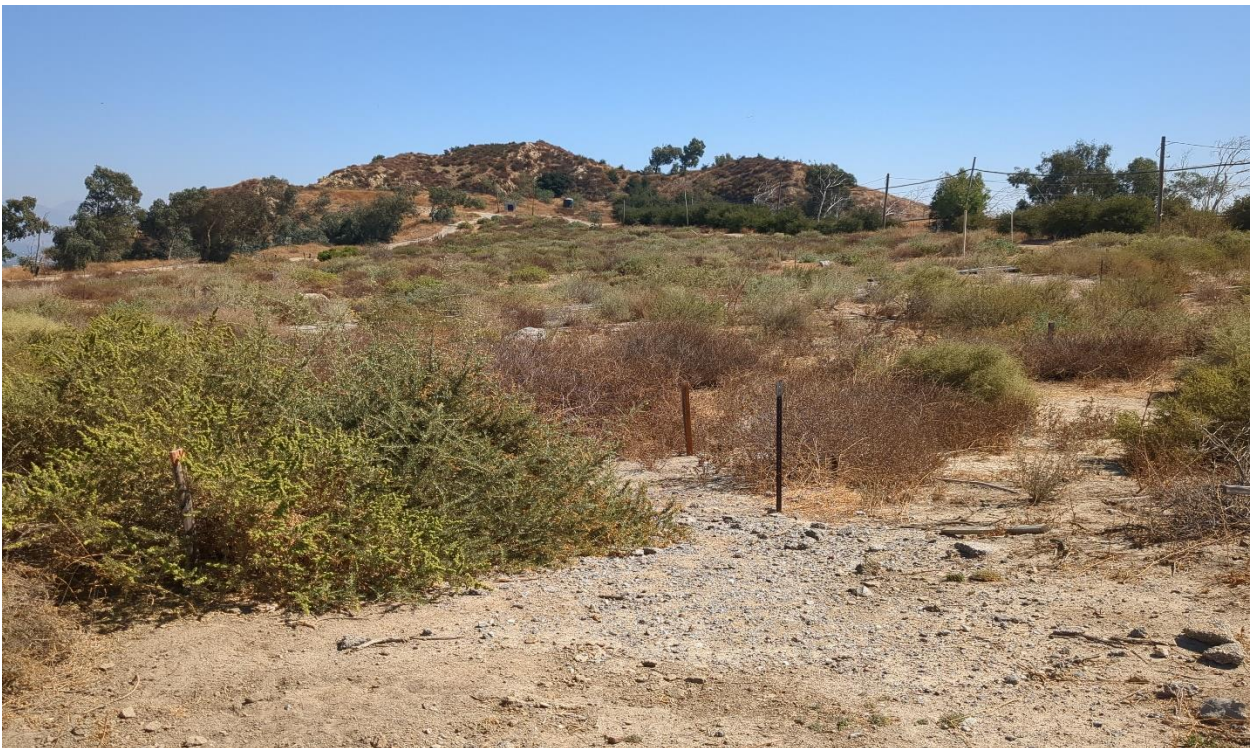
Photograph 2. Lower Deck from western boundary (September 27, 2024).

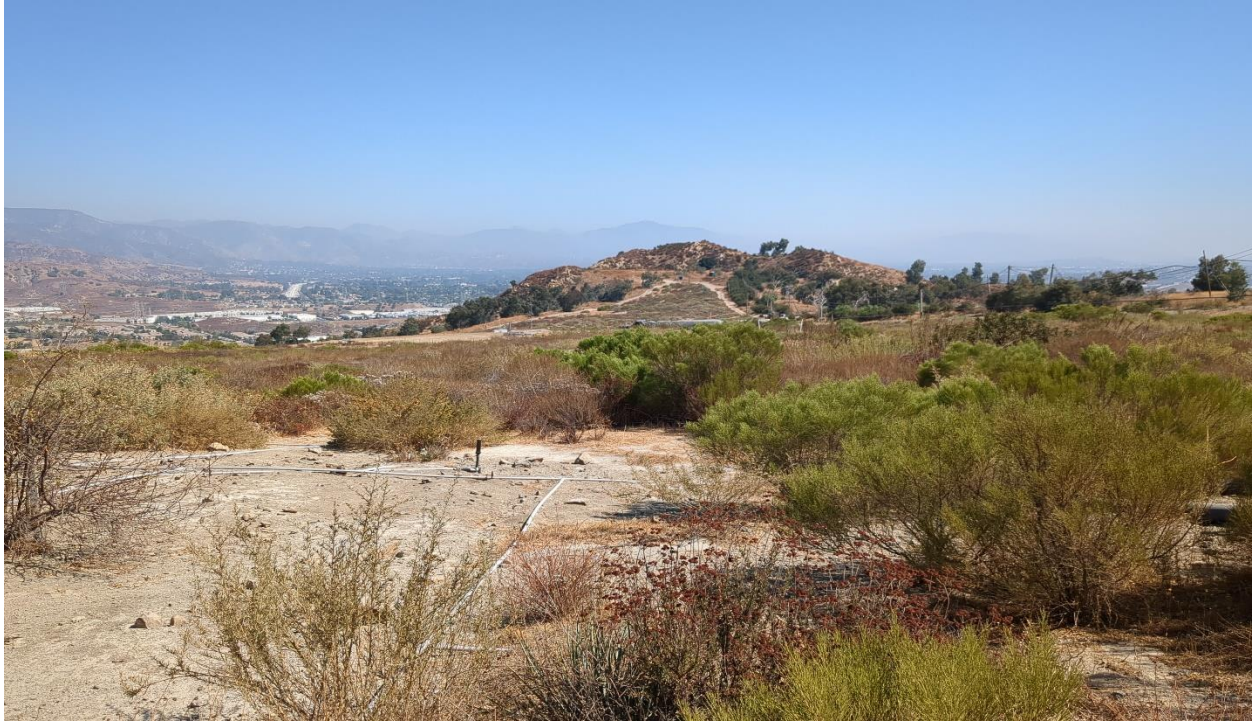
Photograph 3. Facing east at the Middle Deck from western boundary (September 27, 2024).

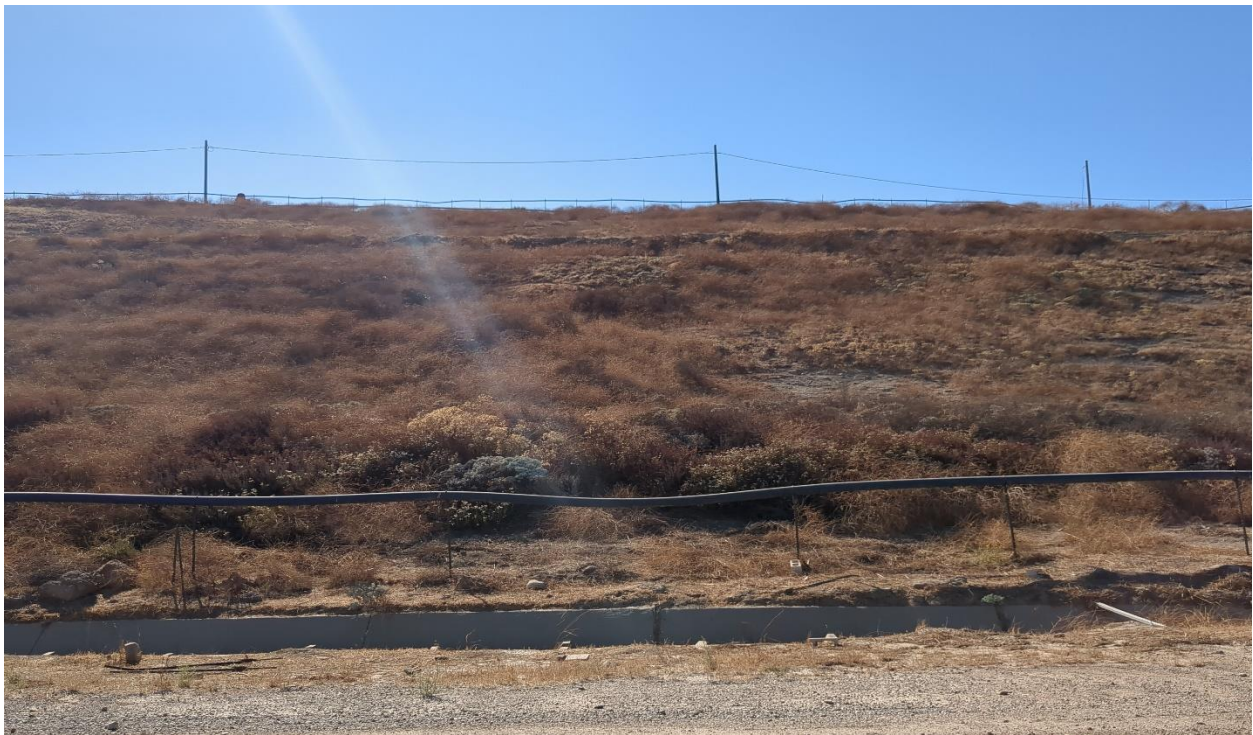
Photograph 4. Facing west at the easterly-facing slope located between the Middle and Upper Decks. The vegetation on the slopes between the Upper Deck is dominated by California buckwheat (currently vegetative) and non-native annual grasses (September 27, 2024).

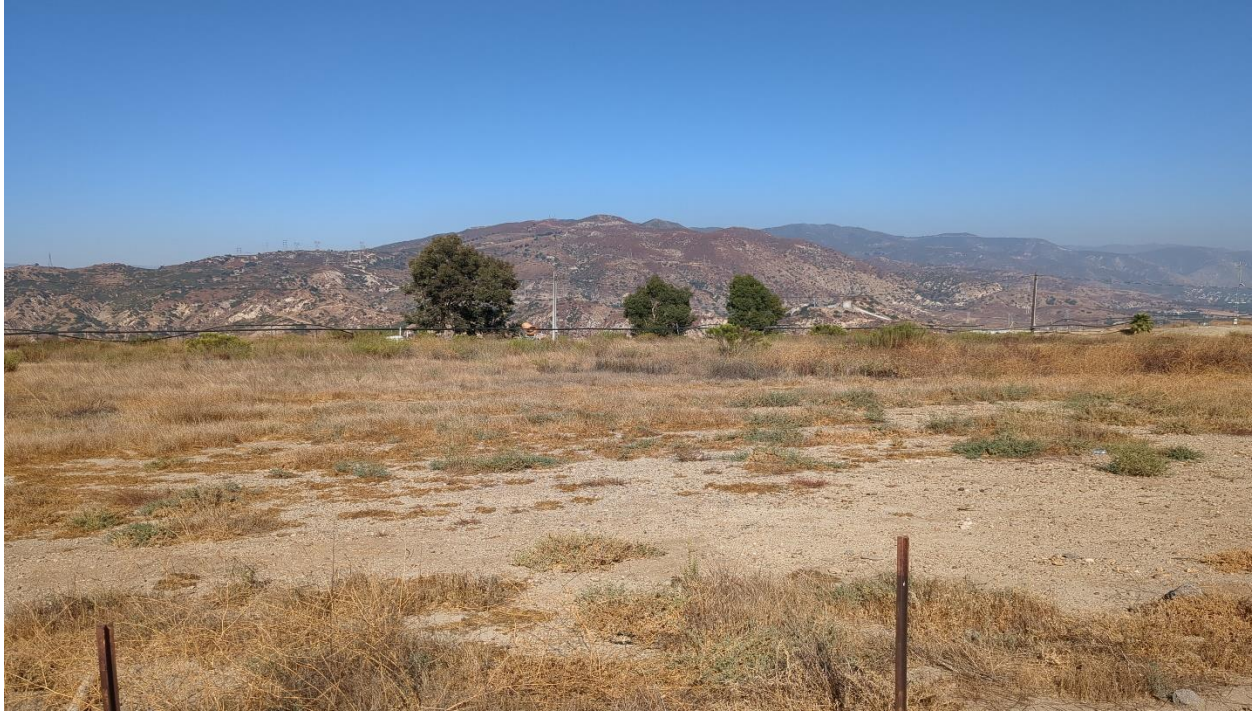
Photograph 5. Facing northeast at the Upper Deck. This area is compacted and gravelly and continues to be problematic for supporting vegetation. Non-native annual grasses and forbs, and California buckwheat shrubs are evident in the background (September 27, 2024).

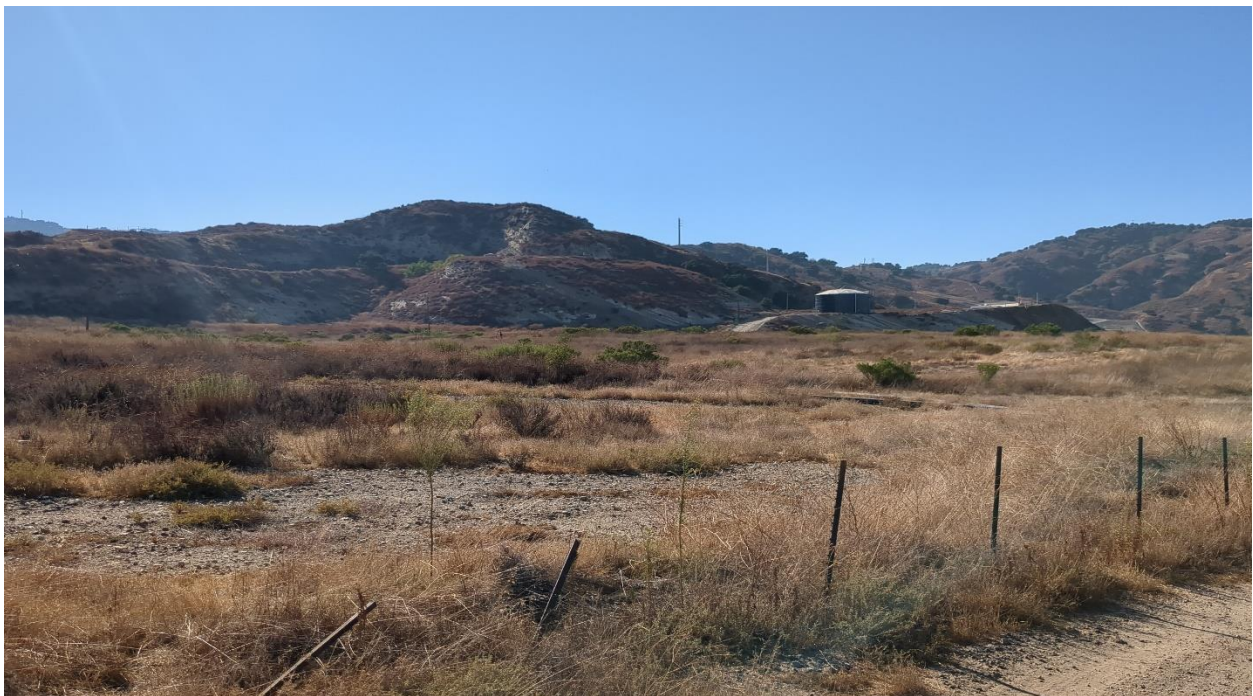
Photograph 6. Facing southwest at the Upper Deck. This area is primarily dominated by wild oats, brome grasses, redstem filaree, and short podded mustard (September 27, 2024).

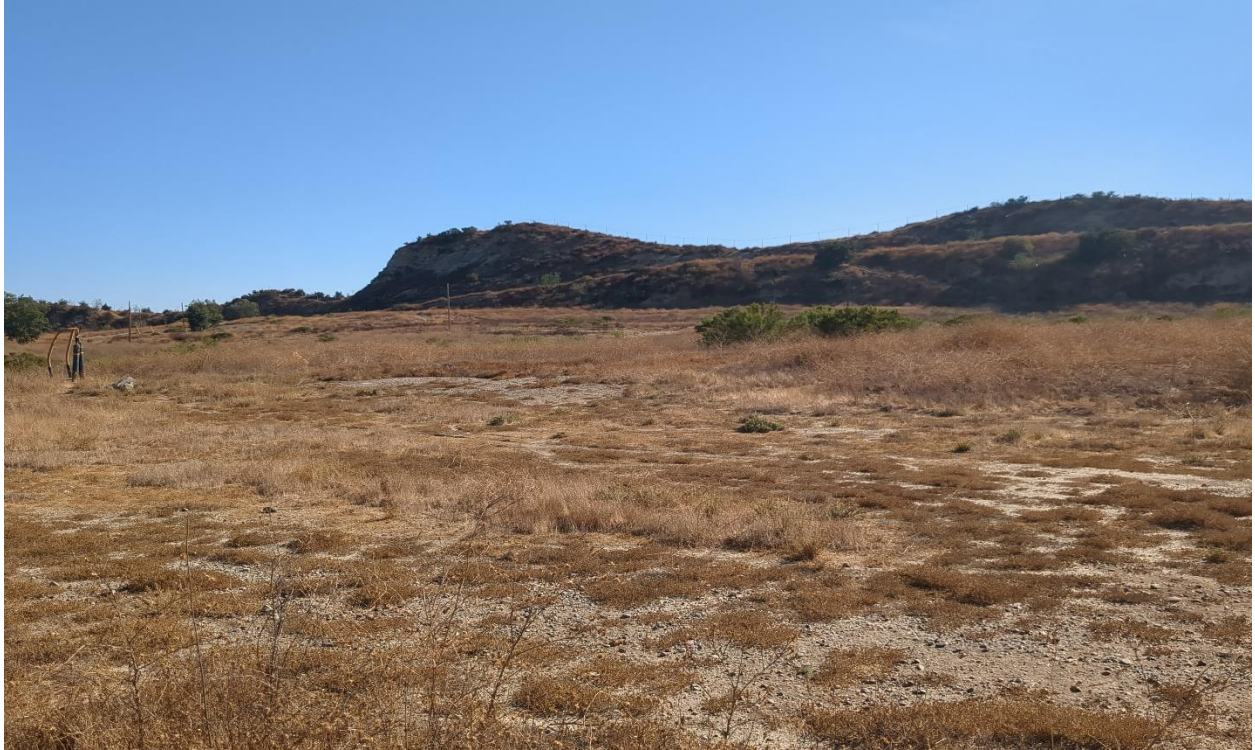
Photograph 7. Facing southeast at the western portion of the Upper Deck. This area is dominated by short podded mustard, Australian saltbush, and Russian thistle (September 27, 2024).

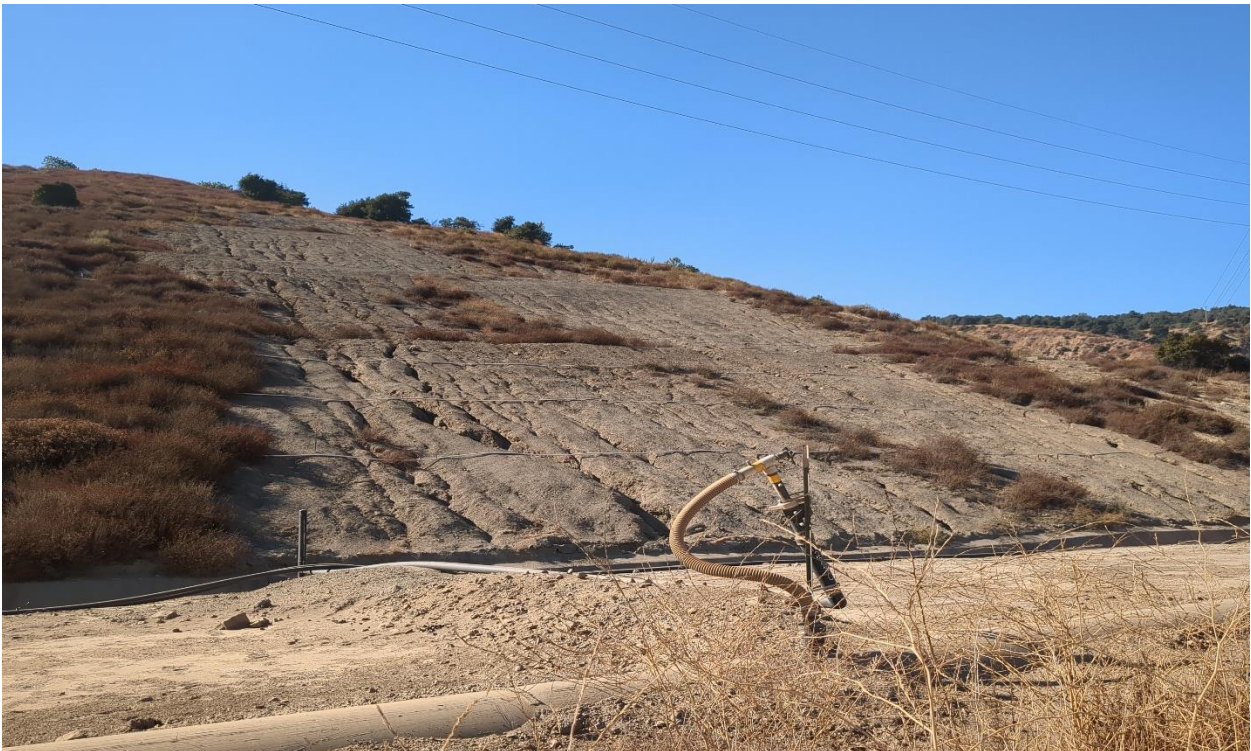
Photograph 2. Facing northwest at the northern portion of the County-Side Sage Mitigation Area where plant growth has been problematic due to poor soil conditions (September 27, 2024).

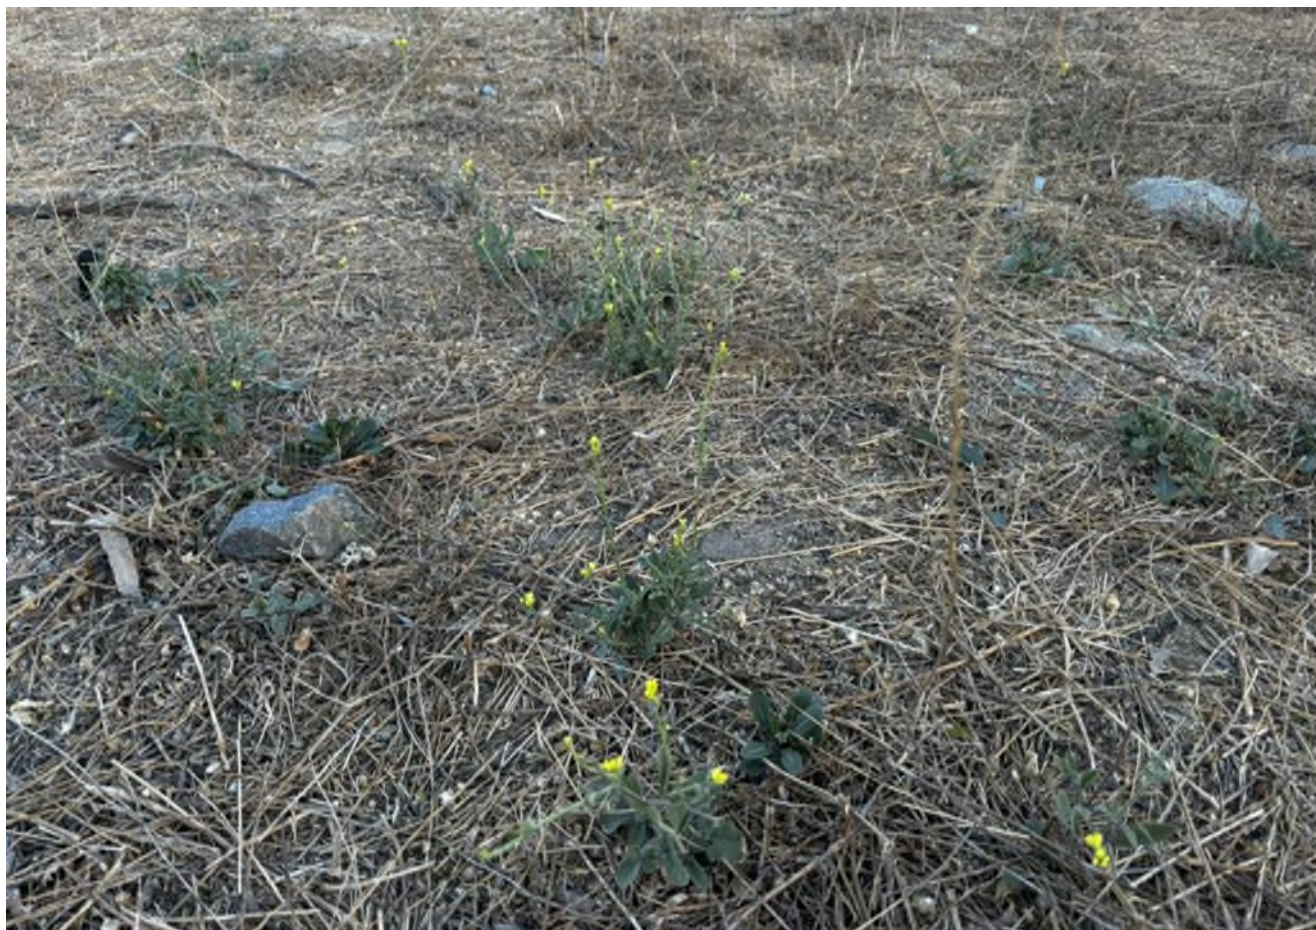
Shortpod Mustard (*Hirschfeldia incana*) emergence amongst seed and vegetation debris from past weed growth

- Unlike last year with the early rains (Tropical Storm Hilary), this fall has been dry. As a result, many of the native VCSS species are still in their summer dormancy period. Some signs of the season change are evident in new emerging growth from some of the Coast Sunflower (*Encelia californica*) and new germinating plants. Shortpod Mustard (*Hirschfeldia incana*) has begun to emerge again, especially in the areas where it previously existed due to seed being left in place. The lack of rain thus far has also limited the number of new weed growth typical of this time of year. Over this next quarter, we expect to see Russian Thistle (*Salsola* spp.), Yellow Thistle (*Centaurea solstitialis*), Horseweed (*Erigeron canadensis*), Tree Tobacco (*Nicotiana glauca*), Red Brome Grass (*Bromus madritensis* ssp. *rubens*), and Shortpod Mustard (*Hirschfeldia incana*) germinating on Deck C. Maintenance personnel should begin targeting these invasive weeds

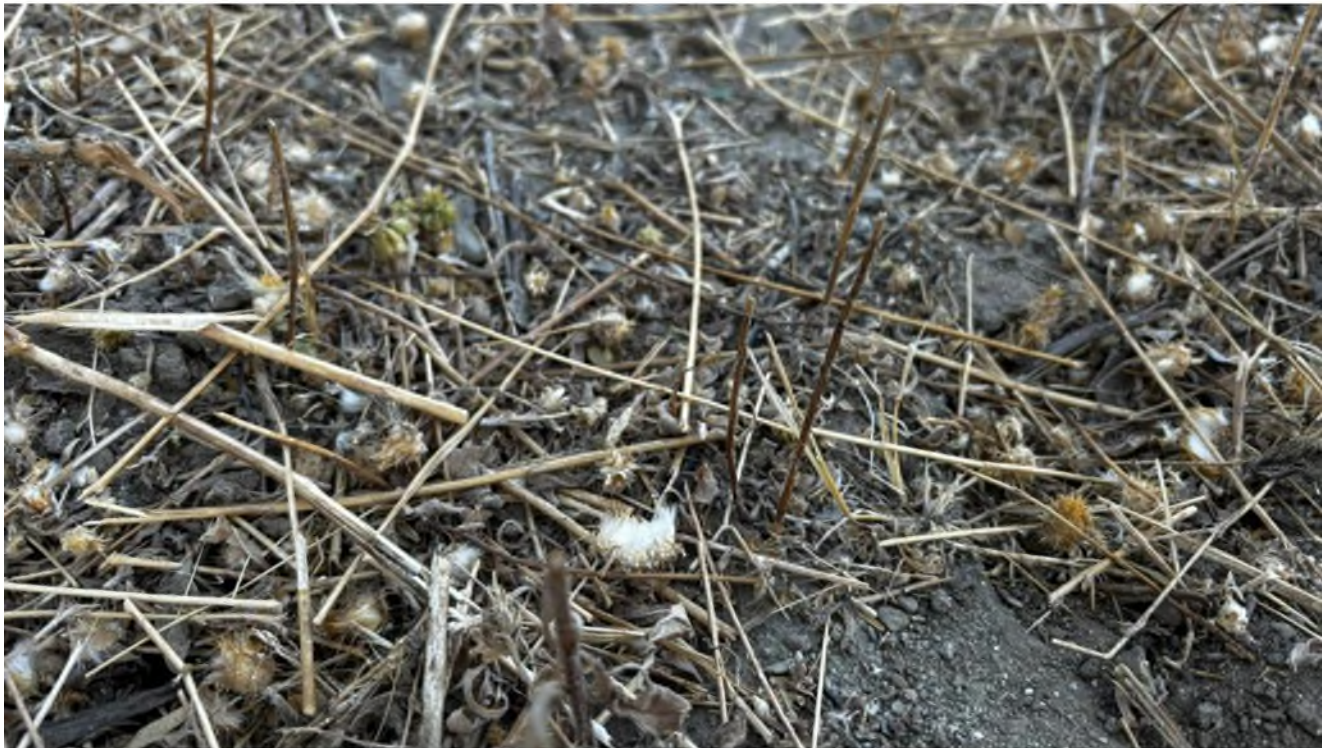
Yellow Thistle (*Centaurea solstitialis*) weed seed heads left on deck

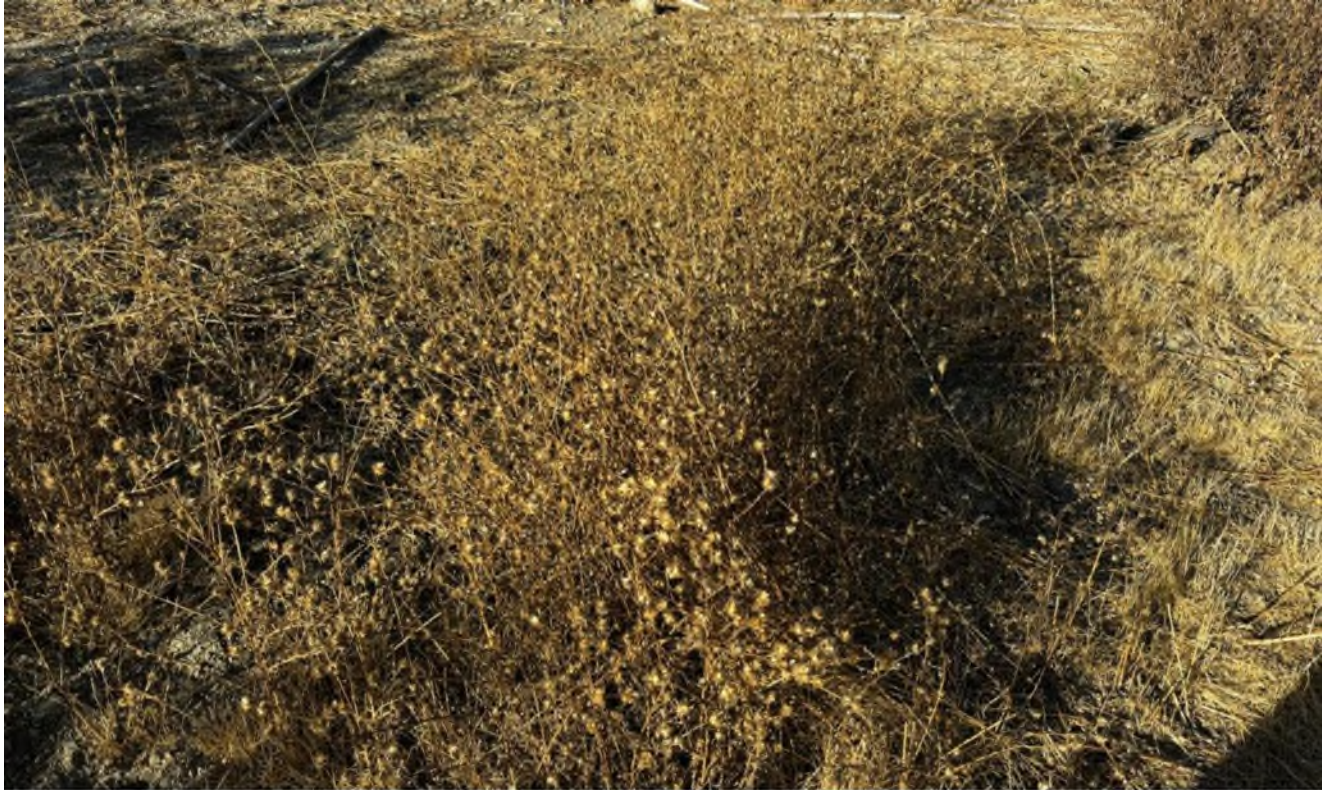
Dormant Yellow Thistle (*Centaurea solstitialis*) left on deck with seed heads

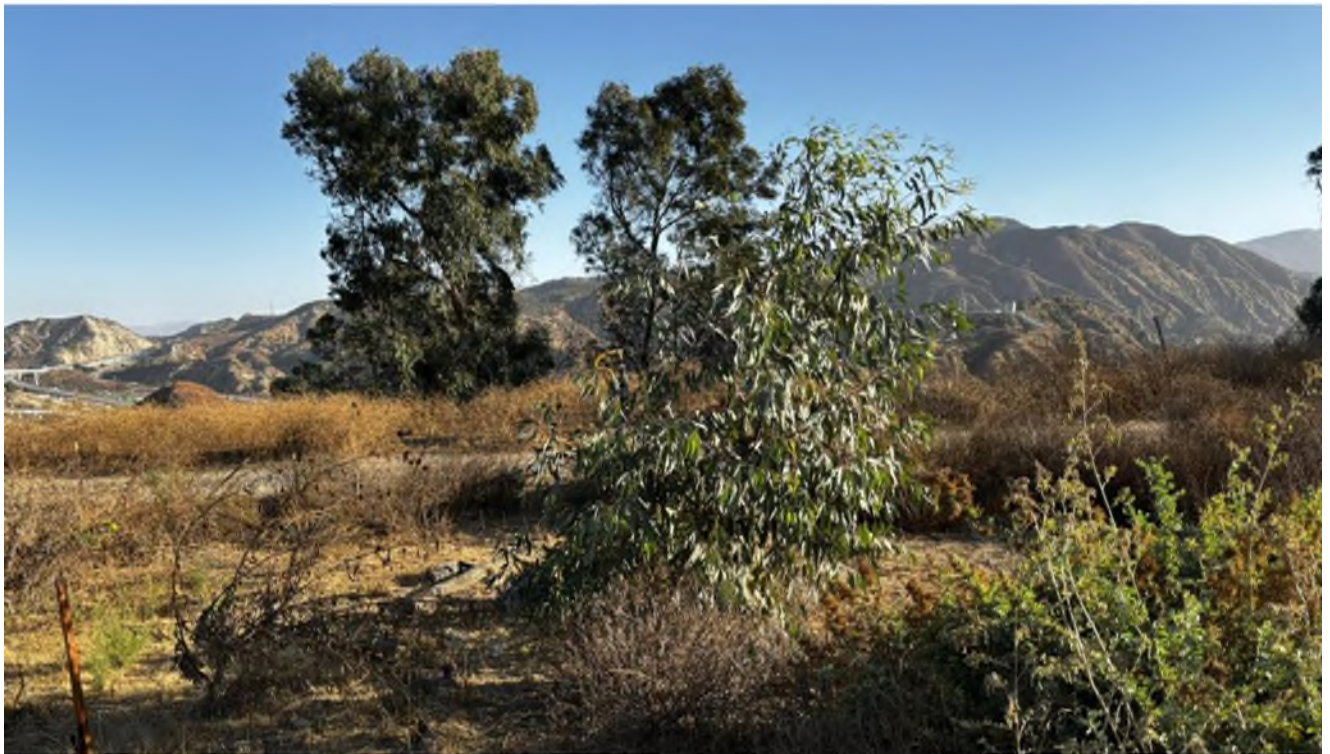
Eucalyptus tree growing on Deck C (To be removed)

- Eucalyptus (*Eucalyptus* sp.), Eucalyptus seedlings (*Eucalyptus* sp.) have established on the deck and should be removed immediately.
- PM10 Coast Live Oak trees are established. It is not clear if the irrigation system is operating at this time. Many of the trees are stunted in growth due to the exposure and winds that are typical at this location. Those trees that have more protection are larger and in some cases 2-3 times larger than those on the ridge.

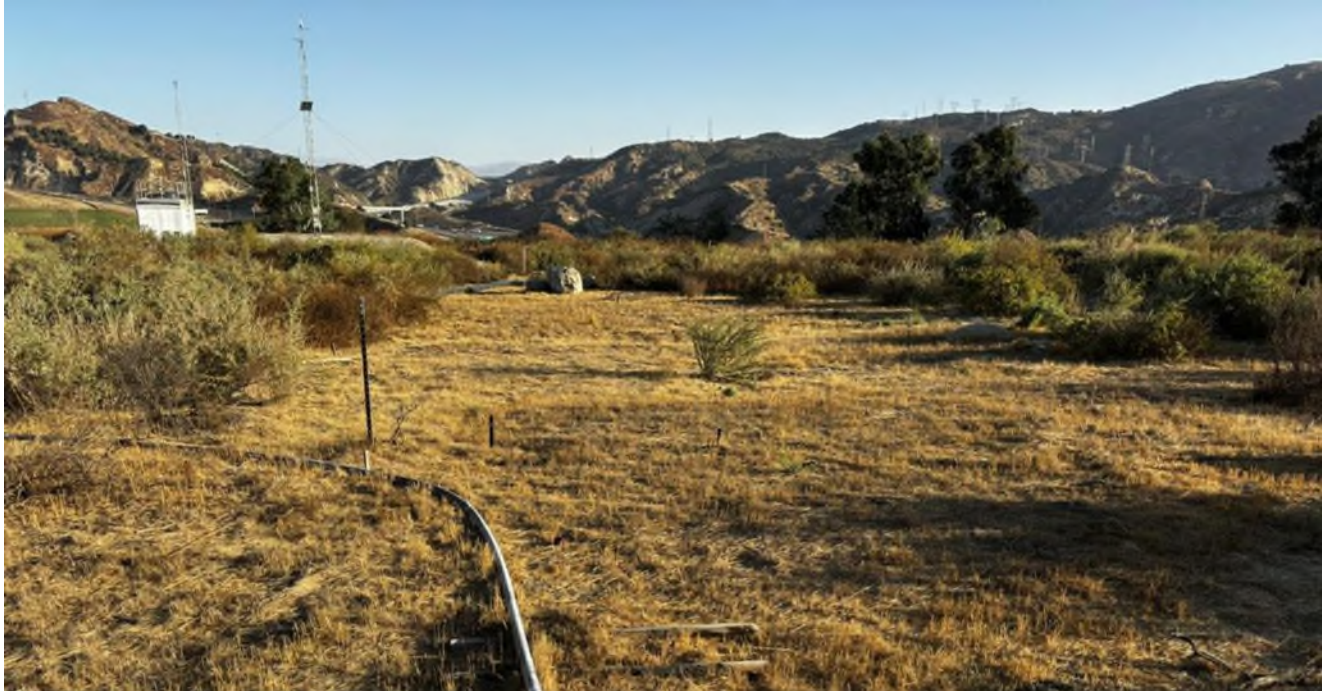
Scalping of Creeping Wild Rye (*Leymus triticoides*)

It was recommended maintenance personnel continue to work on removing non-natives even though they have seeded. In Q3, it was also noted the scalping of native Creeping Rye Grass (*Leymus triticoides*) occurred and to inform maintenance crew to understand and distinguish native versus non-native. Also noted was to identify native species prior to any invasive removals. In addition, the majority of the Coast Live Oaks at the PM 10 berm have recovered from fire damage in 2020. It was also recommended the Eucalyptus also be removed.

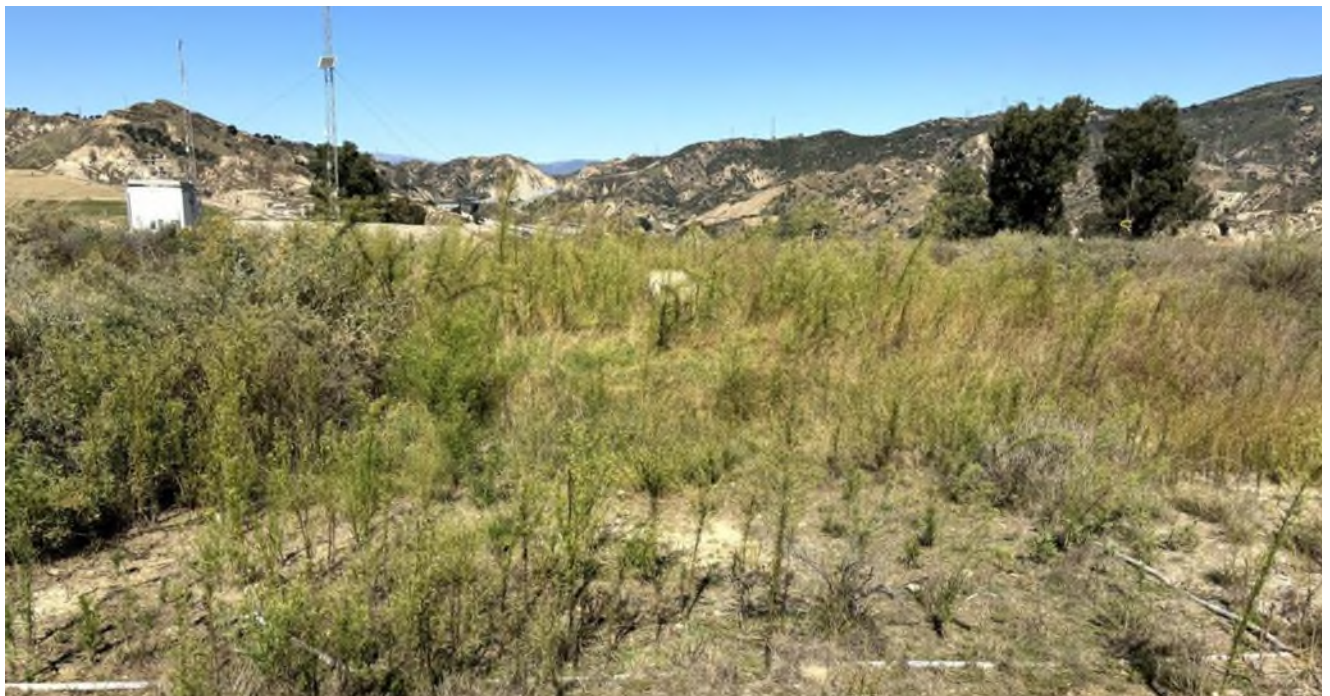
Image from 2023 – Where Horseweed (*Erigeron canadensis*) has taken over where Creeping Wild Rye previously existed.

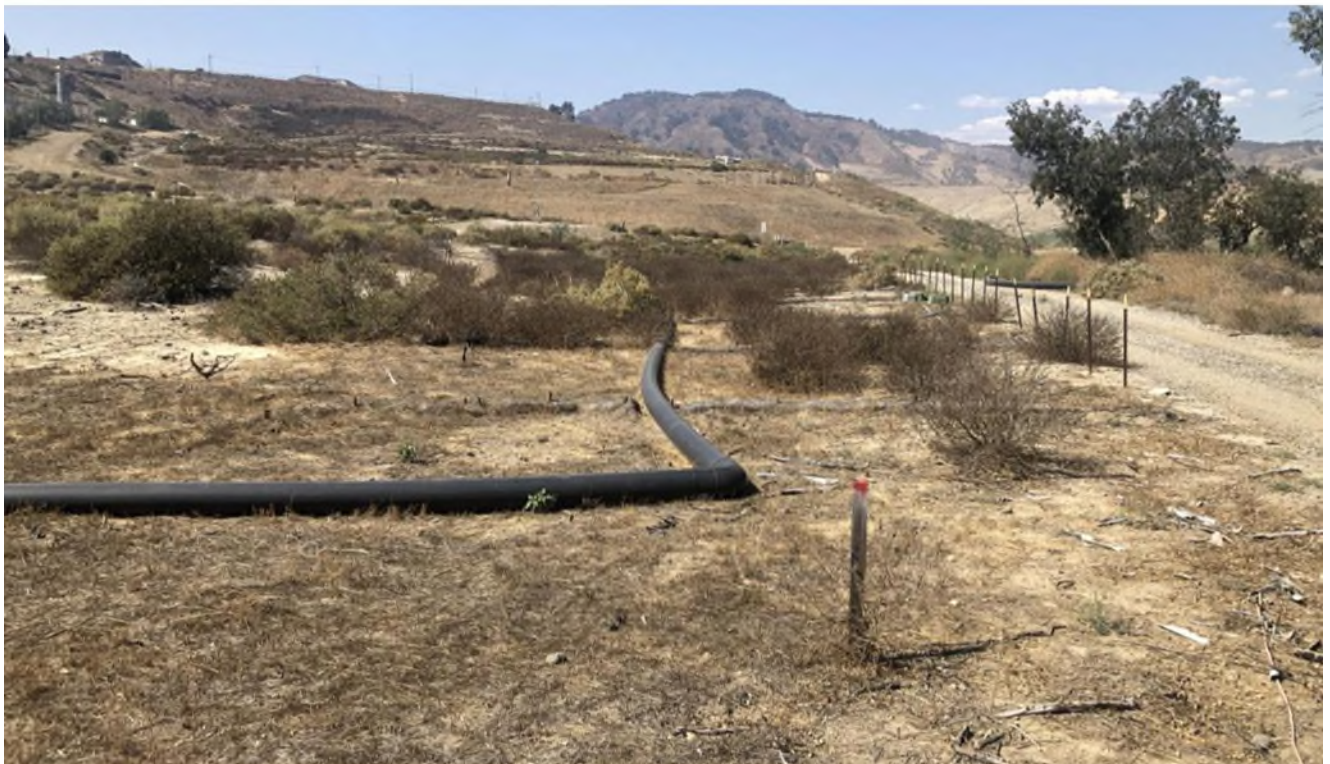
Scalping of Creeping Wild Rye - Fall 2022

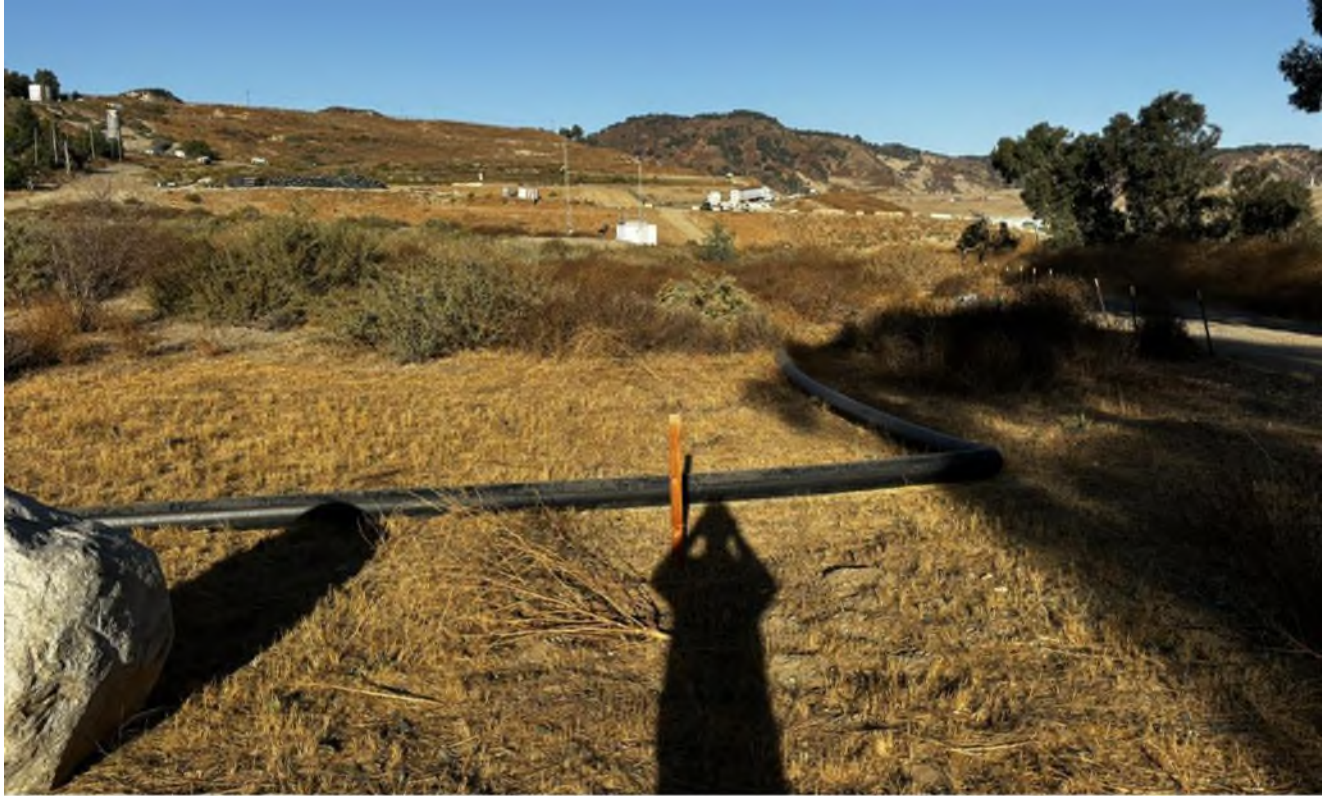
Recent scalping of Creeping Wild Rye – Fall 2024

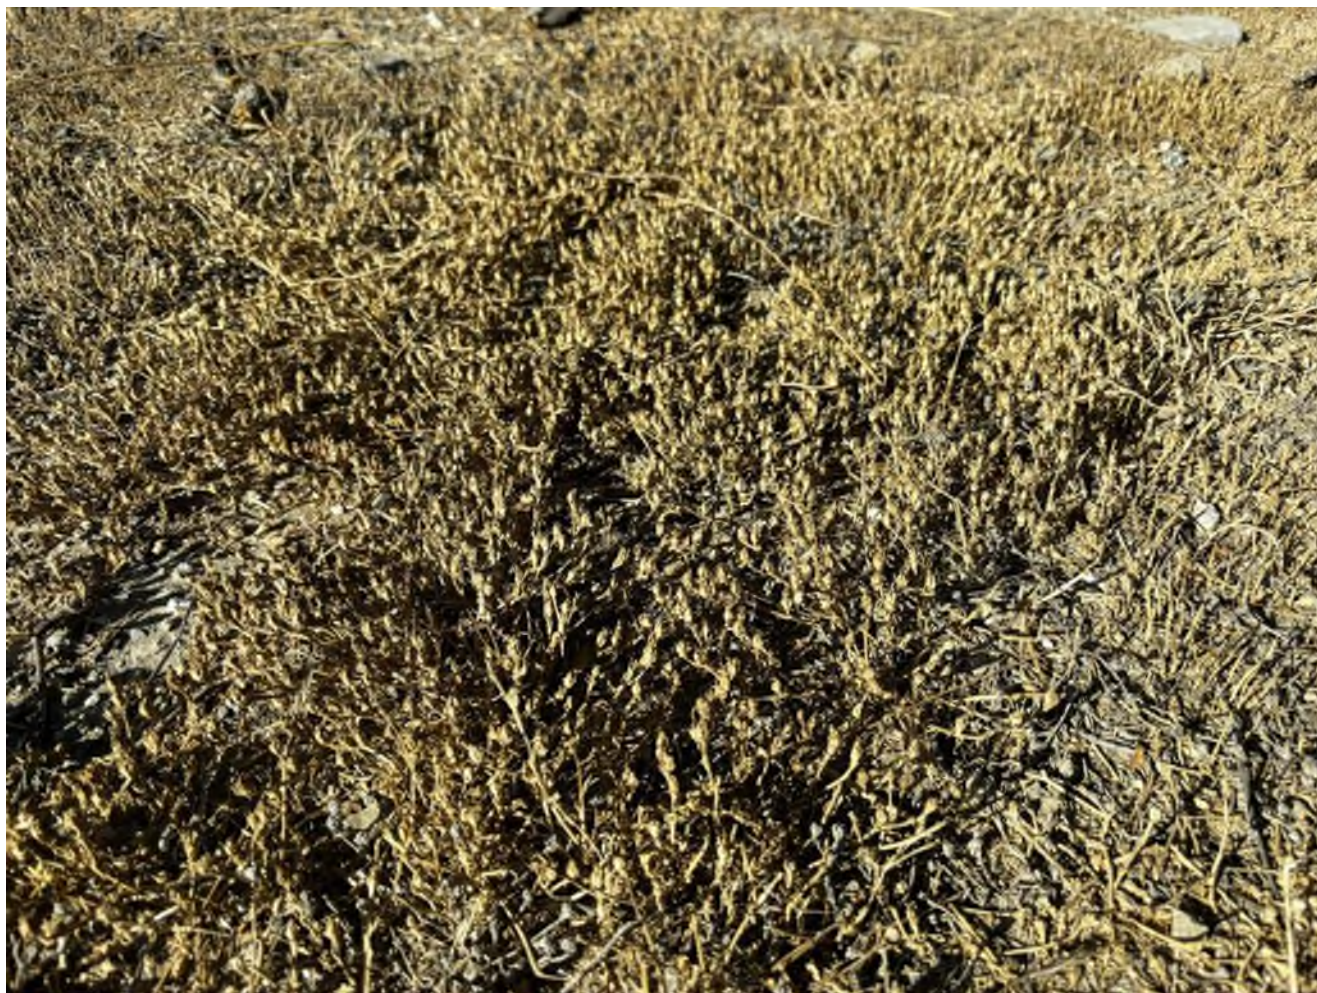
Dormant invasive Slenderleaf Iceplant (*Mesembryanthemum nodiflorum*)

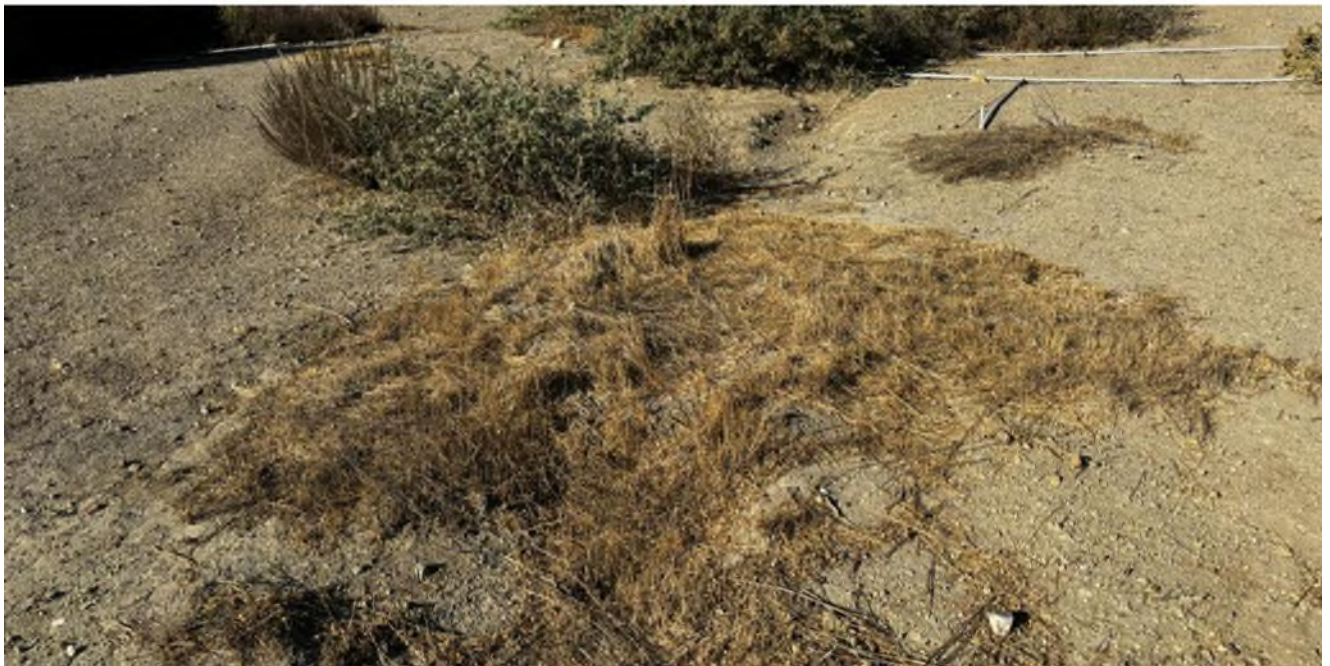
Scalped Creeping Rye Grass (*Leymus triticoides*)

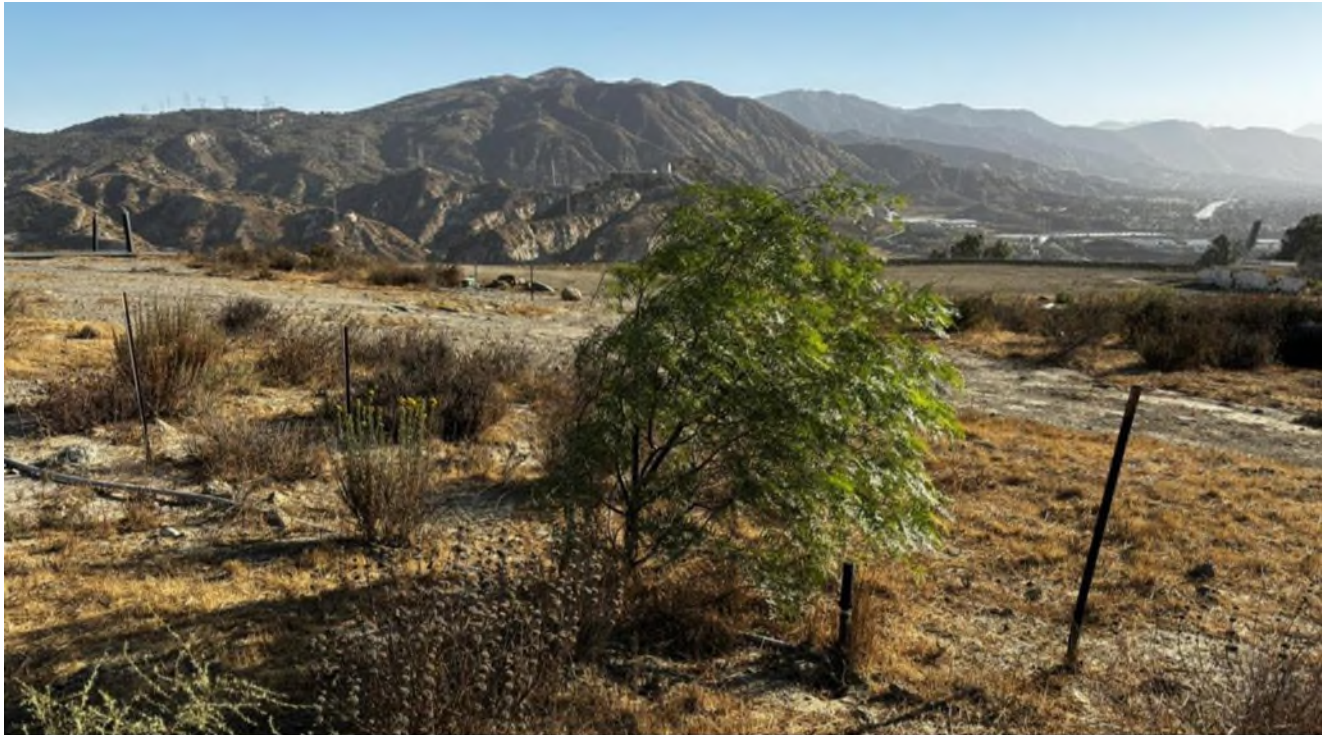
California Pepper Trees (*Schinus molle*) to be removed from Deck B

Overall, there is a good species diversity on this deck and planting is responding well with vigorous growth. It was also noted several California Pepper Trees (*Schinus molle*) and Saltcedar (*Tamarisk sp.*) should be removed.

- Several California Pepper Trees (*Schinus molle*), and Saltcedar (*Tamarisk sp.*) seedlings have established on the deck and should be removed. These species were noted in the last quarter report and have been growing on the deck for over a year.

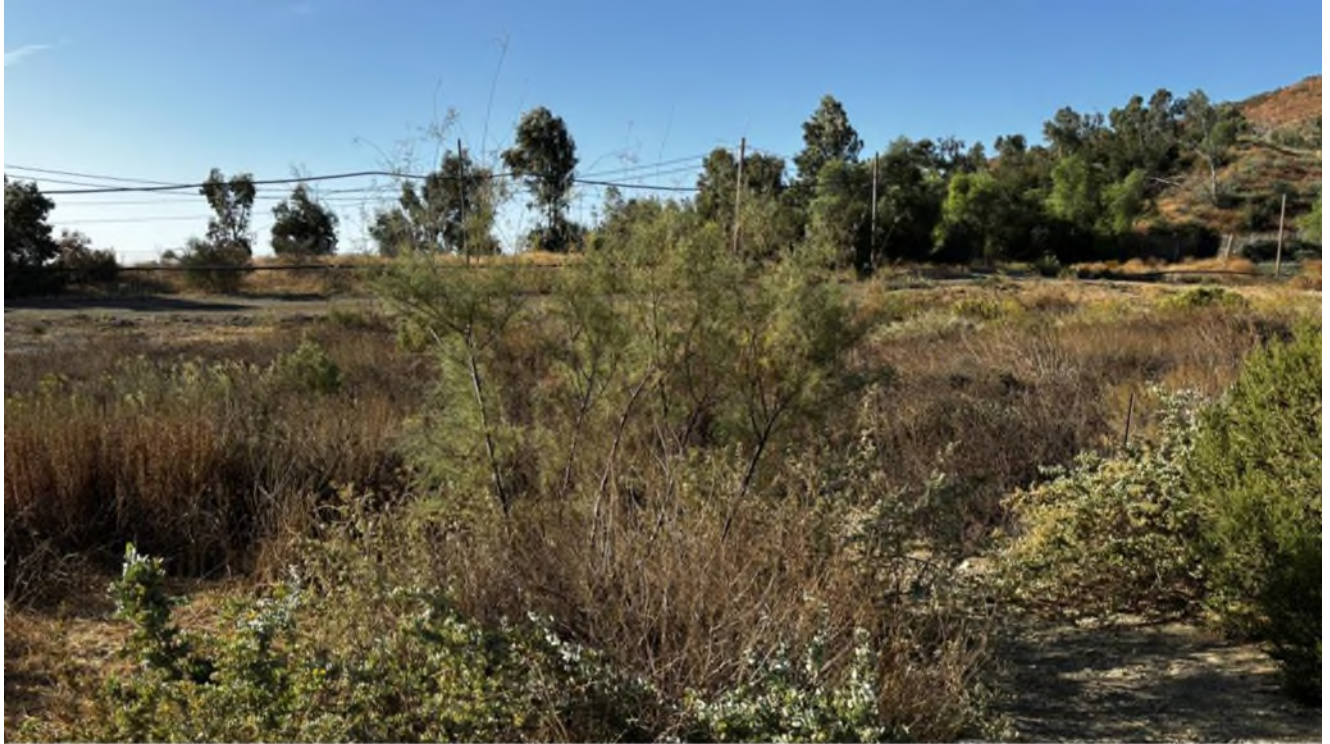
Invasive Salt Cedar (*Tamarix* species) to be removed from Deck B

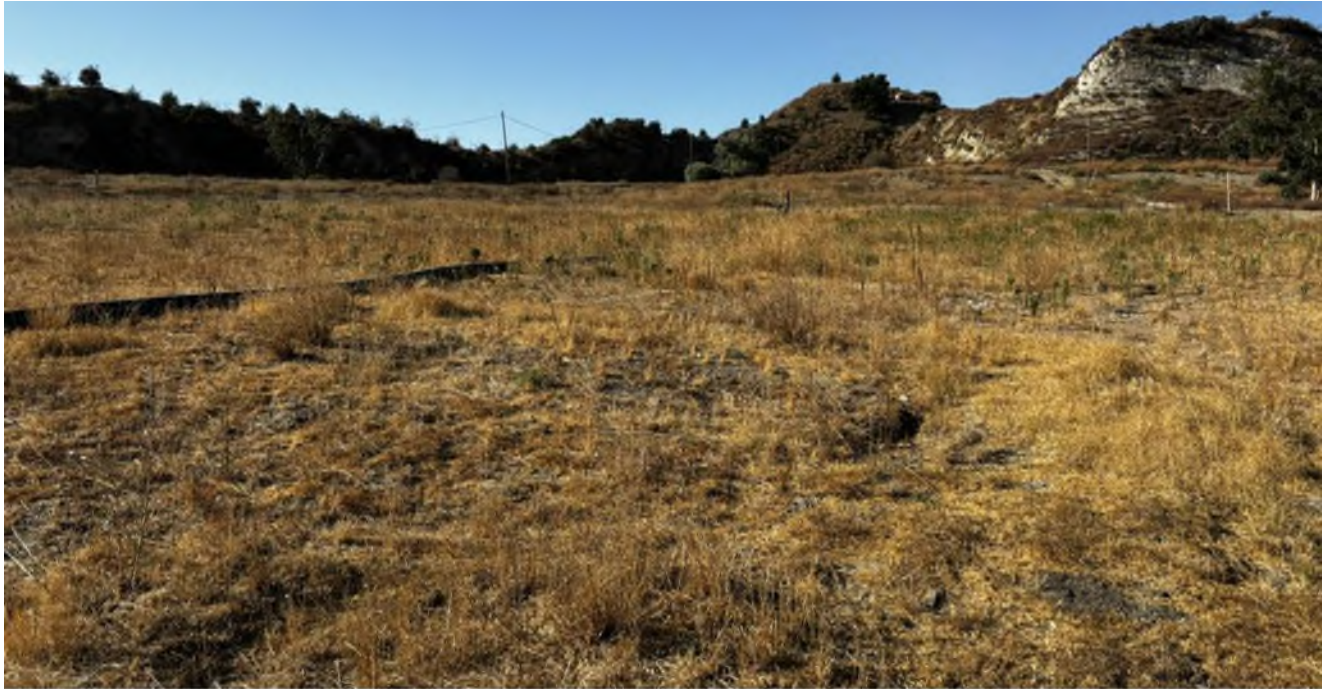
- Area previously repaired is vegetated with mostly exotic weeds, Russian Thistle (*Salsola* spp.), Yellow Thistle (*Centaurea solstitialis*), Horseweed (*Erigeron canadensis*), Red Brome Grass (*Bromus madritensis* ssp *rubens*) and Shortpod Mustard (*Hirschfeldia incana*).

Existing conditions of Deck A
