Los Angeles Regional Water Quality Control Board

NOTICE OF VIOLATION: STORMWATER COMMINGLED WITH UNAUTHORIZED NON-STORMWATER DISCHARGE – CHIQUITA CANYON LANDFILL, 29201 HENRY MAYO DRIVE, CASTAIC, CA 91384, WDID NO. 4 191022488

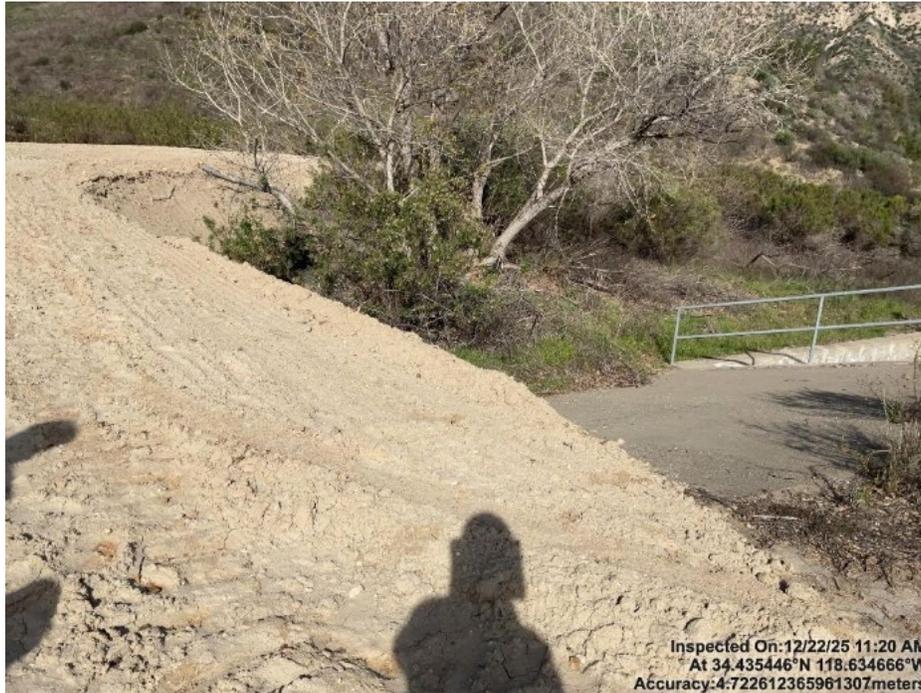
Photo 1

On December 22, 2025, Los Angeles Water Board Staff inspected CCL prior to a forecasted storm event.¹ The Discharger had installed a berm in the East Basin to separate the basin outlet from the East Basin (Photo 1). The Discharger also installed a barrier over the East Basin outlet with steel plates, and a plastic covering with wood braces and sandbags (Photo 2). According to Ms. Amanda Froman of Waste Connections, the barrier also consisted of a sealing foam. The intention of these Best Management Practices (BMPs) was to prevent the discharge of leachate comingled stormwater.

A view of the dirt berm placed in the East Basin during the December 22, 2025, inspection.

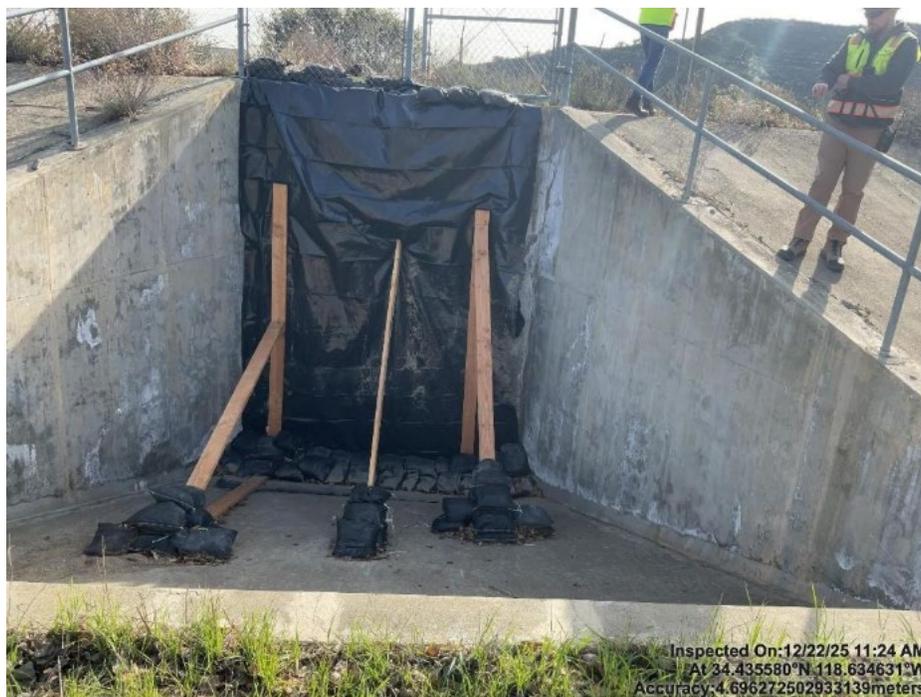
Photo 2

A view of the barrier placed over the East Basin outlet during the December 22, 2025, inspection.

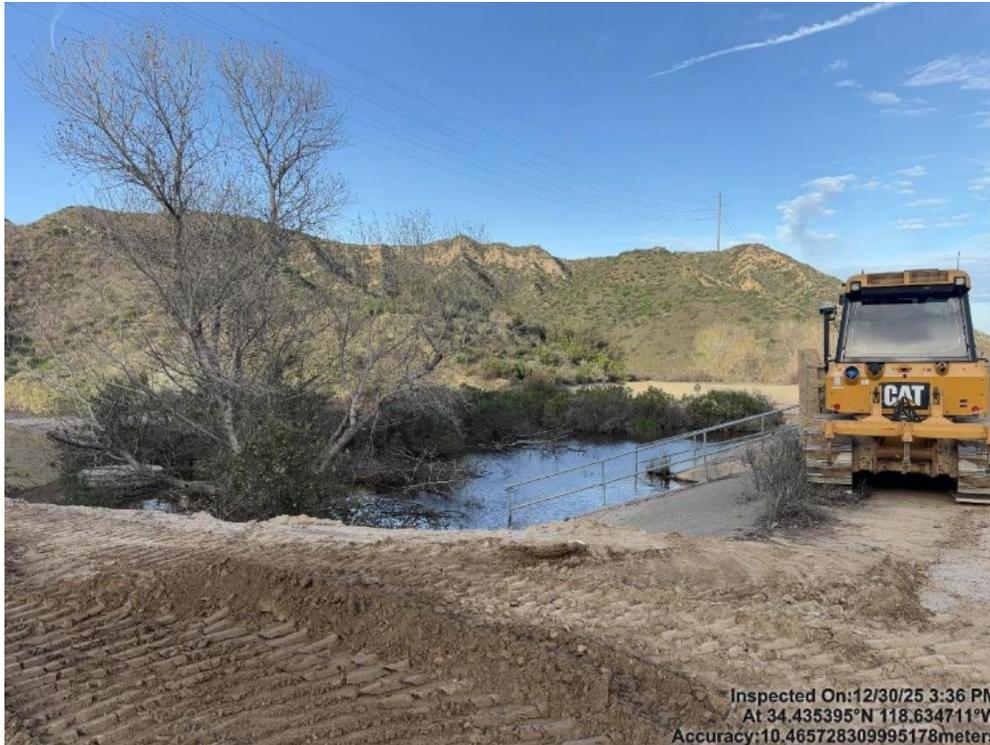
Photo 3

During the storm event that occurred from December 23-26, 2025, the leachate comingled stormwater overtopped the installed berm and filled up the area behind the installed barrier (Photos 3-4). On December 29, 2025, CCL staff heard water from the East Basin flowing through the barrier into the stormwater channel that flows into Castaic Creek. Castaic Creek flows into Reach 5 of the Santa Clara River. Both Castaic Creek and Santa Clara River are designated waters of the United States. The leachate comingled stormwater continued to discharge during and after the December 23-26, 2025, storm event until the water level dropped below the level of the leak.

A photo showing the comingled leachate with stormwater flowed into the area behind the dirt berm.

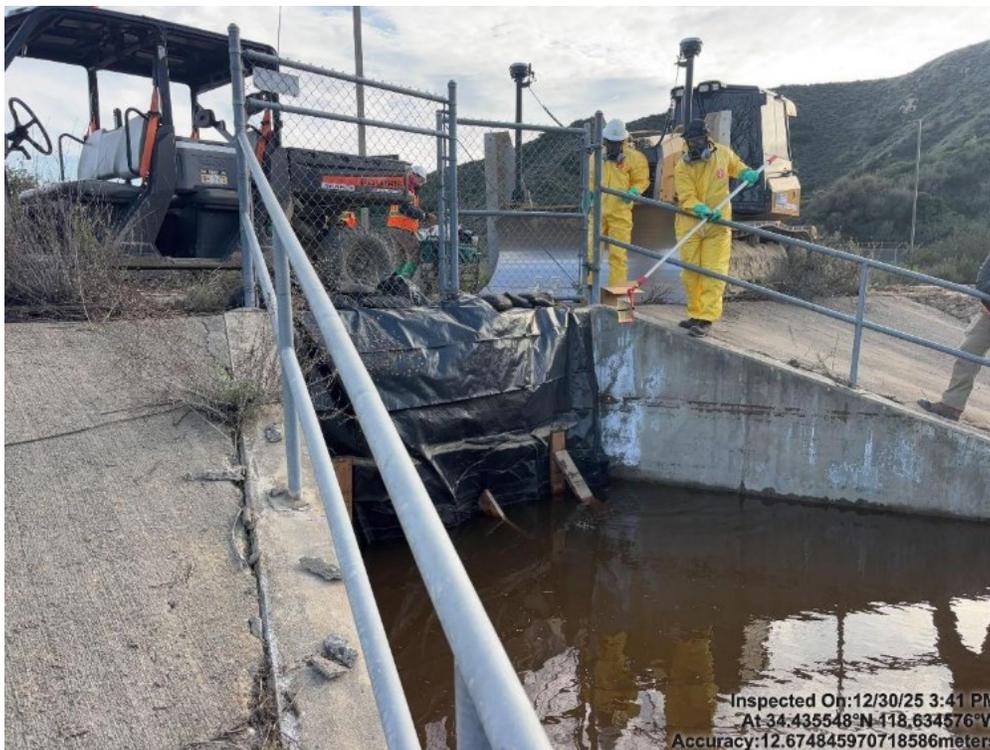
Photo 4

A photo showing the outlet of the East Basin.
