HAZARDOUS MATERIALS ASSESSMENTS

**PHASE I
HAZARDOUS MATERIALS ASSESSMENT
HARBOR UCLA MEDICAL CENTER
1000 WEST CARSON STREET
TORRANCE, CALIFORNIA**

April 30, 2015
Project No. 209023001

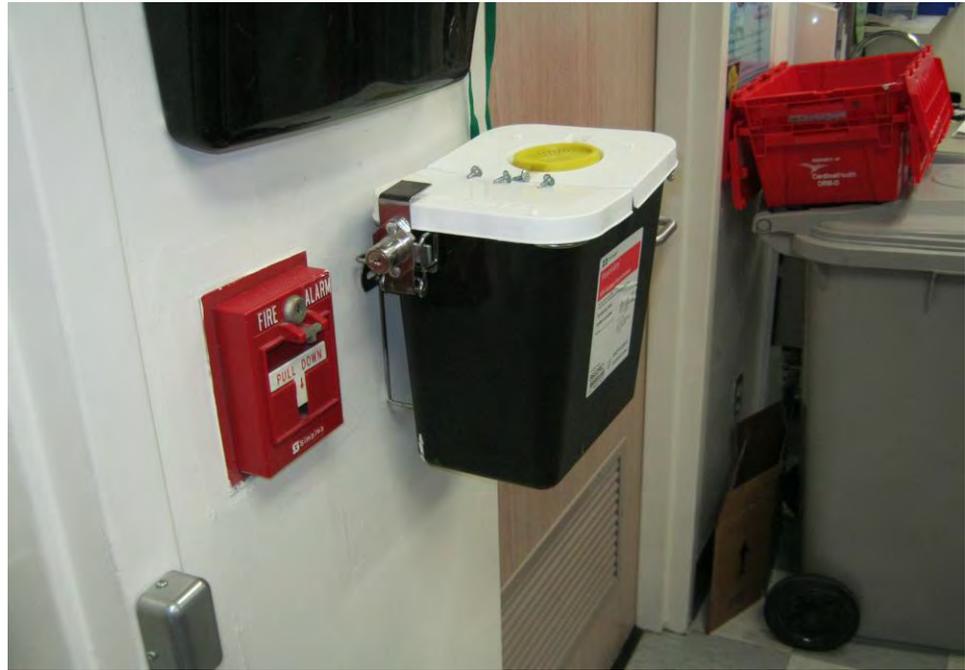
Photograph 3: View of RCRA hazardous waste container in the Pharmacy on the first floor of the hospital.

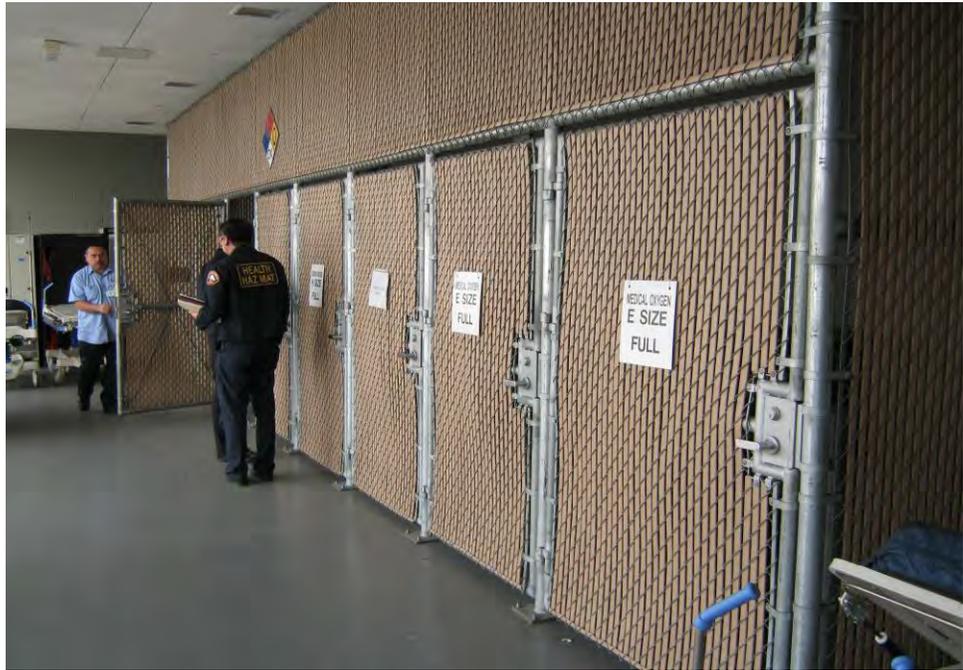
Photograph 5: View of gas cylinder storage area at the loading dock of the hospital, containing oxygen, carbon dioxide medical oxygen, and medical nitrogen.

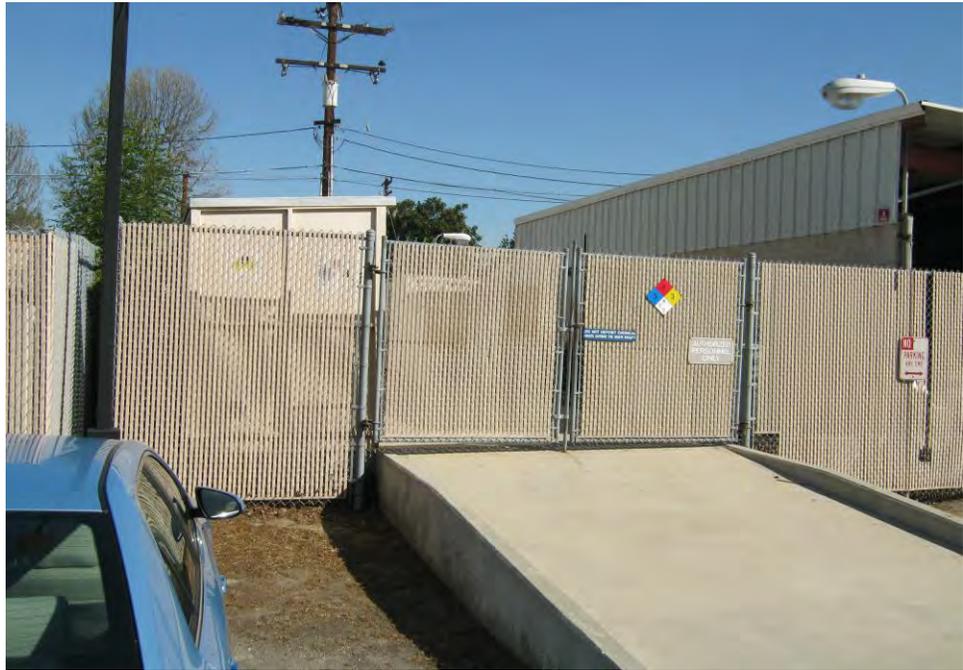
Photograph 7: View of hazardous waste storage area adjacent to Building N32.

Small quantities (less than five gallons) of hazardous waste were observed in designated buildings on the site. Hazardous waste generated at the site is regularly moved to the hazardous waste storage area adjacent to building N32. Six storage sheds with secondary containment were labeled for flammable, corrosive, oxidizing, and poisonous materials. Five of the storage sheds contained several fire closets with small quantities of acids, ammonium sulfate, film fixers, methanol, sodium nitrate, hypochlorite solutions, etc. The remaining storage shed contained used fluorescent light bulbs. Approximately 30 empty one to five-gallon gasoline canisters were observed in the rear of the hazardous waste storage area. Six empty drums (30 to 55 gallons in capacity) and an electrical transformer were observed in secondary containment. Approximately 25 empty 55-gallon drums and one empty nitrogen tank were observed adjacent to the hazardous waste storage area. Staining or signs

of release were not observed in or adjacent to the hazardous waste storage area. Copies of the most recent hazardous waste manifests are provided in Appendix B.

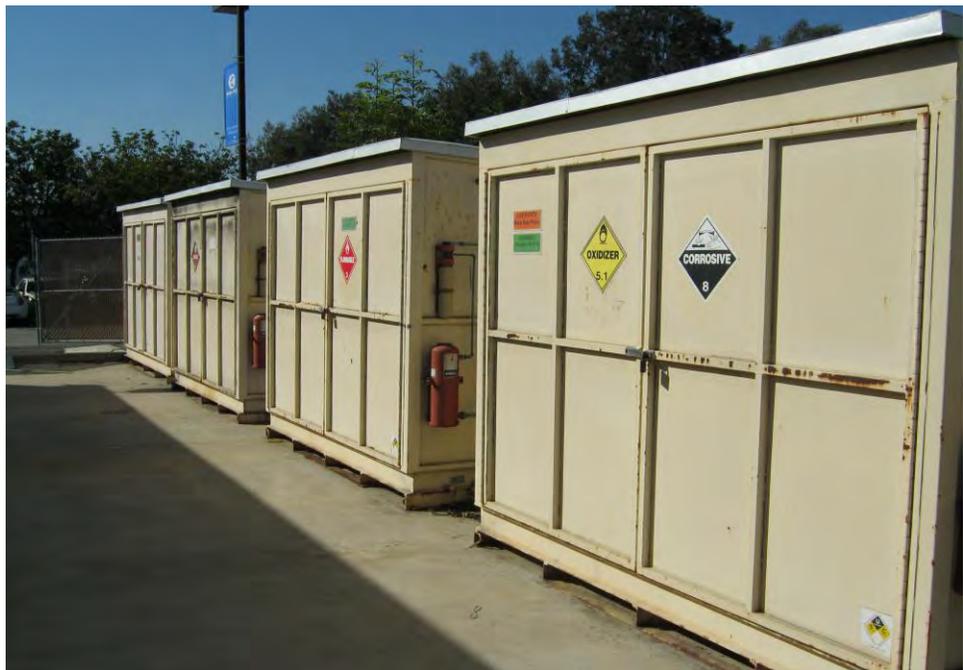
Photograph 8: View of storage sheds in the hazardous waste storage area.

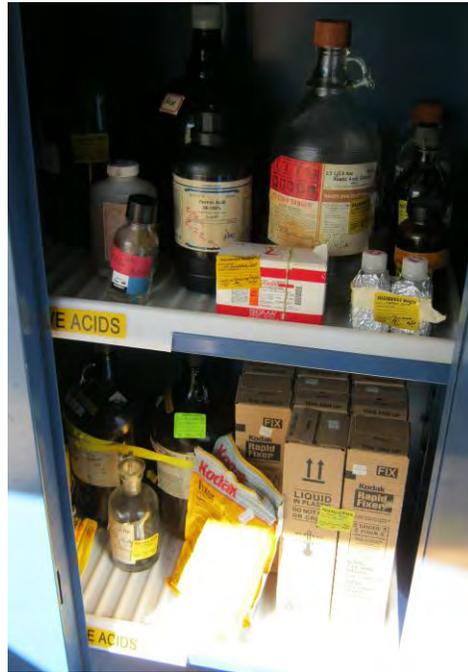
Photograph 9: View of fire closet containing small quantities of acids, film fixer, ammonium sulfate, etc. within a storage shed in secondary containment in the hazardous waste storage area.

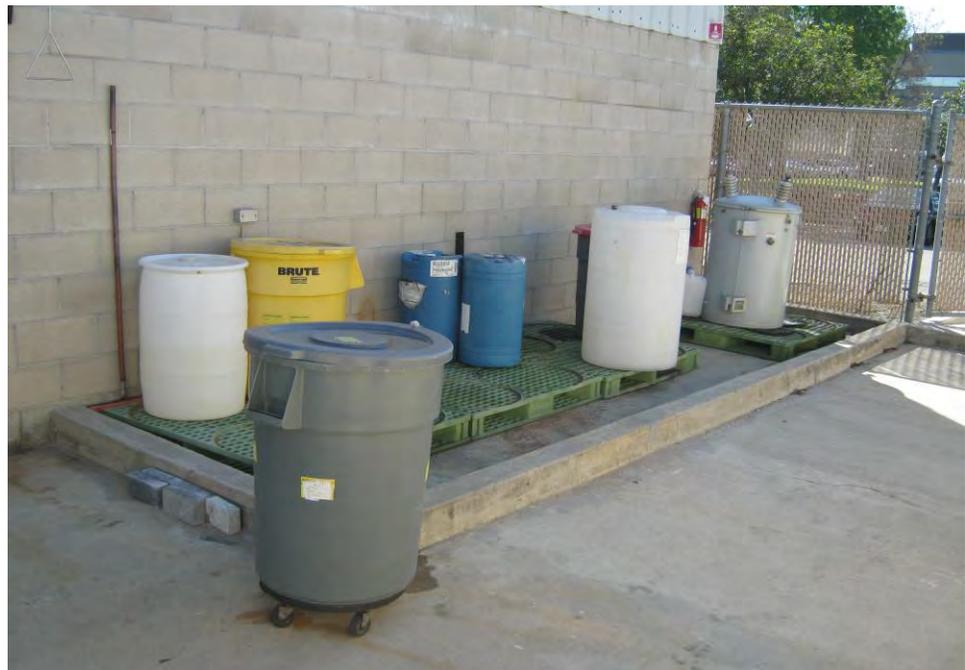
Photograph 10: View of empty drums and electrical transformer in secondary containment in the hazardous waste storage area.

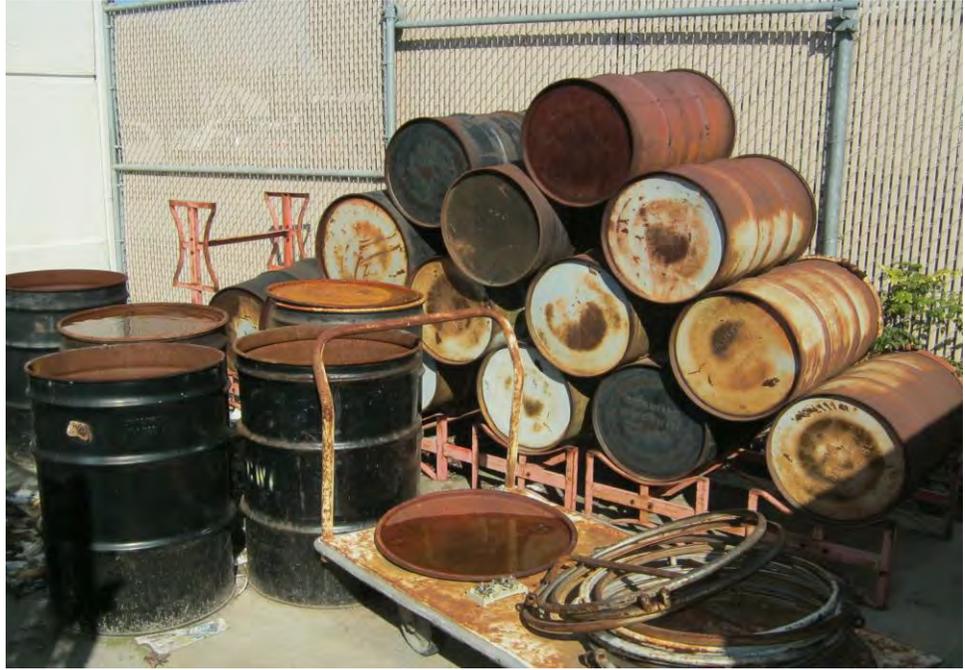
Photograph 11: View of empty 55-gallon drums adjacent to the hazardous waste storage area.

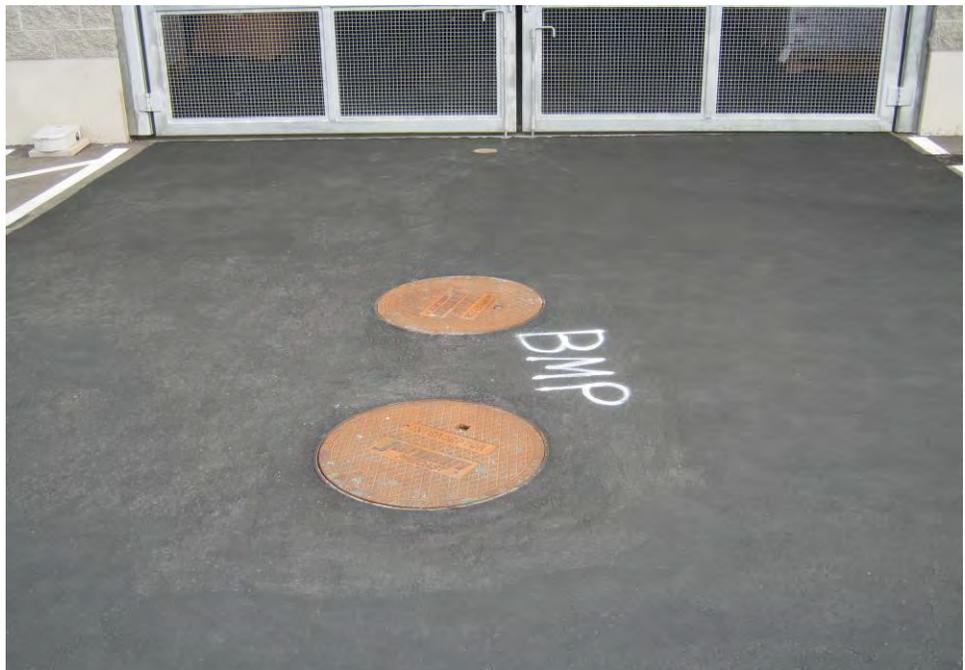
| Area | Location | Tank Capacity (Gallons) | Contents | Construction | Comments |
|---|---|---|---|---|---|
| Helipad | Adjacent to the south | Unknown | Two empty interceptors | Unknown | Emergency spill collection system for potential helicopter fuel release, no staining observed |

Photograph 12: View of empty interceptors adjacent to the helipad.

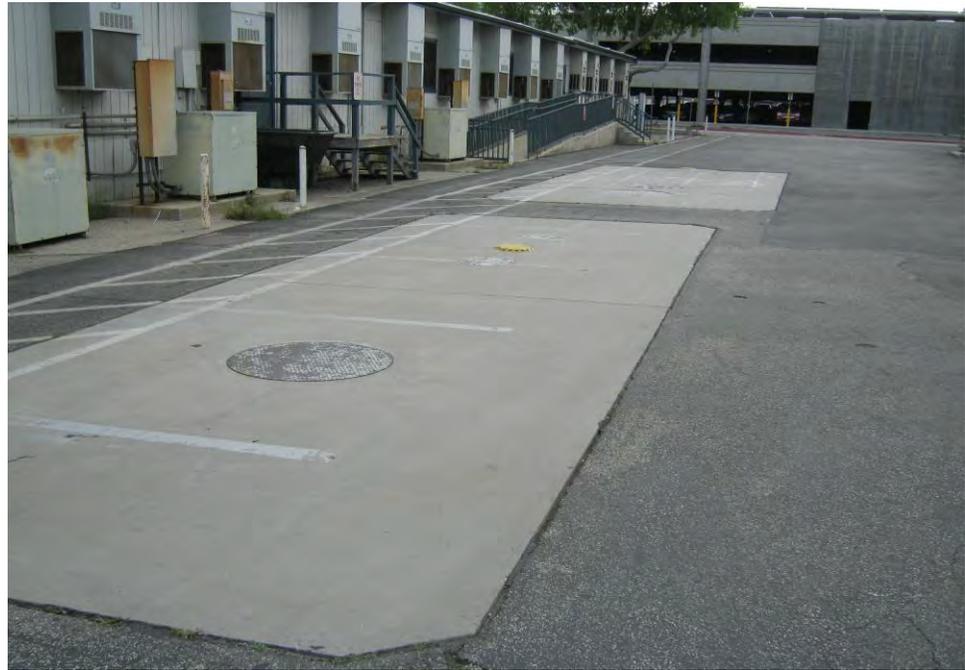
Photograph 13: View of 10,000-gallon and 25,000-gallon amber fuel USTs in the northern portion of the power plant.

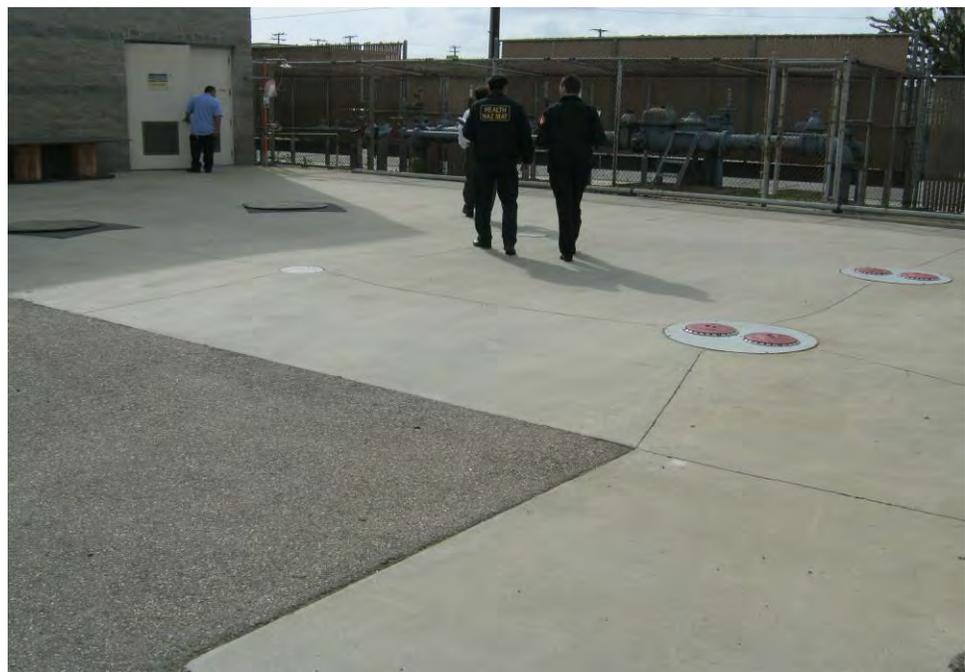
Photograph 14: View of two 15,000-gallon diesel USTs in the southern portion of the power plant.

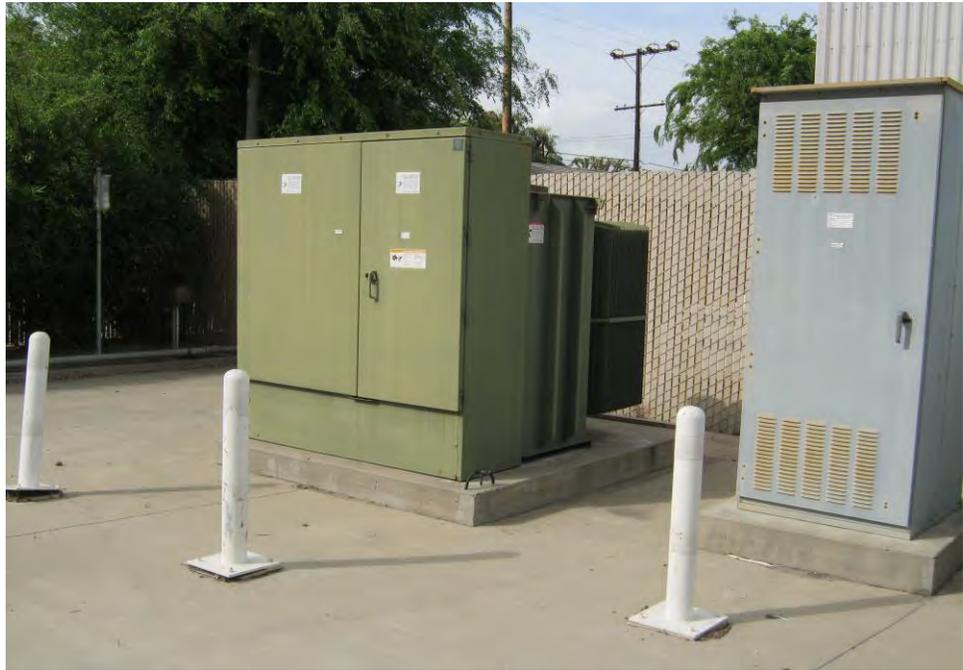
Photograph 15: View of pad-mounted electrical transformer adjacent to the diesel USTs.

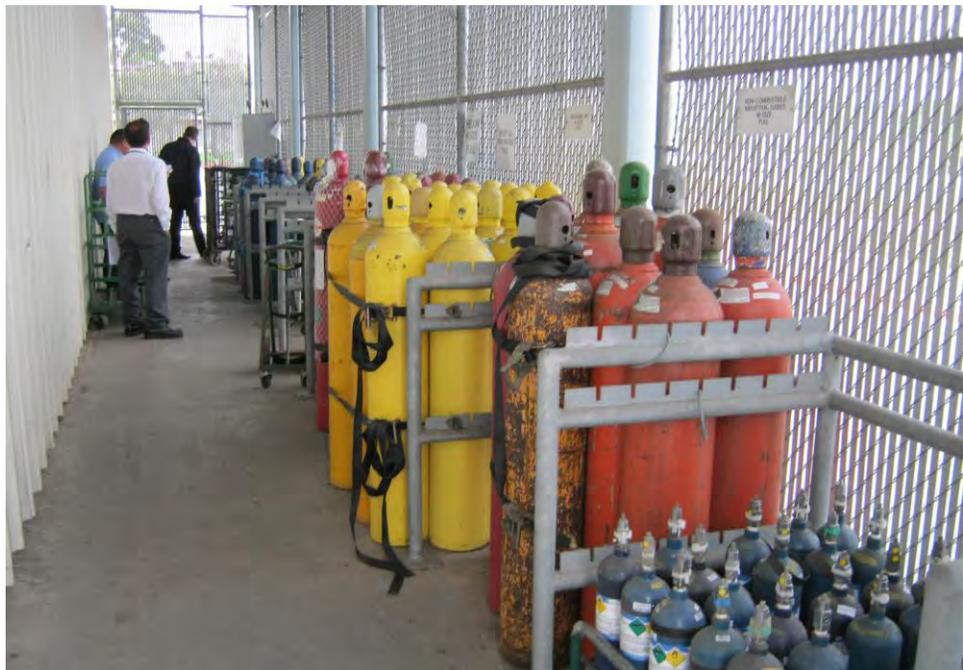
Photograph 16: View of medical gas storage area with cylinders containing helium, argon, nitrogen, oxygen, etc. on the western portion of the power plant.

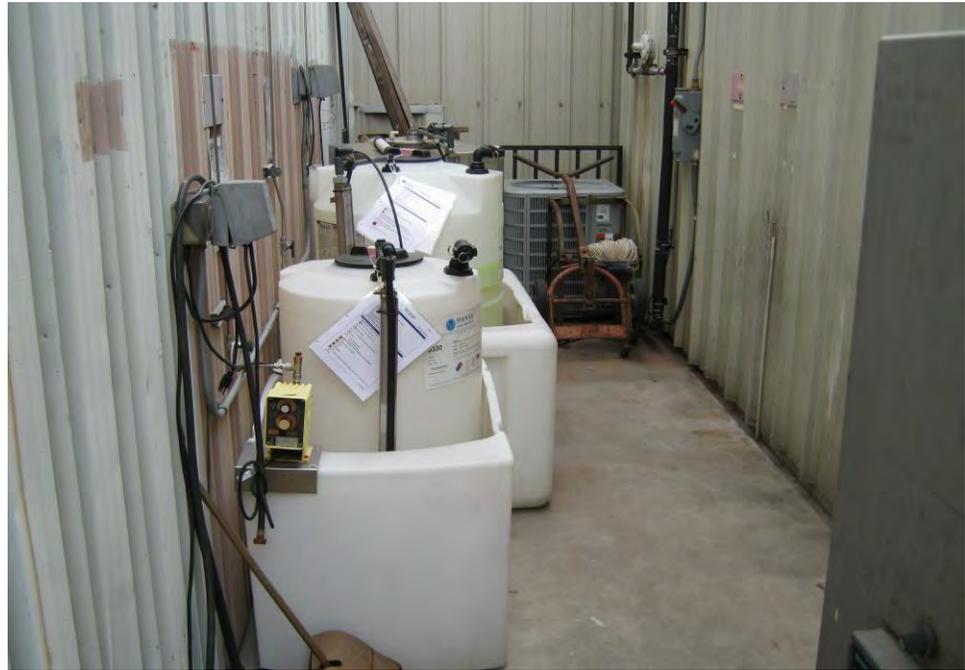
| Area | Location | Tank Capacity (Gallons) | Contents | Comments |
|---|--|---|---|--|
| Power Plant | Boiler Chemical Storage Area | 75 | Morpholine | Chemicals used for maintaining boilers, secondary containment, no staining observed |

Photograph 17: View of 75- to 100-gallon ASTs of chemicals used to maintain boilers in secondary containment in the boiler chemical storage area.

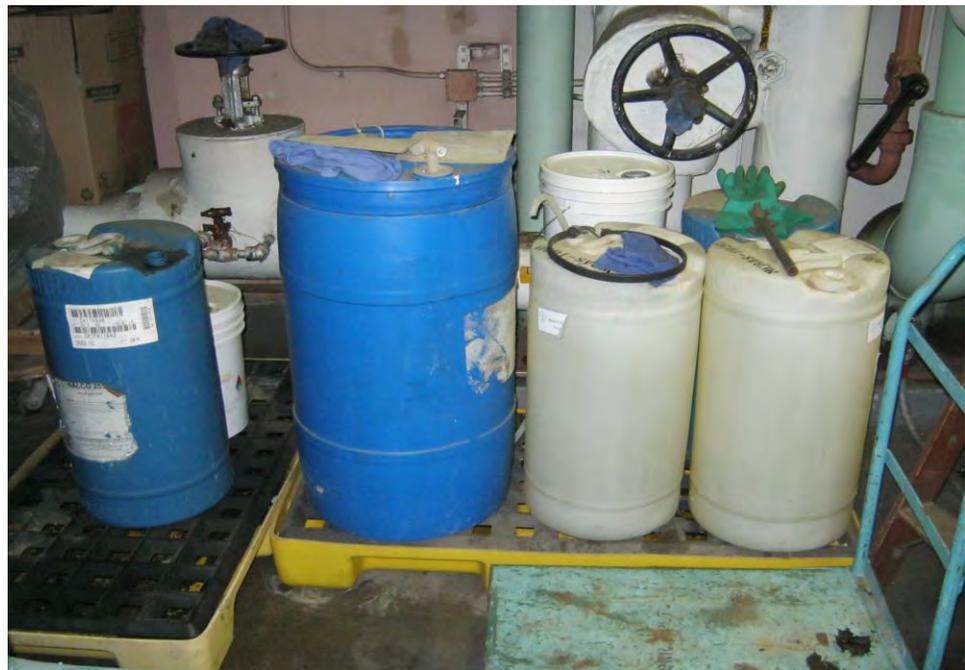
| Building | Location | Storage | Contents | Comments |
|---|---|---|--|--|
| | Boiler room | Corner of room | Oxygen/acetylene cylinders, 5-gallon buckets and 30- to 55-gallon drums of potassium hydroxide, boiler antifoam, chemical cleaner, corrosion inhibitor, oxygen scavenger | Secondary containment |

Photograph 18: View of 30- and 55-gallon drums of corrosion inhibitor, antifoam, and potassium hydroxide in secondary containment in the boiler room of the power plant.

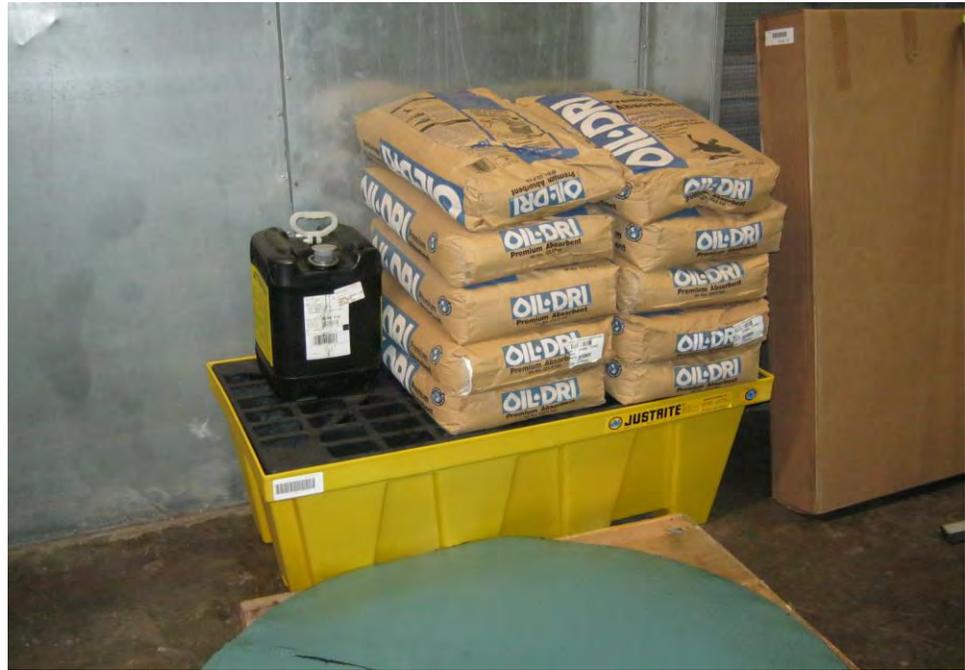
Photograph 19: View of 5-gallon bucket of compressor oil and ten 50-lb bags of absorbent in secondary containment in the equipment room of the power plant.

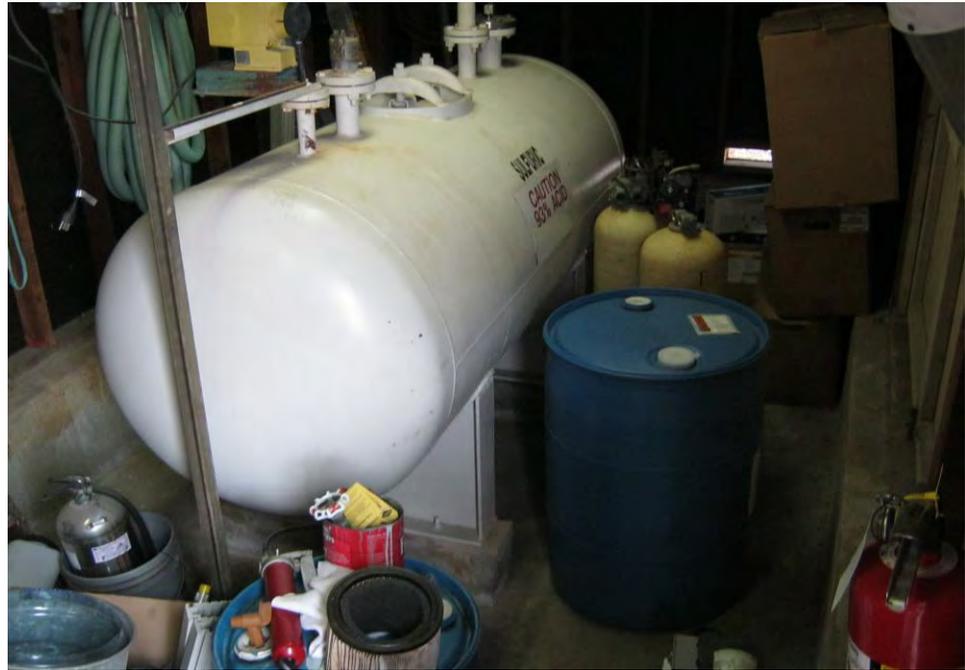
| Area | Location | Tank Capacity (Gallons) | Contents | Comments |
|---|--|---|---|--|
| | Cooling Tower Storage Shed | 300 | Sulfuric Acid | Planned to be removed this year, secondary containment, no staining observed |

Photograph 21: View of 300-gallon sulfuric acid AST in secondary containment in cooling tower storage shed.

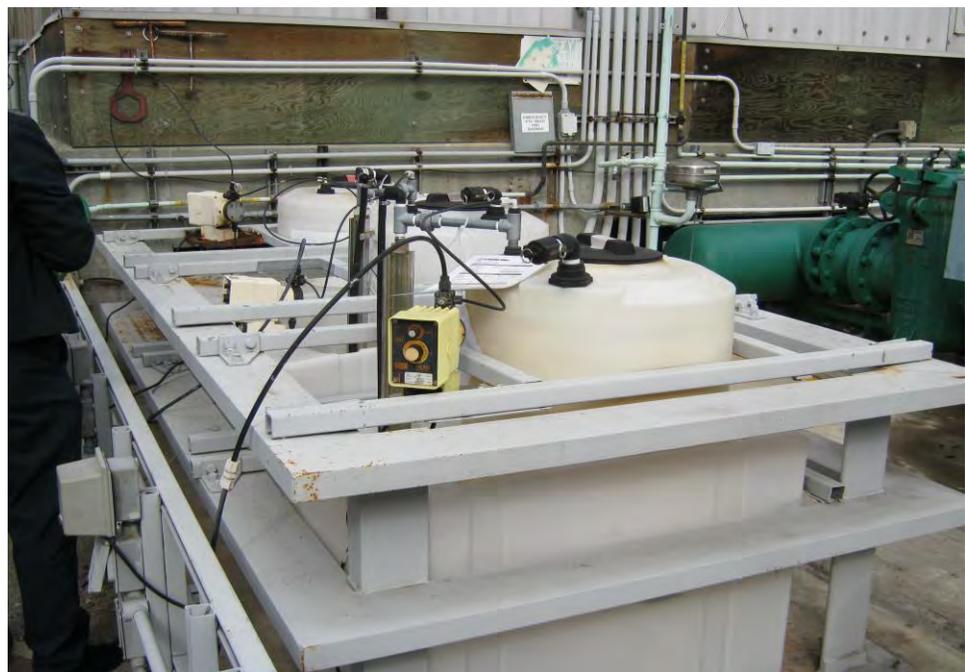
| Area | Location | Tank Capacity (Gallons) | Contents | Comments |
|---|--|---|---|--|
| | Cooling Tower Chemical Storage Area | 75 | Microbicide | Chemicals used for corrosion protection, secondary containment, no staining observed |

Photograph 22: View of 75-gallon ASTs of chemicals used for corrosion protection in secondary containment in the cooling tower chemical storage area.

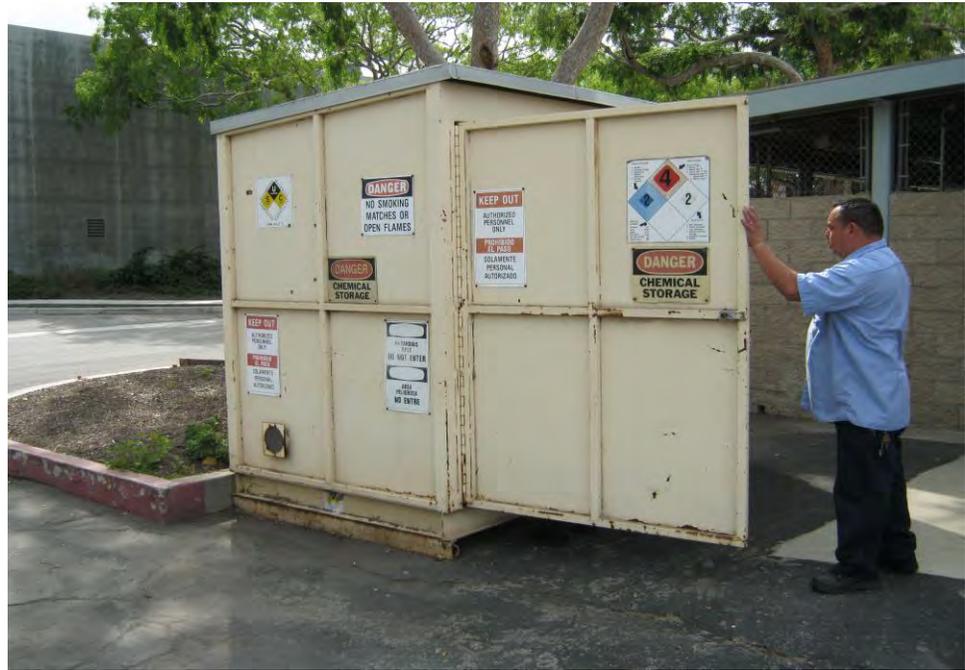
Photograph 23: View of fire closet containing small quantities of alcohols in the northeast portion of the power plant.

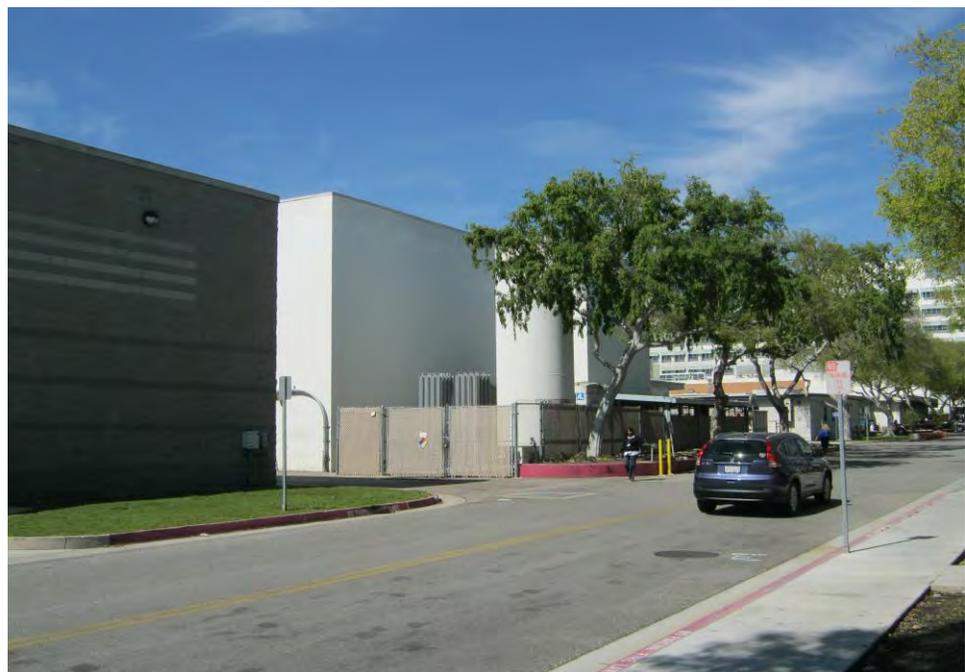
| Area | Location | Tank Capacity (Gallons) | Contents | Comments |
|---|--|---|---|--|
| | Eastern edge | 9,000 | Liquid Oxygen | No secondary containment, no staining observed |

Photograph 24: Looking northwest at the power plant at the 900- and 9,000-gallon liquid oxygen ASTs.

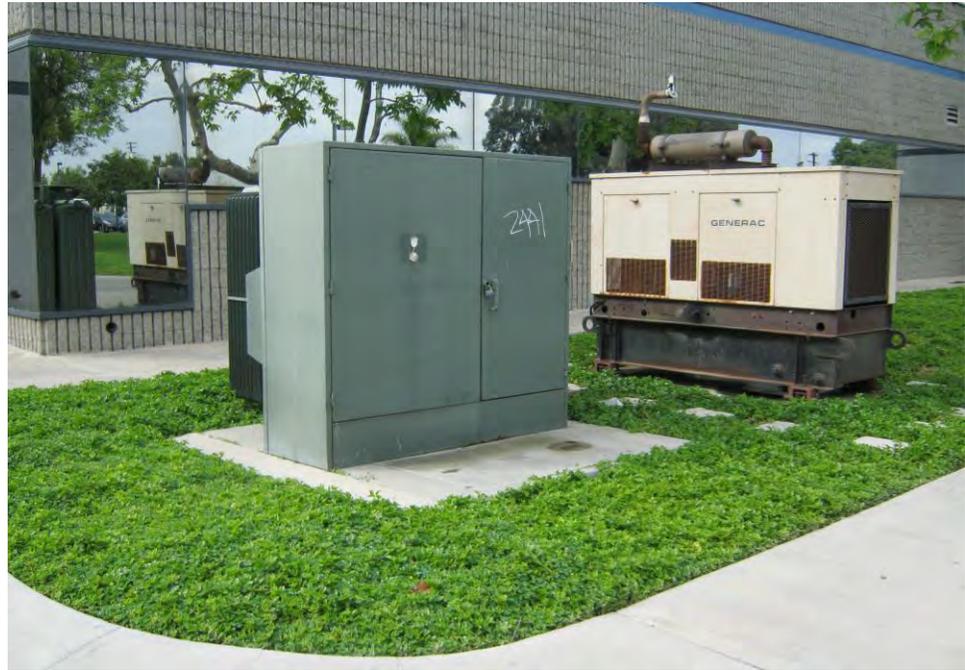
Photograph 25: View of typical pad-mounted transformer and emergency generator outside an LA BioMed building.

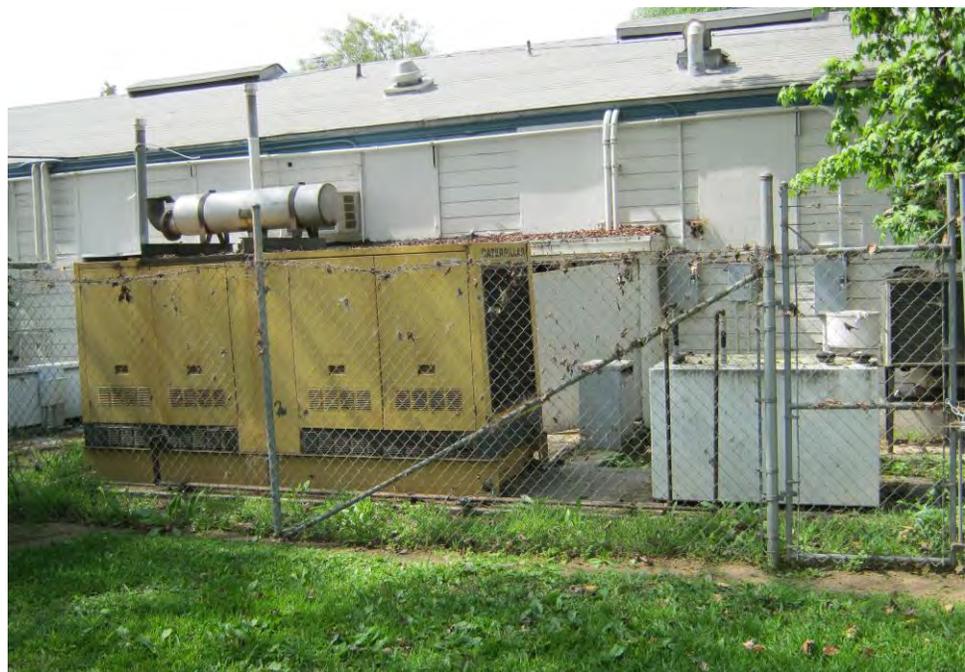
| Area | Location | Tank Capacity (Gallons) | Contents | Comments |
|---|--|---|---|--|
| LA BioMed Buildings | Various | Approximately 200 to 250, one is 500 | Diesel Fuel | Eight exterior emergency generators, no staining observed, no secondary containment |

Photograph 26: View of 500-gallon diesel AST and emergency generator between Buildings E2 and E3.

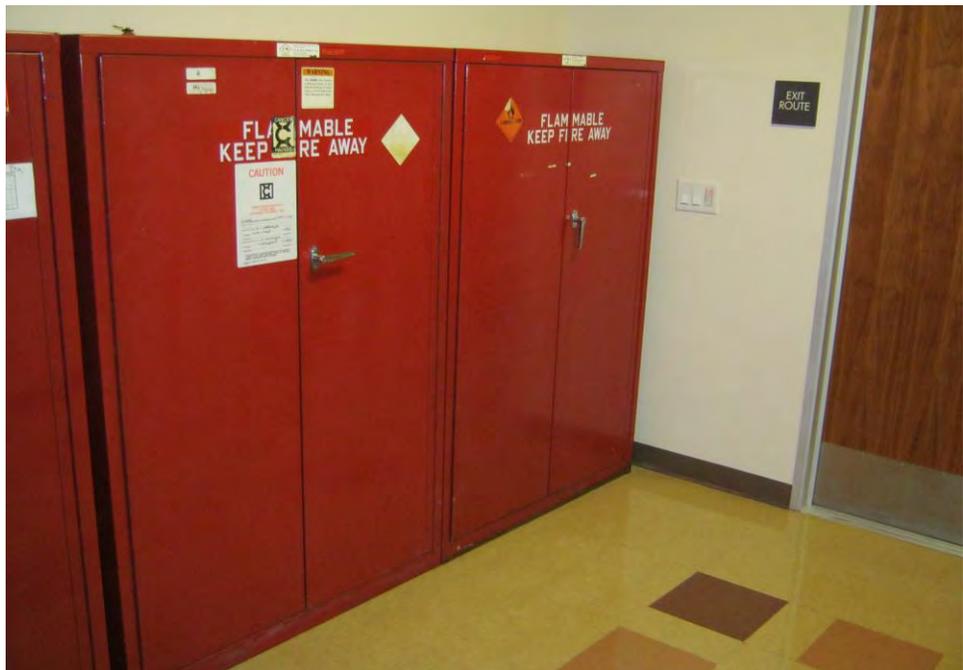
Photograph 28: View of typical fire cabinets in LA BioMed building containing small quantities of acids, hexanes, alcohols, acetone, chloroform, etc.

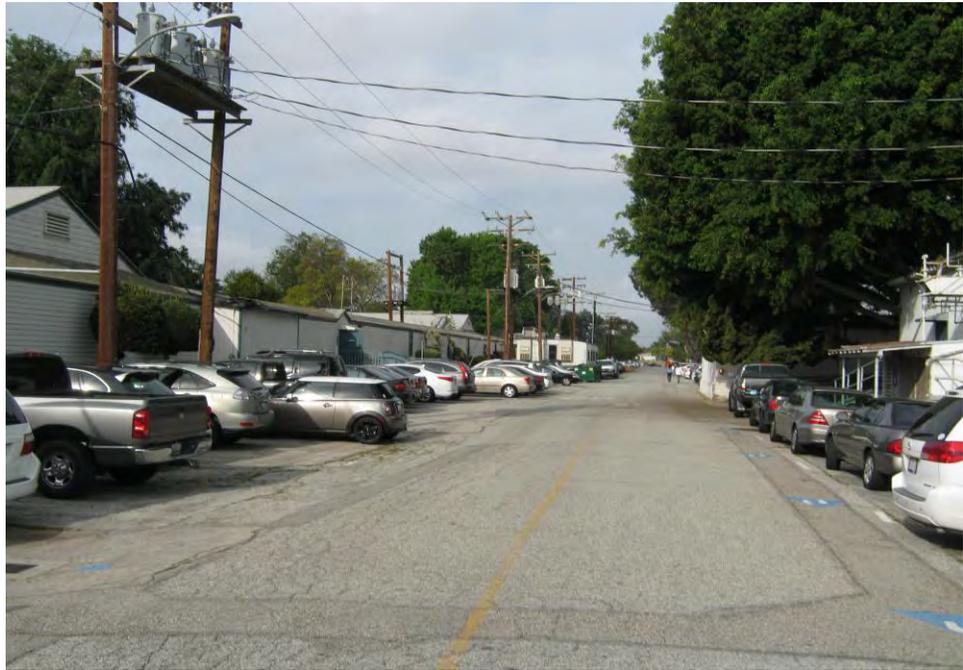
Electrical transformers can be a source of PCBs. Pole-mounted transformers were observed along Medical Foundation Drive, Medical Center Drive, South Drive, and between several buildings at the site. Pad-mounted transformers were observed at the power station and adjacent to LA BioMed buildings. Staining or signs of release was not observed. Transformers were observed in the power station building of the power plant. According to Mr. Juan Oliva, PCBs are not used in the power station transformers.

Photograph 33: Looking west at Medical Center Drive with pole-mounted transformers.

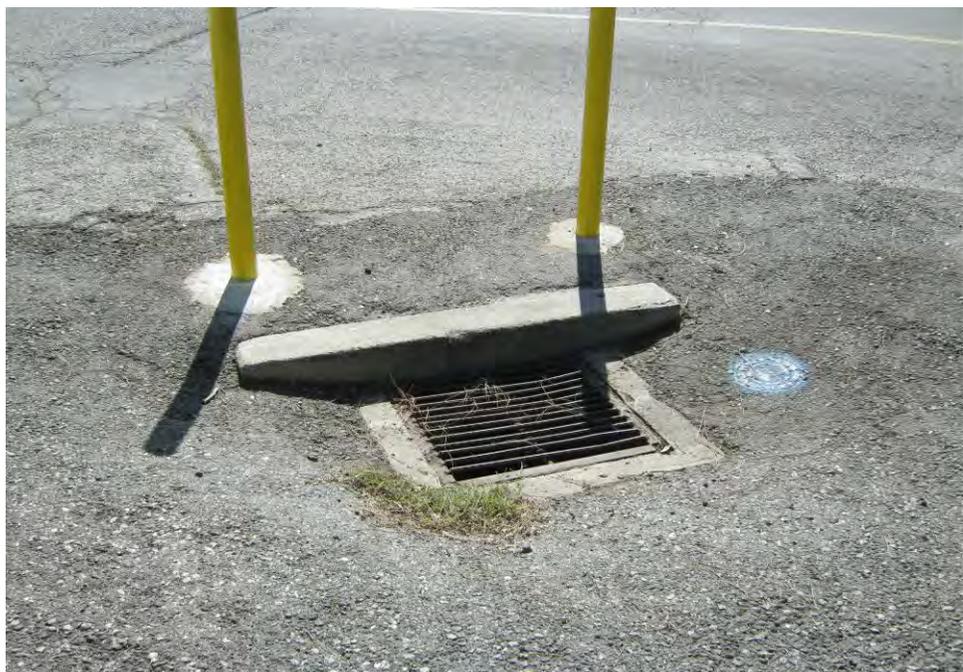
Storm water catch basins and drains were observed throughout the site during the site reconnaissance. A storm water channel trending east-west was observed at the southern boundary of the site. Staining was not observed at the catch basins, drains, or channel.

Photograph 34: View of typical storm drain on the northern portion of the site.

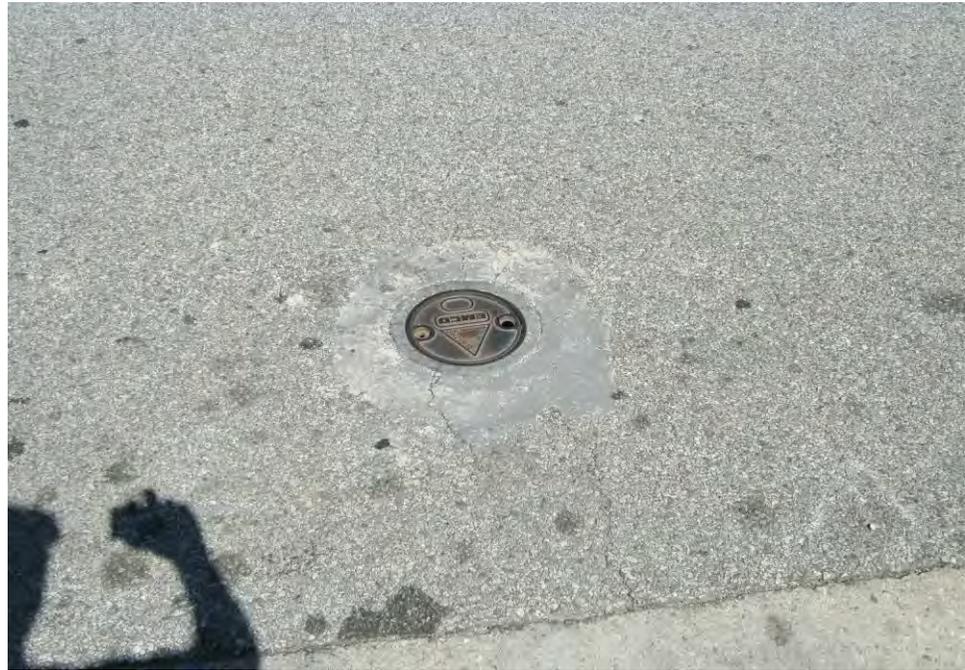
Wells were not observed on the site during the site reconnaissance. One monitoring well was observed adjacent to the north of the site on West Carson Street, assumed to be part of one of the former gasoline service stations at 1259 West Carson Street (Section 6.14). Two monitoring wells were observed adjacent to the east of the site on South Vermont Avenue, which are associated with Mobil #11-MAF at 21700 South Vermont Avenue (Section 6.14).

Photograph 37: View of monitoring well on West Carson Street, adjacent to the north of the site.

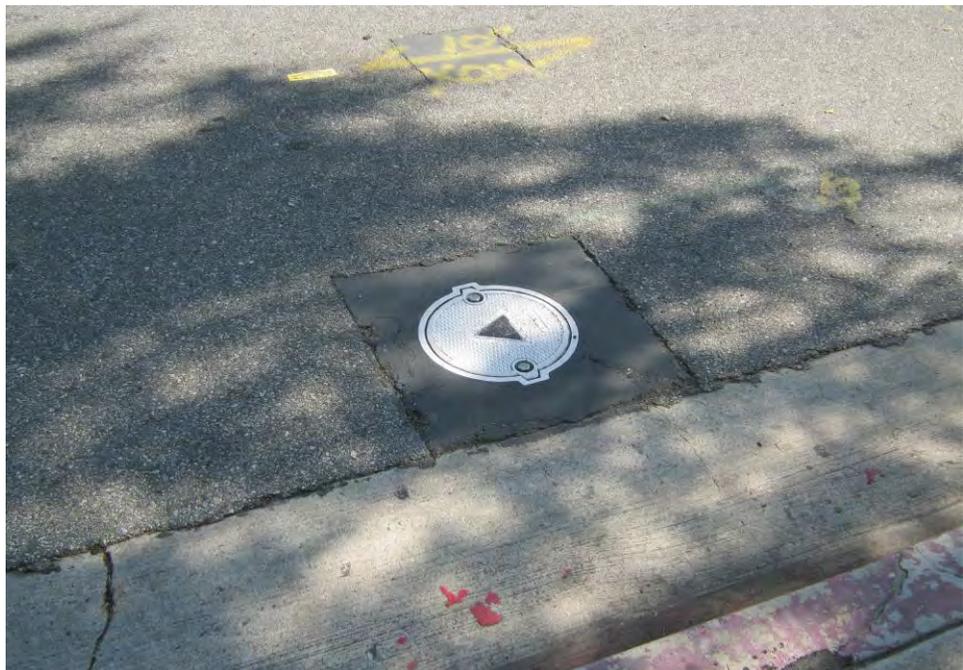
Photograph 40: View of groundwater monitoring well on South Vermont Avenue, adjacent to the east of the site.
