INITIAL STUDY

HARBOR-UCLA MEDICAL CENTER CAMPUS MASTER PLAN PROJECT

CITY OF TORRANCE, CALIFORNIA

Historic Resource Report

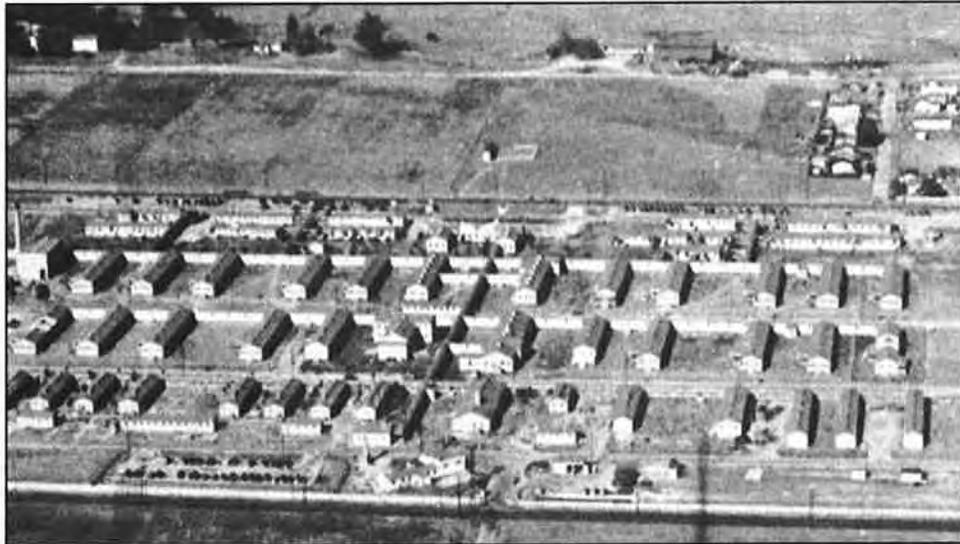
Figure 2: Photograph of the site in 1943. Source: www.labiomed.org.

The site consisted primarily of one-story rectangular buildings with gabled roofs and wood clapboard siding. The barracks had multi-light double-hung windows and partially-glazed paneled doors. The majority of the long, thin buildings were oriented facing north-south with covered walkways that connected the buildings running east to west. At the

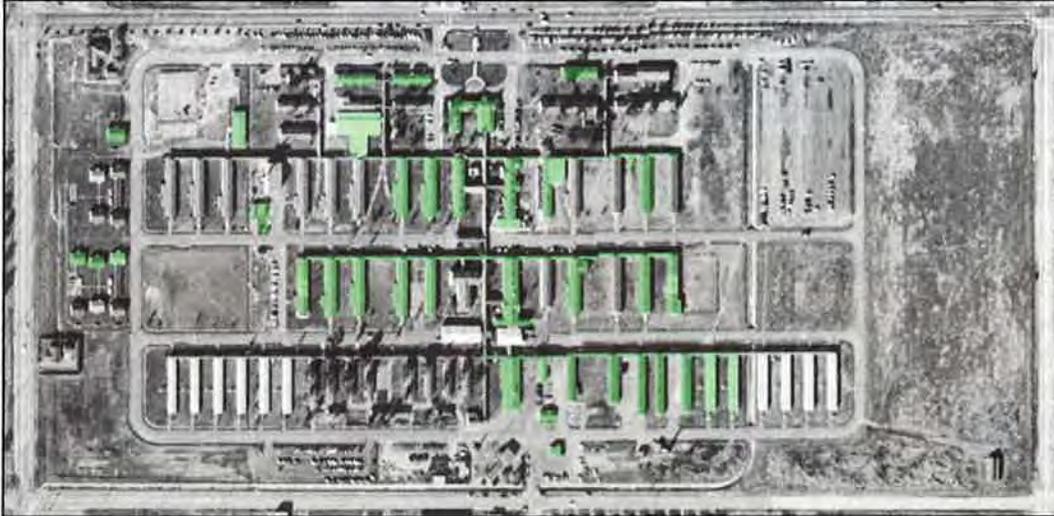
Figure 7: Original buildings that remain, in whole or in part, are shaded green. Source: *Historicaerials.com*.

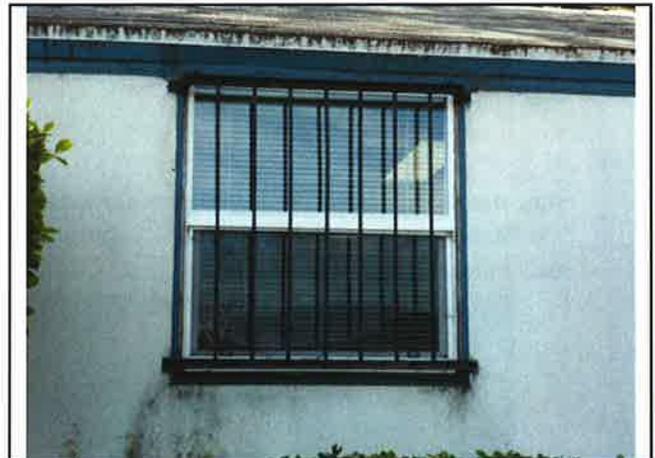
North elevation, typical window. 6/11/13.
