Ms. Mitzi Kim Rios
Los Angeles County Public Works
900 South Fremont Avenue, 9th Floor
Alhambra, California 91803

Re: *Devil's Gate Reservoir Restoration Project – Phase 1 Restoration Qualitative Monitoring Conducted on May 22, 2023*

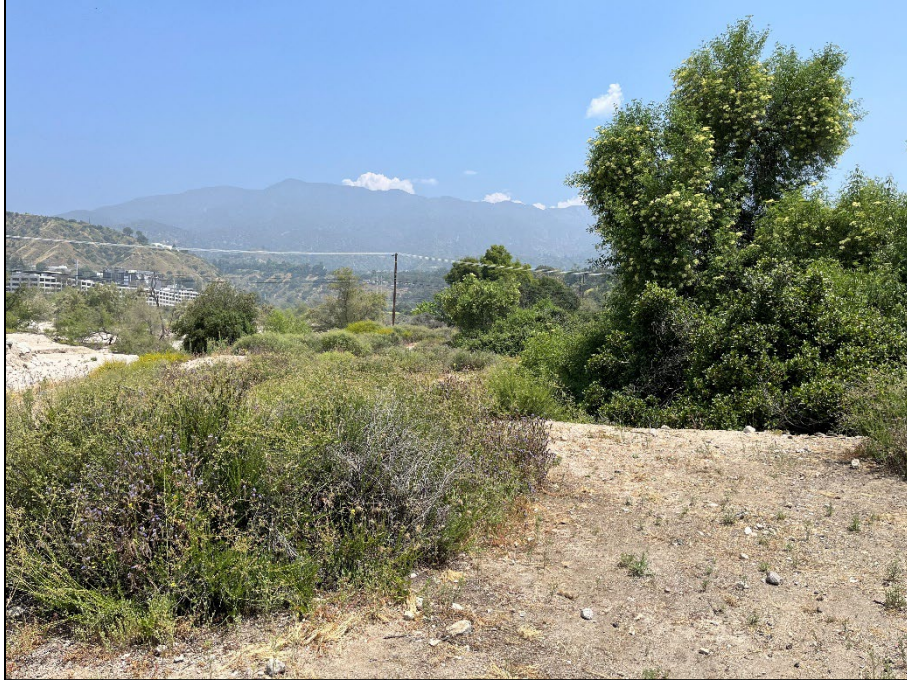
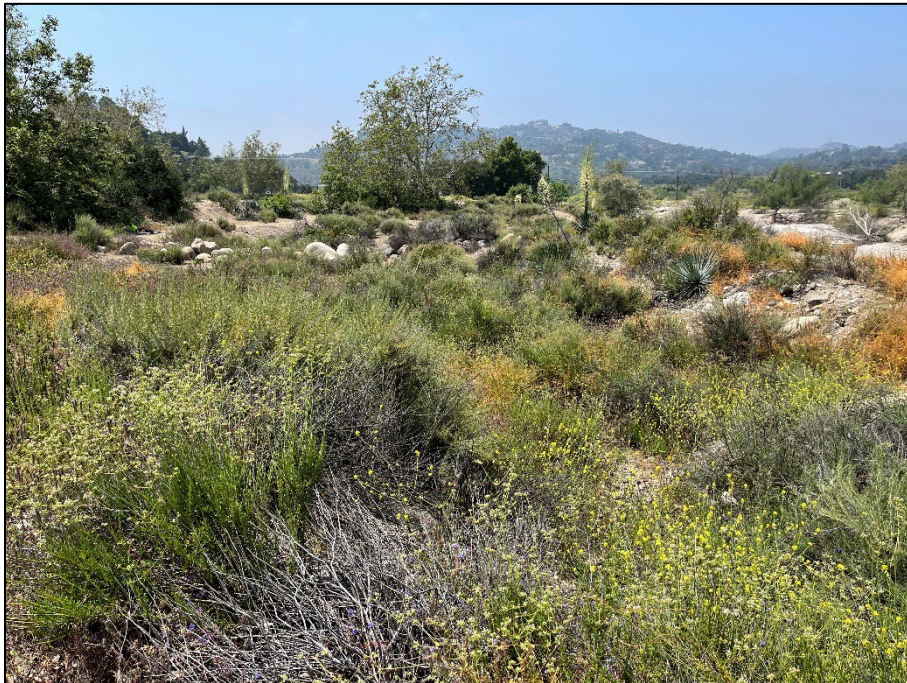
Container plants were not installed in the DG-1 or DG-1 WOUS mitigation areas, but these areas were seeded with native plant species. Native plant growth, including perennials and annuals, was noted throughout the DG-1 and DG-1 WOUS mitigation areas, likely both from natural recruitment and from seeding; however, germination was observed to be minimal in most of these mitigation areas. Portions of DG-1 WOUS were noted as being scoured during the 2020, 2021, 2022, and 2023 wet seasons and had minimal plant growth. Native plants such as California sagebrush (*Artemisia californica*), spencer primrose (*Camissoniopsis micrantha*), California dodder (*Cuscuta californica*), California buckwheat (*Eriogonum fasciculatum*), telegraph weed (*Heterotheca grandiflora*), common phacelia (*Phacelia distans*), and chia (*Salvia columbariae*) were observed sprouting in the DG-1 and DG-1 WOUS mitigation areas. Native cover for the DG-1 and DG-1 WOUS mitigation areas was estimated to be approximately 65 to 70 percent with some areas having relatively dense cover and other areas being scoured and/or having minimal cover. Photos 1 and 2 in Attachment B document the status of the mitigation areas during the monitoring visit.

Nonnative weed cover in DG-1 and DG-1 WOUS was estimated to be approximately 10 percent, which is approximately five percent higher than the level of weed cover that was observed during the previous qualitative monitoring event. It should be noted that weed cover in this mitigation area during the spring of 2022 was approximately five percent. The minor increase in nonnative cover during the spring of 2023 in this mitigation area is likely due to the increase in precipitation during the 2023 wet season and a higher level of weed cover is typical during the spring and summer months. Nonnative species observed in DG-1 and DG-1 WOUS included black mustard (*Brassica nigra*), red brome (*Bromus madritensis*), red-stemmed filaree (*Erodium cicutarium*), and Indian plantain (*Plantago arenaria*). Most nonnative weeds were just starting to germinate and had not gone to flower or seed.

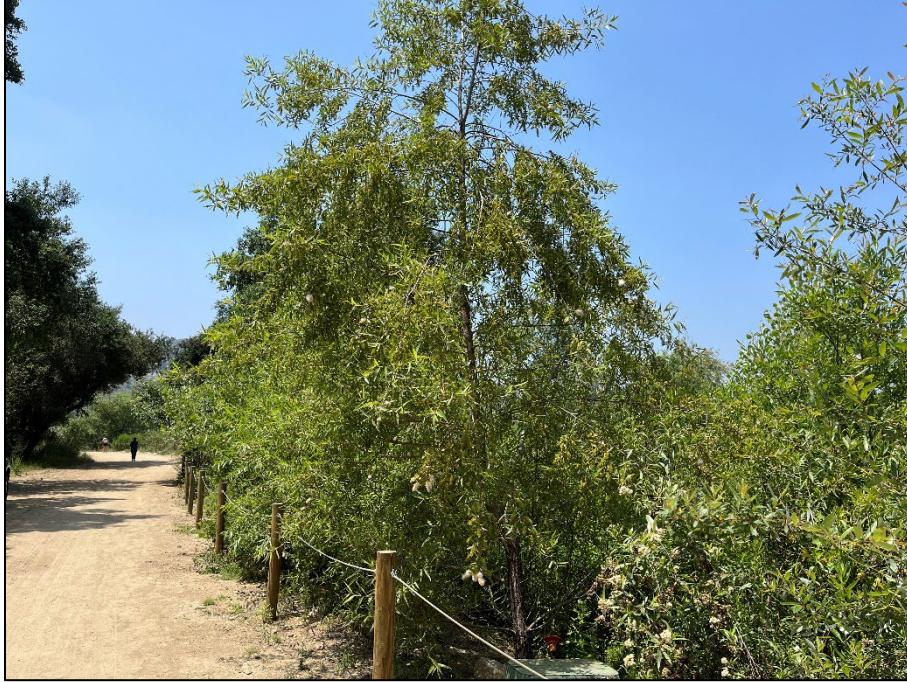
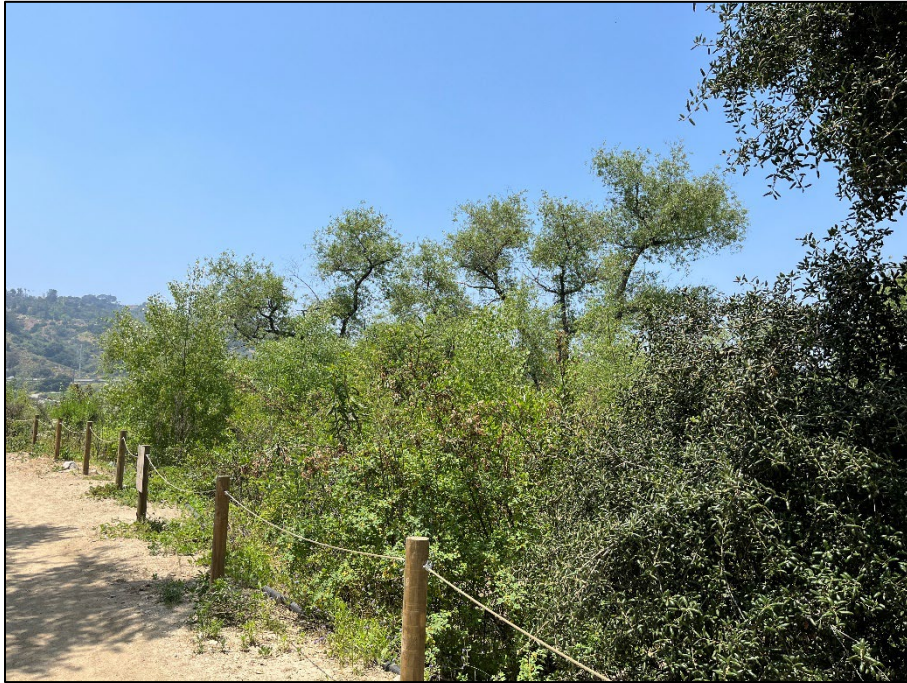
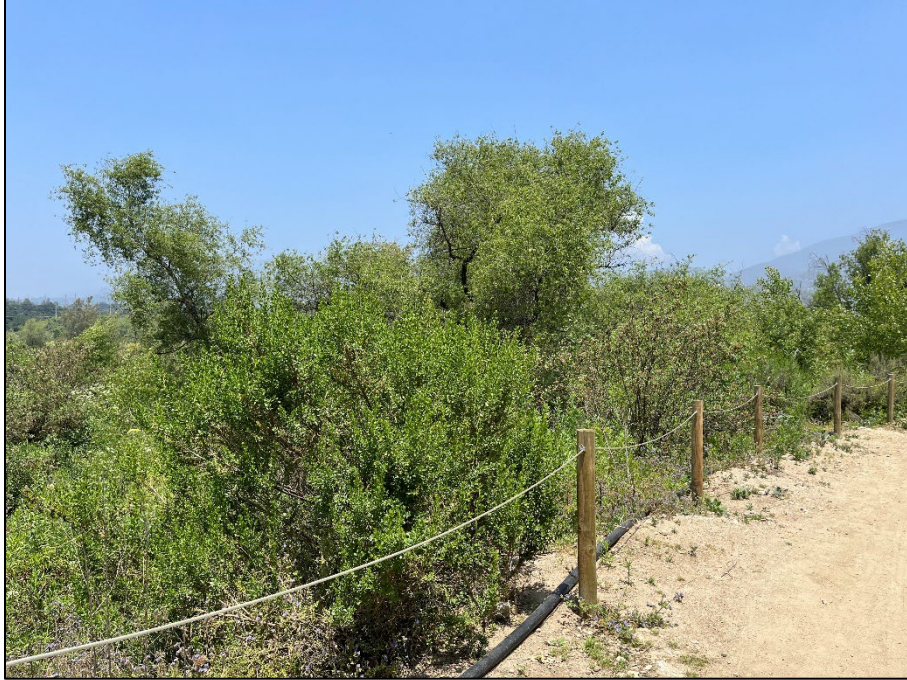
The overall health of the container plants in DG-2A was noted as being good. Approximately less than five percent of the container plants in DG-2A were noted as showing varied levels of stress, which is approximately the same as the percentage of container plants that were showing stress during the previous qualitative monitoring event. Stress may be occurring as a result of 1) competition from nonnative and invasive weeds, 2) misplaced emitters, or 3) recreational traffic through the mitigation areas. There were no additional container plants noted as being missing or dead. Formal mortality counts were taken for DG-2A during the 2020, 2021, and 2022 quantitative monitoring events. Most of the willows (*Salix* sp.) and Fremont's cottonwoods (*Populus fremontii*) were no longer showing signs of seasonal dieback. The installation of plants in the DG-2A mitigation area appears to have been completed successfully. The current issues identified during the monitoring visit are not expected to have an effect on the continued growth of the plants in the mitigation area. Photos 3 through 5 in Attachment B document the status of the mitigation area during the monitoring visit.

Native plant growth was noted throughout the DG-2A mitigation area, likely both from natural recruitment and from seeding. Native plants such as western bursage (*Ambrosia psilostachya*), annual bursage (*Ambrosia acanthicarpa*), spencer primrose, Canada horseweed (*Erigeron canadensis*), telegraph weed, common phacelia, ladies' tobacco (*Pseudognaphalium californica*), and stinging nettle (*Urtica dioica*) were observed sprouting in the DG-2A mitigation area. Native cover for the DG-2A mitigation area was estimated to be 80 percent.

Nonnative weed cover in DG-2A was estimated at approximately one percent, which is approximately four percent lower than the level of weed cover that was observed during the previous qualitative monitoring event. It should be noted that weed cover in this mitigation area during the spring of 2022 was approximately less than two percent which shows that weed cover in this mitigation area has been consistently low. Nonnative species observed in DG-2A during the monitoring visit included black mustard and perennial pepperweed (*Lepidium latifolium*). Most nonnative weeds were just starting to germinate and had not gone to flower or seed.

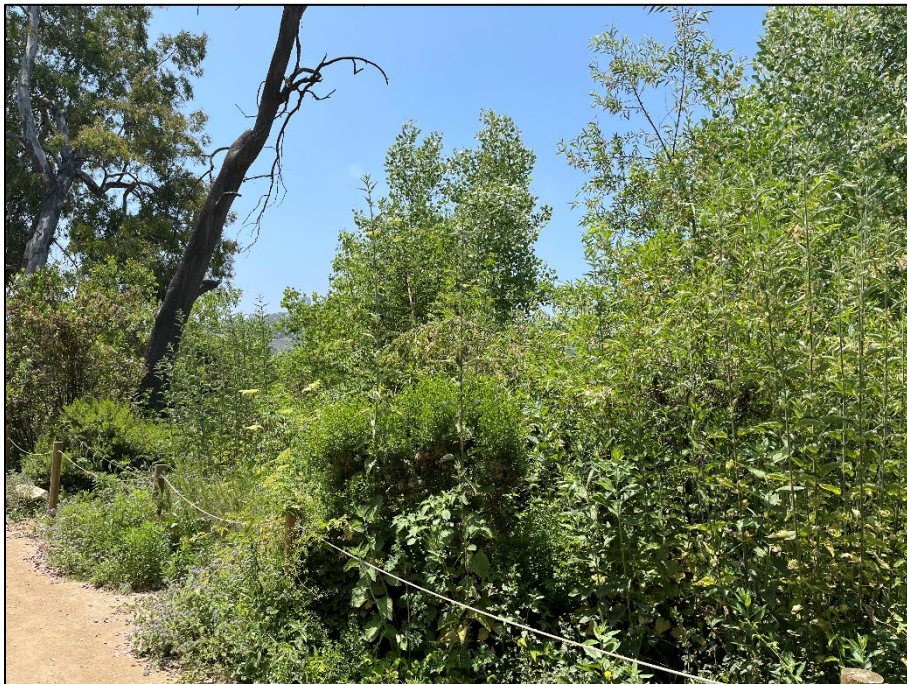
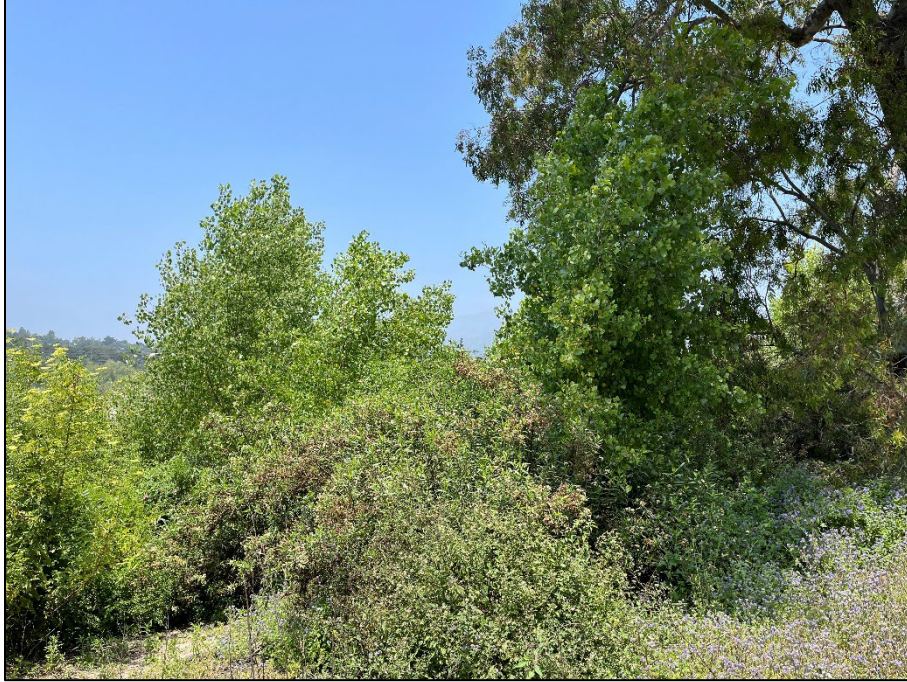
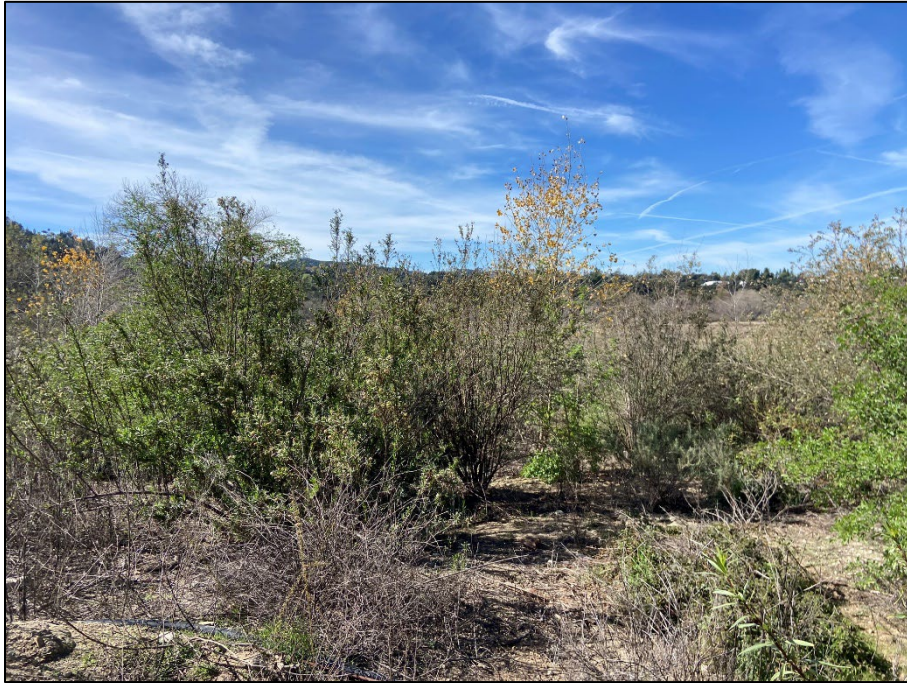
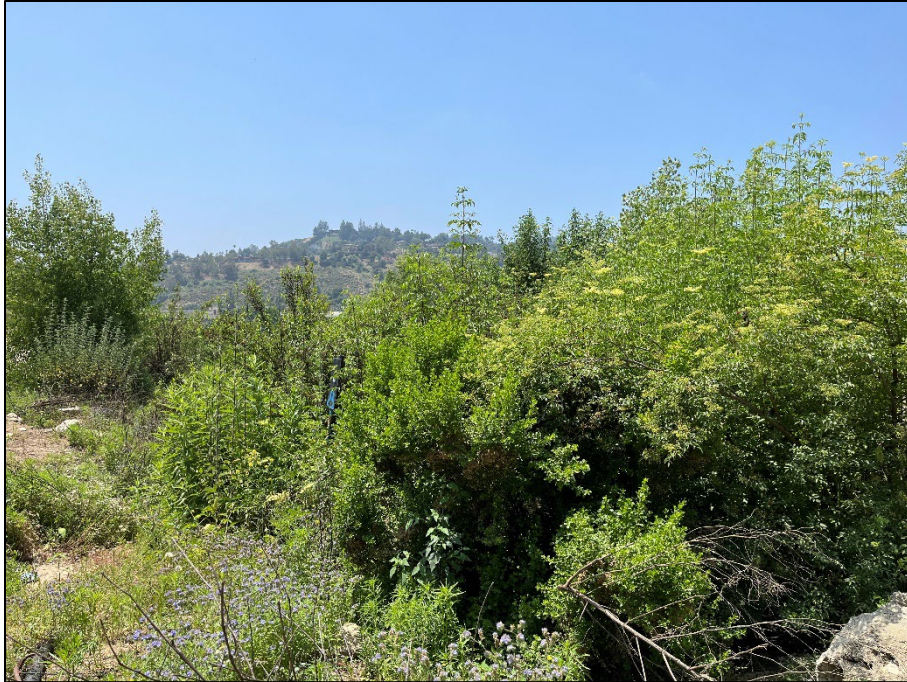
The overall health of the container plants in DG-2B was noted as being good. Approximately less than five percent of the container plants in DG-2B were noted as showing varied levels of stress, which is approximately the same percentage of container plants that were showing stress during the previous qualitative monitoring event. Stress was likely due to the same reasons as those described for DG-2A. In addition, insect galls were observed on several of the willow species. Formal mortality counts were taken for DG-2B during the 2020, 2021, and 2022 quantitative monitoring events. Similar to DG-2A, most of the willows and Fremont's cottonwoods were no longer showing signs of seasonal dieback. The installation of the plants in the DG-2B mitigation area appears to have been successfully completed. The current issues identified during the monitoring visit are not expected to have an effect on the continued growth of plants in the mitigation area. Photos 6 through 9 in Attachment B document the status of the mitigation area during the monitoring visit.

Native plant growth was noted throughout the DG-2B mitigation area, likely both from natural recruitment and from seeding. Native plants such as annual bursage, western ragweed, spencer primrose, cobweb thistle (*Cirsium occidentale*), Canada horseweed, common bedstraw (*Galium aparine*), telegraph weed, common phacelia, ladies' tobacco, Douglas' nightshade (*Solanum douglasii*), and stinging nettle were observed sprouting in the DG-2B mitigation area. Native cover for the DG-2B mitigation area was estimated to be 85 percent.

Nonnative weed cover in DG-2B was estimated at approximately one percent, which is approximately four percent lower than the level of nonnative cover that was observed during the previous qualitative monitoring event. It should be noted that weed cover in this mitigation area during the spring of 2022 was approximately less than five percent which shows that weed cover in this mitigation area has been consistently low. Nonnative species observed in DG-2B during the monitoring visit included black mustard, scarlet pimpernel (*Lysimachia arvensis*), and yellow sweetclover (*Melilotus indicus*). Most nonnative weeds were just starting to germinate and had not gone to flower or seed.

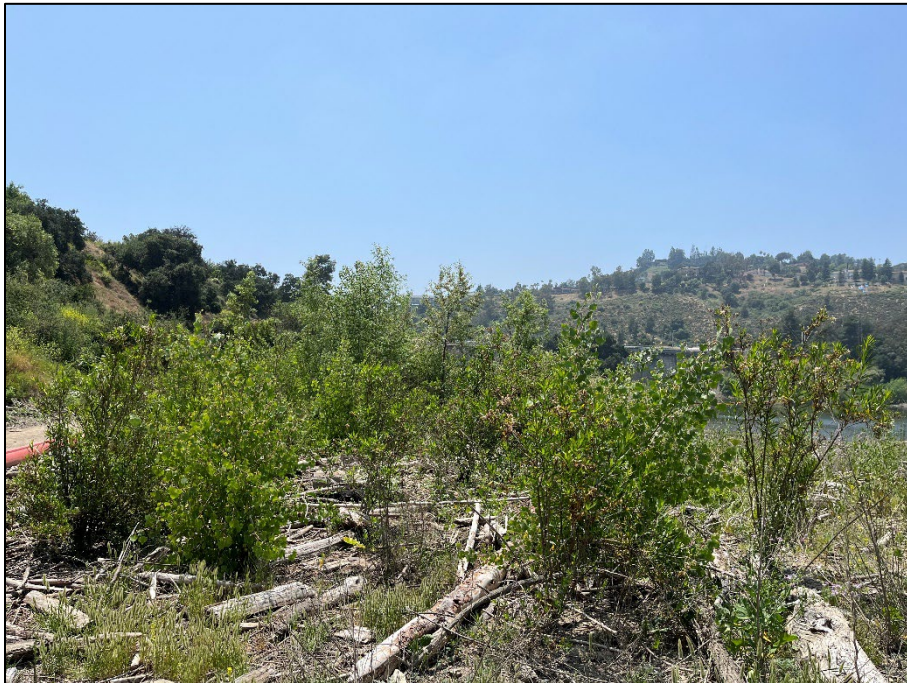
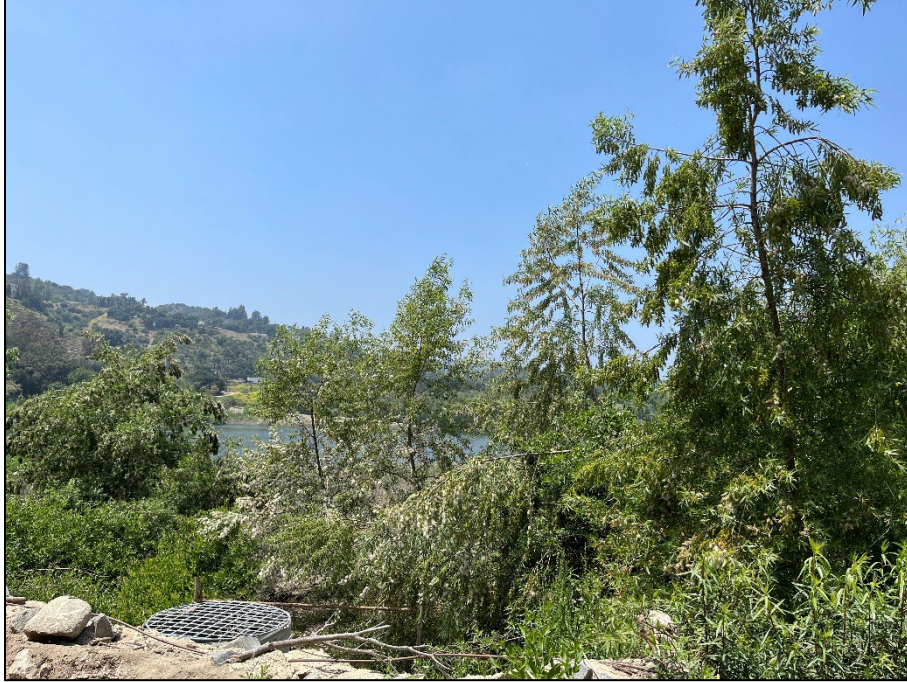
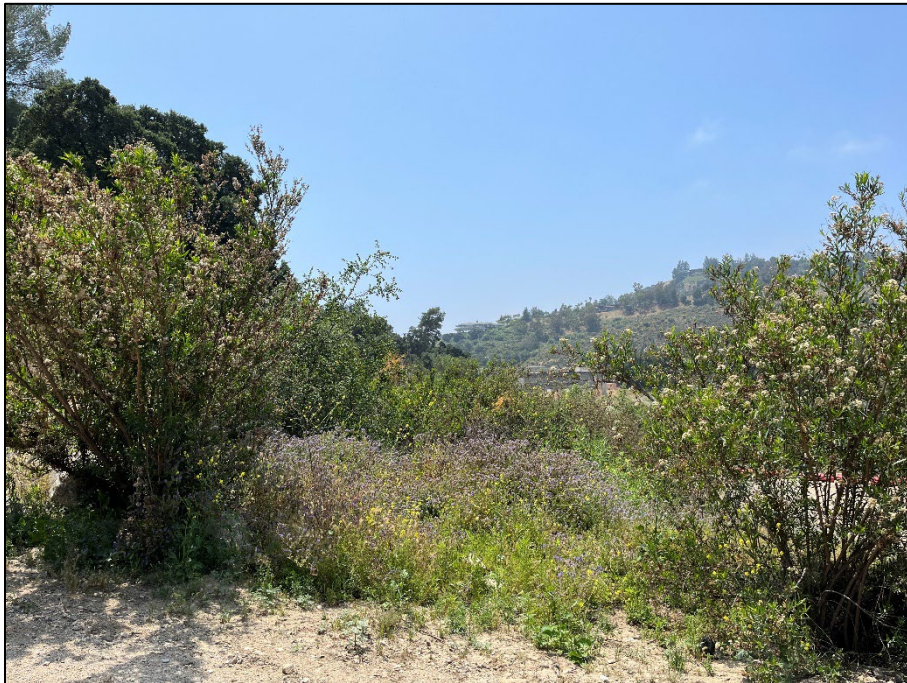
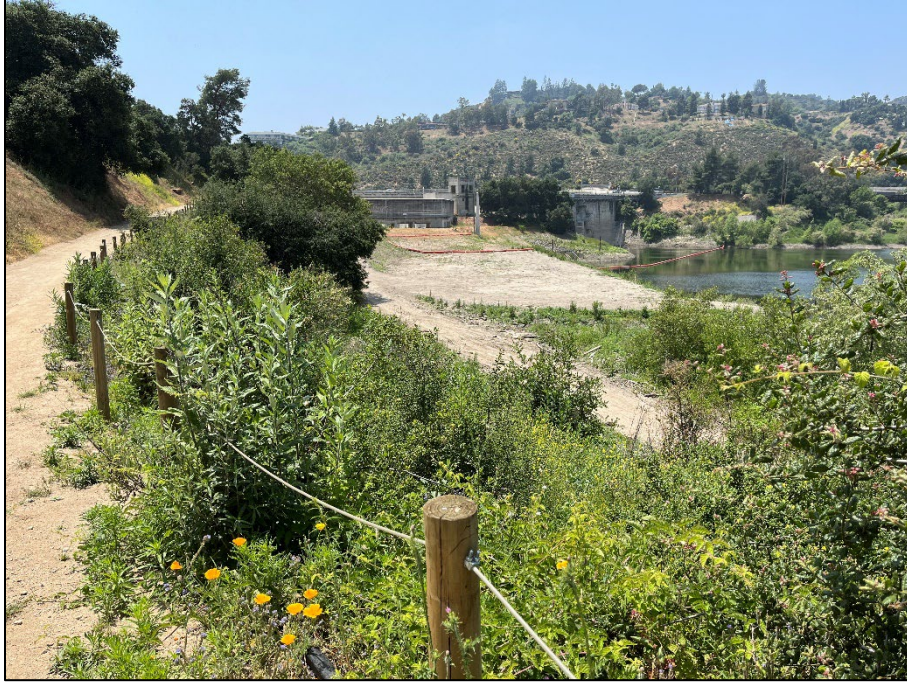
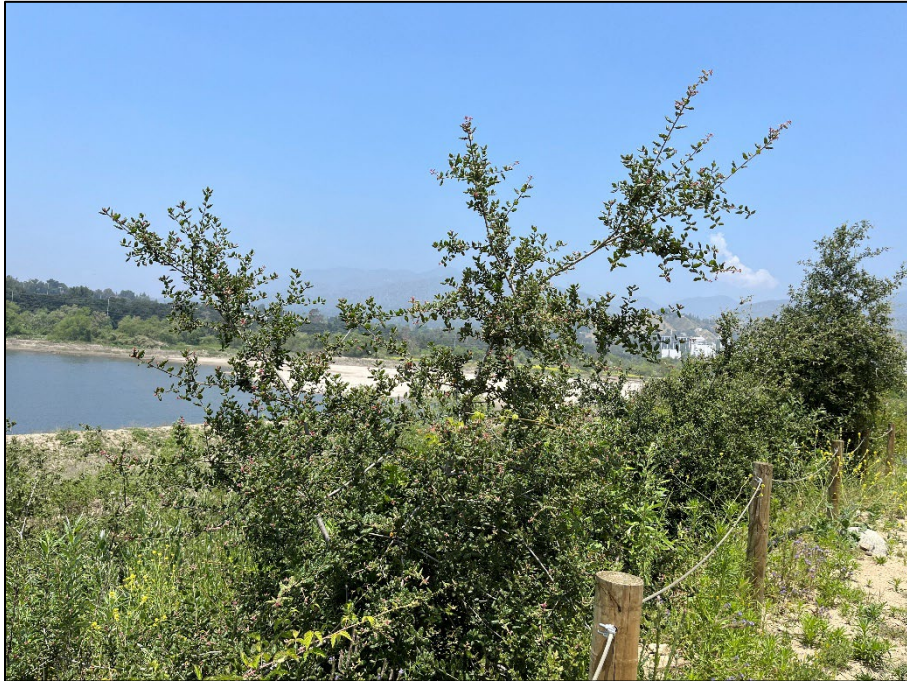
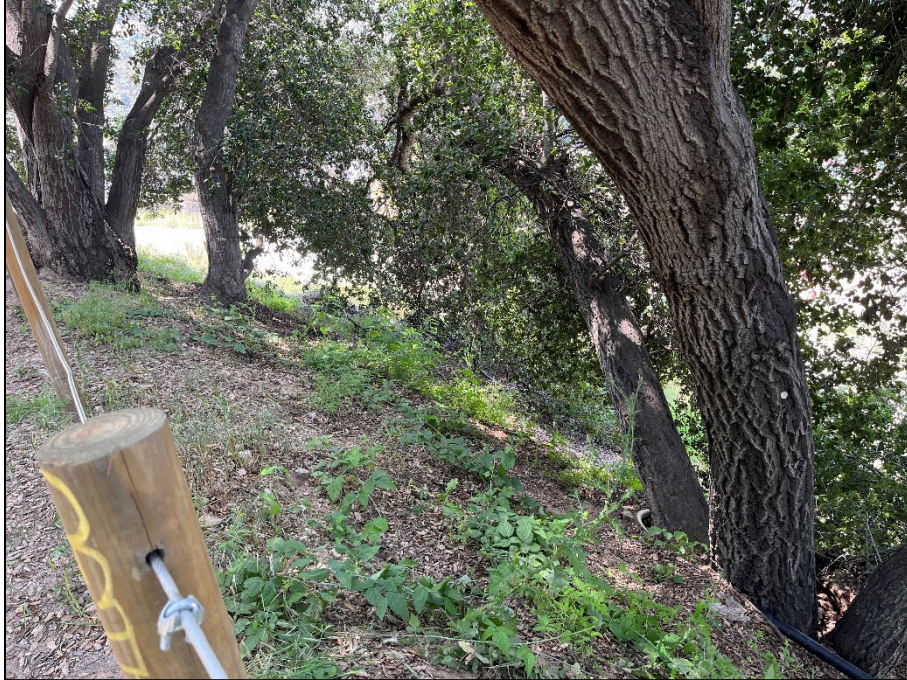
The overall health of the container plants in DG-3A was noted as being good. Approximately 10 percent of the container plants in the Coast Live Oak Woodland portions of DG-3A were noted as showing varied levels of stress, which is approximately the same percentage of container plants that were showing stress during the previous qualitative monitoring event. During the monitoring visit, the planted coast live oak acorns were inspected for survivorship and health. Approximately 20 germinated coast live oak acorns appear to still be present in DG-3A. The majority of the germinated acorns appear to be in good health. During the monitoring, it was noted that an existing coast live oak tree (Tree Tag #39) is continuing to experience branch failure for multiple branches. The cause of the branch failure was unclear.

Approximately five percent of the container plants in the Mulefat Thickets portions of DG-3A were noted as showing varied levels of stress, which is approximately 10 percent less than the percentage of container plants that were showing stress during the previous qualitative monitoring event. It should also be noted that many of the container plants and stakes installed near Altadena Drain were observed to be thriving. Formal mortality counts were taken for DG-3A during the 2020, 2021, and 2022 quantitative monitoring events. The types of stress the plants were exhibiting are the same as those described for the plants in DG-2A. However, erosion is also a problem in some areas of DG-3A. In addition, the Mulefat Thickets portions of DG-3A and the lower extent of the Coast Live Oak Woodland portions of DG-3A experienced approximately 16-days of inundation following heavy storm events in January 2023. Following the inundation, many portions of DG-3A had a high level of woody debris within the mitigation area. Most of the container plants and stakes appear to be recovering from the inundation. Some of the planting basins were observed to have varied levels of erosion and should be repaired. The willow and mulefat stakes were observed to be thriving in this mitigation area. The installation of the plants in the DG-3A mitigation area appears to have been completed successfully. The current issues noted during the monitoring are not expected to have an effect on the continued growth of the plants in the mitigation area. Photos 10 through 15 in Attachment B document the status of the mitigation area during the monitoring visit.

Native plant growth was noted throughout the DG-3A mitigation area, likely both from natural recruitment and from seeding. Native plants such as annual bursage, spencer primrose, cobweb thistle Jimson weed (*Datura wrightii*), Canada horseweed, California poppy (*Eschscholzia californica*), telegraph weed, common phacelia, Parry's phacelia (*Phacelia parryi*), and stinging nettle were observed sprouting in the DG-3A mitigation area. Native cover for the DG-3A mitigation area was estimated to be approximately 65 percent in the coast live oak woodland portion of the mitigation area and 80 percent in the mulefat thickets portion of the mitigation area.

Nonnative weed cover in DG-3A was estimated at approximately 15 percent, which is approximately 10 percent higher than the level of nonnative cover that was observed during the previous qualitative monitoring event. It should be noted that weed cover in this mitigation area during the spring of 2022 was approximately 10 to 15 percent and a higher level of weed cover is typical during the spring and summer months. Nonnative species observed in DG-3A included black mustard, Italian thistle (*Carduus pycnocephalus*), poison hemlock (*Conium maculatum*), perennial pepperweed, wild raddish (*Raphanus sativus*), and curly dock (*Rumex crispus*). Most nonnative weeds were just starting to germinate and had not gone to flower or seed.

Minor erosion to planting basins was observed throughout the Phase 1 mitigation areas. The severe erosion noted in DG-3A near Altadena Drain during previous monitoring visits was noted as showing signs of worsening from the recent heavy rainfall in the area. Due to the steepness of the slope in the Coast Live Oak Woodland portion of the DG-3A mitigation area, erosion will likely continue to be somewhat of an issue in this area; however, jute nettings are currently in place on the slope and will help to lessen the severity of erosion issues. As native cover increases in this area, erosion issues should lessen. The severity of the erosion should continue to be monitored in all planted areas and if warranted, erosion Best Management Practices (BMPs) should be installed in appropriate areas. This may only require the installation of straw wattles at select sites to prevent existing rills from becoming larger. However, until more native perennial plants become established in these areas, there is the potential that intense rainfall may create additional erosion problems.

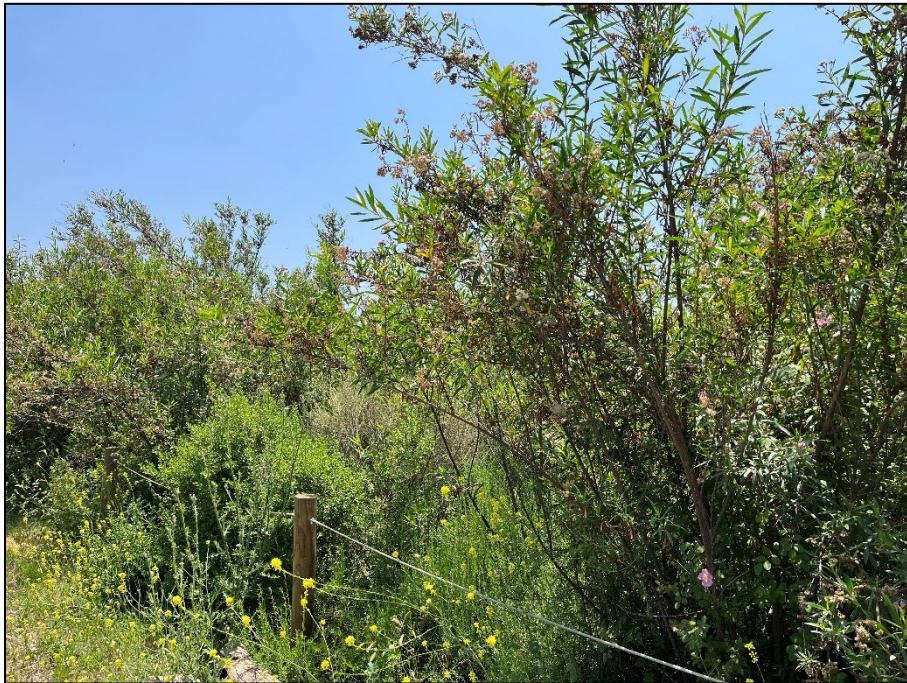
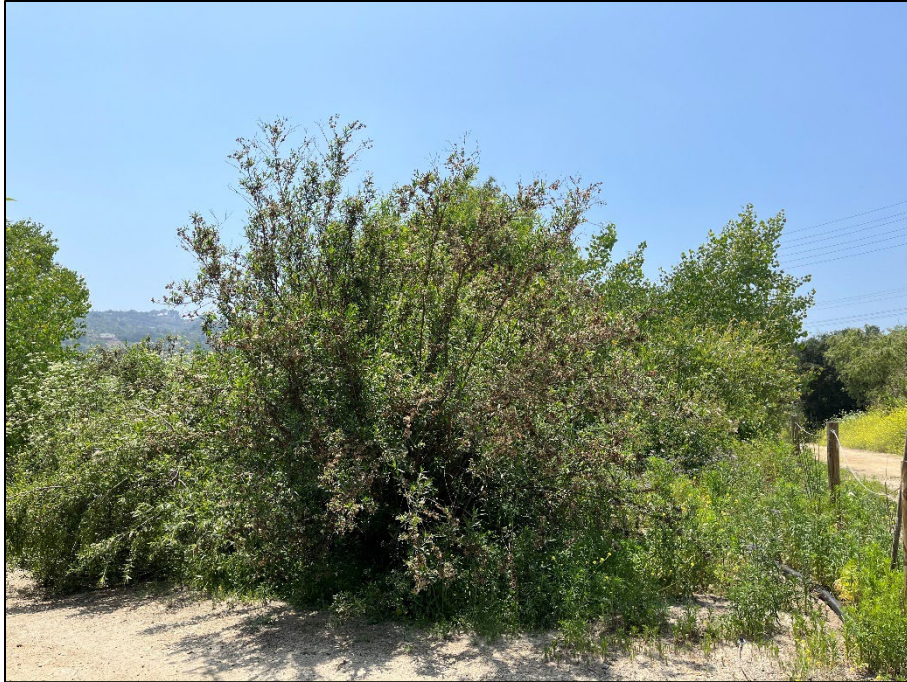
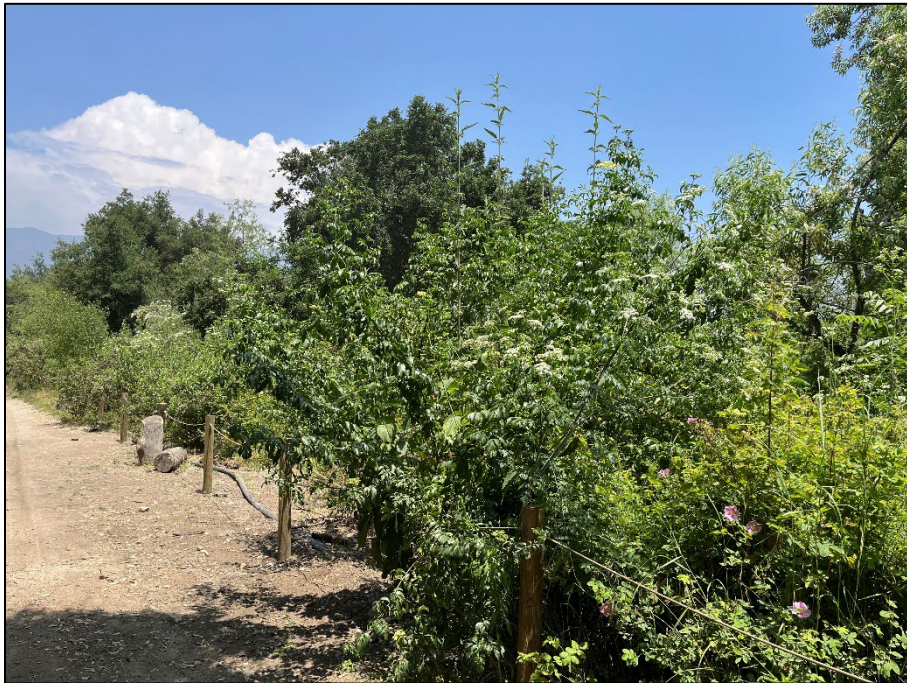
The overall health of the container plants in mitigation area DG-4 was noted as being good. Approximately five percent of container plants in the coastal sage scrub portions of DG-4 were showing varied levels of stress which is approximately the same percentage of plants showing stress during the previous qualitative monitoring event. Approximately 10 to 15 percent of container plants in most of the riparian portions of DG-4 were showing varied levels of stress, depending on the section of DG-4, which is approximately the same percentage of plants showing stress during the previous qualitative monitoring event. The causes of stress appear to be mostly due to the same reasons described in DG-2A. In addition, the southern portions of DG-4 experienced approximately 16-days of inundation following heavy storm events in January 2023 and some of the container plants in this area appear dead or in a condition unlikely to recover. For most portions of DG-4 that did not experience inundation, only a negligible number of container plants were noted as being missing or dead. Formal mortality counts were taken for DG-4 during the 2020, 2021, and 2022 quantitative monitoring events. Similar to DG-2A, the willows and Fremont's cottonwoods were no longer showing signs of seasonal dieback. Some of the planting basins were observed to have minor erosion and should be repaired. The installation of plants in the DG-4 mitigation area appears to have been completed successfully and the issues noted during the monitoring are not expected to have an impact on the continued growth of the plants. Photos 16 through 18 in Attachment B document the status of the mitigation area during the monitoring visit.

Native plant growth was noted throughout the DG-4 mitigation area, likely both from natural recruitment and from seeding. Native plants such as annual bursage, California sagebrush, mugwort (*Artemisia douglasiana*), mulefat (*Baccharis salicifolia*), Canada horseweed, California poppy, telegraph weed, wild cucumber (*Marah macrocarpa*), common phacelia, and stinging nettle were observed sprouting in the DG-4 mitigation area. Native cover for the DG-4 mitigation area was estimated to be approximately 70 to 80 percent in the riparian portion of the mitigation area and 70 percent in the coastal sage scrub portion.

Nonnative weed cover in DG-4 was estimated at approximately 25 percent, which is approximately 20 percent higher than the percentage of nonnative cover that was observed during the previous qualitative monitoring event. It should be noted that weed cover in this mitigation area during the spring of 2022 was approximately 20 to 50 percent, depending on the area, and a higher level of weed cover is typical during the spring and summer months. In addition, bird nests in DG-4 during the spring of 2022 and 2023 prevented crews from being able to conduct weed abatement activities in these areas. Nonnative species observed in DG-4 included tree of heaven (*Ailanthus altissima*), scarlet pimpernel, black mustard, poison hemlock, foxtail barley (*Hordeum murinum*), perennial pepperweed, and nonnative brome grasses (*Bromus* spp.). Nonnative weed cover, especially perennial pepperweed, is a significant problem in portions of the DG-4 mitigation area. Because perennial pepperweed can produce dense colonies through seed germination and underground rhizomes (rhizomatous roots), removal of this species without the use of systemic herbicide is very difficult. Some of the nonnative weeds in this mitigation area were starting to produce flowers and or seed and should be removed as soon as the bird nests in this area fledge or are determined to be inactive.

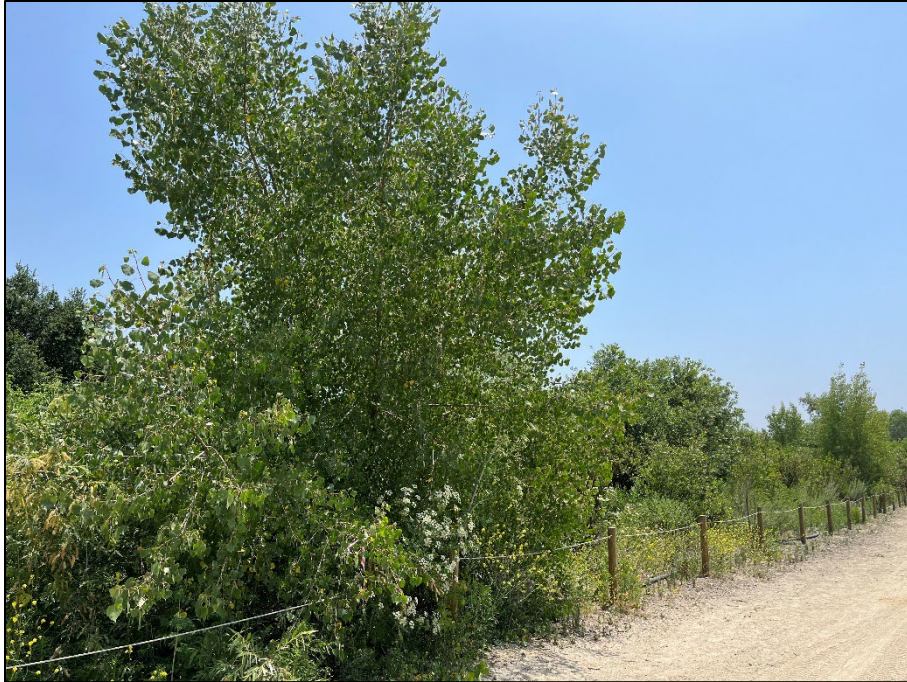
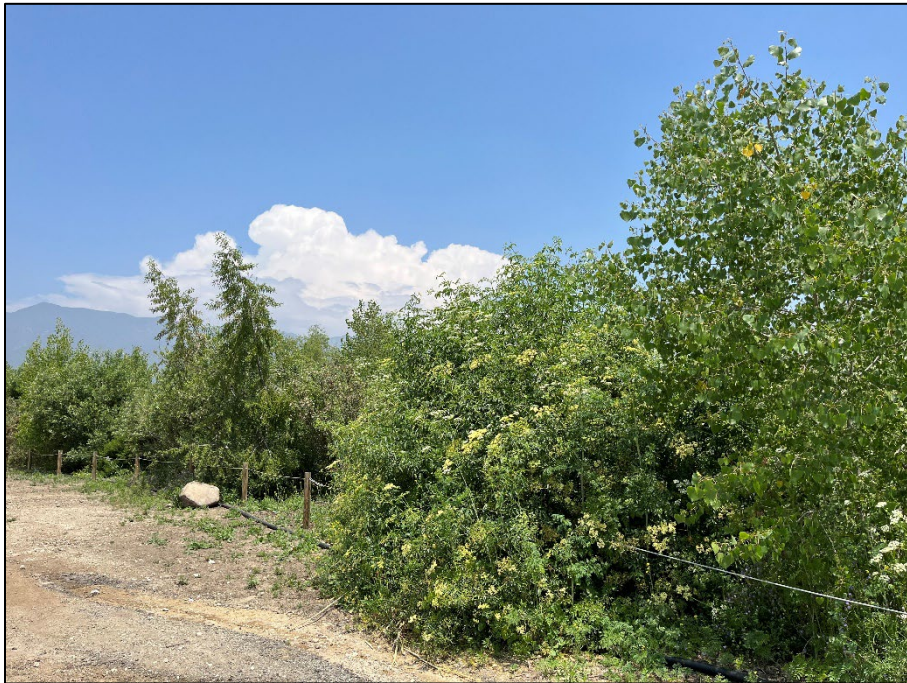
The overall health of the container plants in mitigation area DG-4B was noted as being good and this mitigation area is becoming well established. Approximately less than five percent of container plants were showing signs of drought stress which is approximately the same percentage of plants that were stressed during the previous qualitative monitoring event. The types of stress the plants were exhibiting are the same as those described for the plants in DG-2A. A negligible number of container plants were noted as being missing or dead. Formal mortality counts were taken for DG-4B during the 2020, 2021, and 2022 quantitative monitoring events. Some of the planting basins were observed to have minor erosion and should be repaired. The installation of plants in the DG-4B mitigation area appears to have been completed successfully and the issues noted during the monitoring are not expected to have an impact on the continued growth of the plants. Photos 19 and 20 in Attachment B document the current status of the mitigation area during the monitoring visit.

Native plant growth was noted throughout the DG-4B mitigation area, likely both from natural recruitment and from seeding. Native plants such as mugwort, spencer primrose, cobweb thistle, Canada horseweed, telegraph weed, and common phacelia were observed sprouting in the DG-4B mitigation area. Native cover for the DG-4B mitigation area was estimated to be approximately 85 percent.

Nonnative weed cover in DG-4B was estimated to be approximately 10 percent, which is approximately five percent higher than the percentage of nonnative cover that was observed during the previous qualitative monitoring event. It should be noted that weed cover in this mitigation area during the spring of 2022 was approximately 10 to 15 percent and a higher level of weed cover is typical during the spring and summer months. Nonnative species observed in DG-4B included black mustard, Italian thistle, poison hemlock, perennial pepperweed, and wild radish. Most nonnative weeds were just starting to germinate and had not gone to flower or seed.

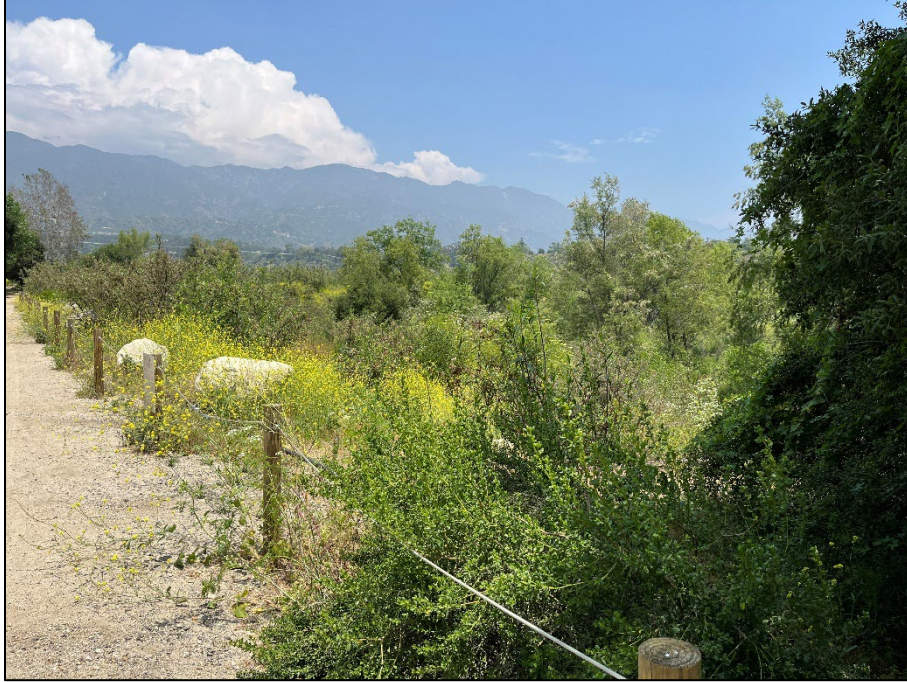
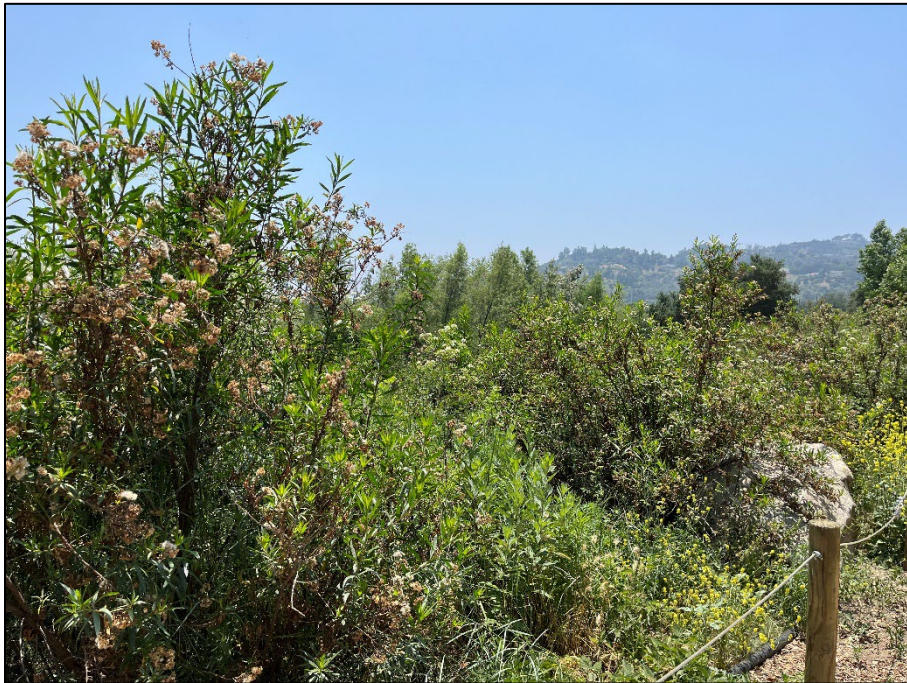
The overall health of the container plants in mitigation area DG-4C was noted as being good. Approximately five percent of all container plants were noted as showing minor levels of stress, which is approximately five percent less than the percentage of plants that were showing stress during the previous qualitative monitoring event. The types of stress the plants were exhibiting are the same as those described for the plants in DG-2A. A negligible number of container plants were noted as being missing or dead. Formal mortality counts were taken for DG-4C during the 2020, 2021, and 2022 quantitative monitoring events. Similar to DG-2A, most of the willows and Fremont's cottonwoods were no longer showing signs of seasonal dieback. Some of the planting basins were observed to have minor erosion and should be repaired. The installation of plants in the DG-4C mitigation area appears to have been completed successfully and the issues noted during the monitoring are not expected to have an impact on the continued growth of the plants. Photos 21 and 22 in Attachment B document the status of the mitigation area during the monitoring visit.

Native plant growth was noted throughout the DG-4C mitigation area, likely both from natural recruitment and from seeding. Native plants such as annual bursage, mugwort, spencer primrose, Canada horseweed, telegraph weed, and common phacelia were observed sprouting in the DG-4C mitigation area. Native cover for the DG-4C mitigation area was estimated to be approximately 70 percent.

Nonnative weed cover in DG-4C was estimated at approximately 30 percent, which is approximately 25 percent higher than the percentage of nonnative cover that was observed during the previous qualitative monitoring event. It should be noted that weed cover in this mitigation area during the spring of 2022 was approximately 15 to 20 percent. The increase in nonnative cover during the spring of 2023 in this mitigation area is likely due to the increase in precipitation during the 2023 wet season and a higher level of weed cover is typical during the spring and summer months. In addition, bird nests in DG-4C during the spring of 2023 have prevented crews from being able to conduct weed abatement activities in these areas. Nonnative species observed in DG-4C during the monitoring visit included black mustard, tocalote (*Centaurea melitensis*), poison hemlock, perennial pepperweed, and nonnative brome grasses. Some of the nonnative weeds in this mitigation area were starting to produce flowers and or seed and should be removed as soon as the bird nests in this area fledge or are determined to be inactive.

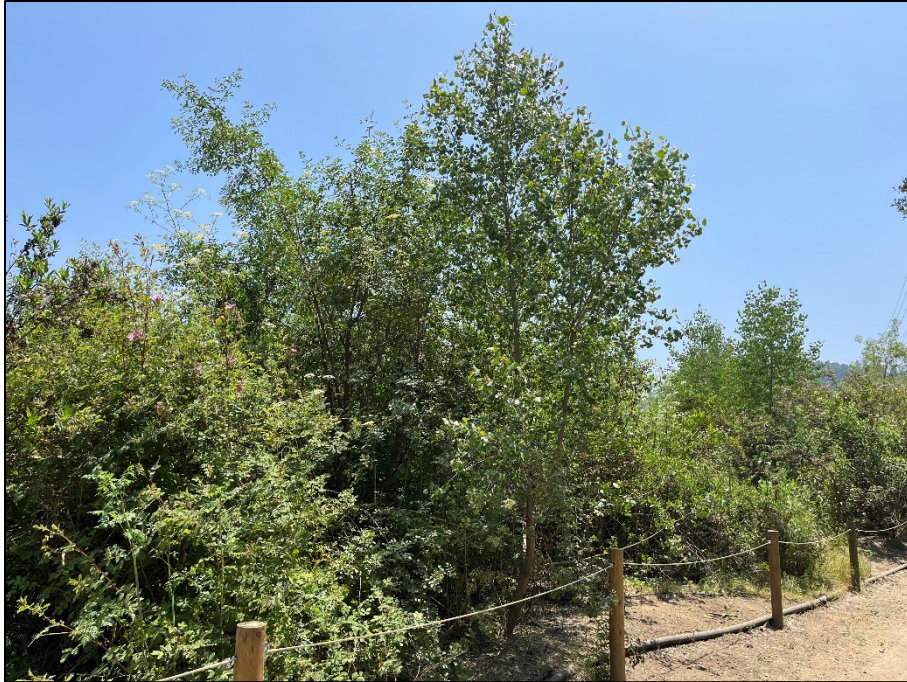
The overall health of the container plants in the DG-5 mitigation area was noted as being good. Approximately less than five percent of all container plants were noted as showing varied levels of stress, which is approximately the same as the percentage of plants that were showing stress during the previous qualitative monitoring event. Formal mortality counts were taken for DG-5 during the 2020, 2021, and 2022 quantitative monitoring events. Similar to DG-2A, most of the willows and Fremont's cottonwoods were no longer showing signs of seasonal dieback. Some of the planting basins were observed to have minor erosion and should be repaired. The installation of plants in the DG-5 mitigation area appears to have been completed successfully and the issues noted during the monitoring are not expected to have a negative impact on the continued growth of the plants. Photos 25 and 26 in Attachment B document the status of the mitigation area during the monitoring visit.

Native plant growth was noted throughout the DG-5 mitigation area, likely both from natural recruitment and from seeding. Native plants such as Canada horseweed, common phacelia, and stinging nettle were observed sprouting in the DG-5 mitigation area. Native cover for the DG-5 mitigation area was estimated to be approximately 85 percent and the site is thriving.

Nonnative weed cover in DG-5 was estimated at approximately 20 percent, which is approximately fifteen percent more than the percentage of nonnative weed cover that was observed during the previous qualitative monitoring event. It should be noted that weed cover in this mitigation area during the spring of 2022 was approximately 25 to 30 percent and a higher level of weed cover is typical during the spring and summer months. In addition, bird nests in DG-5 during the spring of 2022 and 2023 prevented crews from being able to conduct weed abatement activities in these areas. Nonnative species observed in DG-5 included black mustard, soft brome (*Bromus hordeaceus*), poison hemlock, and perennial pepperweed. Some of the nonnative weeds in this mitigation area were starting to produce flowers and or seed and should be removed as soon as the bird nests in this area fledge or are determined to be inactive.
